**THE RADAR STATION, DIRLETON, EAST  
LOTHIAN: BUILDING SURVEY**

*by Dr T G Holden*

*October 2001*

*Client: Mr Howard Wallace*

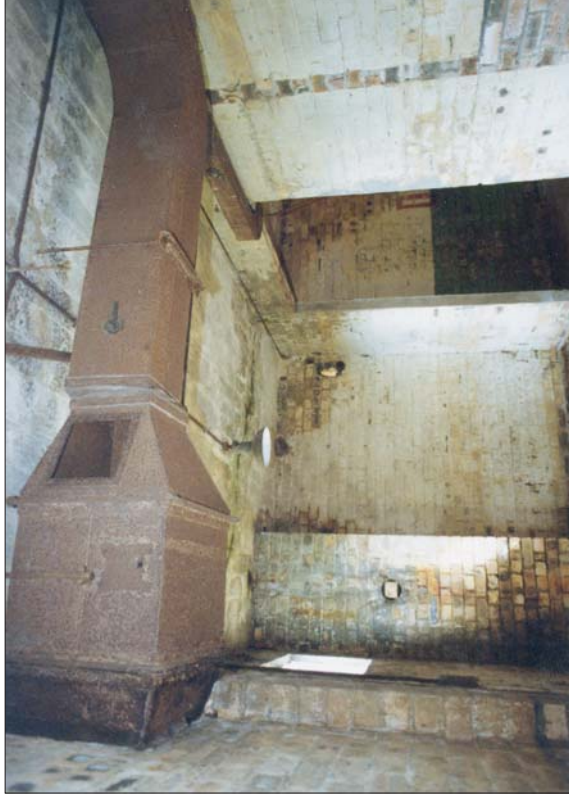
Plate 11 - Part of the air filtration system (TJ)

Within the air filtration room, the stance for the ventilator machinery with vents both to the roof and through the west wall could be seen (Plate 11). This apparently also fed into the main operations room via an opening at ground level and at first floor level via a large square opening in the centre of the south wall (Plate 14). While the full function of this ventilation system is uncertain it is possible that it was designed to provide a slight positive pressure within the building in the event of a gas attack (Ian Brown, pers. comm.).

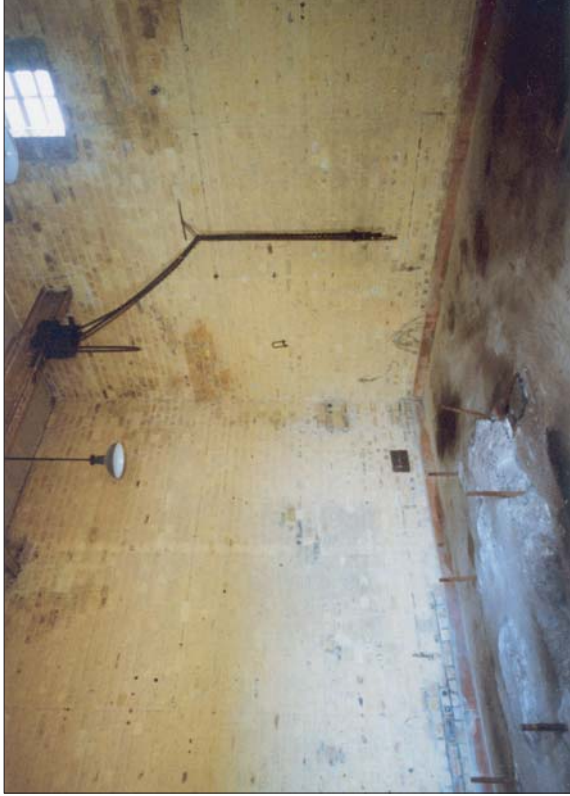
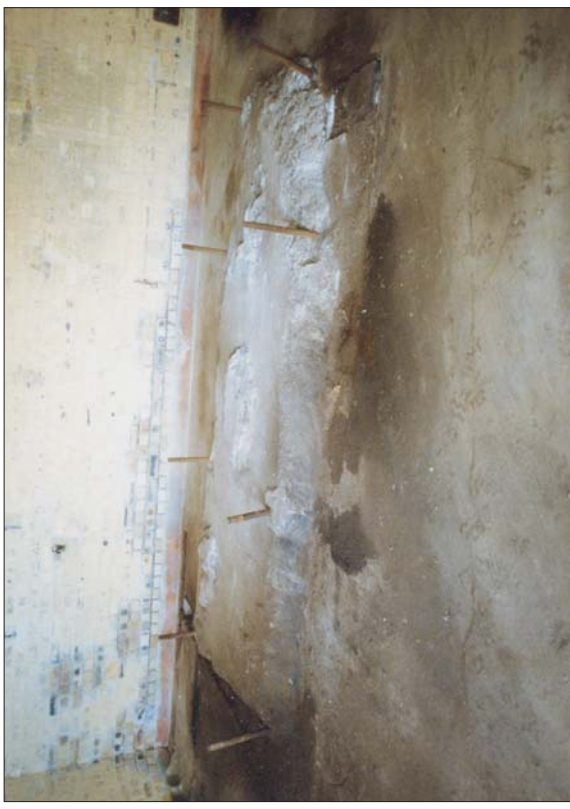
The generator house comprised a large single storey room with annex to the north and walled courtyard to the west. No features relating to the function of the building survive but earlier photos (Plates 15 & 16) indicate the form of the generator stance and the block and tackle in the ceiling for manoeuvring this into place.

Plate 15 - The interior of the generator house (TJ)

Plate 16 - The interior of the generator house (TJ)

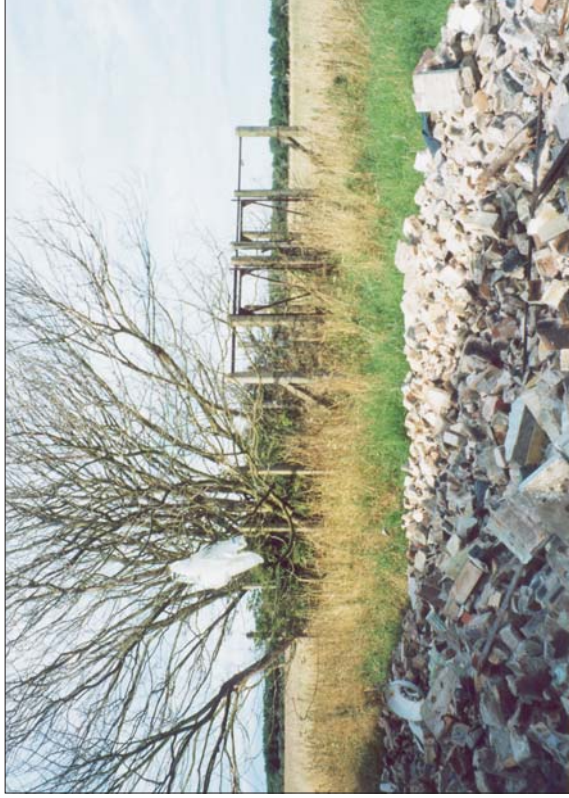
Plate 27 - The guard dog enclosure from the southwest

To the east of the main operations room the remains of a dog enclosure 7 m x 8.5 m was surveyed. This comprised a concrete slab around which were set concrete posts supporting the wire fence. Entry to the enclosure was via a set of double gates at the south end.
