**Ardvorlich Estate
Hydro Scheme**

**Report on
Archaeological Work
Desk Study, Survey, Standing Building
Recording and Watching Briefs**

**Ardvorlich Estate and
Hydroplan UK**

February 2011

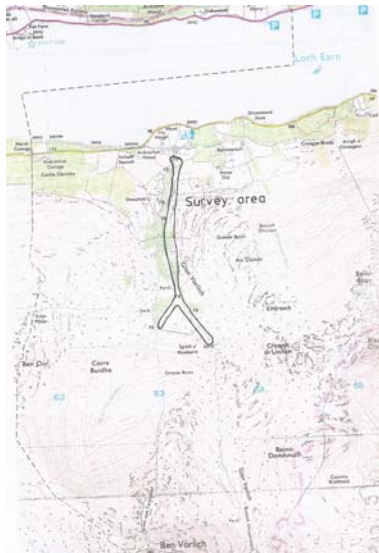
Figure 3: Location Map from OS Explorer 368 (© Crown copyright 2007. All rights reserved. Licence number 10044103)

The area is situated on the South shore of Loch Earn on the lower slopes of Ben Vorlich, within the Loch Lomond and Trossachs National Park. The survey area consists of a strip of land, 50m either side of the proposed pipeline along the East bank of the Ardvorlich Burn, from the proposed powerhouse at NN 6322 2287 to Intakes 3 and 4, just below the confluence of the Ardvorlich Burn and its tributary, Allt a' Choire Bhuidhe. Further pipelines extend along the SE bank of the Allt a' Choire Bhuidhe to Intake 5 at NN 6301 2118 and along the SW bank of the Ardvorlich Burn to Intake 6 at NN 6362 2100. A 100m radius around the powerhouse and a 50m radius around the intakes were also investigated.

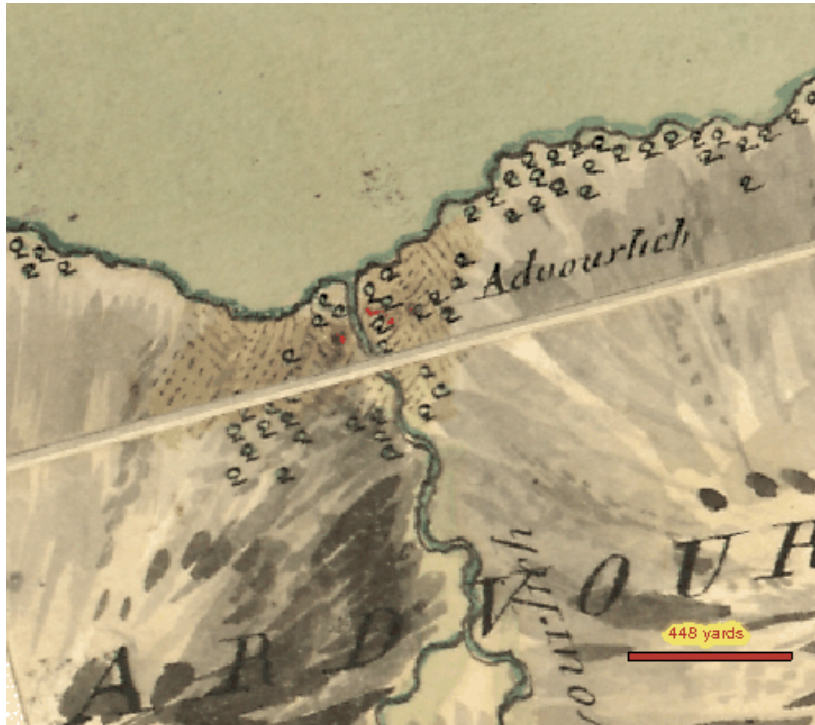
Figure 4: Extract from Roy's Military Survey of Scotland, 1747-55 (National Library of Scotland)

These summer grazings may well have been the shieling site, **Site 2**, at the confluence of the Ardvorlich Burn and the Allt a' Choire Bhuidhe. This shieling site was presumably associated with permanent dwellings around the foot of Ardvorlich Burn. Roy's map, dated 1747-55, shows a cluster of buildings at "Advourlich" on either side of the burn, surrounded by arable ground, near the shore of Loch Earn.

A farmstead consisting of two buildings, possibly a house and byre or barn, is situated in the field above and to the South of the Ardvorlich farm buildings, **Site 23**. The farmstead may have been part of the 18th century settlement depicted on Roy's map of 1747-55. (See Fig. 2) One roofless building, probably **Site 21a**, was depicted on the OS 1st Ed. 6 map (See Fig. 4), which suggests that it was abandoned up to around 25 years before 1861.

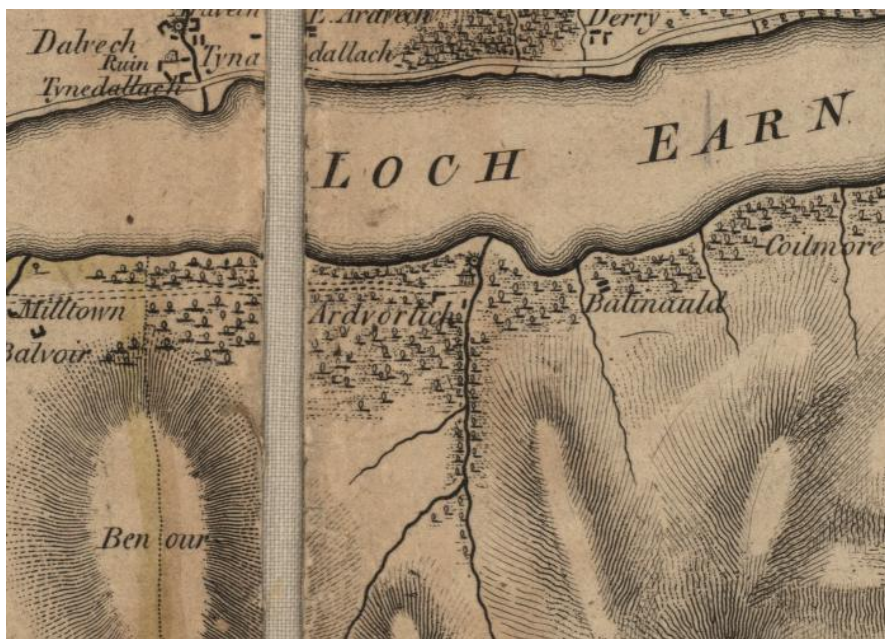
Figure 5: Extract from James Stobie: The Counties of Perth and Clackmannan, 1783 (National Library of Scotland)

The mansion house is clearly marked on James Stobie's plan of 1783, but the ancillary buildings are also on the West side as well as a mill downstream from Ardvorlich House.

The area within the head dyke, **Site 7**, is an old wood pasture, featuring several pollarded trees. (See Fig. 5) A number of cairns of cleared stone suggest that some areas may have been cleared for the purpose of cultivation on the moderately-sloping ground, though no evidence of rig and furrow was visible on the ground or from the air. Clearance cairns may be found throughout this area but the following were recorded adjacent to the proposed pipeline:

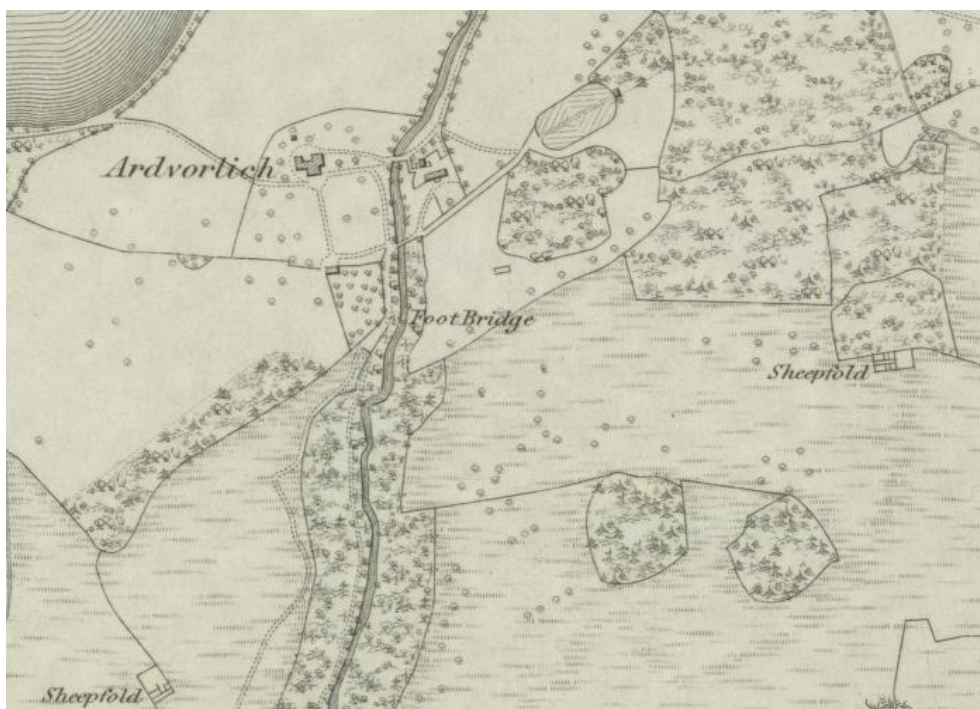
Figure 6: Extract from OS 1st Ed. 6" map Perthshire xciii, surv. 1861, publ. 1867.

By 1861, the farm steading had been constructed on the east bank of the burn along with a walled garden but a previously unrecorded building within the survey area, **Site 21**, was already roofless and abandoned (OS 1st Ed. 1867).

A narrow strip of ground along the East bank of the Ardvorlich Burn was enclosed some time before 1861, for the protection of woodland, probably the Scots Pines, which are extant today (See Fig. 4). The enclosure is defined by a wall of roughly piled up stones, 1.20m in width and 0.50m in height. A new deer fence encloses much of this area for a woodland grant scheme. An old track, **Site 17**, flanks the East side of the enclosure at its northern end.

pre-dates both enclosures, which have incorporated it. (See Fig. 4) The bank, consisting of stones roughly piled up rather than coursed, is cut by a drain at NN 6331 2263.

A well-built and well-preserved wall encloses a large field to the South of the Ardvorlich farm buildings, **Site 23**. It was constructed some time before 1861. (See Fig. 4) It consists of coursed drystone masonry with a coping layer, topped with an iron post-and-wire fence. It has a slight batter, tapering from a width of 0.70m at the base to 0.50m at the top. The drain, **Site 19**, flows under it in a culvert. The proposed pipeline will cross the wall to the West of a gateway at NN 6327 2277.

An enclosure containing woodland is depicted on the OS 1st Ed 6" map, in the field to the South of the farm buildings, **Site 23**. (See Fig. 4) There is now no trace of any enclosure; it may have been a fence, which was removed once the trees were mature. A stand of Scots Pines still occupies this knoll.

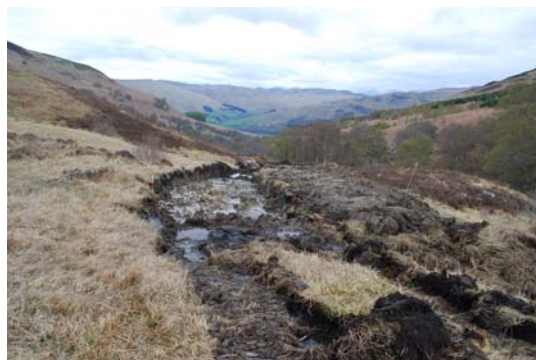
A well-built but dilapidated wall runs to the SE from the Allt a' Choire Bhuidhe, near the foot bridge, to NN 6333 2109, where it turns to the NE towards the Ardvorlich Burn. It may have been designed to mark the limit of the shieling ground, **Site 2**, though several structures, **Sites 2.23 – 2.25**, lie beyond it, to the SE. It consists of coursed masonry and turf, 1m in width and 0.70m in height, and is crossed by the track, **Site 4** at NN 63409 21137.

Cutting of dyke Site 1 by the upgrading track Site 4. View to the N.

Actual Impact and Mitigation: The dyke was cut by the pipe route for a distance of 2m to the W of the existing track due to deep peat up to 3m deep making it impossible to lay the pipe on the line of the existing track Site 4 where it crosses the dyke. The 2m long section of dyke was removed under watching brief conditions and a plank lined stone filled field drain was located along side the dyke.

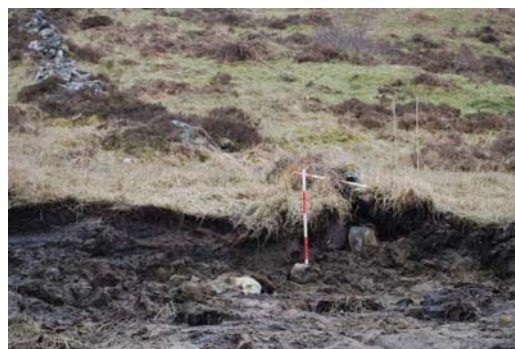
Machine cut section through dyke, Site 1, view to the W.

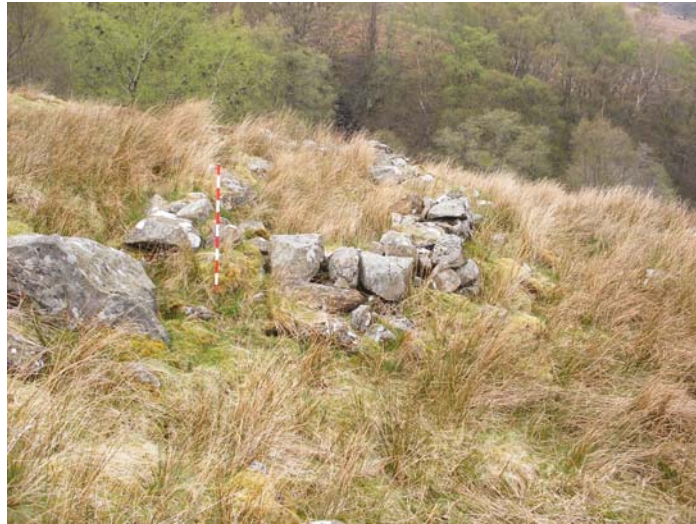
A relatively large rectangular structure, 8.8m E-W by 3.5m, is situated at the SW side of the shieling settlement. It is defined in the North side by a well-built double-faced wall with rubble fill, 0.75m in width and 0.75m in height, and elsewhere by roughly piled up boulders. A well-defined entrance opens in the North side.

Shieling hut Site 2.1 view to the W.

Actual Impact and Mitigation: The site was avoided by the development and remains undisturbed.

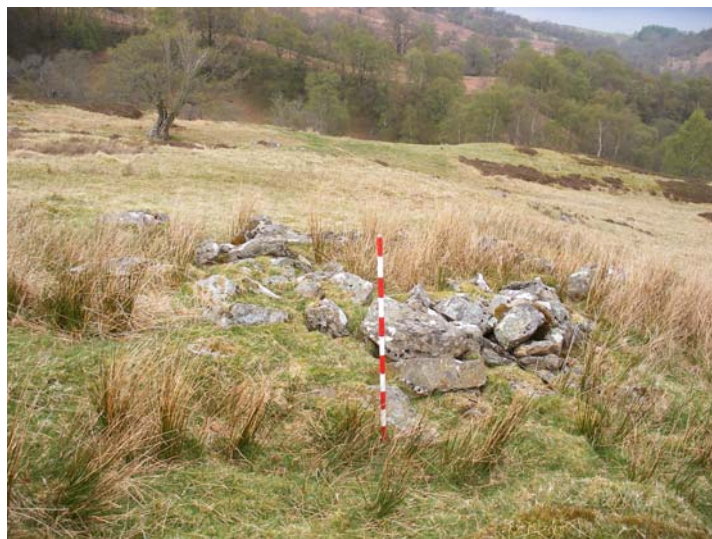
A dilapidated structure, 5.5m N-S by 4m, is one of a cluster of three huts, **Sites 2.2 – 2.4**, situated on a small knoll. It is defined by a wall, 0.80m in width and 0.40m in height.

Shieling hut Site 2.2, view to the NW.

Actual Impact and Mitigation: The site was avoided by the development and remains undisturbed.

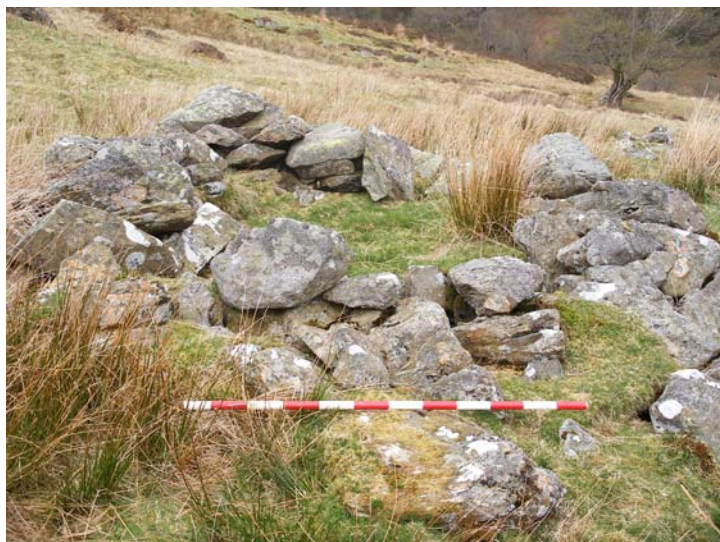
A small structure, 4m E-W by 2.70m, is one of a cluster of three huts, **Sites 2.2 – 2.4**, situated on a small knoll. It is defined by a wall, 0.70m in width and 0.90m in height.

Shieling hut Site 2.3, view to the W.

Actual Impact and Mitigation: The site was avoided by the development and remains undisturbed.

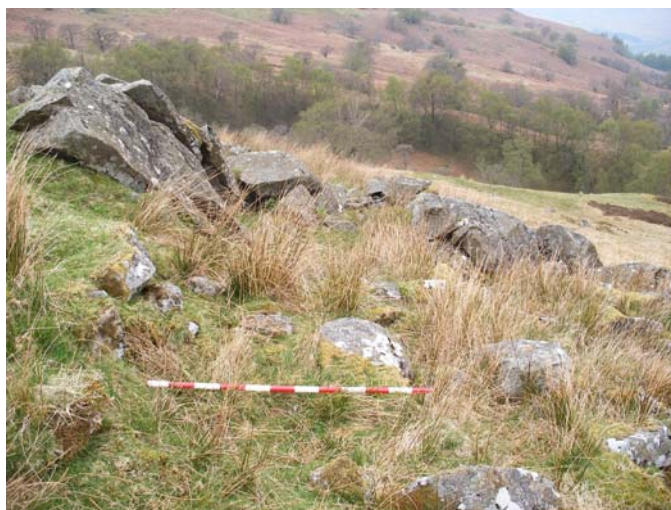
A structure, 9m E-W by 2.5m (internally), is one of a cluster of three huts, **Sites 2.2 – 2.4**, situated on a small knoll. It is defined by a roughly coursed drystone wall, abutting a natural outcrop on the South side and a large boulder on the north.

Shieling hut Site 2.4, view to the W.

Actual Impact and Mitigation: The site was avoided by the development and remains undisturbed.

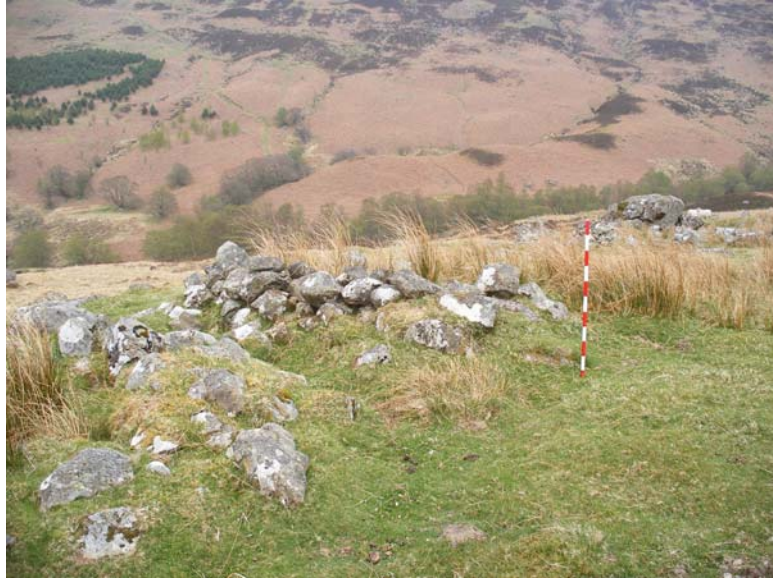
A relatively large rectangular structure, 8m E-W by 3.5m, is one of a group of three huts, **Sites 2.5 – 2.7**, situated at the South end of the shieling ground. It is defined by a wall, 0.80m in width and 0.40m in height. An annexe, 4m by 3m, abuts the western end.

Shieling hut Site 2.5, view to the NE.

Actual Impact and Mitigation: The site was avoided by the development and remains undisturbed.

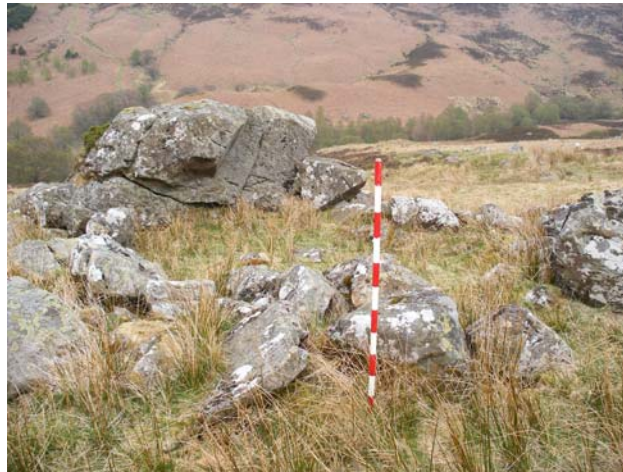
A structure, 8m E-W by 6m, is one of a group of three huts, **Sites 2.5 - 2.7**, situated at the South end of the shieling ground. It is defined by a wall, 0.80m in width and 0.40m in height, and abuts a large boulder.

Shieling hut Site 2.6, view to the NE.

Actual Impact and Mitigation: The site was avoided by the development and remains undisturbed.

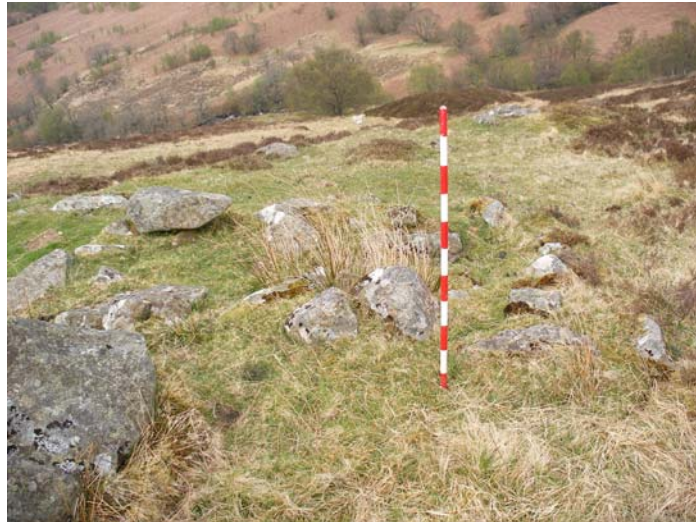
A small structure, 3m E-W by 1.5m, is one of a group of three huts, **Sites 2.5 – 2.7**, situated at the South end of the shieling ground. It is defined by a wall, 0.70m in width and 0.30m in height.

Shieling hut Site 2.7, view to the N.

Actual Impact and Mitigation: The site was avoided by the development and remains undisturbed.

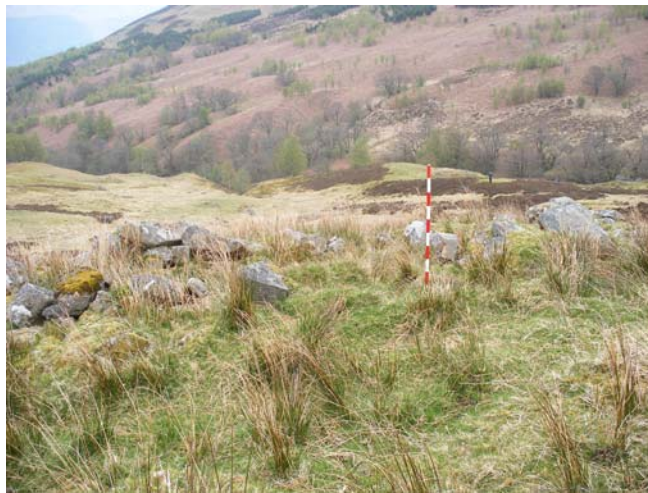
A well-defined rectangular structure, 7.70m E-W by 4.10m, is situated on a small knoll, on the East bank of the Allt a' Choire Bhuidhe. It is defined by a wall of coursed drystone masonry on the South side and of roughly piled up boulders elsewhere. A well-defined entrance opens in the North side.

Shieling hut Site 2.8, view to the NE.

Actual Impact and Mitigation: The site was avoided by the development and remains undisturbed.

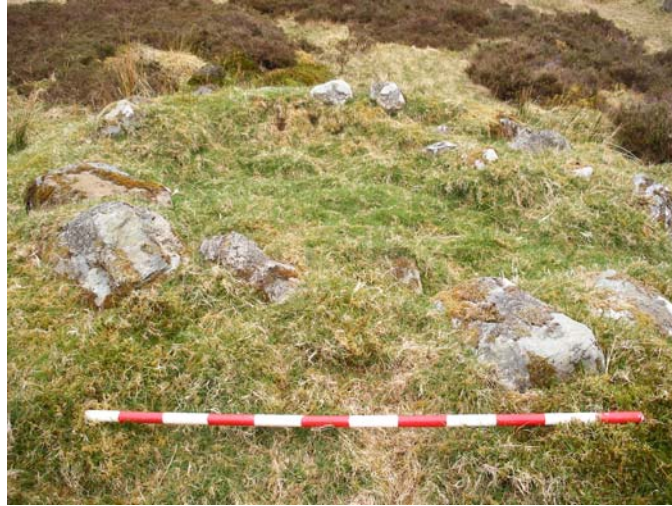
A small circular structure, 3m in diameter, is defined by a wall, 0.60m in width and 0.40m in height.

Shieling hut Site 2.9, view to the WSW.

Actual Impact and Mitigation: The site was avoided by the development and remains undisturbed.

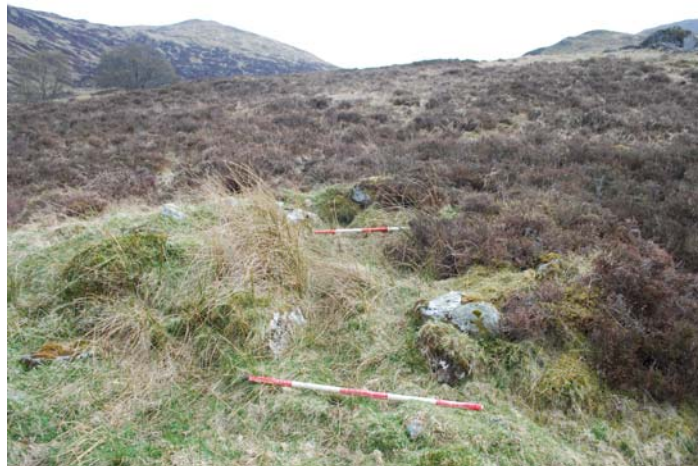
A small circular structure, 3m in diameter, consists of a roughly built wall of piled up stones, 0.70m in width and 0.40m in height.

Shieling hut Site 2.10, view to the S.

Actual Impact and Mitigation: The site was avoided by the development and remains undisturbed.

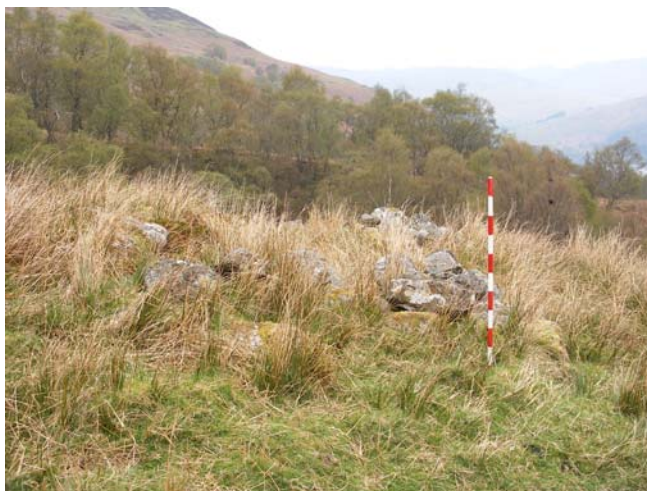
A long narrow, rectangular structure, 8.50m N-S by 3.70m, is situated on the West side of the shieling ground. It consists of a wall of roughly piled up stones, 1m in width and 0.60m in height.

Shieling hut Site 2.11, view to the N.

Actual Impact and Mitigation: The site was avoided by the development and remains undisturbed.

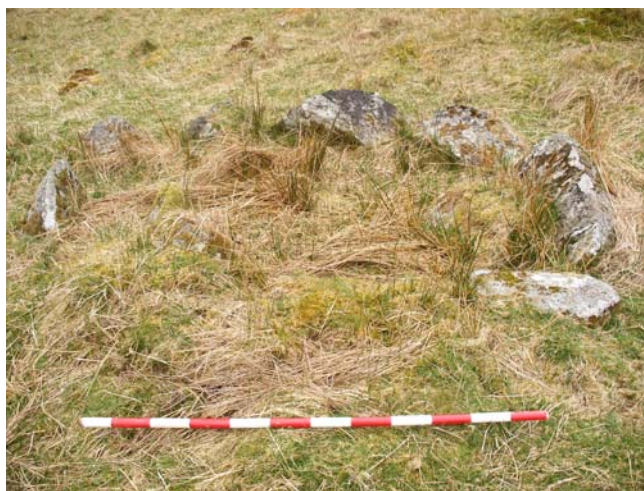
A sub-circular stone setting, 2.80m N-S by 2.50m externally and 1.50m by 1.20m internally, is situated on the West side of the shieling ground. The perimeter is defined by single boulders.

Shieling hut / stone setting Site 2.12, view to the S.

Actual Impact and Mitigation: The site was avoided by the development and remains undisturbed.

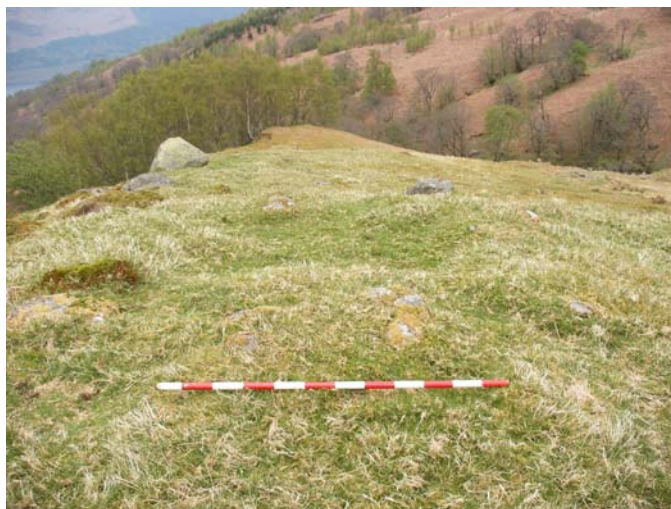
A small structure, 4.90m N-S by 3.30m, is situated on a level spur to the South of a cluster of shieling huts, **Sites 2.14 – 2.16**. It is defined by a low turf bank, 0.60m in width and 0.20m in height, from which occasional stones protrude.

Shieling hut Site 2.13, view to the N.

Actual Impact and Mitigation: The site was avoided by the development and remains undisturbed.

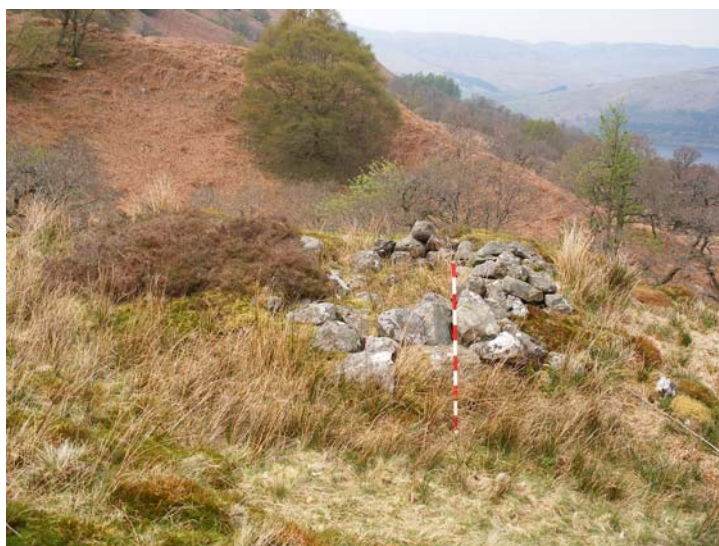
A small dilapidated rectangular structure, 5.20m N-S and 3.70m, is the westernmost of a group of three shieling huts, **Sites 2.14 – 2.16**, on a natural terrace at the North end of the shieling ground. It is defined by up to three courses of roughly coursed stone, 0.80m in width and 0.70m in height. The SW part is infilled with stone and overgrown with heather. The E side wall appears to have been remodelled more recently, perhaps for use as a shooting butt.

Shieling hut Site 2.14, view to the N.

Actual Impact and Mitigation: The site was avoided by the development and remains undisturbed.

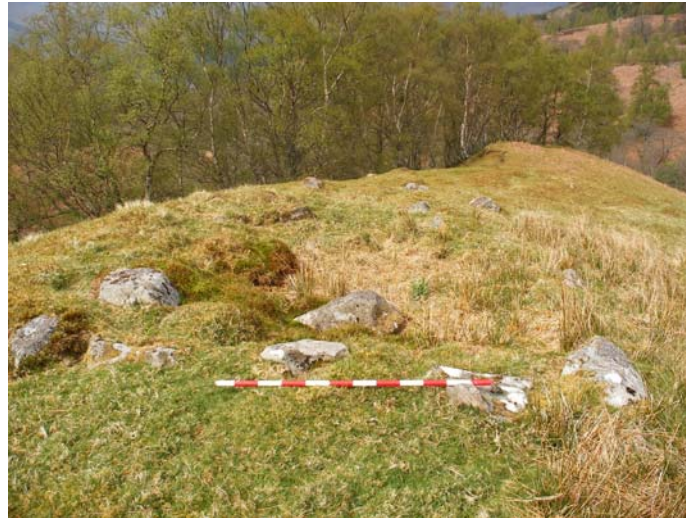
A round-angled rectangular structure, 6.50m N-S by 4.20m, is the central of a group of three shieling huts, **Sites 2.14 – 2.16**, on a natural terrace at the North end of the shieling ground. It is defined by a low earth and stone bank, 0.90m in width and 0.30m in height.

Shieling hut Site 2.15, view to the N.

Actual Impact and Mitigation: The site was avoided by the development and remains undisturbed.

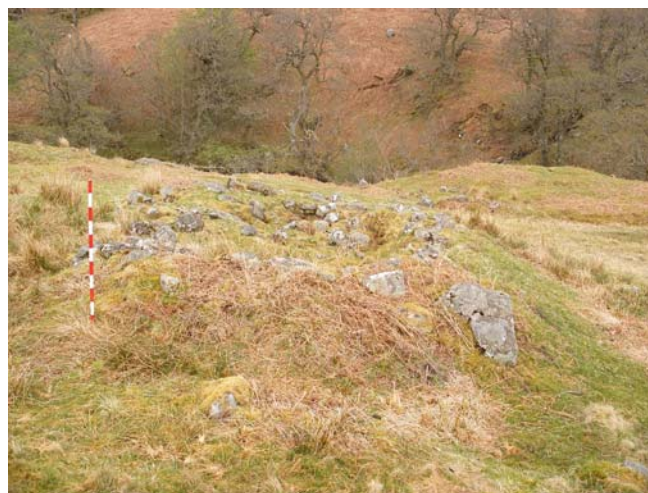
A round-angled rectangular structure, 8.20m N-S by 3.90m, is the easternmost of a group of three shieling huts, **Sites 2.14 – 2.16**, on a natural terrace at the North end of the shieling ground. The South side consists of an earthen bank, faced with stones internally; elsewhere it is defined by a wall of piled up stones, 1m in width and 0.70m in height. A well-defined entrance opens in the North side. The structure is situated just to the West of the proposed pipeline.

Shieling hut Site 2.16, view to the E.

Actual Impact and Mitigation: The site was avoided by the development and remains undisturbed.

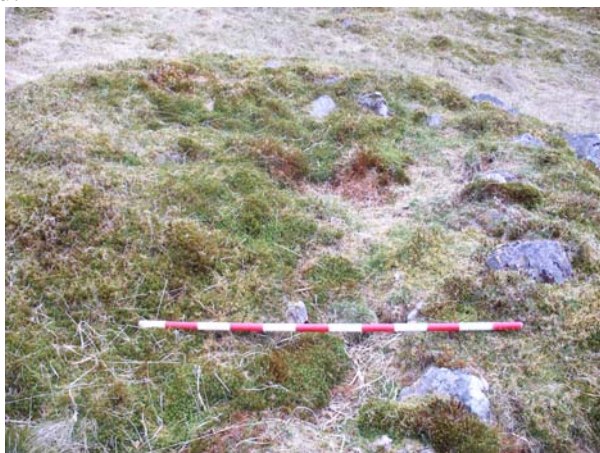
is well defined. The entrance is located on the E side where there are also the possible remains of a smaller 2.5m diameter circular structure, possibly an earlier much denuded shieling hut.

Shieling hut Site 2.17.

Actual Impact and Mitigation: The site was avoided by the development and remains undisturbed.

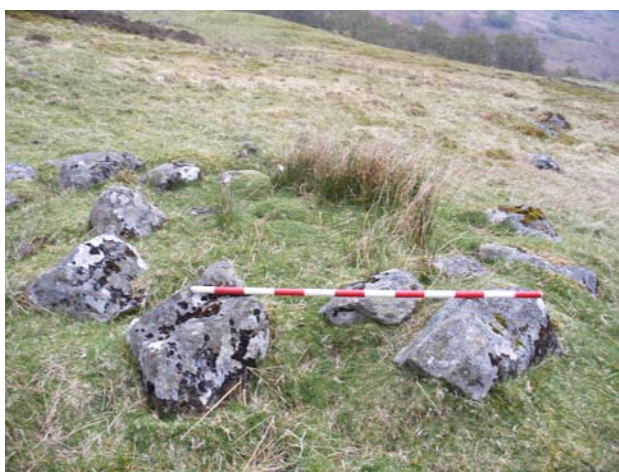
A stone setting, 4m NE-SW by 3m and sub-oval in plan is situated on the North side of the shieling ground. This dilapidated and collapsed structure stands to a maximum height of 0.40m and the stone and turf walls are 0.60m thick. There is a possible platform extending for 3m on the NE side which, although a raised area is lumpy ground. This bumpy ground, which is also present to a lesser extent on the S side, suggests collapsed material.

Shieling hut Site 2.18, view to the NW.

Actual Impact and Mitigation: Watching brief maintained during excavation of the pipe route. The site was avoided and is undisturbed.

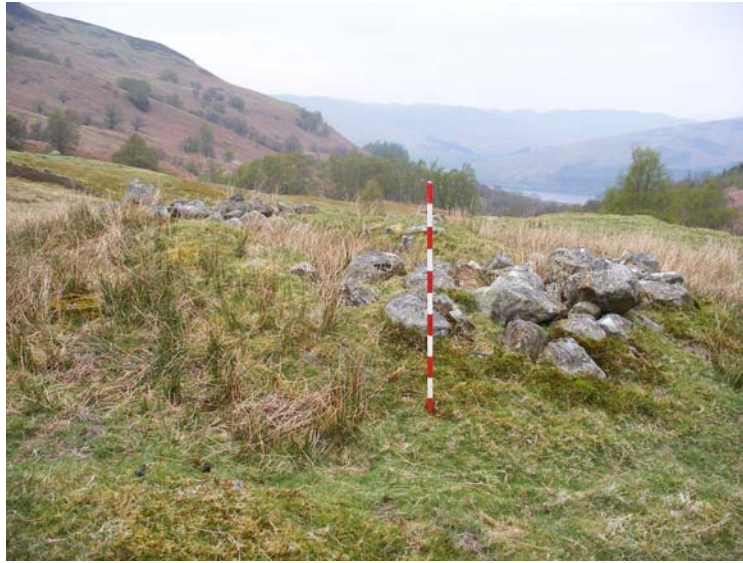
A round-angled rectangular structure, 7m NW-SE by 4.50m, is situated very close to the eastern pipeline. It is defined by a stone wall, 0.70m in width and 0.50m in height. A pile of stones at the NW end may be the remains of another compartment.

Shieling hut Site 2.19, view to the NW.

Actual Impact and Mitigation: The site was avoided by the development and remains undisturbed.

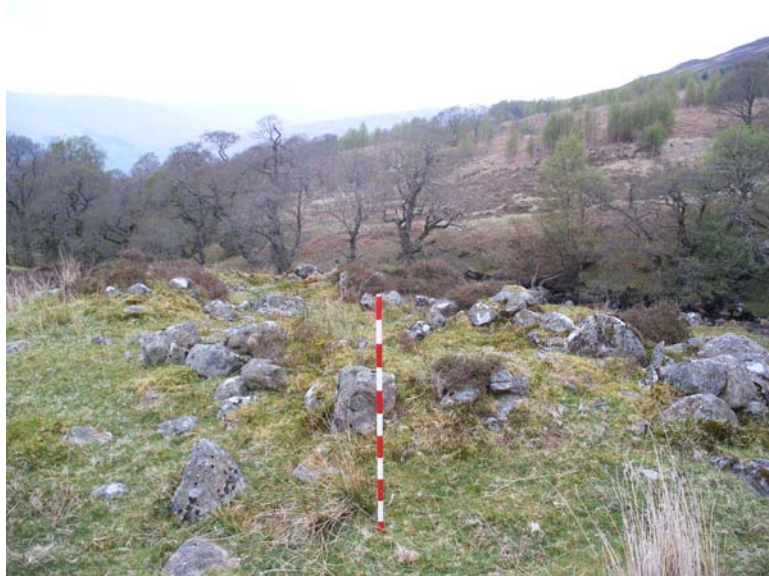
A substantial round-angled rectangular structure, 9m N-S by 4m, is situated immediately East of the track, **Site 4**, and West of the proposed eastern pipeline. It is defined by a stone wall, 0.80m in width and 0.50m in height.

Shieling hut Site 2.20, view to the NE.

Actual Impact and Mitigation: Watching brief maintained during excavation of the track **Site 4** which was upgraded in this area. The site was avoided and is undisturbed.

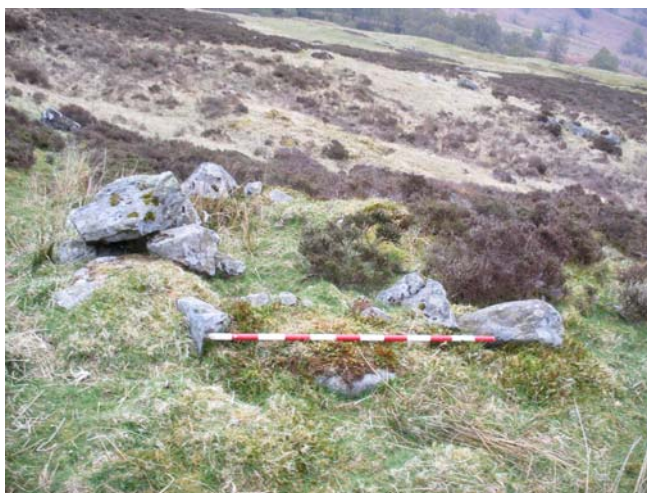
Two structures, a sub-rectangular turf and stone building measuring 7.50m NNW – SSE x 4m and at 336° and a smaller sub-circular structure at its S end. The larger building is up to 0.7m high and the walls are slumped to a width of 1m. The visible interior space is quite narrow and only 1.4m wide. The smaller circular structure at the S end is c. 4m diameter and is separated from the larger structure, which is probably the earlier of the two, by a 0.60m wide gap. The track **Site 4** runs along the W side of this site.

Shieling hut Site 2.21, view to the W.

Actual Impact and Mitigation: Watching brief maintained during excavation of the track **Site 4** which was upgraded in this area. The site was avoided and is undisturbed.

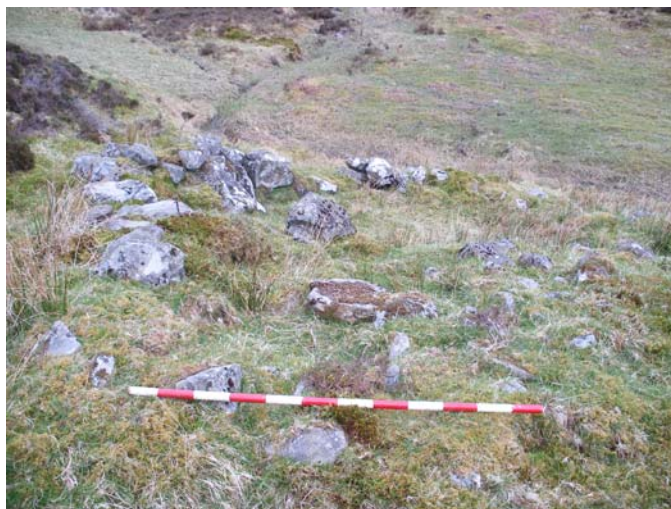
A shieling hut measuring c. 7m x 6m and aligned WNW-ESE at 298° is located approximately 5m to the west of the established track. The site consists of two buildings, a sub-rectangular / sub-oval foundation of stone boulders and turf measuring 0.70m wide and standing up to 0.6m high and a smaller circular foundation 3m in diameter at the E side of the larger building. This smaller circular structure may be an earlier shieling hut that has been built over, the west wall of the smaller structure is shared with the larger sub-oval structure. The circular structure is also on a low mound suggesting collapsed turf walls or a turf mound and cell construction style.

Shieling hut Site 2.22, view to the W.

Actual Impact and Mitigation: A watching brief was maintained during development; the site was avoided by the development and remains undisturbed.

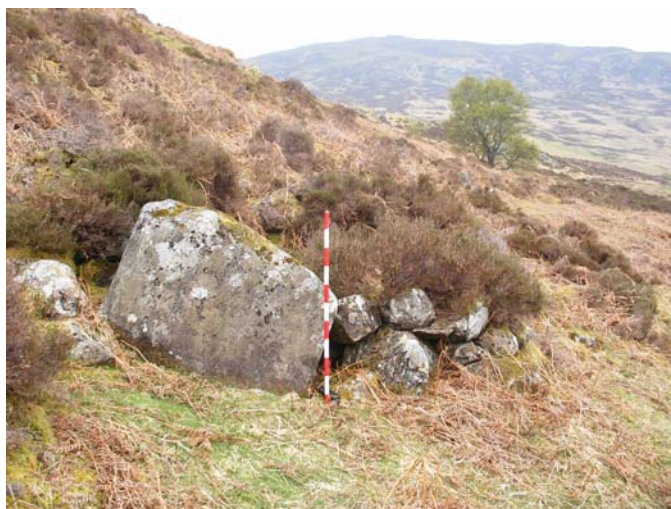
A sub-circular structure, 4.80m E-W by 4.40m, abuts a large earthfast boulder. It is one of a group of four structures, **Sites 2.23 – 2.26**, situated above the head dyke, **Site 1**, which partially encloses the shieling ground. The circular plan suggests a prehistoric date but the construction of coursed boulders, 0.70m in width and 0.60m in height, is more likely to be contemporary with the other shieling huts in the area.

Shieling hut Site 2.24, view to the W.

Actual Impact and Mitigation: The site was avoided by the development and remains undisturbed.

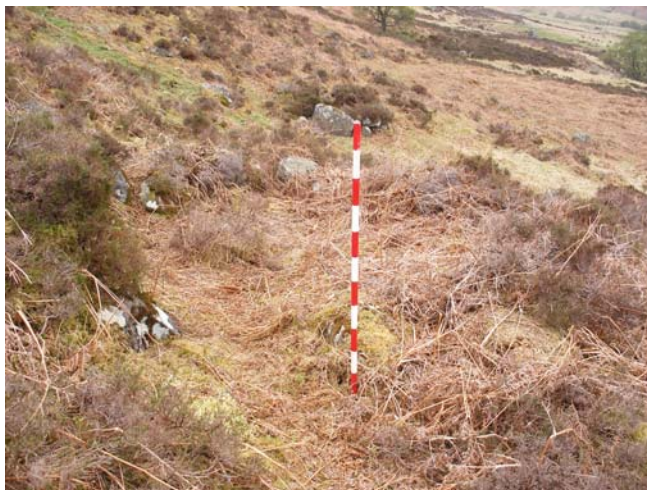
A sub-circular structure, 4.70m E-W by 4.60m, is one of a group of four structures, **Sites 2.23 – 2.26**, situated above the head dyke, **Site 1**, which partially encloses the shieling ground. It is defined by a wall of single boulders, 0.60m in width and 0.50m in height. The circular plan suggests a prehistoric date but it seems more likely to be contemporary with the other shieling huts in the area.

Shieling hut Site 2.25, view to the NW.

Actual Impact and Mitigation: The site was avoided by the development and remains undisturbed.

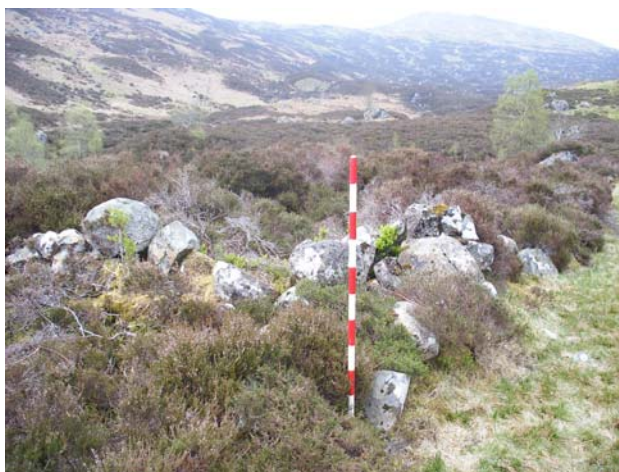
A rectangular, heather-covered structure, 6m N-S by 0.60m, is situated immediately East of the track, **Site 4**. It is defined by a wall of roughly-coursed stone, 0.90m in width and 0.60m in height.

Shieling hut Site 2.26, view to the SE.

Actual Impact and Mitigation: The site was avoided by the development and remains undisturbed.

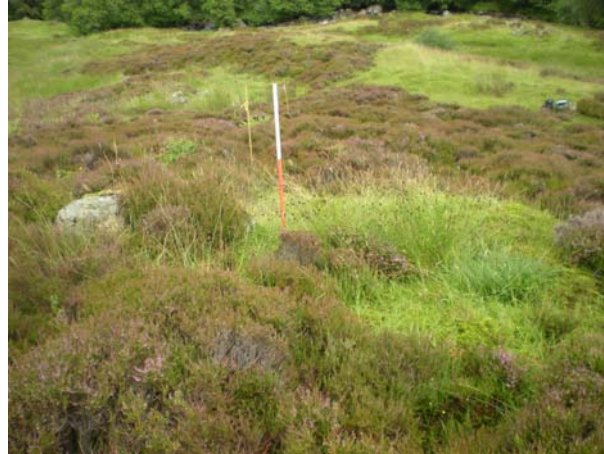
mound with a central depression and is very overgrown. It is not obvious to the inexperienced eye, especially compared to some of the other shieling huts. Located up slope is a spring indicated by shrubby vegetation. Shieling hut **Site 2.28** is located c. 20 metres away and the pipe route runs between the two sites.

Shieling hut Site 2.27, view to the NNE.

Actual Impact and Mitigation: A watching brief was maintained during development; the site was avoided by the development and remains undisturbed.

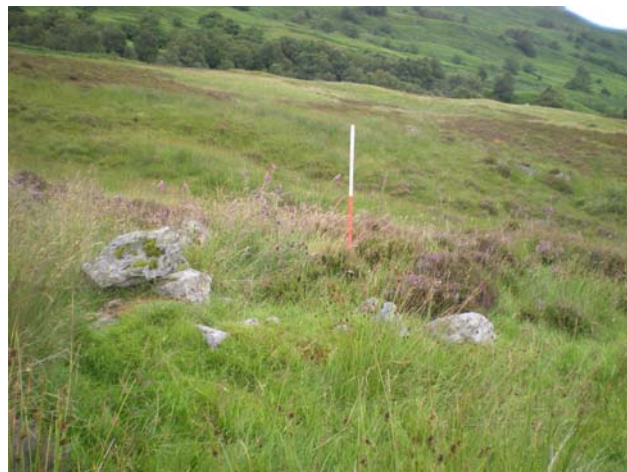
A 3.5m diameter turf and stone walled shieling hut with a 0.6m wide wall standing up to 0.5m high enclosing a space only 2m in diameter. Located an area of good pasture grass, no other structures were visible but the vegetation indicates a well used shieling site. Sites **2.27** and **2.28** are located less than 20m apart and the pipe route runs between them.

Shieling hut Site 2.28, view to the W.

Actual Impact and Mitigation: A watching brief was maintained during development; the site was avoided by the development and remains undisturbed.

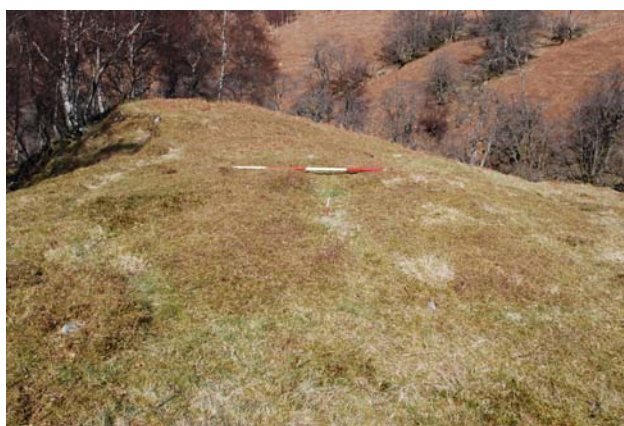
1.60m wide so that only a narrow channel is visible in the interior space, the banks are up to 0.40m high. A narrow gap at the S end may represent the entrance. Located 0.5m to the SW is a small sub-rectangular stone setting measuring 2.60m NNE-SSW x 2m. This stone setting consist of single stones forming a foundation 0.40m wide and 0.10m high and is covered with vegetation. It may represent a storage room, perhaps associated with dairying.

Shieling hut Site 2.29, view to the NE.

Actual Impact and Mitigation: The site was avoided by the development and remains undisturbed.

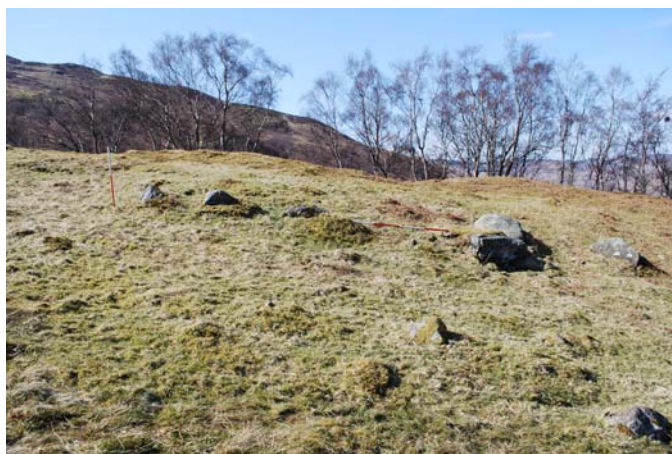
A line of six boulders forming a rough wall. Three of the boulders are in situ natural boulders. The wall is 11.20m long, 0.80m wide and 0.40m high and although largely natural it has been enhanced to form a retaining wall, perhaps to create a small vegetable plot or level area.

Wall of some natural and some placed boulders, Site 30, view to the NW.

Actual Impact and Mitigation: The site was avoided by the development and remains undisturbed.

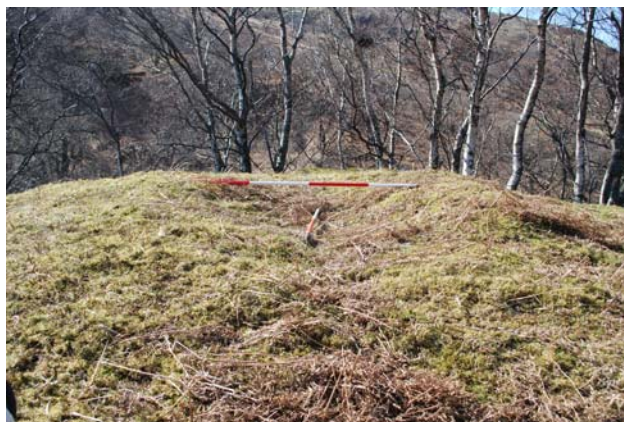
The banks are 1.20m wide and up to 0.40m high. No entrance is visible and it has eroded and collapsed down the steep slope on its W side.

Shieling hut Site 2.31, view to the W.

Actual Impact and Mitigation: The site was avoided by the development and remains undisturbed.

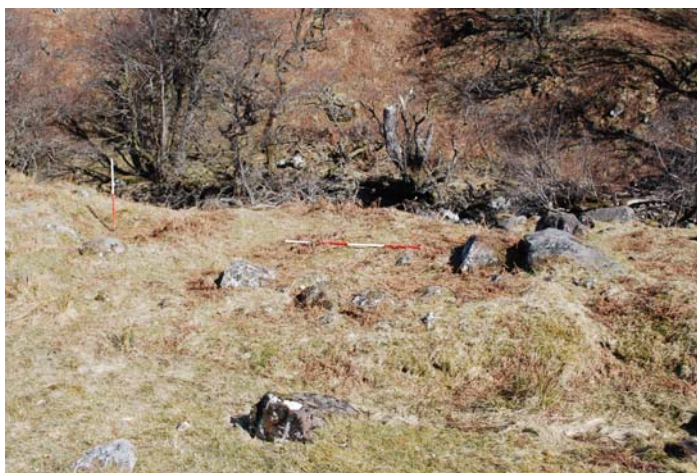
A denuded building adjacent to **Site 2.32**. This poorly defined structure measures a maximum of 6.00m N-S x 5.50m and stands to a maximum height of 0.50m. There is a 0.80m wide turf and stone wall along its E side and two large boulders at the W end of the S wall. There is a small depression in the interior. The bank and ditch **Site 2.34** runs along the W side of the structure and there is an earthwork at the N end of it, which appears to abut the well defined hut **Site 2.32**. **Site 2.33** is poorly defined and is perhaps best described as earthworks rather than a shieling hut although a shieling hut is what it is most likely to represent.

Shieling hut Site 2.33, view to the ENE.

Actual Impact and Mitigation: Watching brief maintained during excavation to upgrade the track **Site 4**. The site was avoided and is undisturbed.

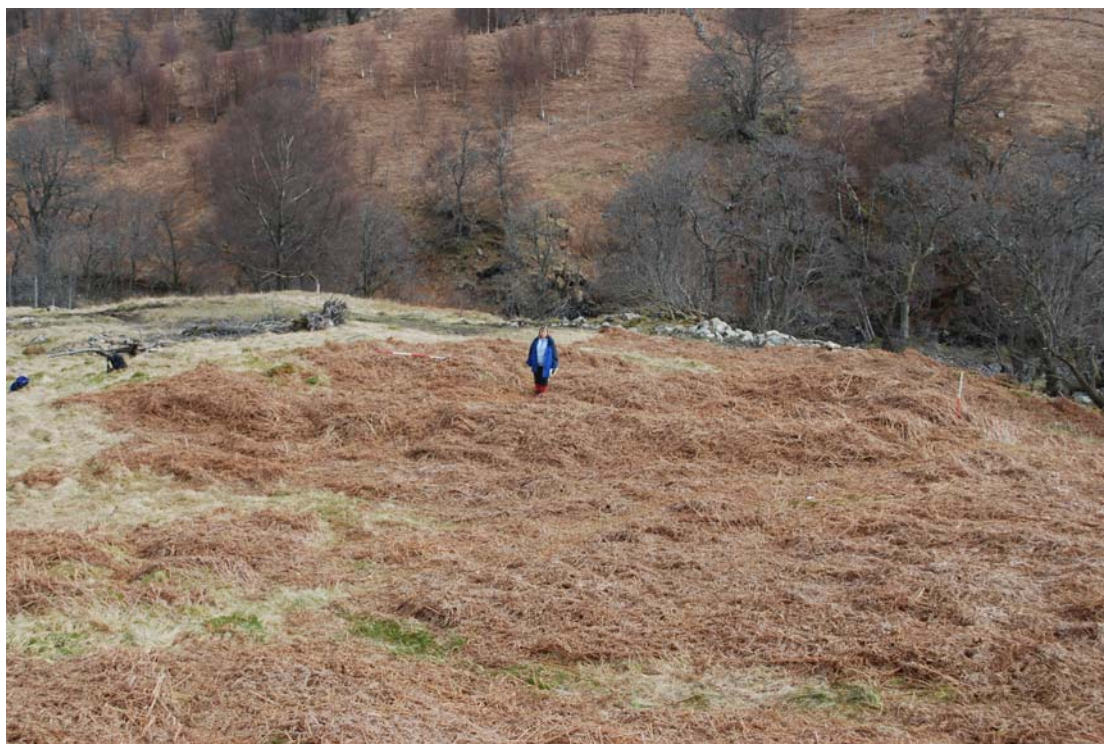
A sub-rectangular structure with rounded corners measuring 6.50m N-S x 5.10m and aligned N-S at 350°. The entrance is centrally placed in the N end and is 0.50m wide. The walls are 0.80m thick and stand to a maximum external height of 0.80m. The walls are constructed of turf and stone but there was no evidence of coursing visible and the structure is overgrown, there is a depression in the interior.

Shieling huts Sites 2.35 (left) and 2.36 (right). View to the NE, Jennifer Robertson is standing in between the two huts.

Sites **2.35** and **2.36** are associated and both located on a low natural knoll, the slope rises to the west and the Allt a Coire Bhuidhe runs along the south side of the site and an unnamed burn runs along the N side. The track **Site 4** is on the east. Heavily overgrown with bracken. These two huts take advantage of a well sheltered spot on a natural knoll with good drainage. They are quite substantial structures and are separated by a 1.50m gap suggesting they may be contemporary and both occupied at the same time. The still site **Site 2.37** may be associated with them.

Actual Impact and Mitigation: A watching brief was maintained during development; the site was avoided by the development and remains undisturbed.

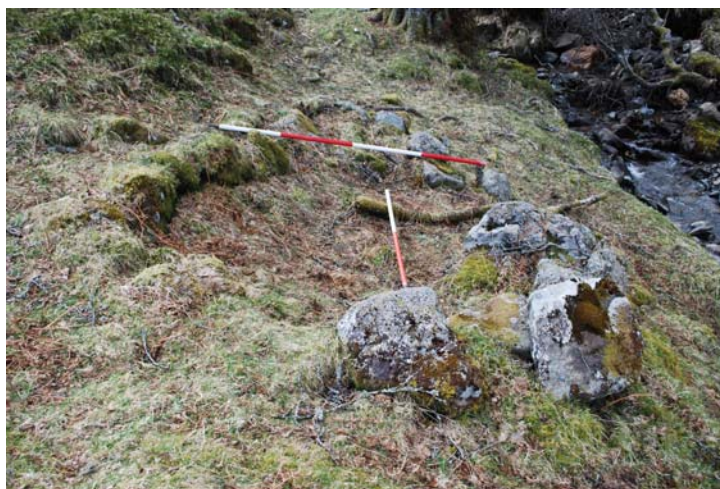
Located approximately 25m N of the two huts Sites **2.35** and **2.36** is a small circular structure on the bank of the un-named burn. The structure measures 3.60m E-W including a small platform x 2.90m N-S. It is located only 1.6m from the edge of the burn and the flood channel of the burn indicates it will be flooded when the burn is in spate. The structure is constructed of boulders and stones measuring up to 0.5m x 0.4m x 0.05m in size and is up to 0.50m wide and stands up to 0.60m high. There are possibly two courses of stone at the NE corner. There is a 0.80m wide entrance on the N side at the burn and a larger boulder measuring 0.75m x 0.40m x 0.25m has been set on its edge to form the E jamb of the entrance. In the interior the wall is a well defined edge and there is a central depression. A small platform constructed of stones is present at the NW corner of the structure. This measures 1.40m N-S x 1.00m E-W. This structure is interpreted as a still. Its location so close to the burn in a flood channel is one indication for this and also the small platform which could have been used during the distilling process. Presumably the main hearth for the mash tun would have been in the interior.

Whisky still Site 2.37, view to the W. Note the small platform at the W side and the proximity of the Allt a Choire Bhuidhe to the N.

Actual Impact and Mitigation: The site was avoided by the development and remains undisturbed.

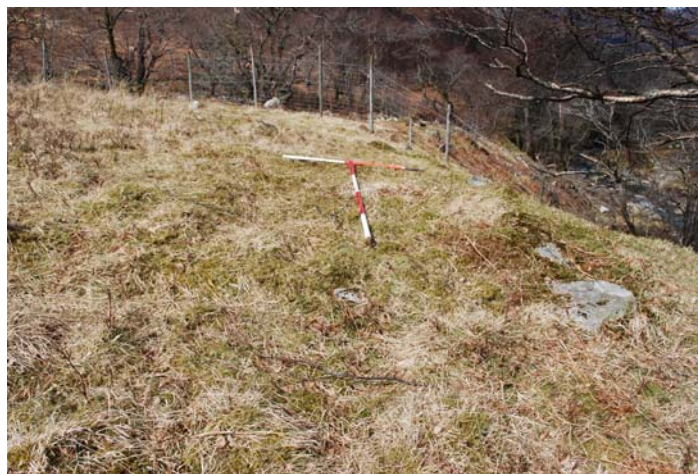
A small rectangular structure represented by a single course of flat stones. The west side is overgrown and not visible but probing suggests it is present under the turf. The building measures 2.90m NW-SE x 2.30m and is aligned at 310°. The walls are 0.40m wide and 0.20m high and the building has square corners. It is located on the E side of the track **Site 4** at the edge of the steep bank down to the Ardvorlich burn. It is probably associated with **Site 2.39** which is located only 3m to the south of it. There is also a 4m long, 0.40m wide and 0.30m high line of stones located about 3m

to the NNW which probably also represents a wall associated with these structures. They were all avoided by the development works.

Site 2.38, stone foundations, view to the NW.

Actual Impact and Mitigation: A watching brief was maintained during development; the site was avoided by the development and remains undisturbed.

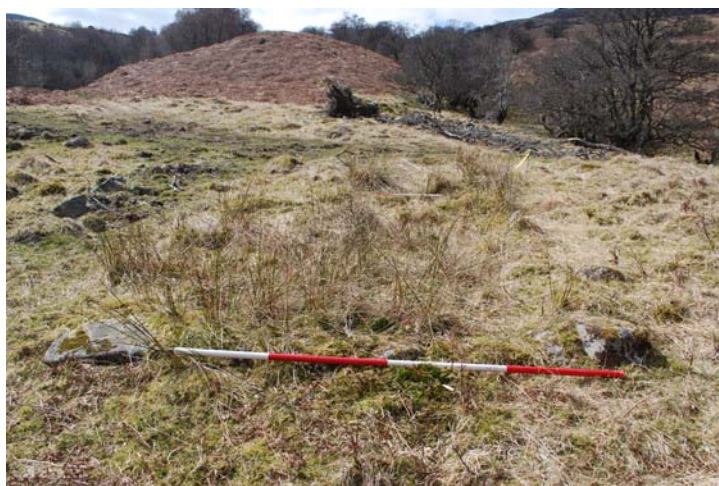
A rectangular structure measuring 4.10m x 2.85m aligned NE-SW at 227°. The walls are 0.40m wide and 0.20m high and are defined by a single course of boulders, it is overgrown and visibility is poor. There is no sign of an entrance and the NE end is most clearly defined. The building has square corners and is located on a slight slope running from SW to NE in a level area on top of the steep bank down to the Ardvorlich Burn. It is probably associated with **Site 2.38** and a short stretch of wall c.5m to the NNW.

Site 2.39, rectangular building foundations, view to the SW. Shieling huts Sites 2.35 and 2.36 are on the low knoll in the background and track Site 4 runs between them.

Actual Impact and Mitigation: A watching brief was maintained during development; the site was avoided by the development and remains undisturbed.

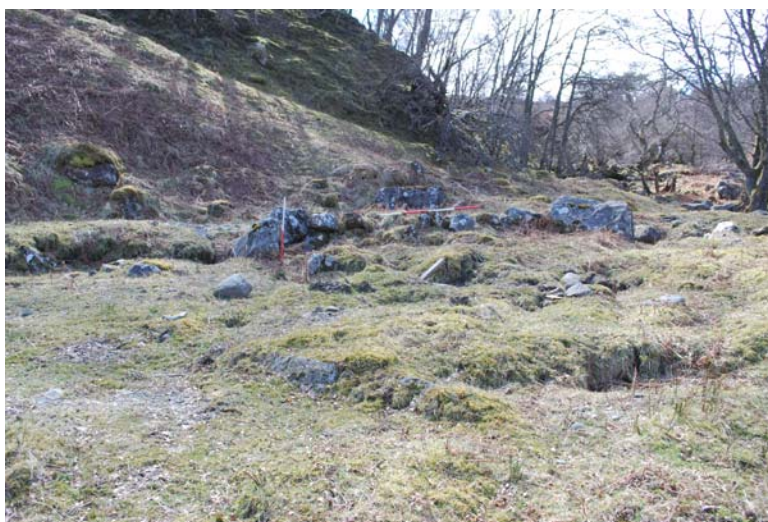
Raised or causewayed track Site 40 with retaining wall, view to the S.

Actual Impact and Mitigation: This track has been covered over by spoil and is in effect preserved under upfill.

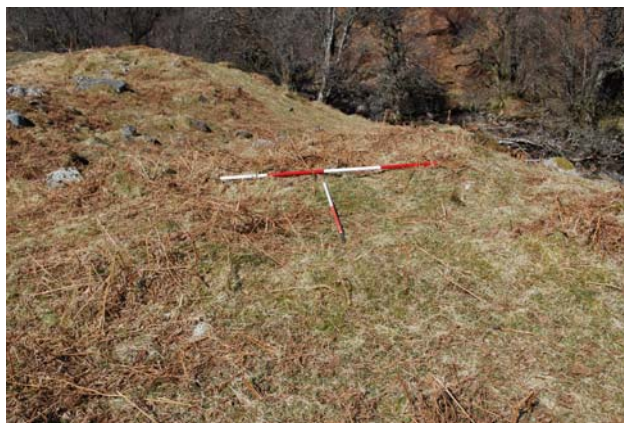
A sub-circular turf and stone hut foundation measuring 3.80m diameter located on a knoll at the top of the steep bank down to the Ardvorlich Burn. On the N side of the well defined circular foundation, which has an entrance on its W side, is a possible further turf and stone curvilinear bank which may represent an earlier hut or an annexe. It is poorly defined and has a possible entrance on its W side and extends for 2.40m to the N of the main foundation. The wall / bank that forms the main hut is 0.90m wide and up to 0.35m high and encloses a small interior space. At the NW side of the foundation is a 4m long stretch of stone wall which runs NW towards the bank and ditch **Site 2.34**, this wall has a possible return for a short distance to the NE. The bank and the ditch **Site 2.34** has a break in it directly opposite the entrance to **Site 2.41** which is in fact a causeway crossing point over the ditch to access **Site 2.41**. It seems likely that this causeway over the ditch and bank and the stretch of wall are associated with the control of livestock.

Shieling hut Site 2.41 with Sites 2.32 and 2.33 in the background. View to N.

Actual Impact and Mitigation: Watching brief maintained during excavation to upgrade the track **Site 4**. The site was avoided and is undisturbed.
