**Ardvorlich Estate
Hydro Scheme**

**Report on
Archaeological Work
Desk Study, Survey, Standing Building
Recording and Watching Briefs**

**Ardvorlich Estate and
Hydroplan UK**

February 2011

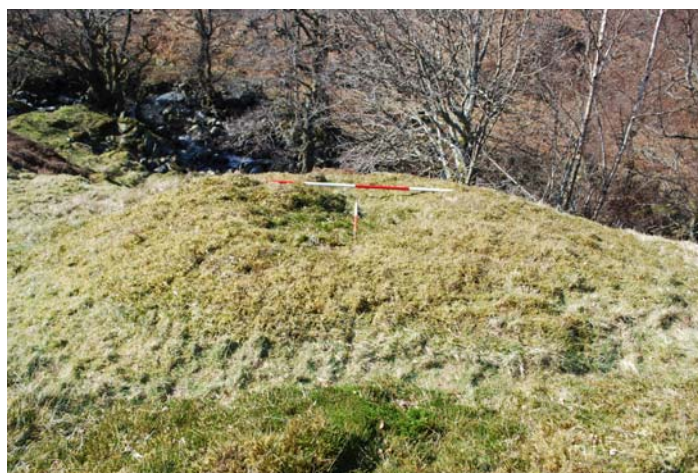
A circular moss and turf covered hut, more accurately described as a donut shaped mound with a central depression. It measures 3.30m NW-SE x 3.70m and stands to an external height of 0.60m and an internal height of 0.40m. The collapsed walls have spread to 1m wide. Largely a turf construction only a few small stones were located by probing. No entrance is apparent.

Shieling hut Site 2.42, view to the NW.

Actual Impact and Mitigation: The site was avoided by the development and remains undisturbed.

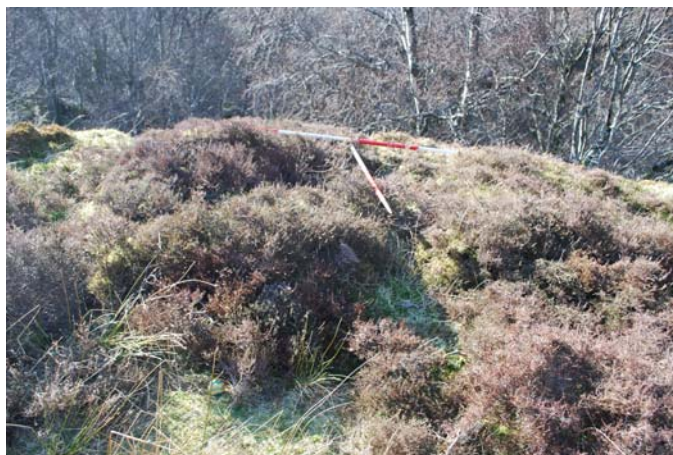
A sub-circular hut foundation overgrown with heather and with very poor visibility. The structure measures 2.70m NW-SE x 3.00m and has a distinct curve on its SW side. It is located on top of the steep ridge down to the burn. There is a possible entrance on the SEW side. The bank is 0.80m wide and the maximum height is 0.40m. Some stone was located in the foundation on probing.

Shieling hut Site 2.43, view to the NW.

Actual Impact and Mitigation: The site was avoided by the development and remains undisturbed.

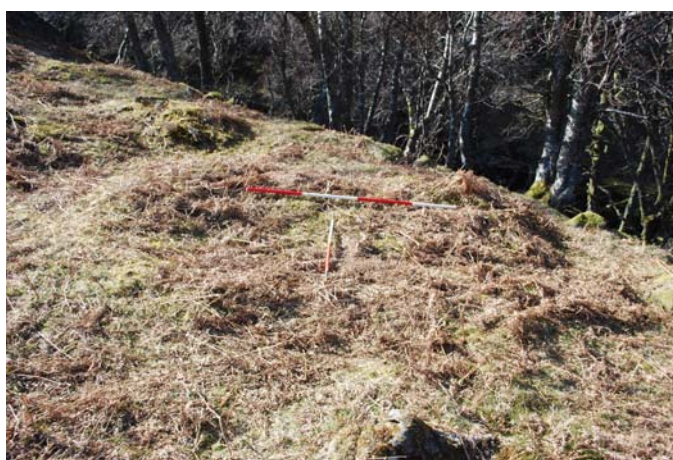
A very denuded and overgrown sub-rectangular foundation located on top of the steep bank down to the Allt a Choire Bhuidhe. The building is aligned NNE-SSW at 26° and measures 4.00m x 2.60m and stands to a maximum height of 0.20m. The W wall is the most convincing although stones were located on probing along the other indistinct wall lines.

Shieling hut Site 2.44, view to the NW.

Actual Impact and Mitigation: The site was avoided by the development and remains undisturbed.

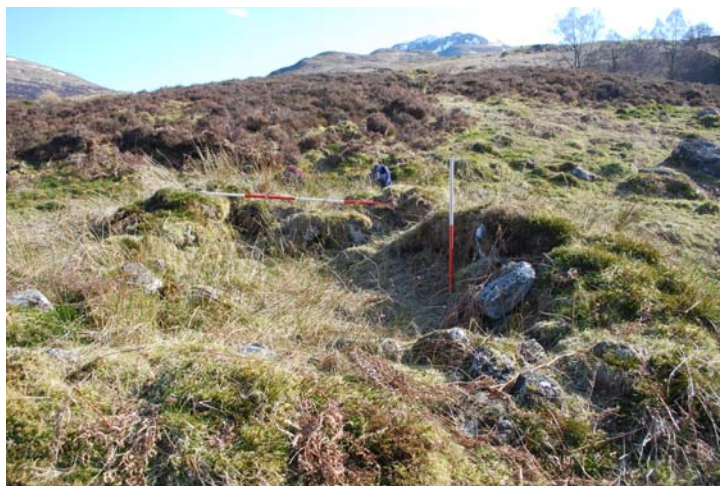
A well preserved rectangular structure measuring 6.20m x 3.80m overall. It is aligned NNW-SSE at 340°. The walls are 0.80m thick and stand to 0.60m high on the interior. The interior space measures 2.95m x 2.20m and the building is slumped on its N, W and NE sides suggesting the upper courses of the wall were constructed of turf. The entrance is located in the E wall and is 0.70m wide. Four courses of stone wall survive and the interior face is visible on the N and W walls.

Shieling hut Site 2.45, view to the S.

Actual Impact and Mitigation: The site was avoided by the development and remains undisturbed.

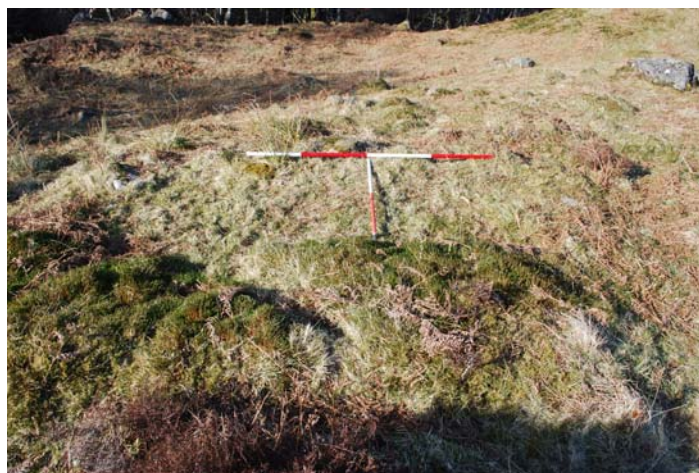
Foundations of a rectangular building on an artificially levelled terrace set into the N facing slope above Allt a Choire Bhuidhe. The stone foundations of a single course of stones are 0.70m wide and stand to a maximum height of 0.60m. The structure measures 4.20m x 3.00m and is aligned E-W at 277°. The S wall is slumped and overgrown with moss. There is a possible entrance at the E end. There is no obvious sign of stone collapse suggesting it may have had turf walls.

Shieling hut Site 2.47, view to the N.

Actual Impact and Mitigation: The site was avoided by the development and remains undisturbed.

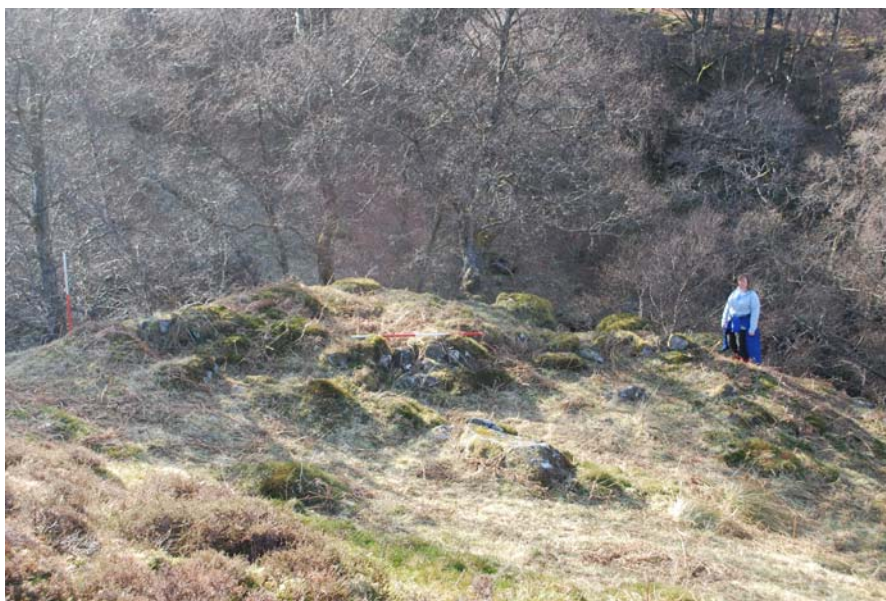
A rather confusing structural complex located at the top of a steep bank above the Allt a Choire Bhuidhe. It appears to consist of two rooms and an external partially enclosed yard. The main structure is aligned NW-SE and measures 5.60m x 4.00m. There are two rooms within this sub-rectangular building with very narrow entrances opening to the SE which may in fact be flues. The southern room is oval and has a very distinct curved wall 0.60m high around its SW end and the interior space measures 2.90m NW-SE x 1.10m. An entrance measuring 0.45m long and 0.30m wide with a distinct step into the interior is present set centrally in the NE wall. The room to the NW is sub-circular measuring 2m x 1.70m and has a very narrow blocked entrance at the E side on a rather odd angle if it represents access to a room used for occupation. The walls surrounding the two rooms vary from 0.80m thick to 1.30m thick and are rather irregular. An L shaped wall of drystone boulders abuts the NE corner of the structure and runs for a distance of 4m to the N before returning to the SSE for 7m. This wall forms a partially enclosed yard on the E side of the building. A number of natural large boulders are also present in the vicinity which may have been incorporated into the overall enclosure. It is also of note that the structures immediately in the vicinity, **Sites 2.44, 2.46 and 2.47** are rather out of character compared to the other shieling huts suggesting they may be associated with this site **2.48** and that an activity other than shieling occupation took place here. Our interpretation of this structure is that it most likely represents a double corn drying kiln although excavation would be required to confirm this.

Site 2.48, possible corn drying kiln, view to the WNW.

Actual Impact and Mitigation: The site was avoided by the development and remains undisturbed.

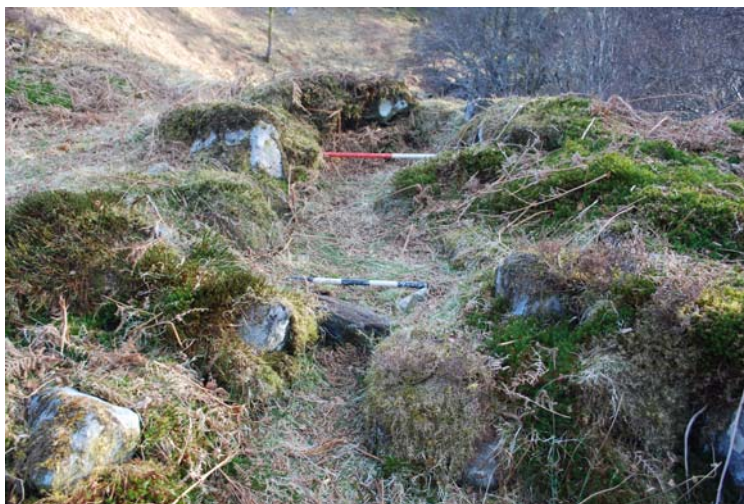
Site 2.48, entrance to SW room, possible flue to corn drying kiln with bowl in background, view to the S.

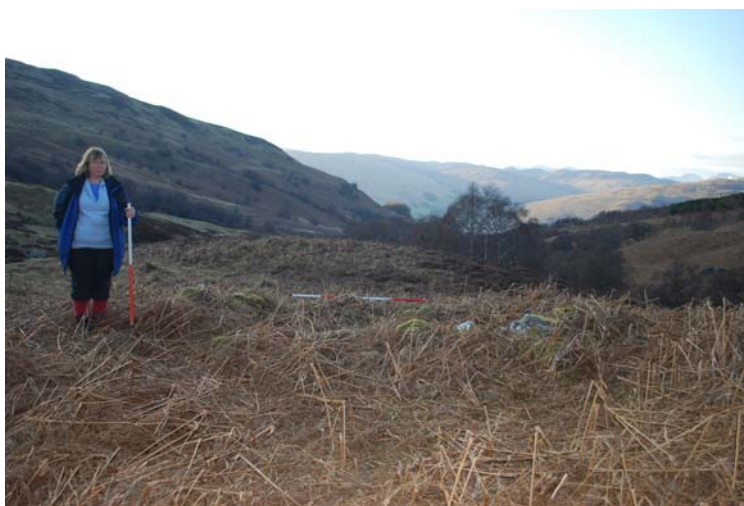
A square structure constructed of stone and overgrown with bracken. It measures 4.70m x 4.20m and is aligned NW-SE at 324°. There is a smaller structure best described as an annexe at the NE end which measures 3.10m NW-SE x 2.50m. Although overgrown with bracken the structure is well defined and the stone walls, of which two courses are visible, are 0.90m wide and stand up to 0.50m high. There is a possible entrance on the S side. Two other sites are associated with this structure, **Sites 2.50 and 2.51**, although these are of a completely different character and probably earlier in date. **Site 2.49** is later than **Site 2.51** and partially overlies it.

Shieling hut Site 2.49, view to the NW.

Actual Impact and Mitigation: Watching brief maintained during excavation of the pipe route. The site was avoided and is undisturbed.

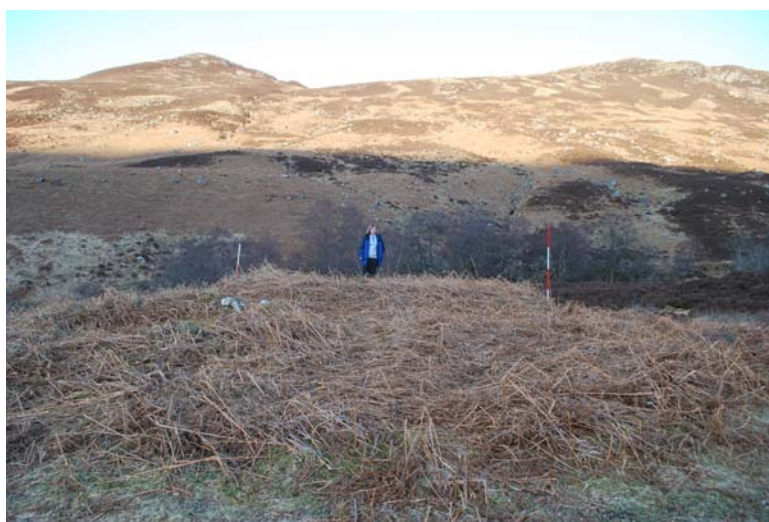
bracken. There was no sign of stones and none were located on probing with a ranging rod though any stones might have been robbed to build **Site 2.49** which appears to be the latest structure in this group of three sites (**Sites 2.49, 2.50** and **2.51**). This raised platform is only 1m from the SE corner of **Site 2.49**. The function and date of this platform is unknown. It might be prehistoric in date or perhaps a dry storage area for fuel or grain or even a house platform

Platform Site 2.50 with Jennifer Robertson, platform Site 2.51 covered with bracken in the foreground and stone foundation shieling hut Site 2.49 at left. View to the E.

Actual Impact and Mitigation: Watching brief maintained during excavation of the pipe route. The site was avoided and is undisturbed.

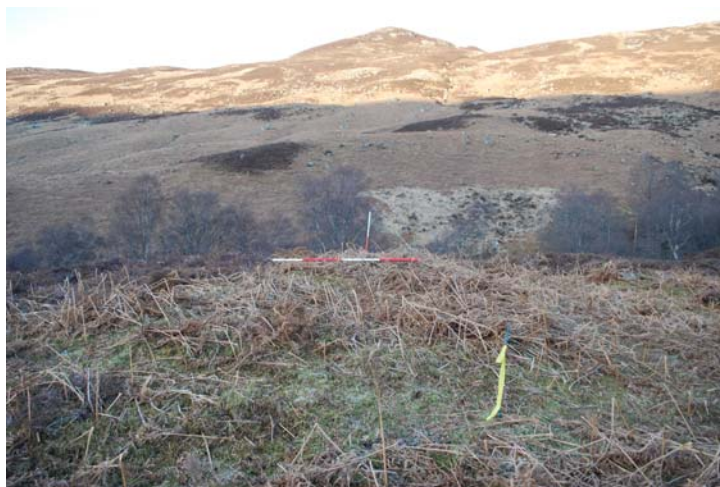
A rectangular turf structure that tapers (narrows) towards its E end. The building is 8.20m long x 3.80m wide at the W end and 3.20m wide at the E end. It is aligned ENE-WSW at 60°. The walls are turf although some stone was noted on probing, and measure 0.80m wide and stand to 0.30m high. There is possibly an interior partition but the structure is overgrown with bracken and moss and it was impossible to be certain of this.

Shieling hut Site 2.52, view to the ENE.

Actual Impact and Mitigation: The site was avoided by the development and remains undisturbed.

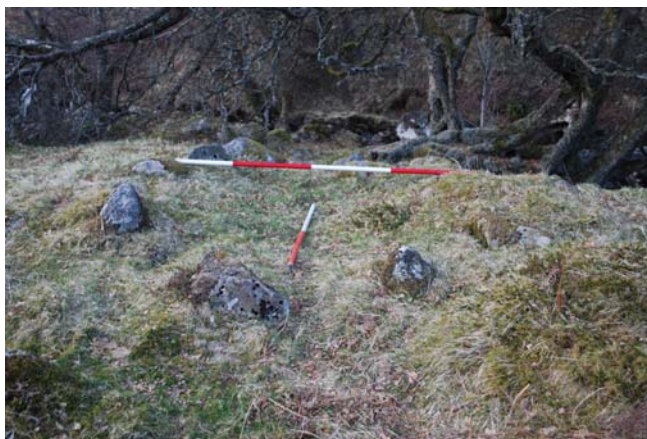
2.53) Shieling Hut.

A small oval structure measuring 3.60m NE-SW x 2.50m, aligned at 46°. The building is well defined by an arc of small boulders on its NW side. The walls are 0.60m wide and stand to 0.40m high and there is an entrance on the SW side. **Site 2.54** is very similar and is located 5m to the N.

Structure Site 2.53, view to the NE.

Actual Impact and Mitigation: Watching brief maintained during excavation of the track **Site 4** which was upgraded in this area. The site was avoided and is undisturbed.

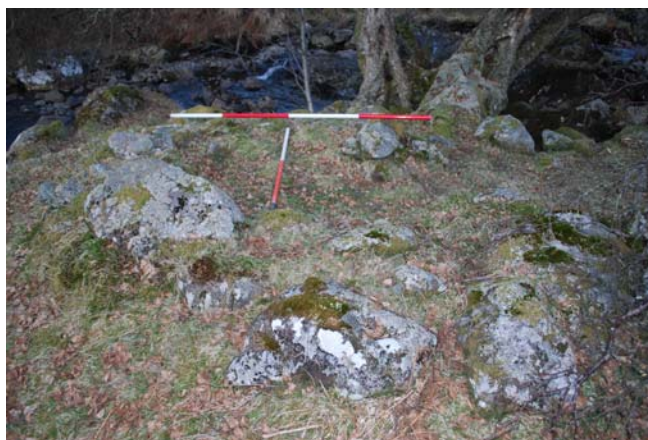
2.54) Shieling Hut.

A small irregular oval structure measuring 3.30m NE-SW x 2.40m. The interior is level and there are three courses of boulders in the wall at the N end. The wall is 0.60m wide and stands to 0.60m high on the exterior and 0.40m high in the interior. This structure is quite similar to **Site 2.53** and the two may be associated. They are possibly associated with dairying activities as they are within 5m of the river where it is cooler.

Structure Site 2.54, view to the E.

Actual Impact and Mitigation: Watching brief maintained during excavation of the track **Site 4** which was upgraded in this area. The site was avoided and is undisturbed.

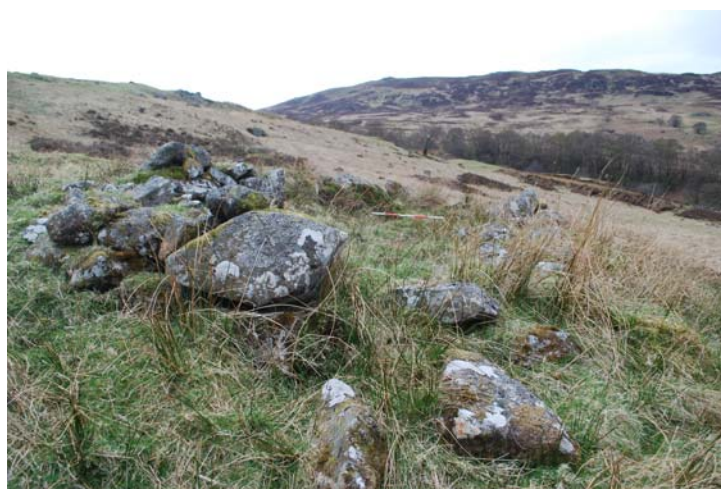
2.55) Shieling Hut.

Part of a group of huts comprising **Sites 2.55, 2.56, 2.57 and 2.58** located on a grassy knoll indicating an area of enriched (manured) and well drained land.

Shieling hut Site 2.55, view to the W.

Actual Impact and Mitigation: The site was avoided by the development and remains undisturbed.

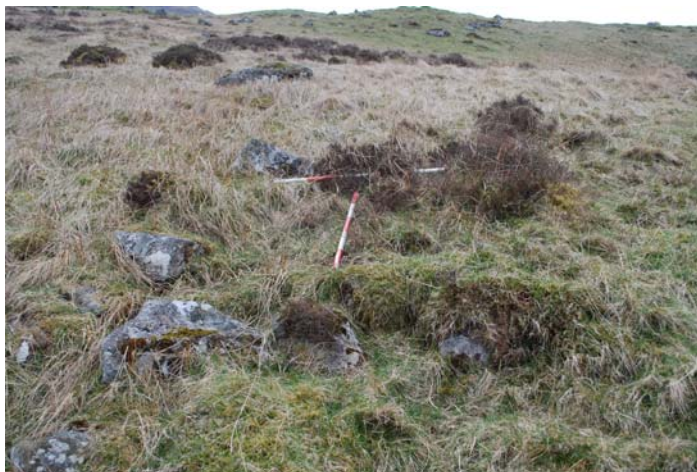
2.56) Shieling Hut.

A sub-square structure defined by a setting of boulders which is overgrown with heather on its SW side and is poorly defined. The building measures 2.50m E-W x 2.20m N-S. The wall of boulders is one course high, 0.40m wide and stands to 0.25m in height. It is collapsed on the N side and there is no clear indication of an entrance. Part of a group of huts comprising **Sites 2.55, 2.56, 2.57 and 2.58** located on a grassy knoll indicating an area of enriched (manured) and well drained land.

Shieling hut Site 2.56, view to the S.

Actual Impact and Mitigation: The site was avoided by the development and remains undisturbed.

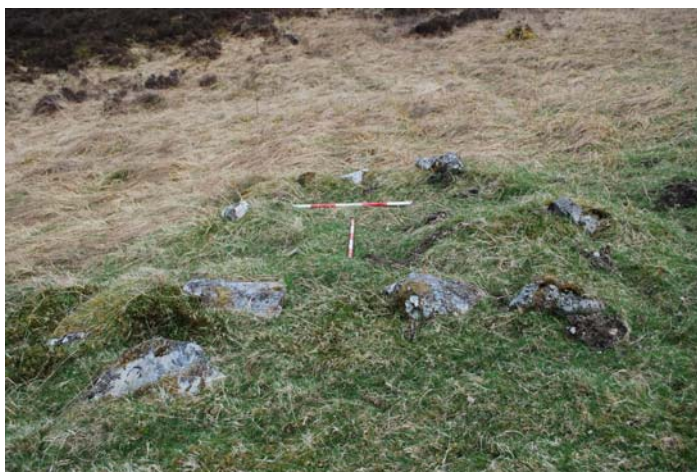
2.57) Shieling Hut.

A well defined sub rectangular structure measuring 3.80m x 2.30m and aligned NW-SE at 325°. The walls consist of one course of boulders and are 0.60m thick and 0.25m high. There is a possible entrance centrally placed in the NE wall. Part of a group of huts comprising **Sites 2.55, 2.56, 2.57 and 2.58** located on a grassy knoll indicating an area of enriched (manured) and well drained land.

Shieling hut Site 2.57, view to the SE.

Actual Impact and Mitigation: The site was avoided by the development and remains undisturbed.

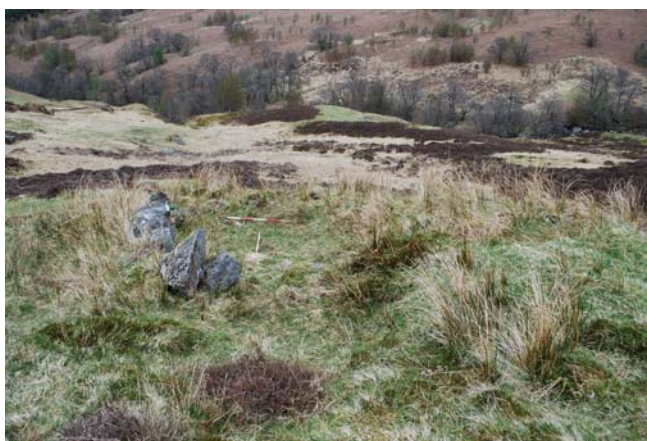
2.58) Shieling Hut.

A well defined site, two individual shieling huts probably of two phases. The larger hut is oval in shape and measures 5m x 4m and is aligned N-S at 20°. It is in good condition and has a well defined entrance at the SW end which is 0.45m wide. The walls are 0.70m wide and stand up to 0.60m high, three courses of stone are visible. The stones are quite tightly packed and the construction style is similar to **Site 2.55**. The smaller circular hut is located at the SE corner of the larger hut. It measures 2.5m diameter and is overgrown with turf but some stones are visible especially on its NE side. The walls are 0.70m wide and stand to 0.30m high. It is quite collapsed and poorly defined in comparison to the larger oval hut. The smaller hut's N side may have been incorporated into the wall of the larger hut or it has been built over by the larger oval hut. The smaller hut is at a higher ground level and stands 0.50m above the present ground surface level in the larger hut. The junction between the two huts is quite tumbled down and it is not possible to determine if they were in use at the same time and if the smaller hut was accessed from the larger hut. The ground outside the huts slopes away to the NE and E.

Shieling hut Site 2.58, view to NE of entrance to larger hut and smaller structure is on the right of the photograph.

Actual Impact and Mitigation: The site was avoided by the development and remains undisturbed.

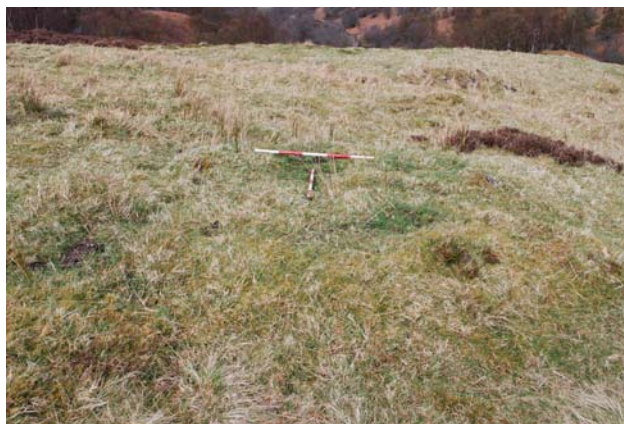
2.59) Shieling Hut.

A low oval donut mound with a slight central depression measuring 3.60m N-S x 2.60m E-W. The turf and stone walls are 0.70m wide and stand to c. 0.25m high. There is a possible entrance on the NNW side. This site is much denuded and visibility is poor.

Shieling hut Site 2.59, view to the N.

Actual Impact and Mitigation: Watching brief maintained during excavation of the track **Site 4** which was upgraded in this area. The site was avoided and is undisturbed.

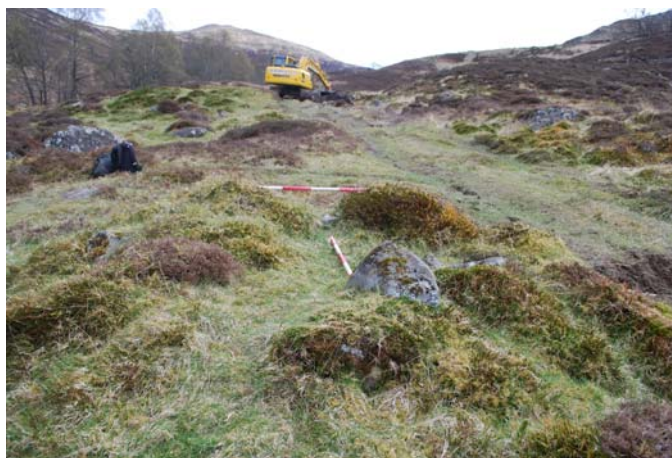
2.60) Shieling Hut.

A poorly defined low turf covered mound with an irregular sub circle of boulders incorporating bedrock outcropping on its E side. Measuring 3.50m diameter and located immediately to the E of the track **Site 4**. There is also a rough track down to a ford over the Ardvorlich Burn along the S side of this site.

Shieling hut Site 2.60, view to the SE.

Actual Impact and Mitigation: Watching brief maintained during excavation of the track **Site 4** which was upgraded in this area. The site was avoided and is undisturbed.

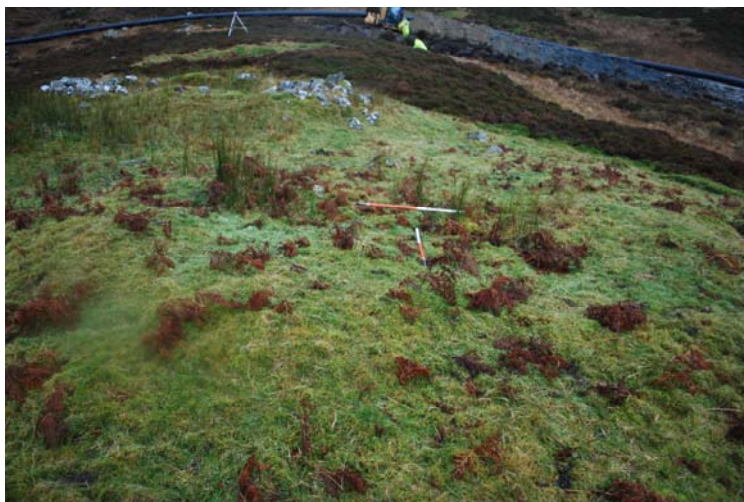
2.61) Shieling Hut.

Shieling hut Site 2.61, view to the SSW.

Actual Impact and Mitigation: The site was avoided by the development and remains undisturbed.

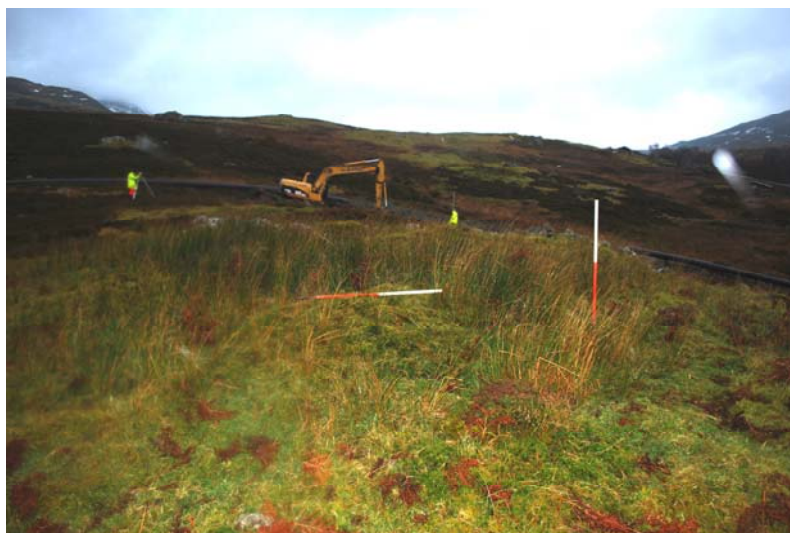
2.62) Shieling Hut.

Shieling hut Site 2.62, view to the SW.

Actual Impact and Mitigation: The site was avoided by the development and remains undisturbed.

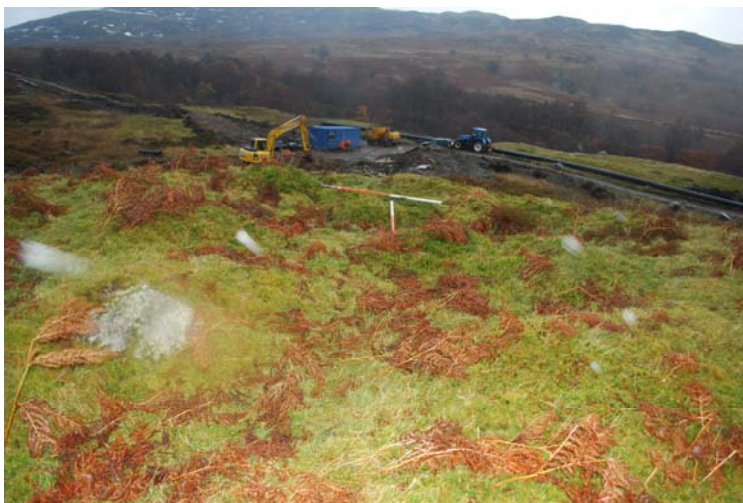
2.63) Shieling Hut.

A very collapsed and spread sub-rectangular turf and stone building measuring approximately 5m x 5m overall. It is overgrown with turf, no entrance is apparent and there may be a wall running parallel to the exterior of the S wall suggesting it may be of more than one phase. However, this building is in poor condition and its plan is not easily be interpreted.

Shieling hut Site 2.63, view to the W towards route to Intake 5 and working compound.

Actual Impact and Mitigation: The site was avoided by the development and remains undisturbed.

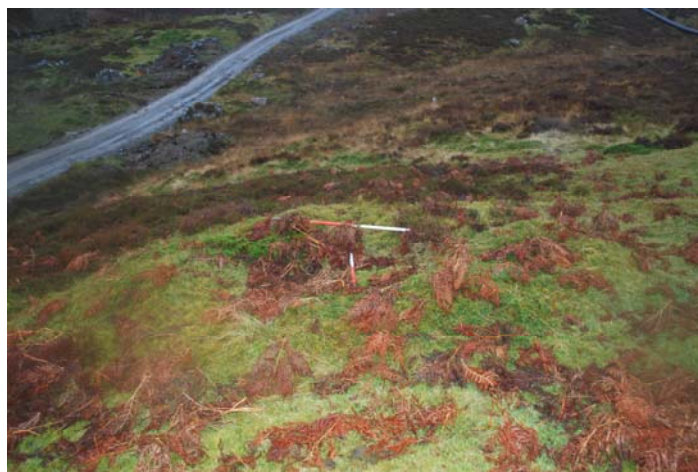
2.64) Shieling Hut.

Shieling hut Site 2.64, view to SSE and upgraded track Site 4 in the background.

Actual Impact and Mitigation: The site was avoided by the development and remains undisturbed.

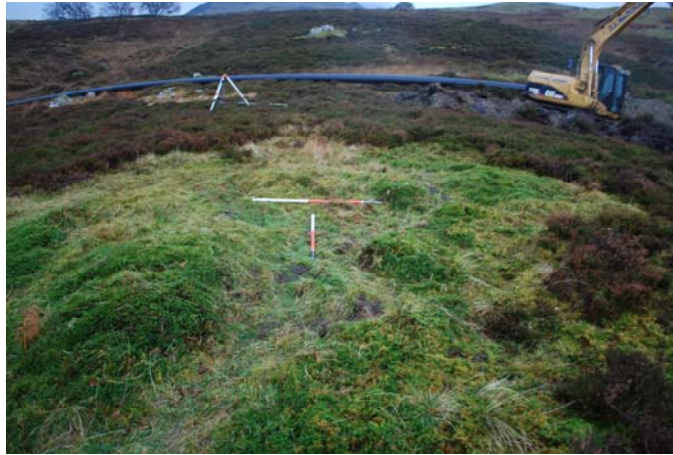
2.65) Shieling Hut.

Possible shieling hut Site 2.65, view to the S with pipe across the shieling ground in the background.

Actual Impact and Mitigation: The site was avoided by the development and remains undisturbed.

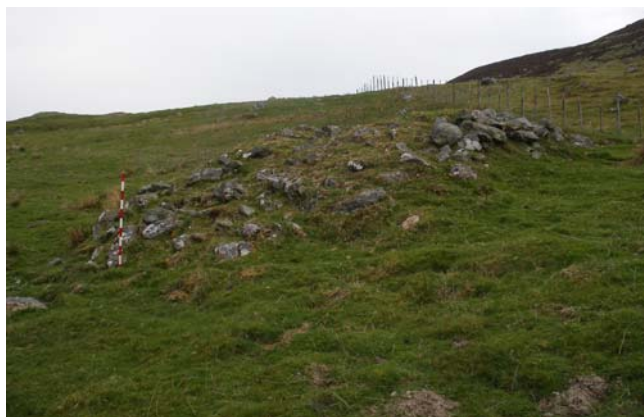
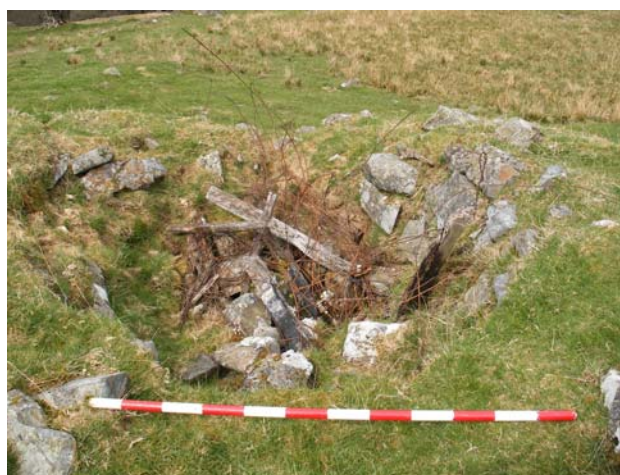
General view of the corn drying kiln Site 13, to the E.

The bowl of the corn drying kiln Site 13, view to the N.

Actual Impact and Mitigation: The site was avoided by the development and remains undisturbed.

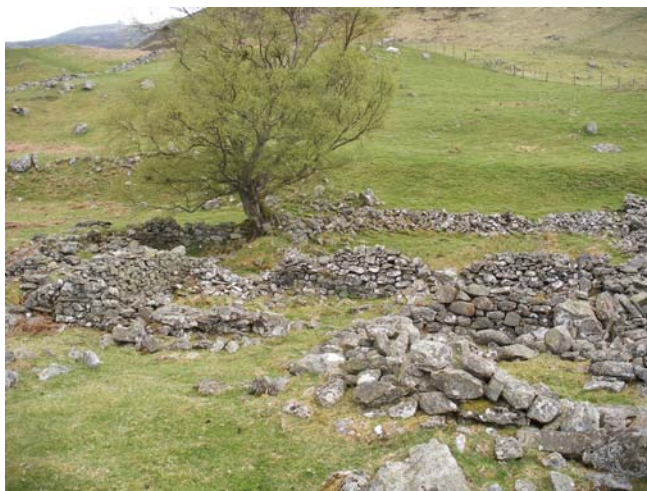
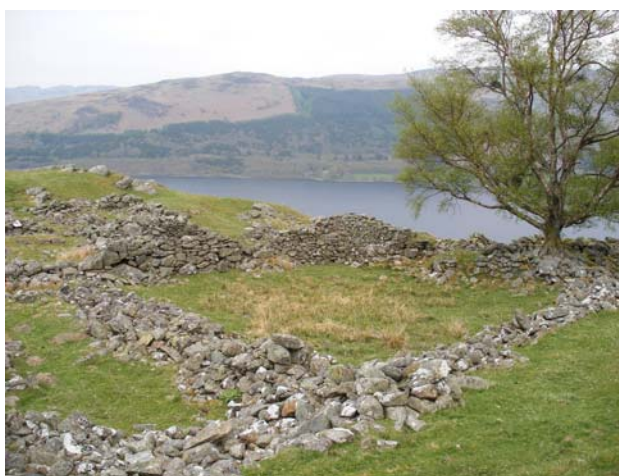
14. Farmstead.

Farm steading Site 14, view to the S.

Farm steading Site 14, view to the NE.

Actual Impact and Mitigation: The site was avoided by the development and remains undisturbed.

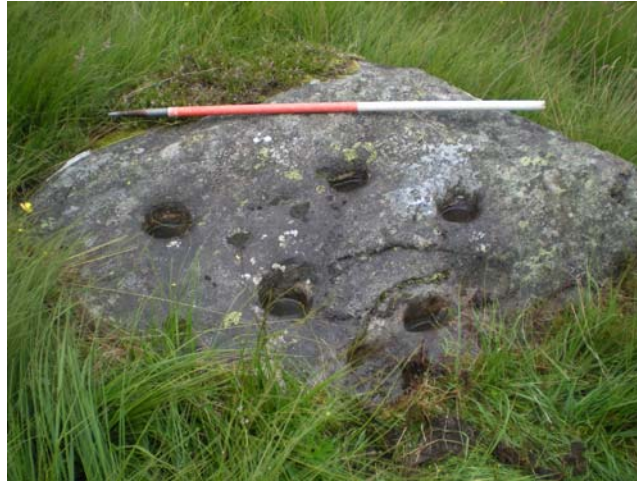
An earthfast glacial erratic boulder measuring 1.8m E-W x 1.2m N-S and c. 0.5m high above ground. Eight obvious sub-circular depressions are visible on its surface and at least three of them show signs of wear suggesting a knocking stone (or mortar for grinding oats). The deep cups may have initially been created by glacial scarring or grinding of pebbles against the surface but the depth and signs of wear indicate the stone has been utilised. The deepest cups measure 0.14m diameter and are up to 0.16m deep and would have been used as mortars for grinding oats and/or other substances. There was no sign of prehistoric cup and ring marks on the boulder.

Site 24 Knocking Stone viewed to the NW. This cups in this stone are up to 0.16m deep and would have been used as mortars for grinding oats and /or other substances.

Actual Impact and Mitigation: The site was avoided by the development and remains undisturbed.

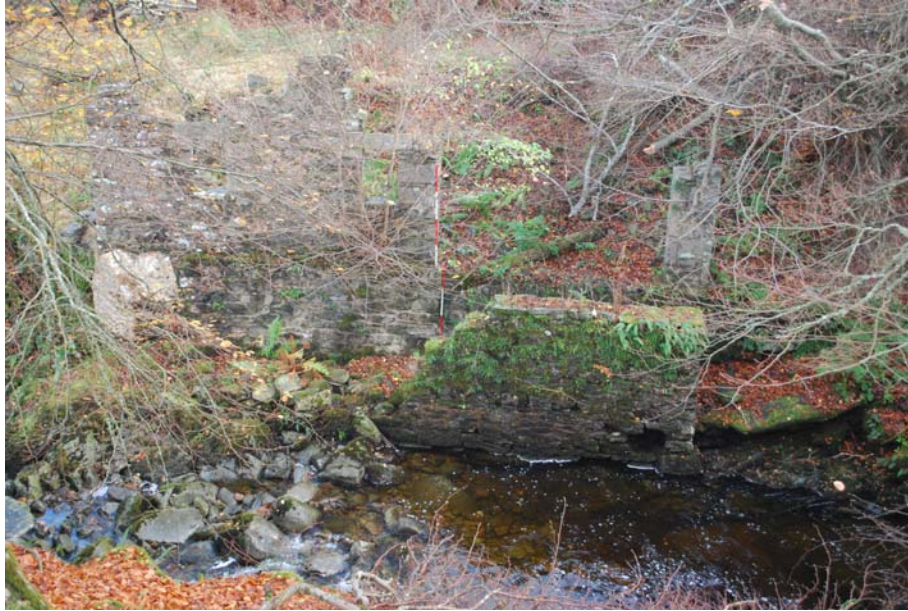
The Saw Mill Site 22 general view to the East showing the wheel pit Element 7, the bedrock shelf where the launder entered the wheel pit at the S (right) end of the structure and the outflow from the wheel pit into the river (Elements 14 and 18). Two storeys of different builds are the W wall of the actual mill building and the pillar (Element 3) at the right indicates the S side of the aperture between the mill building into the wheel pit.

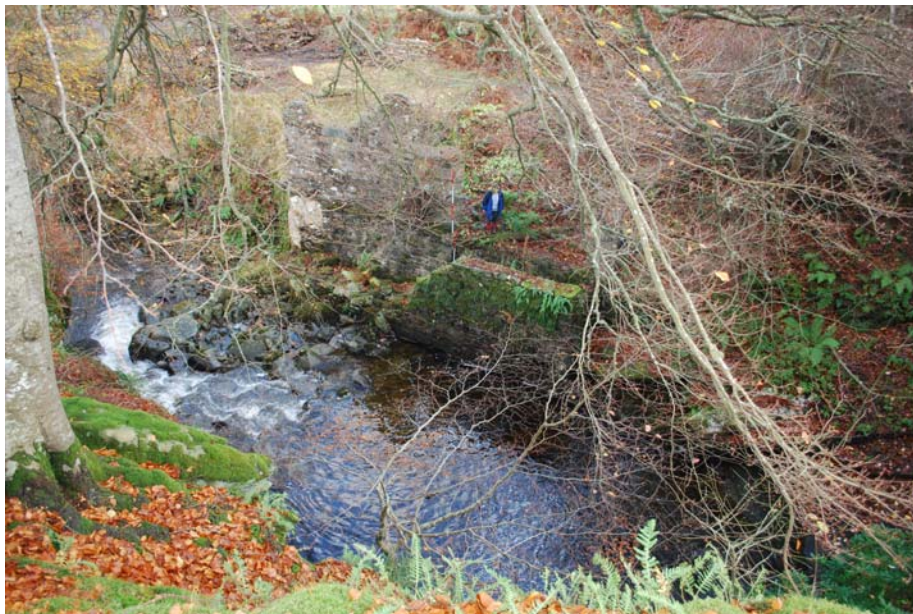
General view of the saw mill Site 22 towards the NE with the Ardvorlich Burn in the foreground.

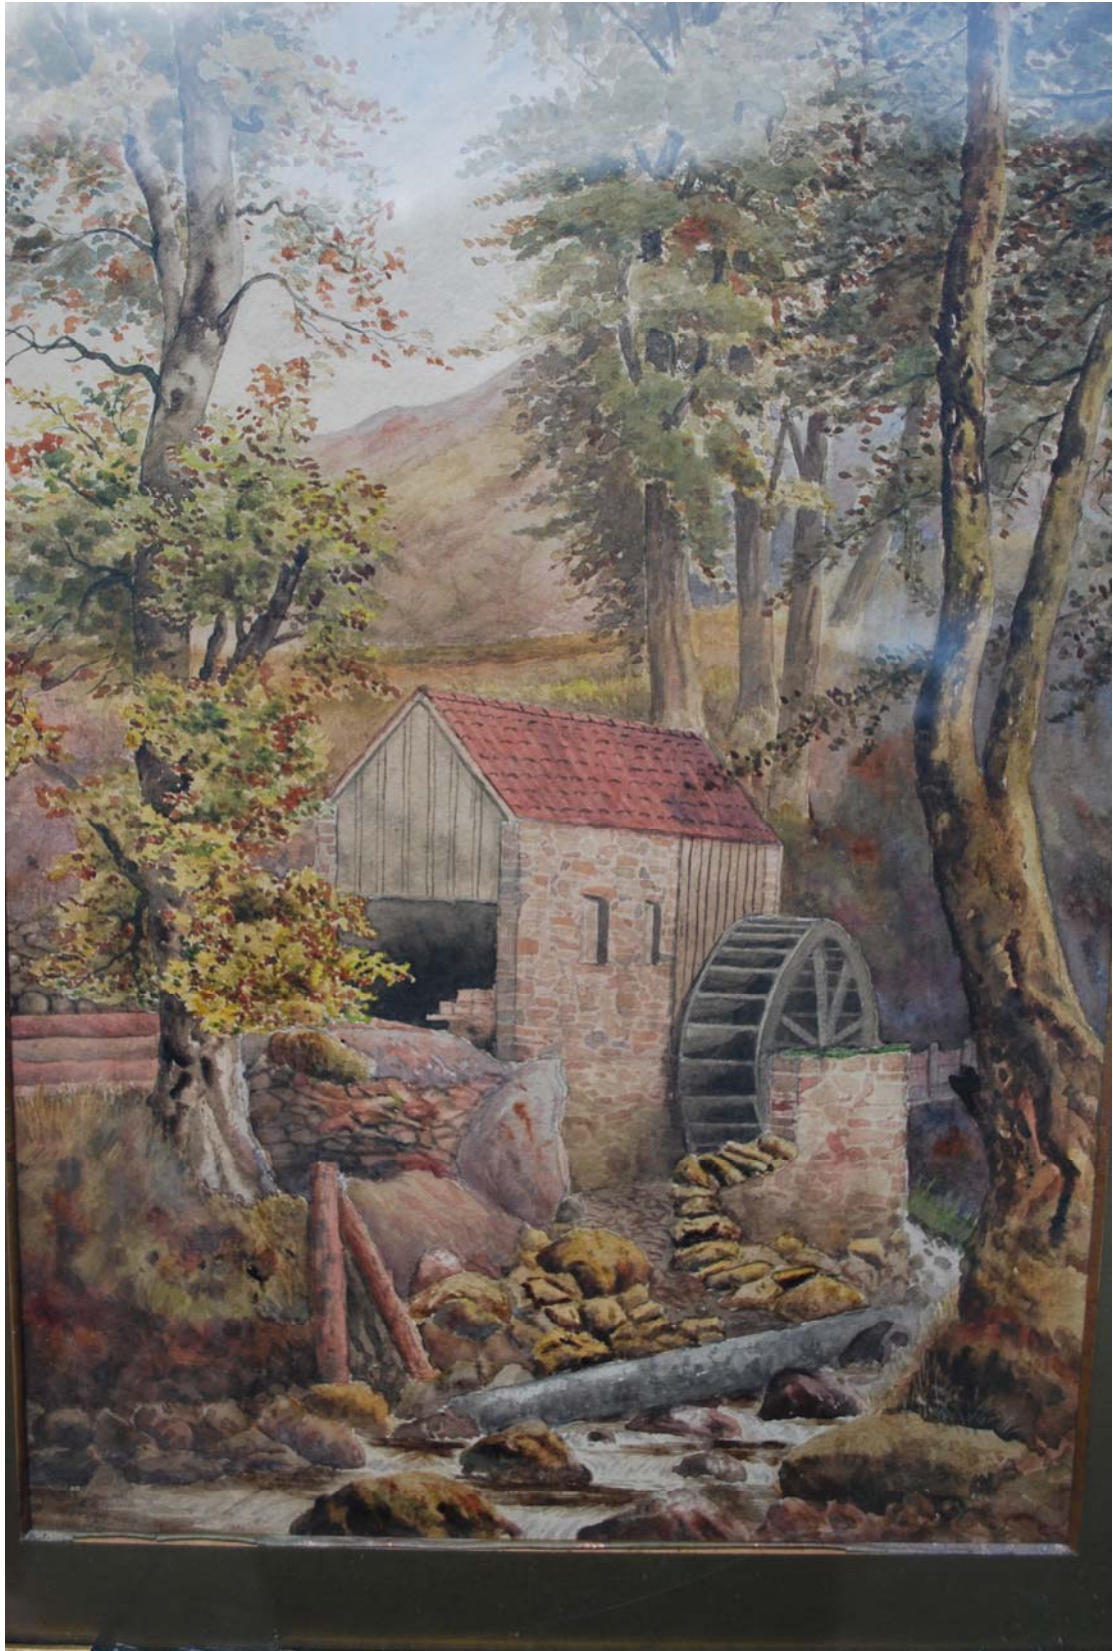
Figure 10: Painting of the saw mill painted by Roberts and dated 1878. Owned by Mr and Mrs Stewart of Ardvorlich Estate.

The 1878 painting of the saw mill by Roberts shows several details which agree with the information retrieved from the standing building recording. The mill building is shown as entirely open on its N side and there was no sign of a wall or foundations along the N side of the structure. The aperture between the pillars Elements 3 and 19 between the mill building and the wheel pit is shown as covered with wood. The building break in the W wall of the mill building, described as the lower (Element 4=9) and upper (Element 10) storeys in the above description shows clearly on the painting. The wooden launder that fed water to the mill wheel is shown in the background of the painting. The outer wall of the wheel pit, Element 7, is shown as decreasing in height towards its N end, Element 18, and the stones Element 14 that form a kind of dam are shown as lining the outflow from the mill wheel. It is also of note that the lowermost part of the outer wheel pit wall, Element 7, are shown as a more irregular construction, perhaps represented by Element 6.

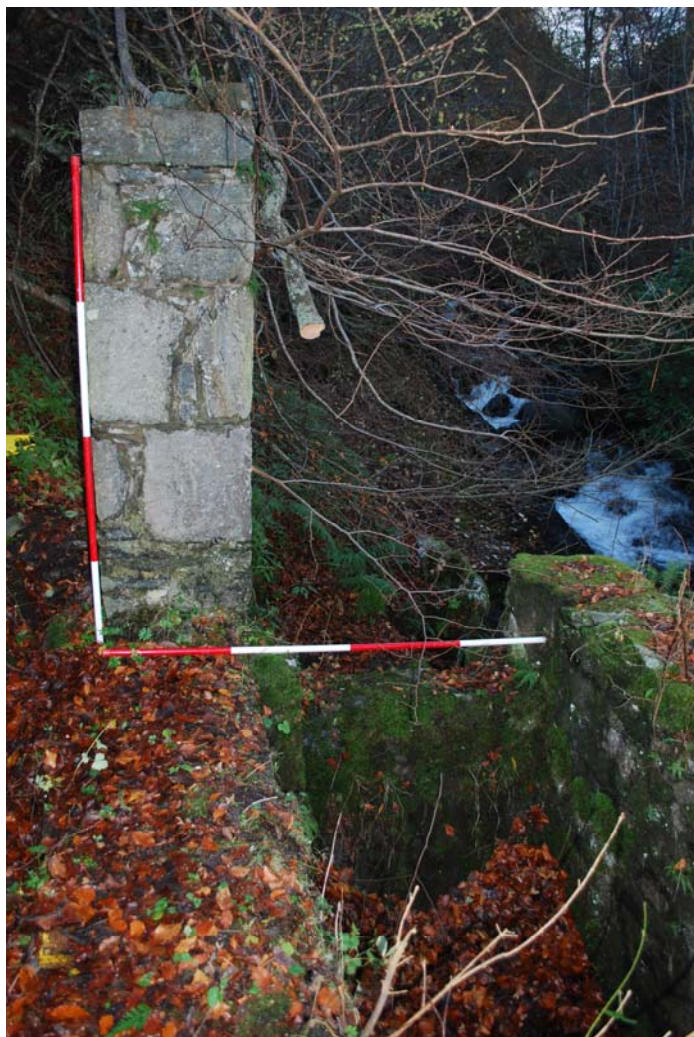
its S external side. There is lower step in the middle of the wall which is Element 20, the shute where the water was fed in from the launder to the wheel.

View to the S of the S wall of the wheel pit Element 5 and the wheel pit with wall Element 7 on the right of the photograph. The pillar, Element 3, on the left of the photograph forms the S side of the aperture between the mill building and the wheel pit. The stone slab capping on top of the wall Element 9 is just visible.

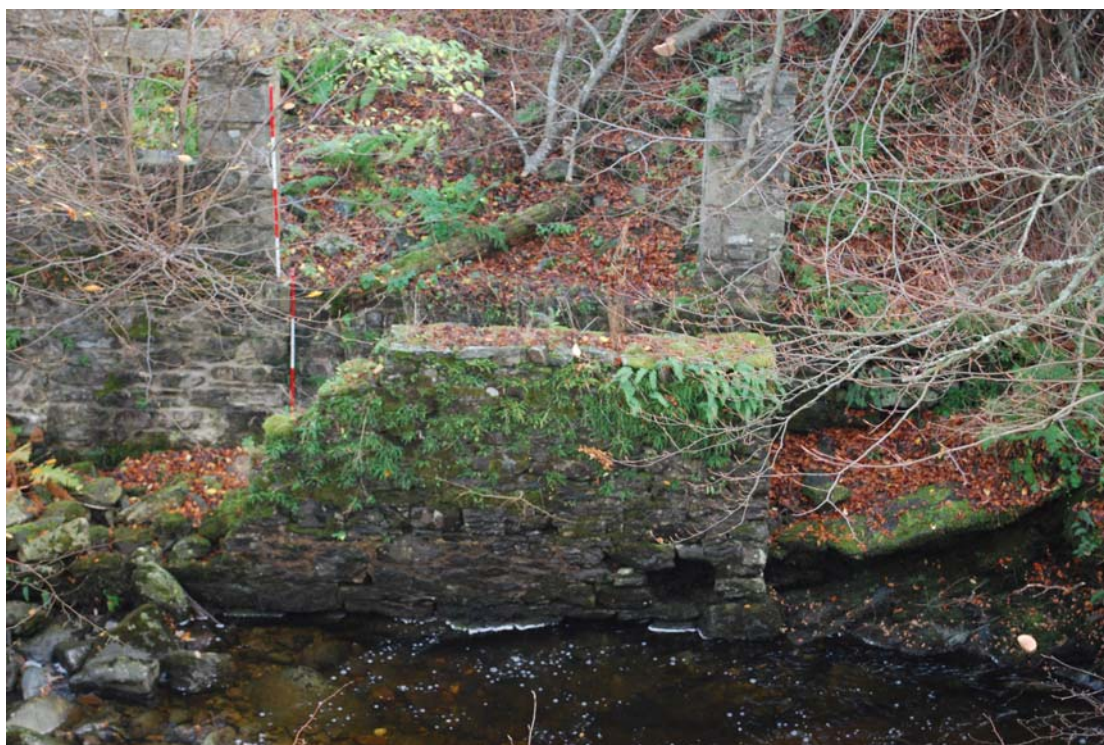
note that the mortar on the lower courses is much heavier and thicker which would have been to guard against erosion from the flow of the river. Six possible dook holes or slots are visible on the line of this building break but it was not possible to access this wall and determine if these were real features or simply a result of erosion. The upper part of the wall above the building break is rather obscured by moss and ferns but it is possible other dooks might be present. The water flow of the burn runs up against this wall and then curves back to the W where it is deflected off the stones Element 14 that form a dam and this has created a deeper scoured out pond beside the wall Element 7. The wall Element 7 continues N as a lower wall, Element 18, but it is collapsed and obscured by collapsed stones. However it is clear that it continues parallel to wall Element 10, probably as far as the quartz boulder retaining wall Element 11 and again it is clear that natural rock outcropping has been utilised. Wall Element 7 is standing to its full height and is capped with flat stone slabs. There are no signs of any fittings set into the top of the wall but it is obscured by moss.

Element 7 the W wall of the wheel pit. Note the possible socket Element 6 at the bottom of the wall and the distinct building break towards the bottom of the wall. In the background the aperture between the mill building and wheel pit defined by pillar Element 3 on the right and pillar Element 19 on the left. View to the E.

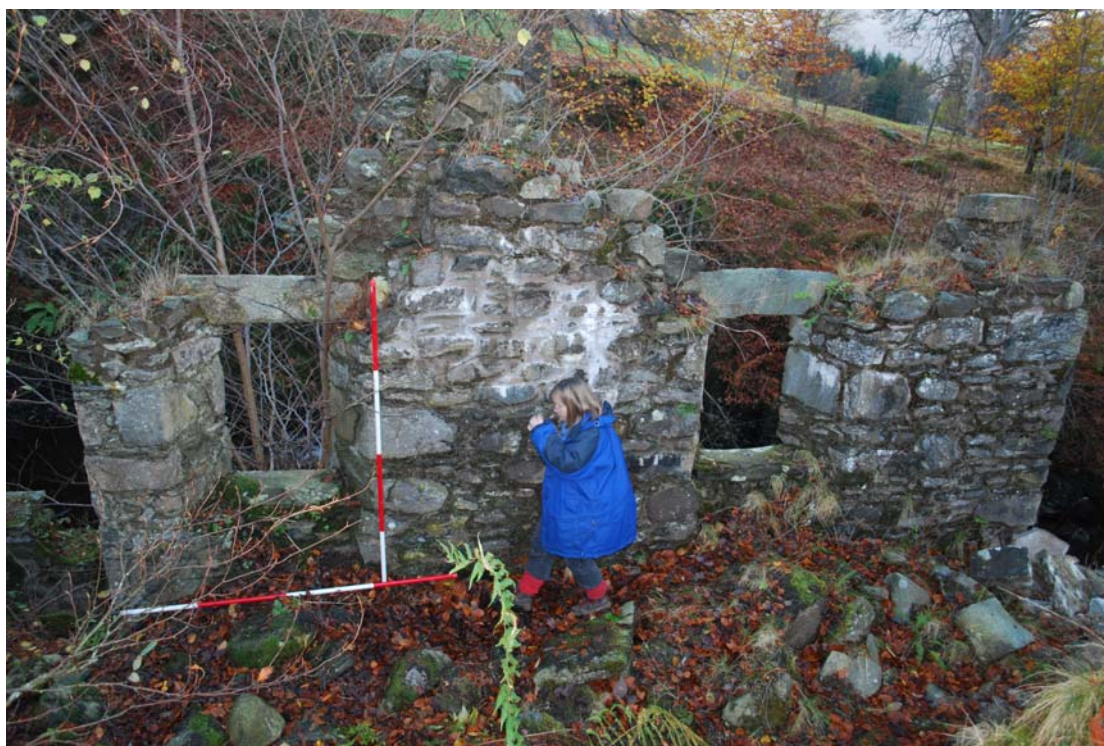
Two windows are present in the wall and the height of upstanding masonry above them suggests there may have been another third storey to the structure. This makes sense when considering the height of the ground to the E of the mill building where it appears a yard had been built up against the E side to the same height as the top of the second storey. However, the 1878 painting indicates that it was simply a high upper storey as opposed to two separate upper storeys. It is of note that one window had a re-used sandstone sill which was a smooth dressed sandstone block with a hole for a window bar drilled in it. This was the only piece of re-used masonry observed in the structure.

The interior elevation of the W wall of the mill building, Element 10 and Jennifer Robertson. Note the collapsed stones in the interior. View to the W.

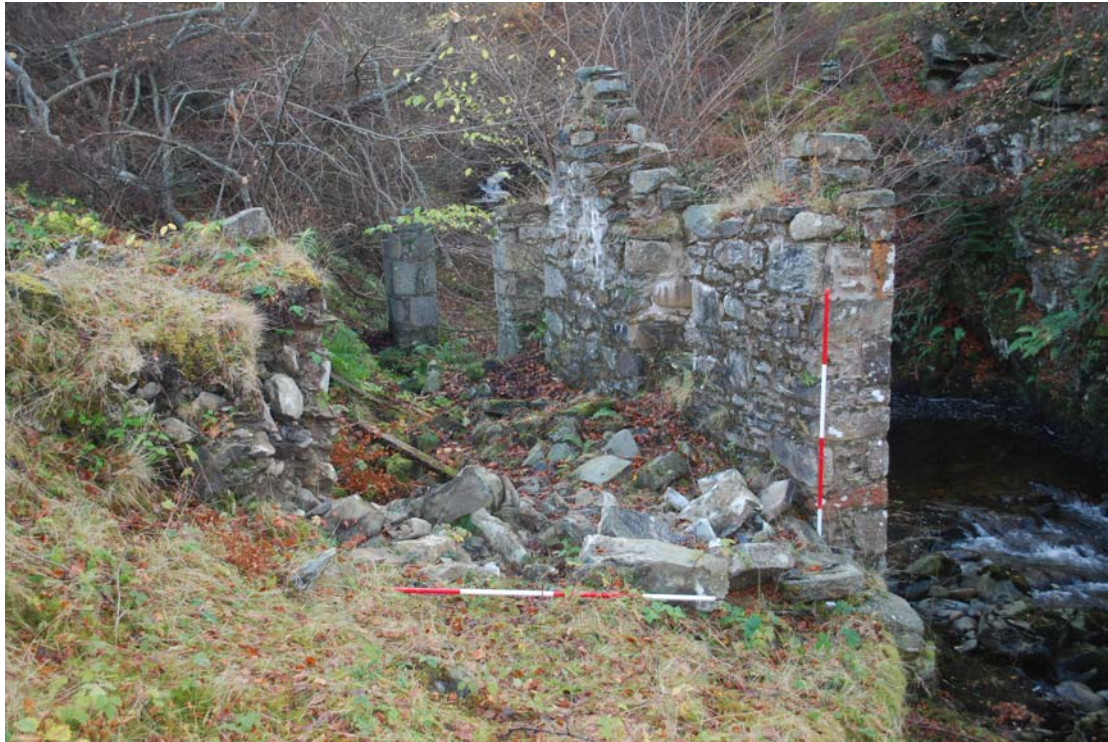
The interior of the mill building was rough uneven ground with frequent collapsed stones, fragments of wooden planks and broken red tile fragments. One 0.20m x 0.20m square wooden beam fragment in the interior might have been part of the wheel's structure. The interior stands c. 0.6m higher than the top of wall Element 9 though it is likely the floor level would originally have been flush with this wall head and this build up of material in the interior is collapse. The interior measures 11.5m x c.3.2m.

View to the S of the interior of the saw mill building showing the interior of the W wall Element 10 and aperture to the wheel pit. On the left side of the photograph the collapsed E wall and exterior platform are visible.

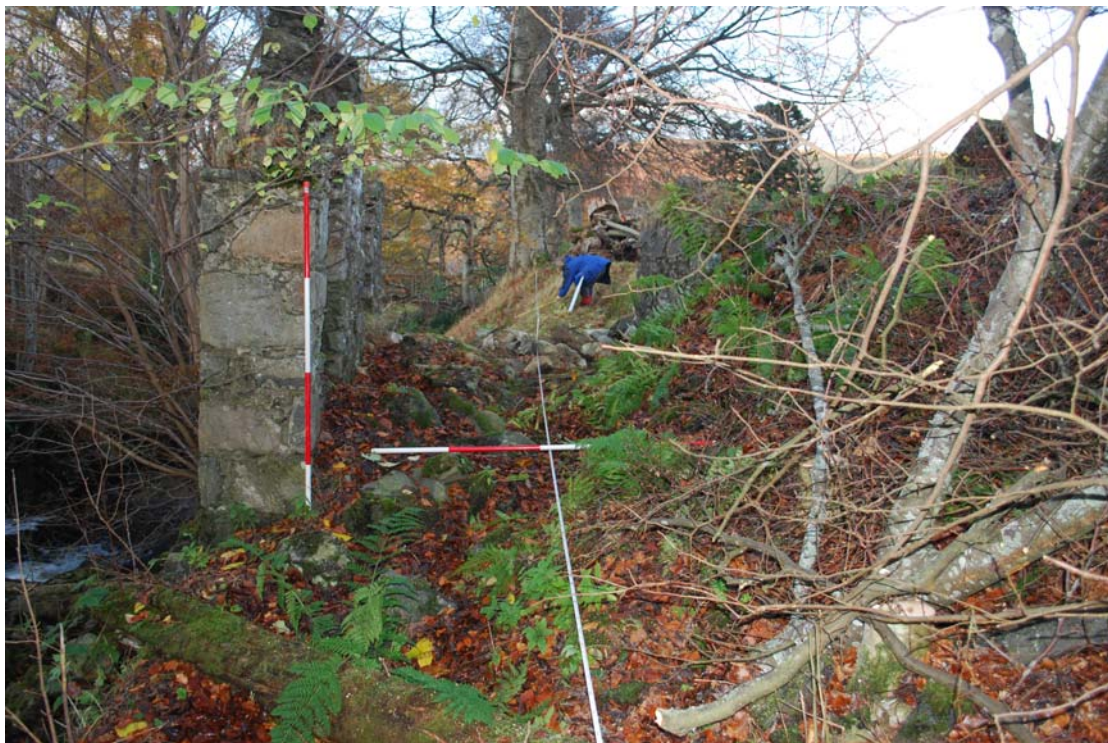
View of the mill building's interior from the S. Pillar Element 19 is at the left of the photograph.

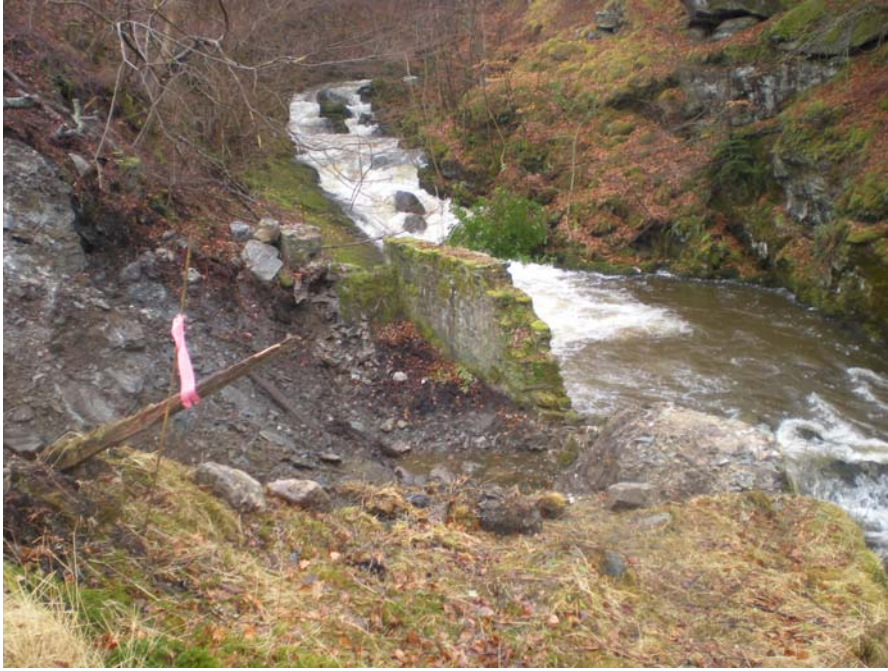
View of the saw mill Site 22 following demolition, note the S and W walls of the wheel pit (Elements 5 and 7) have been retained.
