**Ardvorlich Estate
Hydro Scheme**

**Report on
Archaeological Work
Desk Study, Survey, Standing Building
Recording and Watching Briefs**

**Ardvorlich Estate and
Hydroplan UK**

February 2011

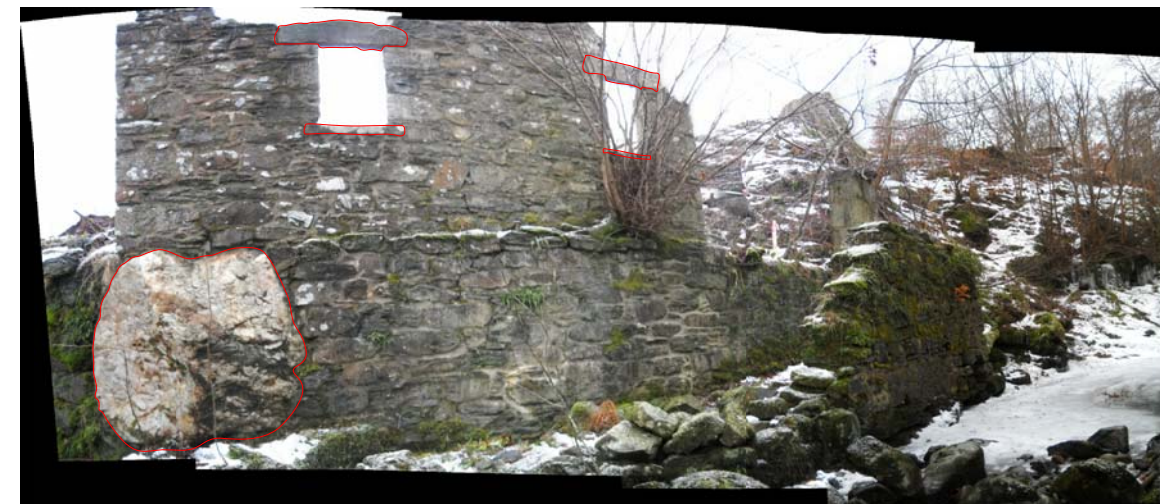
PHOTO DETAILING KEY BUILDING STONES (RED)

1. CONSTRUCT ACCESS FROM BR4 TO POWERHOUSE
2. MARK, REMOVE & STORE KEY BUILDING STONES ON PALLETS (SEE BELOW PHOTO)
3. DEMOLISH & EXCAVATE STRUCTURE TO 14mAOD. ALL STONE MASONRY FROM STRUCTURE & EXCAVATION TO BE COLLECTED AND STORED FOR INTERGRATION INTO THE NEW POWERHOUSE
4. SEDIMENT PROTECTION & DRY WORKING AREA TO BE ESTABLISHED ACCORDING TO BEST PRACTICE
5. FOUNDATION WORKS & TAILRACE CONSTRUCTION
6. SUPERSTRUCTURE CONSTRUCTION
7. STORED STONE MASONRY RETURNED TO SITE AND USED TO STONE CLAD BUILDING. KEY BUILDING STONES TO BE RE-INTERGRATED IN SAME FORMAT.
8. POWERHOUSE AREA TO BE LANDSCAPED.

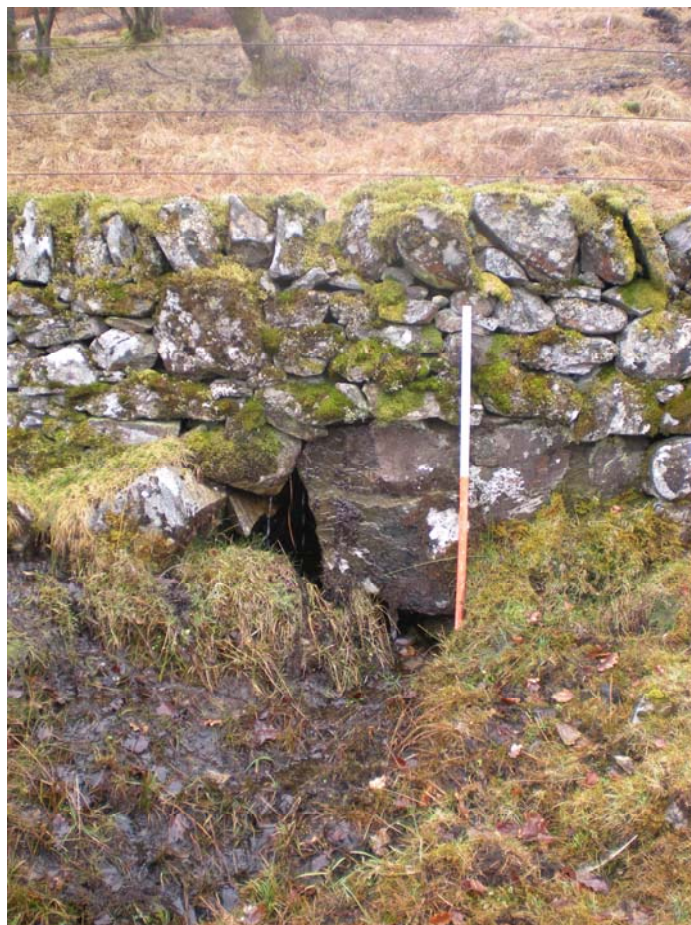
Culvert 18A, on the N side of Wall Site 18, start of drain Site 19. View to SSE.

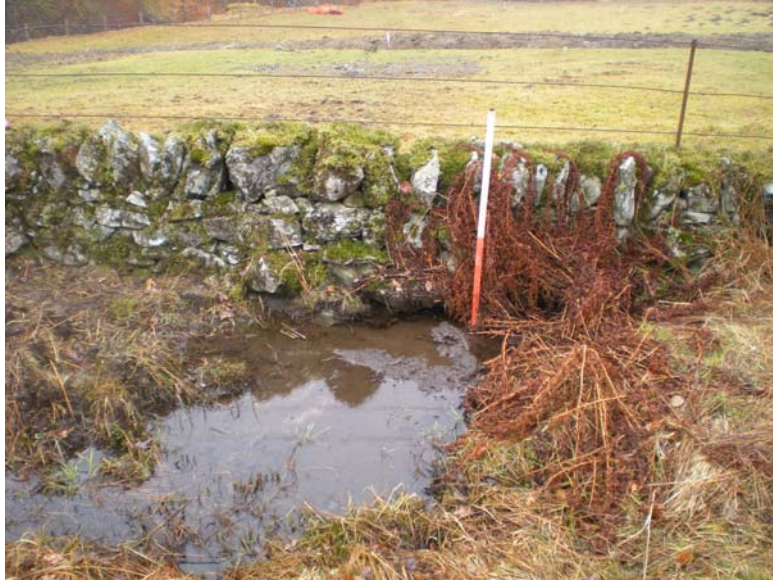
Culvert 18A, badly silted up, on the south side of Wall 18, View to NW.

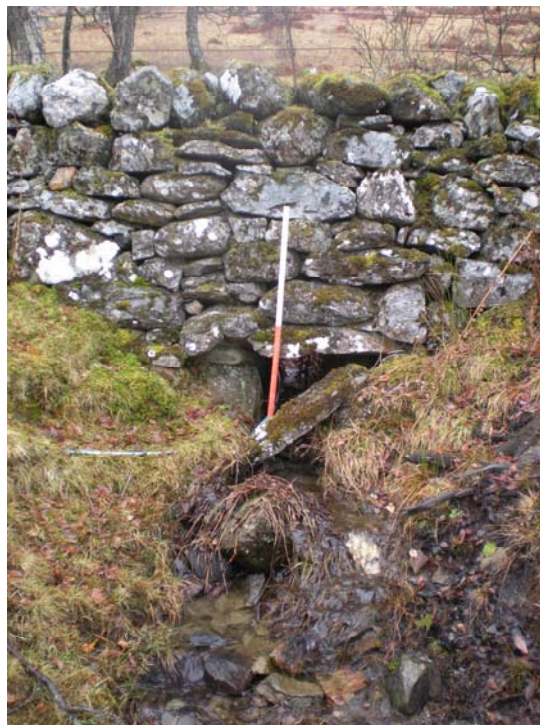
Culvert 18A in wall Site 18, view to the SSE.

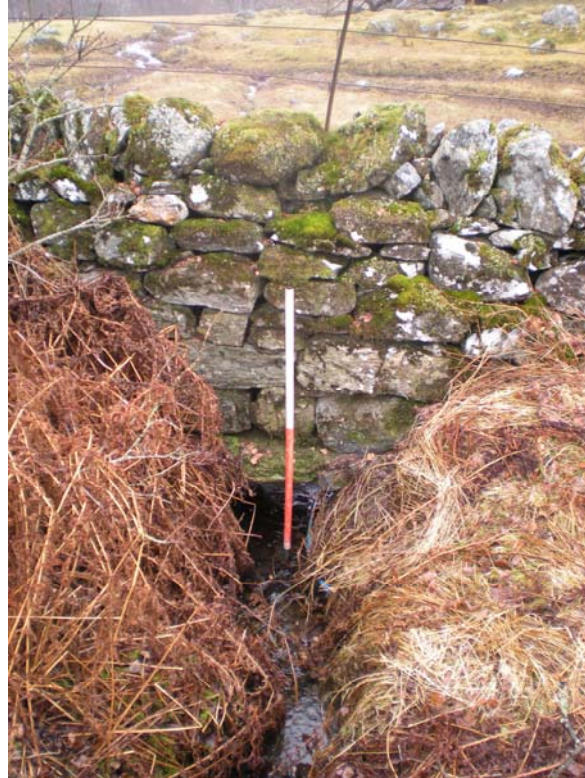
Culvert 18A in wall Site 18, view to the NNW.

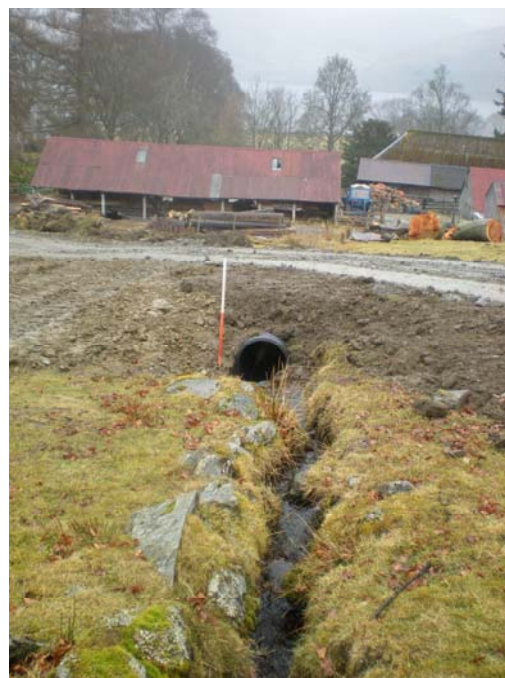
To the north the new access road, which is an upgrade of an existing track, crosses over the stone lined drain **Site 19**. A plastic pipe culvert has been placed on the line of the drain where the road crosses it. The disturbance to the stone lined drain is minimal, its flow has not been altered and it continues to the north of the new road.

Site 19 drain showing new pipe under built up upgraded track and farm buildings Site 23 in the background.

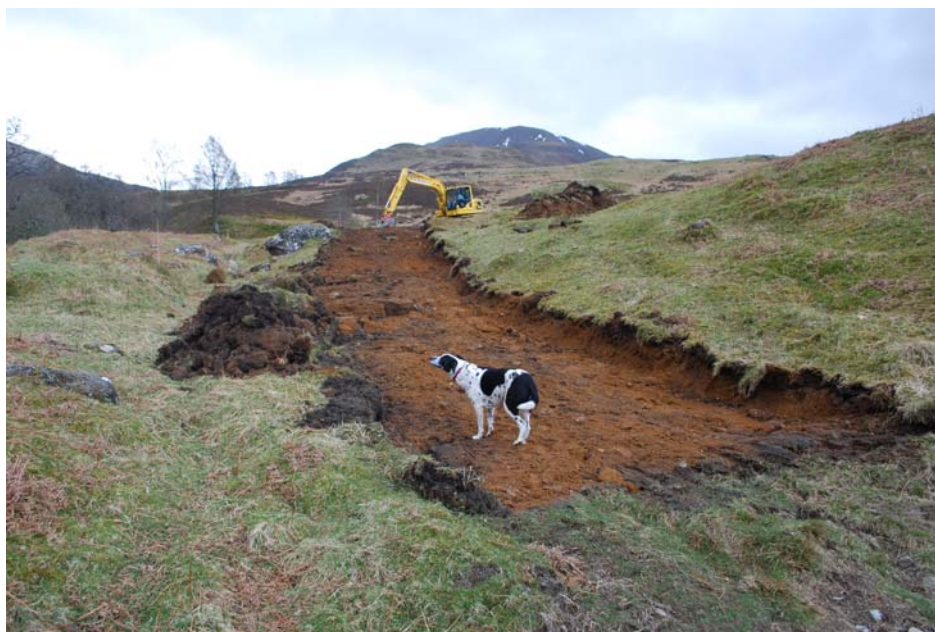
Excavation of existing track Site 4 to upgrade it and install pipe and knoll that was cut back on the right of the picture. View to the S, machine is at the turn to the W to Intake 5. Individual spoil heaps utilised to avoid dumping on shieling sites.

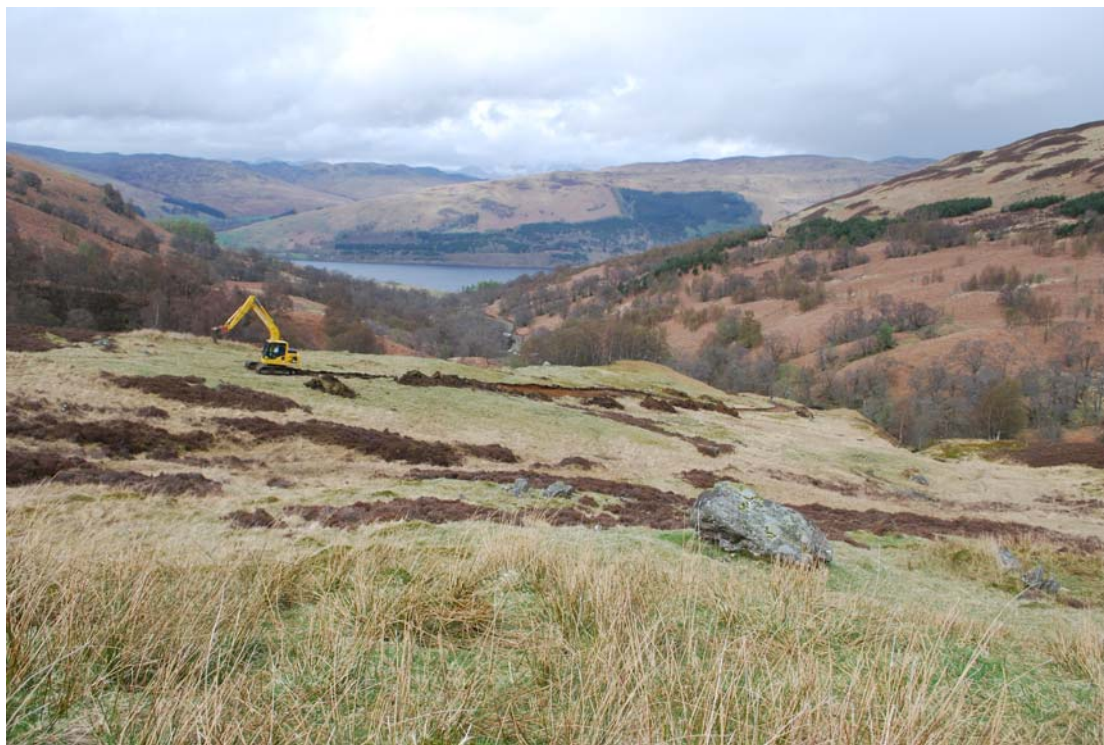
View over excavations of pipe route to Intake 5, view to the N from Site 2.55.

The new pipe route track W to Intake 5 from the existing track **Site 4** is between 3.50m and 3.60m wide and the depth of excavation varied between 0.30m and 0.50m deep. Basically the peaty topsoil and natural boulders were removed to compact subsoil level. In better drained areas the topsoil was grey-brown silty clay with some orange mottling and was 0.20m or less deep underlying 0.05m of peaty humic soil. The subsoil was orange sandy clay with frequent sub-rounded and sub-angular cobbles and boulders. Once the subsoil has been reached it is spread and compacted as the track surface. The minimum of excavation was undertaken to create the new pipe route track to Intake 5. GPS points were taken along the line of the existing track and new pipe route track where excavations were monitored and have been plotted on the plan of the shieling ground **Site 2**. The new pipe route track runs to the N of **Site 2.17** and the S of **Sites 2.16, 2.11, 2.12 and 2.13**. **Sites 2.1, 2.2, 2.3, 2.4 and 2.9** are located on the S side of the new pipe track. A small works compound area measuring 13m x 13m was cleared of topsoil to the NW of **Site 2.18** at NN 63191 21360, NN 63198 21352, NN 63199 21268 and NN 63209 21360 (corners). All of the archaeological sites were avoided and undisturbed by the development. The Intake 5 pipe track will be entirely backfilled and return to vegetation.

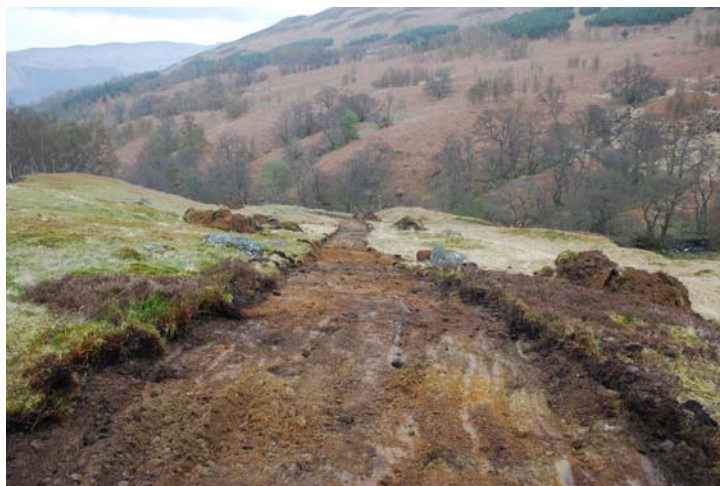
View to NNE along pipe route for Intake 5 as excavated.

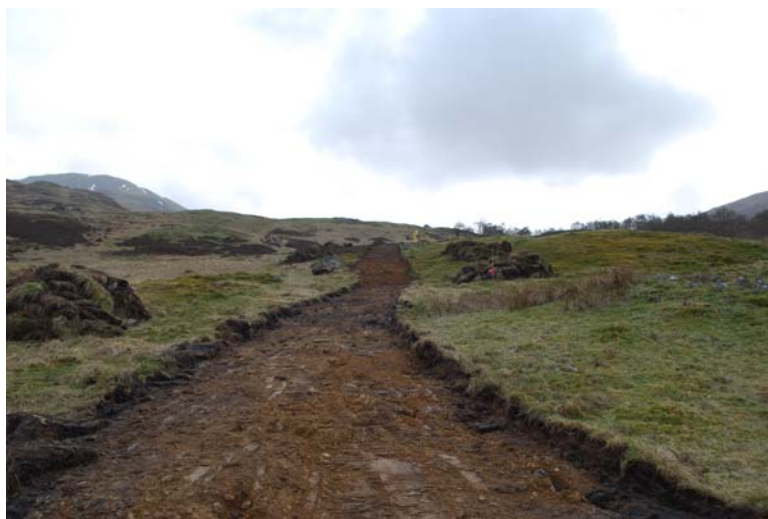
View to SW along pipe route to Intake 5 as excavated from the junction with existing track Site 4.

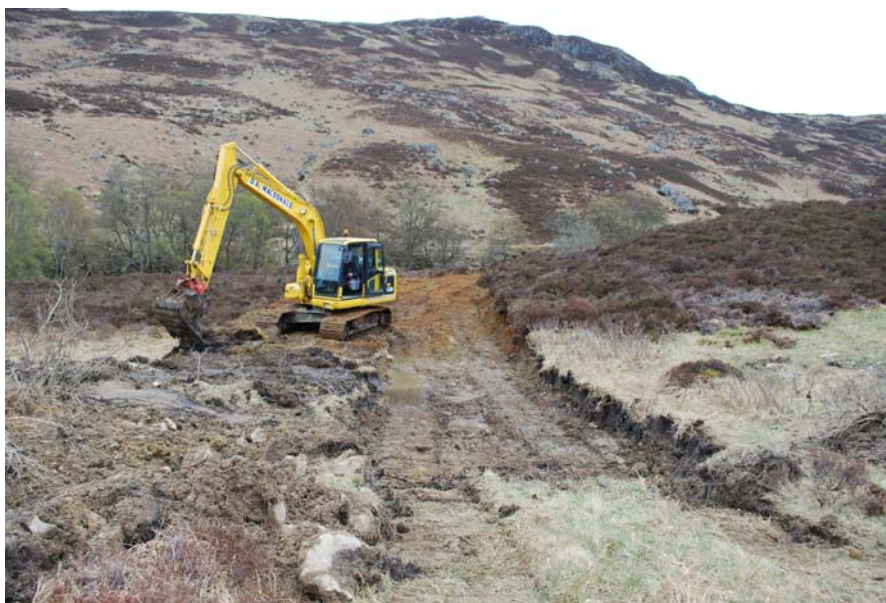
A watching brief was carried out by Fiona Baker in dry, overcast conditions with some sunny spells of the new pipe route between Intakes 6 and the existing track **Site 4**. The identified sites in this area, **Sites 2.49, 2.50 and 2.51** and the whole length of the track were subjected to archaeological monitoring. All archaeological sites were avoided by the development and remain undisturbed. The existing track **Site 4** remains undisturbed to the S from the junction of the new pipe route from Intake 6B with **Site 4** at NN 63440 21090. The new pipe route is between 3.50m and 4m wide and the average depth of excavation was 0.50m but in places was up to 2m deep where it cut through knolls. The excavation area monitored is between NN 63563 21012 and NN 63411 21122. The trench for the pipe will be excavated to approximately 1.5m wide and 1.2m deep in this track but this was not observed as the absence of archaeological remains was confirmed by the monitoring of the main track.

General view to the E over the pipe route to Intake 6B.

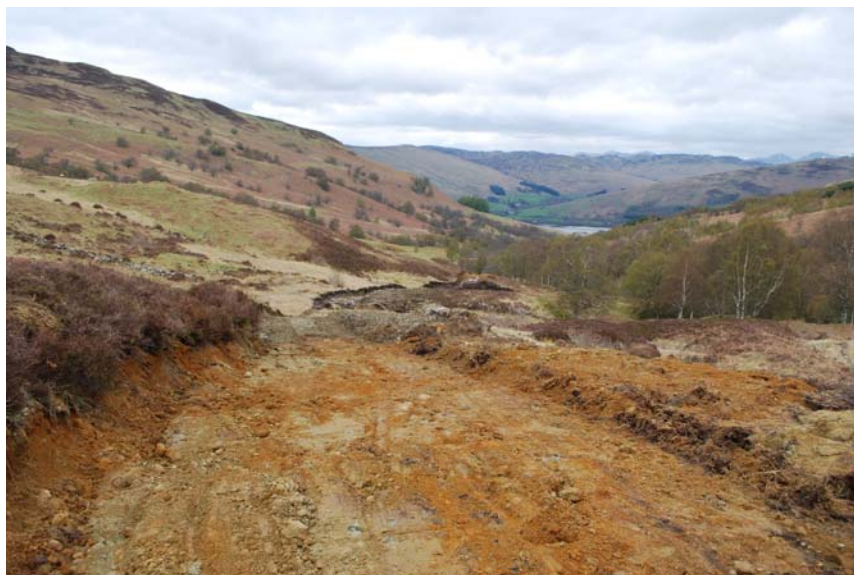
General view to the NW over the pipe route to Intake 6B.

The soil conditions varied depending on topography. On the higher and drier knolls the subsoil was orange clayey sand. In the lower lying area peat on pale brown stony clay was present. The excavations were shallower on the higher and drier areas of orange clayey sand and deeper in the areas where peat had formed. The spoil for the excavations was cast to the S side in the vicinity of **Sites 2.49, 2.50 and 2.51** to ensure the sites were not disturbed during backfilling and to the N side of the pipe track along the rest of the route. The overall width of disturbance along the new pipe track was between 6m and 8m.

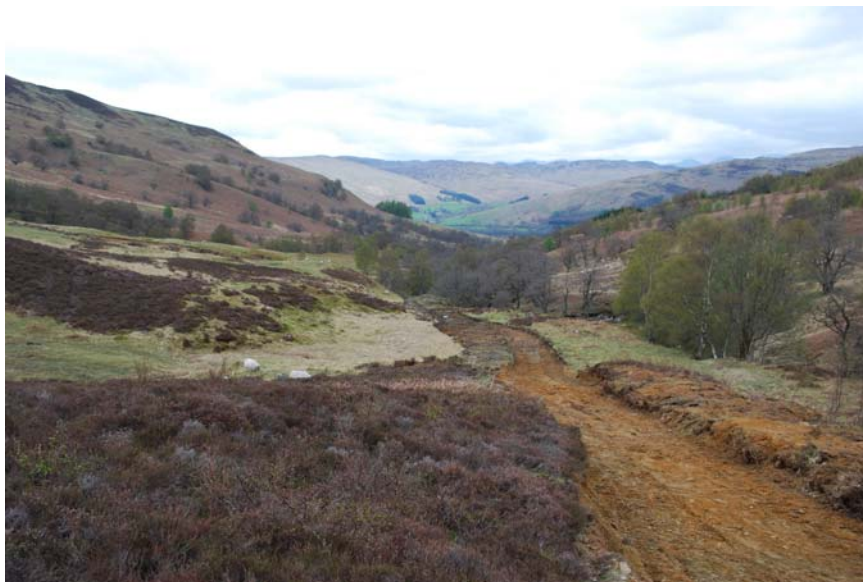
The excavations now continued on the line of the existing track **Site 4** on the S side of the Allt a Coire Bhuidhe. The excavations in this area are to upgrade the existing track, which had been cut to subsoil level when it was originally built. The new excavations to upgrade the track removed 0.10m of silt and regraded the track. On the S side of the Allt a Coire Bhuidhe burn the ground rises up and turns a slight corner around the edge of knoll at NN 63234 21478.. The edge of this knoll was removed to straighten the track and line of the pipe which will be in the track or just to the W of it at this point. No archaeological sites were affected. The spoil from the removal of the end of this knoll was infilled into a natural depression at the bottom of the slope on the E side of the track.

General view to the N of upgraded track Site 4 as excavated.

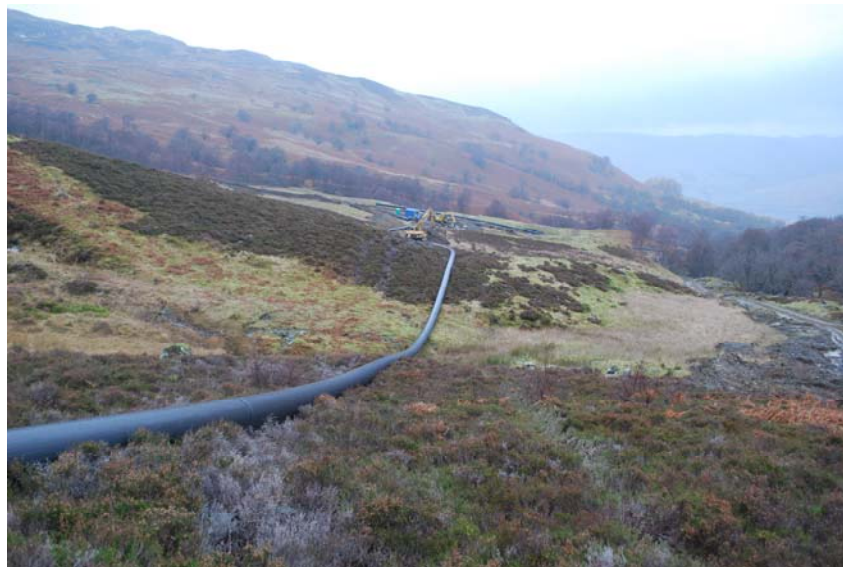
A watching brief was carried out by Fiona Baker of the pipeline branch that crosses over the shieling ground between **Sites 2.22 and 2.18**. The weather was very poor and dark with wind, rain and sleet. Snow was lying further up on the hills. The pipe trench is generally 1.50m wide and on average 1m deep although it was necessary to

dig as deep as 3m in places due to crossing over a knoll so that there would be sufficient fall for the flow of water in the pipe. Wet ground, peat and collapsing baulks made the machine excavations difficult at times. The excavations were undertaken with a toothed bucket under archaeological supervision. The excavations commenced at the small compound located at NN 63232 21354 to the N of **Site 2.18** and the pipe route runs 5m to the NW of **Site 2.18**. **Site 2.18** was avoided and undisturbed by the excavation work. The pipe route passes in between **Sites 2.27** and **2.28**, where the pipe trench is 2m deep, and both sites were avoided and undisturbed. The pipe trench passes to the W side of **Site 2.22** and again the archaeological site was avoided and is undisturbed by the development.

General view to the NW of the pipe route across the shieling ground.
