BLAIRS
ABERDEENSHIRE

Part 3:
Standing Building Survey
of the Steading

Carried out March 2012
by
Murray Archaeological Services Ltd

Report No: MAS 2012-08
by
H K Murray and J C Murray

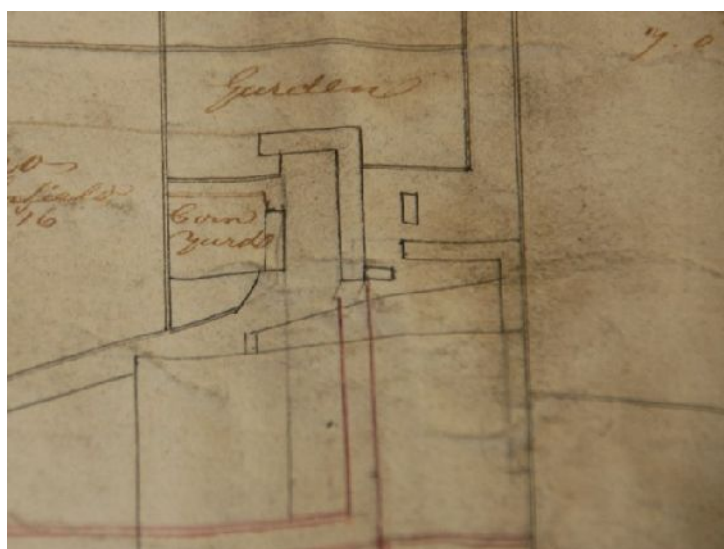
Illus 107 18th century estate plan (Blairs Museum T6270 BLRBM)

The 18th-century plan (Illus 107) shows an L shaped steading to the S and E of what appears to be the mansion. This line is continued S by a pencilled range. Other buildings lie on the N and E of the cornyard which is situated W of the buildings. Some parts of the SE range may have been incorporated into the later steading but it is difficult to identify individual buildings. The mill was one of the Improvement additions and is not shown. Nor can the doocot be identified. The cornyard was moved from this position as part of the Improvements. The building on the E side of the cornyard appears to be on the same footprint as the old chapel (see Part 2 of this report).

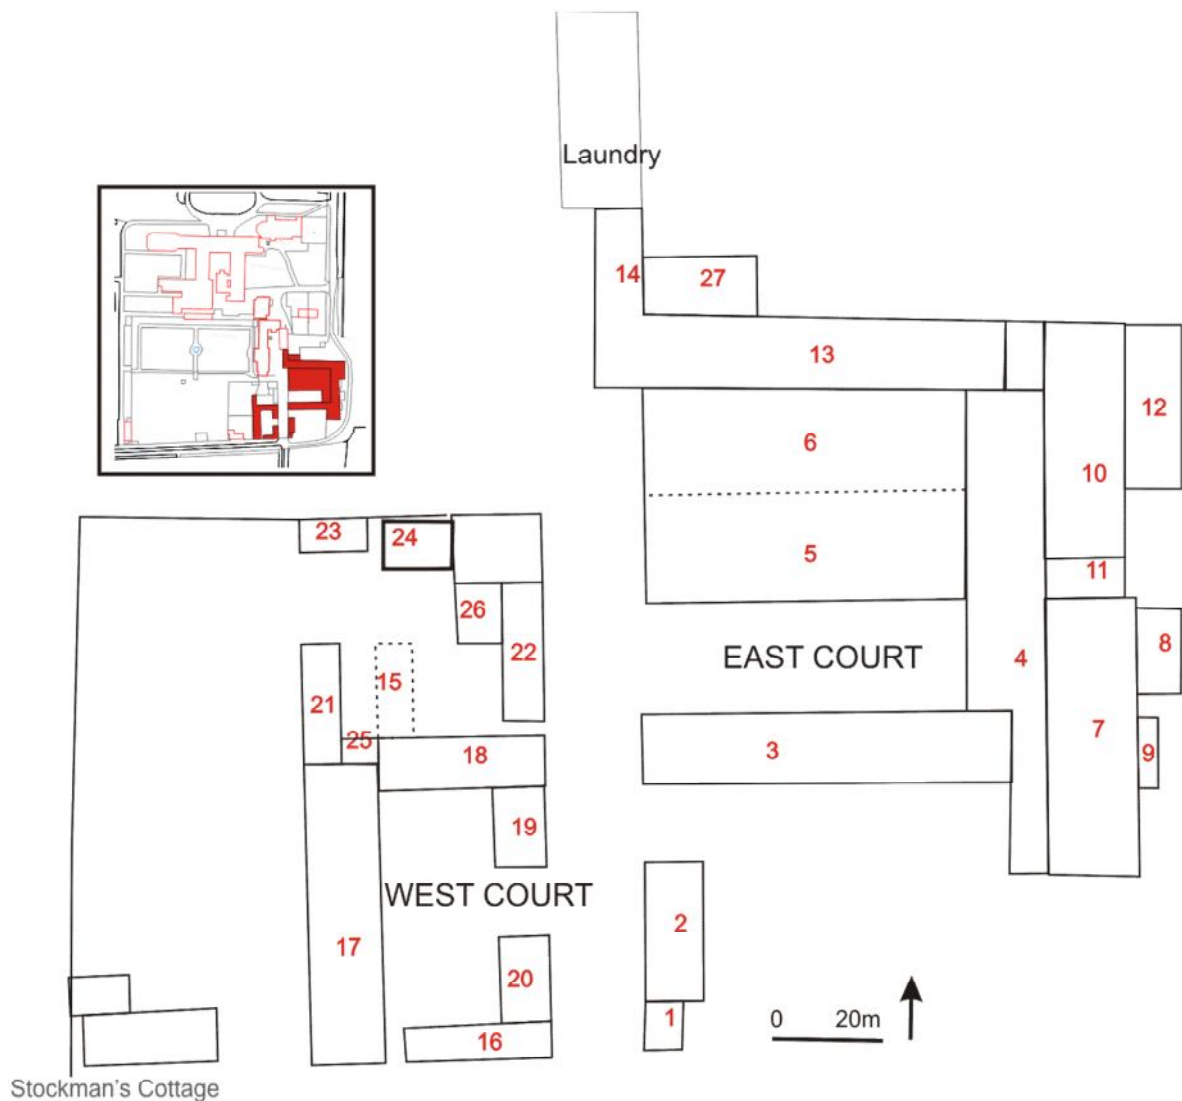
Illus 108 Plan of steading Inset location based on OS. Reproduced from Ordnance Survey digital map data, © Crown Copyright, All rights reserved. 2012. License No 0100031673)

As it now stands the steading comprise two separate courts to the E and W of a central passage with a small number of ancillary buildings added at different times. The table below indicates on which maps each building is shown. Illus 108 shows the overall plan with the numbering used in this section of the report. Details are shown in Illus 121, 122.

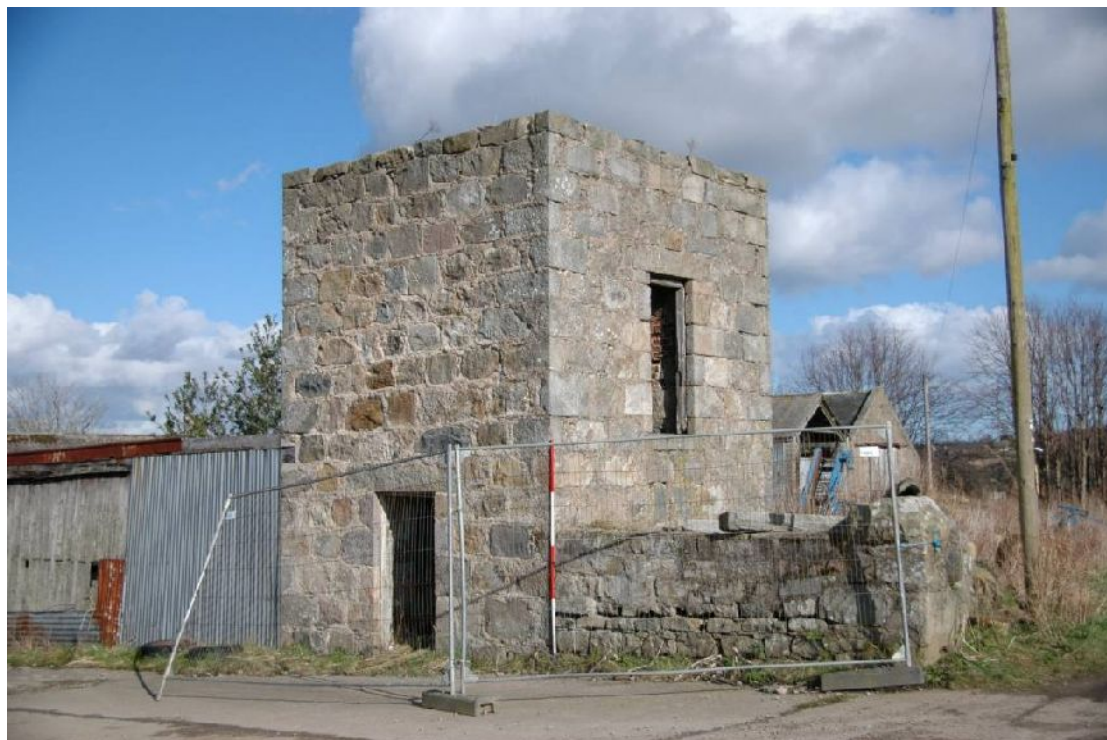
Illus 109 Doocot looking NE

Square plan of squared granite rubble c. 700mm thick with small cherry pinnings. A ground level door faced W to the road through the steading. This appears to have opened into a small chamber c. 1.8m high at ground level with joist holes indicating the floor of the pigeon loft above this chamber. The ground floor chamber is full of collapse from the roof etc and there is no indication or oral knowledge of its function. The pigeon house was entered from the S at 1st floor level with a wooden door. Two iron hooks below the door suggest access was originally by an external ladder but subsequently the ground on the S side of the doocot has been built to a ramp.

W door: 1.75m high, width at outside: 930mm with inner rebate for door.

S (upper) door: 1.75m high 800mm wide.

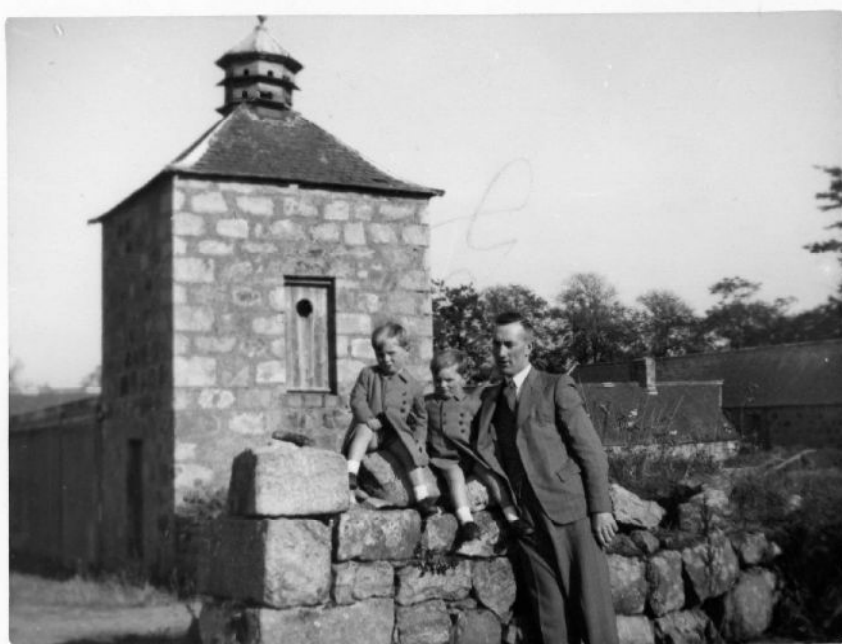
Illus 110 Doocot in the 1950s (Blairs Museum 712)

Now missing, this was a pyramidal-form slate roof with birch lining. A (hexagonal?) cupola or glover at the apex provided two rows of flight holes and ledges for the birds to alight on. A Photograph c. 1950s shows the detail (Illus 110)

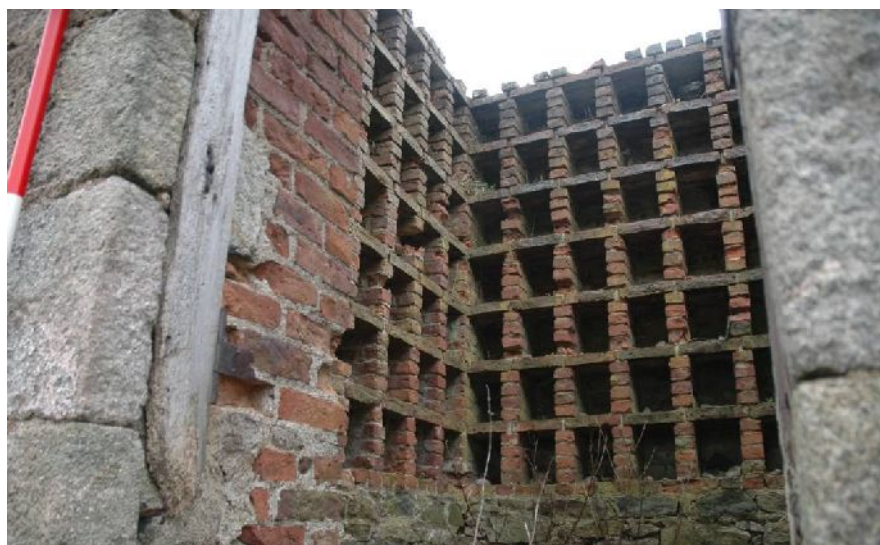
Illus 111 View into doocot through upper (S) door showing nesting boxes

Brick-built nest boxes lined the walls of the upper chamber from c. 700mm above the floor. On the N, E and W walls there appear to have been 7 rows of 8 boxes, with fewer on the S wall because of the door. The boxes are 320mm high, 250mm wide and 380mm deep. The bricks were 220-230 x 100-110 x 70mm and hand-made.

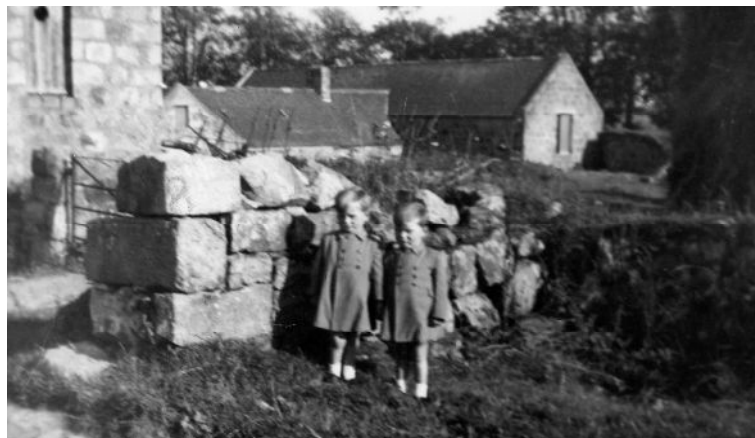
Illus 112 From beside doocot. Building 7 gable and building 3 abutting it. (Blairs Museum 715)

Roof Reroofed with metal frame with corrugated asbestos, plastic roof lights and ridge ventilation. A photograph c. 1950s (Illus 112) shows the E end of the building with a slate roof abutting Building 7 and a chimney at the E end. This appears to show a W gable further to the E than the present W wall.

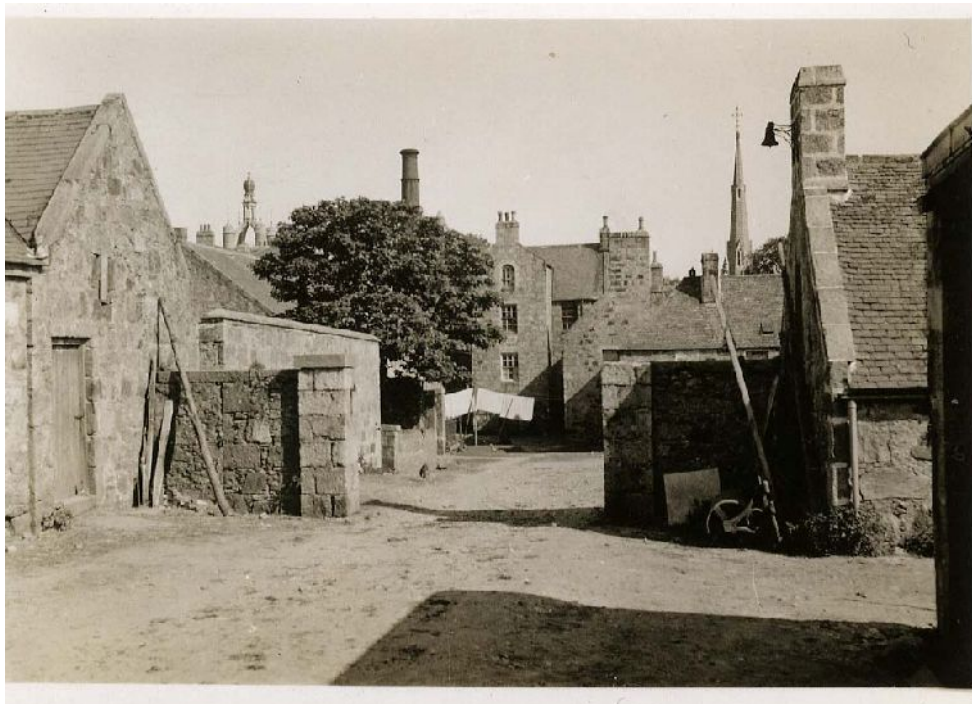
Illus 113 Looking N, showing gables of Building 18 (LHS) and Building 3 (RHS). Note gateway into the main yard. This is shown on maps from 1842-1923. (Scottish Catholic Archives CH/SCA/PG/964)

Another photograph (Illus 113) shows the building extending to the present line – it is possible that this was originally two buildings, later joined. This photograph shows a chimney over the W gable with a bell.

Date of construction The wall shown from 1842. Also see this as a wall in photograph Illus 113, so possibly the lean-to is post c. 1950.

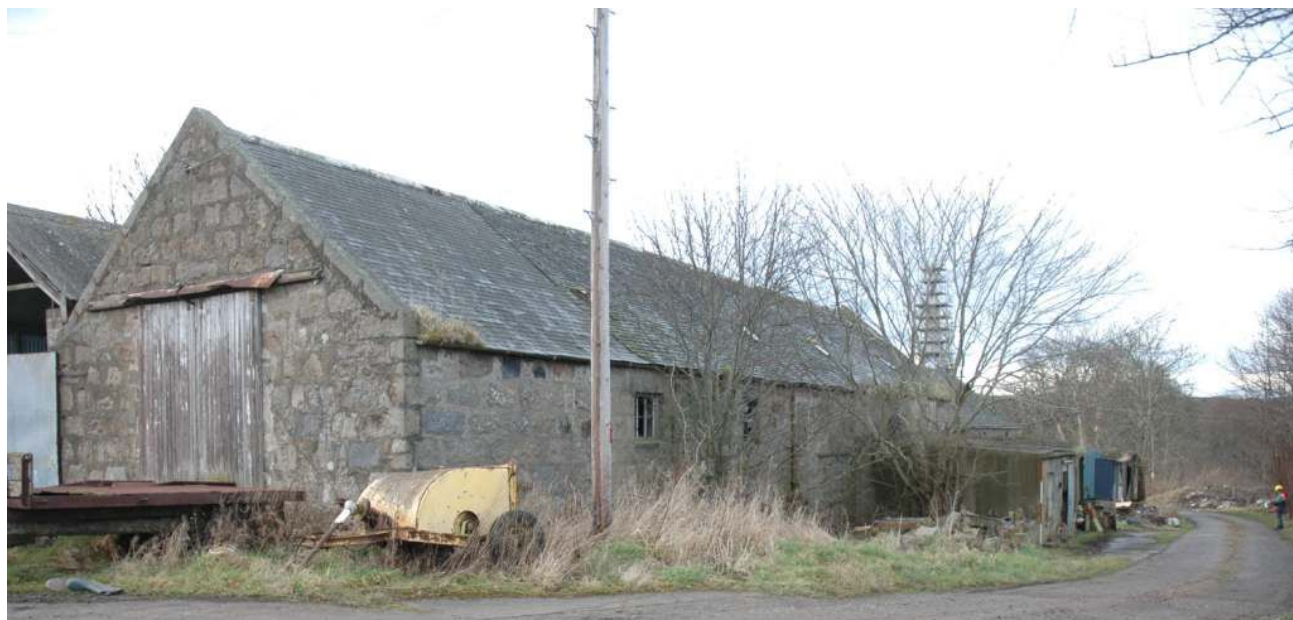
Illus 114 Building 7: The Mill, looking NNE. The wheel would have been near the position of the small tree behind the GPO pole.

Description Two-storied building originally with attic grain store above mill (Illus 114).

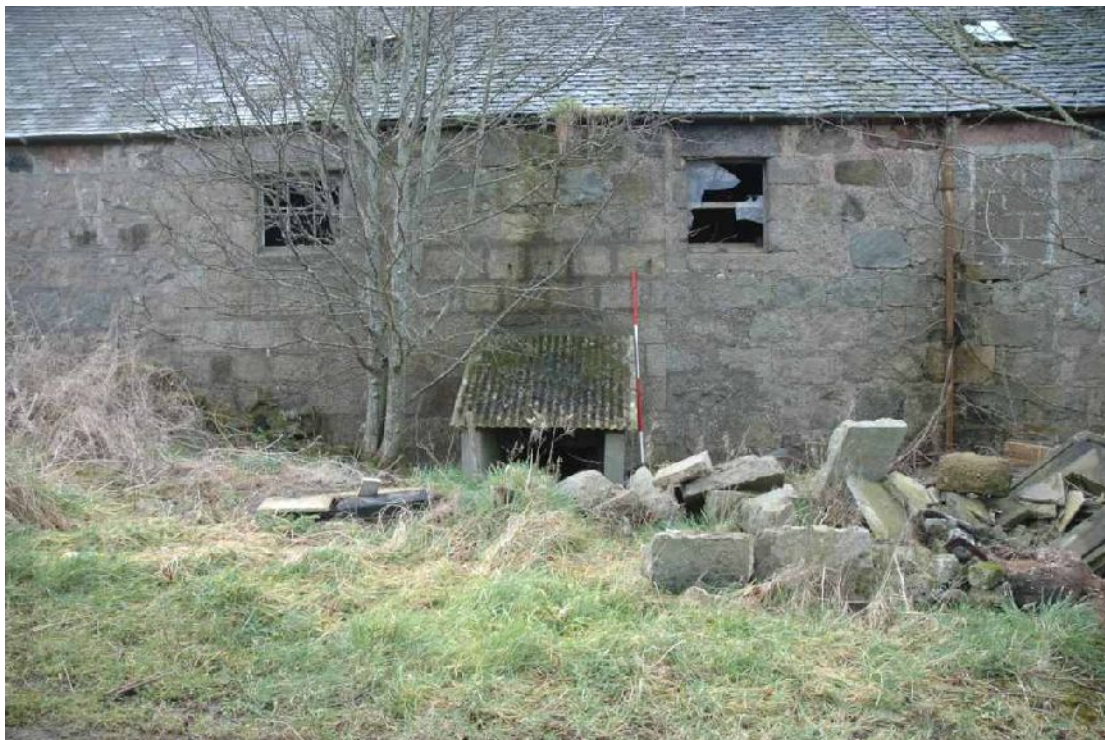
Illus 115 Ranging rod on RHS of ashlar section of wall where mill wheel would have been fixed.

Walls Large rubble stone blocks with dressed granite at rybats and skewes. Skewputs with upper curved recess to hold skew stones. Granite ashlar in E wall beside original wheel pit where mill wheel originally attached (Illus 115). Original 4 windows on E and W into grain loft. Door blocked at attic N gable for access through to Building 10/11.

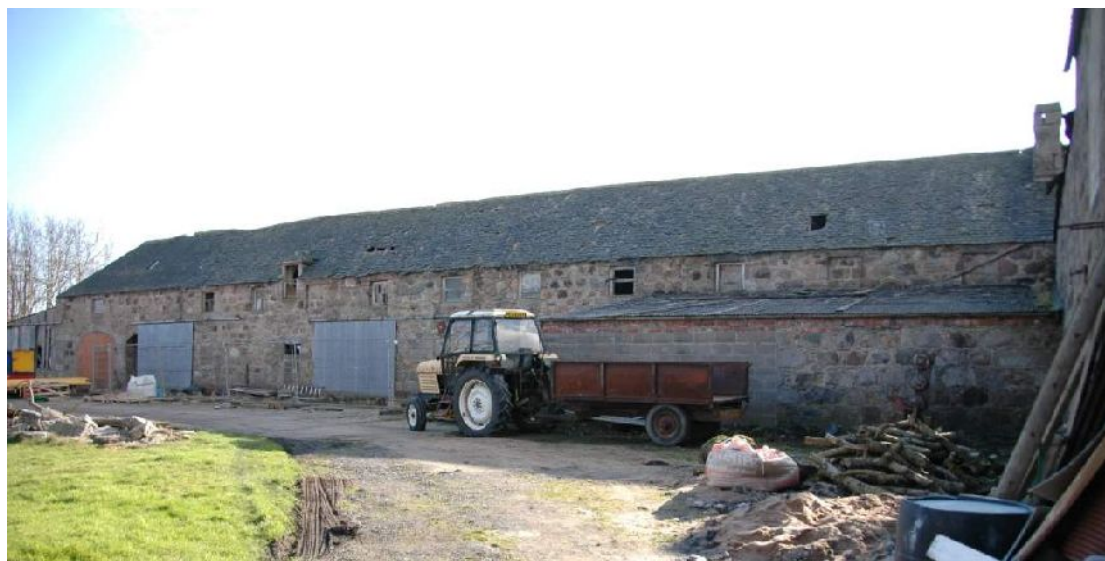
Description Two storied building forming N end of E range (Illus 116), N end continued by arch over entry of original 1828 road to steading (Illus 117). The attic level continued over arch and opened into Building 13 attic. Slightly narrower and lower than Building 7 to which it was linked by Building 11. Granite archway in N wall with iron pivots for double doors now replaced by modern doors. There is a small door in W wall into entrance archway. This N end may have been a carriage bay; the doorways suggest it was divided off internally. To the S of this there is a window, then two high doors 2.55m high and 1.25m wide) with narrow vertical ventilation slits. This suggests the S end may have been stabling for carriage/riding horses. There is an attic above with a blocked opening in the S gable and attic windows to E and N (W obscured by Building 12). The S gable also has a blocked opening at ground level.

Illus 116 Looking SE across the frontage of Buildings 13 and 10. Note the arches at far end (Building 10). The LHS arch was carriage bay. Next to it, partially covered by metal door is archway into central courtyard.

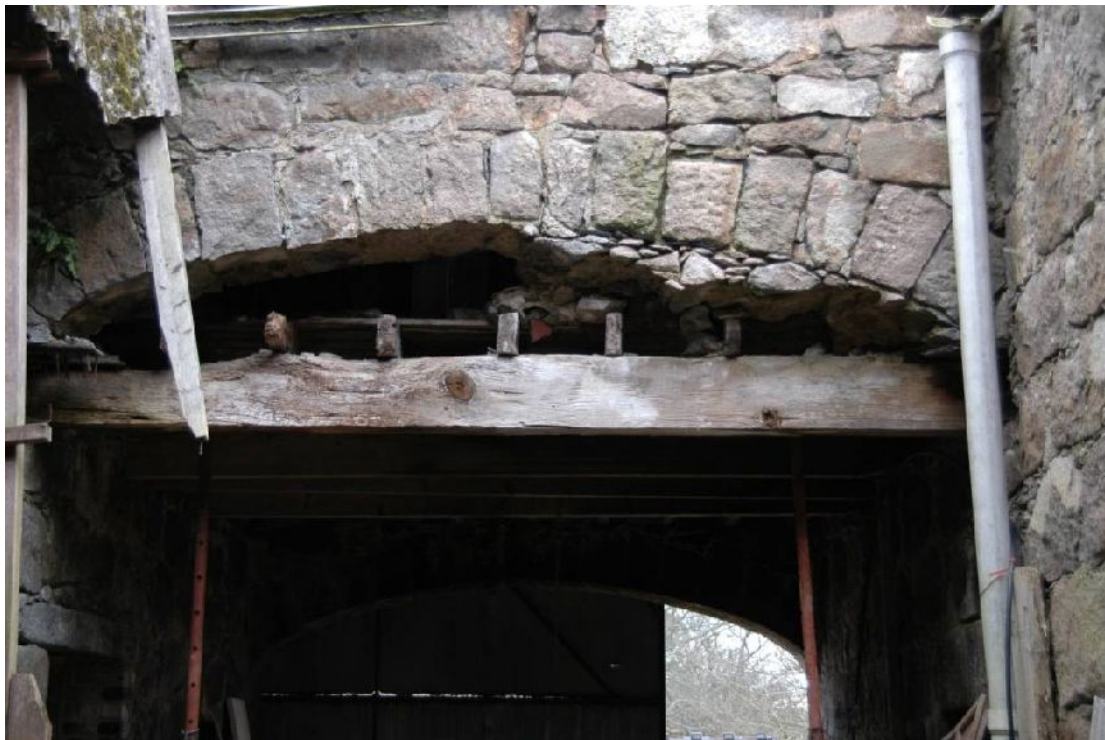
Illus 117 S (Inside) of archway over road into courtyard. Building 10 RHS, Building 13 LHS. Attic continued across above arch.

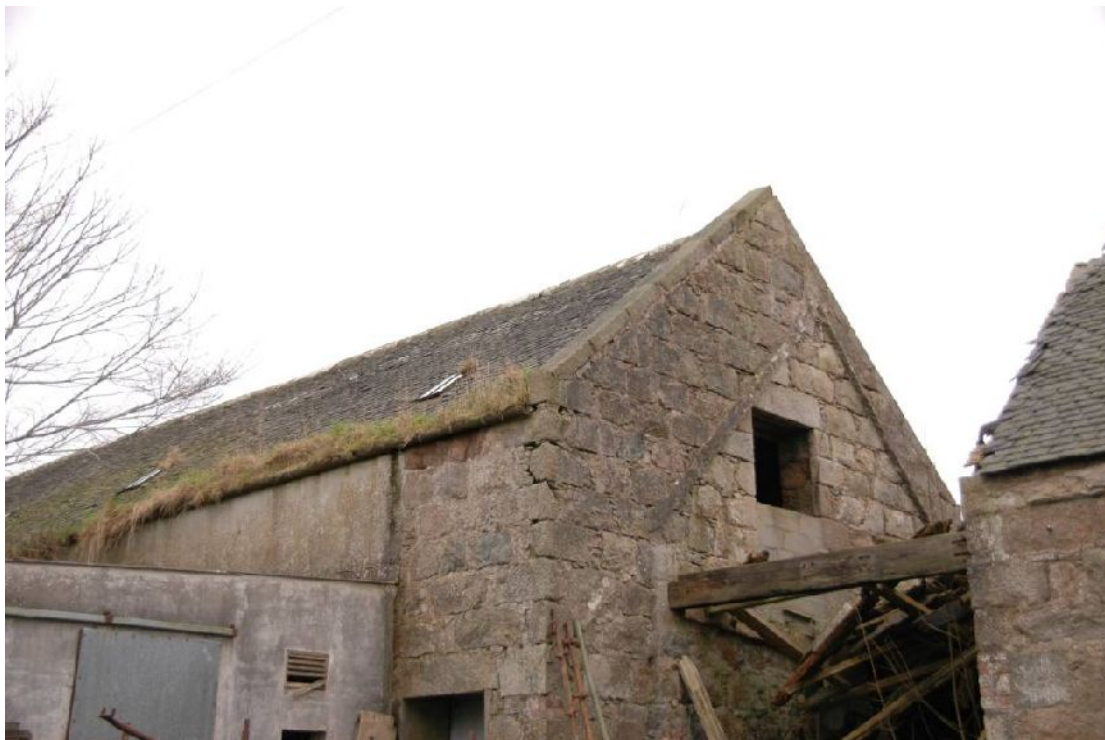
In its present form it is much collapsed but the stone wall has clearly been replaced by concrete blocks.

Illus 118 Remains of Building 11 between building 7 (LHS) and Building 10 (RHS)

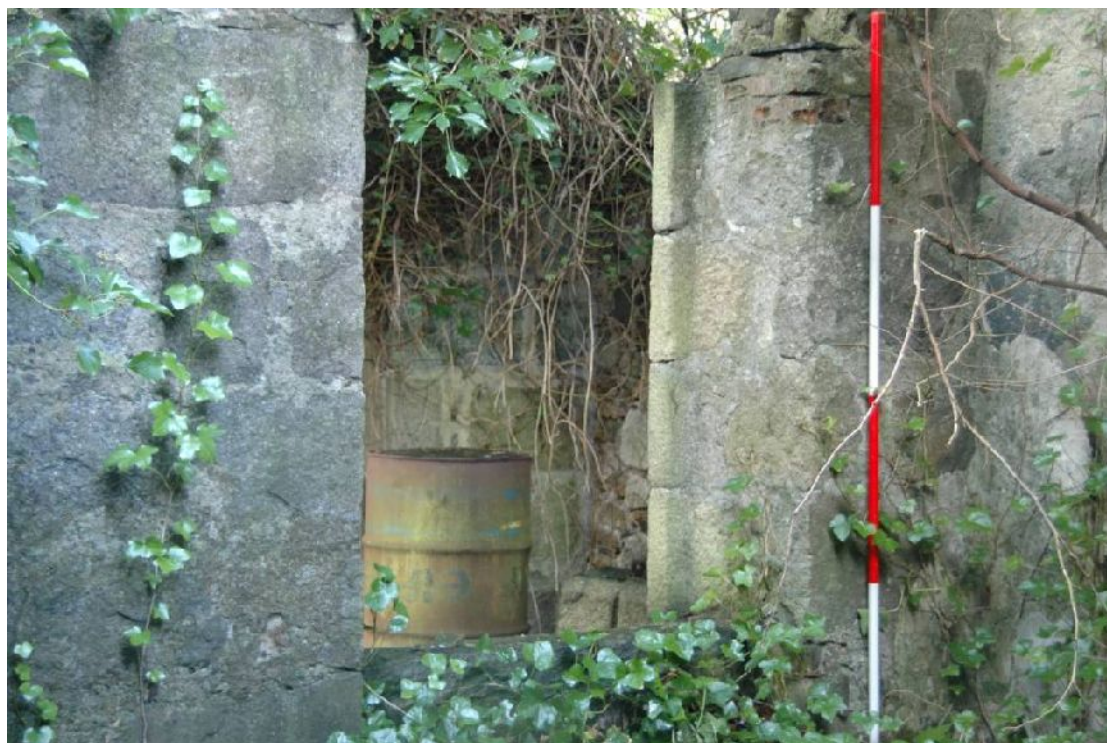
Walls Squared stonework with well dressed granite lintels, sills and rybats. Large window (1.45m high x 0.93m wide) in the W wall (Illus 119) with door (1.85m high x 0.93m wide) beside it. A second door in the E wall. Blocked window quite high in S wall.

Illus 119 Building 24, detail of window molding.

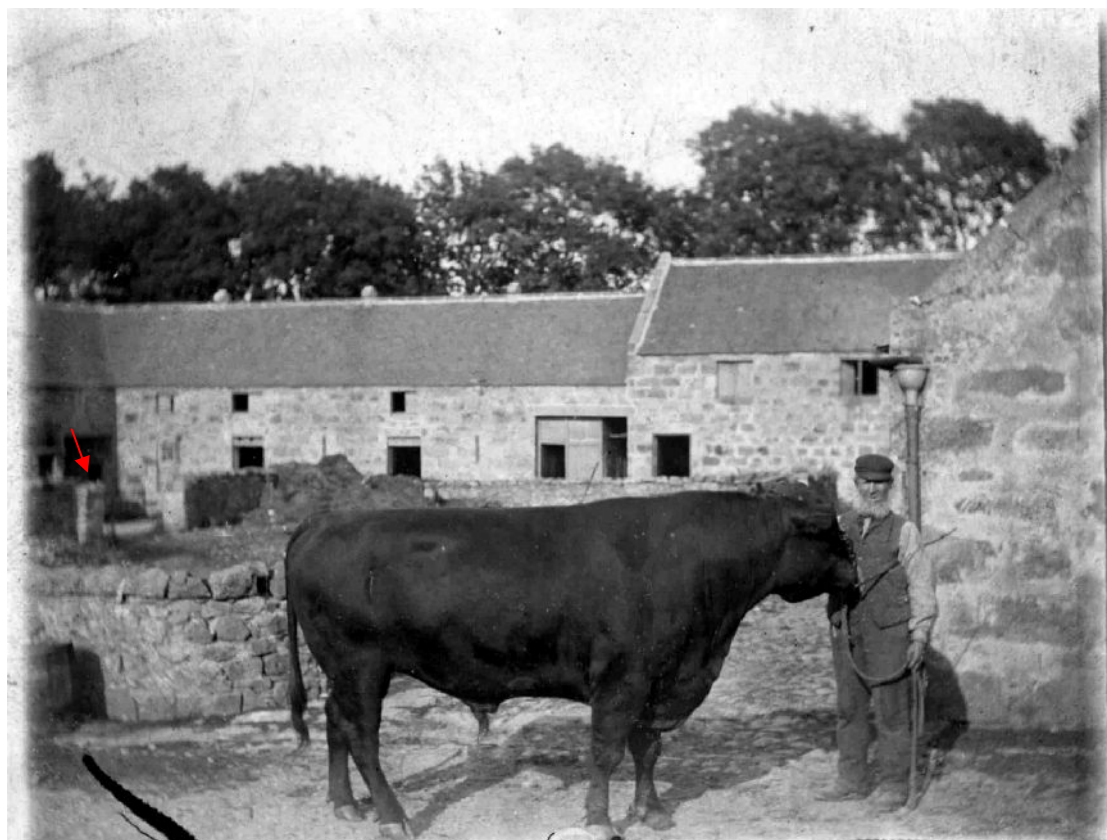
Walls Infill between the N and S buildings of E range with access through attic level between the two. A photograph (Illus 120) shows this as a stone-walled continuation of Building 10 with an archway below a straight stone lintel with an attic floor above. At this stage is partially blocked by what appears to be a stone wall with two doors in it.

The 1865 OS map clearly defines a rectangular area alongside the S range of the E court. A photograph (Illus 120) shows this to have been a stone walled enclosure. Space was left alongside the S side of Building 13, to allow access of carts through the archway entrance and into the cart bays in that building.

Illus 120 Photograph of the steading E court showing enclosed central yard. Man with bull standing by W gable of building 3. Mill building 7 in RHS background, with Buildings 10, 11 to LHS. The archway into the courtyard (red arrow) can just be seen in LHS. Note the tall stable doors and slit ventilators of the W wall of Building 10. (Blairs Museum T1001-8)

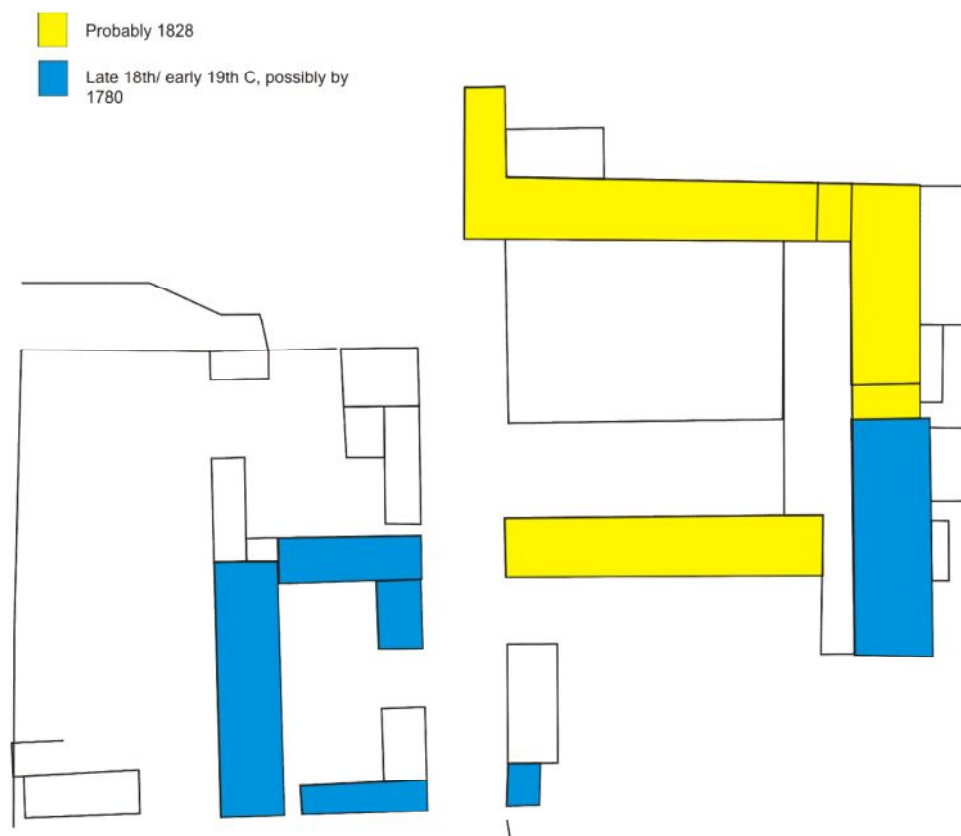
Illus 123 Suggested dates of main steading phases

The 18th century pre-Improvement steading appears to have been a long range to the E and smaller structures by the corn yard which was then where the formal garden now lies. No certain parts of this steading remain and it may have been demolished in the late 18th century when the grid layout was established and the road to the S realigned. By 1830 the steading comprised two courts (Illus 123).

The smaller W court has noticeably finer stonework than the large E court with large squared rubble blocks with characteristic stacks of three vertical stones. This suggests the two courts are not contemporary. The position of the W court in line with the old chapel and the W end of the original Menzies House, and its small domestic scale give some grounds for suggesting this was the earlier part of the steading. The similarity of the stonework with that used for the back E walls of the N and central parts of the chapel would support this. It is reasonable to suggest that this is the late 18th century court described by Rev Charles Gordon (see extract above) as not sufficient for the needs of the college. He also specifically mentions the mill (Building 7) as in use before the college took possession. The doocot may also be regarded as part of this initial layout. It appears likely that this was part of the work undertaken by John Menzies' uncle, prior to 1780 and continued by John between 1780 and 1827.

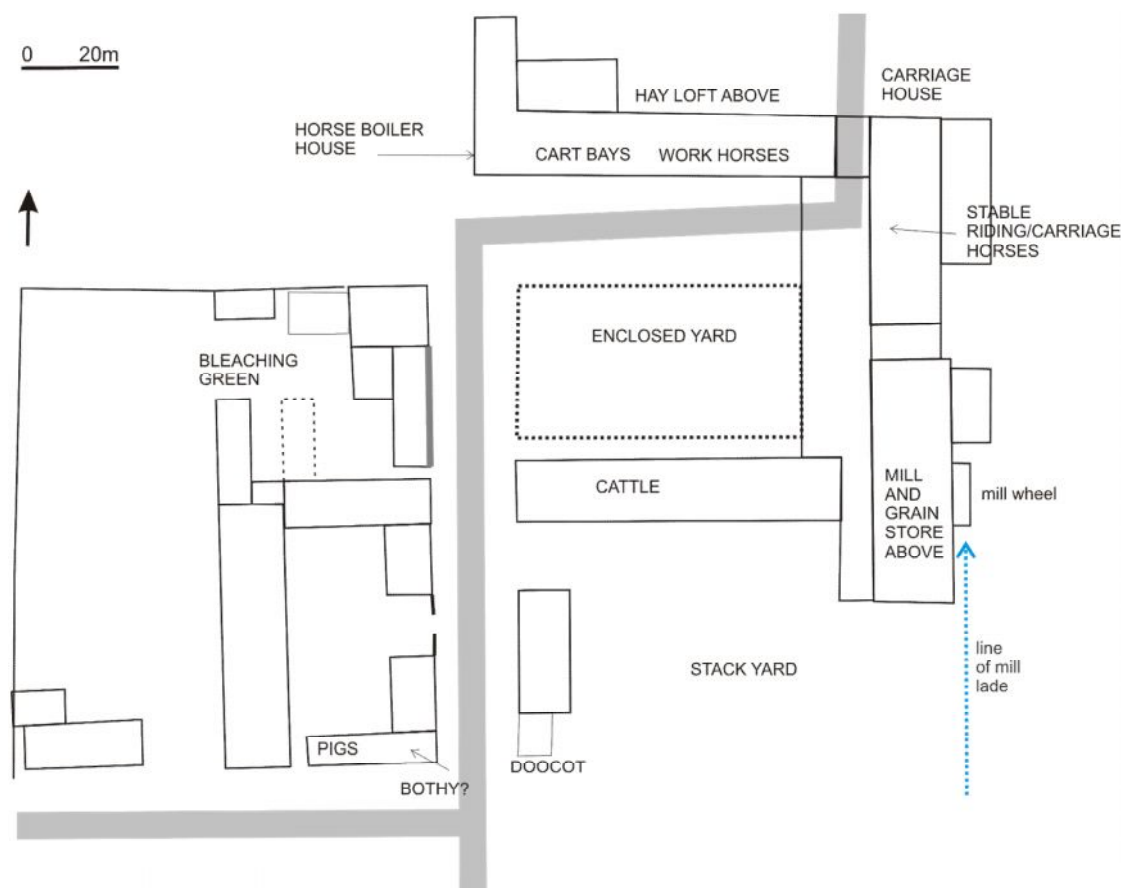
As far as possible the original (Illus 124) and 20th century (Illus 125) functions of the steading are shown below. The 19th-century functions are based on the structural evidence. The 20th-century functions are based on oral evidence (IF, ES) as well as the structural alterations.

Illus 124 Functions 19th century as suggested by the structural evidence Inset location based on OS. Reproduced from Ordnance Survey digital map data, © Crown Copyright, All rights reserved. 2012. License No 0100031673)

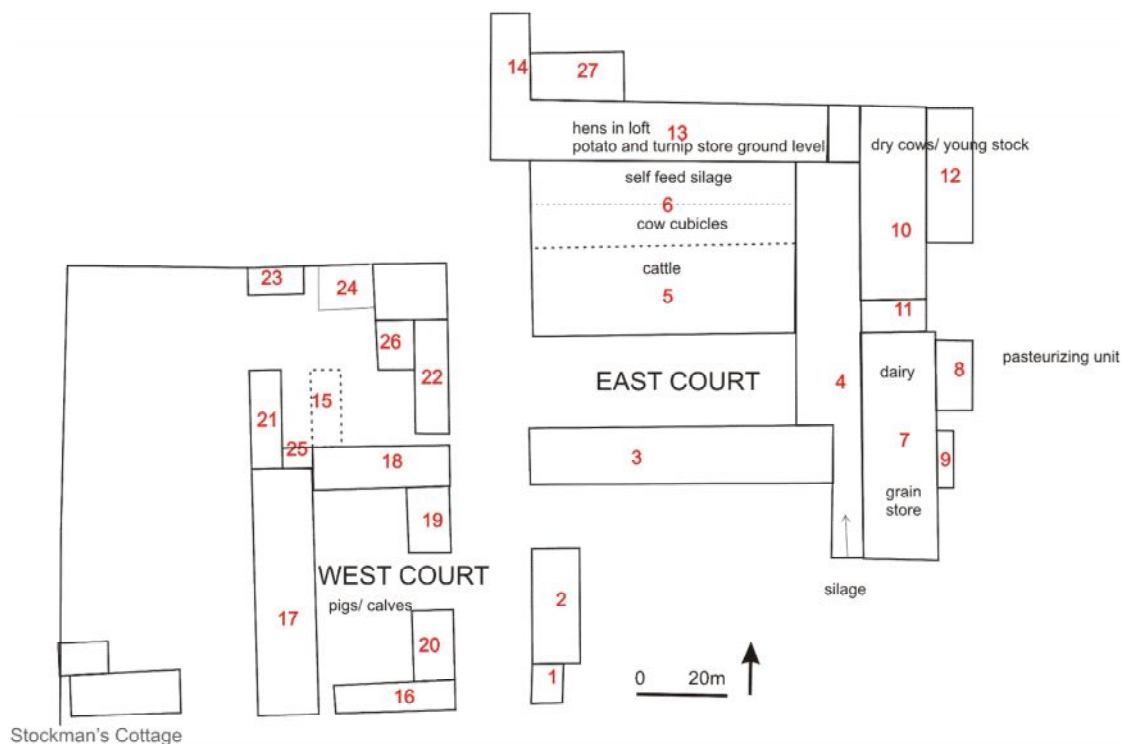
Illus 125 Functions c 1986 from oral evidence Inset location based on OS. Reproduced from Ordnance Survey digital map data, © Crown Copyright, All rights reserved. 2012. License No 0100031673)
