Amlaird Mainout: Archaeological Assessment Project 4233

On behalf of: Scottish Water

Project Number: 4233

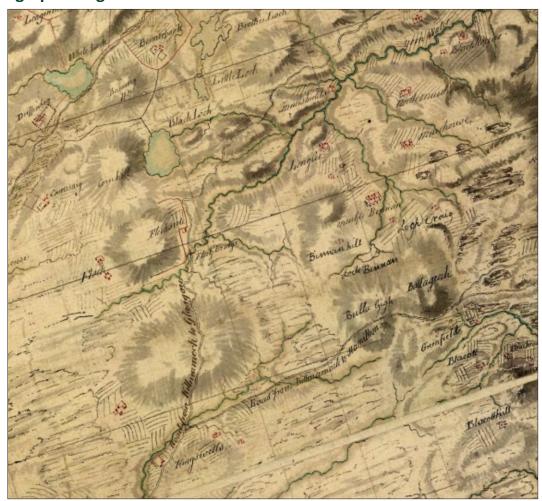
Figure 5: Excerpt from Roy's 1747-55 Military Survey of Scotland. Reproduced by permission of the Trustees of The National Library of Scotland.

- 6.1 Consultation of Roy's map (Figure 5) indicates that much of the land in question was used for agricultural purposes as it still is today. It also indicates that many of the current place-names were in use such as Kingswell, Flock Bridge (Floak), Longlee, Pilmuir, Pollok, Lyonscroft and Darnley.
- 6.2 The First Edition Ordnance Survey maps that cover the extent of the proposed water pipe route (Figures 6 8) shows that for most of the proposed water pipe route very little has changed. The most significant change in this area was the construction of the M77 in 1997 as a bypass to the A77.

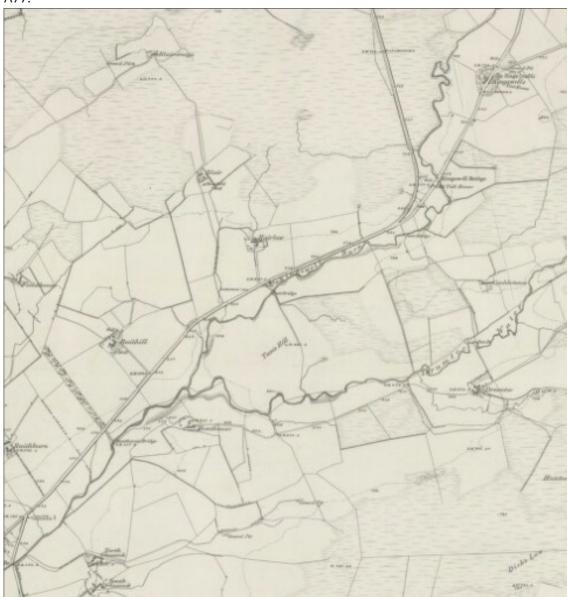
Figure 6: Excerpt from Ordnance Survey Ayrshire, Sheet XIII (includes: Fenwick; Stewarton) 6" map of 1858.

- 6.3 An area that has significantly changed is the area that was once occupied by Darnley House to the north of Waulkmill Glen (Figure 6). The house is still noted on the 1957 Ordnance Survey Map, however is no longer noted on the 1968 map. It is presumed after this date that a programme of large scale landfill was undertaken across this area of the country park. This land is marked on current mapping as workings (disused) and can clearly be seen as it consists of construction material including bricks and metal. The ground here is unsafe and has sunk in areas.
- 6.4 Figure 9: Excerpt from Ordnance Survey Renfrewshire, Sheet XII (includes: Eastwood; Neilston; Paisley), 6" map of 1864. Reproduced by permission of the Trustees of The National Library of Scotland
- 6.5 No further cultural heritage sites are noted on any later maps consulted for this assessment.

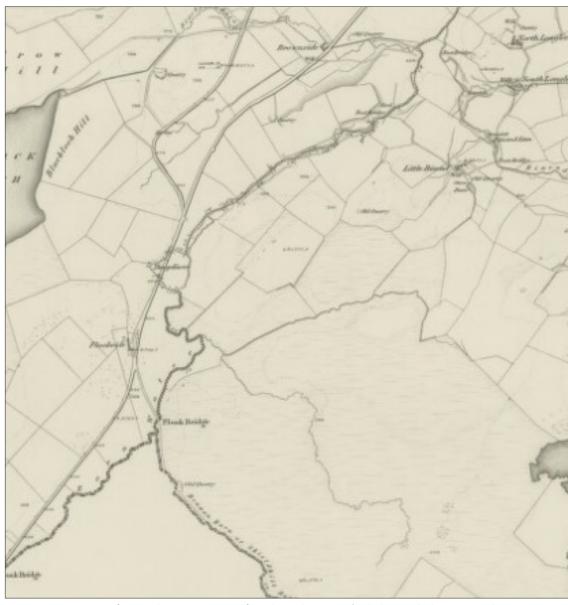
Figure 7: Excerpt from Ordnance Survey Renfrewshire, Sheet XVIII (includes: Eaglesham; Fenwick; Mearns; Stewarton), 6" map of 1863. Reproduced by permission of the Trustees of The National Library of Scotland.

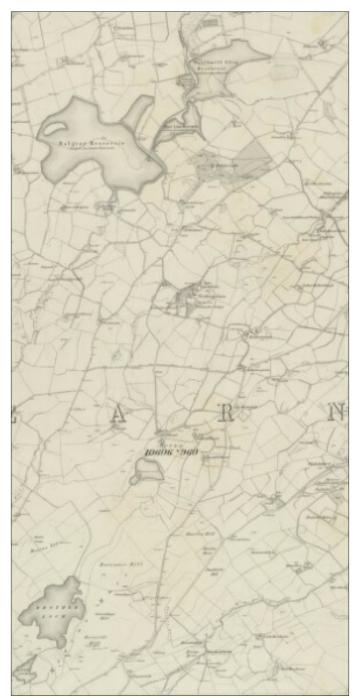
Figure 8: Excerpt from Ordnance Survey Renfrewshire, Sheet XVI (includes: Mearns; Neilston), 6" map of 1863. Reproduced by permission of the Trustees of The National Library of Scotland.
