**St Machar's Cathedral, The Chanonry, Aberdeen,
AB24 1RQ**

Data Structure Report (DSR)

Aberdeen City Council planning application 200072/LBC

**Alison Cameron
Cameron Archaeology
7 May 2021**

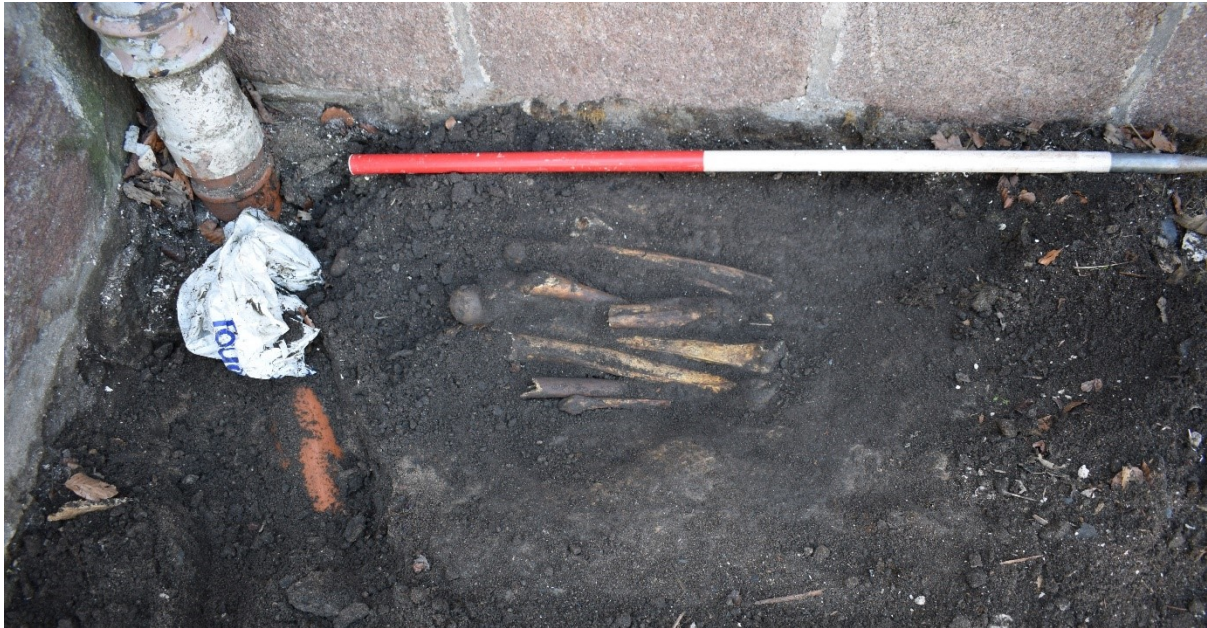
Trench 1 was hand-dug 0.5x0.5x0.5m to investigate a drain and allow for insertion of CCTV on the N side of the cathedral. A plastic pipe had been previously inserted and all the bone recovered had already been disturbed at that time. A shallow pit had been dug to rebury the

bone (Illus 4) which included 5xR femur, 6xL femur, 5 tibiae, 2 fibula, 4 humerus, 1 skull with depression and green stain, 3 innominate 1 male, 1 female and fragments of bone. Also one sherd of 20th-century transfer printed plate.

Illus 4 TP1 showing human bone reburied in shallow pit after repair of plastic drain pipe; facing S

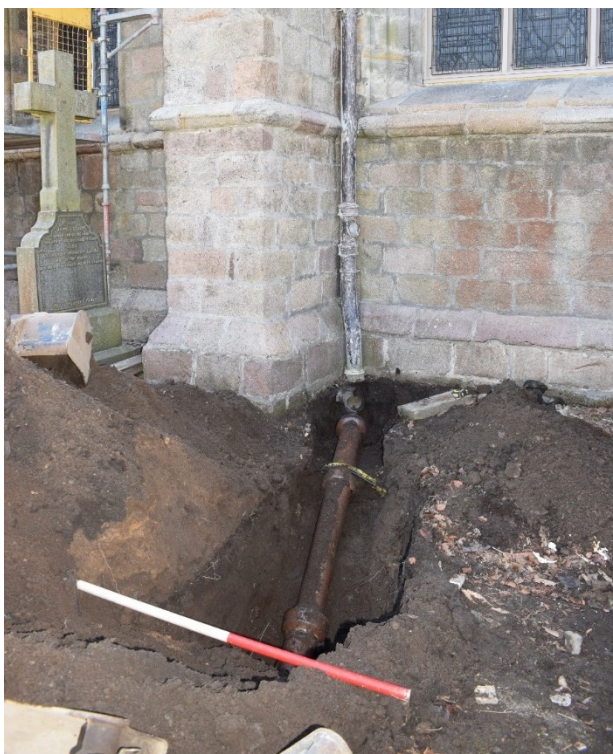
Illus 5 TP2; facing SE

Trench 2 was hand-dug 0.5x0.5x0.5m to investigate a drain and allow for insertion of CCTV on the N side of the cathedral (Illus 5). It was later extended to uncover a broken pipe. Small amounts of very fragmentary human bone were recovered from this trench. The broken pipe was stamped GARTCRAIG/GLASGOW (Illus 6) manufactured between 1862 and 1921 (<https://www.scottishbrickhistory.co.uk/>).

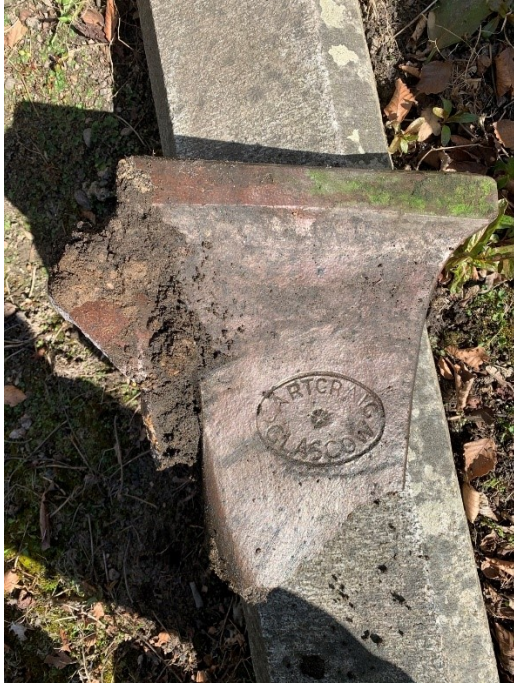
Illus 6 TP2 ceramic water pipe stamped GARTCRAIG/GLASGOW.

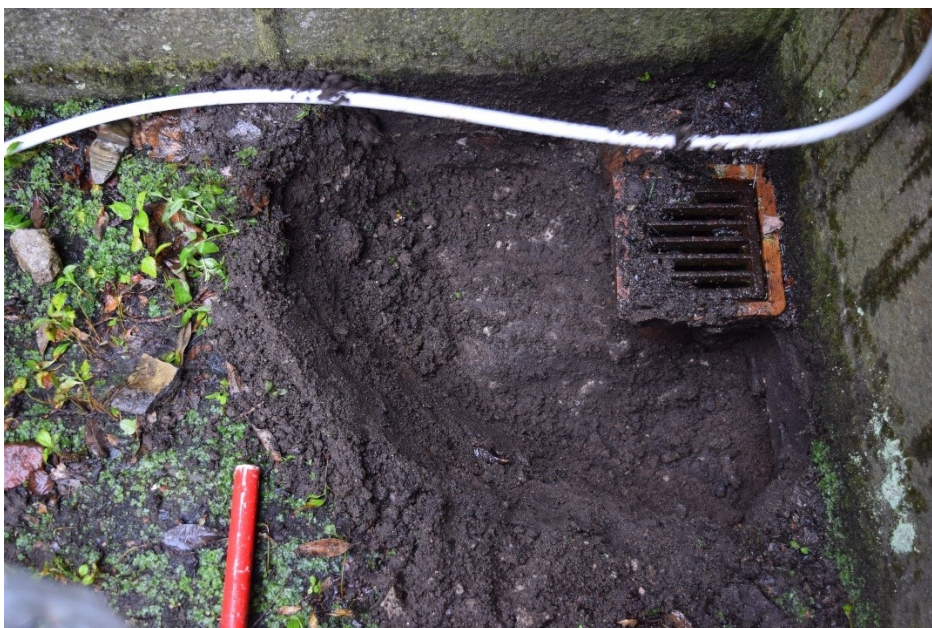
Illus 7 TP5 facing E

Trench 5 was hand-dug 0.5x0.5x0.5m to investigate a drain and allow for insertion of CCTV on the N side of the cathedral (Illus 7).

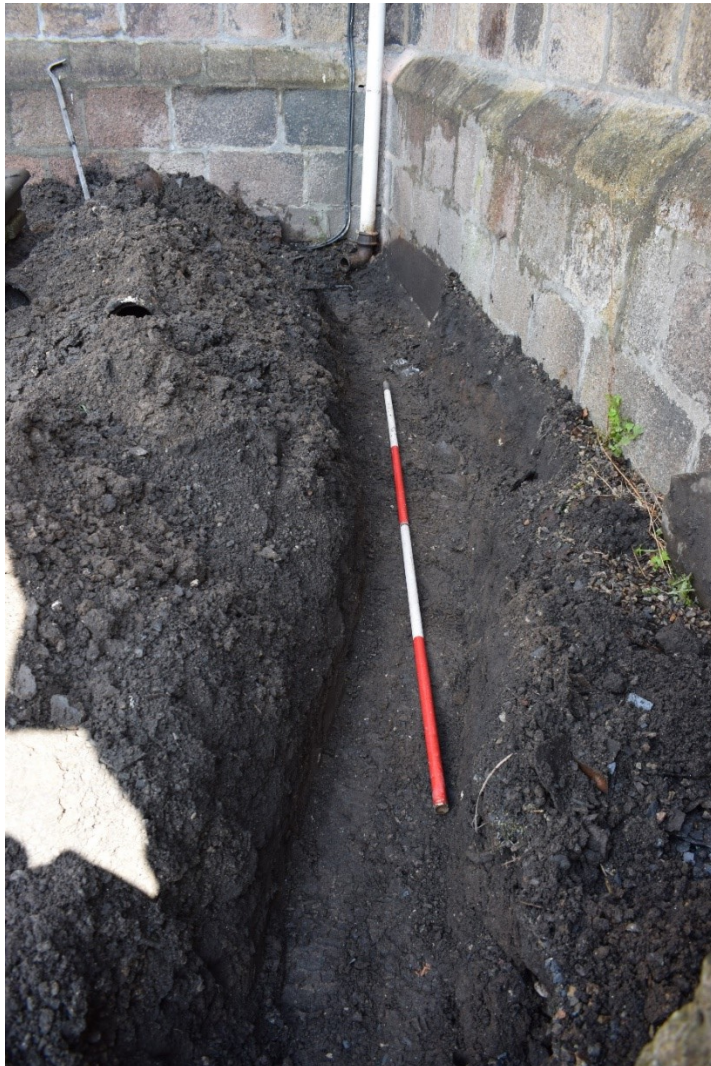
Trench 7 was hand-dug 0.5x0.5x0.5m to investigate a drain and allow for insertion of CCTV on the S side of the cathedral. At a later date TP7A was dug WNW-ESE along the line of an existing ceramic pipe and TP7B N-S between TP7 and TP15 along the line of a ceramic drain (Illus 8). The base course of the porch was revealed and a further arrow masons' mark (Illus 9-11, 22) recorded (there are similar examples on the wall above). The base course of the buttress of the porch W wall was uncovered but no further masons' marks identified (Illus 12).

Illus 8 Trench 7B with porch base course stones revealed (top, centre); facing N

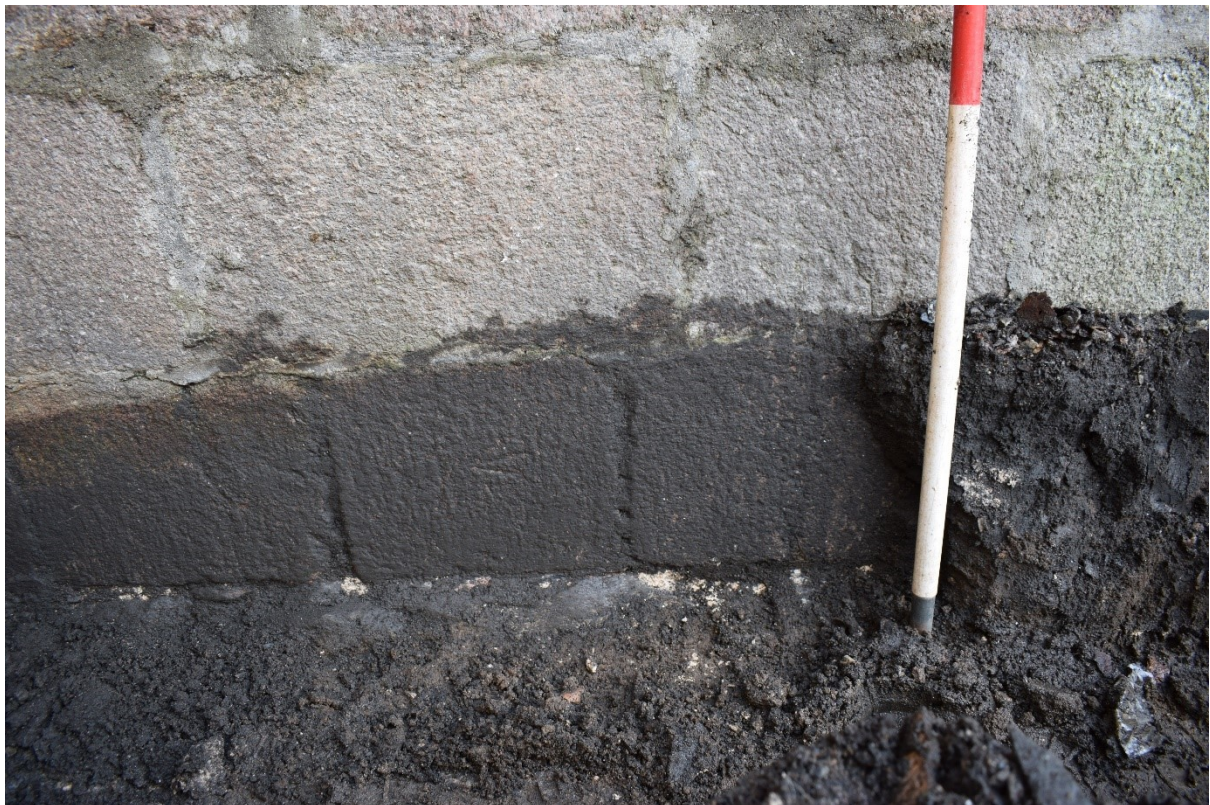
Illus 10 Trench 7B porch base course stones with F5 (centre); facing E

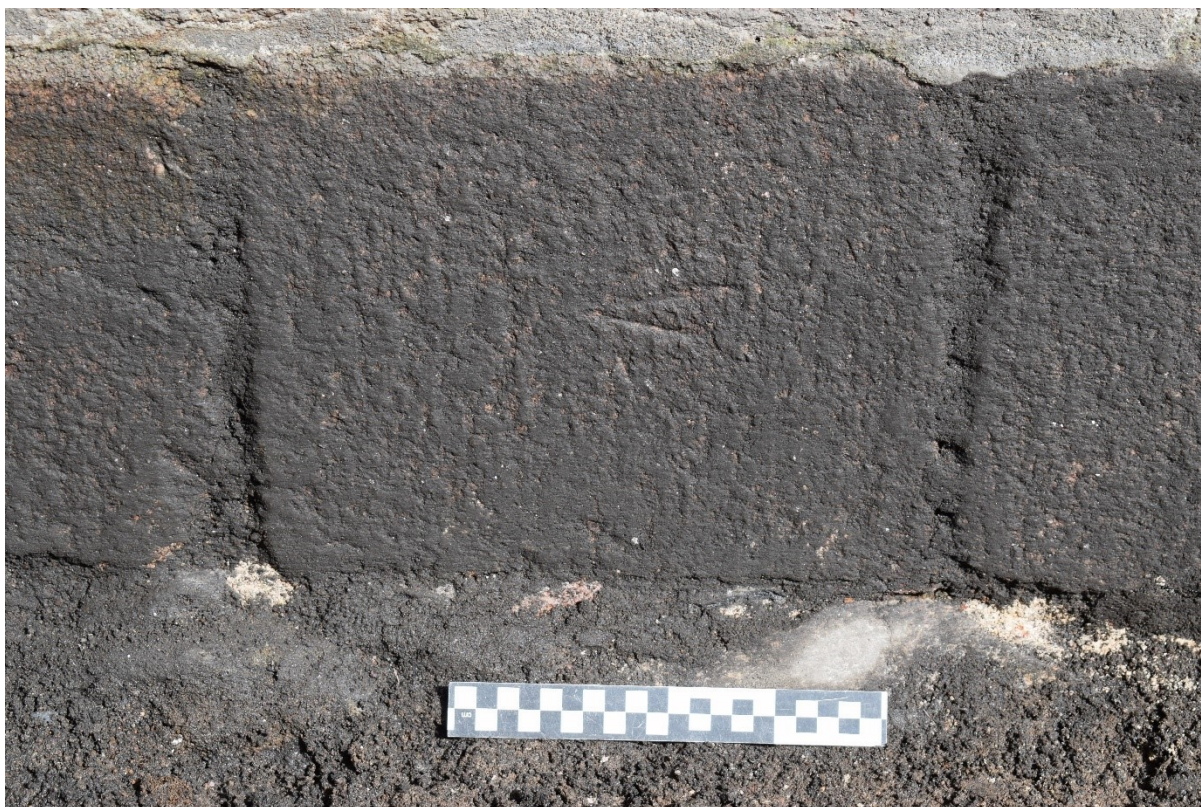
Illus 11 Trench 7B porch base course stones with F5 detail; facing E

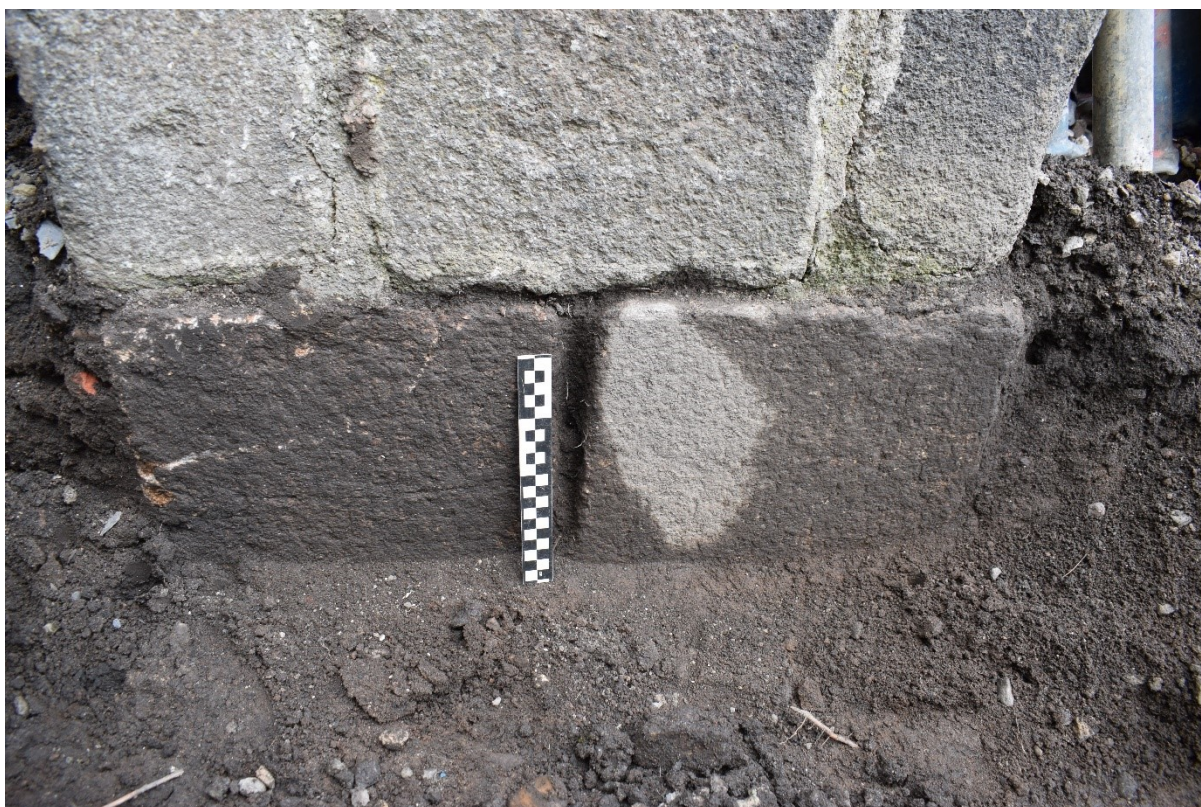
Illus 12 Trench 7B porch W wall buttress base course stones; facing E

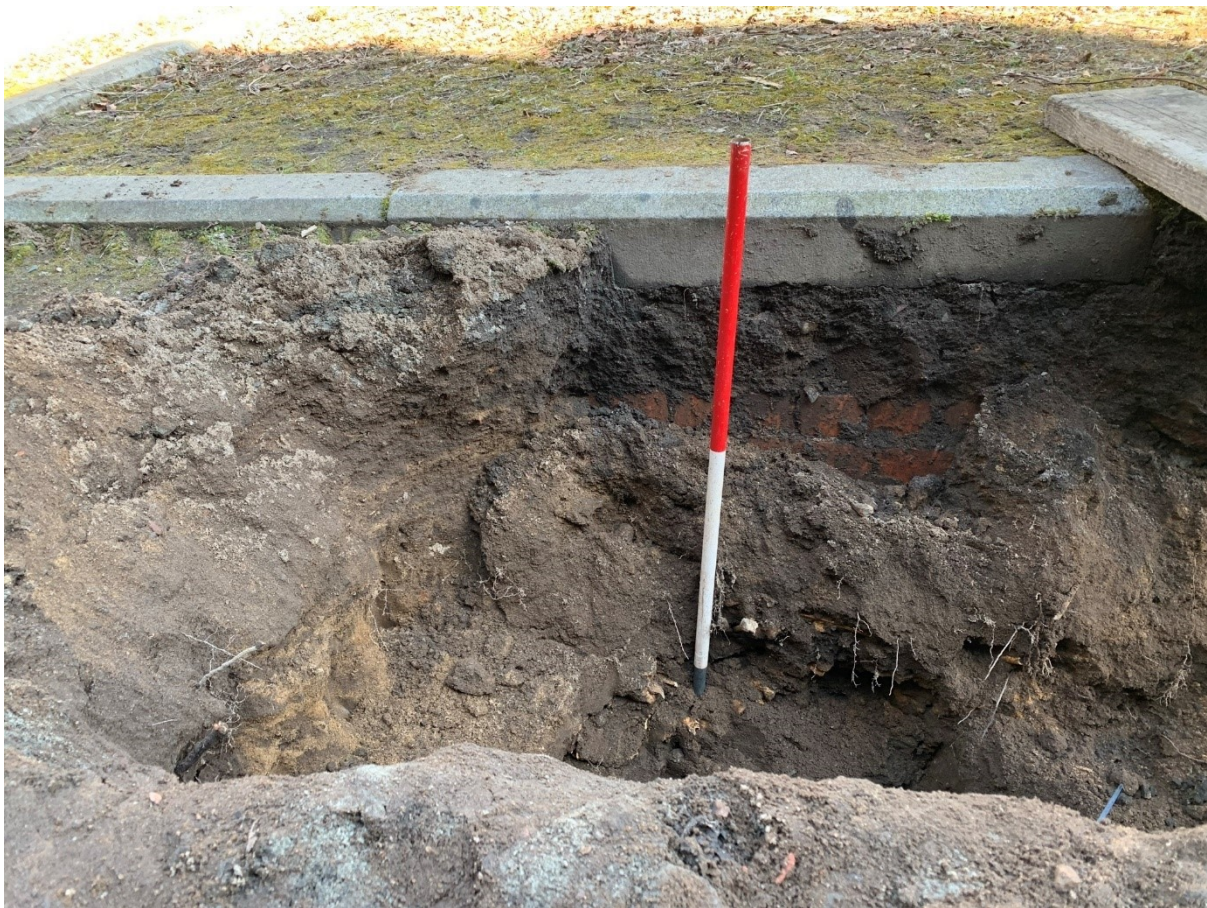
TP 10 was initially hand excavated but a mini machine was brought in to excavate a trench 0.4m wide and 1m deep to reveal an existing ceramic pipe which needed to be repaired (Illus 13). The brick wall of the adjacent Pirie vault was revealed in the N edge of the trench (Illus 14). Finds included iron possible coffin fitting, an iron bar, 1 ceramic jar base and the rim of a skink or large white glazed bowl.

Illus 14 TP10 N trench edge showing brick wall of Pirie vault; facing N

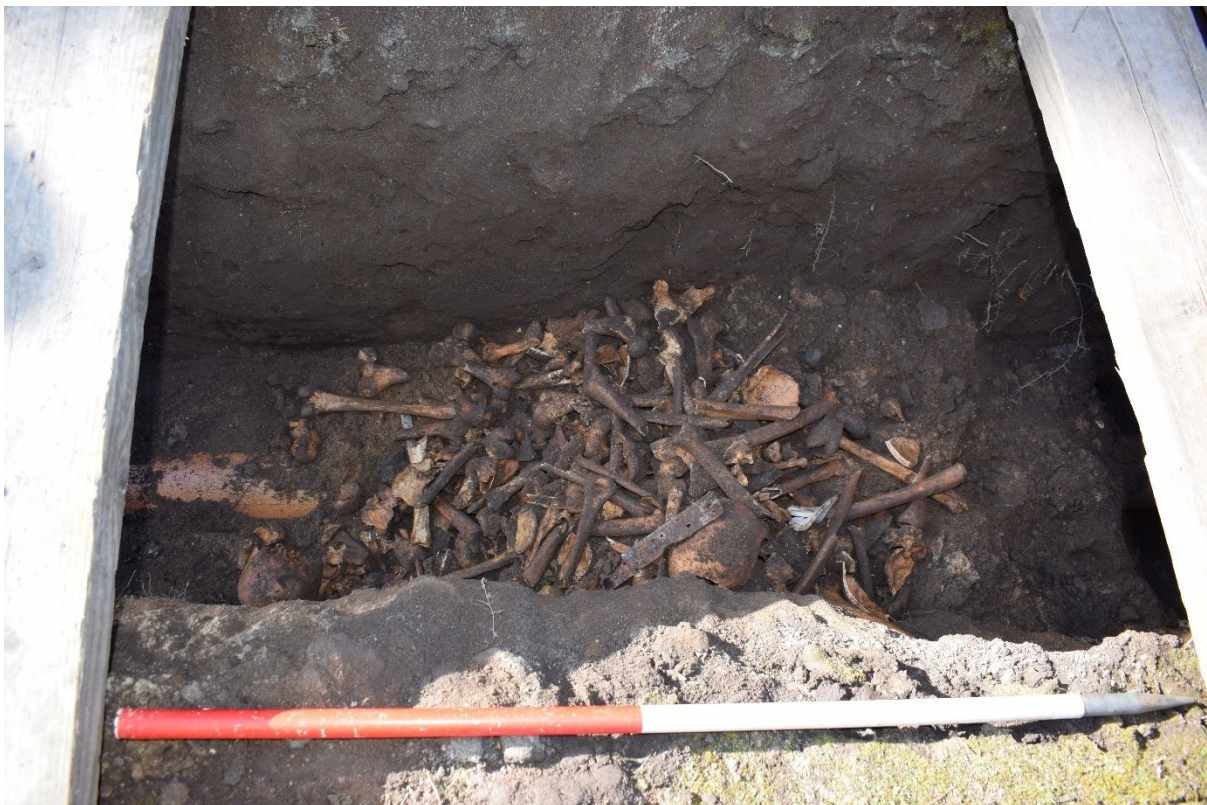
A large number of disarticulated human bones were removed; some had been buried with care along the line of the ceramic pipe. Eight large bags of bone were sorted and catalogued. There were elements of at least 6 individuals. 12 tibiae, 7 humerus, 8 R femur, 9 L femur, 7 radius/ulnae, vertebrae, hand and feet bones, 3 complete crania, 3 mandibles, 2 maxillae. There was a middle aged adult mandible, 1 old adult mandible, 1 ?female crania, 2 male and 7 female sciatic notches. All bones were re-interred above the repaired pipe (Illus 15)

Illus 15 TP10 bone reburied; facing S

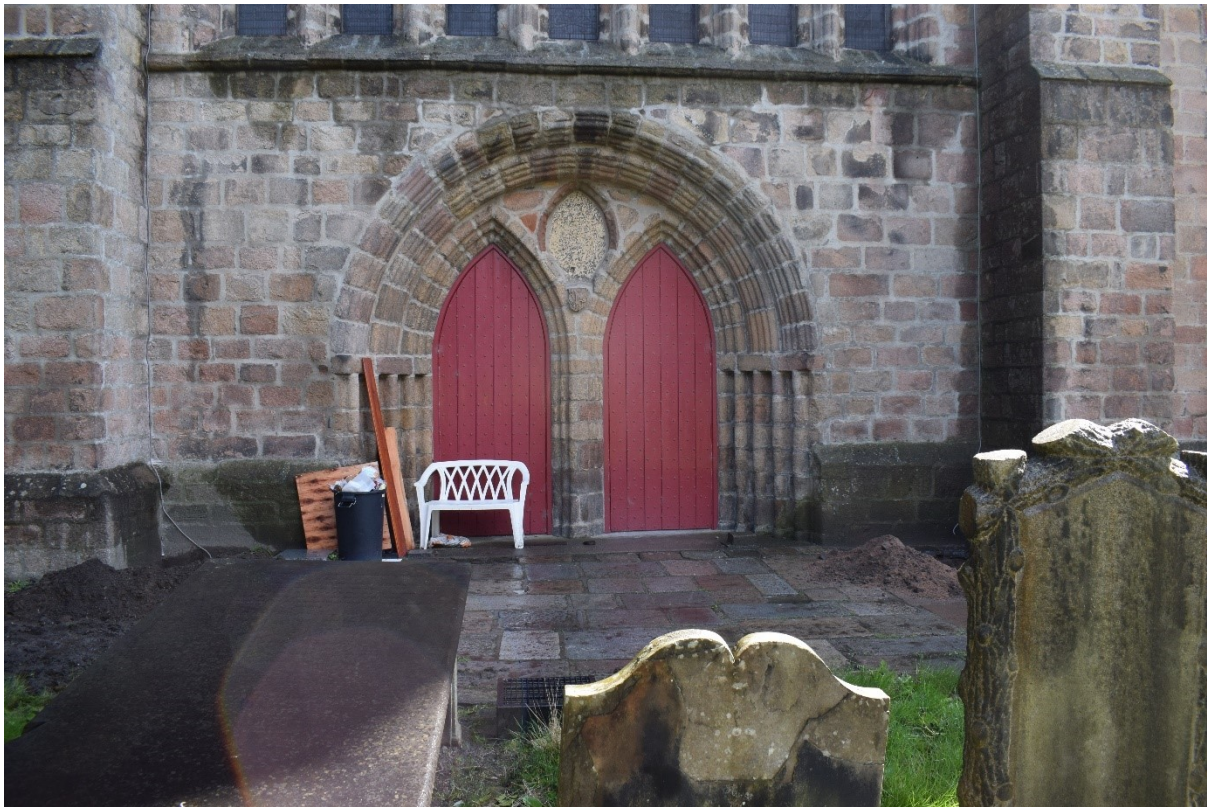
Trench 11 was 1x0.5m in size and excavated on the N side of the main W door of the cathedral (Illus 16) to allow for the burial of lightning conductor. The foundation of the W cathedral wall was 0.5m wide and consisted of very large stone. No bonding material was identified. The mortar-bonded stone foundation of the buttress was 0.3m wide and was butted onto wall foundation F2 (Illus 17, 18). A section of the wall base course was revealed but no masons' marks were recorded. One disarticulated human long bone fragment was recovered from the clean sandy clay fill which so clean that it may be imported soil to make up the level of the ground.

Illus 16 Trench 11 (left) and TP12 (right) flanking main W cathedral door; facing E

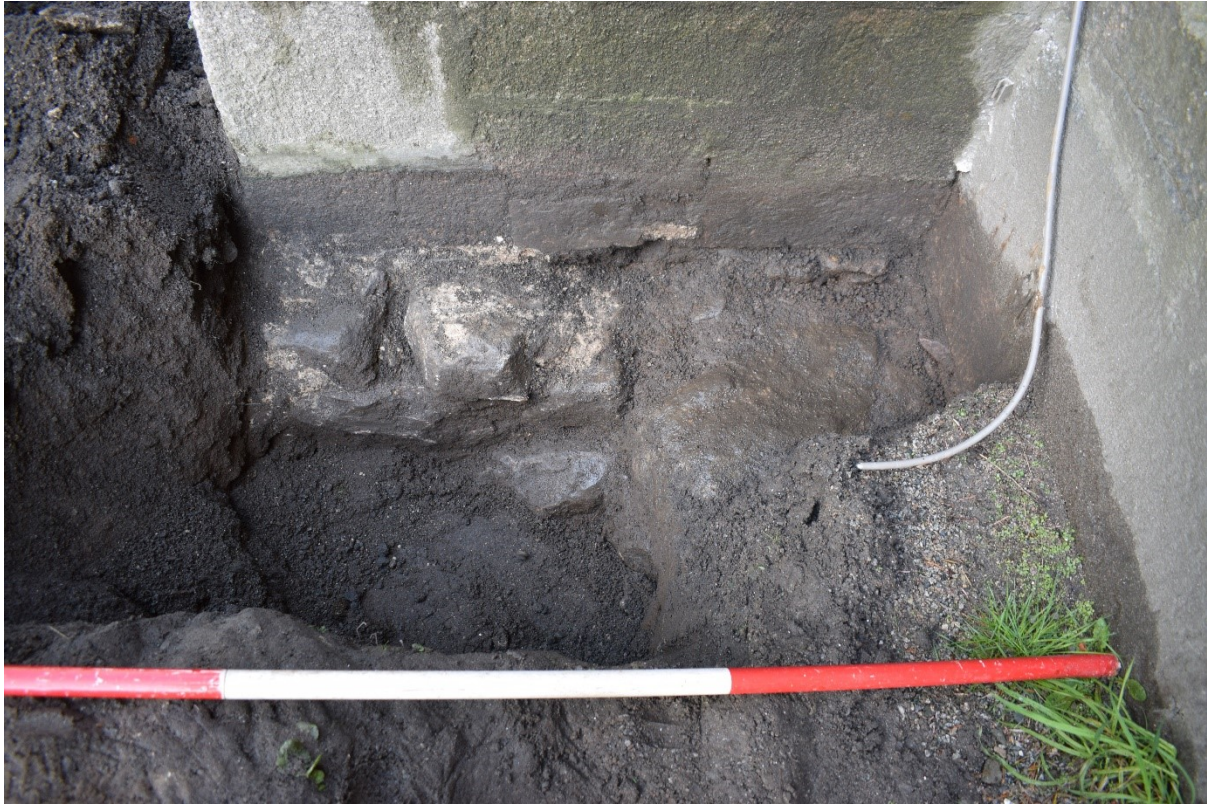
Illus 18 TP11 showing mortar bonded buttress foundation F1 (left) and wall foundation F2 (right); facing N

Feature no	Description	TP
F1	Mortar bonded stone wall foundation for buttress, 0.3m wide	11
F2	Stone foundation for W wall of cathedral, no obvious bonding, 0.5m wide	11
F3	Large stone foundation of W wall of cathedral 0.35-0.45m wide	12
F4	Large stone under buttress, possible remains of foundation	12
F5	Masons' mark. Examples found within western towers on steps, doorways and newels, mid 15th century (http://www.masonsmarkproject.org.uk/)	7
F6	Masons' mark. Examples found within western towers on steps, doorways and newels, mid 15th century (http://www.masonsmarkproject.org.uk/)	13
F7	Masons' mark. Examples found on exterior of the south side of St Machar's aisle and south porch(re-used?) ?15th-16th century (http://www.masonsmarkproject.org.uk/)	13
F8	Masons' mark. Examples found within western towers on steps, doorways and newels, mid 15th century (http://www.masonsmarkproject.org.uk/)	13

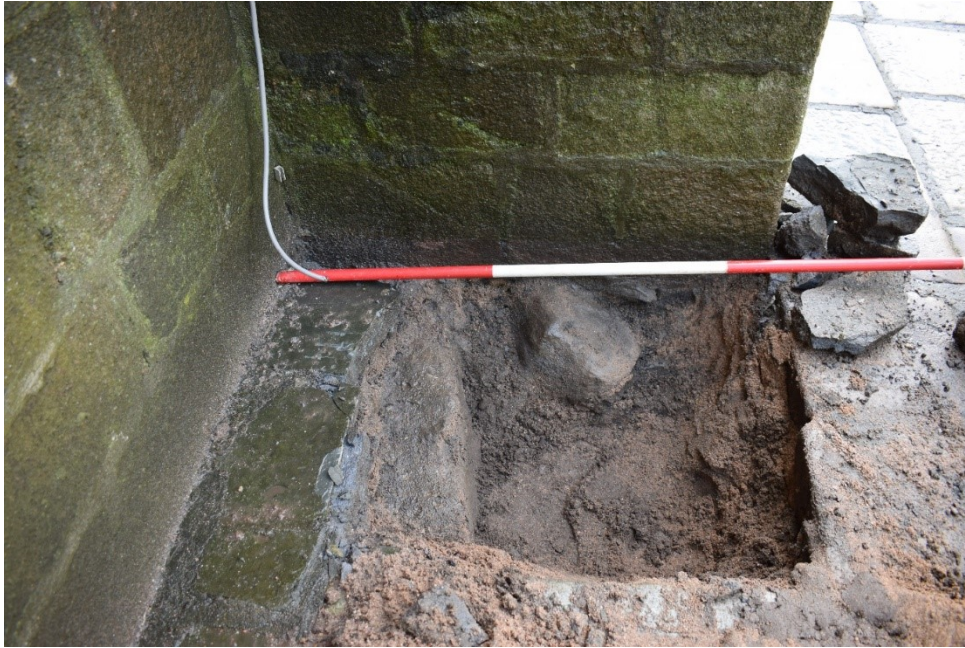
Trench 12 was 1x0.5m in size and excavated on the S side of the main W door of the cathedral (Illus 16) to allow for the burial of lightning conductor. The large stone foundation of the W cathedral wall consisted of a large stone at least 0.45m wide set at an angle (Illus 17, 19). A large stone under the buttress may be the remains of a foundation which has been disturbed. A section of the wall base course was revealed but no masons' marks were recorded. No human bone was recovered from the clean sandy clay fill which so clean that it may be imported soil to make up the level of the ground.

Illus 19 TP12 with foundation F3 (left) and large stone F4 (centre); facing S

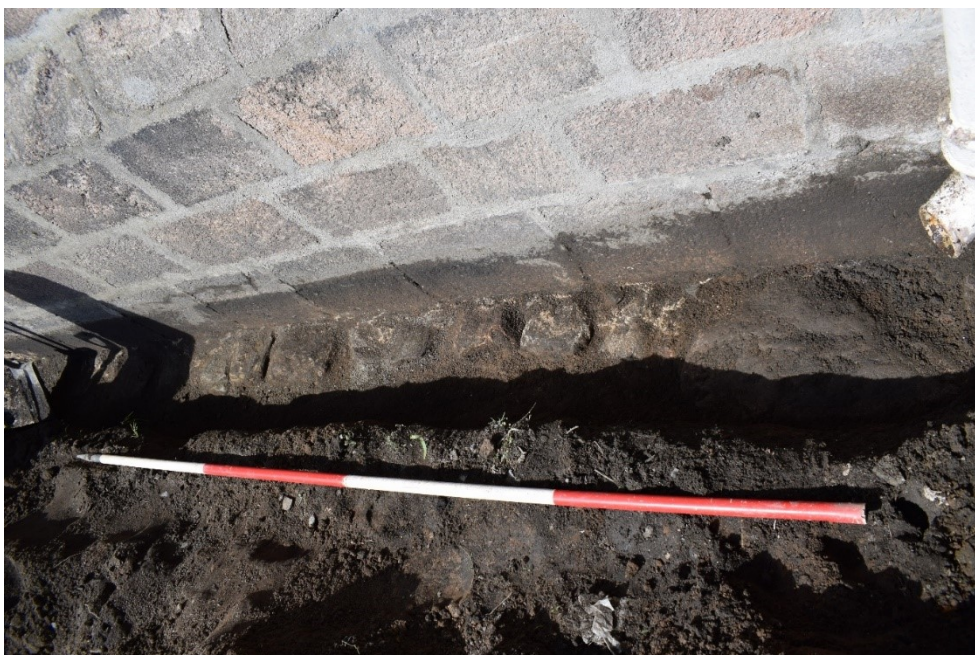
Trench 13 was 0.4m wide and 4.4m long between two buttresses on the S wall. A mortar bonded stone foundation 0.2m wide was recorded (Illus 20, 21). One large stone at least 0.65m wide was recorded at the E end of Trench 13 at the junction of the buttress and this appeared to part of a more substantial foundation at the junction of these two building elements. The base course of the cathedral wall and the buttresses was revealed. Masons' marks were recorded on eight granite blocks (Illus 21, 22). The marks were photographed in several lights (sun/shade) and rubbed with paper and wax crayon to record them at 1:1.

Illus 20 Trench 13 mortar bonded foundation F13; facing W

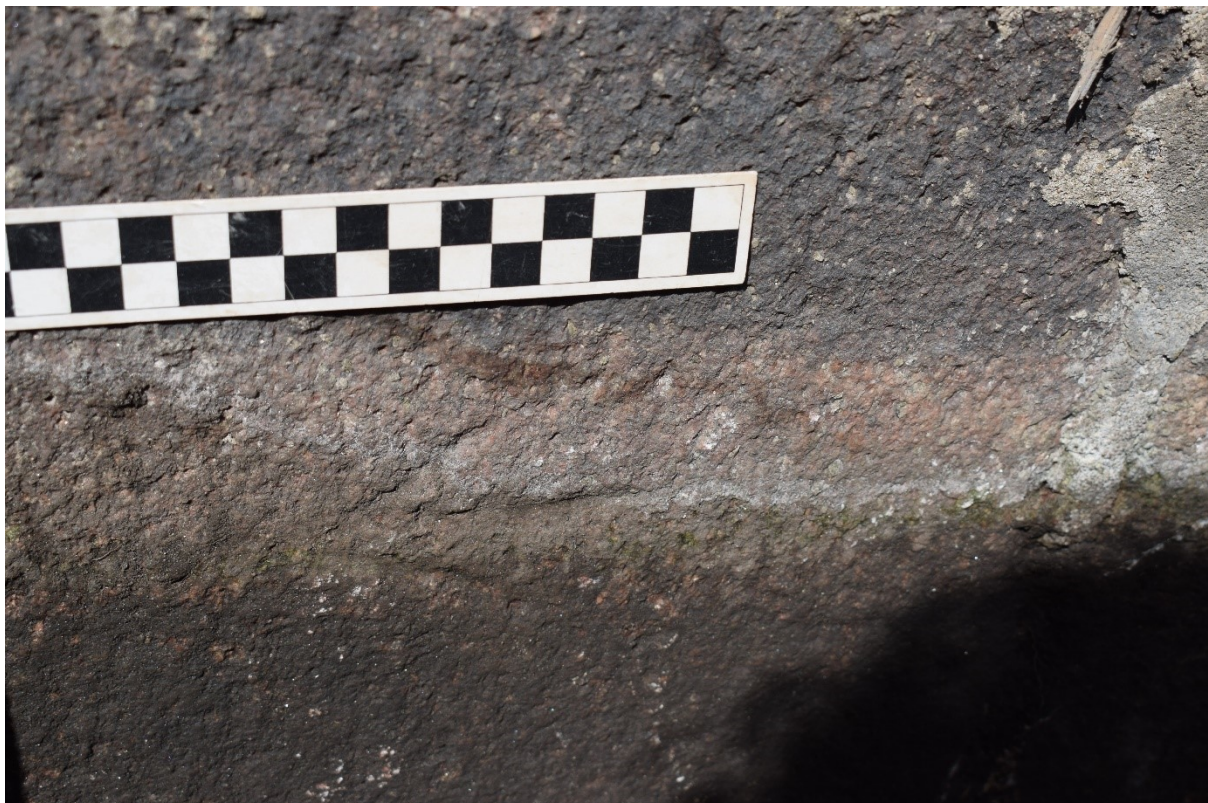
Illus 23 Masons' mark F6; facing N

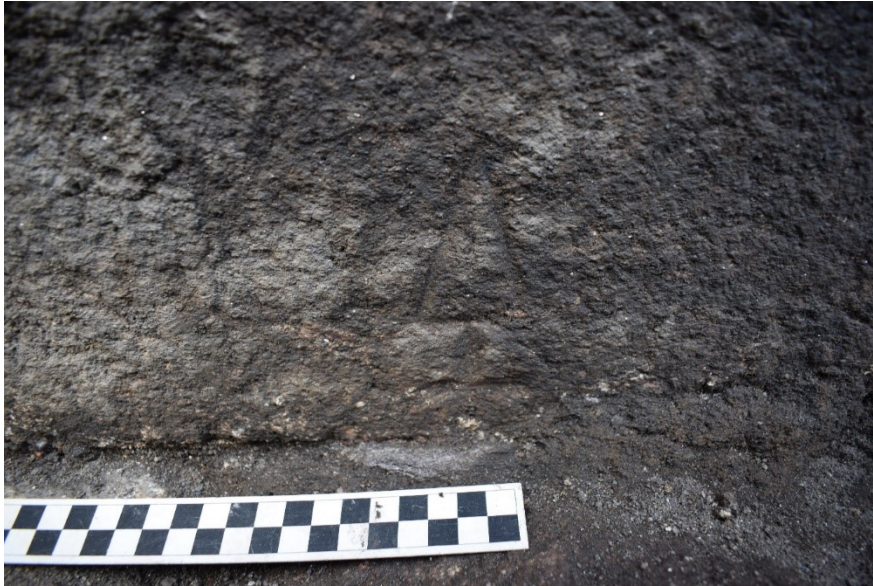
Illus 24 Masons' mark F7; facing N

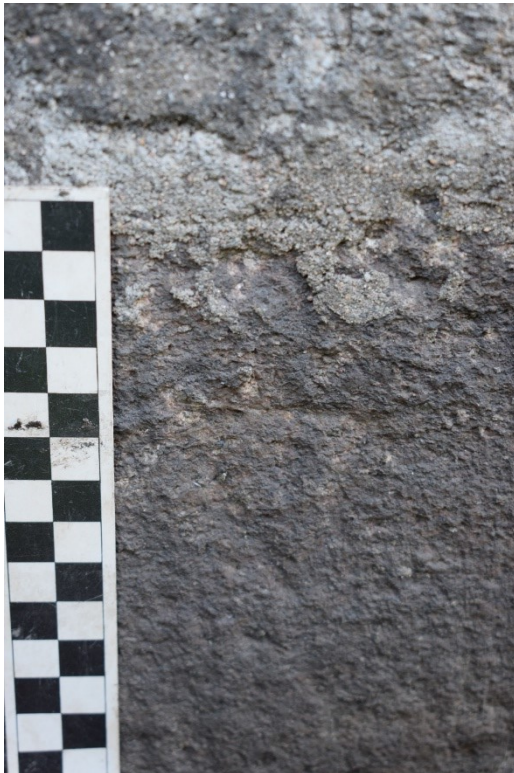
Illus 25 Masons' mark F11; facing N

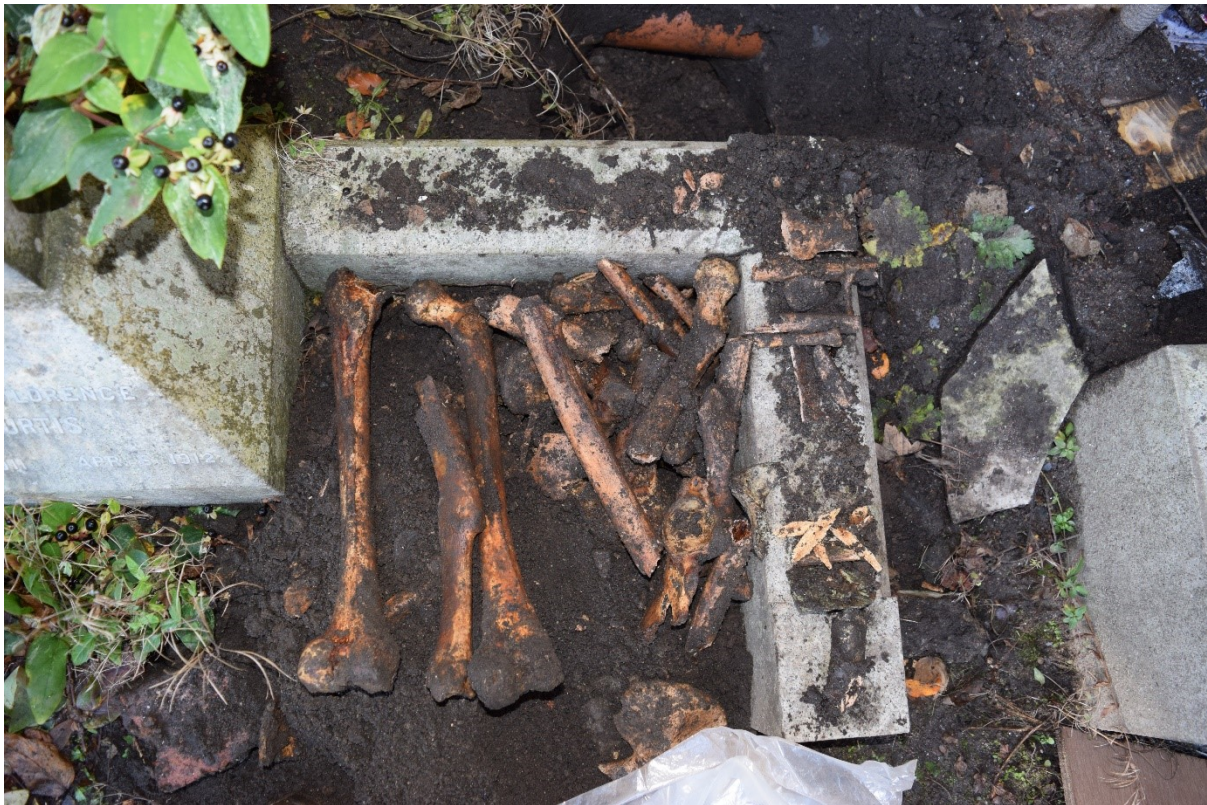
Trench 14 along the E wall of the porch on the S side of the cathedral was initially opened at the N end to inspect existing drains and then dug along the wall between the existing gravestones to insert a downpipe shoe in the corner and then TP14A (0.5x0.5x0.5m) to bury the lightning conductor. TP14B was excavated between graves to 0.3m deep to repair a ceramic pipe. TP14A contained 2 adult femora, 2 tibiae, skull, metacarpals, a child femur as well as several smaller fragments of disarticulated human bone (Illus 26).

Illus 26 Disarticulated bone from TP14A
