King's Quarter, University of Aberdeen, AB24 3SW
Watching Brief
Site Code CA516

Cameron Archaeology

19 November 2021

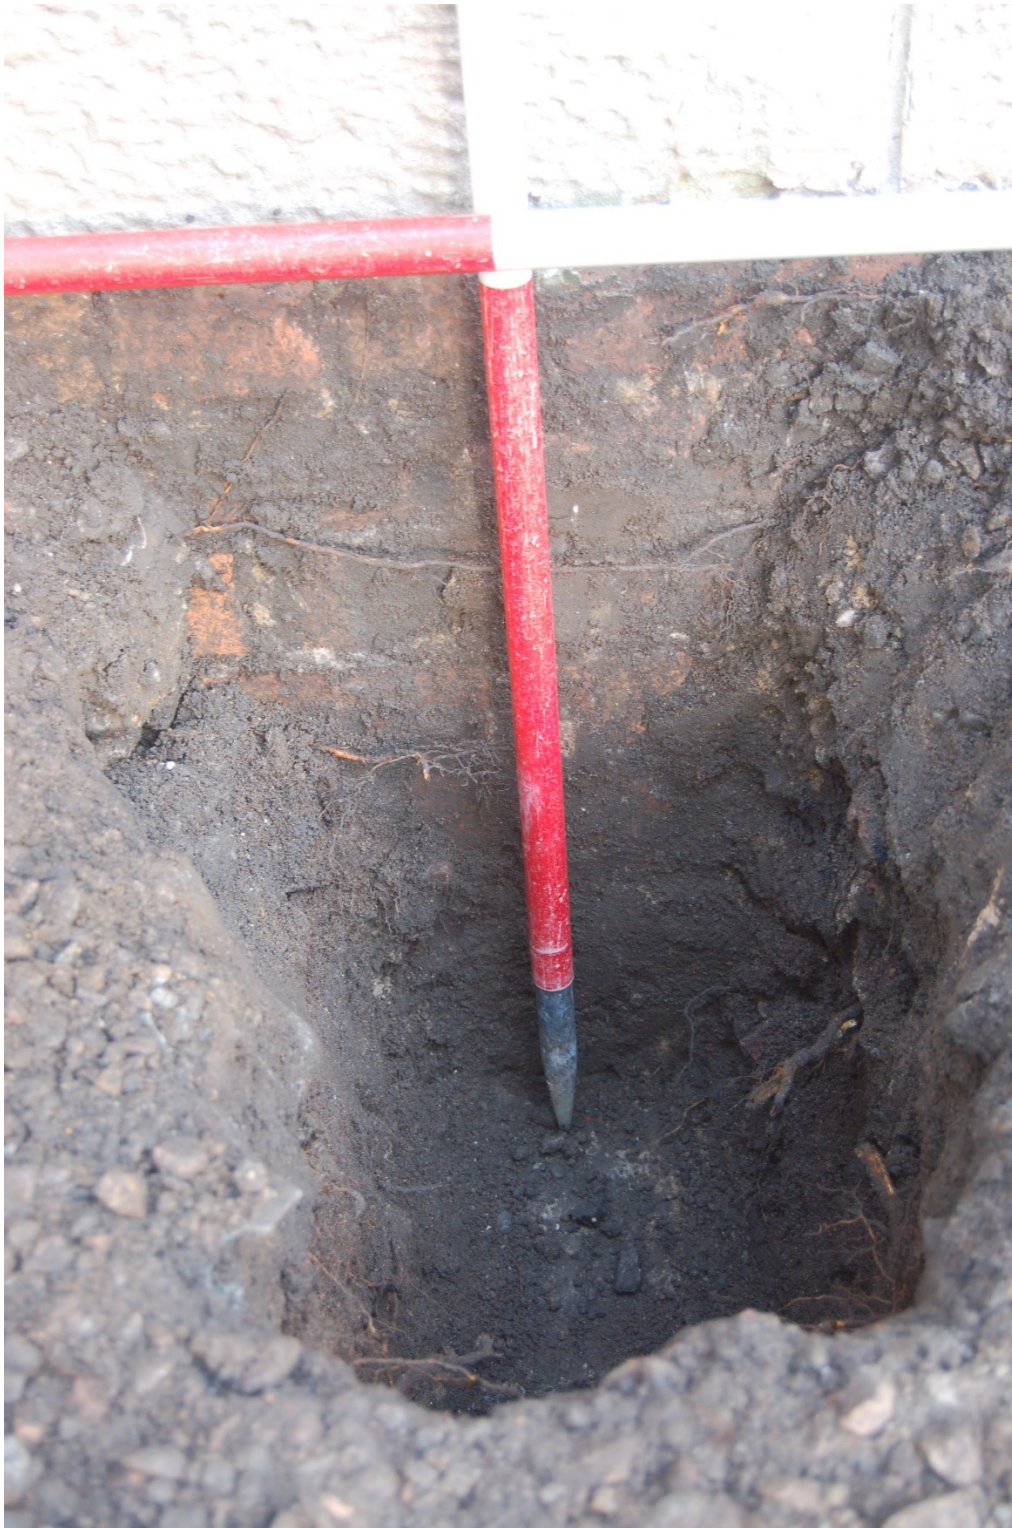
Located against the S facing wall of the E wing extension of the Linklater Rooms (Illus 2 & 3). Test pit dimensions: 0.5m x 0.5m at the surface reduced to 0.5m E-W x 0.25m N-S, 0.66m deep, maximum depth 1.0m. At 0.66m the concrete (0.1m thick) foundation of the adjacent wall protruded 0.25m N-S into the test pit. The wall above was constructed from brick to ground level and stone above ground level (Illus 4). Few pieces of building material and a single sherd of 19th century pottery (Illus 5) were recovered from the dark brown loam fill. No archaeological features or artefacts.

Illus 4 S facing exposed wall showing stone above bricks on a concrete foundation in Test Pit 1: facing N.

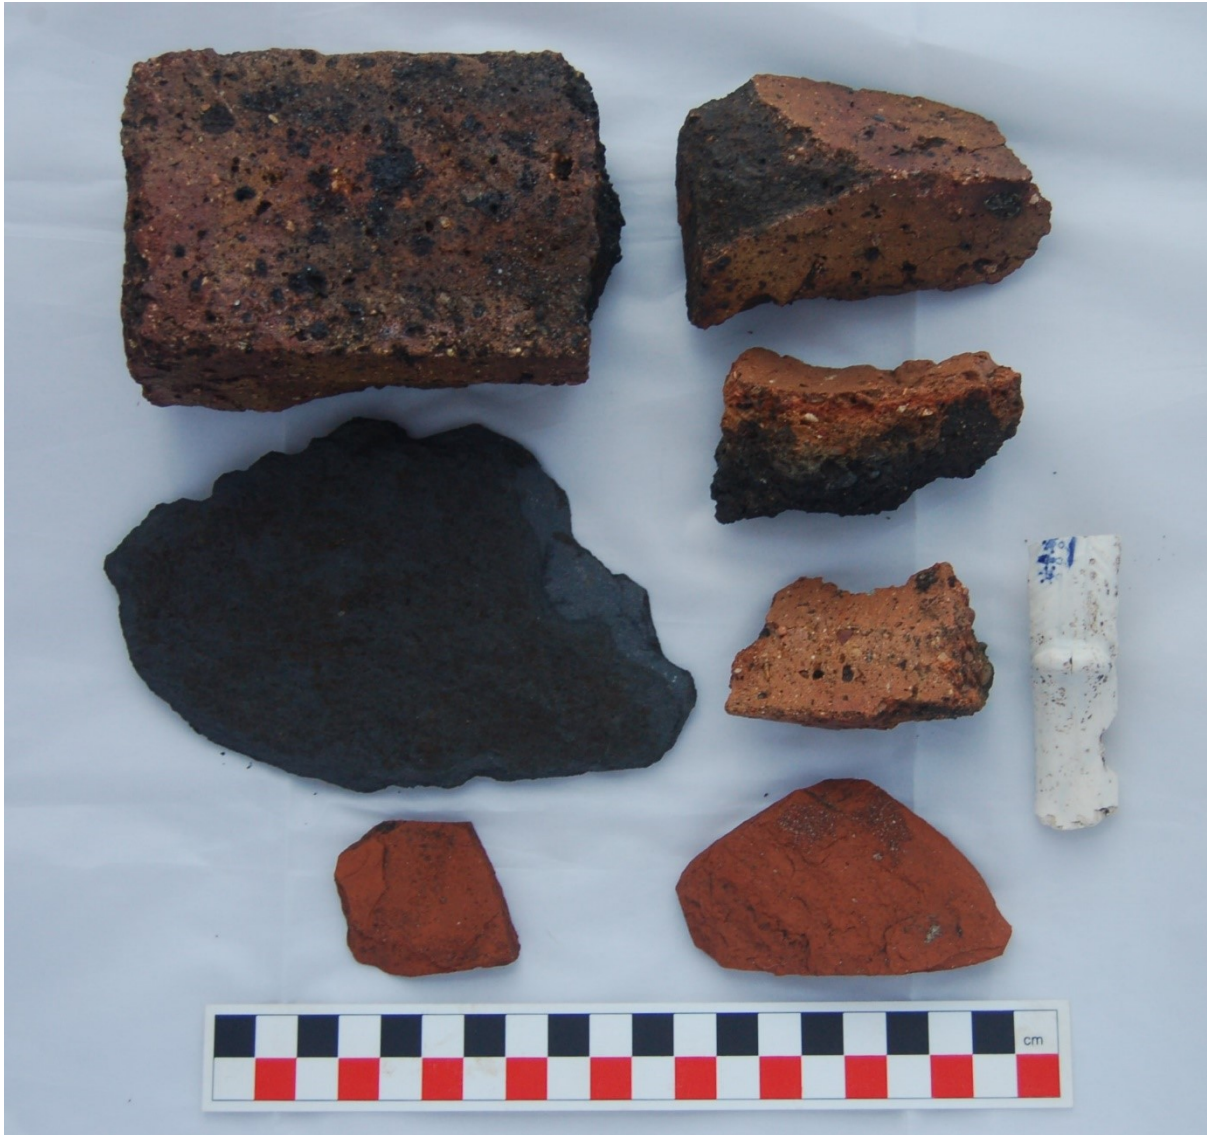
Illus 5 Materials recovered from Test Pit 1; brick, slate, ceramic pipe fragments and 19th century decorated ceramic handle.

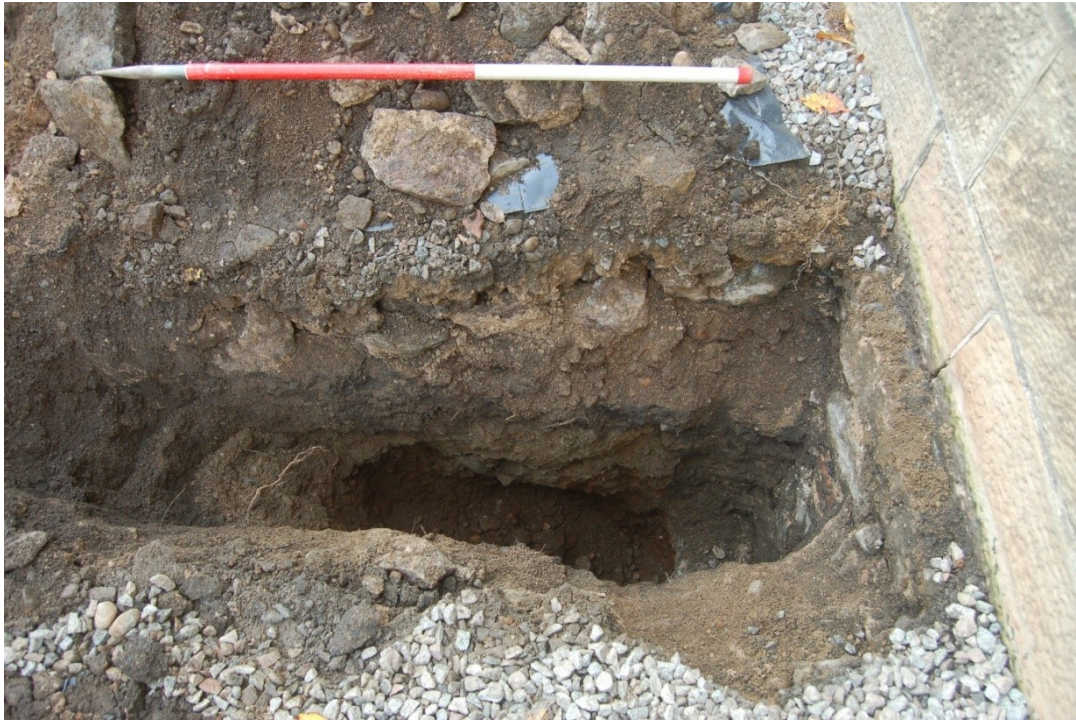
Located against the E facing wall of the Linklater Rooms (Illus 2 & 3). Test pit dimensions: initially 0.5m x 0.5m x 1.2m deep, extended by machine to 0.5m N-S x 1.5m E-W maximum depth 1.3m. Unlike the E wing observed in Test Pit 1, the foundation of the E facing wall of the Linklater Rooms were constructed from rough cut granite with a concrete foundation stepping out 0.25m E-W. The cut of the foundation trench for the Linklater Rooms building ran in line with the concrete foundation (Illus 6) which extended 0.23m E-W from the wall (0.2m thick). The foundation trench was cut through natural sand and was backfilled with dark brown loam containing building materials, glass and ceramic sherds (Illus 7). No archaeological features or artefacts.

Illus 6 N facing section of extended Test Pit 2 showing foundation trench cut through natural sand backfilled with dark loam visible above concrete foundation (right): facing S.

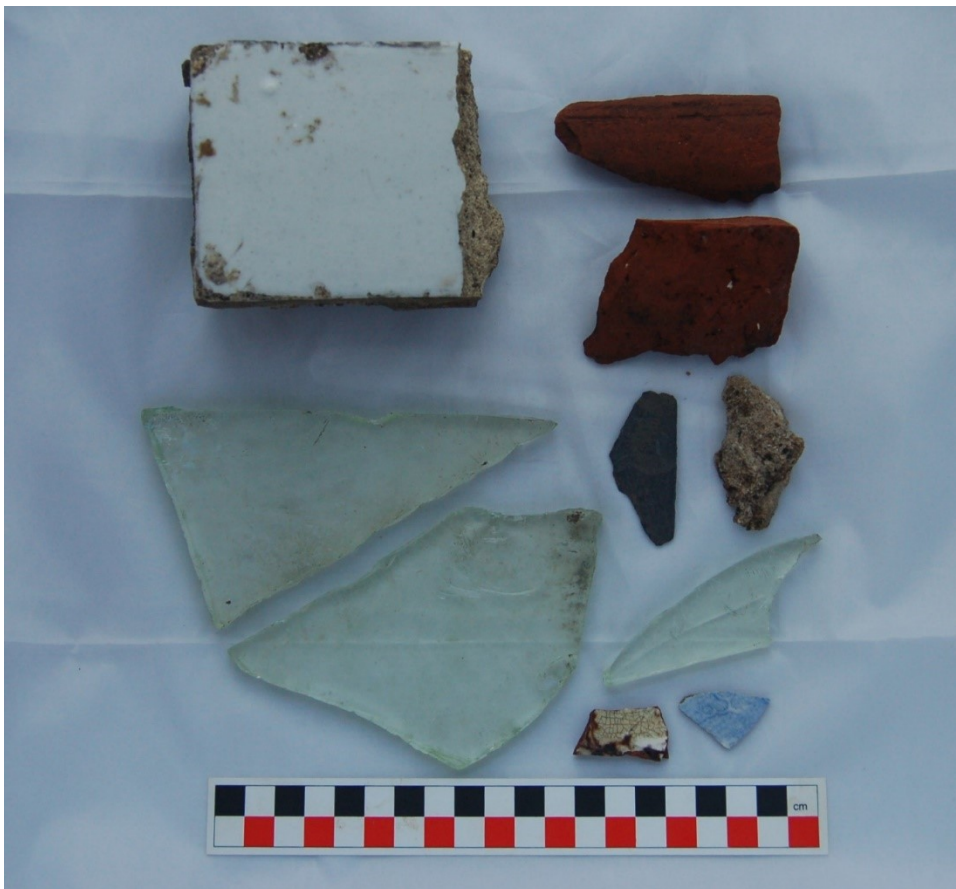
Illus 7 Selection of building materials (glazed brick, brick, slate, mortar), glass and ceramic sherds recovered from Test Pit 2.

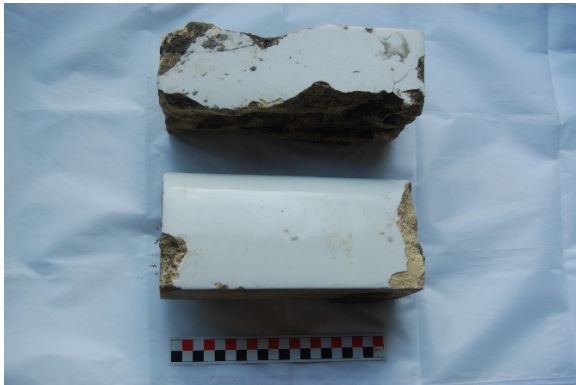
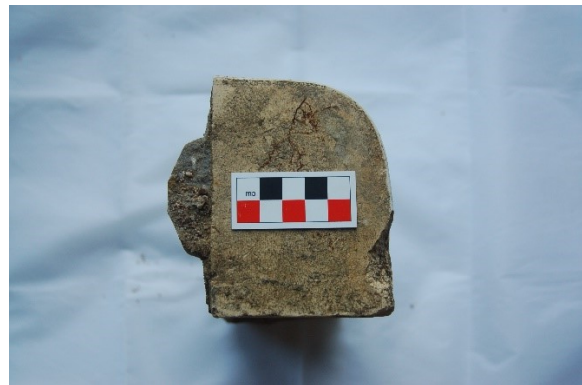
Illus 8 White glazed bricks recovered from Test Pit 3; lower brick (A.) shown in profile (B.).

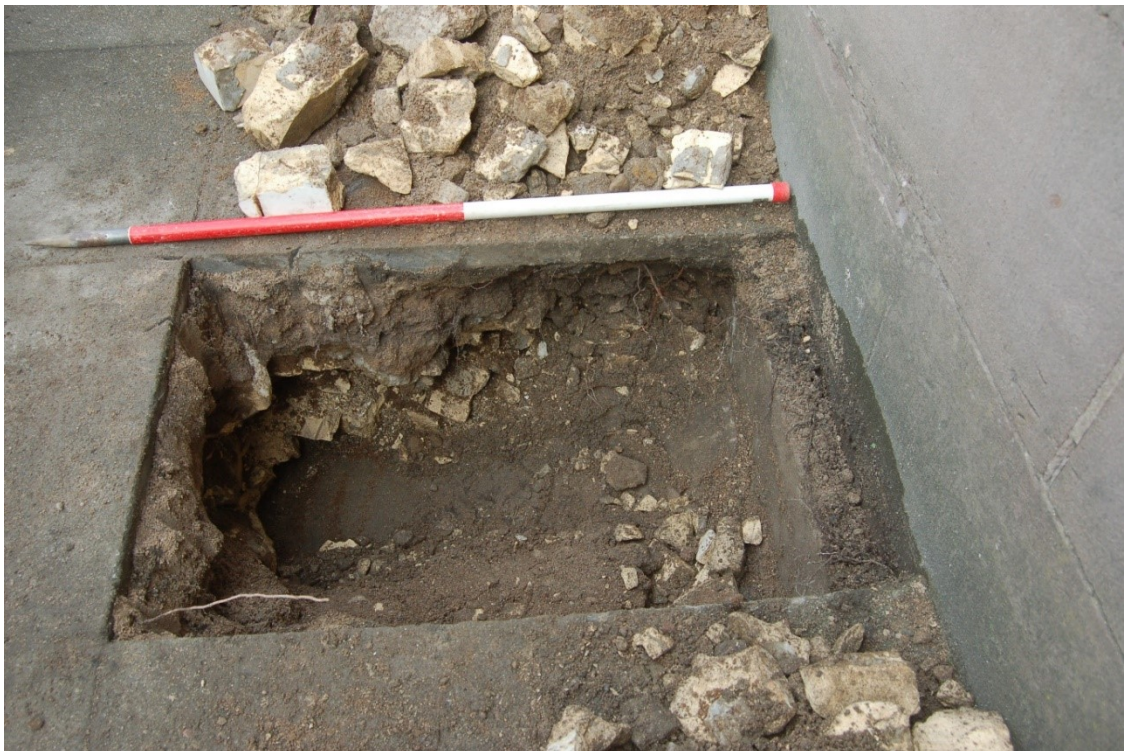
Located against the W facing wall of the Old Senate Wing (Illus 2 & 3). Test pit dimensions: 0.64m N-S x 0.93m E-W, maximum depth 0.55m. A single paving slab was lifted to enable excavation of this test pit. The pit was filled with rubble, primarily of fragments of light yellow bricks with a white glazed outer surface (Illus 8). A cement surface extended across the full dimension of the base of test pit (Illus 9). It sloped slightly from E-W and was 0.5m below the surface immediately adjacent to the building, 0.55m deep 0.93m to W. No archaeological features or artefacts.

Illus 9 Dark grey cement surface visible beneath rubble fill of Test Pit 3: facing N.

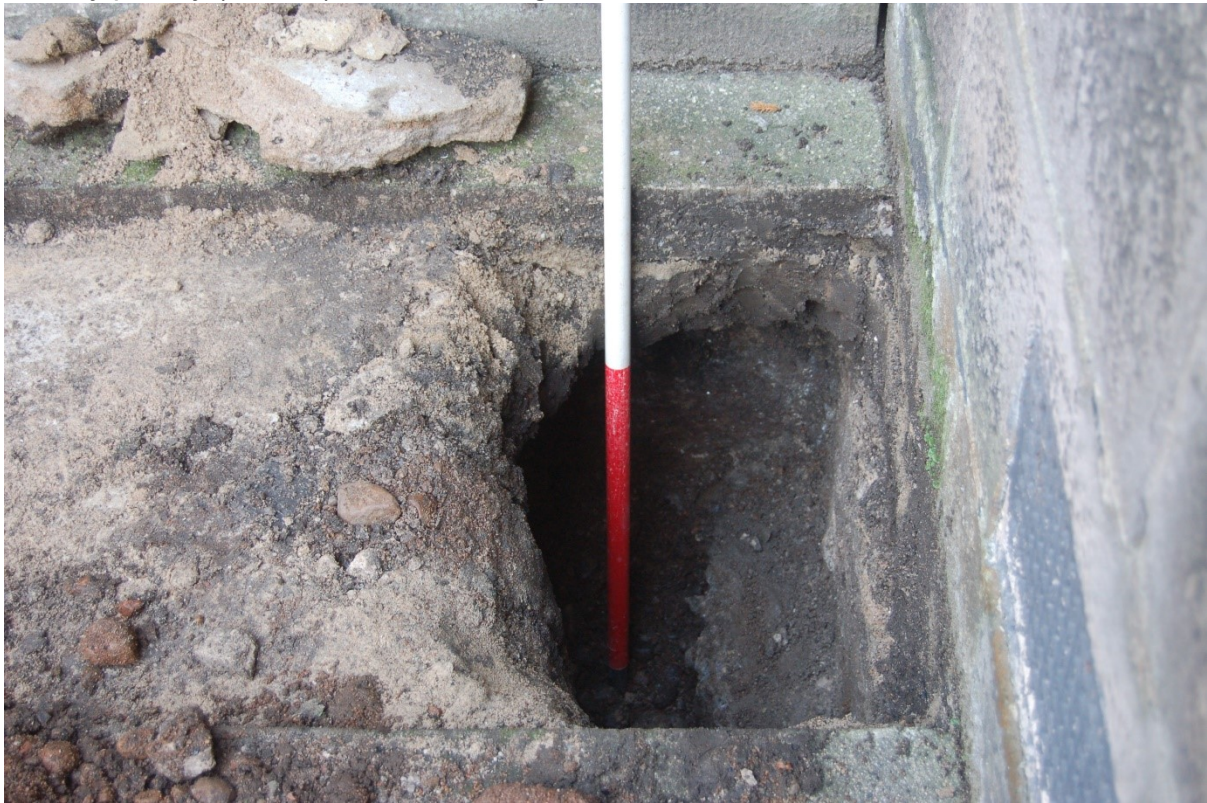
Located in the right angle between the Original Book Stack building and building extending eastwards (Illus 2 & 3). Test pit dimensions: 0.62m N-S x 0.45m E-W, maximum depth 0.89m. A single small paving slab was removed immediately adjacent to the walls of the buildings. The foundations were exposed at a depth of 0.64m (Illus 10) beneath a dark loam fill with few building materials and a single sherd of glazed 19th century pottery (Illus 11). No archaeological features or artefacts.

Illus 10 Test Pit 4 with exposed foundation: facing S.

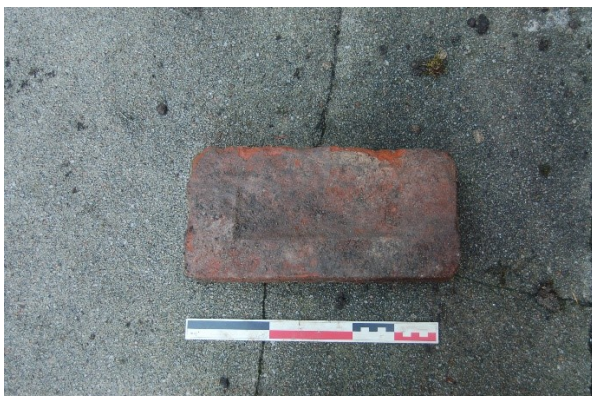
Illus 11 Large brick (A.) and glazed pottery sherd (B.) recovered from Test Pit 4.

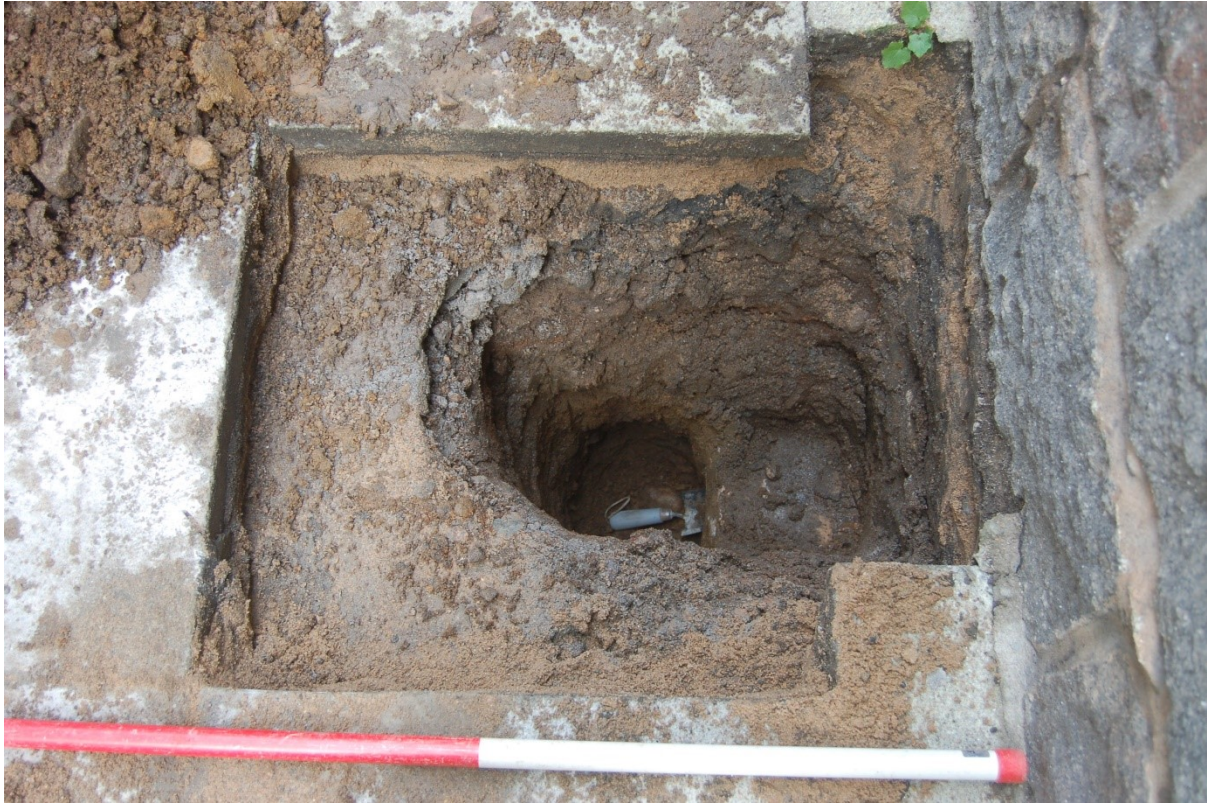
Located against the W facing wall of the Book Stack Extension (Illus 2 & 3). Test pit dimensions: 0.5m N-S x 0.6m E-W, maximum depth 1.12m. The foundation trench for the Book Stack extension was cut through natural sand and backfilled with dark brown loam above a 0.22m thick concrete foundation (0.66m depth) extending 0.25m W from the wall (Illus 12). No archaeological features or artefacts.

Illus 12 S facing section of Test Pit 5 with darker fill of foundation trench visible (right) in line with concrete foundation below: facing N.

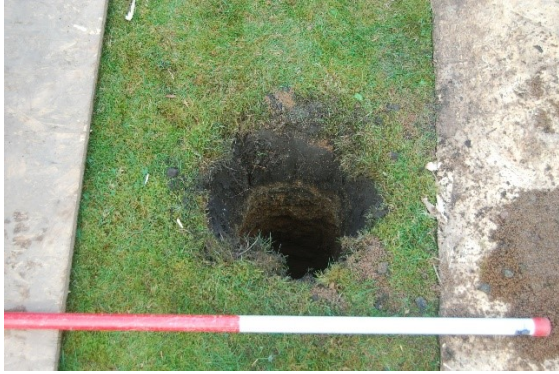
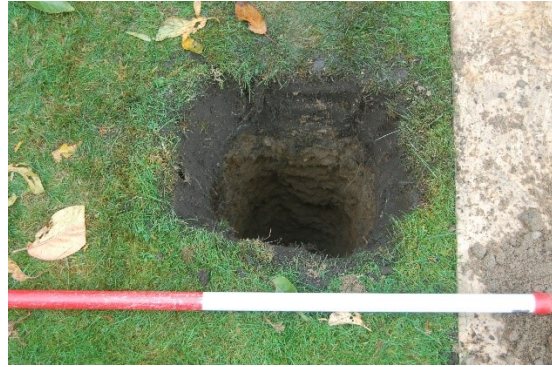
The initial hand digging of 2 bore-holes was observed during this watching brief. Holes approximately 0.25m x 0.25m, 1.2m deep were excavated in the lawn area of the Odell Courtyard Garden (Illus 2 & 3). Natural sand was exposed 0.3m below the surface. This was covered with dark loam and turf (Illus 13). A thin layer of ash material consistent with gardening activities, was located beneath the turf in Bore-hole 2 (Illus 14). No archaeological features or artefacts.

Illus 13 Bore-Hole 1 (A) and 2 (B): facing N.

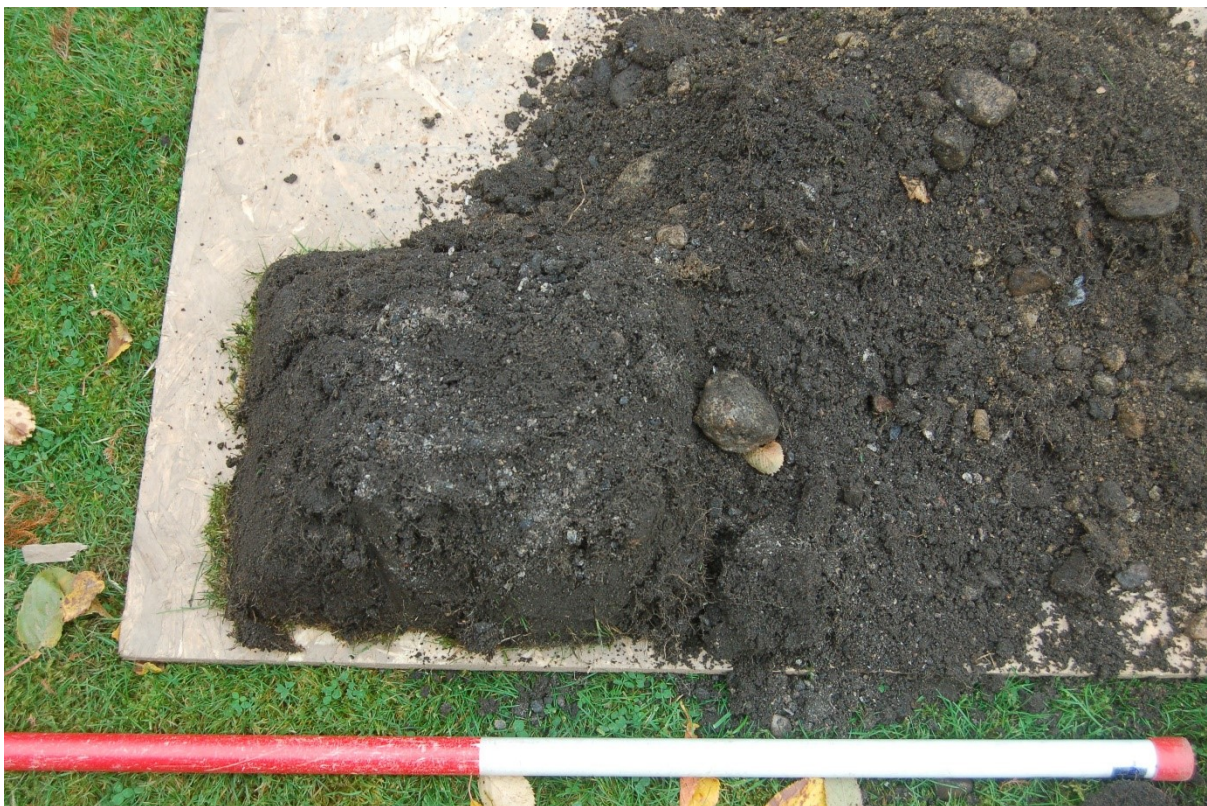
Illus 14 Ash in the base of turf removed from Bore-hole 2.
