17-19 High Street, Fraserburgh, Aberdeenshire, AB43 9AP

Report on Archaeological Watching Brief

Aberdeenshire Council Planning Application APP/2020/0954

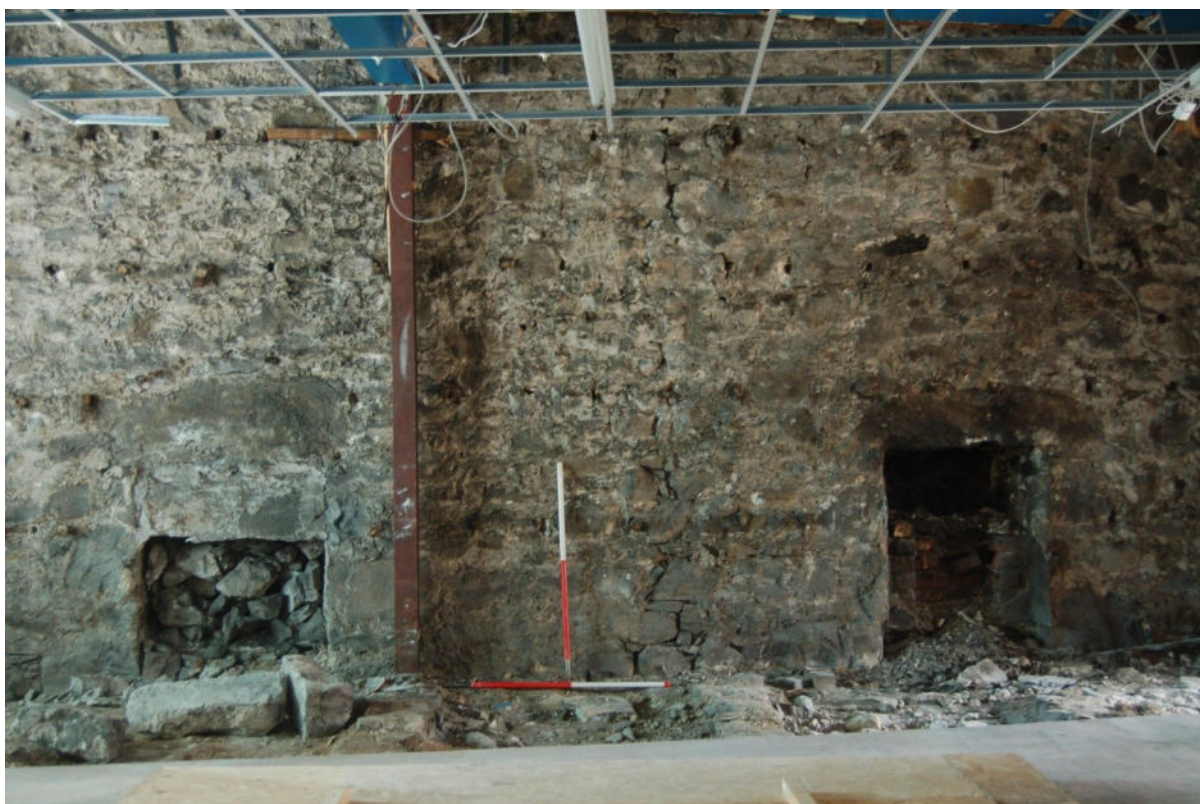
The area had been prepared prior to the arrival of an archaeologist by removal material covering the interior of the ESE walls of the existing retail space exposing two hearths (Illus 2).

Illus 2 WNW facing elevation within the front existing retail space; facing ESE.

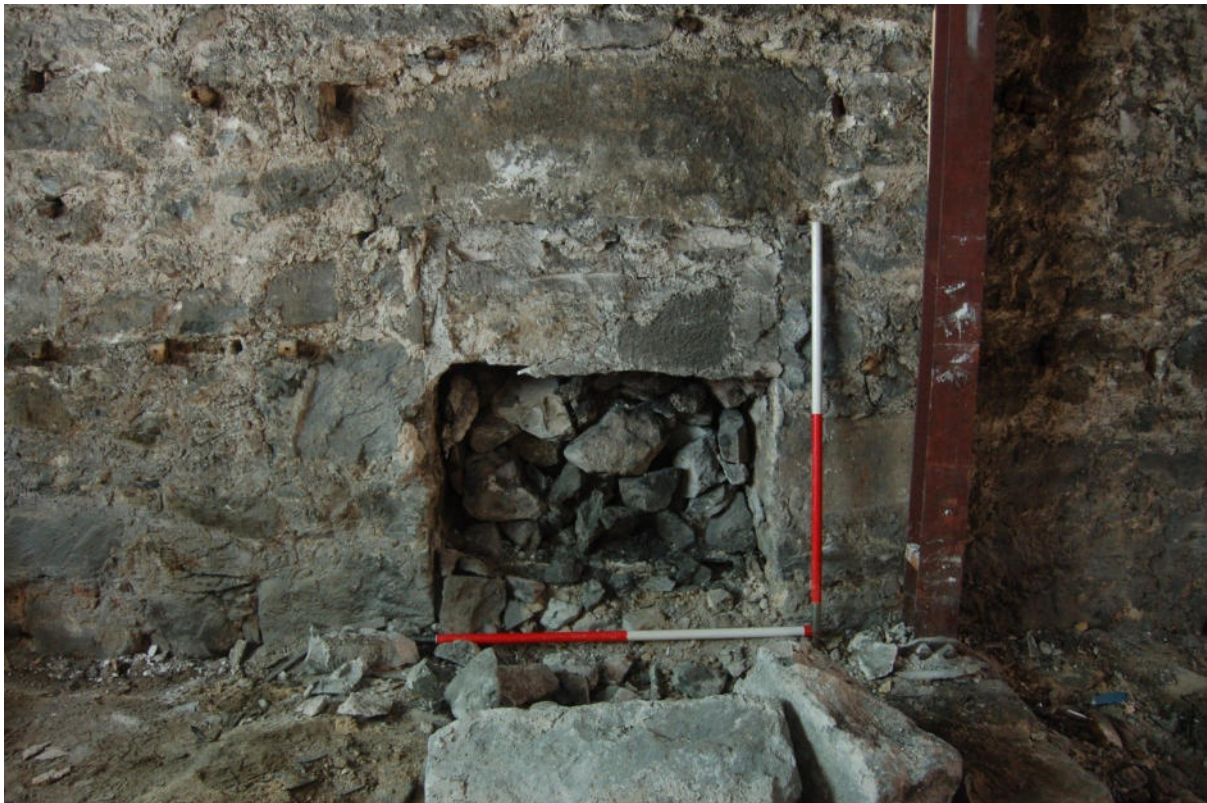
The N-most hearth had been blocked with stone rubble (Illus 3), whilst the S-most retained internal brickwork (Illus 4) which would have supported a grate when the hearth was in use.

Illus 3 N- most hearth infilled with stone rubble within the ESE wall; facing ESE.

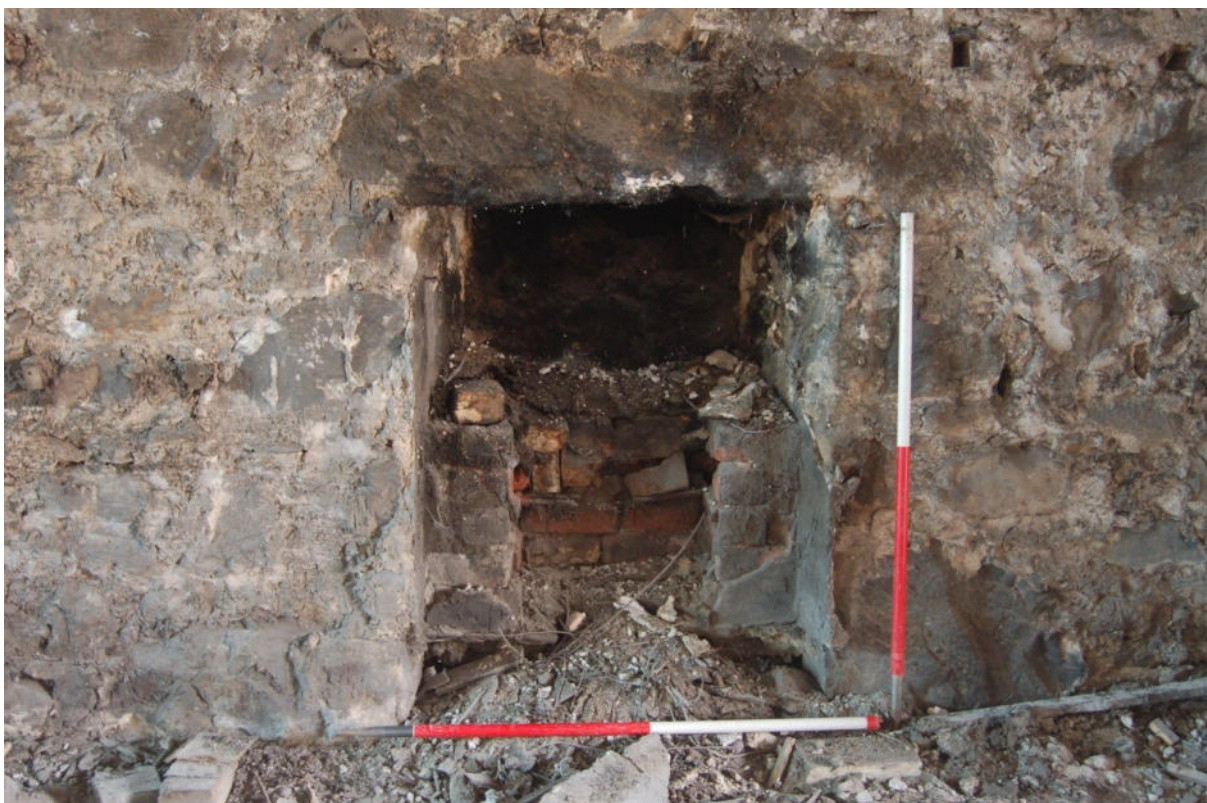
Illus 4 S-most hearth within the ESE wall; facing ESE.

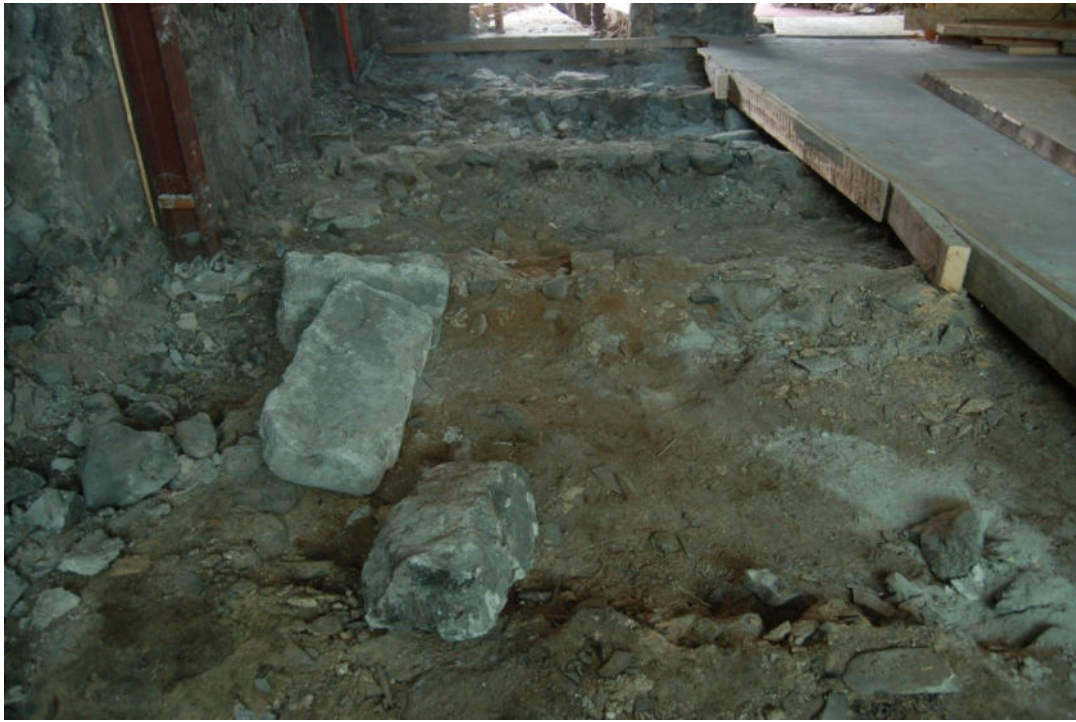
Further preparation had entailed removal of floorboards from the N part of the existing retail space revealing rubble-built sleeper walls at approximately 1.15m intervals (Illus 5). There was no evidence of an internal wall between the two hearths suggesting that, if the room had been divided in an earlier phase of occupation, the division was constructed from timber rather than stone or brick.

Illus 5 Sleeper walls exposed by removal of floorboards within the retail space fronting onto High Street; facing S.

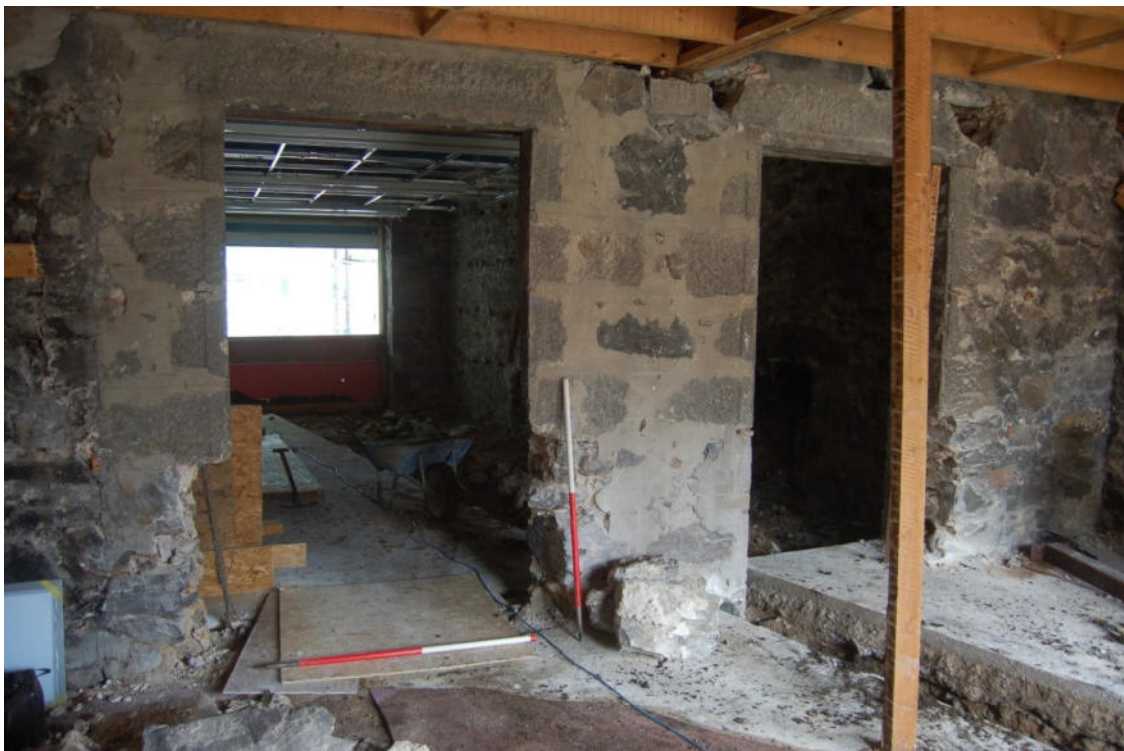
The front and rear retail spaces were separated by a granite wall. Though this is currently interior to the building, originally it was the exterior wall of the structure and was cut by a doorway (E) and window (W). The sill of the window had been removed prior to the watching brief. Both window and doorway were flared with a wider opening to the interior (approximately 1.2m to the exterior and 1.69 m on the interior) and were faced with granite ashlar (Illus 6).

Illus 6 Window (L) and doorway (R) with ashlar dressed surrounds in the rear wall of the earlier building; facing NE.

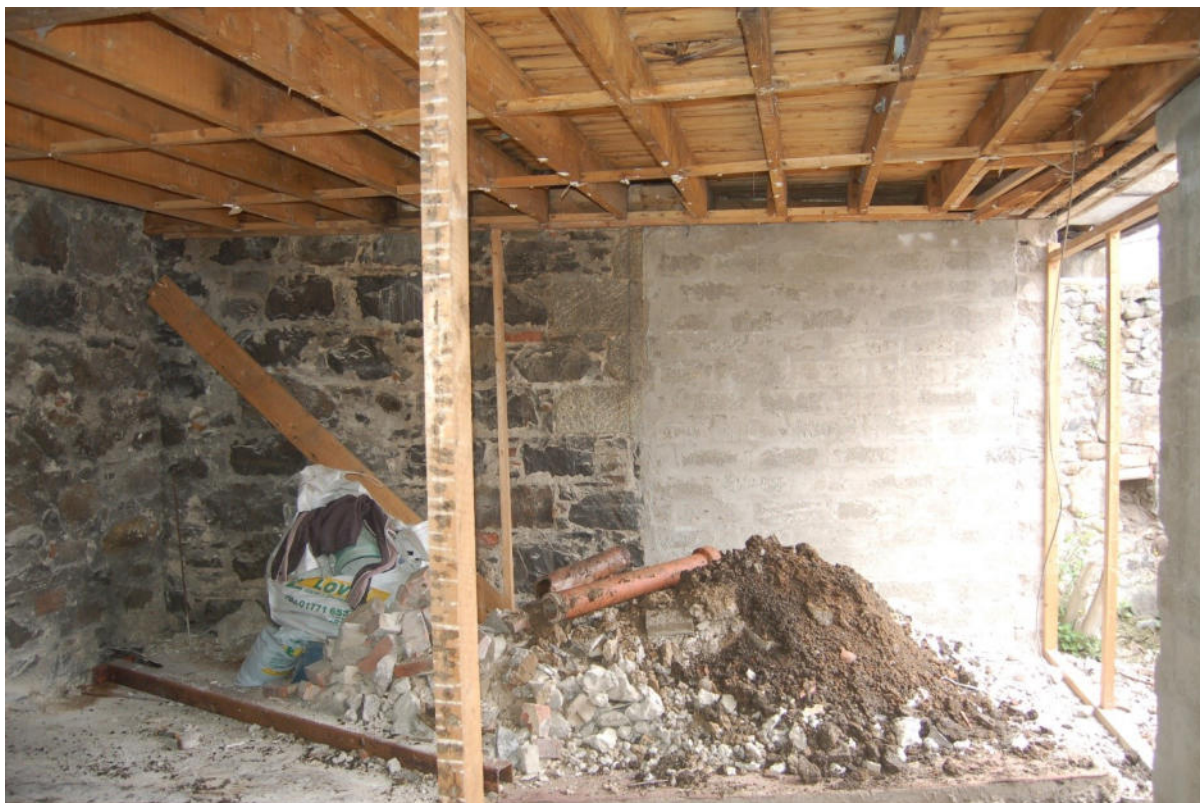
The extension to the earlier structure was visible in the ESE wall (Illus 7).

Illus 7 Working shot showing the modern cement block extension built onto the earlier granite structure of the ESE wall; facing ESE.

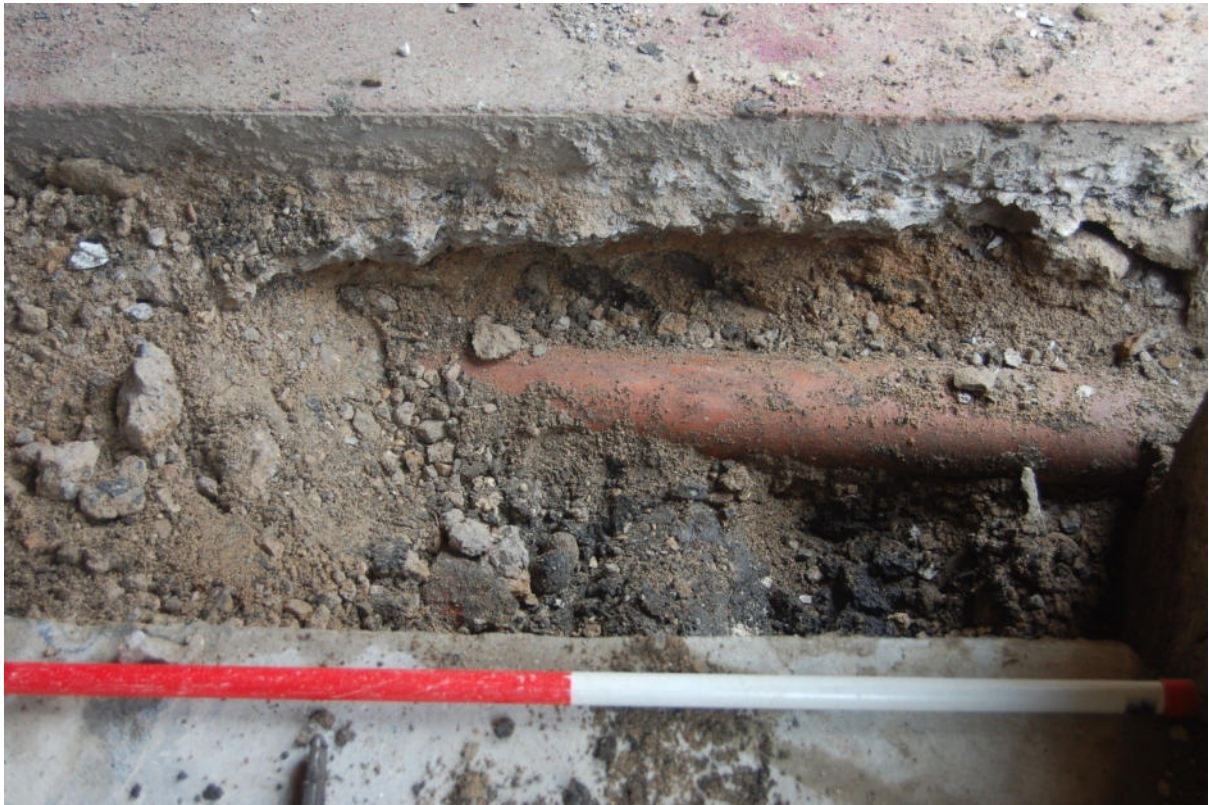
Trench 1 was situated in the rear of the existing retail space in an area which would have been external to the building at one time (Illus 8). It was cut through a modern concrete floor along the line of a drain. A ceramic drain lay beneath the concrete within a bed of sand-based hardcore (Illus 9).

Illus 9 Section of drain located within Trench 1; facing E.

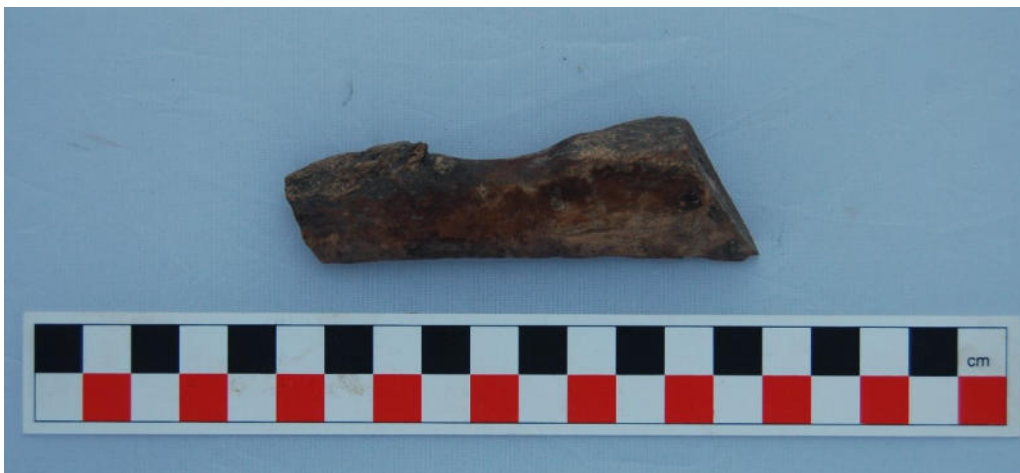
The remaining fill was dark brown compacted clay which showed evidence of disturbance. Building materials and domestic refuse was mixed through the fill. The domestic refuse included bird and animal bones, one of which may have been worked (Illus10), a significant quantity of glazed domestic ceramics, glass, ferrous objects (Illus 11) and a broken clay pipe bowl.

Illus 10 Possible worked bone artefact recovered from Trench 1.

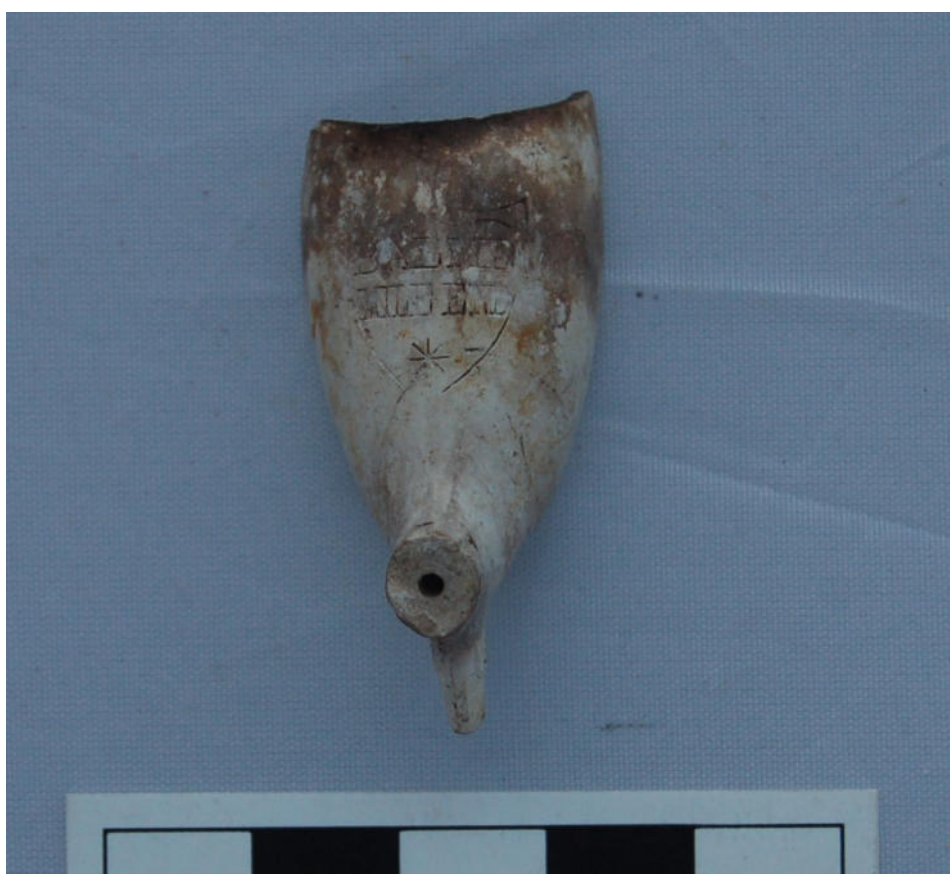
The clay pipe bowl was imprinted with the makers mark “BALME MILE END” (Illus 12); Balme were clay pipe manufacturers working in London during the 19th century (Higgins, 2004).

Illus 12 Clay pipe bowl stamped with the maker's mark “BALME MILE END” recovered from Trench 1.

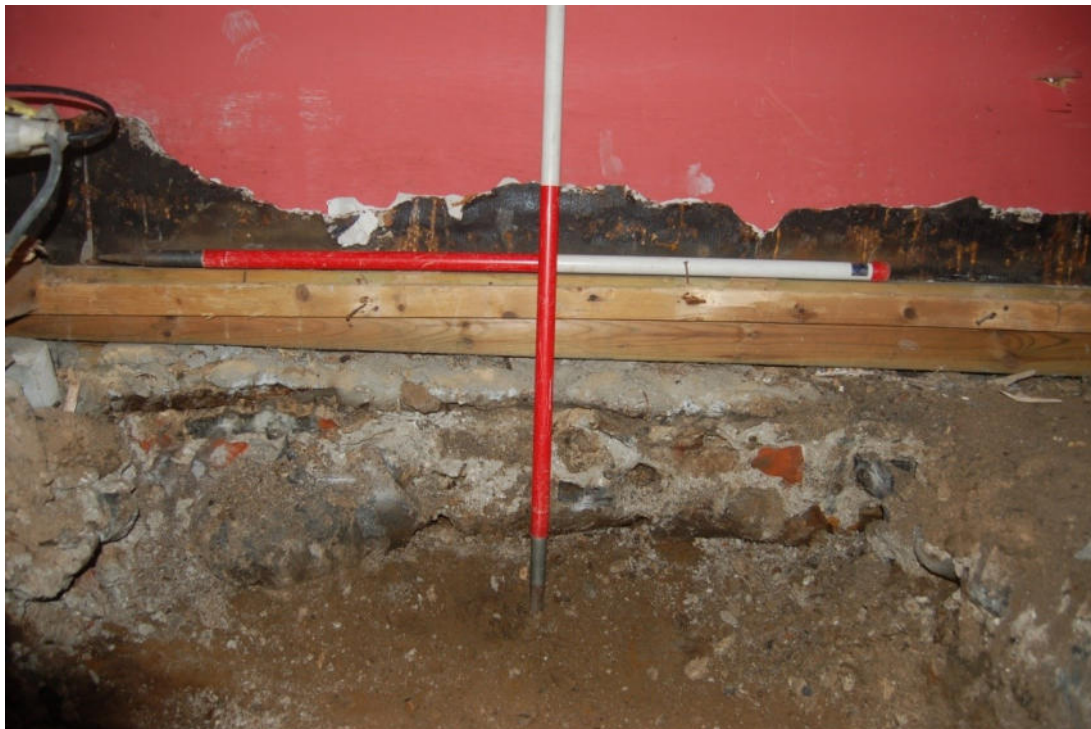
Trench 2 was situated in the front area of existing retail space in the earlier phase of the building (Illus 8). The surface beneath the modern floorboards, between sleeper walls, was strewn with rubble and loose stones with a small quantity of domestic refuse including ceramic and glass sherds and a fragment of clay pipe stem. The fill of Trench 2 was hard compacted mid-orange clay. Foundations of the N wall of the structure truncated at ground level, but surviving to a depth of 0.3m were located to the N end of the trench (Illus 13 & 14) beneath an opening which had latterly housed a large floor-to-ceiling shop window.

Illus 13 Foundation of the N wall of the structure fronting onto the High Street, beneath the frame of a modern floor-to-ceiling window; facing N.

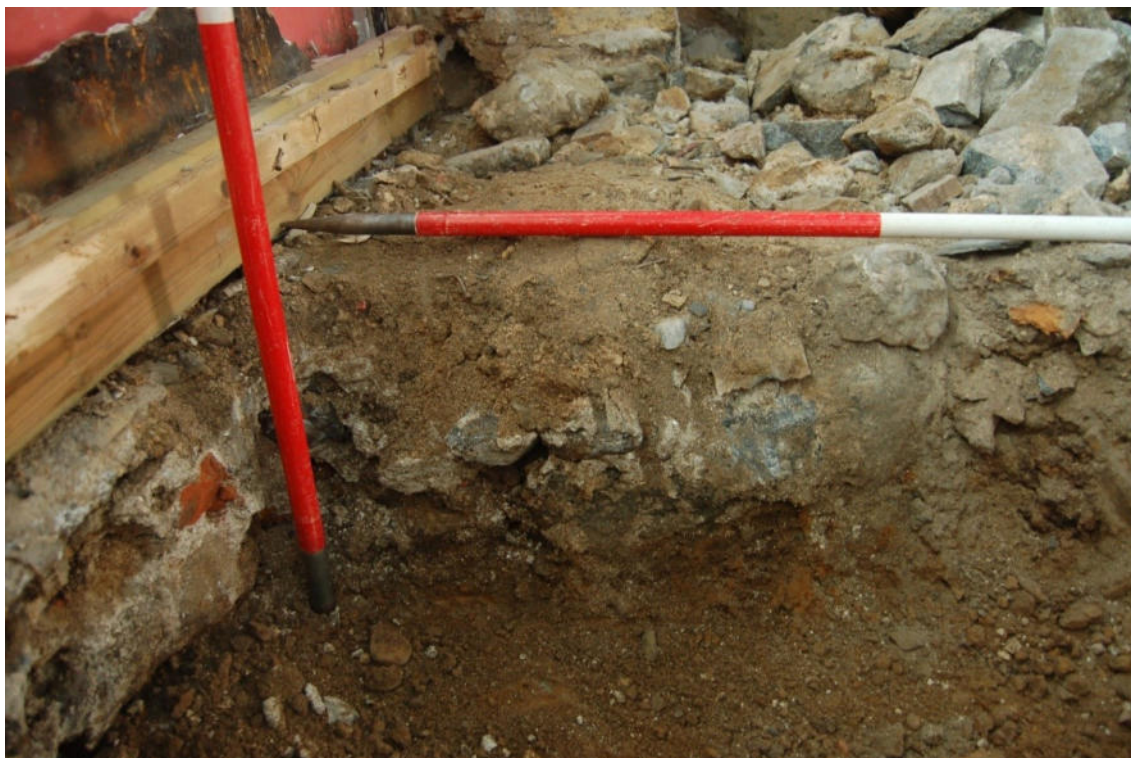
Illus 14 WNW facing section through the N wall of the structure fronting onto the High Street; facing ESE.

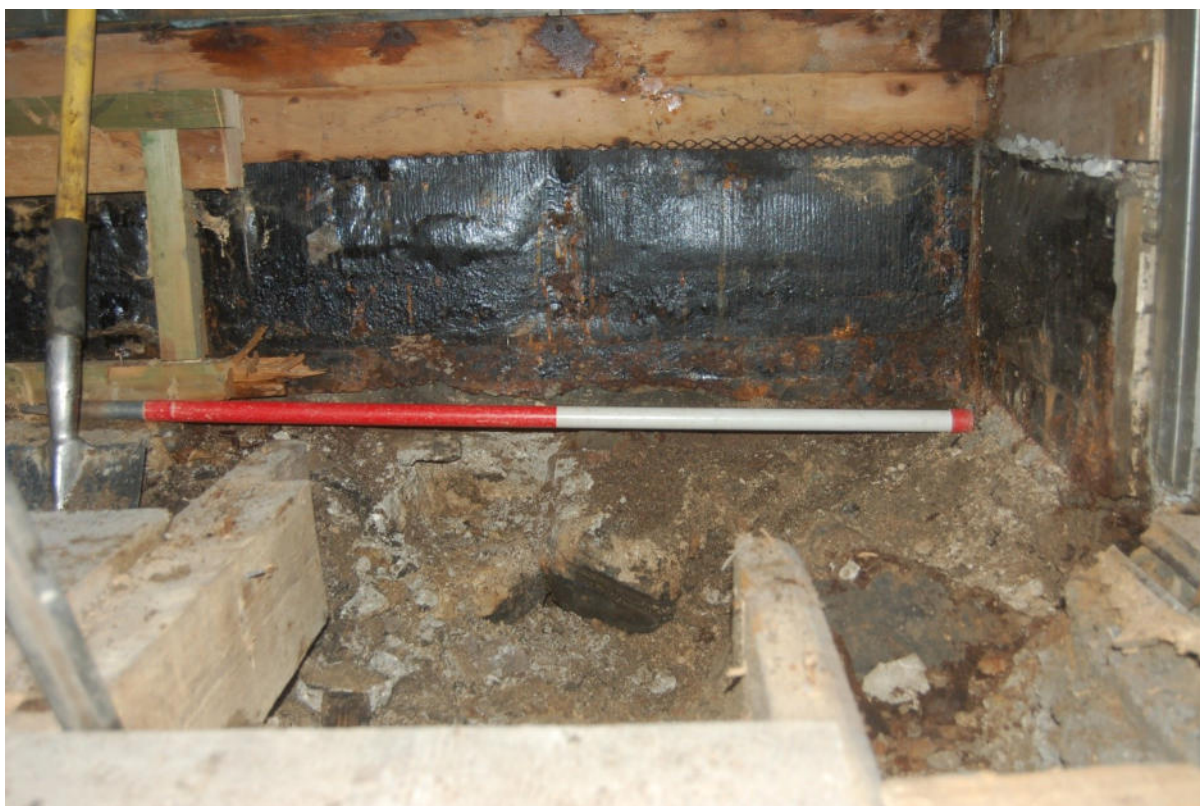
Trench 3 was situated adjacent to the N wall of the building next to an existing doorway (Illus 8). The only light source was a single arc lamp necessitating the use of flash light for all photographs. Prior to excavation the surface beneath the floorboards was strewn with building material including loose stones. The foundation of the N wall, constructed from rough granite stones, supported an I-beam which in turn supported a large window above (Illus 15).

Illus 15 Working shot of Trench 3 showing the granite foundation of the N wall supporting an I-beam and window above; facing N.

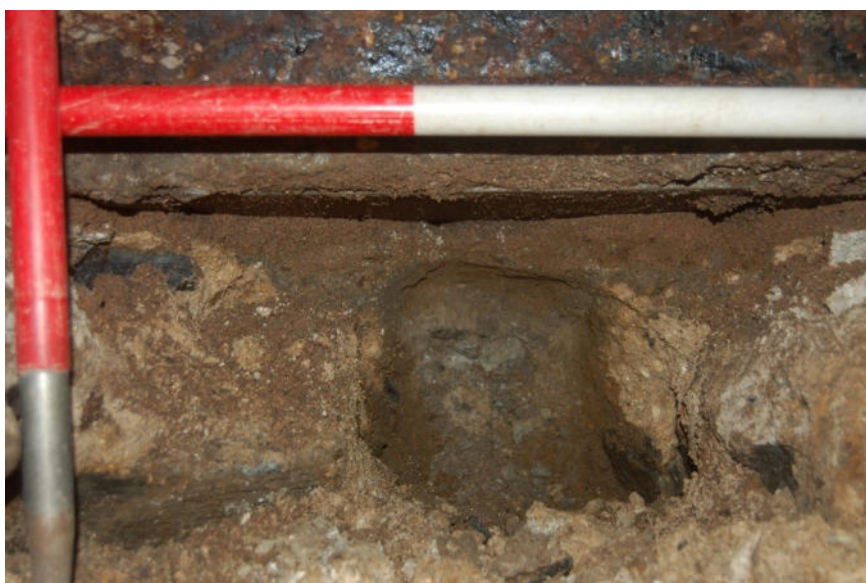
Some foundation stones were removed during excavation exposing the rear of straight cut granite stones used to face the exterior of the building (Illus 16).

Illus 16 Rear face of cut granite stones facing the N wall of the building revealed by removal of a rough foundation stone from beneath the I-beam; facing N.

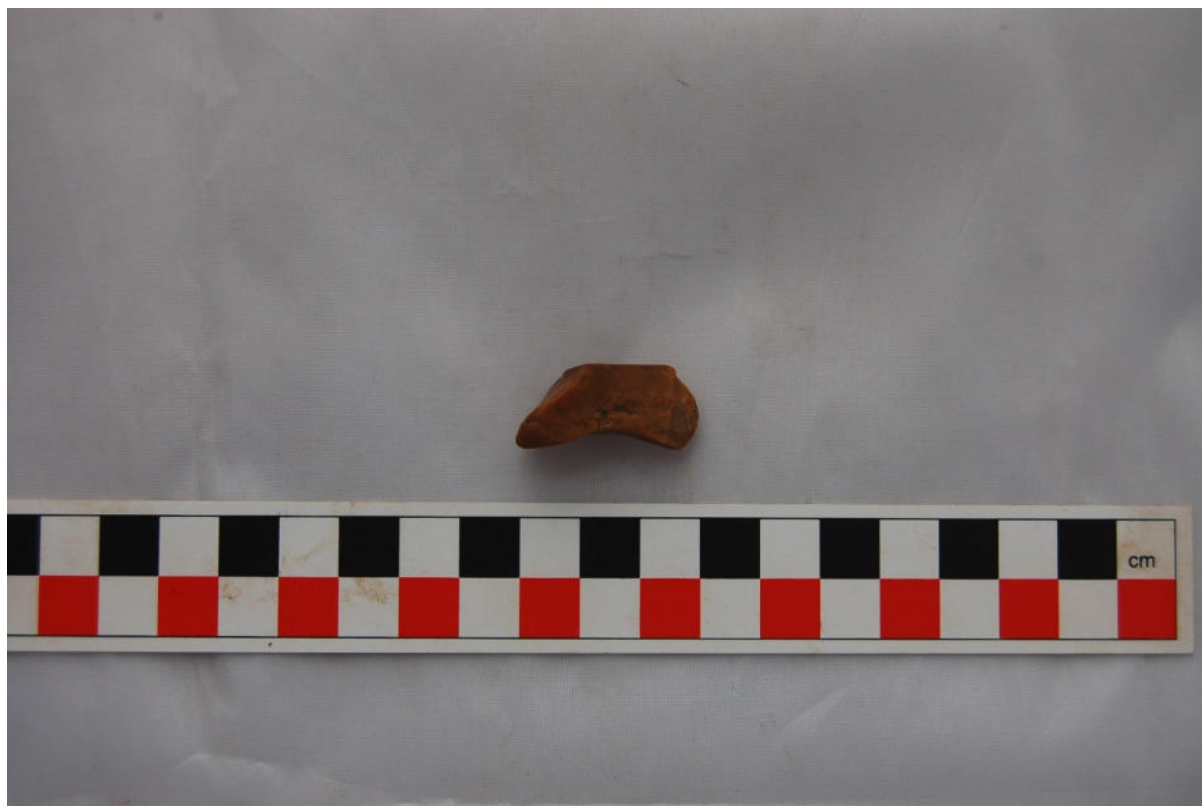
Trench 4 was located abutting a modern cement block wall in the garden S of the building (Illus 8). Initially 3 small test pits were dug to the required excavation depth of 0.7m exposing made ground. A piece of toffee coloured flint was recovered from Test Pit 1. It was quite weathered and polished suggesting it was a natural beach pebble rather than a worked stone tool or debitage (Illus 17).

Illus 17 Flint beach pebble recovered from Test Pit 1.

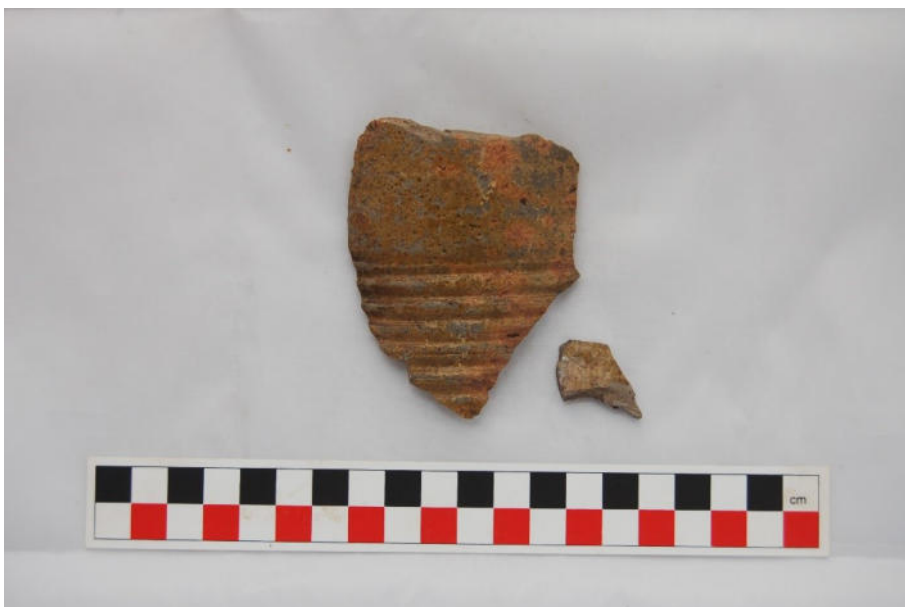
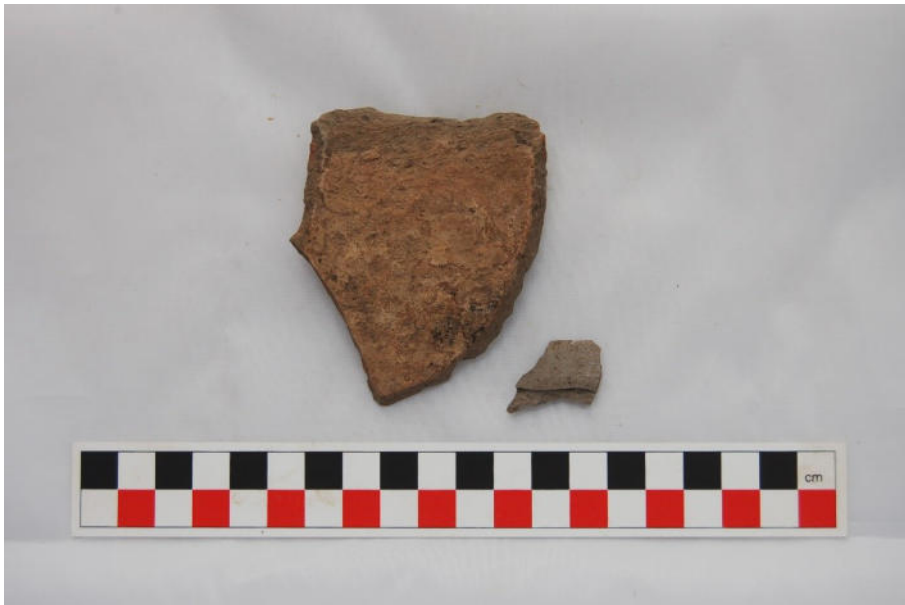
Two pieces of medieval pottery were recovered from the sondage within Trench 4. The glaze and fabric of these sherds is very similar so it is likely they were part of the same vessel (Illus 21).

A.

B.

Illus 21 Exterior glazed (A) and interior unglazed (B) sherds of green glazed medieval pottery of dark grey fabric.
