**Burnfield Road, Thornliebank
Data Structure Report
Project 5114**

On behalf of: Bellway Homes

Project Number: 5114

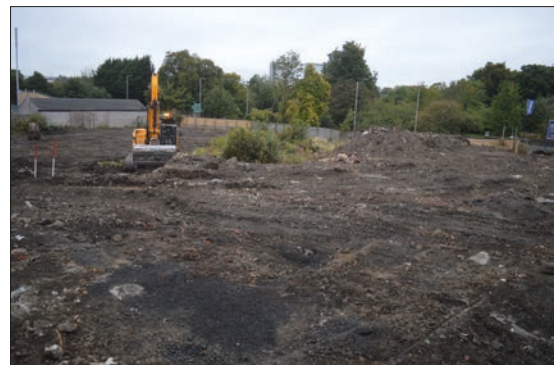
Plate 1: Pre excavation area from south-west

6.3 The topsoil or overburden was removed in spits to the first archaeological horizon or, where none was found, to the natural subsoil. The back-acting excavator was fitted with flat-bladed (toothless) ditching bucket (Plate 1).

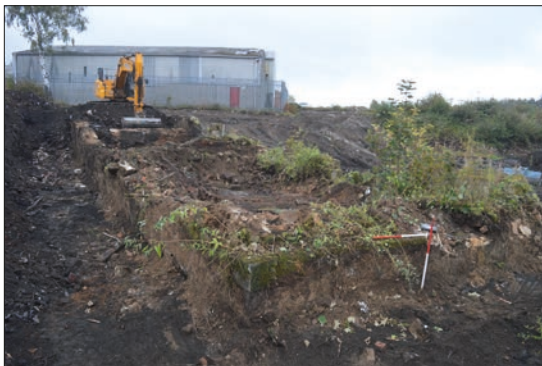
Plate 2: General view of building 003 from north-west

- 7.3 During the course of the watching brief the partially demolished ruins of a rectangular building 003, noted during the evaluation, was recorded (Plate 2). The east/west orientated building was constructed of courses of light brown sandstone blocks 303 of regular shape with an infilling of angular and sub-angular stones 304. Some areas of the south-facing wall were covered by whitewash or plaster (301). The construction materials used in doors and windows were different from the rest of the building. They consisted of rectangular blocks of grey sandstone measuring between 0.50 m and 1.20 m across. Their edges were carved straight with beveled margins and carved raised faces (Plate 3). The foundation 302 was composed of medium to large sandstone blocks that in some areas rested on the bedrock. The total length of the building could not be determined as it extended beyond the site boundary to the east. The visible dimensions recorded were 33 m on its long east/west axis by 7 m wide at the western end, with the walls surviving to a height of between 1.4 m and 2.4 m. The main building was divided into four rooms (rooms A to D) plus another annexe abutting its north wall (room E), of which only its foundations and floor remained.

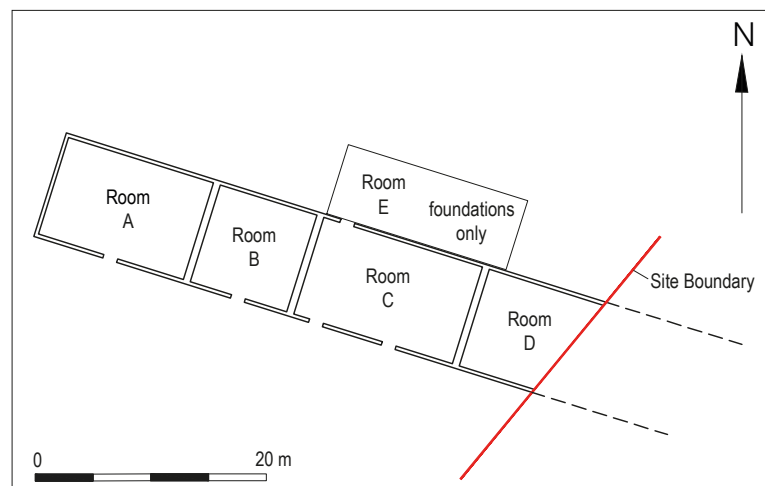
Figure 2: Floor plan of building 003

- 7.4 Room A was located at the western end of the building. It was rectangular in shape with dimensions of 10.50 m by 7 m. Access was through its southern wall through a door between two windows. In the partition wall with room B, the remains of a brick fireplace were documented, which suggests that room A could have been a bedroom or living room.
- 7.5 Room B was located between rooms A and C and was the smallest in the building. It was square in shape with sides measuring 7 m. It had a brick fireplace in the partition wall with room A and a brick oven in the partition wall with room C which indicate that it was most likely the kitchen of the building. A door located between two windows was noted in its southern wall (Plate 4).

- 7.6 Room C was situated between room B and D. It was the largest room in the building with a rectangular shape and dimensions of 11.50 m by 7 m. Two doors were documented in its southern wall and one in the northern wall linking this room with the annex or room E. Remains of internal concrete partition walls and chains suggest that it was probably a stable for livestock (Plate 5).
- 7.7 Room D was located immediately east of Room C. Its dimensions have not been documented as it extended outwith the proposed development. From what was visible, there were no doors or windows.
- 7.8 Room E was an extension or annex of the main building. It was aligned parallel to Room C's northern wall, which it did abut. It was rectangular in plan with dimensions of 15 m by 6 m. Only the west elevation wall was visible along with the floor (Plate 6).

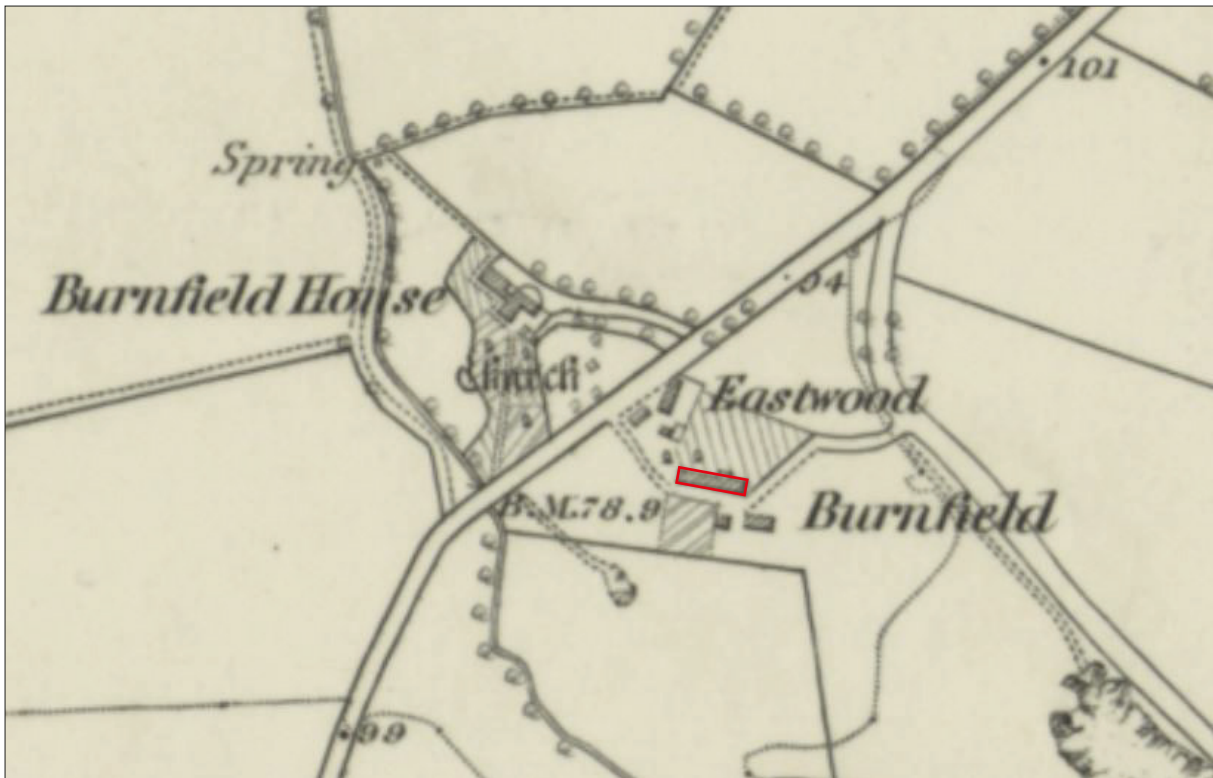
Figure 3: 1863 6-inch OS map Renfrewshire, Sheet XIII (includes: Carmunnock; Cathcart; Eastwood; Glasgow; Govan; Rutherglen)

- 8.1 The watching brief identified the remains of a rectangular building relating to the use of the site during the post-medieval period. The structure corresponds to one of the farmstead buildings first depicted on the 1863 6-inch first edition OS map (Figure 3), and was depicted on OS maps until the middle of the twentieth century.
