# GLENBOIG DEVELOPMENT TO EAST OF M73, NORTH LANARKSHIRE: PHASES 1 AND 2

## ARCHAEOLOGICAL EVALUATION

commissioned by Doug Riddell Consultancy Ltd  
and Muir Homes Ltd

February 2017

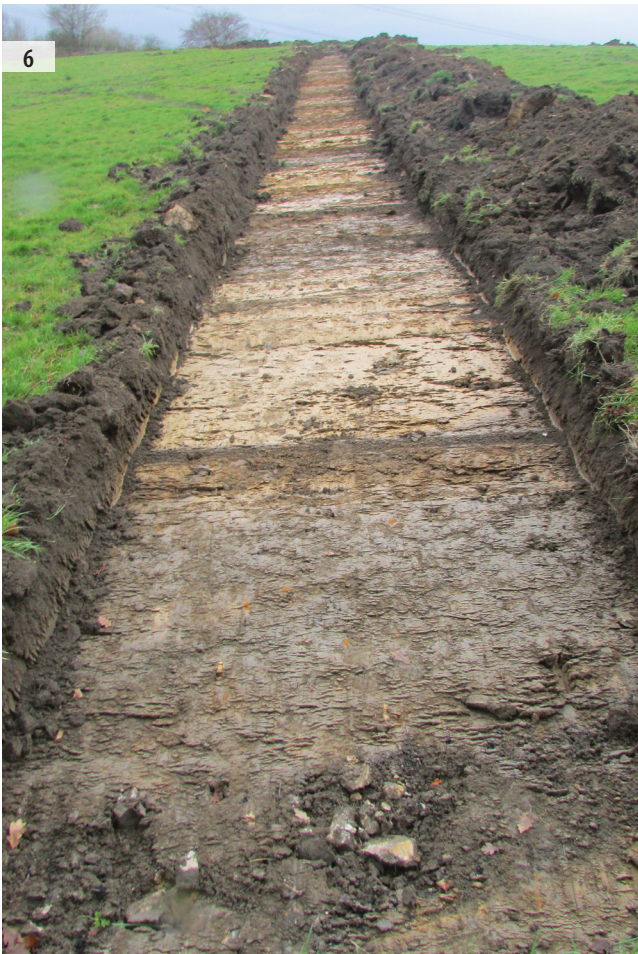
**ILLUS 6** View of the geological subsoil in Trench 38    **ILLUS 7** View of the plough furrows in Trench 22

A total of 60 trenches were excavated totalling 2,995 linear meters which amounted to 5,990m<sup>2</sup> (Illus 5). This equates to approximately 5% of the available area. All of the trenches contained deposits of topsoil, a dark brown peaty loam, overlying either the natural subsoil or in a small number of cases a thin subsoil deposit. The thickness of the topsoil was fairly even across the DA largely between 0.25m and 0.35m with the overburden being slightly thicker across the lower parts of the site. The thin subsoil deposit comprised a mid-yellow brown sandy clay with a maximum depth of 0.05m. The geological subsoil generally comprised of a mottled yellow/grey clay with occasional stone inclusions (Illus 6). Changes to this included small areas of orange mottled clay with occasional blue/grey clay also exposed. The bedrock was also visible in one or two trenches across the higher ground.

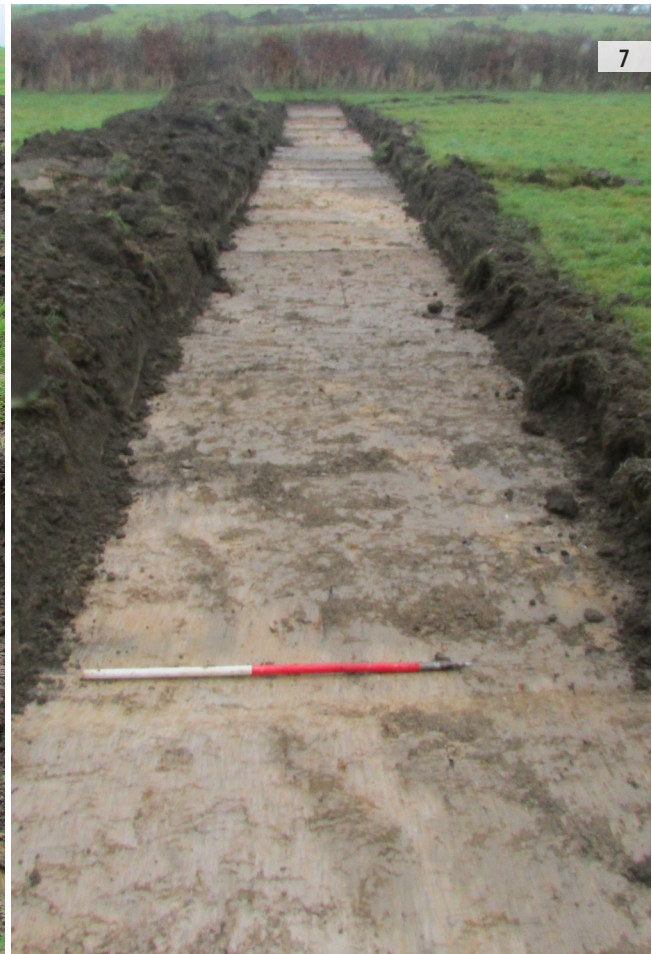
By far the most predominant feature recorded within the majority of the trenches comprised the remains of plough furrows (Illus 7). These were all aligned north-west to south-east with the exception

of Trenches 57 to 60 that were aligned east to west. The furrows were generally 2m wide and 3m apart with a shallow fill of mid yellow brown sandy clay. The fills consistently produced fragments of 19th/20th century. A small number of field drains were also recorded across the site.

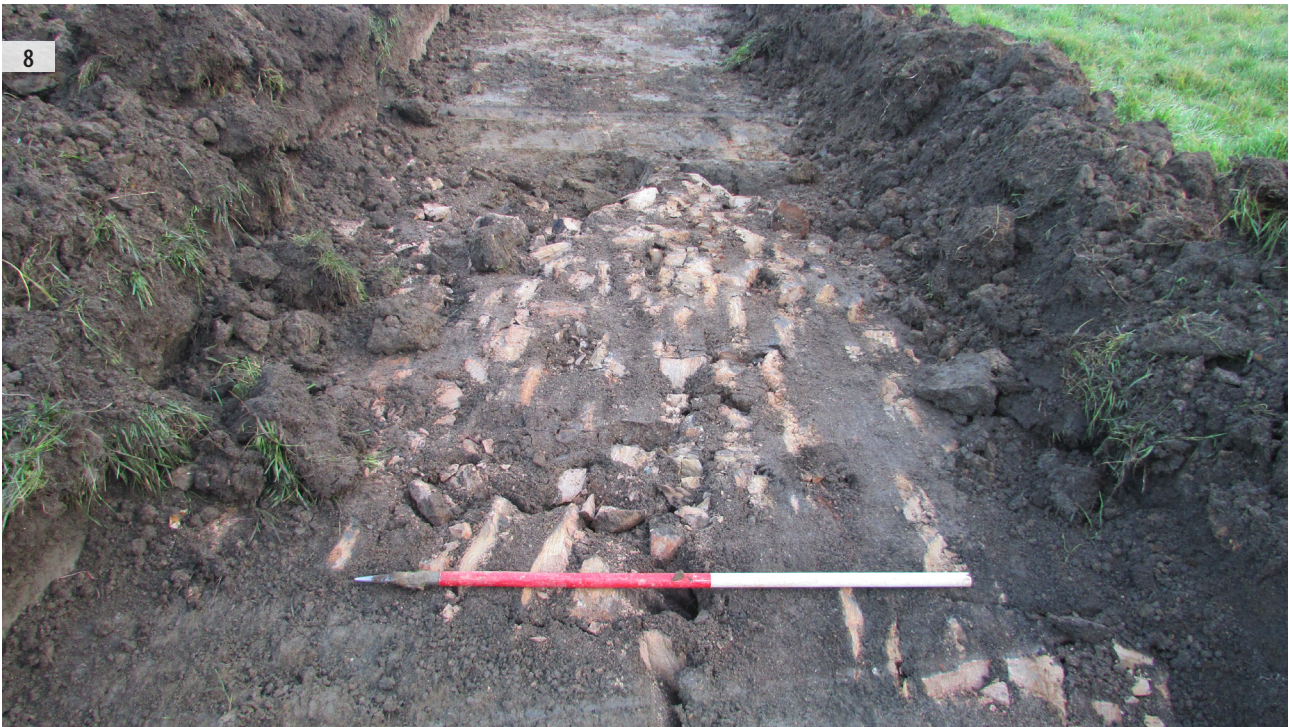
Features of archaeological interest were present in three trenches – Trenches 48, 55 and 56. This comprised of two areas of sandstone cobbling (Trench 48 and Trench 55) and a linear stone filled foundation (Trench 56). The stone cobbles were 3m wide formed of a series of poorly preserved upright stones forming a cobble surface (illus 8) 0.3m below the surface of the topsoil. The foundation (illus 9) comprised of both stone and brick although it had been disturbed and truncated. Bricks recovered from this area included Glenboig ‘Starworks’ bricks and ‘FREW’ frogged bricks. All these features formed the remains of the Garnqueen Purification Works that was established on the site in the 1930s.

**ILLUS 8** Detail of the stone cobble surface in Trench 48 **ILLUS 9** View of the stone foundation in Trench 56

The evaluation identified that the area has been part of an agricultural landscape at least since the early 1800s. The woodland that is enclosed by the farmland also appears to date to the same period. The only other activity recorded during the works was the remains of a 1930s water purification plant decommissioned in the 1960s. Due to the limited value of these remains no further work in the Phase 1 and 2 development areas is recommended.
