UFC05-GLT

Date: August 2006

Client: Historic Scotland

**Upper Forth Crossing: Kincardine
Data Structure Report for the Archaeological
Excavation and Building Recording at Garlet
House, Kilbagie, Clackmannanshire**

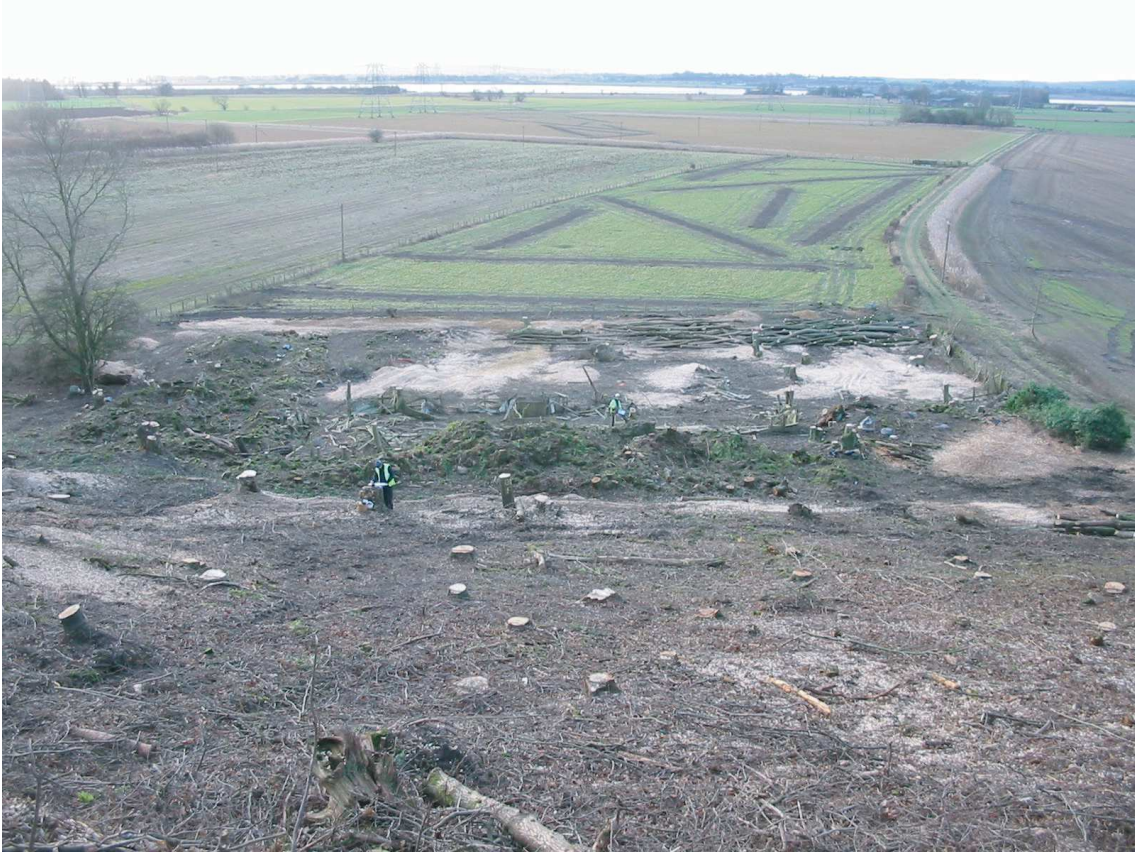
UFC05-GLT: Plate 1 - General shot, before clearance (facing S)

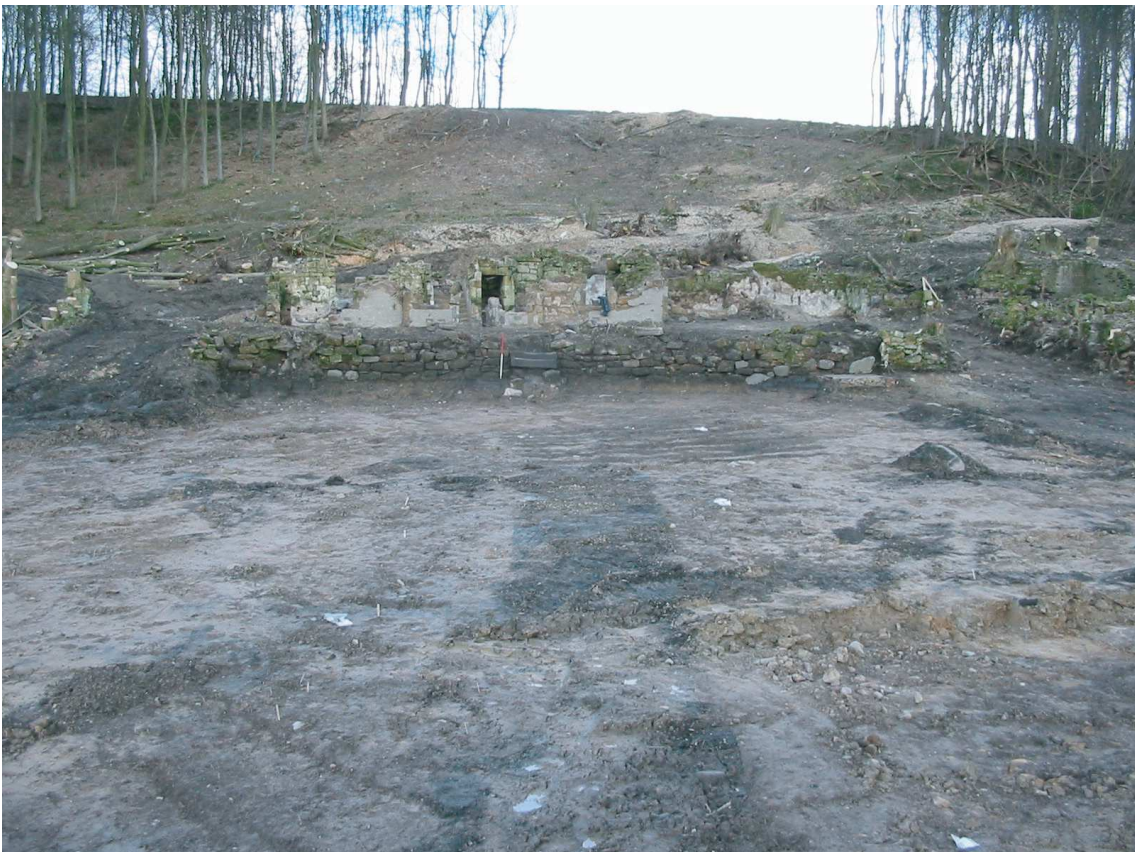
UFC05-GLT: Plate 2 - Front of house, showing terrace garden (facing N)

The terrace at the front of the house comprised re-deposited subsoil (as noted above) with a stone rubble retaining wall (context 1321) and steps. This wall survived intact although possible later rubble additions were noted to the east and west. Cut into the subsoil in the eastern half of the terrace was a stone culvert, running from the main house on a northwest to southeast axis. Above this was a layer of crushed brick and cinder, forming a modern surface and noted throughout the site.

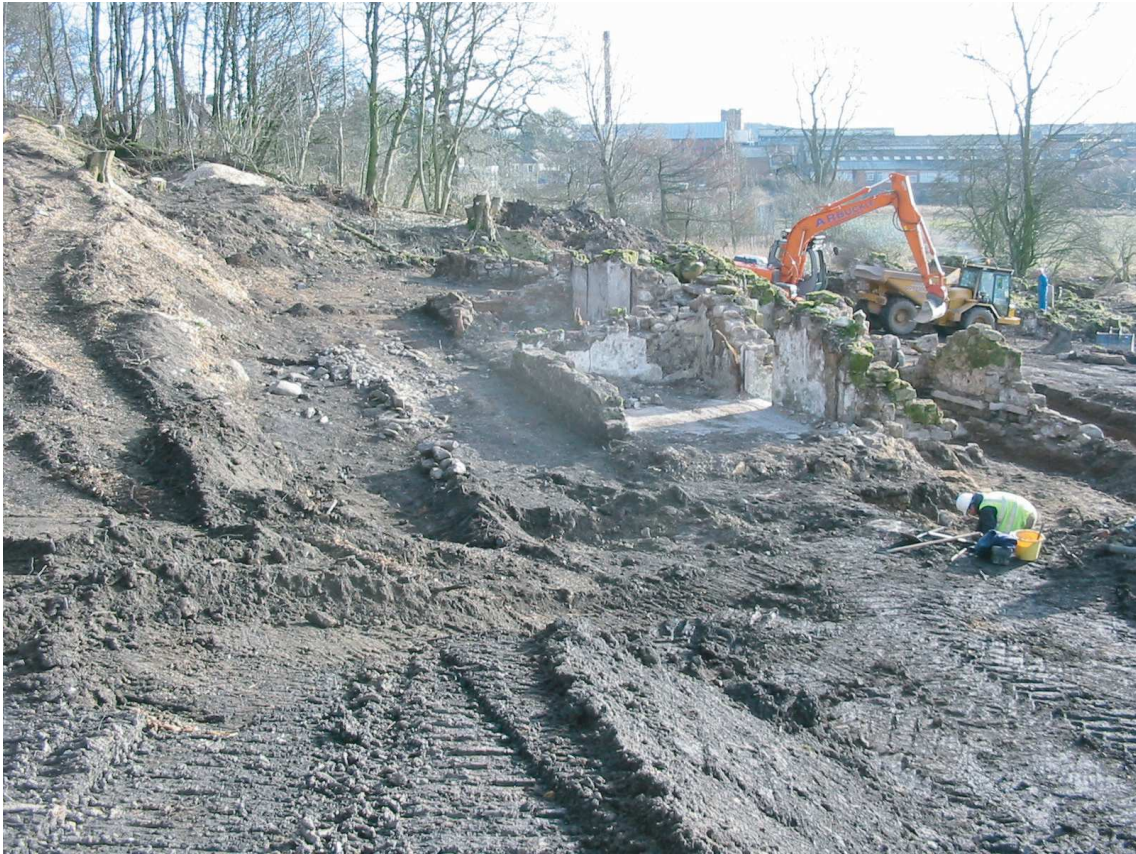
UFC05-GLT: Plate 3 - Rear of house showing surfaces and track (facing E)

The area to the rear of the main house and extensions was also cleared of vegetation and topsoil. This revealed a layer of mixed material representing overburden and hill wash (context 1414) that sealed the site after being abandoned. Beneath this were the remains of a stone kerb (context 1355) above a former track/yard area with the fragmentary remains of a cobbled surface (context 1352) with later patching and repairs (context 1353). The cobbles were compacted into the natural clayey subsoil and appeared to follow the line of an earlier track, noted as a cut track/holloway continuing to the northeast of the main house (the line of the track was noted continuing through the wood out-with the road corridor towards Kilbagie House). Bordering the track to the north was a drainage ditch (context 1483) to catch excess run-off from the escarpment. This had been filled in and modified at a later stage with the introduction of a stone culvert (context 1357), which formed part of a series of stone drain structures to the south (context 1499) and west (contexts 1430, 1495 & 1497). It is possible that the culverts along with the cobbled surface relate to the phase of activity during which extension 1C was built behind the main house. This is supported with drain 1354 that comprises a north wall (1354) built parallel to and respecting the line of the north wall of extension 1C. This culvert continues to the west where the southern wall of the culvert (context 1430) is noted extending from the northwest corner of extension 1C. Although the current drain comprises a modern ceramic pipe, remnants of the location of the capping stones for the original culvert are evident with the presence of grooves cut into the lower course of the exterior of the north wall (context 1384) of room 1C. The date of the culverts is intimated by the associated finds (early to mid 19th century) and the discovery of graffiti on a capping stone from culvert 1357 that reads the “9th June 1813” with the initials “CG”. It has been suggested that this may be the signature of the person responsible for the building of the drain. As it is likely that the culverts are contemporary with the building of extension 1C, it also supports a likely date for this phase of construction. The western end of the rear excavation area revealed a series of modern deposits (contexts 1427 and 1428) that represent modern track/yard surfaces similar to those noted across the site. To the north and upslope of the excavated area to the rear of the house was noted another track that appears to be more recent than that noted above. This track is visible on the 1st edition OS (1861) and is likely to have provided a replacement to the original track once the extensions had been added to the rear of the main house in order to create a yard area and make more room.

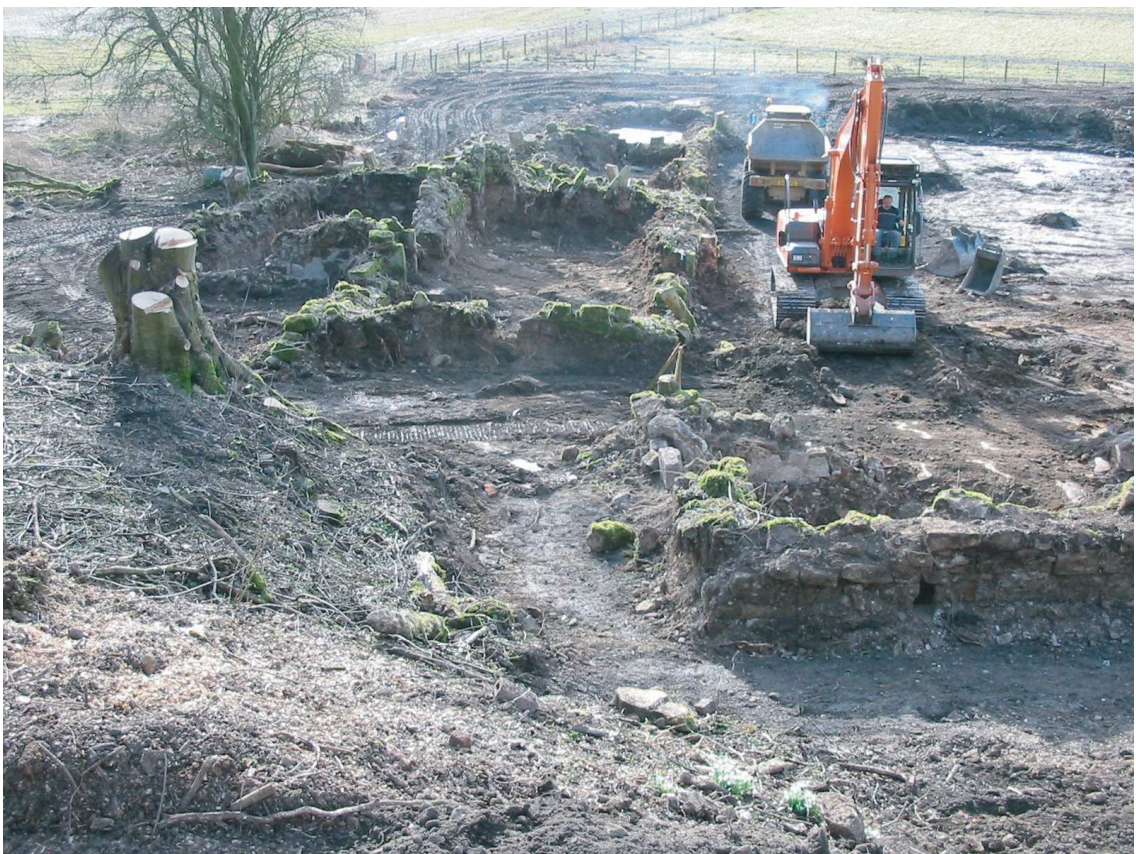
UFC05-GLT: Plate 4 - Clearing the cottages (facing S)
