FORMER ODEON CINEMA, EDINBURGH

Historic Building Recording

for G1 Group

October 2016

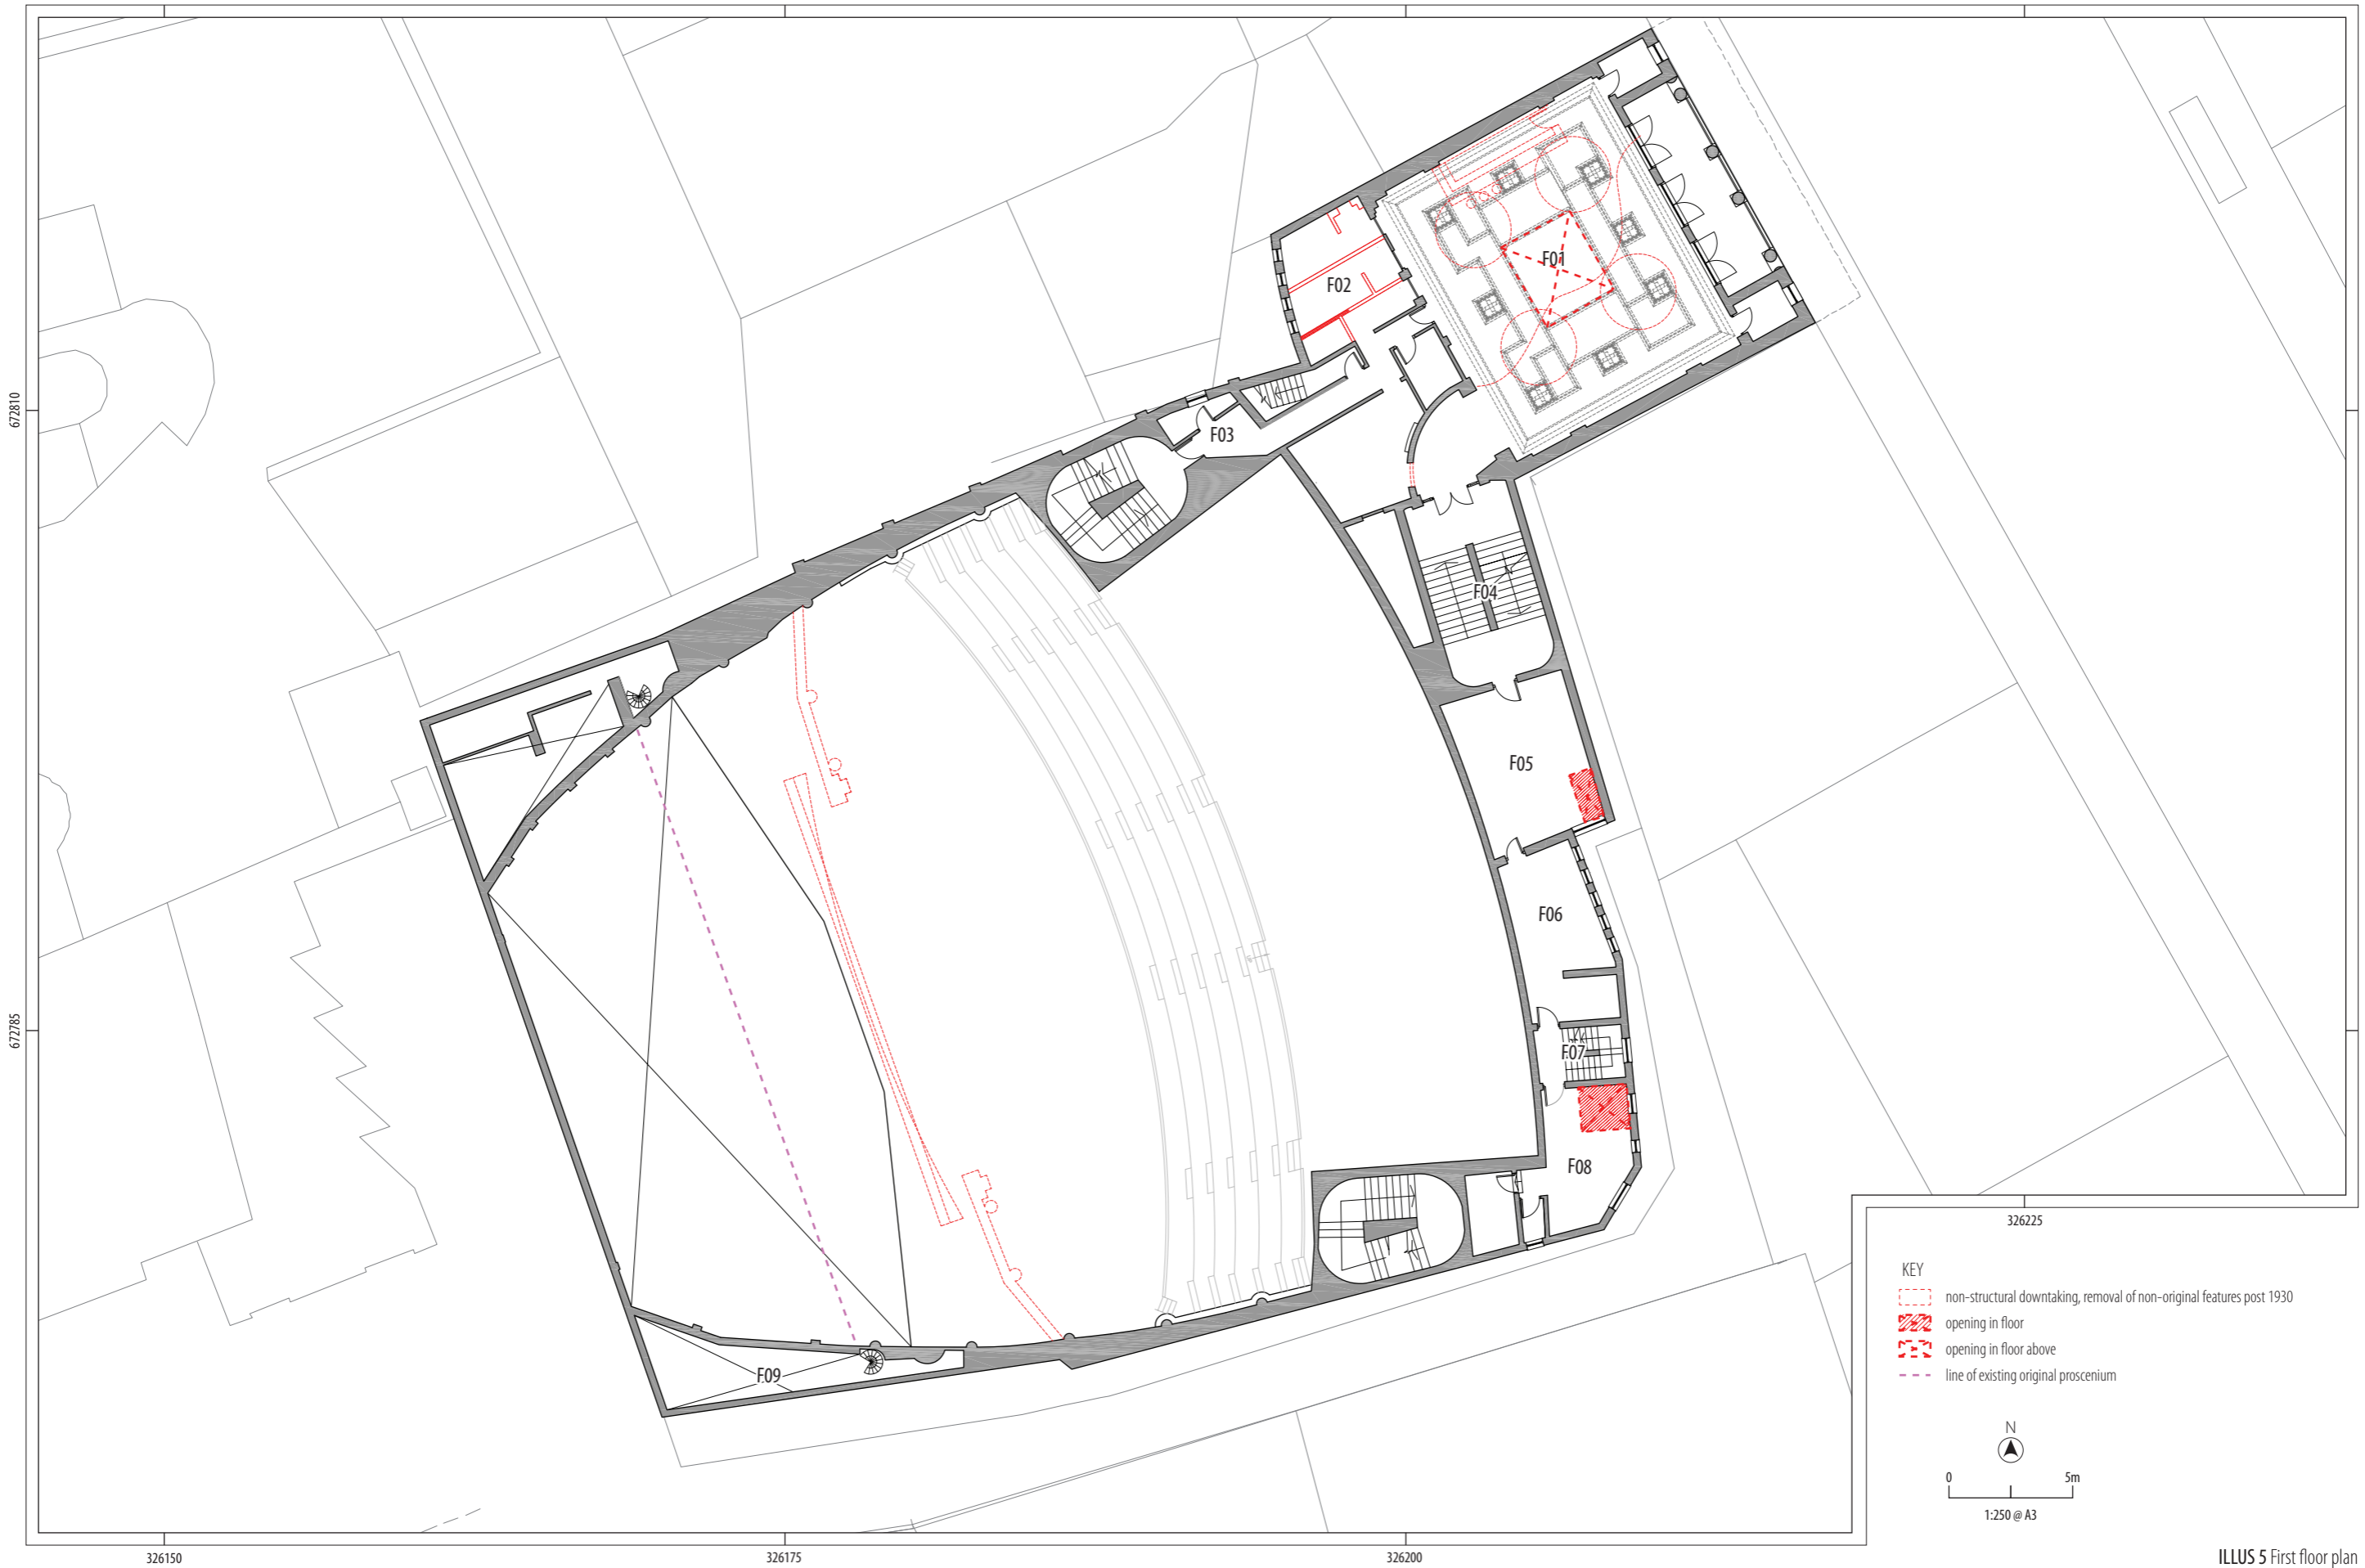
ILLUS 5 First floor plan

The first floor (Illus 5) broadly matches the footprint of the ground floor, albeit without the northern corridor (G09). The space above the foyer (G01) is occupied by a former café (F01) and associated toilets (F02). The level of this northern part of the first floor is around half a storey above the southern part, to allow additional height in the foyer (G01) below. This is most clearly evident in the north-east circulation, where an extra flight of steps takes the visitor from store (F05) up to the café (F01). The crush hall (F02) is also afforded extra ceiling height by its position under the higher section of the raked circle seating – the seats at this level are shown on the second-floor plan (Illus 6) and the circle seating generally is described as S07 below. Several stores were located east of the main auditorium (F05-08).

Since the cinema was divided into several smaller screens in the 1980s, the first floor level has been extended across the auditorium from the balcony forwards. This floor had been removed by the time of the survey, exposing the full scale of the original auditorium (Illus 9). This will only be a temporary situation, as this floor level will be reinstated during the present redevelopment work. The new upper screen will be positioned further back than the old one so more of the original decoration and the proscenium will be visible.

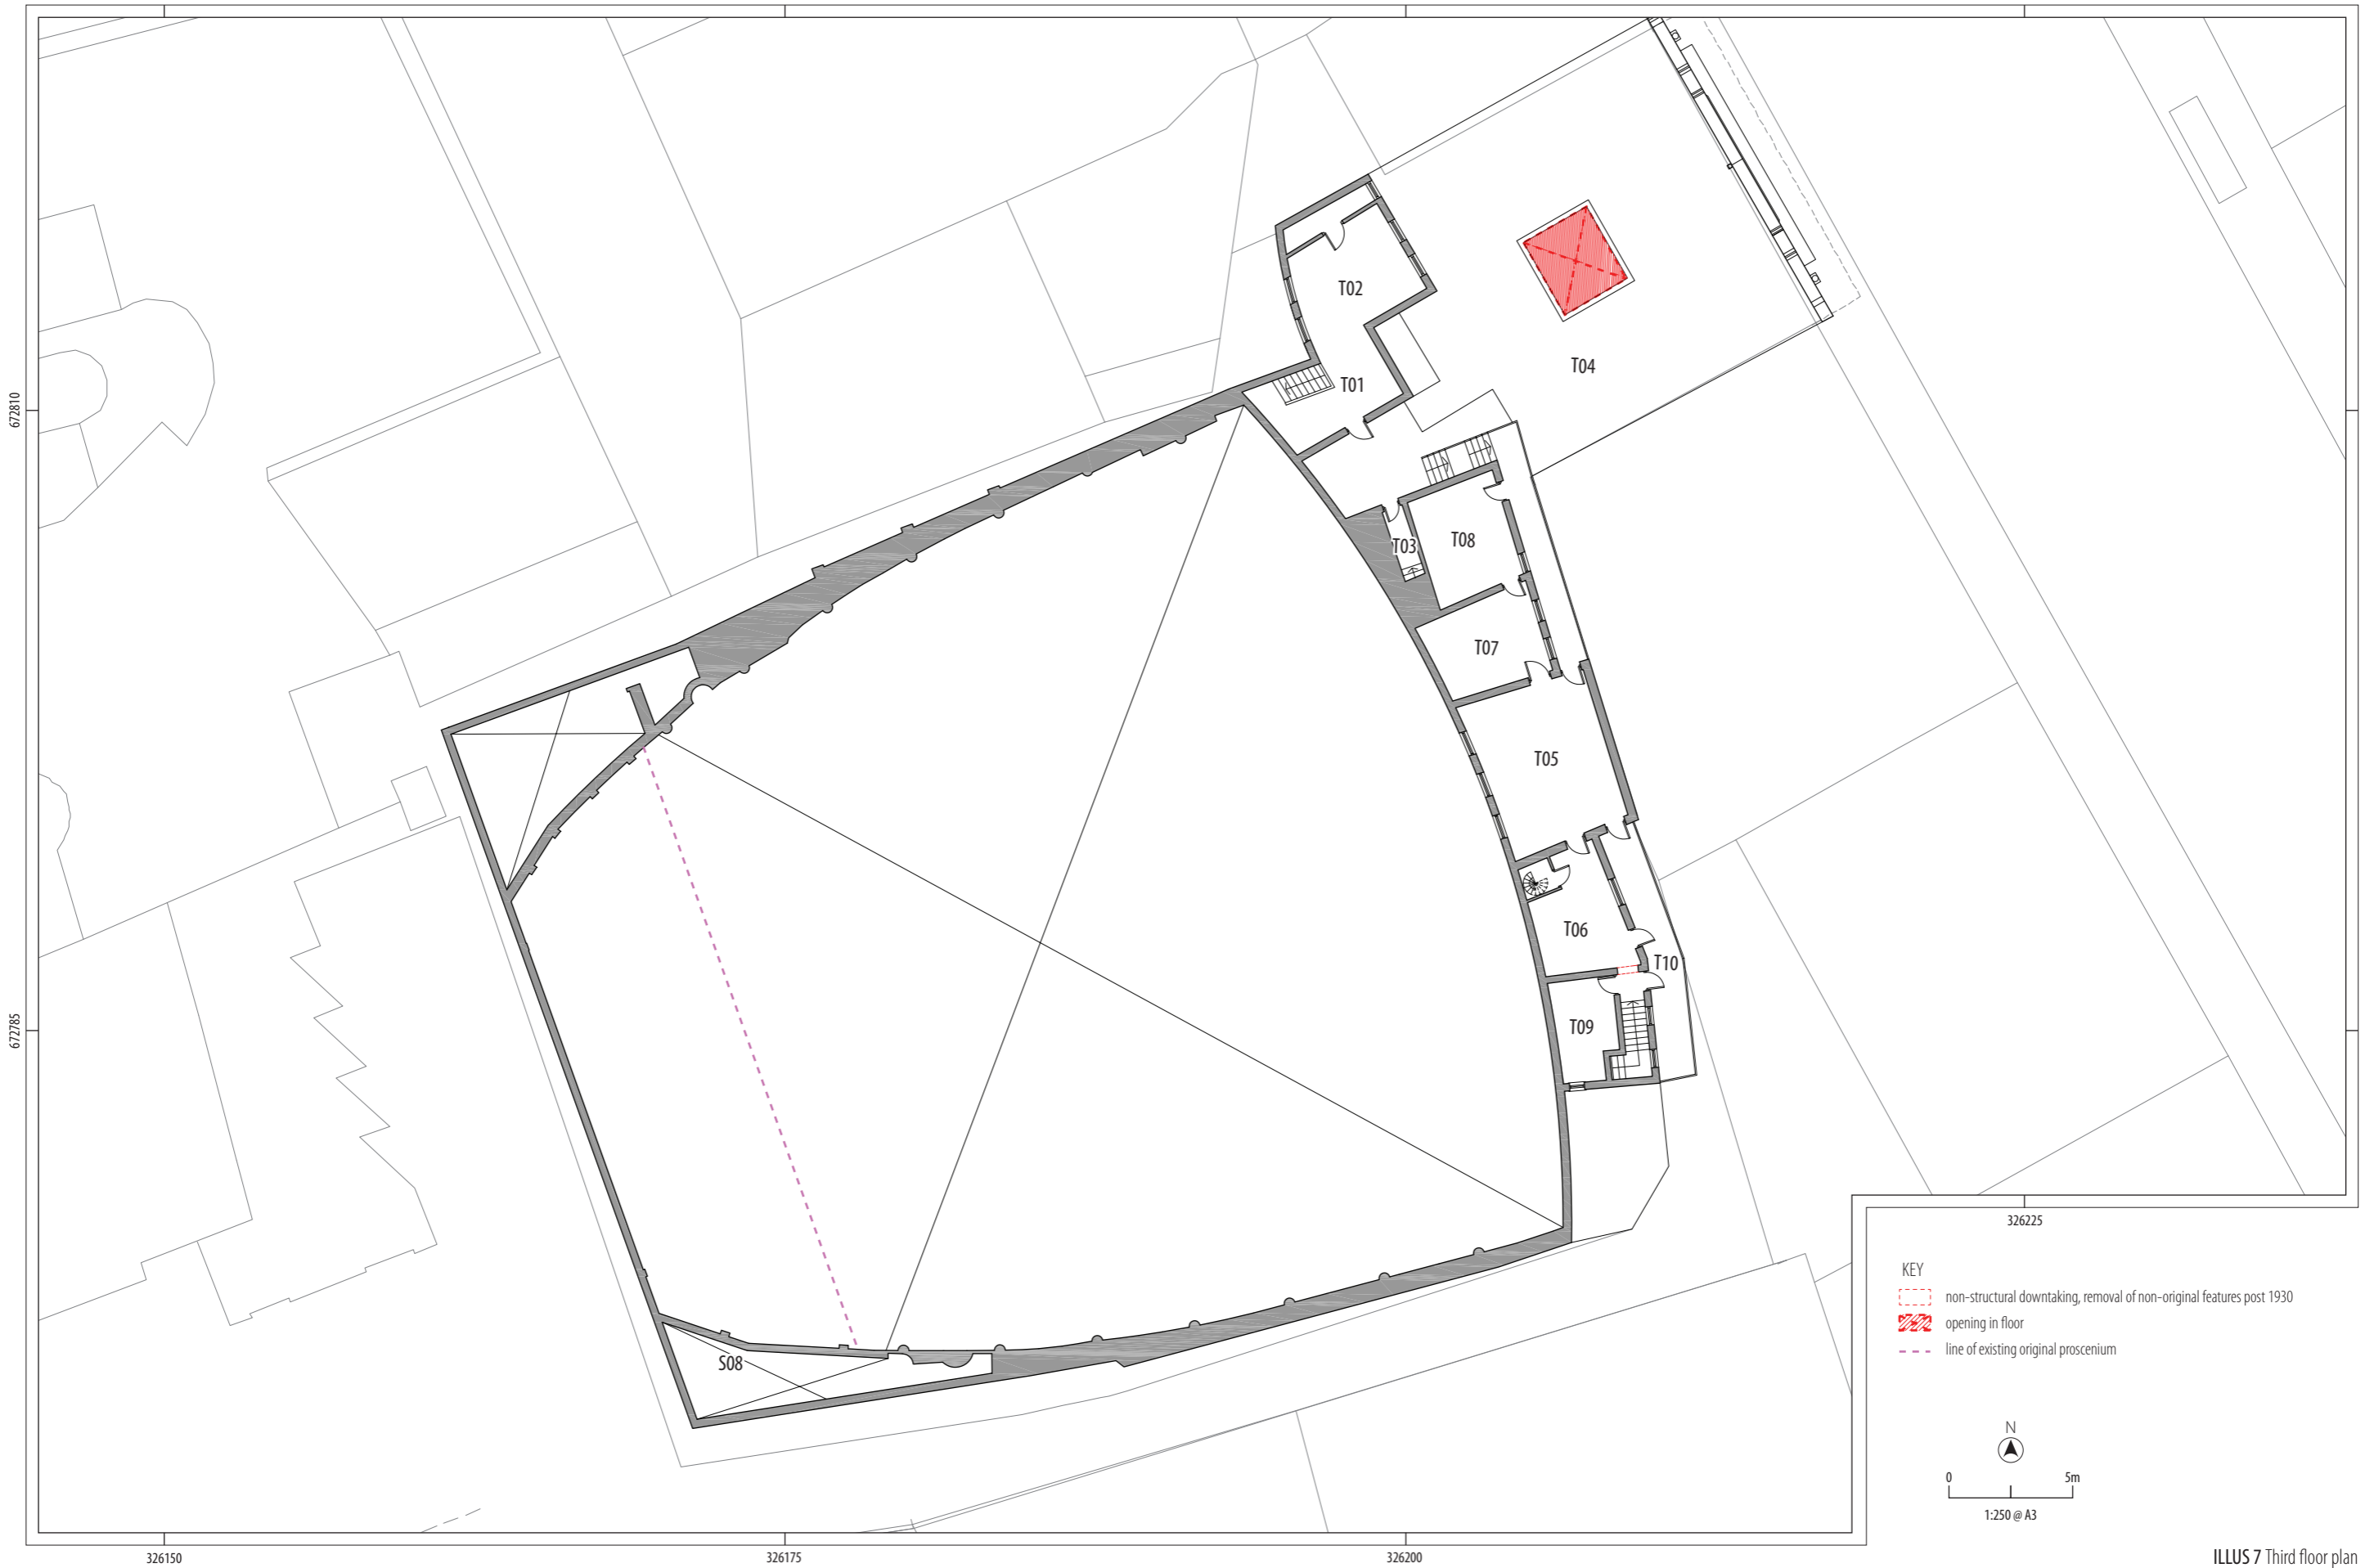
ILLUS 7 Third floor plan

The third floor (Illus 7) comprises a number of stores and offices (T01-02, T06-10), as well as the projector room (T05). The roof above the café (F01) is also accessible at this level. There is not currently any internal route to the

projector room, only small external walkways to north and south sides. This will be remedied by the current development. With none of these spaces being public-facing, there is little decoration or other original niceties, although there are still indications of the use of some of the rooms, such as projector equipment and film storage cabinets.

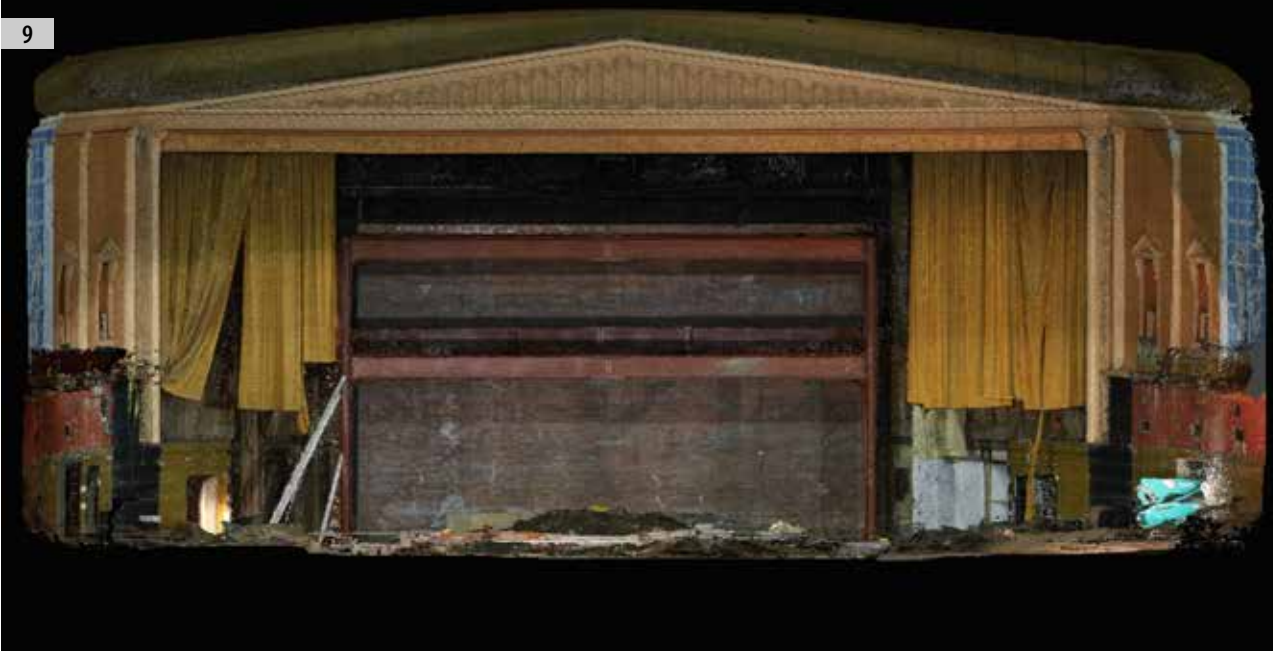
ILLUS 9 View of photogrammetric 3D model of west elevation of auditorium.
