Ailsa Drive, Kirkintilloch, Archaeological Evaluation Data Structure Report Project 4733

On behalf of: Scottish Water

Project Number: 4733

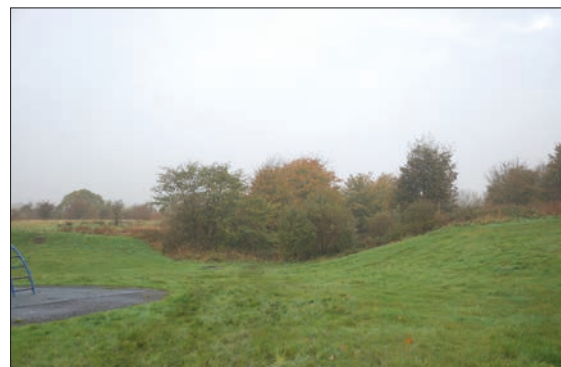
Plate 1: General shot of cutting

- 3.1 The development site is located opposite Ailsa Drive and across the Forth and Clyde Canal, Kirkintilloch, in East Dunbartonshire (NGR NS 66642 74662). The area of the proposed work currently consists of open recreational space and is within an earlier 'cutting' with a flattish base and steep sides which contains the present sewer pipes and associated manholes (Plate 1). It is very overgrown with long vegetation comprising nettles, brambles, grasses and mature trees and slopes downwards towards the Canal to the north. The line of the Antonine Wall which extends NE/SW alongside the Forth and Clyde Canal, is crossed by the proposed development on an approximate north/south alignment.

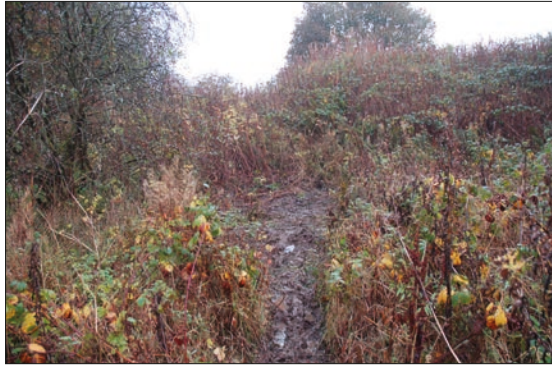
Plate 2: Trench 1 position

7.2 Trench 1 was located near to the base of the eastern slope and was covered in long grass and nettles (Plate 2). The topsoil comprised mid grey clay silt 001 with inclusions of plant roots and contained modern debris including glass and pottery sherds. It measured 0.12 m in depth. Below was found a grey clay silt 002 followed by a redeposited pink grey silty clay 003, with a combined depth of 0.48 m. Both deposits contained modern detritus including glass and pottery sherds suggesting they were modern dump layers. Below was found a layer of relatively flat sub-rounded cobbles 010 which appeared to be set within the natural subsoil 011 which comprised an orange silty sand with light grey sand below. The cobble layer appeared of drystone construction with the cobbles measuring on average 0.2 m x 3 m in size. The cobbles did not extend across the whole trench but appeared to form a relatively straight line orientated roughly NE/SW at the south-east end (Plate 3). Above and in between several of the stones was a very thin patchy grey silt deposit 012 which was sampled for possible environmental and dating evidence. No artefacts relating to Roman activity was uncovered during the work. Prior to backfilling, geotextile membrane was placed across the stones to aid their protection.

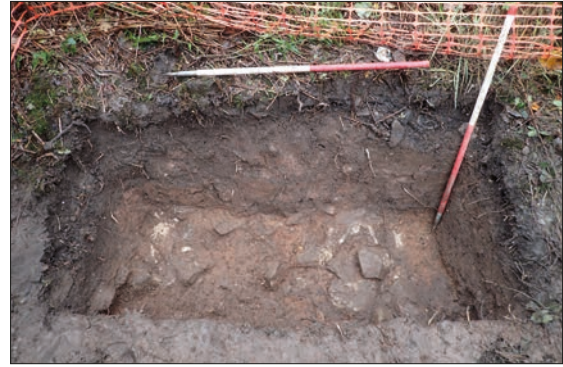
Plate 3: Possible wall base 010

8.1 The archaeological evaluation has uncovered the possible remnants of the stone foundation of the rampart associated with the Antonine Wall in Trench 1. Unfortunately no artefacts of Roman date were recovered during the work to aid the structures dating and interpretation. However, despite the lack of dating material, it is very likely that the stone structure uncovered

is associated with the Antonine Wall and/or its construction due to its location and context. No features relating to Roman or other archaeological activity were found in either Trenches 2 or 3 which comprised mainly modern overburden deposits, probably a result of construction work associated with the present sewer pipe. Both these trenches were lower lying than Trench 1 and it is reasonable to assume that they may lie below the level of any surviving Roman activity. These trenches were also closer to the approximate location of the present sewer pipeline and any surviving Roman structures/deposits may have been destroyed during its construction.

- 9.1 The present work programme has uncovered possible remnants of the Antonine wall base in Trench 1 only. It is therefore, recommended that further archaeological works be carried out within the environs of Trench 1, and in the area leading southwards along the proposed pipeline route, to establish the full extent of any remains that could potentially be impacted upon by the proposed works. These further investigations will enable the works to avoid any unnecessary disturbance of Roman deposits relating to the WHS. In addition, it is recommended that any and all ground disturbance associated with the proposed pipeline works, outwith and to the north of Trench 1, will be monitored under an archaeological watching brief to ensure that any other archaeological deposits surviving are investigated and recorded to an appropriate level prior to the pipe being installed. Should the watching brief encounter other remains of possible Roman origin, HES will be consulted on an appropriate mitigation strategy prior to works continuing in such areas.

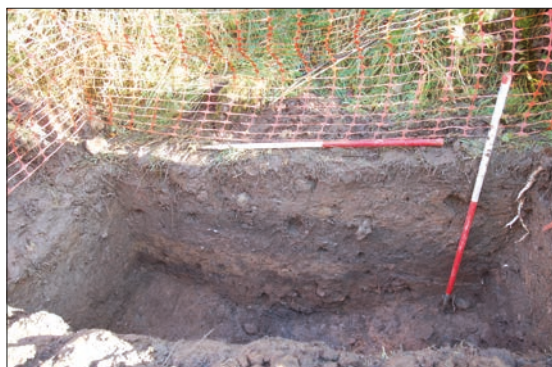
Plate 4: NW facing section of trench 2 with overburden deposits

7.3 Trench 2 was located within the central area of the cutting and to the east of the present sewer pipe, as indicated by the upstanding manholes. It was also covered in thick vegetation which was removed prior to work commencing. It slope downwards towards the north. The topsoil 001 and redeposited clay 003 deposits were similar to those found in trench 1 although the underlying deposits differed slightly, with more overburden deposits present including a dark grey silty clay 005 and an orange/beige/pink sandy clay 006. Both contained modern debris suggesting their non-archaeological origin. However, below 006 and at the northern end of the trench was found a dark brown clay silty sand which might represent an old topsoil deposit 013. This was located 0.6 m below the present ground surface. A mixed beige sandy silt 014 was located at the southern end and was probably redeposited natural. Below both deposits was a beige/pink sand with cobble and pebble inclusions 016 which contained a very thin grey silt 015 on its surface, which again is of probable natural origin. No archaeological features or finds were encountered within this trench.

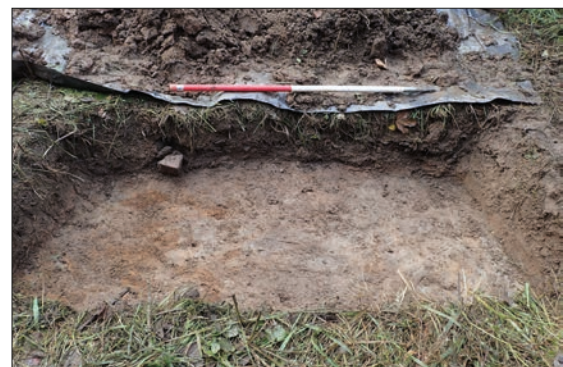
Plate 5: Trench 3 subsoil

7.4 Trench 3 was also located to the east of the line of the present sewer and was located on the flat ground and was lowest in height of all the trenches, due to the sites downwards slope to the north. The topsoil 001 and redeposited silty clay 003 was similar to trenches 2 and contained similar modern detritus. The subsoil 004 was located at 0.21 m in depth and comprised a light orange sand with mid to dark orange mottling (Plate 5). No artefacts or features relating to Roman activity were encountered.
