PAISLEY ABBEY DRAIN EXCAVATION

DATA STRUCTURE REPORT

PROJECT 2773

carried out
on behalf of
Renfrewshire Council

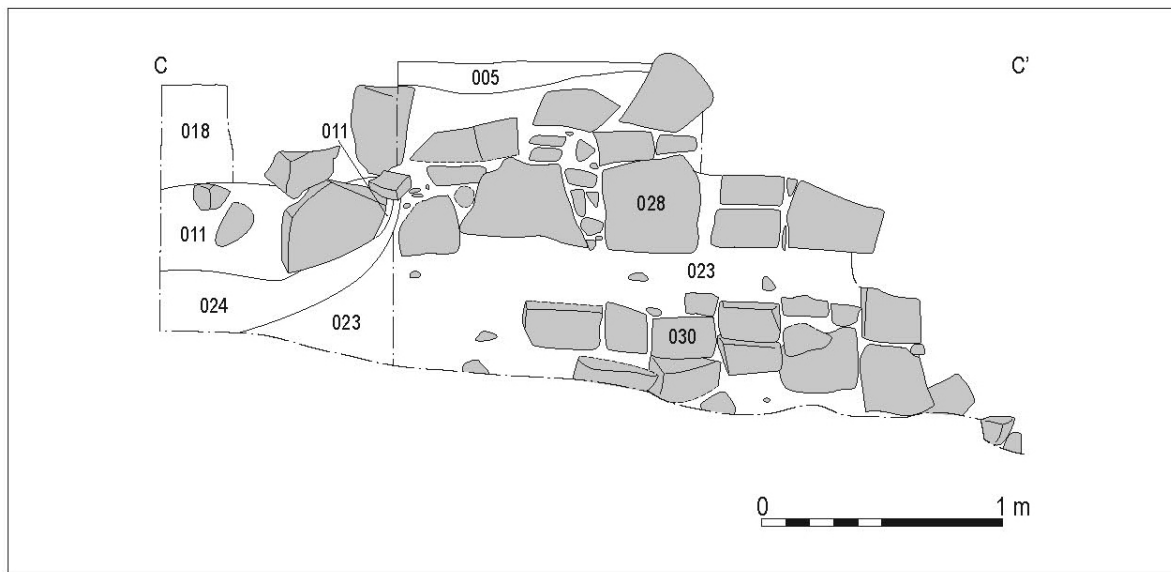
*Figure 7:
Elevation of north wall of drain.*

In the south east corner of the trench excavation revealed a section of the in situ fabric of the medieval drain where the facing stones and part of the rubble core had been removed (fig). At this point it was possible to investigate the relationship between deposit 023 and the core of the wall. The deposit 023 extended into the core of the wall and narrowed to a thickness of only 3-4 centimetres. Therefore the gap in the facing stones filled by 023 may be the result of subsidence and partial collapse of part of the drain or it may reflect different phases of construction, certainly the previous investigations inside the drain has demonstrated different phases of building.

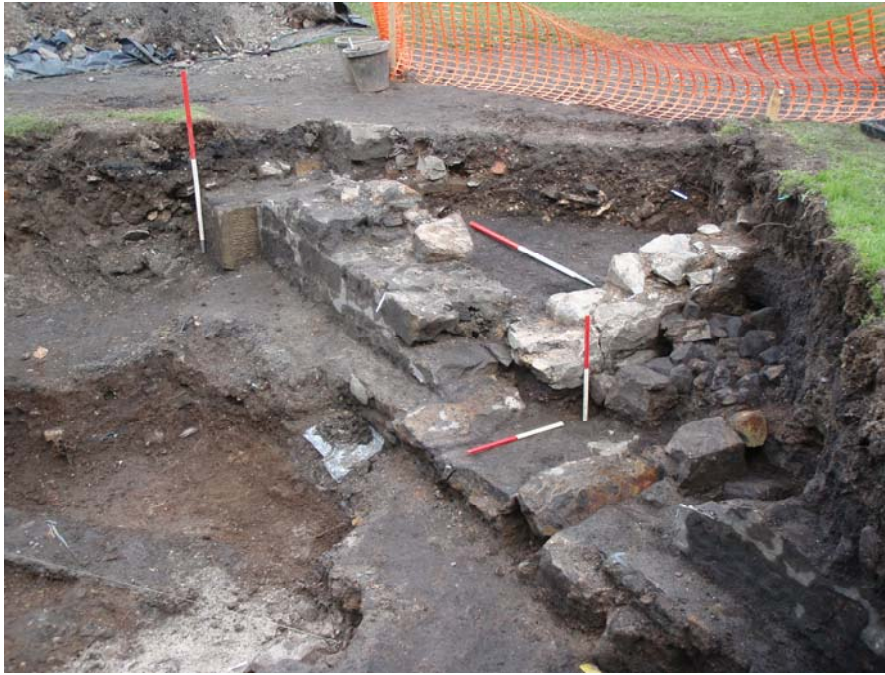
*Plate 1:
19th century tenement walls.*

In the north-east corner of the trench the upper deposits were quite different from the south-west part of the trench, a stone built wall (003) was uncovered immediately below the topsoil and appeared to continue beneath the footpath to the north, another wall (004) joined 003 at right angles and ran under the eastern baulk leaving the small corner of a building within the trench. The material contained by these two walls (016) consisted of demolition debris including bricks, slate mortar and rubble and was 0.3 m thick. Below this was a more compact grey/black silt layer (017) that contained several sherds of orange ceramic flower pots, due to constraints of time no further work was done in this area. The area to the west of wall 003 along the north trench edge was quite restricted as this side was also stepped in for safety reason but the main upper demolition deposits (007) and (010) extended over this area where it overlay a mid to dark brown silt layer (018). The foundation courses of wall 003 were cut into this layer and it may have been a garden soil. A deposit of bright orange burnt clay or possibly daub was uncovered immediately adjacent to and parallel to wall 003 and was initially interpreted as some kind of foundation course but further investigation revealed that this material was actually within 018 and not directly joined to wall 003 although it could still be part of the ground preparation for the wall or a type of damp course.

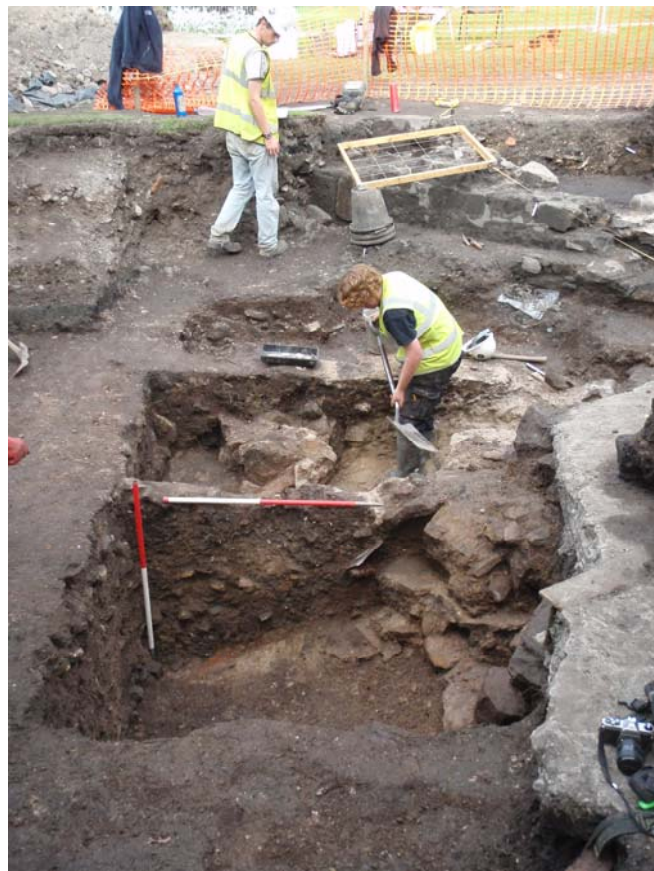
*Plate 2:
Central baulk during excavation.*

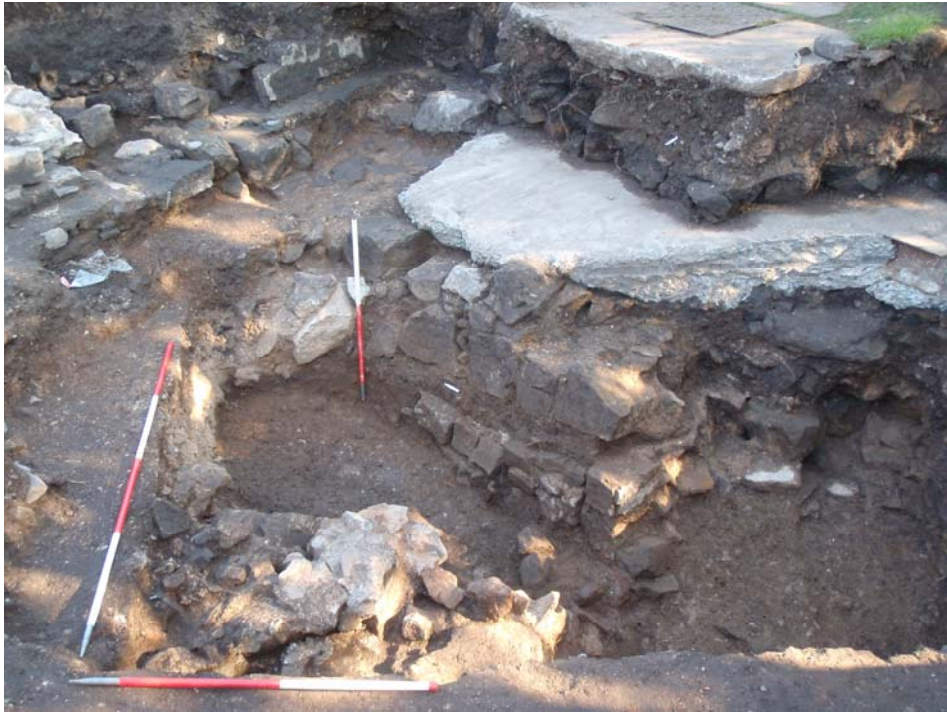
*Plate 3:
Exterior of Medieval drain.*

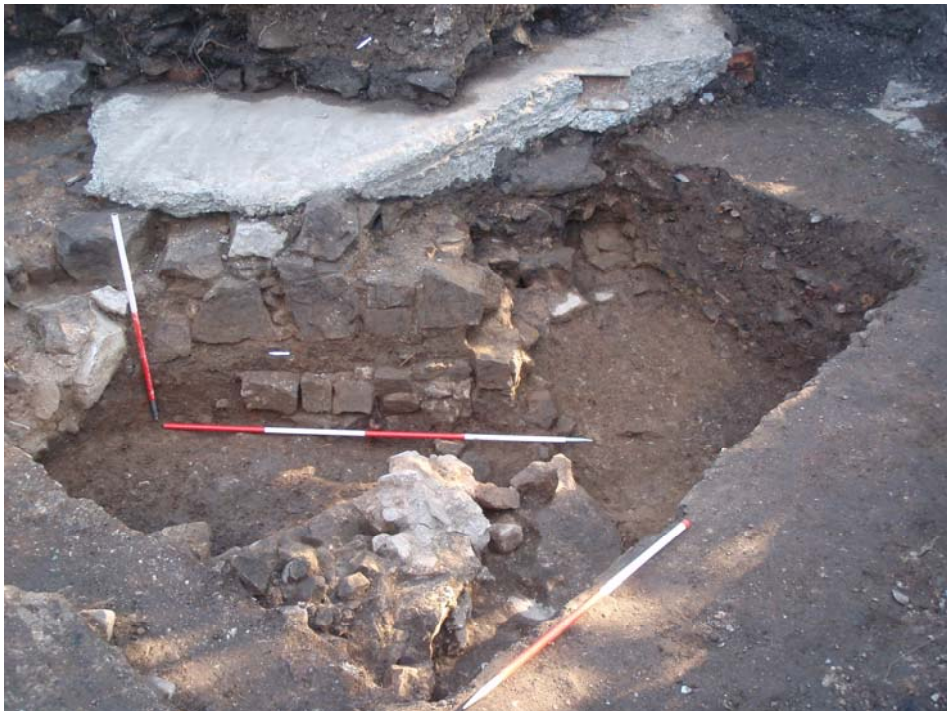
*Plate 4:
Detail of North wall of drain.*

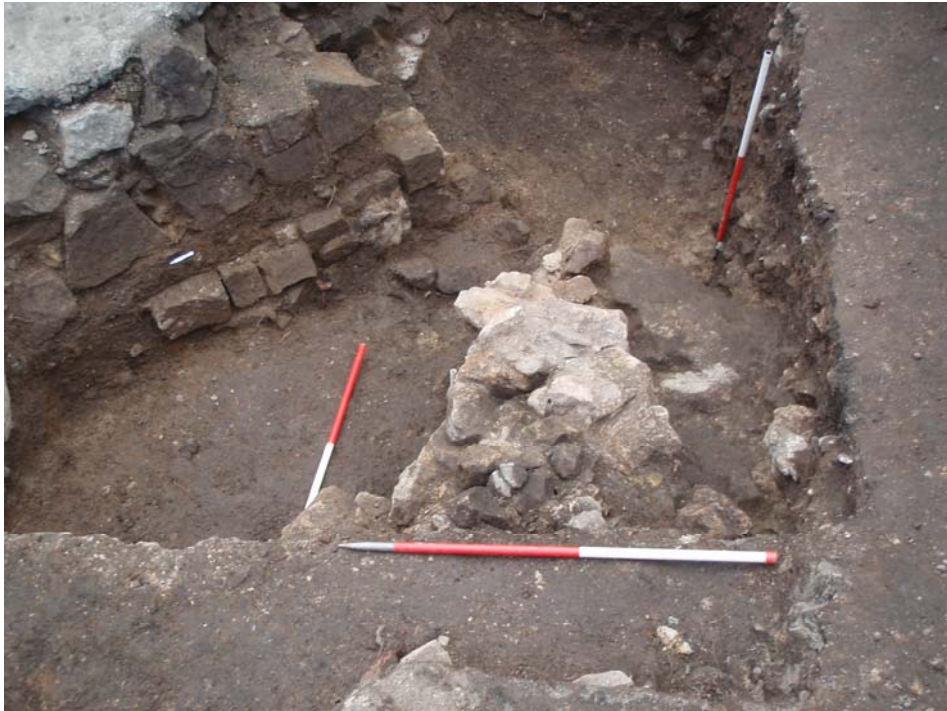
*Plate 5:
North wall of drain and masonry wall.*

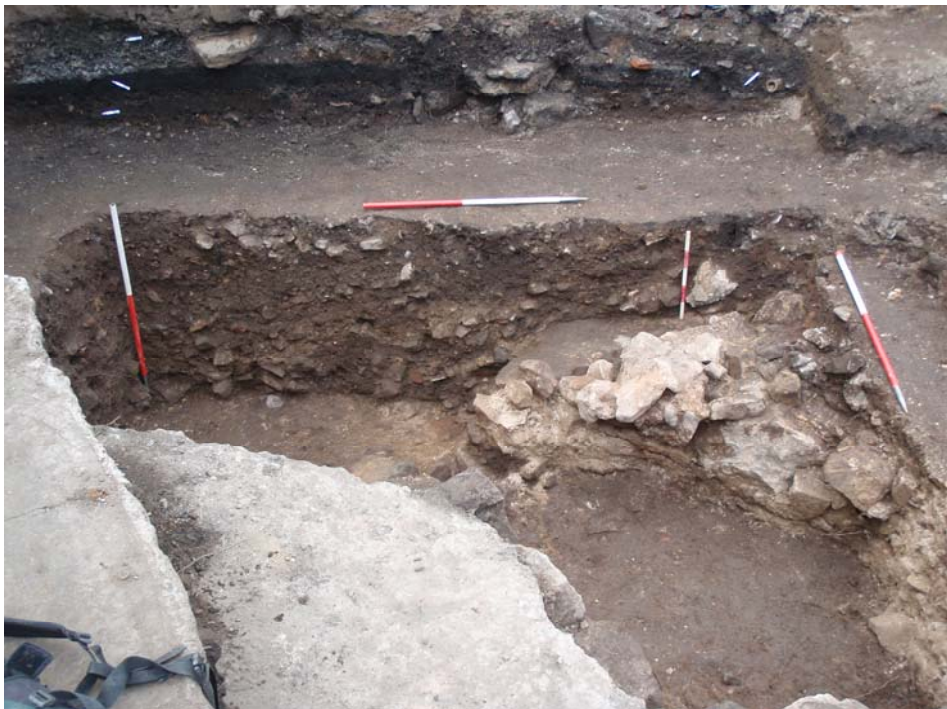
*Plate 6:
South-east facing section and masonry wall.*
