Paisley Abbey Drain Excavation
Data Structure Report
Project 3192

Paisley Abbey Drain Excavation

Data Structure Report

Project Number: 3192

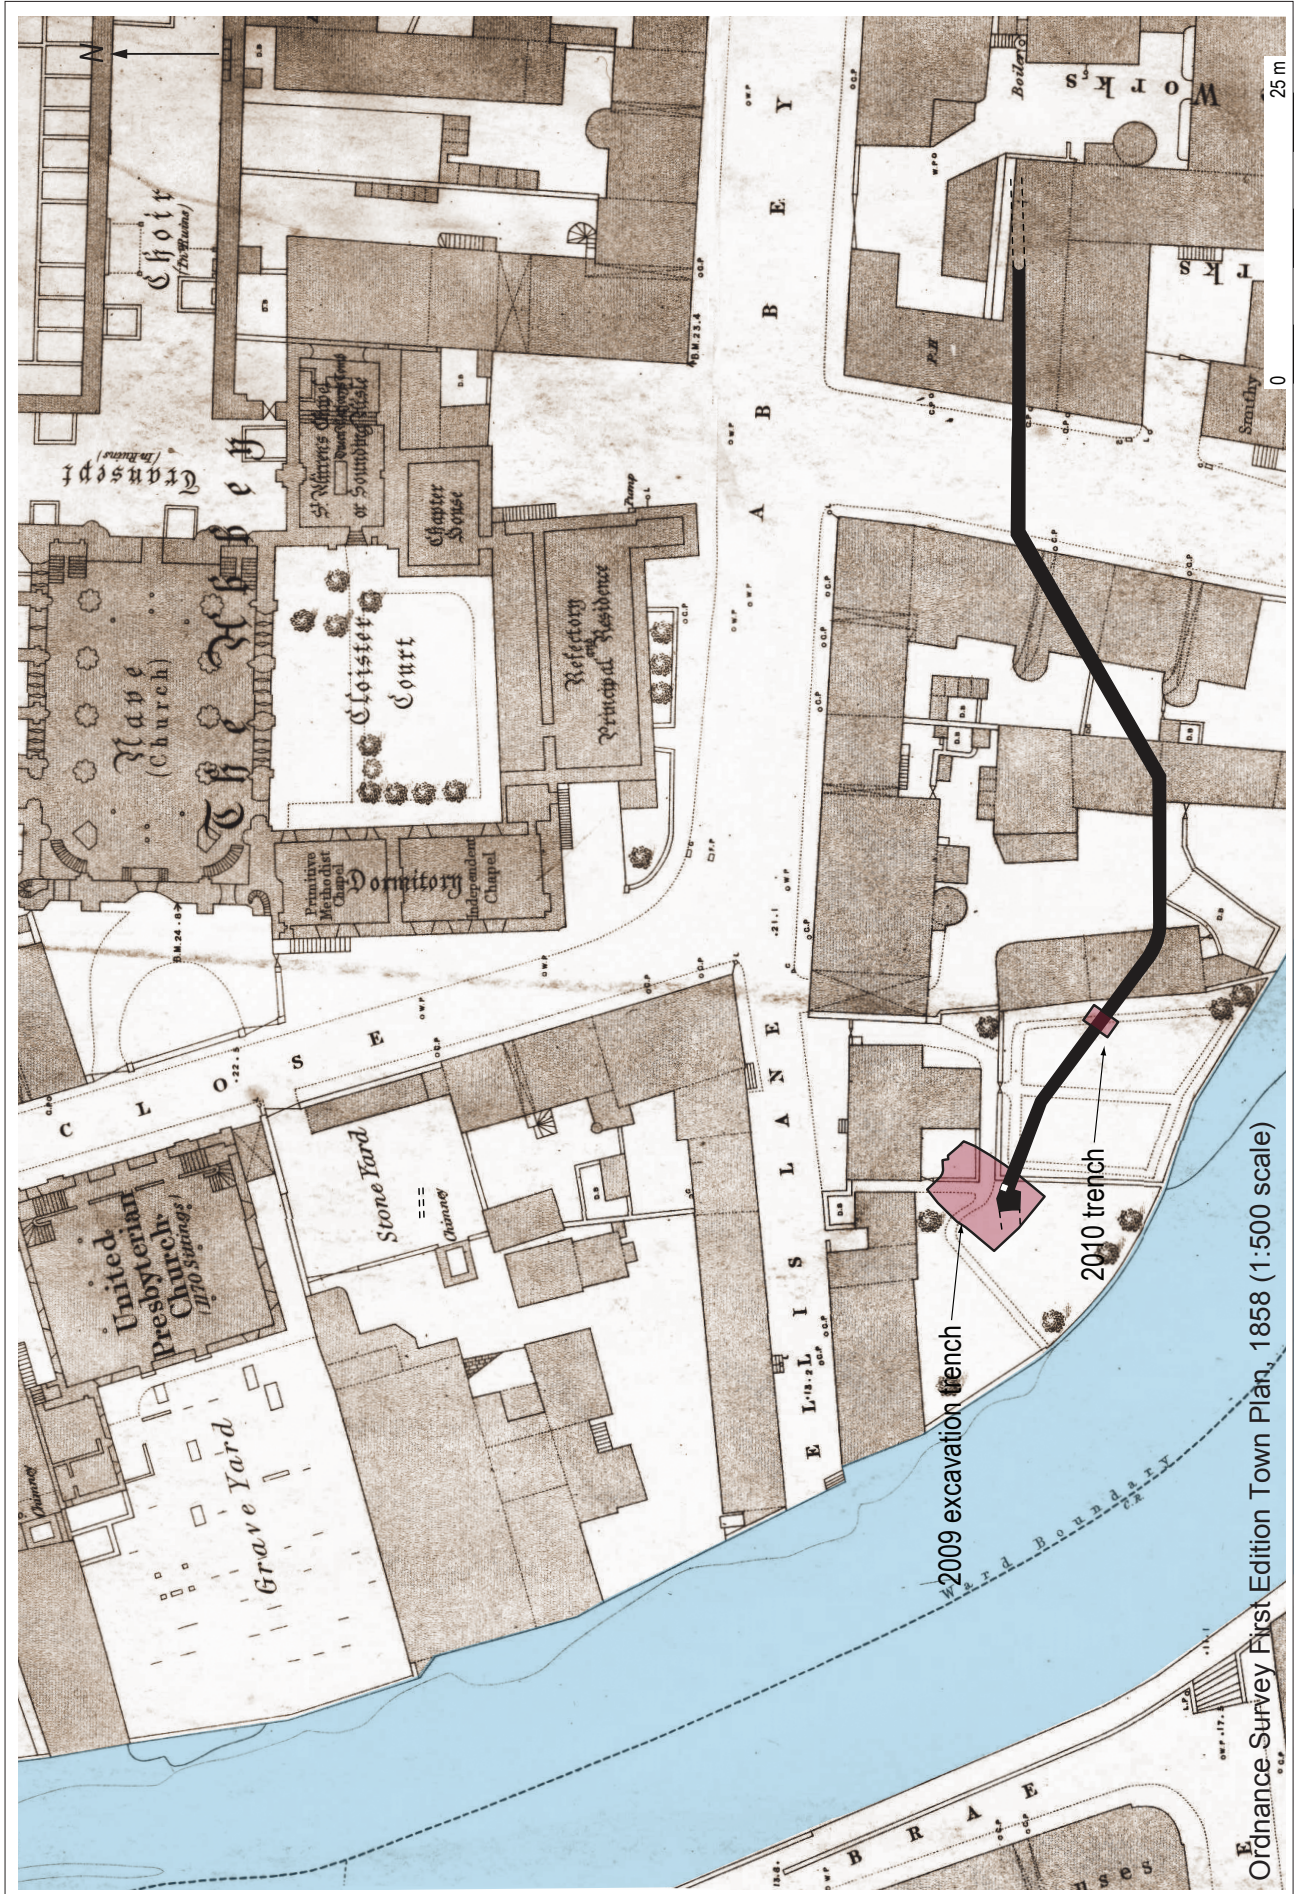
Figure 2: 1st Edition OS map showing drain and trenches.

- 5.2 The trench was located over the point in the drain where a medieval manhole had been identified during the RCAHMS survey of its interior. The manhole is located between two of the roofing arches of the drain and is approximately 0.7 m by 0.5 m in size (Plate 2). In addition, a possible feeder drain also entered the main drain at roof height at this point. The intention was therefore to investigate these two features from the outside, as well as to assess the survival and condition of the drain and any other associated deposits. A map regression exercise identified that this location had been part of a garden area on the First Edition Ordnance Survey (Figure 2) and was therefore less likely to have been subject to recent disturbance.

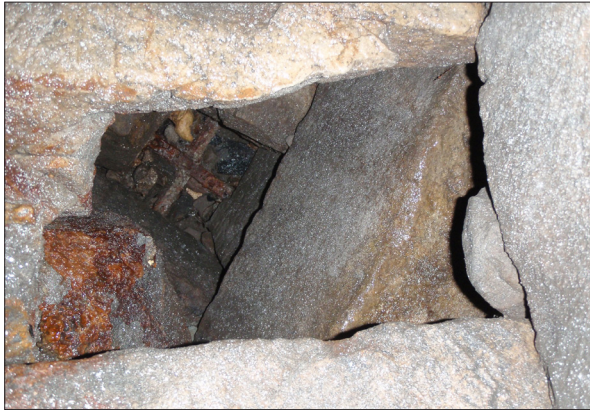
Plate 1: Side drain entering main drain at roof height identified by RCAHMS.

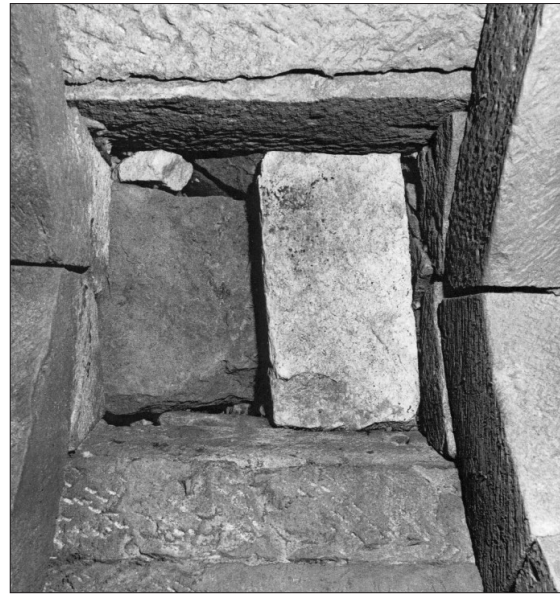
Plate 2: Possible medieval manhole in roof of main drain identified by RCAHMS.

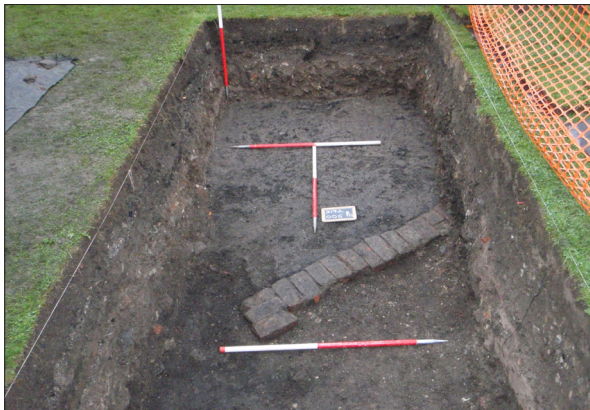
Plate 3: Tarmac surface with brick edging, from south.

- 7.3 After the tarmac and bricks were recorded excavation continued, the tarmac was 80 mm thick and was easily broken up and removed. Beneath was another compacted layer (0.4 m thick) of demolition rubble (008) that contained artefacts of 19th/20th century date. Below this was a dark-grey silt layer (012) up to 0.25 m deep that contained frequent inclusions of animal bones. Two complete clay tobacco pipe bowls were recovered from it along with fragments of pipe stems. As the excavation continued in spits stones began to appear at the north of the trench (009) and further excavation revealed that these stones covered approximately half of the trench and included several large angular stones (010) 0.4 m by 0.4 m by 0.25 m in size, which formed a line or edge that ran NW to SE diagonally across the trench. To the south of this line was another concentration of smaller stones and white mortar (012) 0.7 m wide that lay parallel to

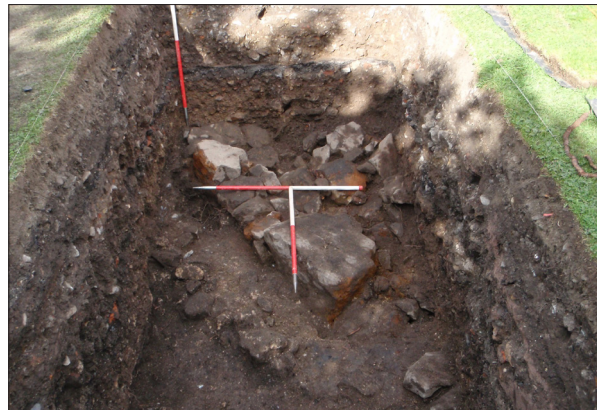
Plate 4: Stone built structures, from south.

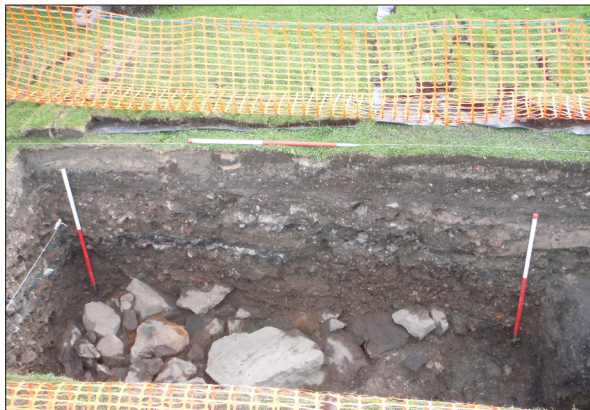
Plate 5: West facing section of trench, from west.

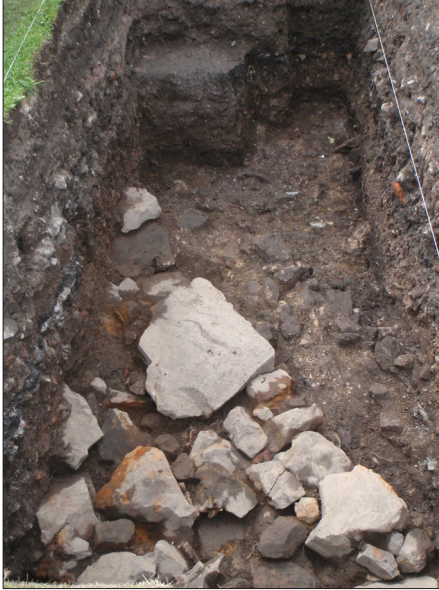
Plate 7: Stone built structures, from north.
