Duart Point, Sound of Mull

Designated Site Assessment Full Report

Ref: 53111.03I

March 2004

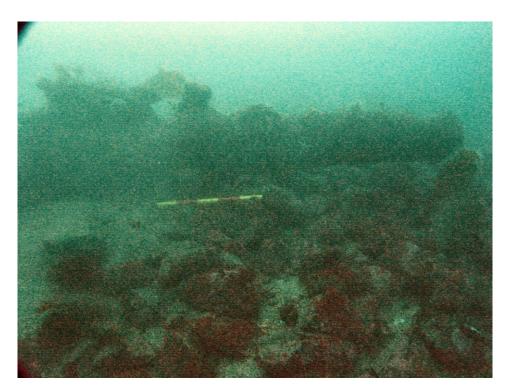
Plate 4: Monitoring photograph 1036

Monitoring Point	Plate No.	Details	Notes
1035	3	Looking ENE from W of Gun 1. The gun is in the background, cascabel to right (out of shot).	No evidence of erosion or other disturbance is apparent.
1036	4	Looking SW from NE of Gun 2. The gun is in the background, muzzle to the right. Ballast stones from E ballast mound are in the foreground.	No evidence of erosion or other disturbance is apparent.
1037	5	Close-up looking SW from NE of Gun 2. The gun is in the background.	The object arrowed (Figure 2) is reported to be a concretion that may have become detached from the gun. This identification is highly uncertain and the diver could not locate the point that it detached from.
1038	6	Close-up looking SE from NNE of Gun 2.	The arrow (Figure 2) identifies the concretion described above.
1039	7	Looking NE from SW of Gun 2. The cascabel of Gun 2 is background right. The E Ballast mound is in the foreground.	No evidence of erosion or other disturbance is apparent.
