WATERMILL FRASERBURGH ABERDEENSHIRE

Archaeological Evaluation and Standing Building Survey

Carried out 8th January 2009
by
Murray Archaeological Services Ltd

Report No: MAS 2009-1
by
H K Murray

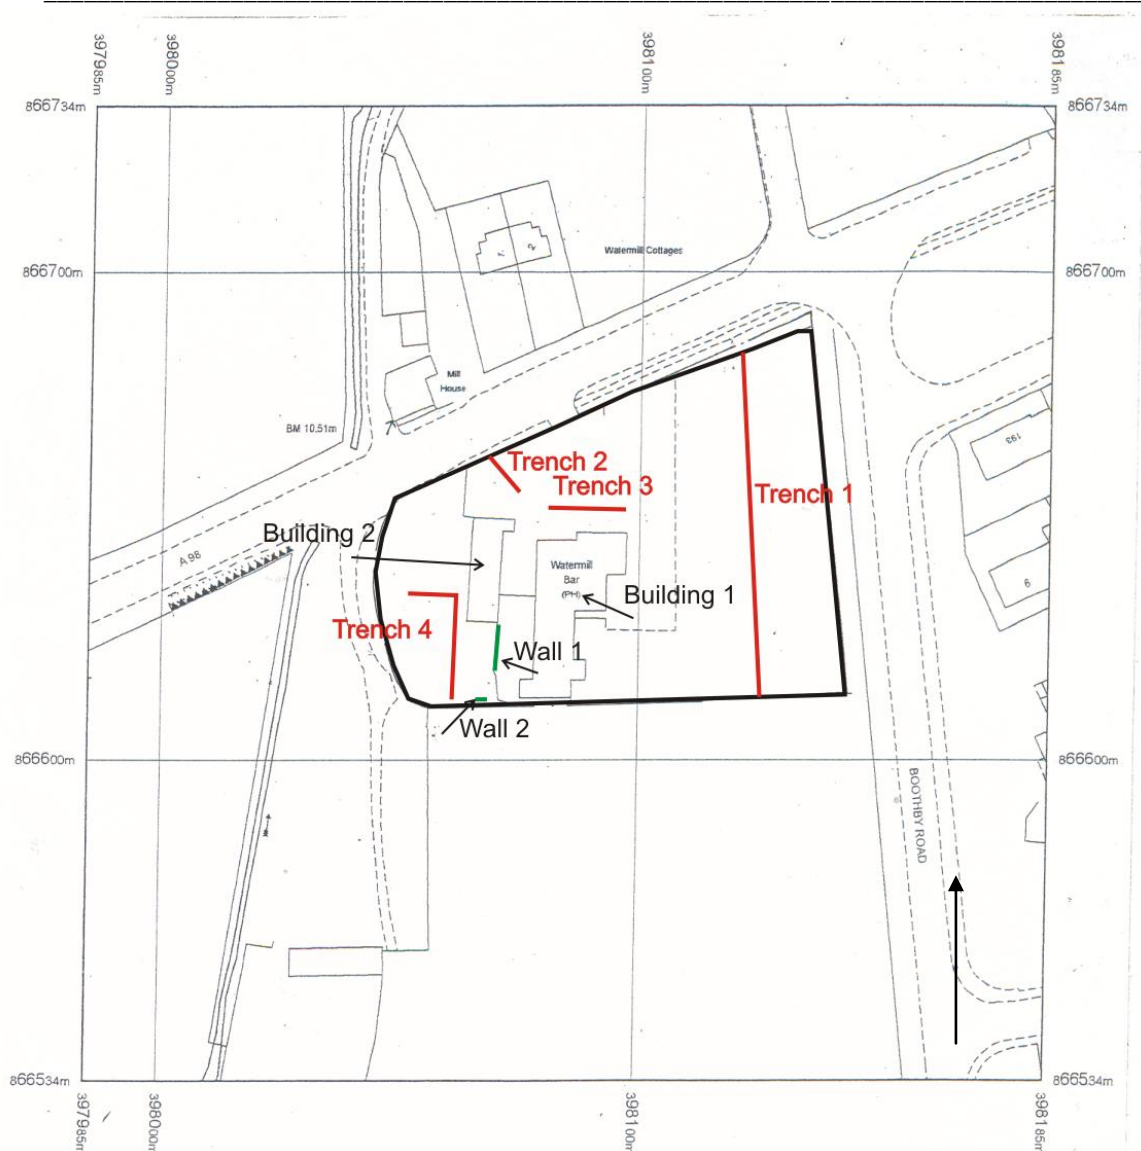
Illus 2 Plan of site showing evaluation trenches and surveyed buildings and features

Illus 4 South end of back (west) wall of Building 2 showing double thickness of gable
Walls to the south of building 2. The line of the front wall of the cottage was continued to the south by a low stone wall foundation, 600mm wide (Illus 2: Wall 1).

Two vertical iron columns were built into this wall. This is thought to be part of the foundation of the brewery- a wall in the bank at the south of the site (Illus 2: wall 2) may have been the back of the building, with traces of a lighter mortared wall with less substantial foundations being possibly an internal wall at right angles to it. Part of the footprint of this building had been reused as a concrete block built garage or shed of which only part of a wall and the sliding door groove remained. This had abutted the south wall of the cottage.

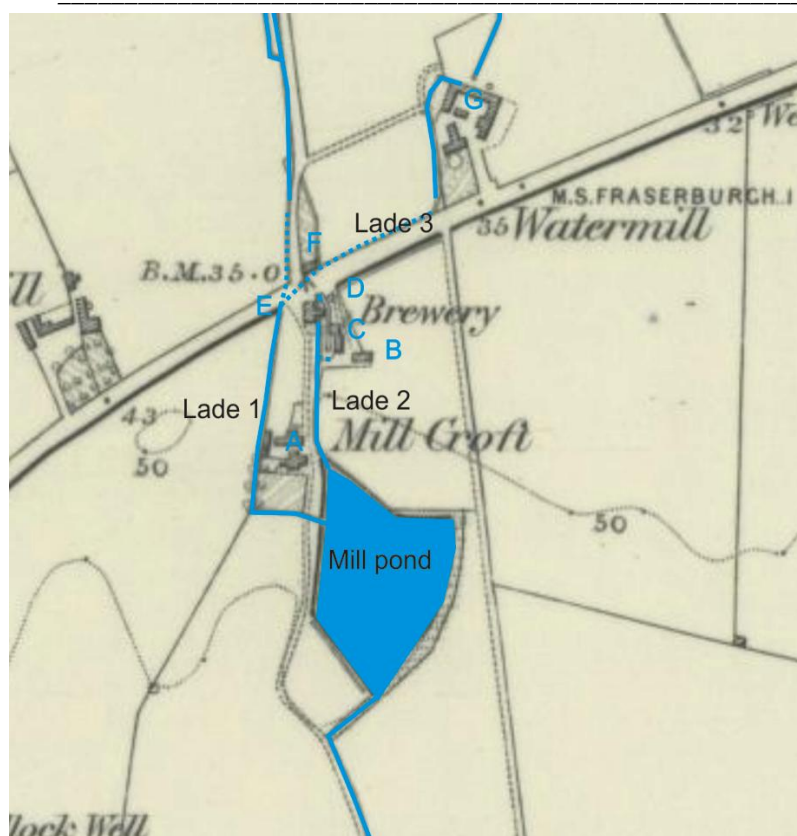
Illus 8 1st edition Ordnance Survey map with overlay highlighting the water courses

- 4.3 The 1st edition Ordnance Survey map of 1874 (surveyed 1871) shows that the mill and brewery formerly on the present site were part of a complex series of different functions using the same burn and mill pond (Illus 8). The mill appears to have been the western building, with the brewery to the east.
- Mill pond* : The map shows the burn to the south of the site diverted to fill a mill pond which is now infilled and only visible as a slight dip in the field to the south. Two lades (lades 1 and 2) are shown leaving the pond.

Lade 2 fed the mill on the present site, with what appears to be a further channel running to the brewery buildings. No positive trace of this lade was observed in trench 4, although it is possible that the cut on the east side of trench 4 filled with midden may have been the line of the channel to the brewery (Illus 13).

Lade 3 is shown emerging at the N side of the road serving the farm building (G) where it may have powered a bruiser for cattle feed etc. The outflow joins the main outflow to the sea.

The outflow to sea flows alongside the lane to the west of the mill house (F) and splits with a channel running to a small building.
