MAINS OF BALNAKETTLE FETTERCAIRN, ABERDEENSHIRE

- Standing Building Survey -

Carried out 24th April 2008
by
Murray Archaeological Services Ltd

Report No: MAS 2008-9

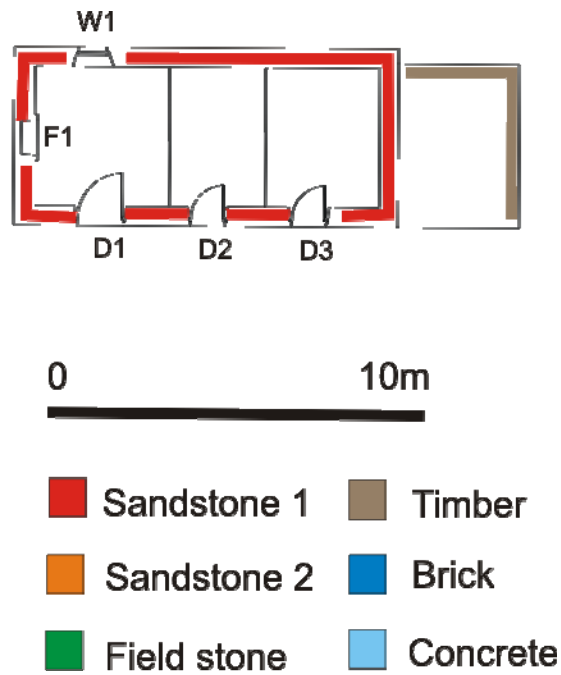
Illus 4 Annotated plan of bothy

Door D1 (W:1.22m. H: 1.93m) sandstone margin LHS only. This has been widened.

D2 and D3 (W: 920mm H: 1.9-1.93m) dressed margins both sides. Original.

W1 (Ext W: 770mm. H:1.24m) Sandstone rybats with dressed margins.

F1. Fireplace with dressed sandstone. (Total W: 1.32m. H: 1.23m. Internal W: 930mm. H:1.02m.) Wooden mantel.

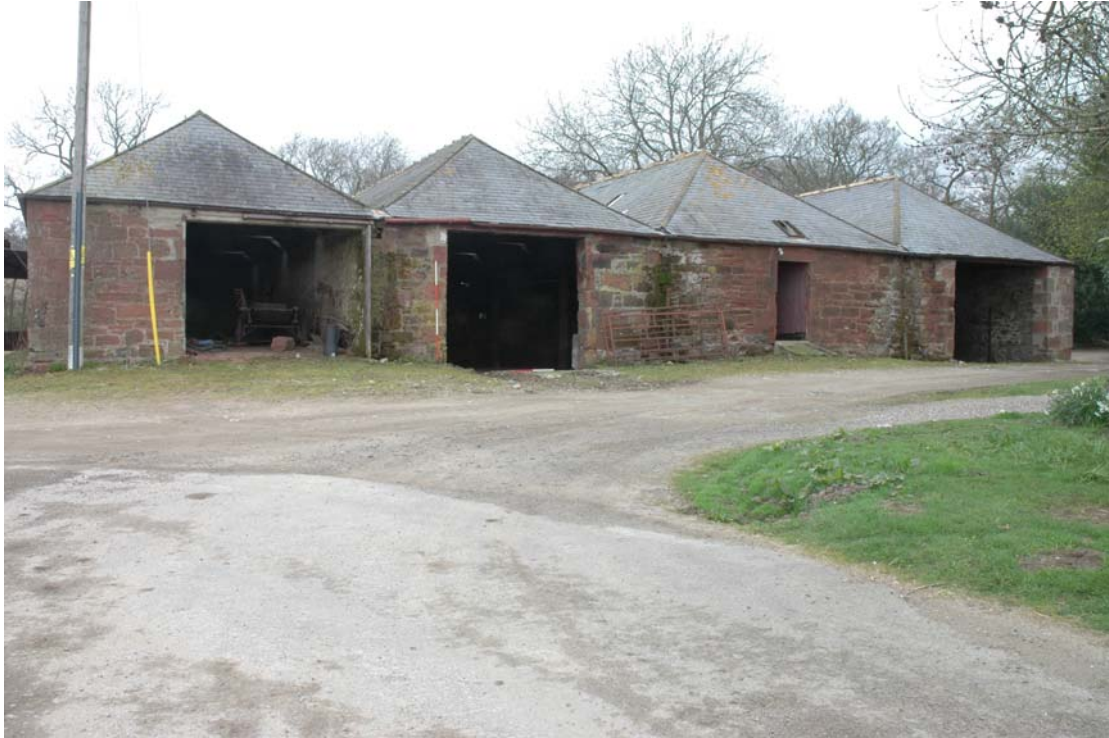
Illus 6 Steading N range, front view

Walls: The external walls are of a mixture of sandstone and field rubble construction. To some extent this may reflect the fairly common practise of having the front wall of superior material (sandstone). However, differences in detail of the structure give some indication of different periods of building.

It is suggested that the front wall of bays 1 and 2 is part of the original steading (1850 estate map and 1st OS map of 1868) , when the front of bays 3 and 4 had not been built. The back range shown on these maps may correspond to the line of wall 3 but the difference in construction suggests a degree of rebuilding. Wall 7, which initially appears early, being of sandstone, does not appear on the 1904 map (2nd edition OS map which shows a smaller structure over the wheel- possibly related to the wraggle on the outside of mill wall (below) and is therefore a later reuse of salvaged building materials.

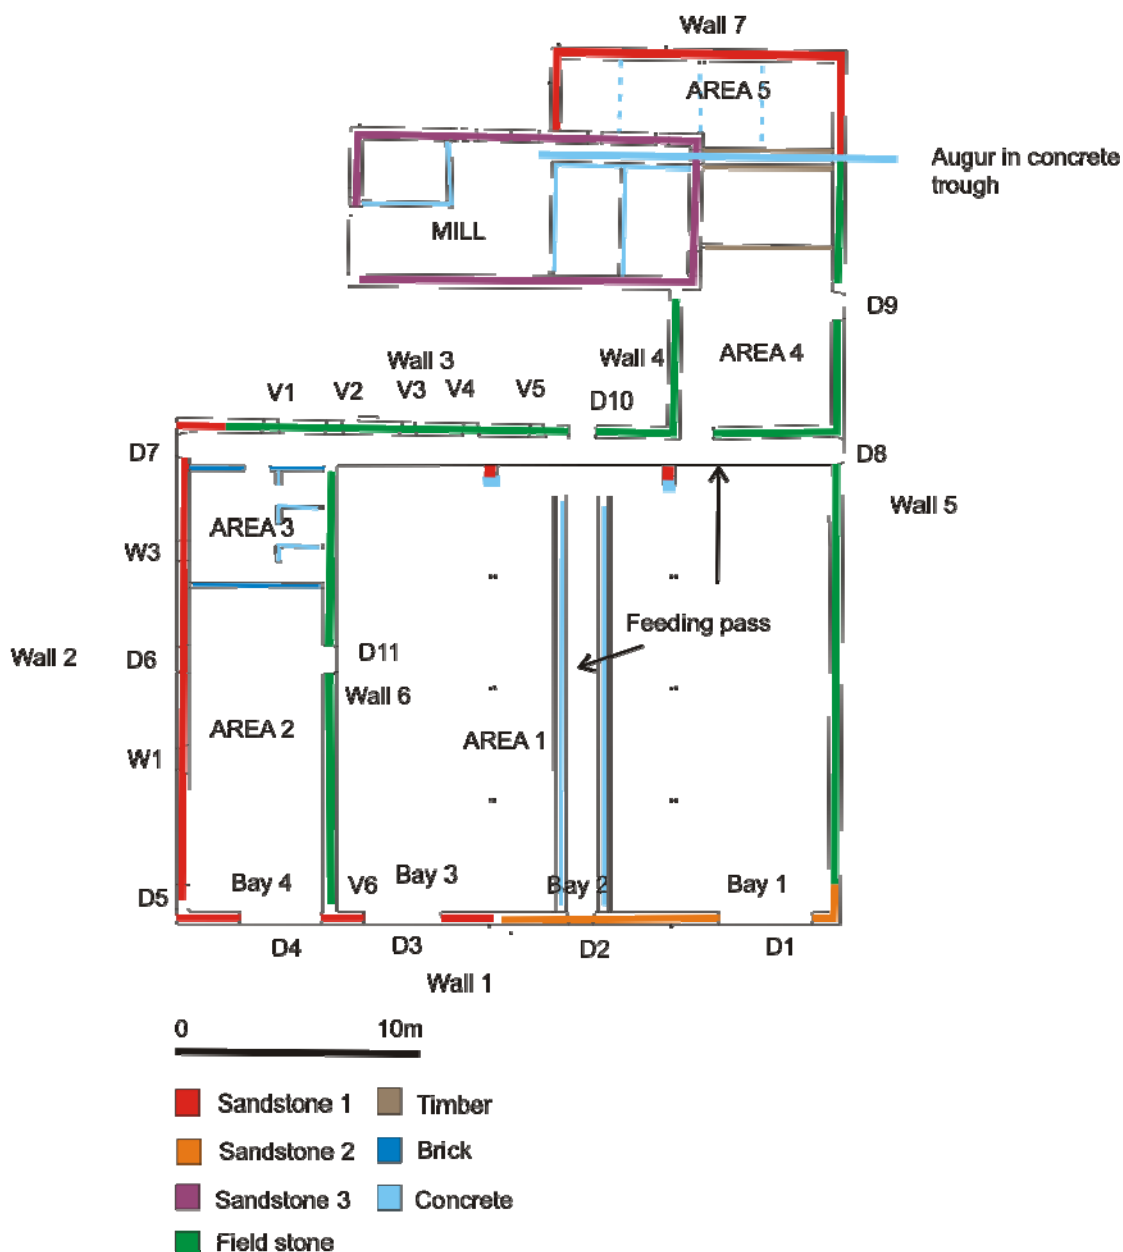
Illus 14 Annotated plan of steading

Discussion In its original form by 1850, the steading extended around the N, W and parts of the S and E sides of a rectangular court. The buildings are likely to have been used for cattle with a central dung yard in the open area surrounded by a walkway. By 1904 the central yard had been roofed and it is suggested that at this stage there was a degree of rebuilding and the insertion of a uniform series of doors and windows. The vents (1-5) in wall 3 may belong to either phase but interestingly appear to have reused some dressed blocks. In each pair the upper vent appears to have been for

ventilation with an external shutter. There is some evidence of a horizontal fitting along the inside wall below the upper vents and it is suggested that this might have been a hay rack. The function of the lower vents is unclear- it is unlikely they were for ventilation as they would have created drafts at livestock leg level which would have potentially caused health problems. The spacing of the vent pairs is suggestive of a row of five individual stalls.

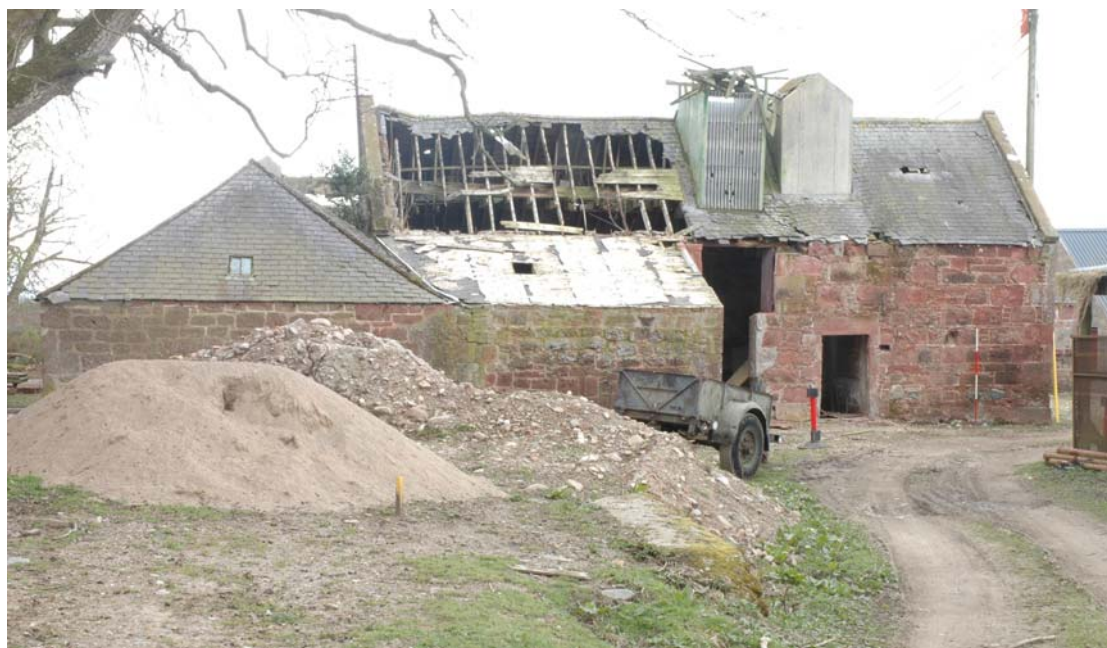
Illus 16 Mill form behind (mill pond to LHS- just off picture)

Roof: The roof is slatted and has been pierced by two modern ventilators constructed of asbestos and corrugated plastic. An original feature of the roof is the sandstone skewes at the gables- the use of skewes is not seen elsewhere in the steading and again may indicate an earlier date. The present slates may be a replacement.

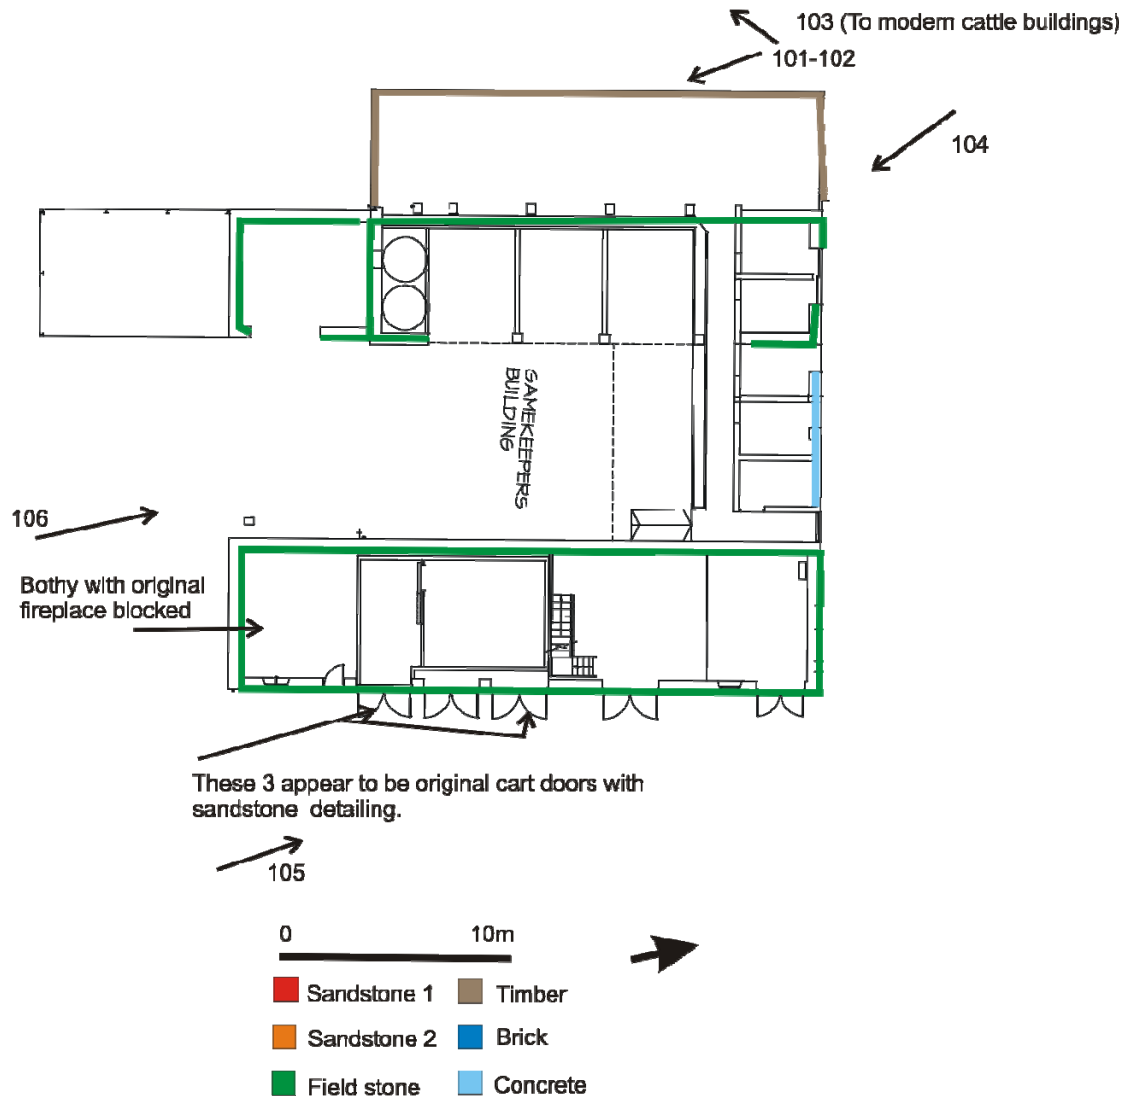
Illus 24 Annotated plan of gamekeeper's steading with photo numbers

Of particular note are three cart openings at the S end- which appear to be the original openings with semi- shaped sandstone at the sides and long sandstone lintels. The room at the S end was originally a bothy- the fireplace still visible inside.

It is possible that this was originally the steading for carts and stabling for farm horses- although this is speculation.
