St Columba's Roman Catholic Chapel and Presbytery, Miùghlaigh

Report 2: Survey.

September 2013

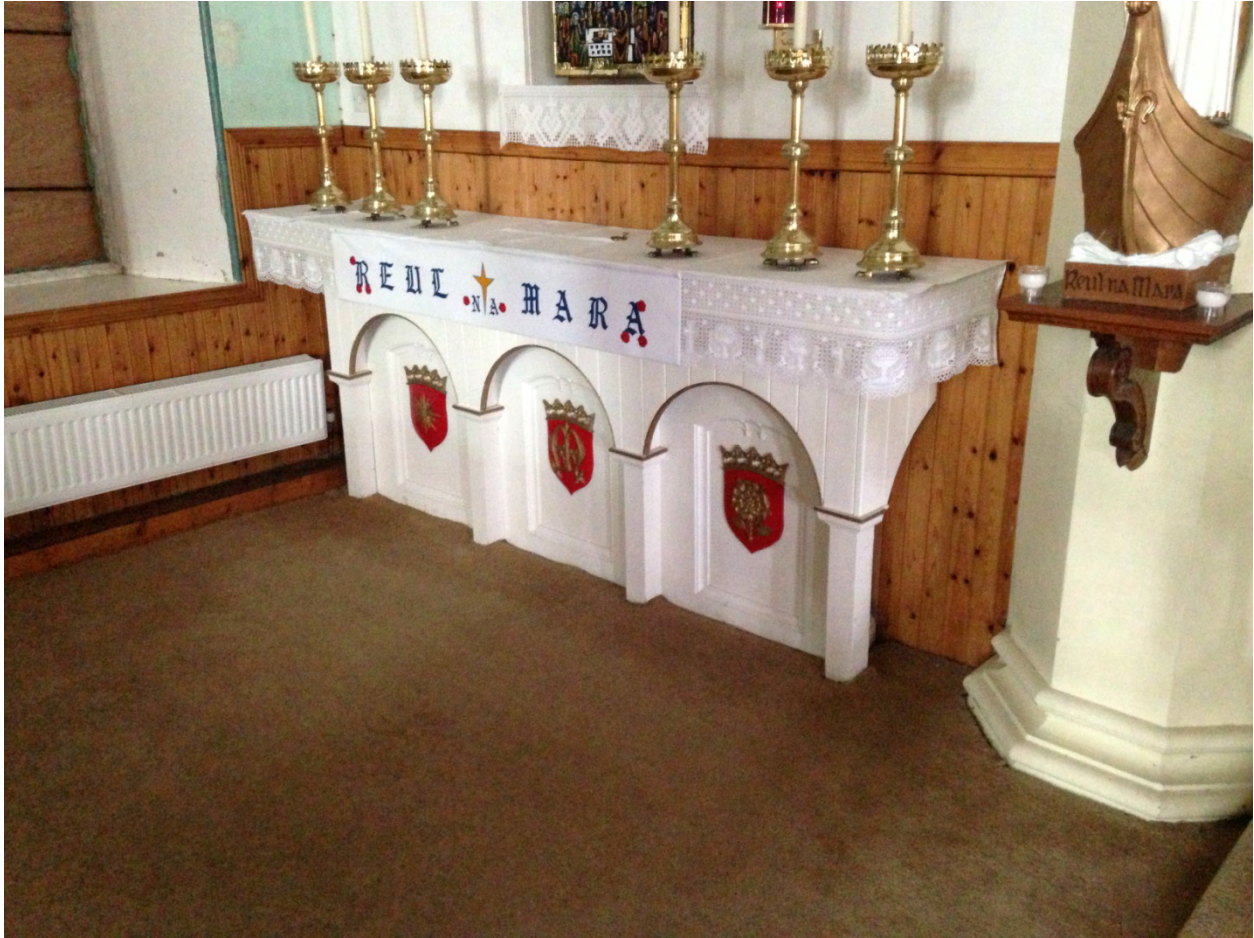
The altar from Mingulay was taken to Castlebay in the 1970s and installed in a side aisle in St Mary's Star of the Sea (Fig 14).

Figure 14 – The altar from Mingulay, now installed in a side aisle at St Mary’s Star of the Sea, Castlebay.

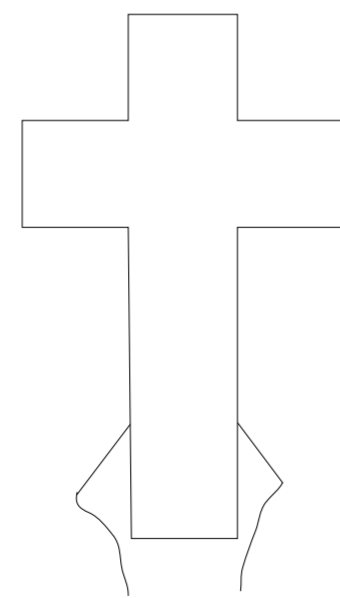
FINIAL DETAIL 1:10

The concrete cross finial that topped the central dormer has fallen intact to lie in the ruins immediately SW of the main door opening. It was exposed for the purposes of drawing but left in situ. It is important that it is not damaged in any works to the building (Fig 11).

There are no further recommendations with respect to the chapel house, but the original suggestion, that the cross should be retained and used for the focus of a small cairn is still proposed. The worked stones at the rear of the building should also be recorded properly, as it is perfectly possible that some of them have a religious rather than agricultural origin. This could be done by preparing drawings at a scale of 1:10 using basic equipment. John Borland at RCAHMS is able to offer advice on the potential ecclesiastical origins, as well as on recording techniques.
