the National Trust
for Scotland
a place for everyone

St Kilda Archaeologist's Annual Report 2007

**Samantha Dennis
October 2007**

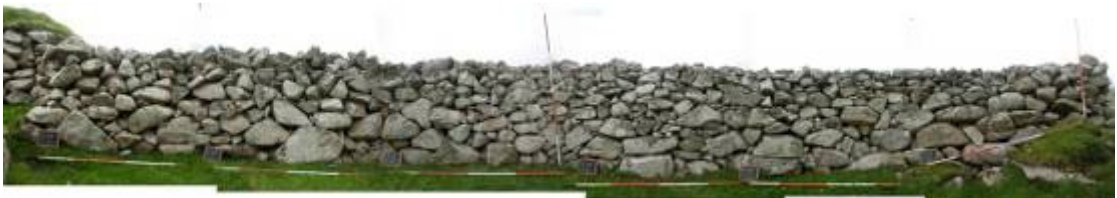
Head dyke – section G panoramic view

Although the entire length of the dyke has been photographed some small sections will have to be re-photographed because parts were obscured by tall vegetation or were inaccessible due to nesting fulmars.

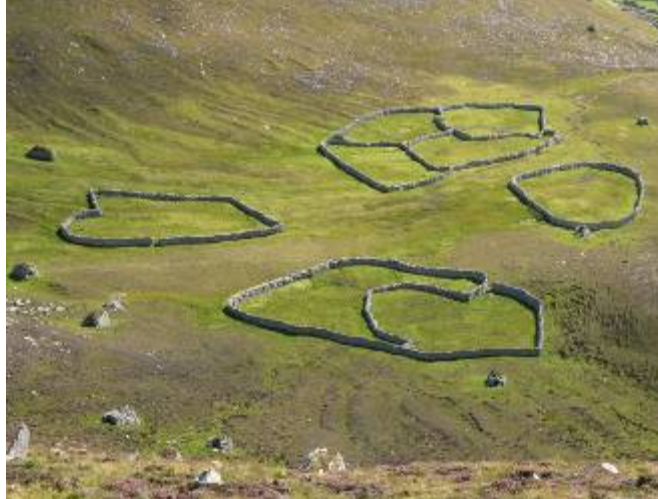
Enclosures in An Lag

The enclosures in An Lag were recorded following a similar method as that used for the head dyke (ie. photographs taken every 2 m of both interior and exterior faces). Additional data gathered included: wall lengths, wall thickness, wall heights, width and height of entranceways, wall condition, evidence of wall repairs, comments on phasing, earthworks within the enclosure, style of wall construction, and any unusual features such as drains or blocked entranceways.

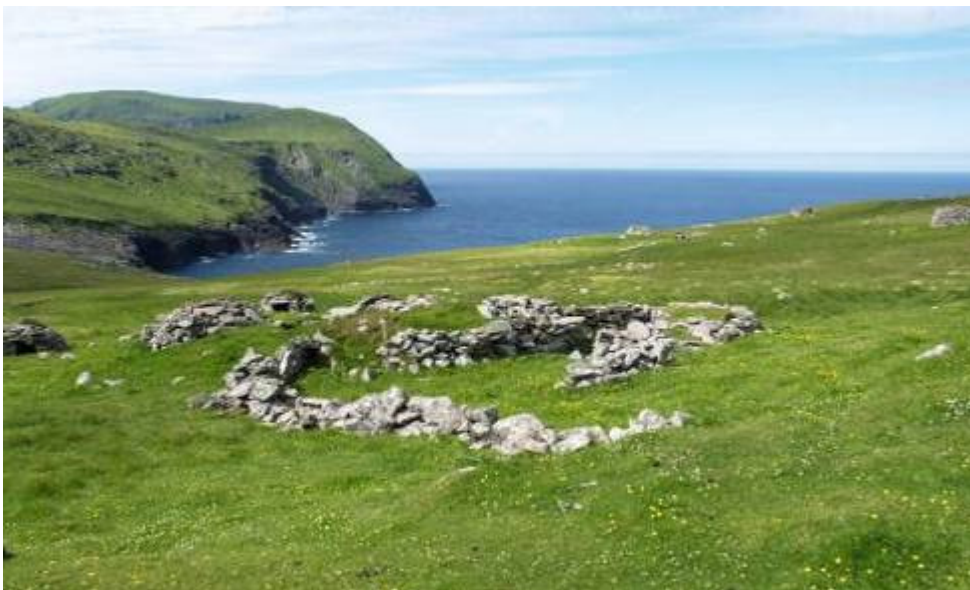
In 2002 the archaeologist noted that there were no major collapses, although a gradual process of deterioration was observed (Bain 2002).

In 2007, the preliminary results of the survey indicate that, similar to observations in 2002, no major collapses have occurred in the past five years. Similarly, there are indications that gradual deterioration is still taking place. For example, the turf on the roof of cell B3 in Structure F (the Amazon's House, also known as Tigh na Banaghaisgeich) has continued to erode causing more stones to become exposed, which has led to more becoming destabilised and ultimately falling.

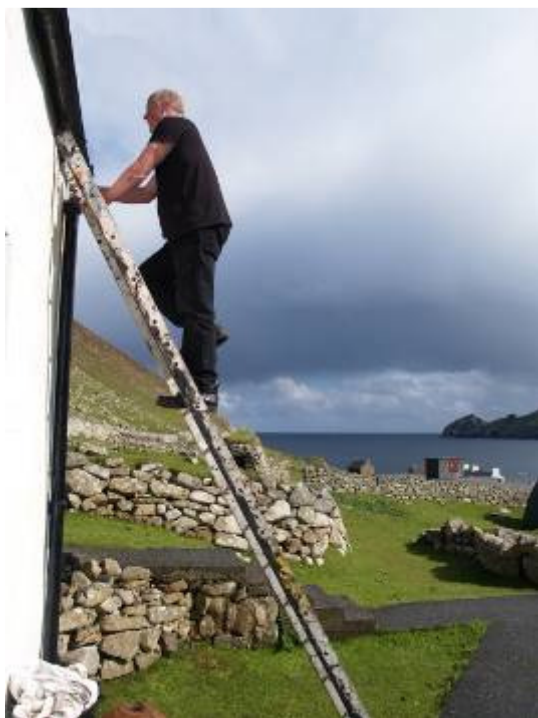
Volunteer painting Factor's House downpipe
