## The St Kilda Archaeologist's Annual Report, May 2008 to January 2009

George Geddes  
26<sup>th</sup> January 2009

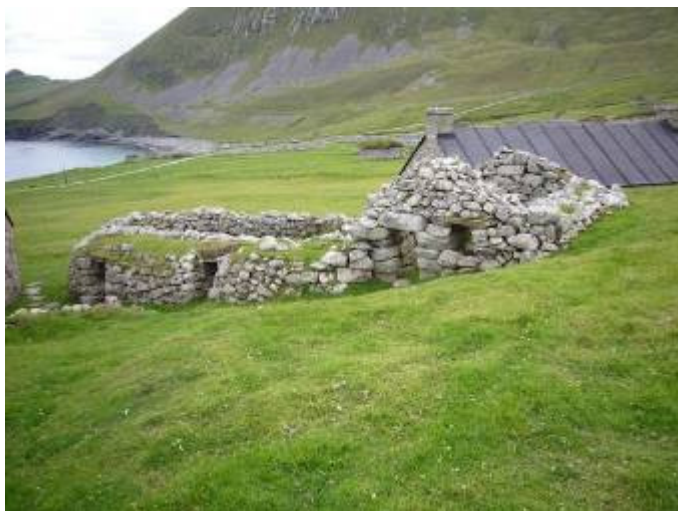
Figure 5 – Blackhouse C

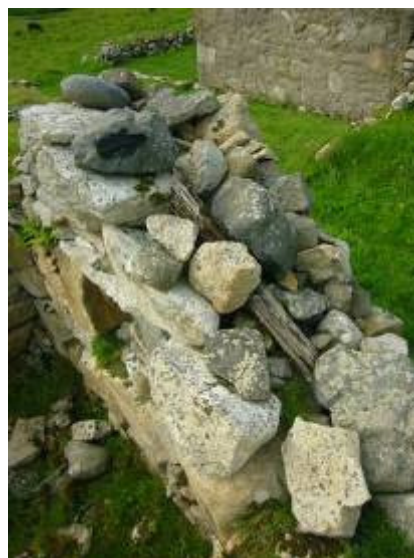
NTS Microsoft Access database. A number of additional features were noted, such as surviving driftwood in Blackhouse S (Figure 6), a number of broken querns, and also the high proportion that have been modified either to cover earlier wall-beds or after a change of use to byre and store in the 1860s. Each building was also photographed completely using a digital camera allowing a re-assessment of condition. I still intend to produce a comparative paper discussing the blackhouse group with reference to similar buildings in Skye and the Western Isles during 2009.

Figure 6 – Driftwood in Blackhouse S

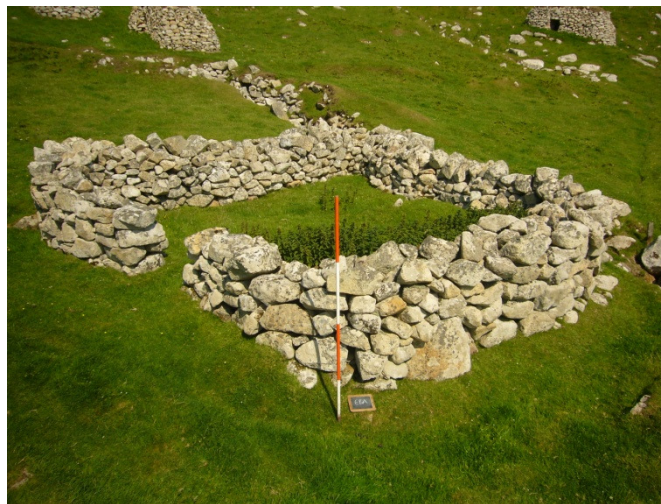
Figure 7 – Enclosure BA

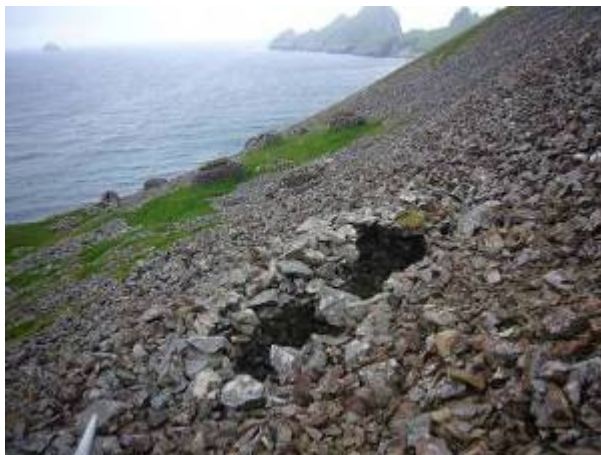
Figure 8 – ‘Hidey Hole’ Scree Structure 06

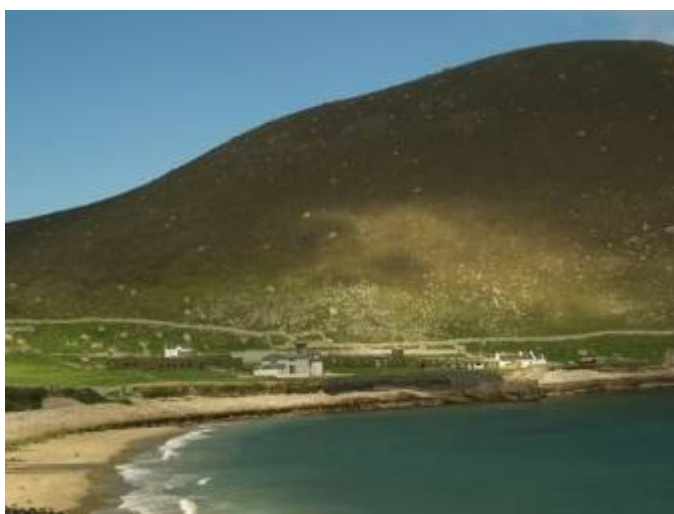
Figure 9 - The coast in Village Bay

undertaken in September 2002 by representatives of Scottish Natural Heritage and the University of Glasgow for SNH and the NTS (Lees 2002; Hansom 2003). Figure 9 shows part of the Village Bay coastline.

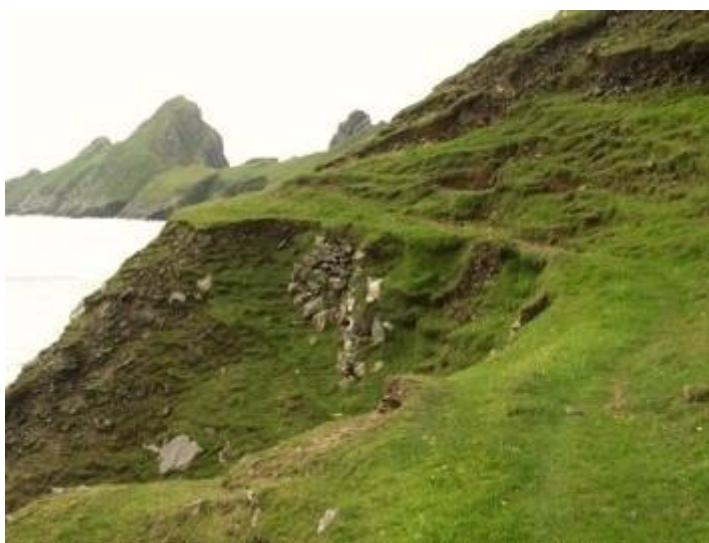
General photographs were also taken of the Village Bay coast line west and south of the current survey limit since there are a number of archaeological structures that are being affected by cliff and/or coastal erosion, whether by direct wave action or not (Figure 10). Dykes and enclosures at the west end of the storm beach are negatively affected by the movement of the boulder beach and by dumped material from the military occupation.

Figure 10 – Revetted track to Ruaival

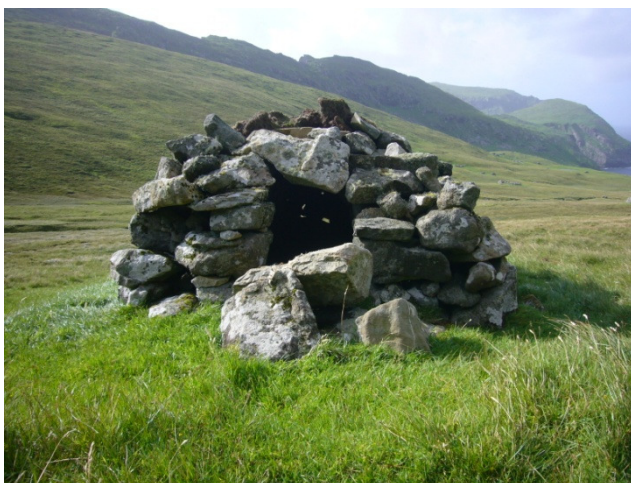
Figure 11 – Cleit 442, one of the CPP cleits

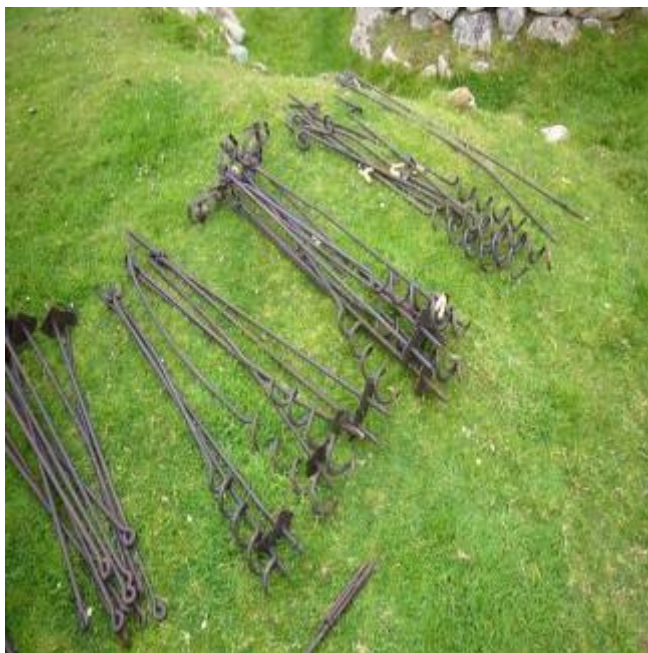
A mixture of finds, including modern material, came from the Church drain and Munitons Store drain excavations; these have been returned to Inverness for processing (STK08-2 and STK08-3). A large collection of screw pickets for supporting barbed wire (with a 1957 patent number) were removed from Cleit

Figure 18 - 1957 Screw Pickets

17 by the Factor's House (Find STK08-3), after notification by Jill Pilkington (Figure 18). After detailed recording, selections were taken to the museum in Stornoway, and the remainder were disposed off. Other finds included a fragment of quern with two peg holes (STK08-4).
