St Kilda Archaeologist's Annual Report, February 2009 to January 2010

Glynn Barratt
January 2010

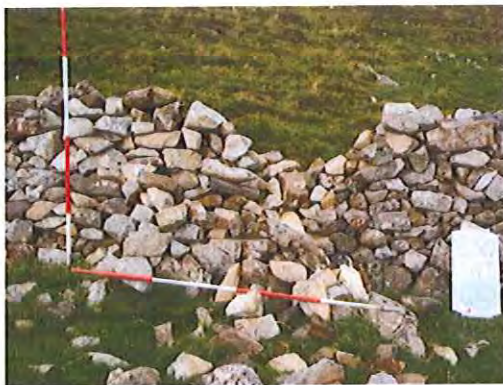
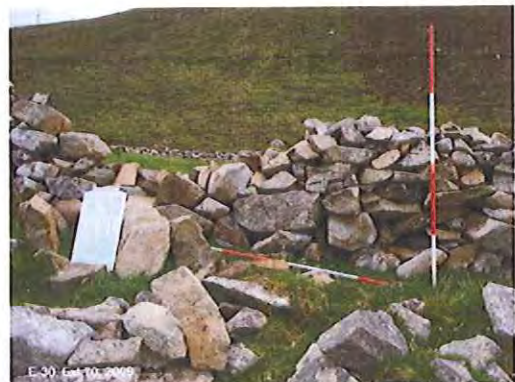
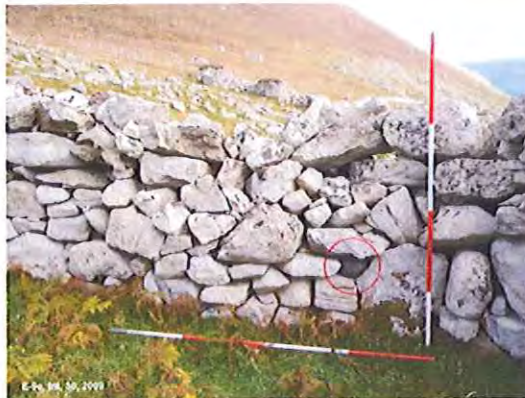
It should be noted that there are areas of substantial dyke collapse at E9, E19, E23, E28, E29, and E30. In addition there are 8 areas of lesser collapse occurring in E9a, E9d, E11, E14, E17, E28 and E29. The areas of collapse appear to have been triggered at or near the dyke tops – the most likely candidate for initiating the falls being sheep accessing and leaving the enclosures. Most of the collapses are within the accepted maintenance zone of intervention. These repairs will be included in the 2010 work programme.

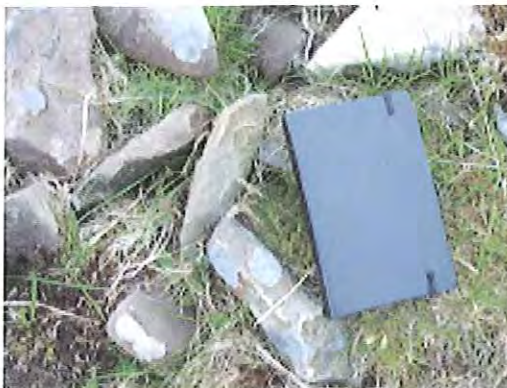
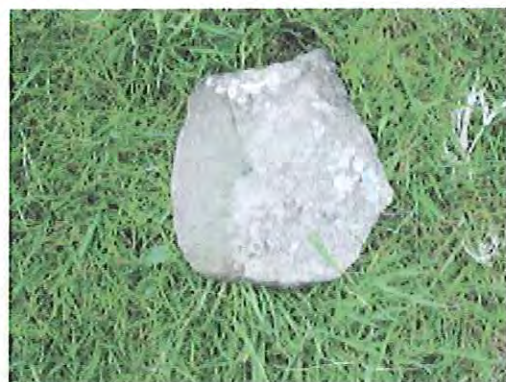
At NF 09612 99050 adjacent to and upslope of the highest cleit on the hillside, a small area of scree eroding out of the slope was observed and within it the edge of what seems to be a worked tool, of the type identified by Clarke as a hoe blade (see photos on previous page). The artefact is 13cm in length, 10cm wide and up to 5cm thick. It is faceted and apparently shaped to form a broad rounded blade, broken at its narrowest end.

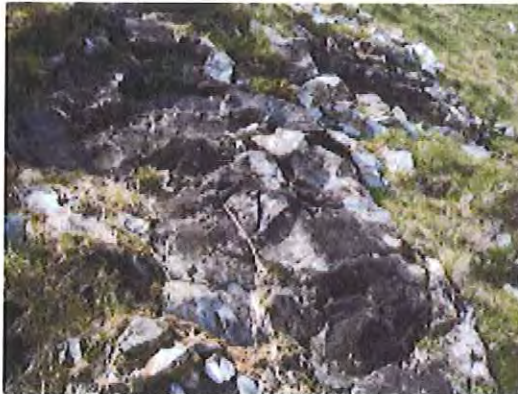
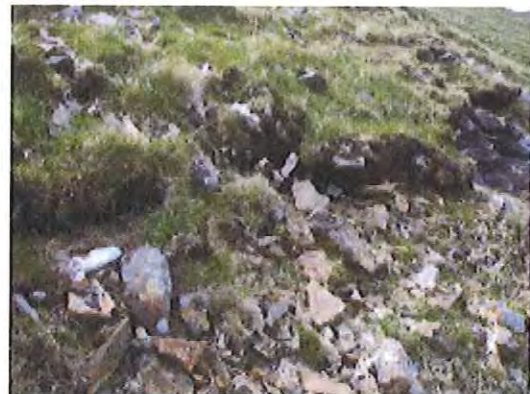
Approximately 10m upslope, and west at NF 09609 99041, a second scree exposure was observed, lying below a small vertical face of fine basalt. The outcrop, up to 2m high is of a good quality stone and appears to fracture naturally into usable sized stone pieces with fracture planes creating an instant edge.

Examination of the scree below the exposure revealed numerous flakes which could be the residue of stone working. Four of these drew the eye as possible examples of part made tools, each of them fitted the hand comfortably. Three were flat scraper like artefacts with convex, sub-crescentic edges ranged in size from 6 to 8cm in length and with an average body thickness of 1.8cm. The fourth was a more linear edge flake, 14.5cm long by 8cm wide and again 1.8cm thick.

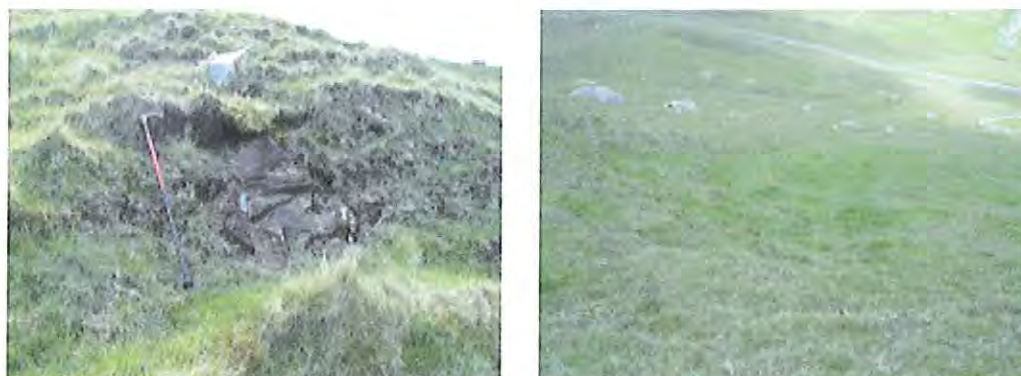
Higher still at NF 09461 99023 lay what appears to be a substantial quarry floor lying roughly north to south transversely across the slope over an area c16m by 12.0m. Along its uphill side a steep, partially exposed quarry face is cut to a height of 4m into the hillside while to the east a downhill terrace slope falls 2m below the quarry floor. The floor itself is flat with vegetation richer than the surrounding hill-slope, including sphagnum and iris, suggesting water retention.

This feature and others in the same area have certainly the superficial appearance of early stone quarry working, as suggested by Edmonds and Fleming. Personally the SKA has seen visually similar early quarry sites (Neolithic to early Bronze Age) in North Wales and South Shropshire. The freshly exposed, fine-grained dolerite would, from personal experience, be far more easily worked than older exposed, oxidised and weathered stone, such as that which lies in the extensive scree slopes.

However, it is also possible and likely that some of the surface hollows in this area are the result of more recent turf cutting. Similarly the possibility that geomorphological landforms may be created on such steep slopes by the effects of solifluction movements should be taken into consideration. Examination by a geomorphologist and possibly a programme of 3-D topographic survey, as suggested by Fleming may answer some of the questions that this area poses, in order to more fully understand this complex but potentially extremely important area of landscape. If Historic Scotland's proposed airborne LiDAR survey is carried out then 3-D modelling of this high resolution data as a DEM (Digital Elevation Model) would offer great potential for a quantitative analysis of this area.
