## The St Kilda Archaeologist's Annual Report, April 2012 to January 2013

Andrew Walsh, February 2013

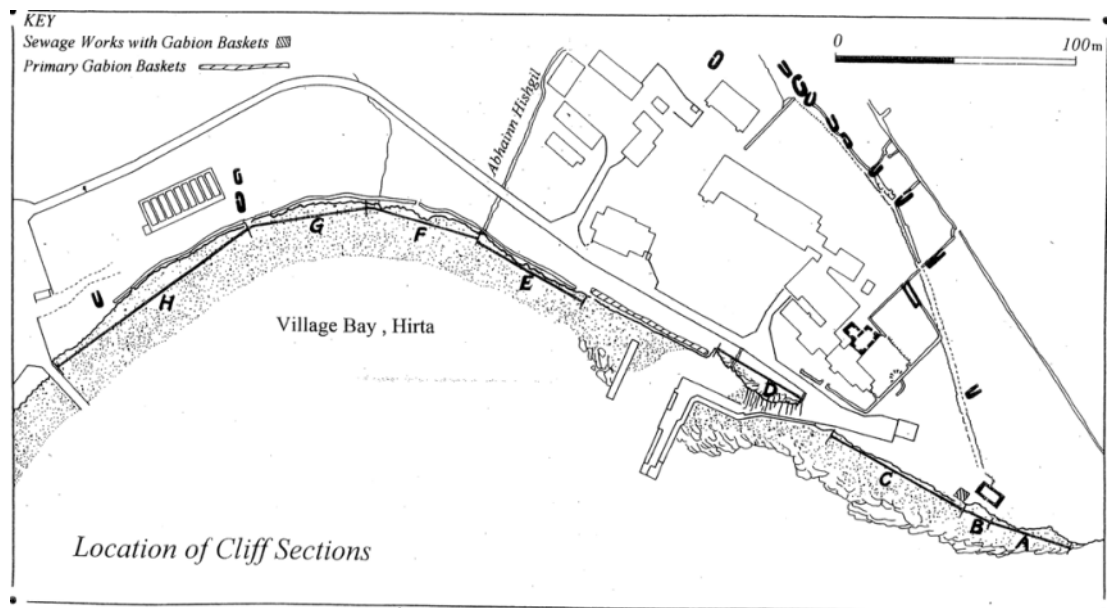
Figure 6. Location of the coastal erosion areas A-H

The rapid coastal erosion assessment is an ongoing project to document the rate of erosion around Village Bay. The coastline between NF 10430 98978 and NF 10084 99094 has been divided into eight sections labelled A to H (Figure 6). The survey has been carried out every year since 1996, with the current methodology in use since 1999 (Johnstone 1999). A 'full set' of new photographs facing straight onto the eroding cliff, are produced every two to three years. They are supplemented with additional photographs taken in the intervening years if change is noted. During 2011 a full set of new photographs were taken so the 2012 coastline was compared to those. The results of the monitoring are presented below.

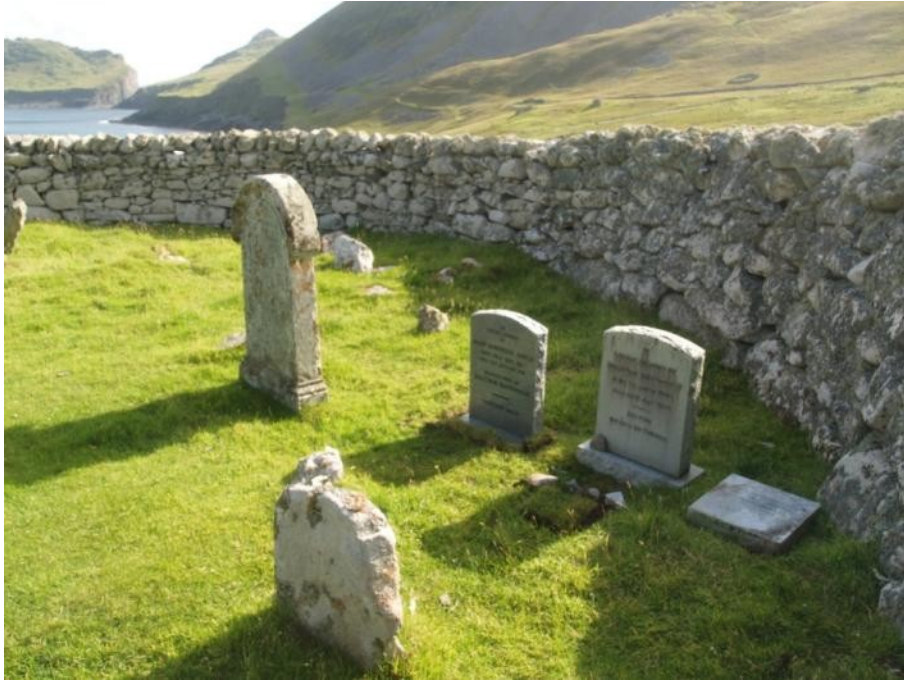
Monitoring photographs were taken for the interior and exteriors of Enclosures 32 and 33 (the Graveyard; Figure 11), completing the photographic recording of the large enclosures within the Head Dyke. Photographic recording of Enclosures 31 (west of the Head Dyke; Figure 12) and Enclosure 39 (An Lag) was also completed (Figures 13 and 14).

Figure 11. The Graveyard wall was photographed in detail during 2012

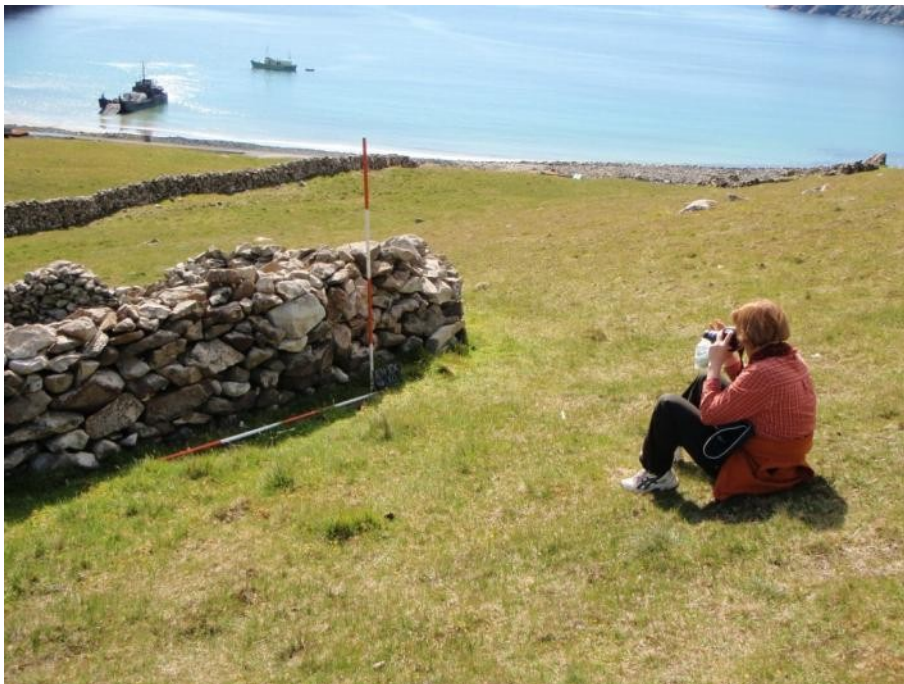
Figure 12. Photographing Enclosure 31 with the assistance of Janet Gruber (Work Party 3)

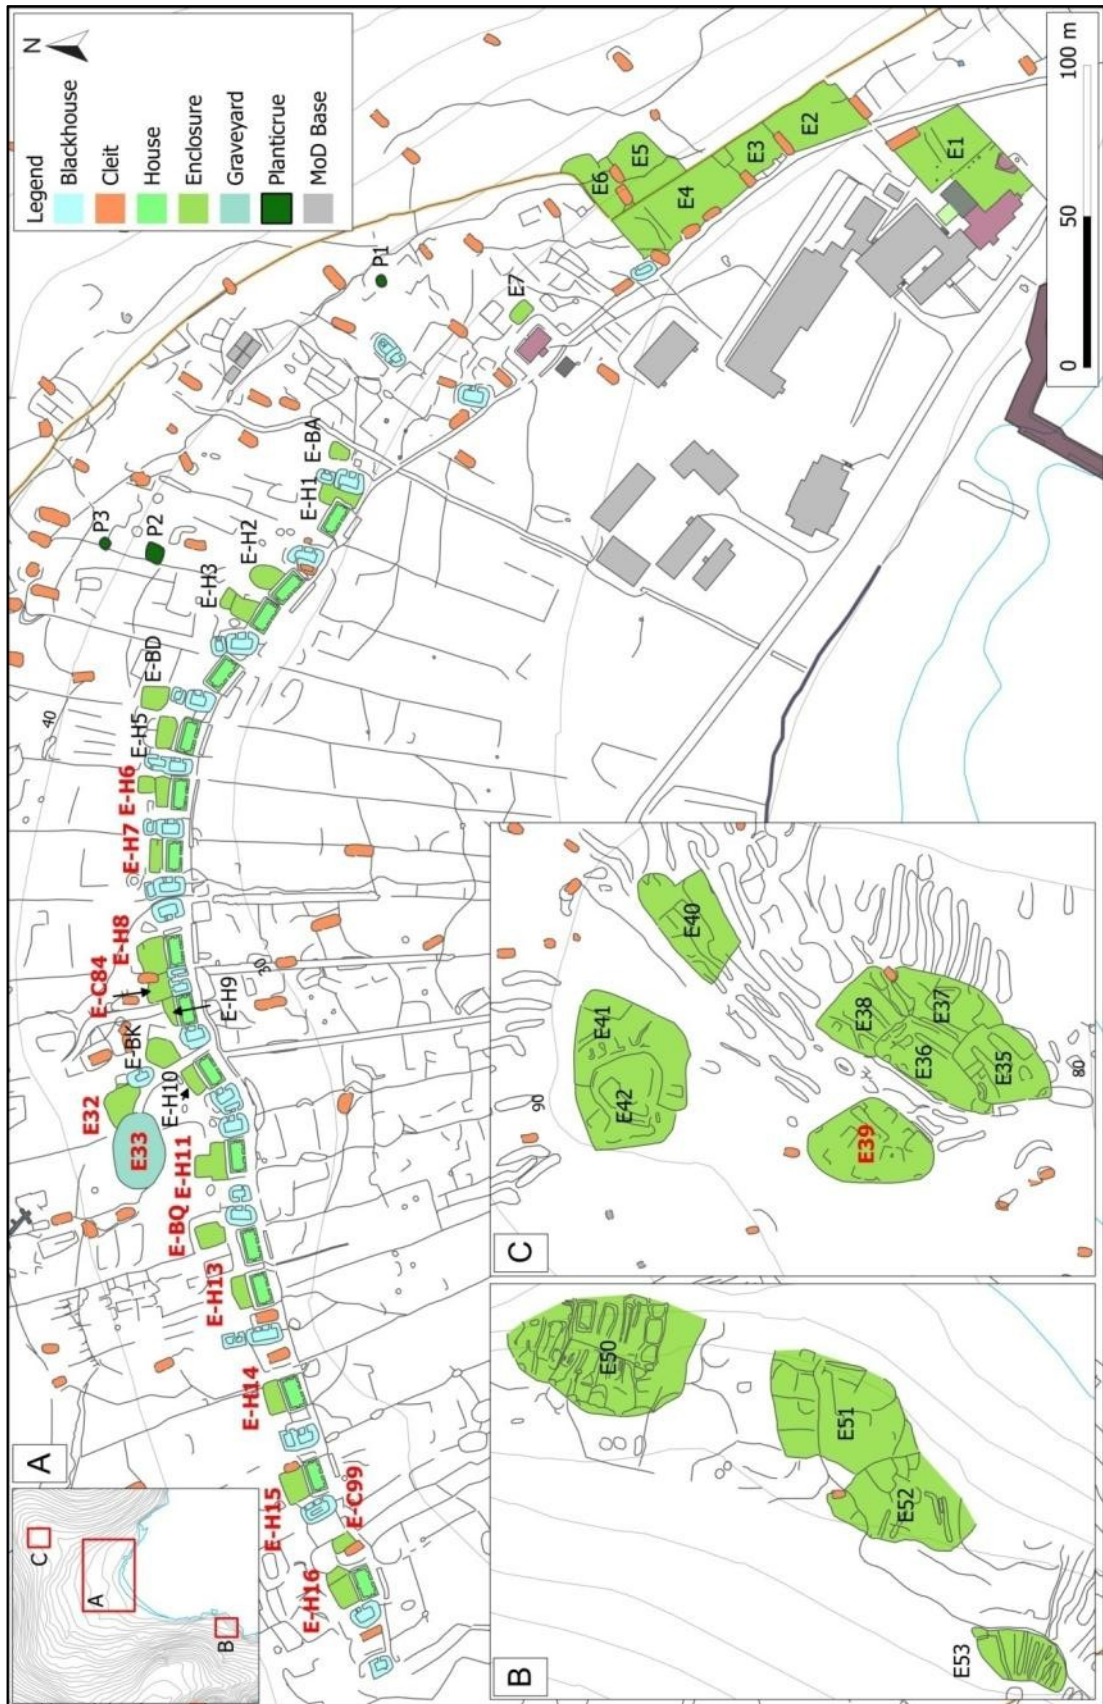
The interiors and exteriors of Kaleyards E-H6, E-H7, E-H11, E-H14, E-H15, E-H16, E-BQ, E-C84 and E-C99, and the interior of E-H8, were also fully photographed (Figure 13). The exterior of E-H8 was not photographed due to dense vegetation cover.

Figure 13. Plan of the enclosures, kaleyards and planticrues. The enclosures photographed in detail during 2012 are highlighted in red (scale: 1:2500 @ A4. Crown Copyright: RCAHMS)

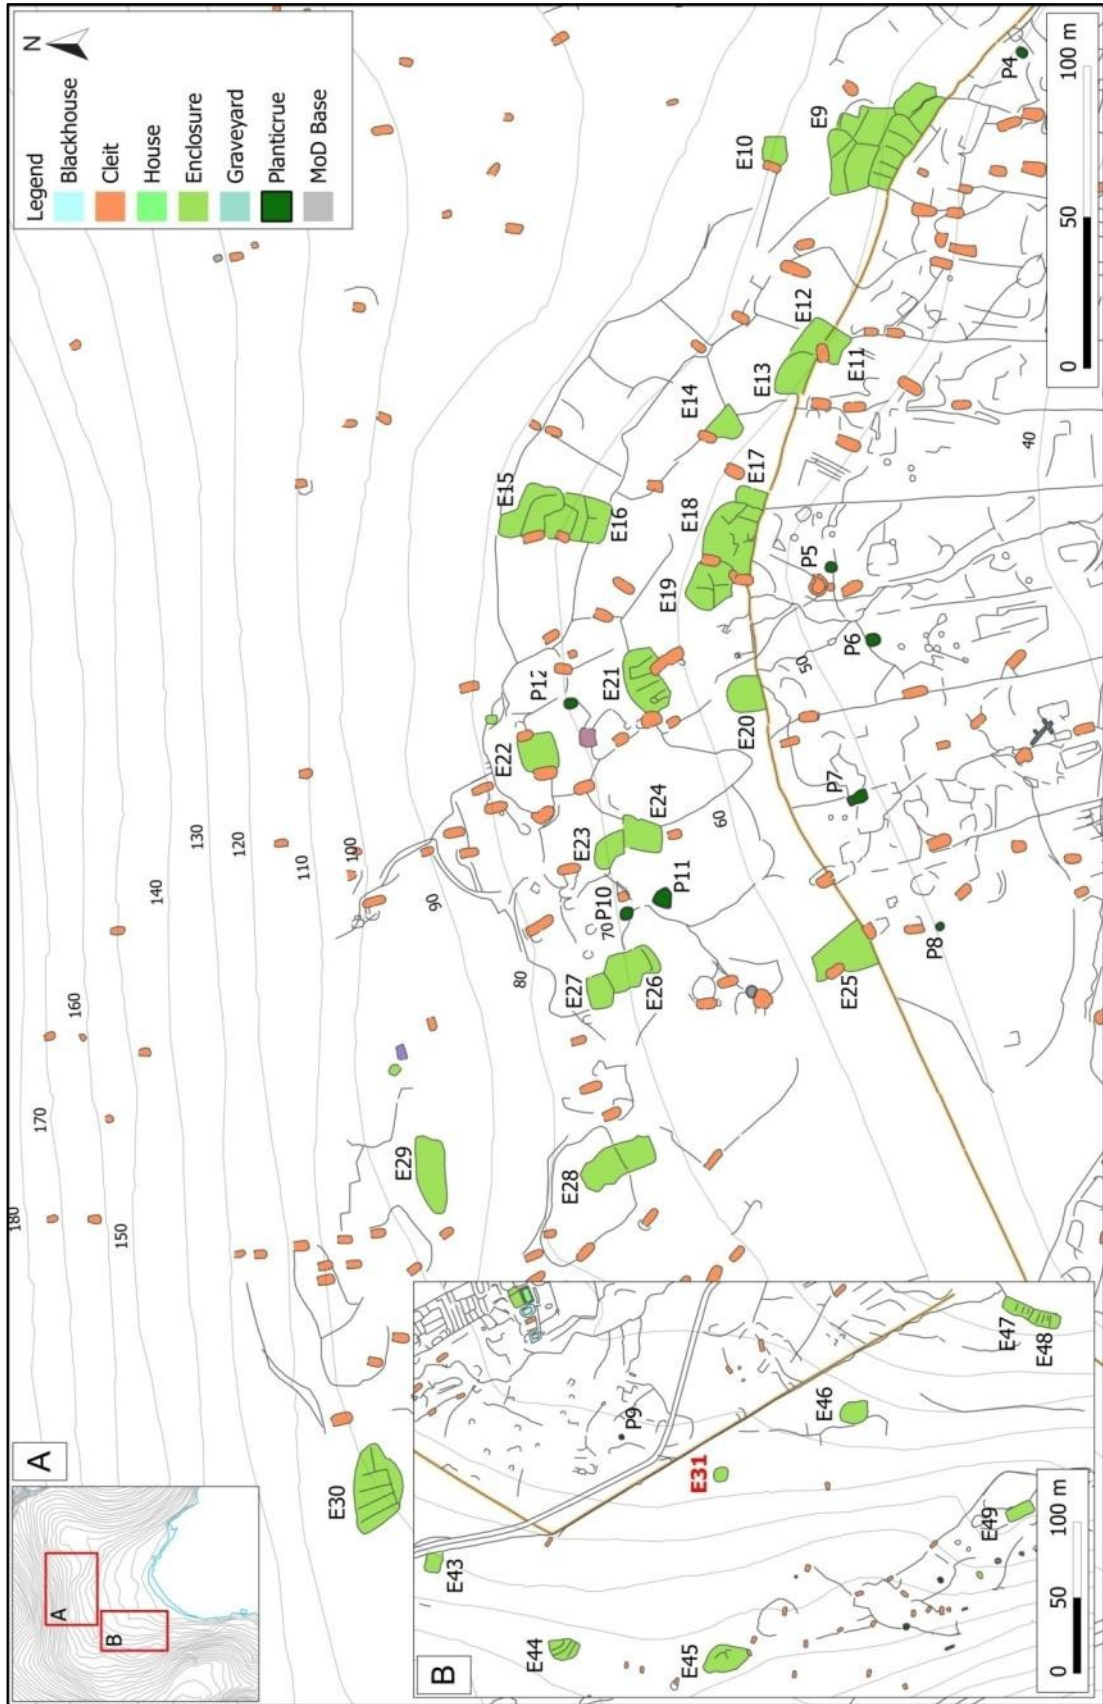
Figure 14. Plan of the enclosures, kaleyards and planticrues. The enclosures photographed in detail during 2012 are highlighted in red (scale: A=1:2500 @ A4; B=1:5000 @ A4. Crown Copyright: RCAHMS)

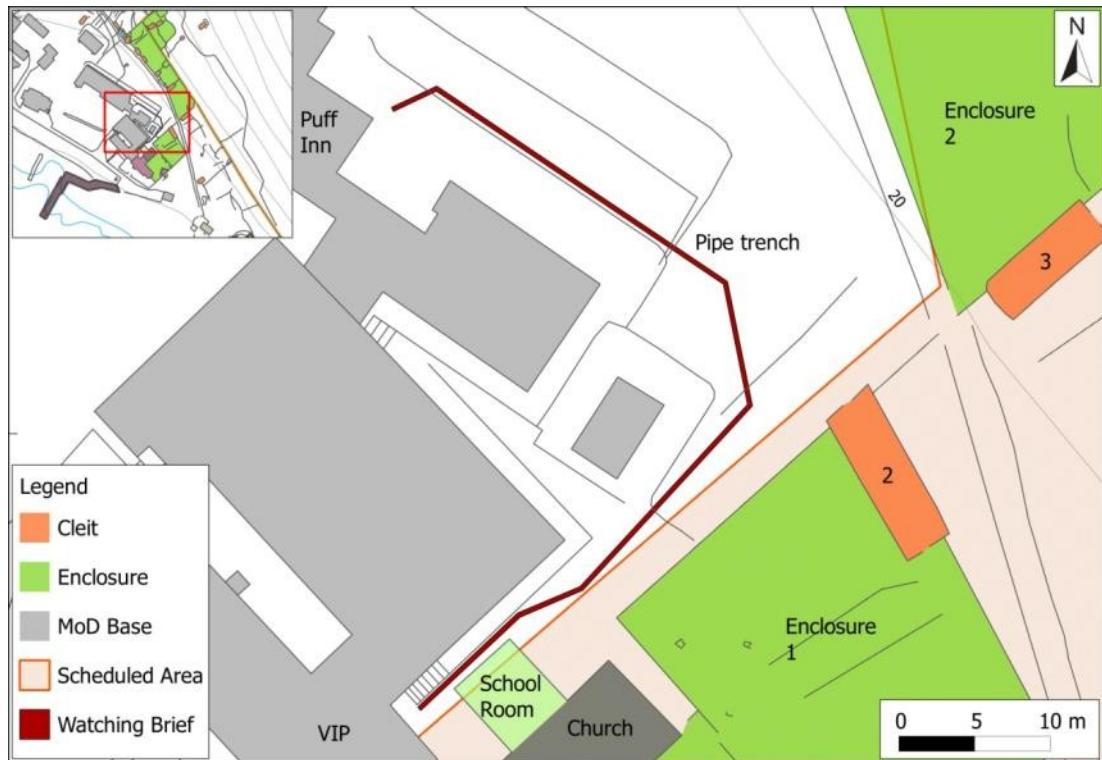
A pipe trench was excavated on the east side of the main accommodation block of the MoD base (Figure 17), in an area which had been subject to extensive terracing and landscaping during construction of the base. It lay outwith the Scheduled Area of Village Bay (Scheduled Monument No 2276).

Figure 17. Location of the pipe trench watching brief (scale: 1:500 @ A4. Crown Copyright: RCAHMS)

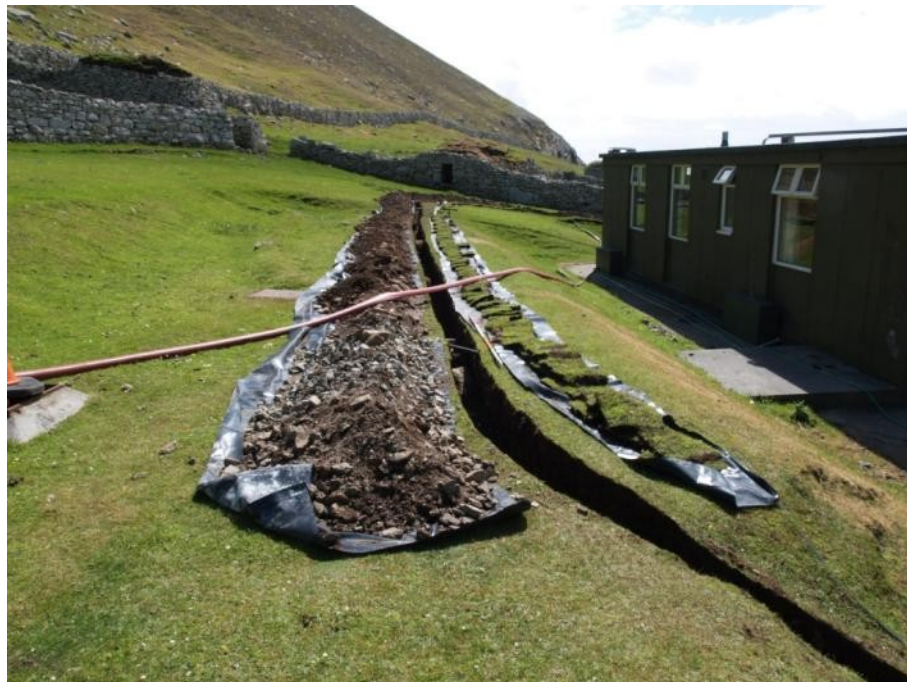
The trench was routed between the rear of the 'Puff Inn' and the 'VIP' (Figures 17 and 18) to allow cold water to run into the VIP and Manse below ground, rather than through the base which was causing it to warm to unacceptable levels.

The trench was dug by hand by QinetiQ staff and sub-contractors between 28<sup>th</sup> and 30<sup>th</sup> June. It measured c.65m in length, 0.3m in width, and a maximum of 0.5m in depth (Figures 18 and 19). Most of the deposits revealed by the works were associated with terracing and landscaping around the MoD base, and the only deposit of note was a dark brown sandy silt which was exposed in the base of the trench nearest to Cleit 2. This was interpreted as a buried agricultural soil. No archaeological features or finds were identified during the watching brief.

Figure 18. The pipe trench after excavation, looking south east

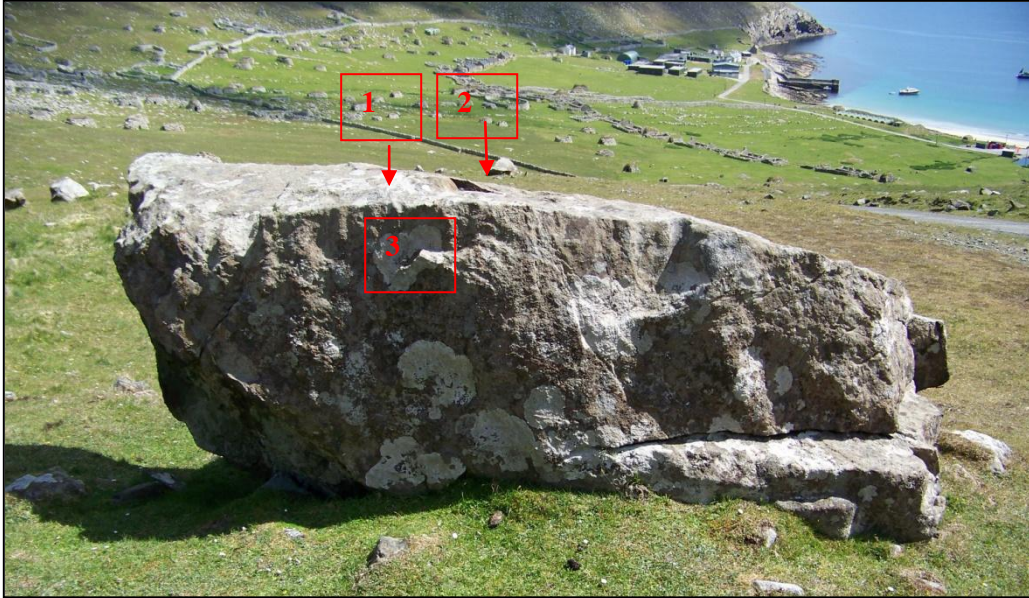
*Milking Stone and positions of the detached pieces*

- Prior to the conservation treatment, the Milking Stone and detached pieces of stone were documented photographically. This photographic record was continued throughout the works.

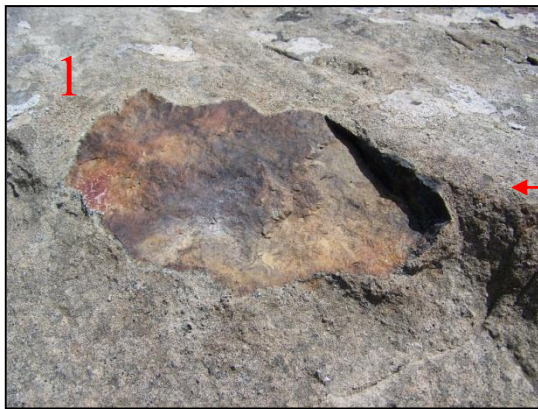
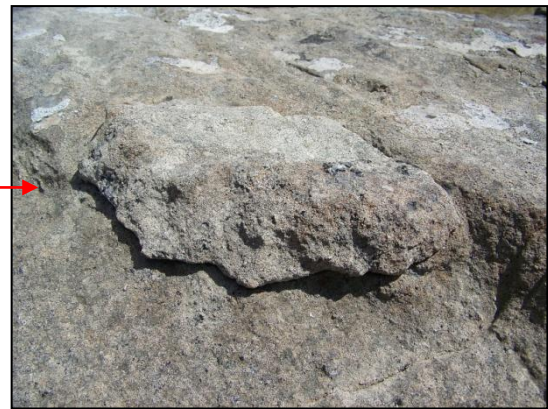
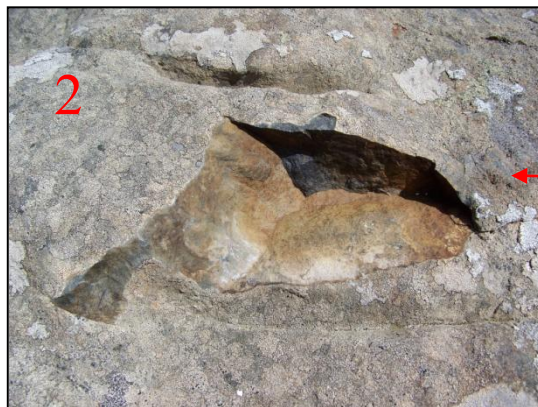
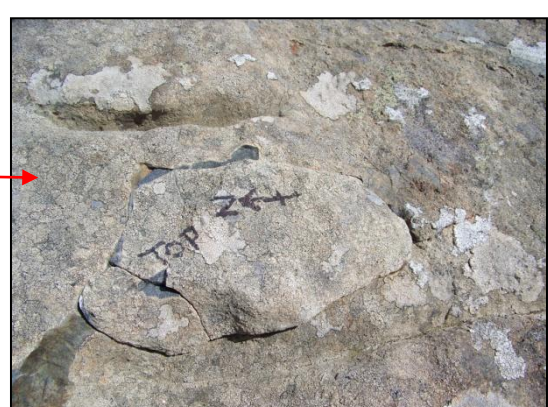
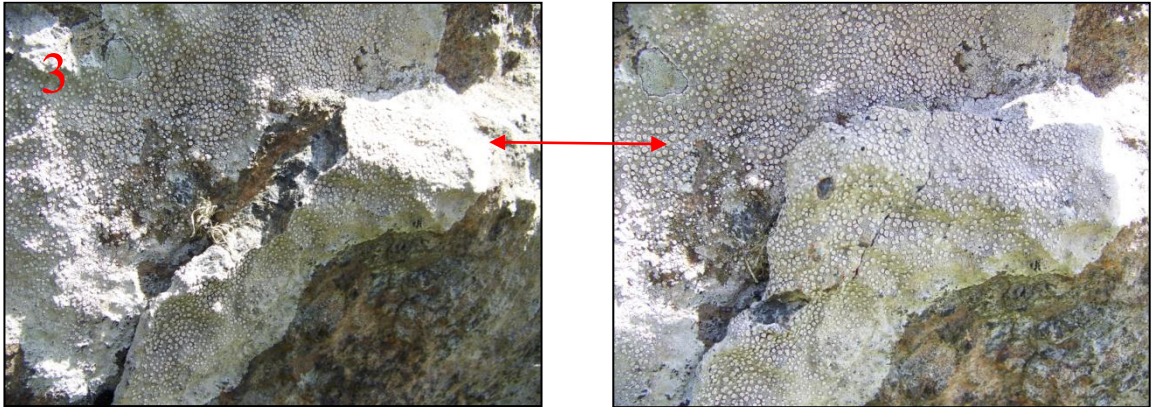
- Following dry cleaning of the detached pieces and the surfaces of the breaks on the Milking Stone, loose fragments were carefully placed on their original position and assessed.
- All of the pieces fitted well, however stone number **2** was broken in to three sections and its top surface was stained with black felt pen. Several fragments, chips to the edges of all three pieces, were missing.
