Roan Head, Flotta

Roan Head Boom Buoy Vessel

Project Report

March 2015

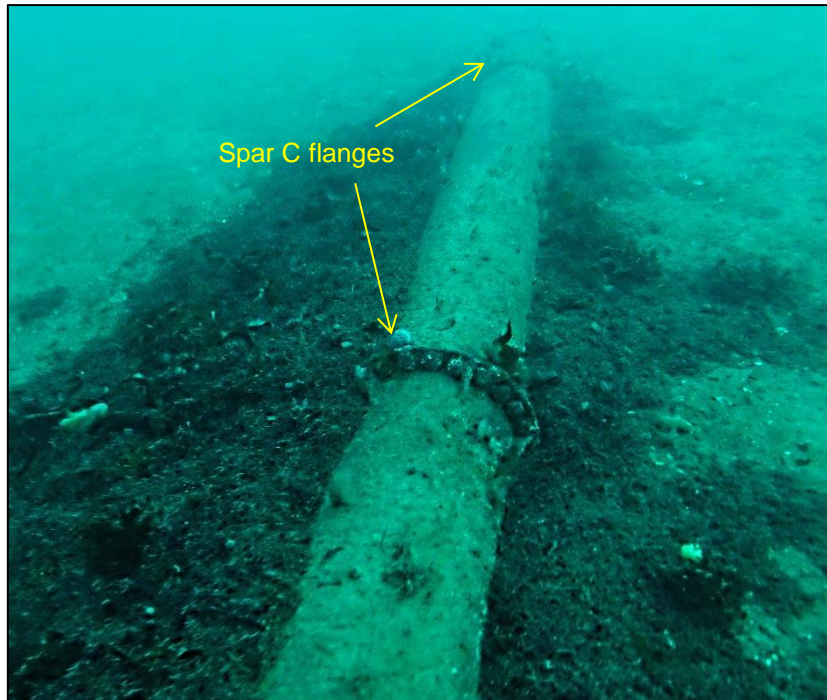
PLATE 3: PHOTOGRAPH OF SPAR C

Both contacts lie under two spars (Spar A and Spar B respectively). Spar A is approximately 22.6m and is oriented northwest to southeast; while Spar B is approximately 24.9 and is oriented east-northeast to west-southwest. Subsequent assessment of the survey data following the diver surveys indicates the presence of a third spar (Spar C) approximately 5m to the east of the main target site. This is visible as three strong returns, which mark the position of flanges visible on the spars underwater (**Plate 3**). Spar C is at least 16m long, however the contact extends beyond the range of the side scan runs.

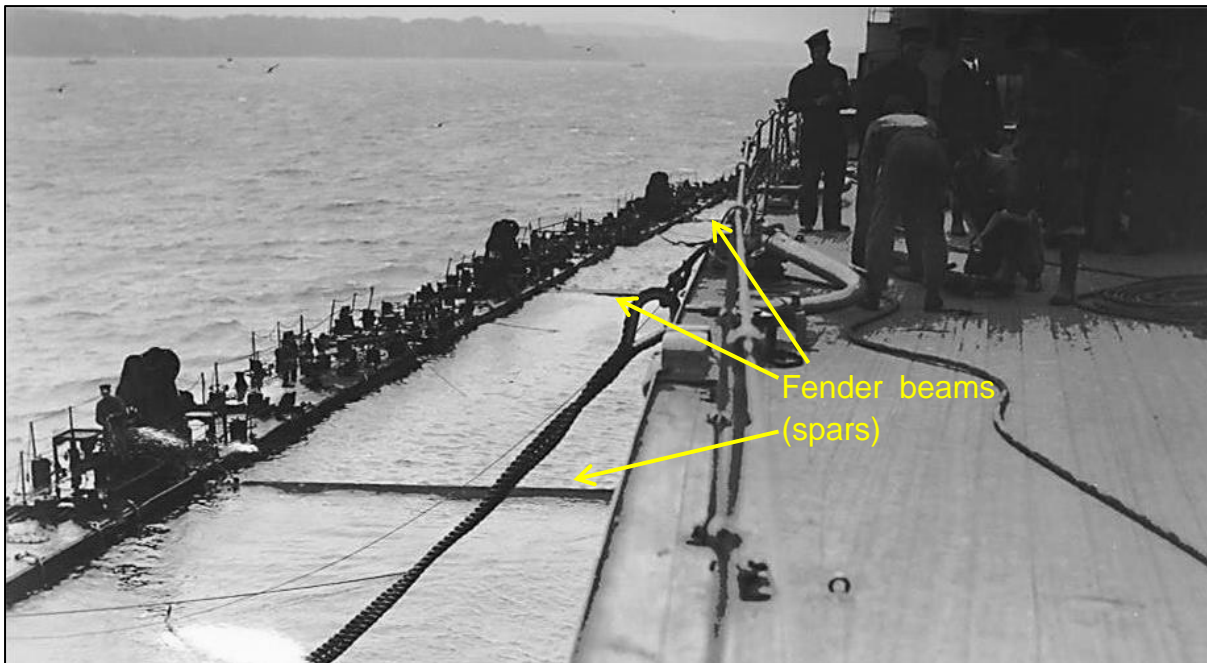
PLATE 11: EXAMPLES OF SPARS USED TO KEEP PONTOONS AWAY FROM THE SHIPS THEY ARE PROTECTING

Fearing that such an attack could be used against British assets, the Royal Navy trialled a number of approaches for ATCP (including concrete barges, dumb barges, roller nets, spar protection and pontoons), before finally opting for deployment of Landing Craft Tanks (LCTs) adapted to take close protection nets (ADM1/12757). It should be noted that the Spars A, B and C identified during the side scan sonar and diving surveys are not considered representative of spar protection defences. Historic photographs show that the pontoons are held away from the ships they are protecting by linear beams known as spars. Spars A, B and C are examples of these **(Plate 11)**.

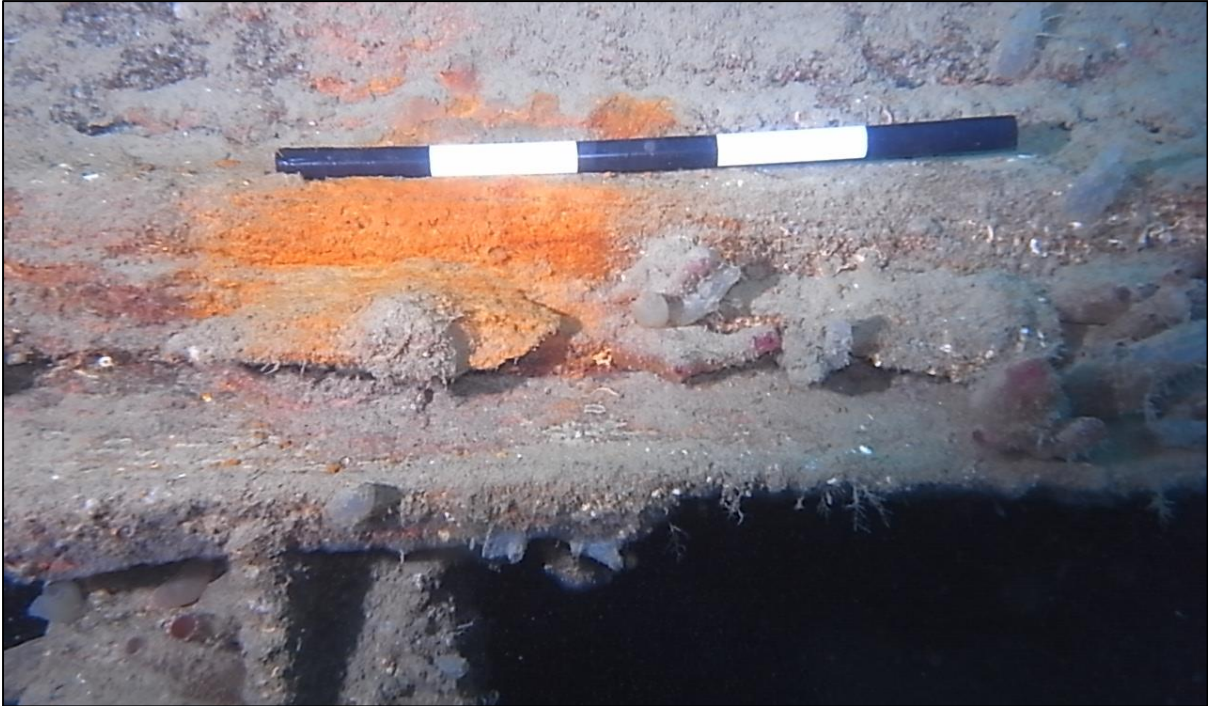
PLATE 12: EVIDENCE OF WOODEN RUBBING STRIP

RC1, RC2 and historic records of the ATCPP's indicate that each 90 foot pontoon comprises three 30 foot sections, made of steel. The top edges of the pontoons have a wooden rubbing strip for protection (**Plate 12**).

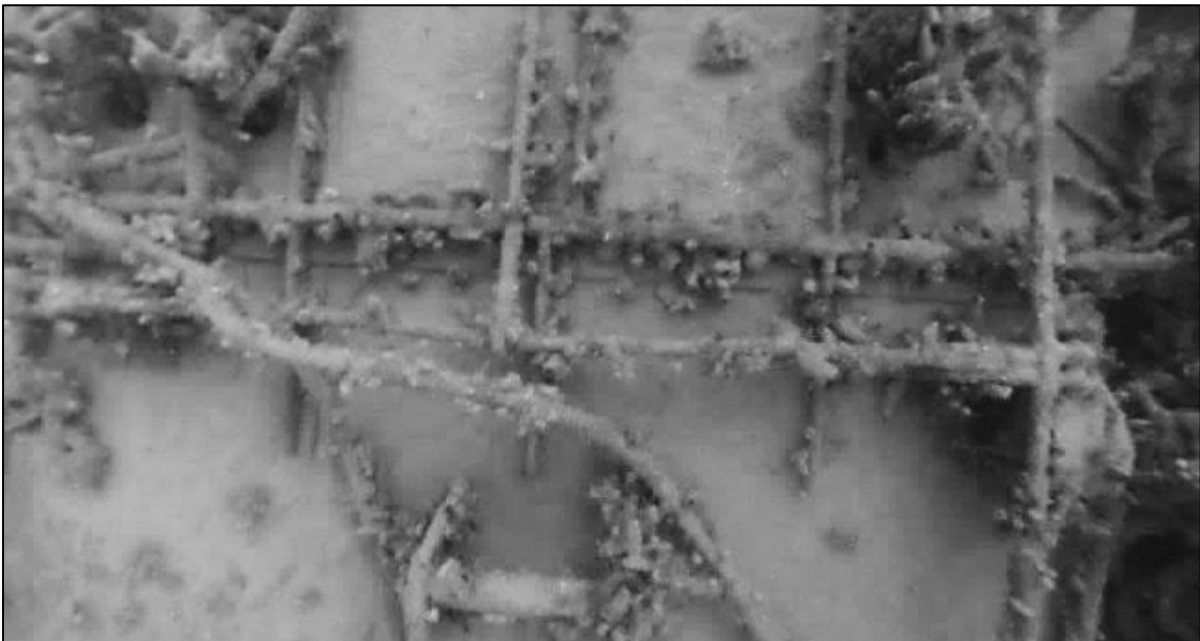
PLATE 13: JOIN BETWEEN TWO SECTIONS OF THE PONTOON

There is an oval access hatch on each section facilitating access to the inside of the pontoon. The sections are bolted together as shown in **Plate 13**.

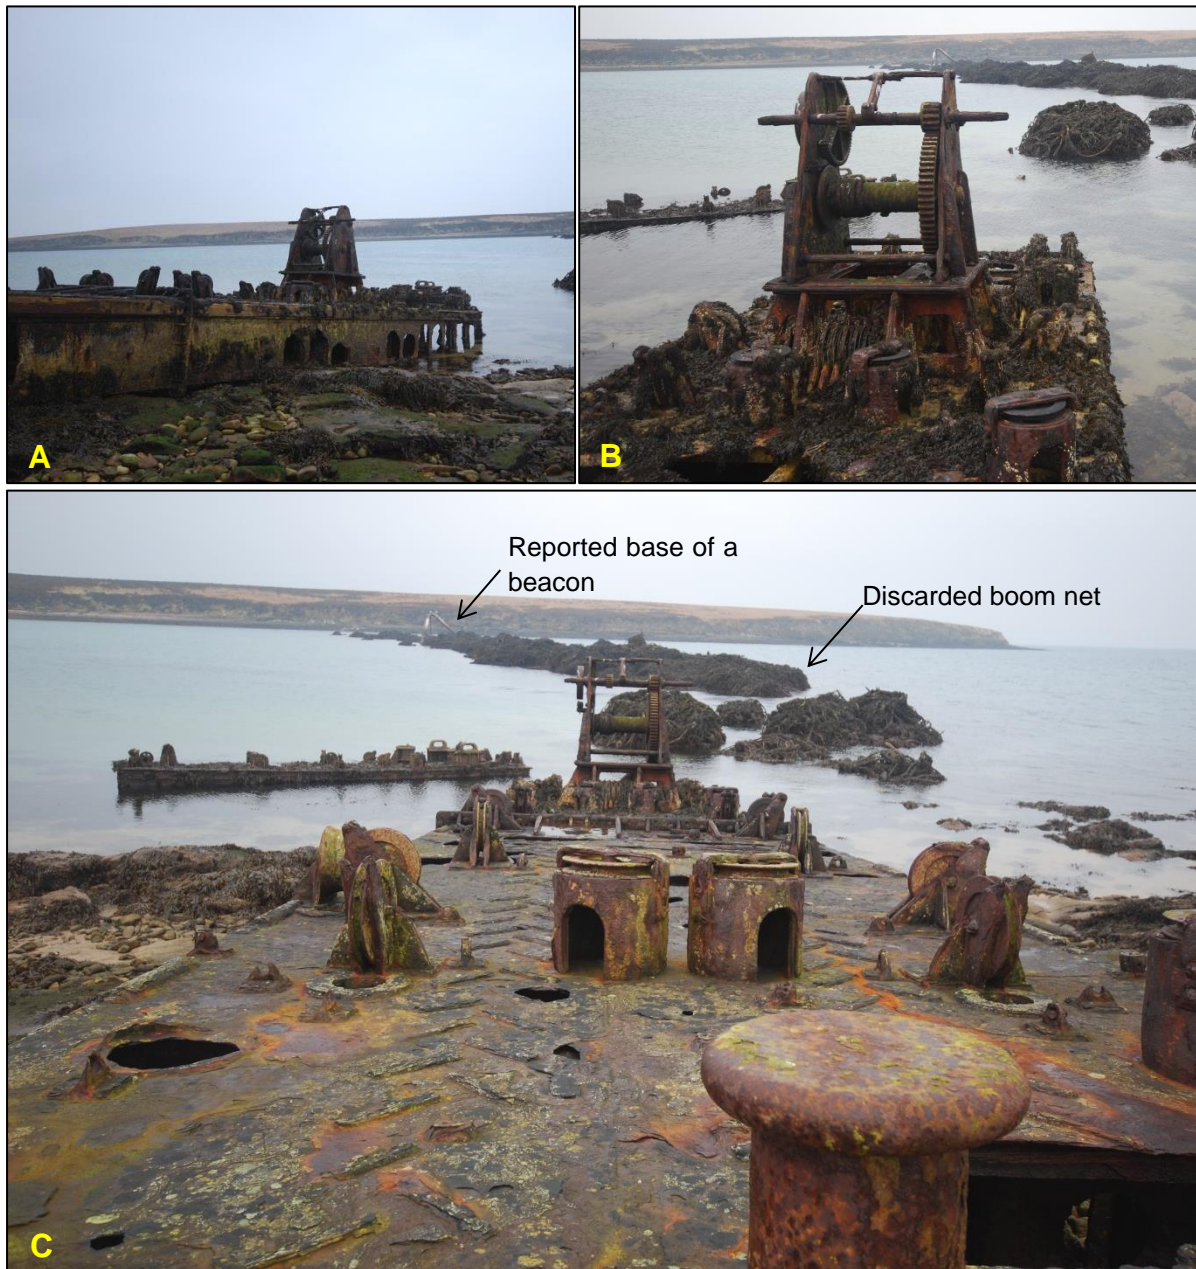
PLATE 16: REMAINS OF A PONTOON ON ROAN HEAD, FLOTTA

The first is the largely intact remains of a pontoon on the beach on Flotta, referenced in the Canmore record for the remains of anti-submarine boom defences (Canmore ID 249683) as "...a flat metal structure extends into the intertidal zone on the Flotta side of Calf Sound. It is 1m wide and at least 5m long. The remnants of winding gear are attached to the seaward end". Images of this pontoon are shown in **Plate 16**.

Two sections of the pontoon currently rest in the inter-tidal zone to the west of a large pile of discarded boom netting and the reported remains of a 20th-century beacon (**Plate 16C**), although it should be noted that there are no charted beacons in the area. It is possible that this is the remains of an anchor for one of the Hoxa booms. The third section has broken away and is resting perpendicular to the midsection in the water. There is evidence to suggest that some salvage has taken place, particularly on the remains of the larger section, as some of the fittings have been removed or partly removed and there is evidence of sections of burning (**Plate 17**).

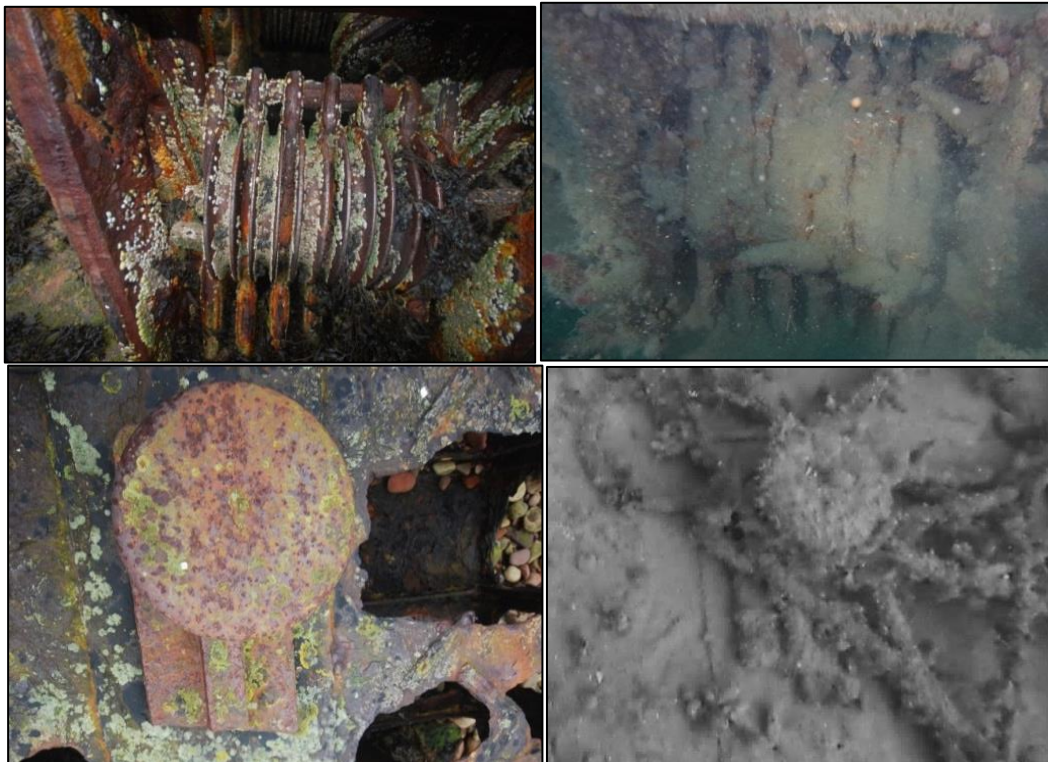
PLATE 18: EXAMPLES OF FEATURES ON THE FLOTTA BARGE REPLICATED UNDERWATER

The features on this pontoon replicate exactly those found on the sites underwater. Examples of these can be seen in **Plate 18**.

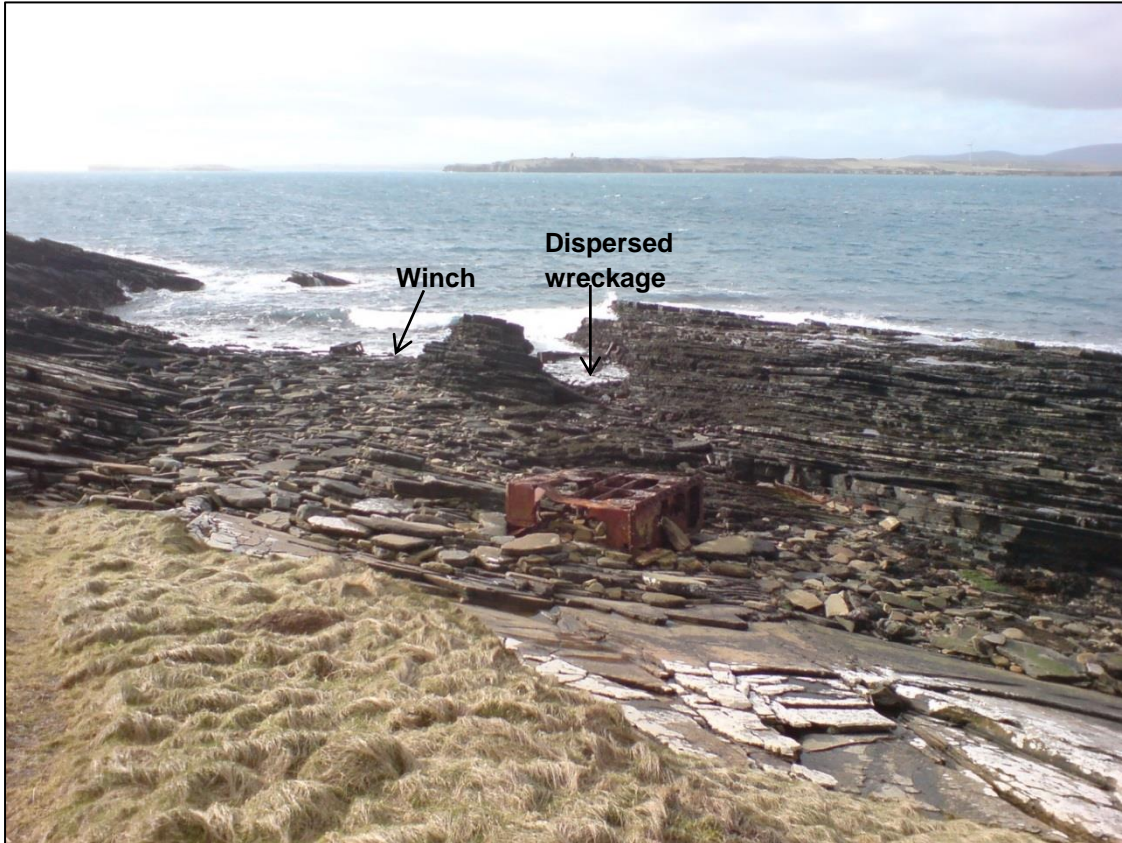
PLATE 19: DISTRIBUTION OF PONTOON WRECKAGE AT HOXA

The more dispersed remains of a second pontoon can be found on the rocks beneath Hoxa battery. The debris is described in the Canmore site record for Leynei Geo (Canmore ID 314006) as “fragments of a large metal structure, possibly part of a ship or boom, are wedged fast between the rocks” (**Plate 19**).

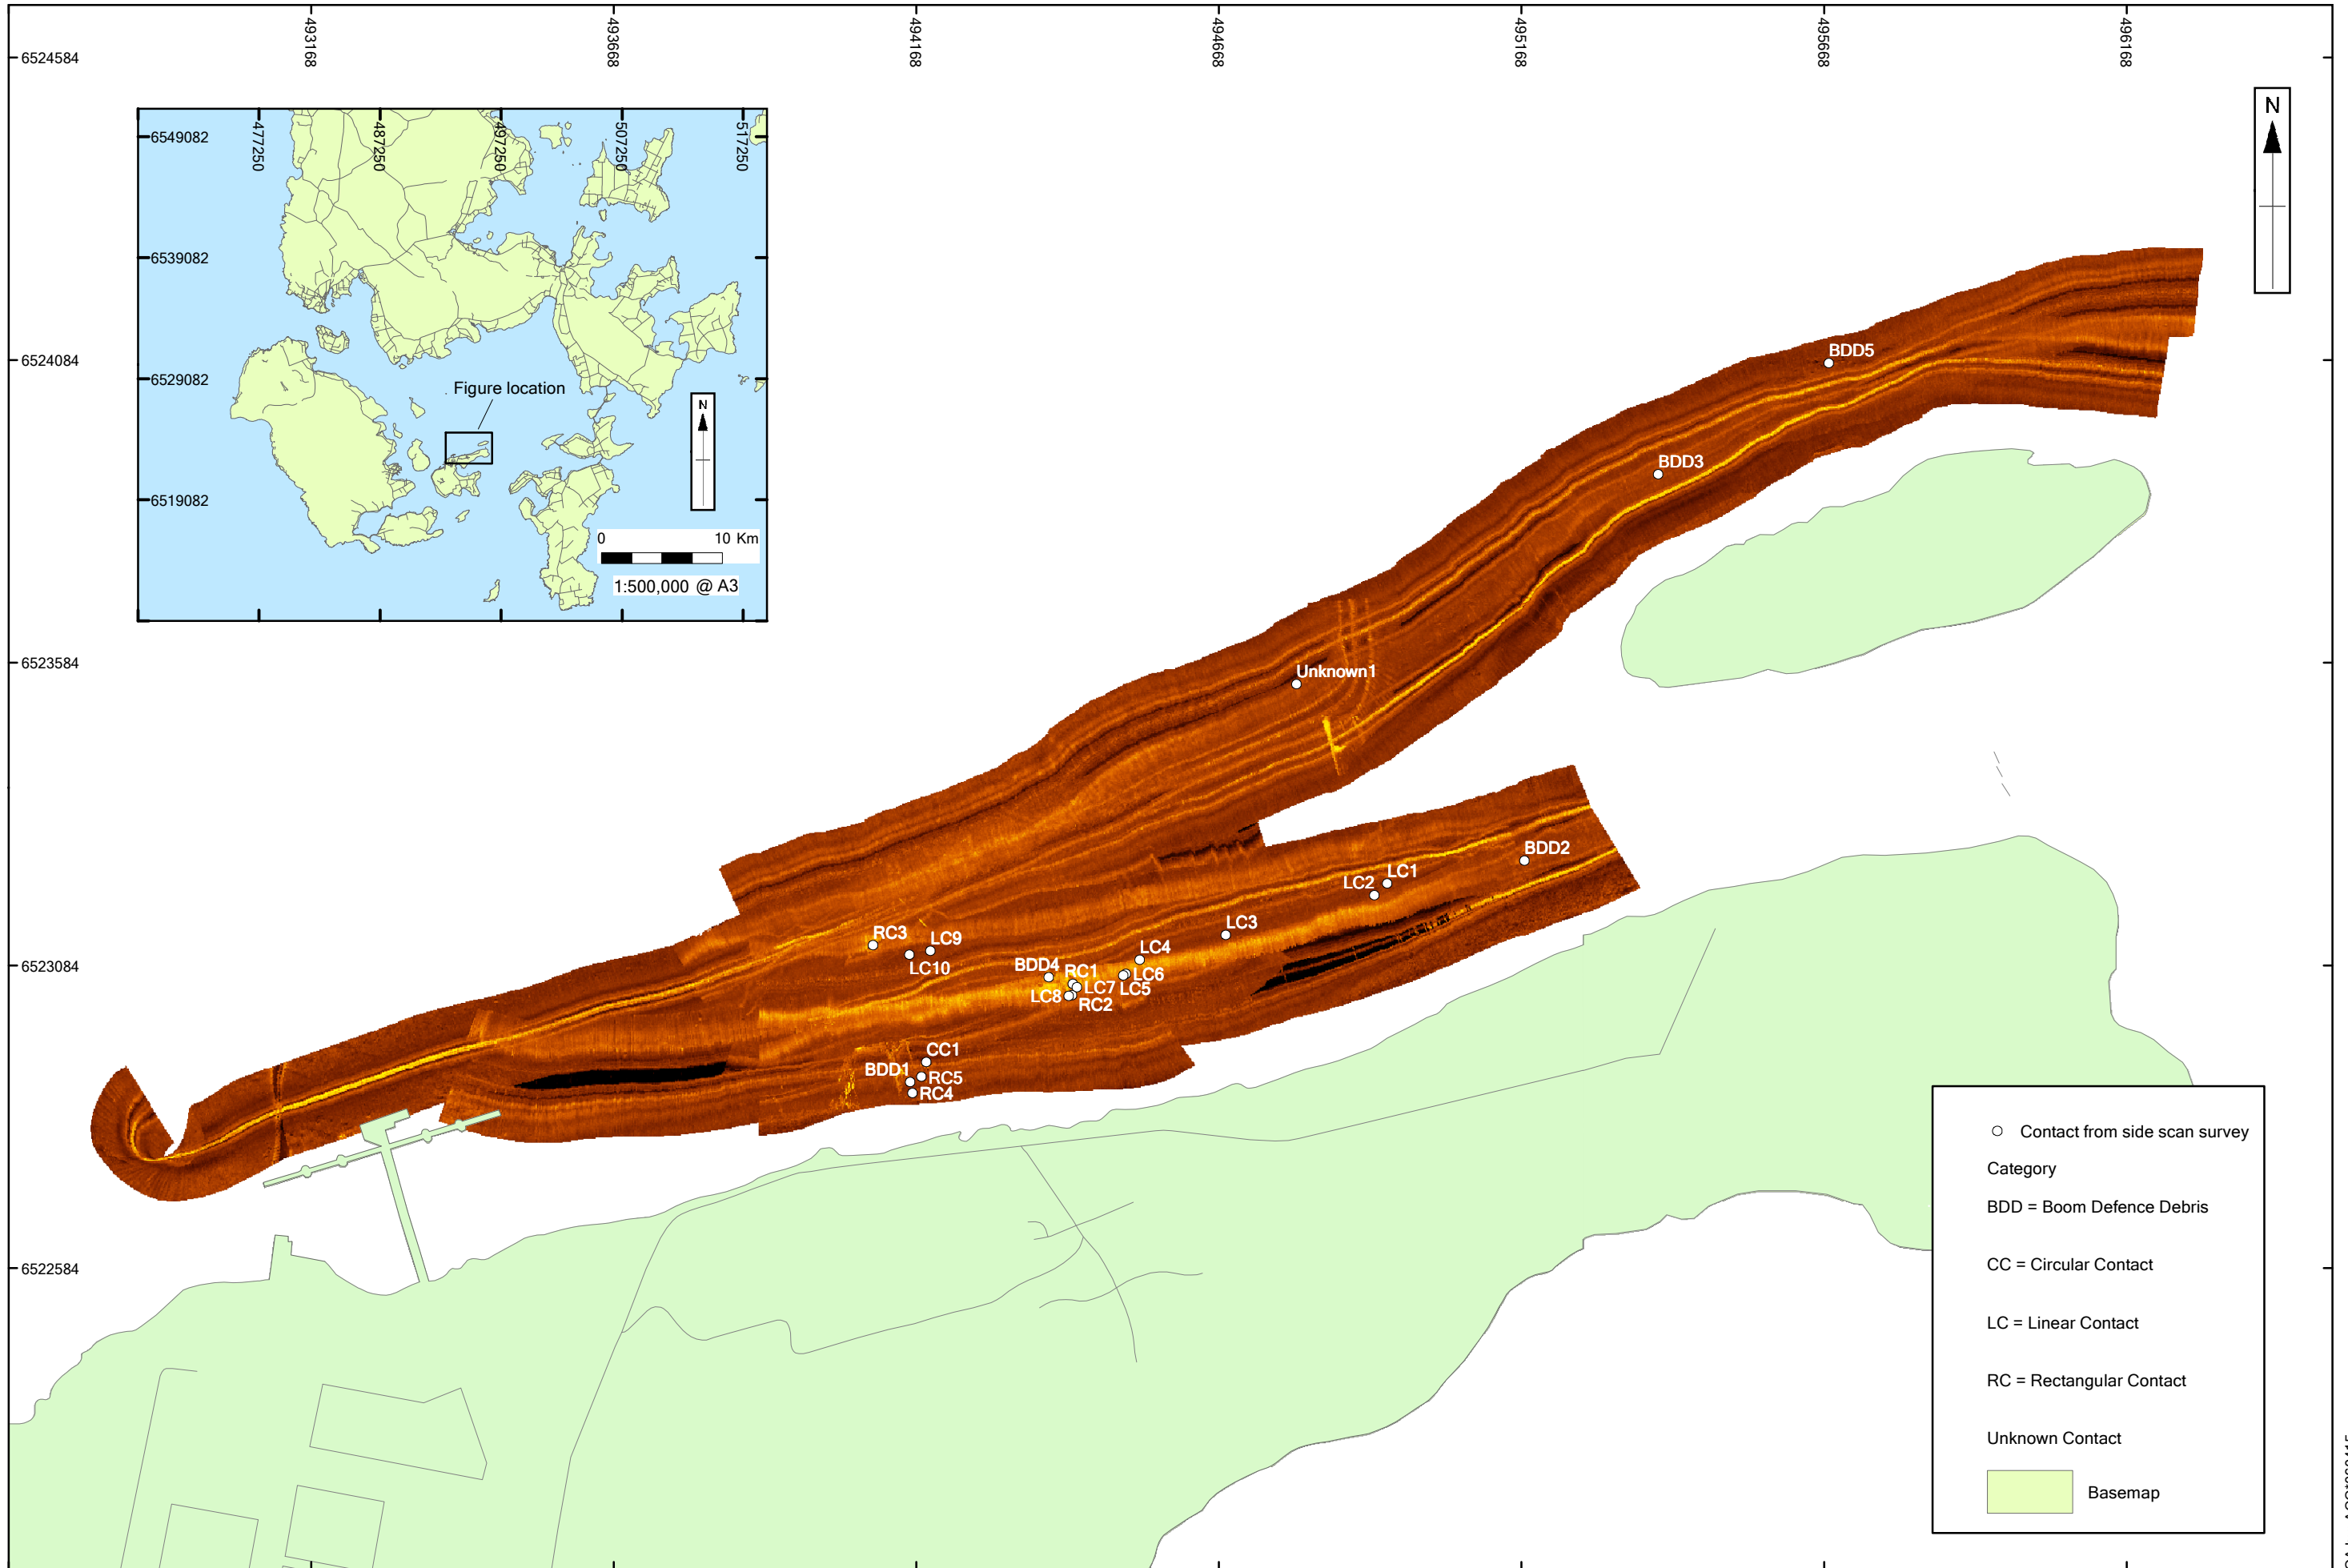
Figure 1: Mosaic of side scan survey runs showing distribution of observed features

The surveys identified the target site as well as the remains of three other similar rectangular contacts. These features are described below. Numerous spars, several square blocks, a large circular contact (CC1) (2m in diameter which stands over 2.4m proud of the seabed) and several concentrations of boom defence debris (piles of net and associated buoys) were also found in the survey area. The boom defence debris was interpreted as such on the basis of previous side scan sonar and drop camera ground truthing completed during the *Scapa Flow 2013 Marine Archaeology Survey* (Christie et al. 2014: 56-60). Each of the contacts identified by surveys was given a unique ID number and a contact report was produced. A list and description of these features can be found in **Annex 1**. Detailed descriptions of the target site and the other three rectangular contacts observed in the surveys are provided below. Their distribution is shown in **Figure 1**.

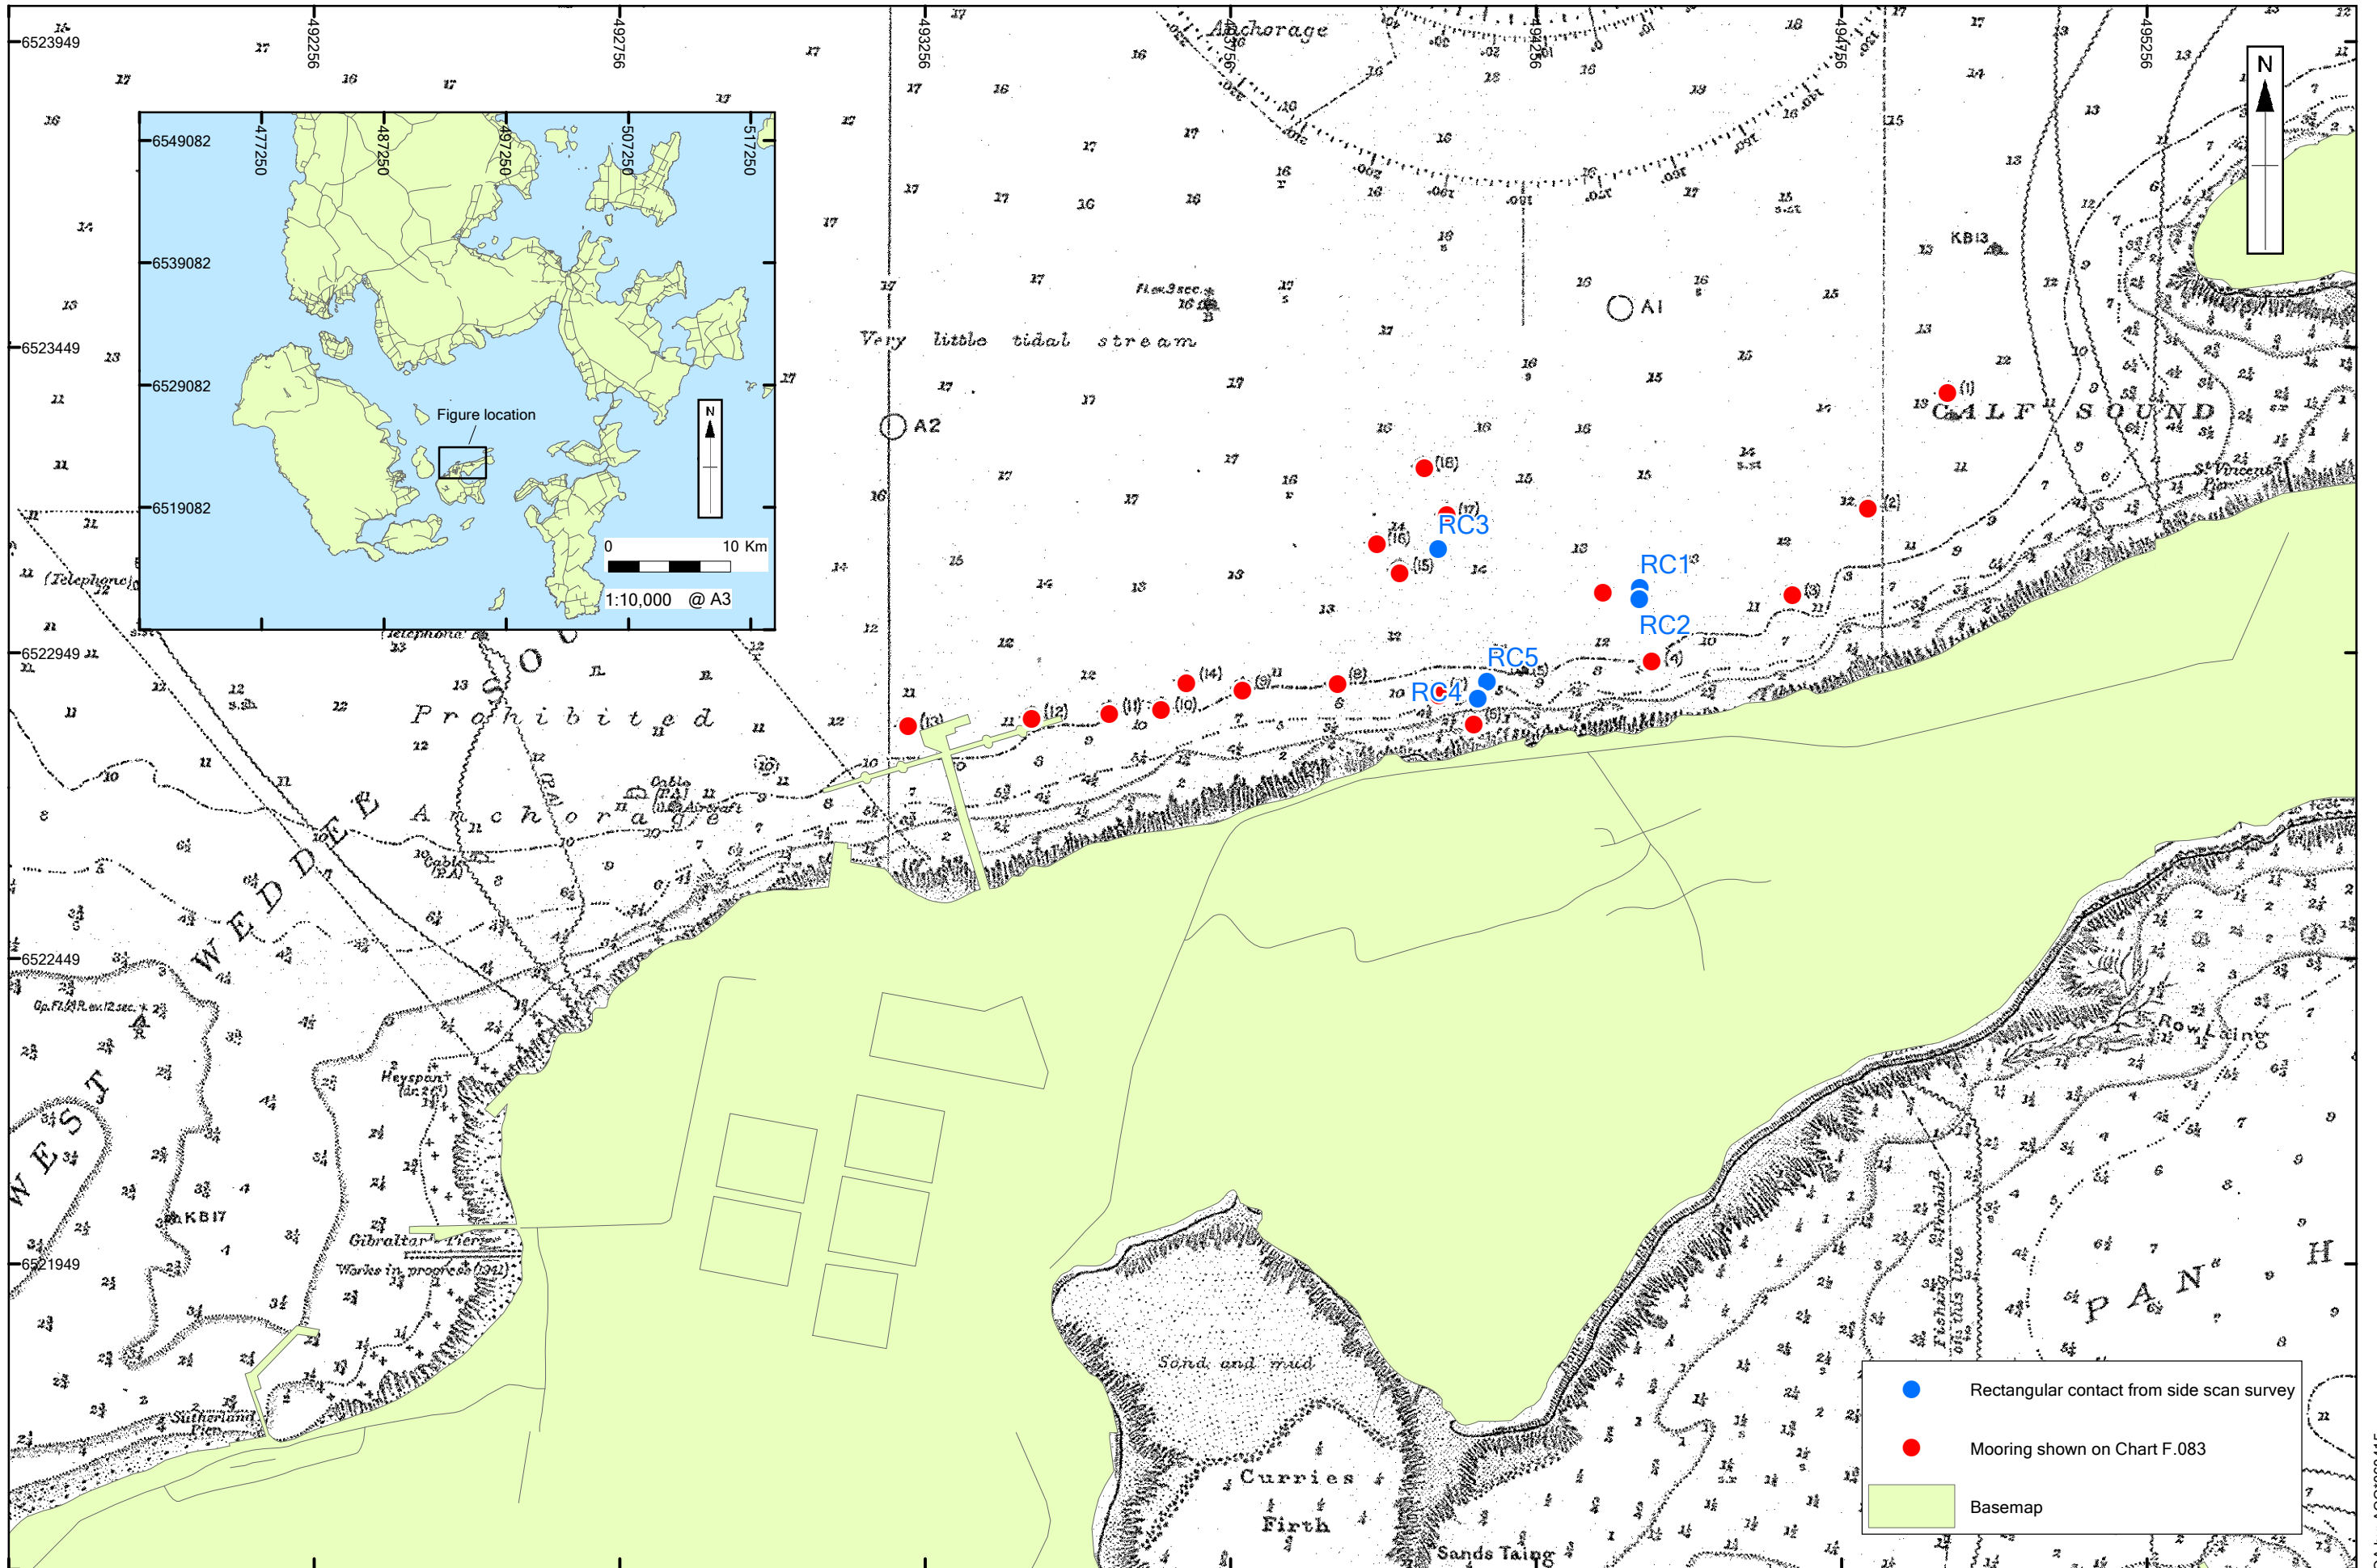
Figure 3: Distribution of rectangular contacts in relation to moorings detailed on historic chart

The depth of netting beneath the vessel also restricted the docking of the pontoons alongside harbour facilities, suggesting that they would have been stored on nearshore moorings. Historic charts of the area to the north of Flotta show the positions of eighteen mooring buoys close to shore but in sufficient water depth to facilitate the storage of these vessels with their associated netting. Post processing of the side scan sonar data show that the target site (RC1 and RC2) and the second pair of rectangular contacts (RC4 and RC5) are situated close to specific moorings indicated on the historic chart. This could support the interpretation that these moorings were used to store the pontoons when not deployed (**Figure 3**).
