HISTORIC
ENVIRONMENT
SCOTLAND

High Seas Fleet Salvage Sites Report

4th April 2017

Authors: Henry, Sandra; Heath, Kevin and Littlewood, Mark

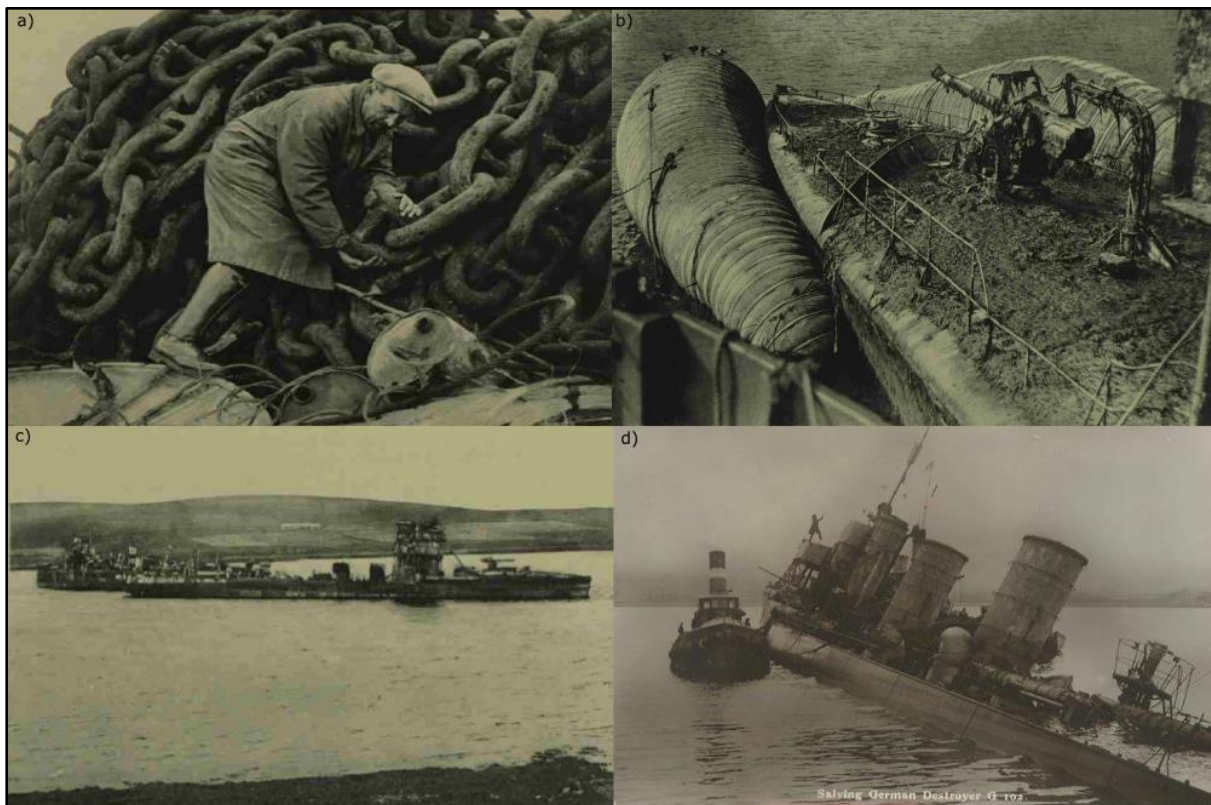
Plate 1 a) The chain that snapped in the first lifting attempt on V70 in July 1924 (Illustrated London News) b) Salvage operations on S131 by ScapaFlow Salvage & Shipbreaking Company (Illustrated London News) c) Salvaged destroyer lying in Cox & Danks 'boneyard' at Mill Bay, Hoy (Illustrated London News) d) Postcard showing salvage operations on G102 by Cox & Danks (courtesy Kevin Heath)

however it failed due to the lifting equipment used ([Plate 1](#)). Nine-inch wires were obtained for future operations. She was successfully lifted on August 9th 1924, and beached at Mill Bay before being towed to Lyness. After lifting, Cox discovered pirate divers had stripped her of her gunmetal torpedo tubes, and all else that could be lifted (George, 1973). She was pumped dry and made watertight, renamed Salvage Unit 3, and function as a floating workshop. She was broken up in 1929 at Scapa (Gröner, 1982). Cox went on to successfully raise twenty-five destroyers in total, often re-using the raised vessels for multiple purposes throughout his salvage operations.

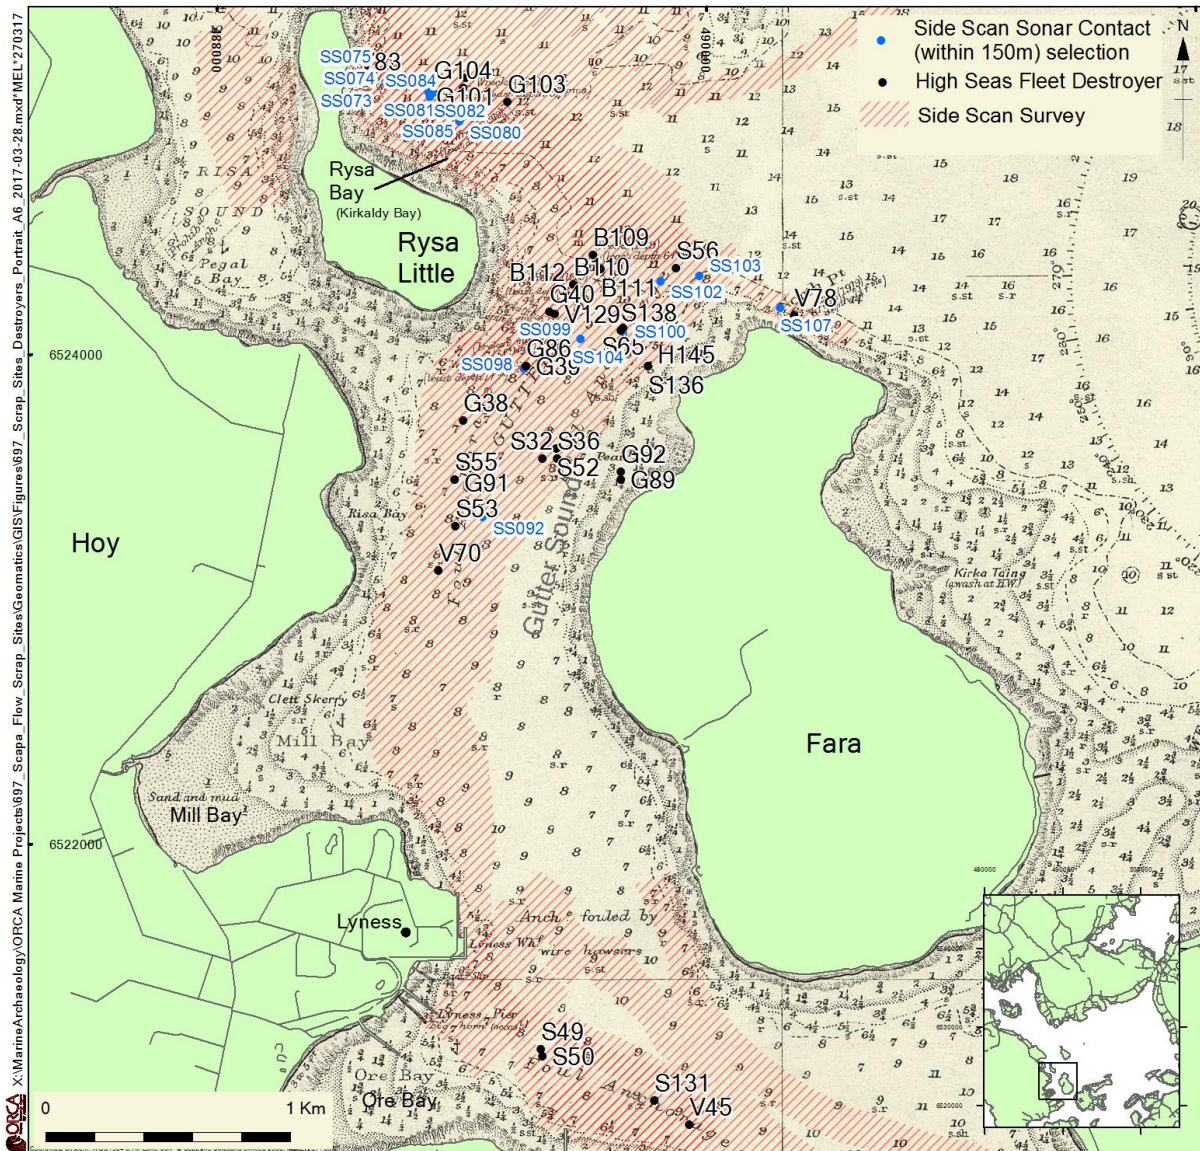
The destroyers were predominantly anchored in Gutter Sound: the 1923 UKHO charts detail the position of the scuttled destroyers. This area was surveyed using side scan sonar survey, and geophysical anomalies were identified ([Figure 2](#)). There were sixteen anomalies identified in the destroyer survey area (see Appendix 1) within 150m of a known destroyer anchorage or scuttled location ([Figure 2](#)). The ground-truthing of contacts located at Rysa Little established that SS080 and SS085 are not materials associated with the destroyer salvage operations. The ground-truthing of the other contacts, potentially associated with destroyer remains, were out with the remit of this phase of work. The majority of destroyers were lifted upright with little or no removal of structural elements of the vessel, therefore only a few features of these salvaged ships are expected to exist on the seabed apart from such items as anchors. The greatest extent of submerged remains of the German High Seas Fleet destroyers are represented in Scapa Flow by wrecks such as *B109*, *S54* and *V83*, along with examples of the re-use of destroyers such as at the site of SMS *Hindenburg*, SMS *Seydlitz* or *S36* (see Appendix 2).

Figure 2 Side Scan Sonar Survey covering area of destroyer wreck sites or anchorages, all anomalies within 150m of a destroyer location are shown on the map.

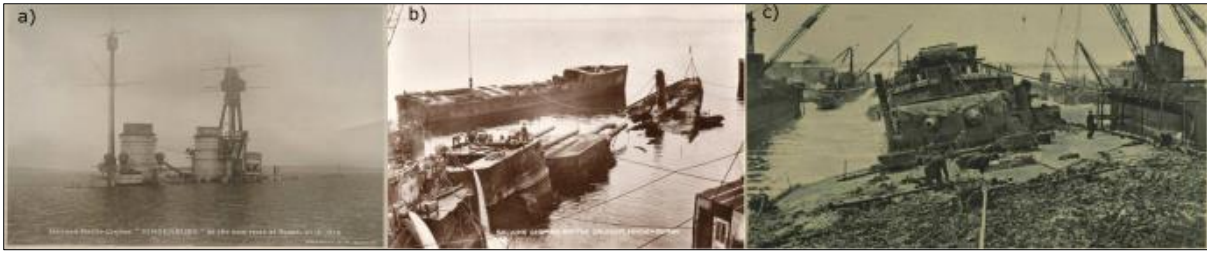
Plate 2 a) Postcard of the iconic image of the Hindenburg superstructure protruding above the water of Scapa Flow after the scuttling (courtesy Kevin Heath) b) Postcard of ongoing salvage operations on Hindenburg, destroyer in use as a barge visible in background (courtesy Kevin Heath) c) Image of workers clearing marine growth from the successfully salvaged Hindenburg (Illustrated London News)

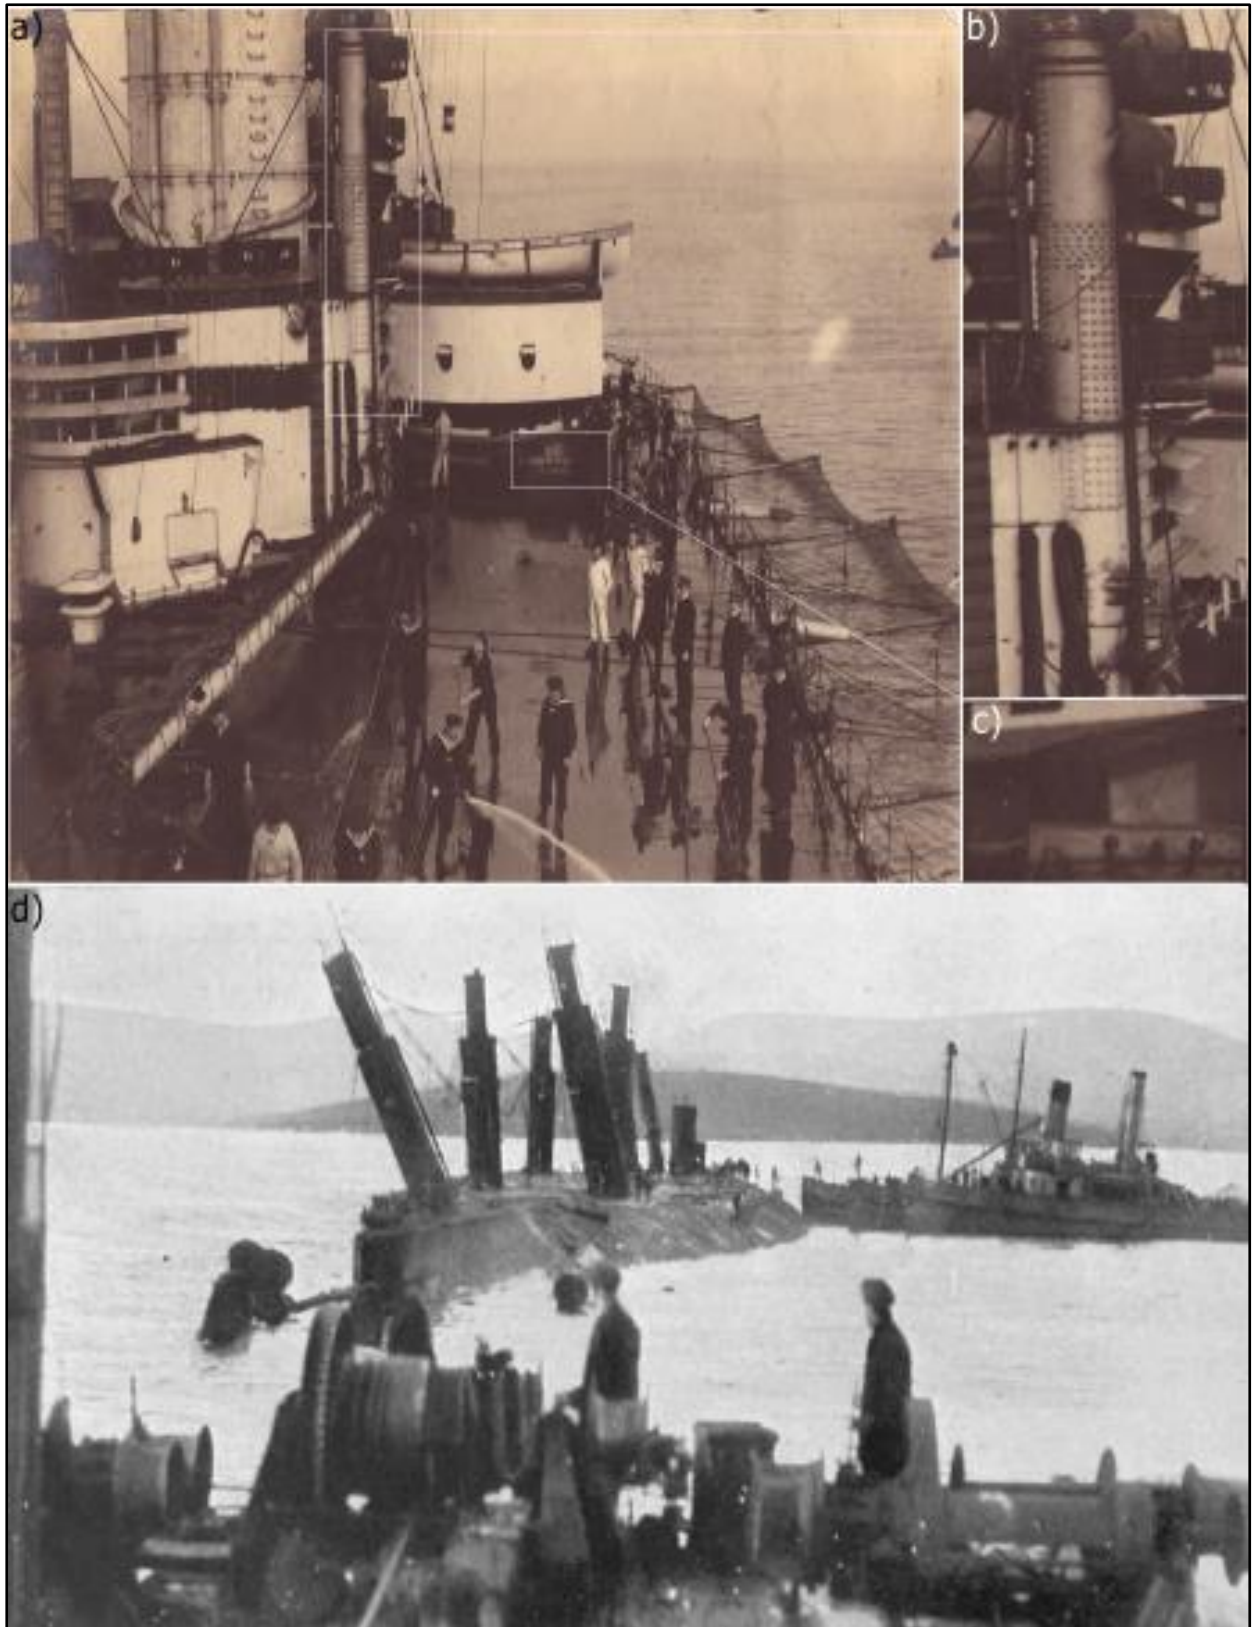
Plate 5 a) Von der Tann (courtesy Gary Staff) b) Riveted samson post c) rectangular storage boxes for sub calibre barrel liners under the gun turrets on Von der Tann d) Von der Tann after lifting, salvage vessel visible in the background (The Sphere 20th December 1930)

fitted each side of the upper deck on *Von der Tann* ([Plate 6](#)) (Friedman, 1992). The two rectangular boxes on this site are containers for sub calibre barrel liners; these were used for training to prevent wear on the gun barrels by firing a smaller round. Heavy wear on the ship's main armament when firing means that after approximately 150 rounds the gun liner needs replacement. This big operation involves returning the gun to the manufacturer. The use of these sub calibre gun liners would have been both time saving and cost effective. The rectangular containers had hatches at each end to facilitate cleaning of the barrel without removing it from the box. The two holes in the back of the gun turret were used to insert the sub calibre tubes. The holes line up exactly with the 28 cm gun barrels inside the turret. This type of rectangular sub calibre storage box is rare, and largely unknown as most were cylindrical in shape ([Plate 5a; 5c](#)) (*per com* Marsden Samuel).

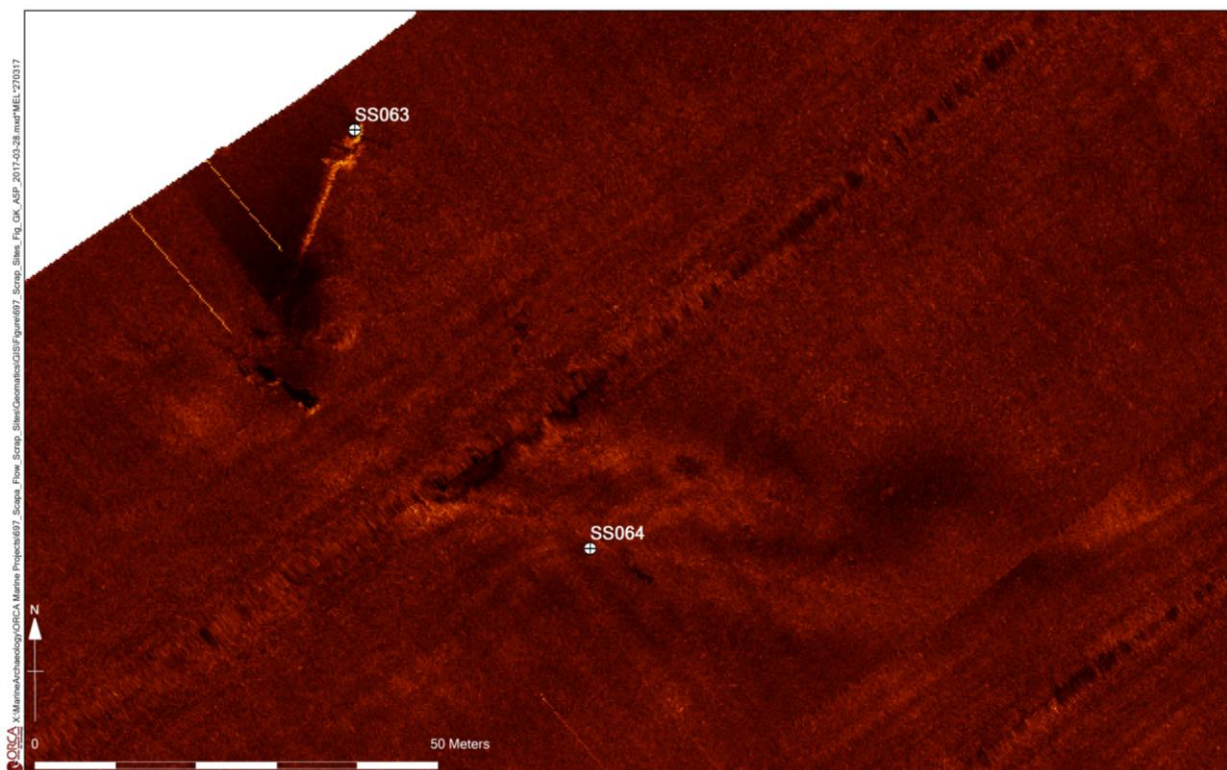
The side scan sonar survey of *Grosser Kurfürst* collected medium frequency data (325KHz) and focused high frequency data (780kHz). This provided an overview of the final scuttled location and salvage area of the battleship. Anomalies SS063 & SS064 (see Appendix 1) were identified as associated with the salvage operations on the *Grosser Kurfürst* at her primary site.

Figure 5 Primary site of the *Grosser Kurfürst* where she sat on the seabed in Scapa Flow until she was lifted by Metal Industries Ltd.

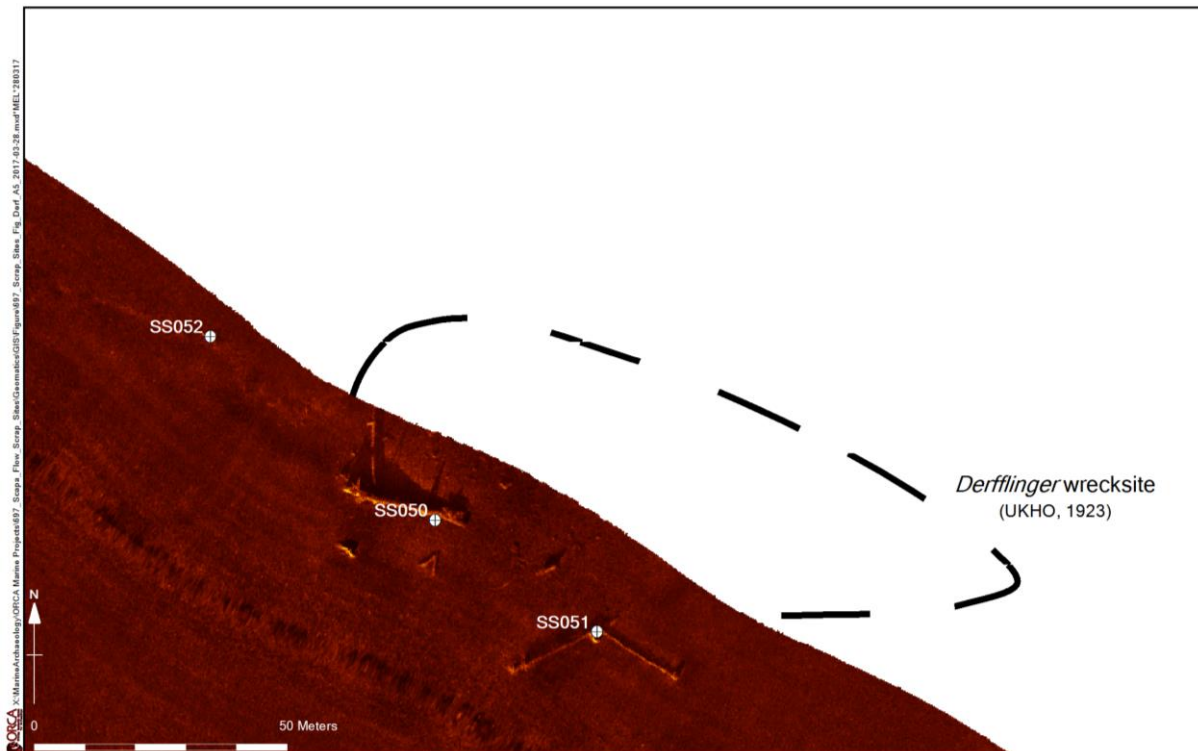
The side scan sonar survey of *Derfflinger* collected medium frequency data (325KHz) and focused high frequency data (780kHz). This provided an overview of the final scuttled location and salvage areas of the battleship. Anomalies SS050, SS051 & SS052 (see Appendix 1) were identified as associated with the salvage operations on the *Derfflinger* at her primary site.

Swannay (1996) describes the site as consisting of two pinnacle diesel engines, masts, spotting tops, searchlights and deep scour. These anomalies were not dived during this phase of work. The sonar survey at Rysa Little identified a number of anomalies that may represent remains of the *Derfflinger* at her secondary site (see [Rysa Little Secondary Sites](#)).

Figure 6 Primary site of the *Derfflinger*

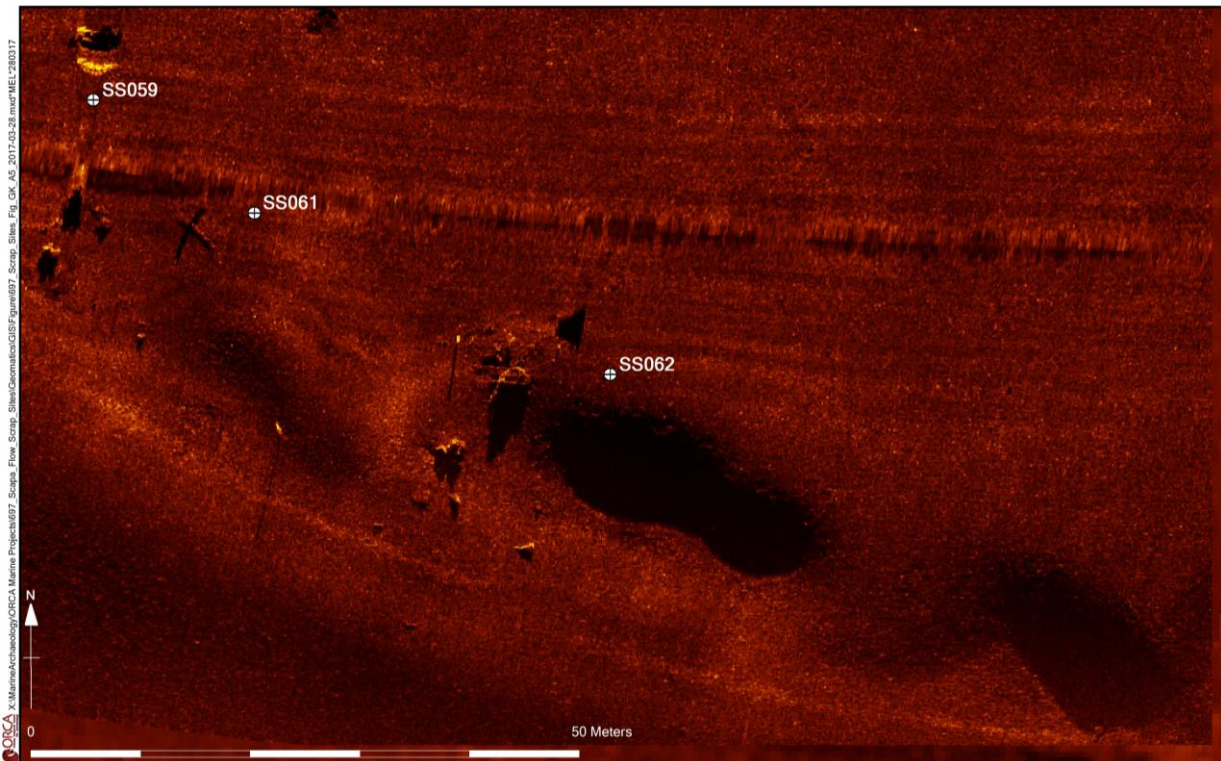
The side scan sonar survey of *Friedrich der Grosse* collected medium frequency data (325KHz) and focused high frequency data (780kHz). This provided an overview of the final scuttled location and salvage areas of the battleship. Anomalies SS059, SS060, SS061 & SS062 (ref. Appendix 1) were identified as associated with the salvage operations on the *Friedrich der Grosse* at her primary site. These anomalies were not dived during this phase of work.

Swannay (1996) describes the site as being scoured out, consisting of a pinnacle, mast and searchlights. The sonar survey at Rysa Little identified a number of anomalies that may represent remains of the *Friedrich der Grosse* at her secondary site. Smith (1989) states that the bell of *Friedrich der Grosse* was recovered from one of the scrap sites at Rysa Little in 1984 by the Golden Lion Sub Aqua Club of Wrexham. The bell is now in Stromness museum.

Figure 7 Primary site of *Friedrich der Grosse*

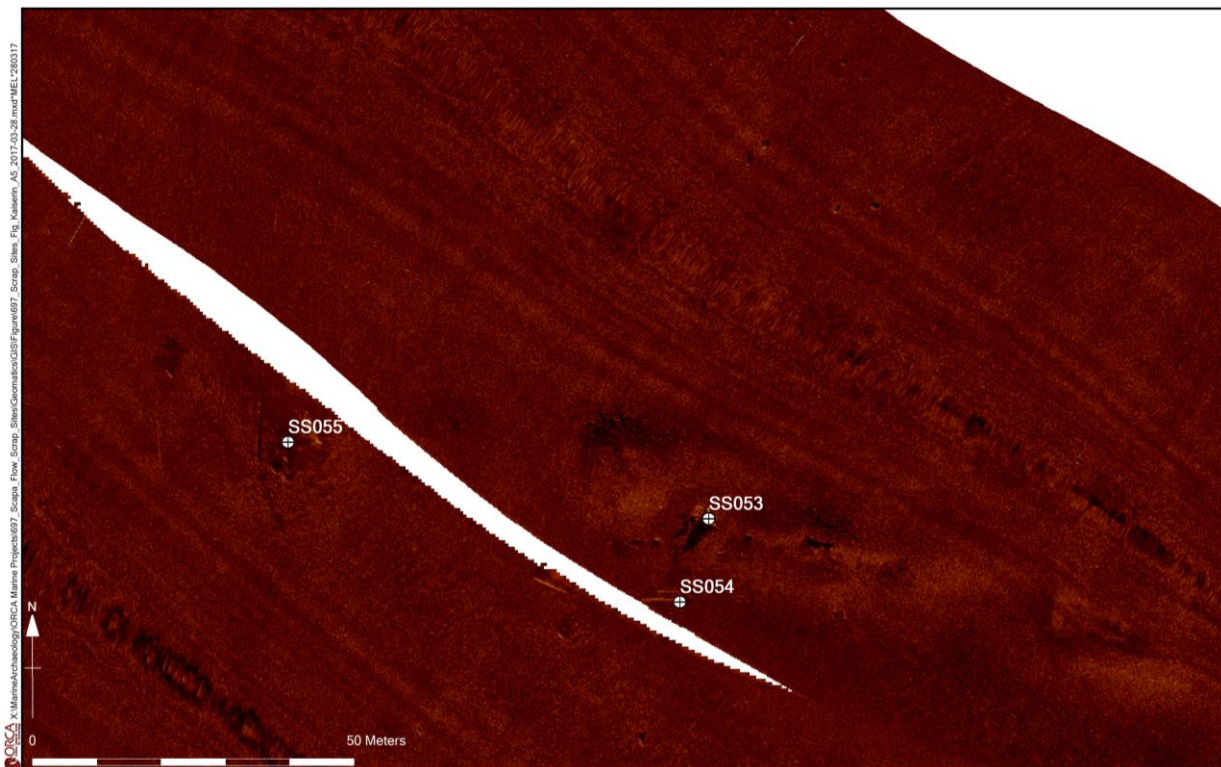
The side scan sonar survey of *Kaiserin* collected medium frequency data (325KHz) and focused high frequency data (780kHz). This provided an overview of the final scuttled location and salvage areas of the battleship. Anomalies SS053, SS054 & SS055 (see Appendix 1) were identified as associated with the salvage operations on the *Kaiserin* at her primary site. These anomalies were not dived during this phase of work. Swannay (1996) describes the site as a double scour with pinnacle and masts. The sonar survey at Rysa Little identified a number of

Figure 8 Primary Site of the *Kaiserin*

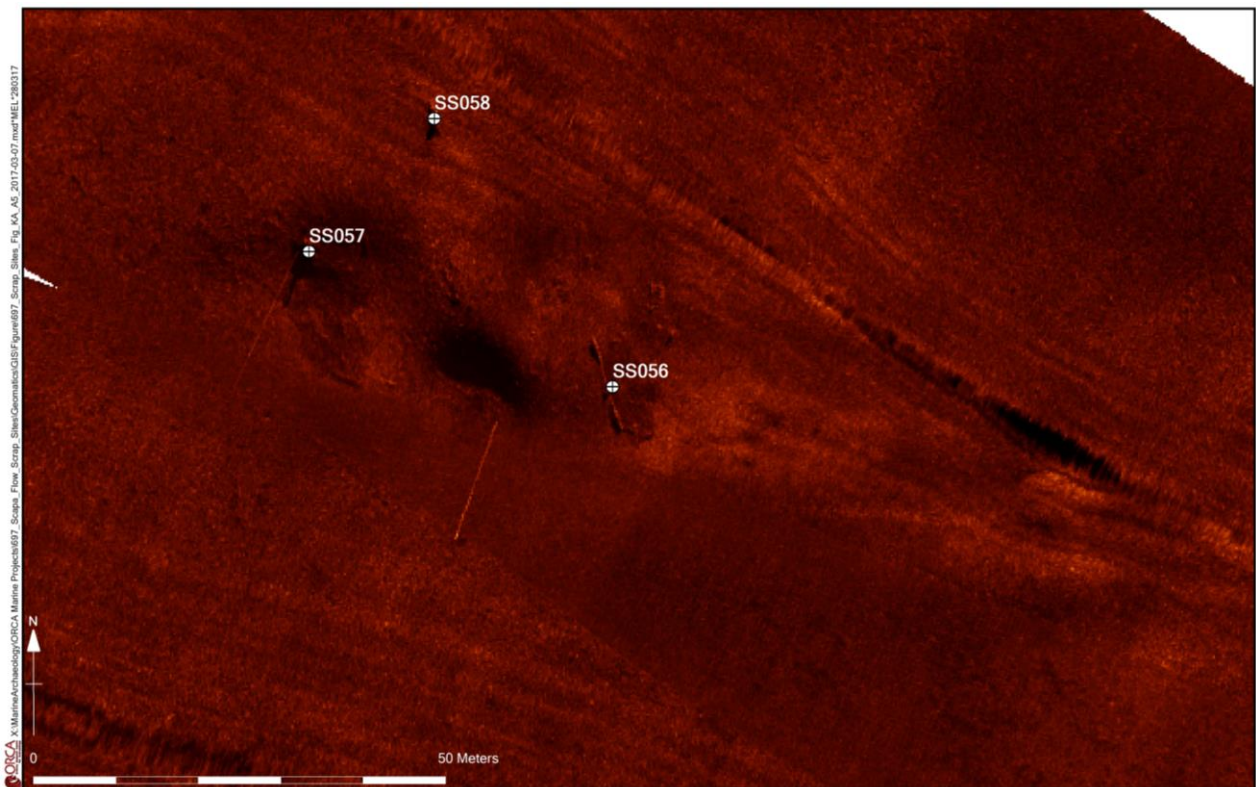
The side scan sonar survey of *König Albert* collected medium frequency data (325KHz) and focused high frequency data (780kHz). This provided an overview of the final scuttled location and salvage areas of the battleship. Anomalies SS056, SS057 & SS058 (see Appendix 1) were identified as associated with the salvage operations on the *König Albert* at her primary site. These anomalies were not dived during this phase of work. Swannay (1996) describes the site as a pinnacle, steam engine and main mast. The sonar survey at Rysa Little identified a number of anomalies that may represent remains of the *König Albert* at her secondary site (see [Rysa Little Secondary Sites](#)).

Figure 9 Primary site of König Albert

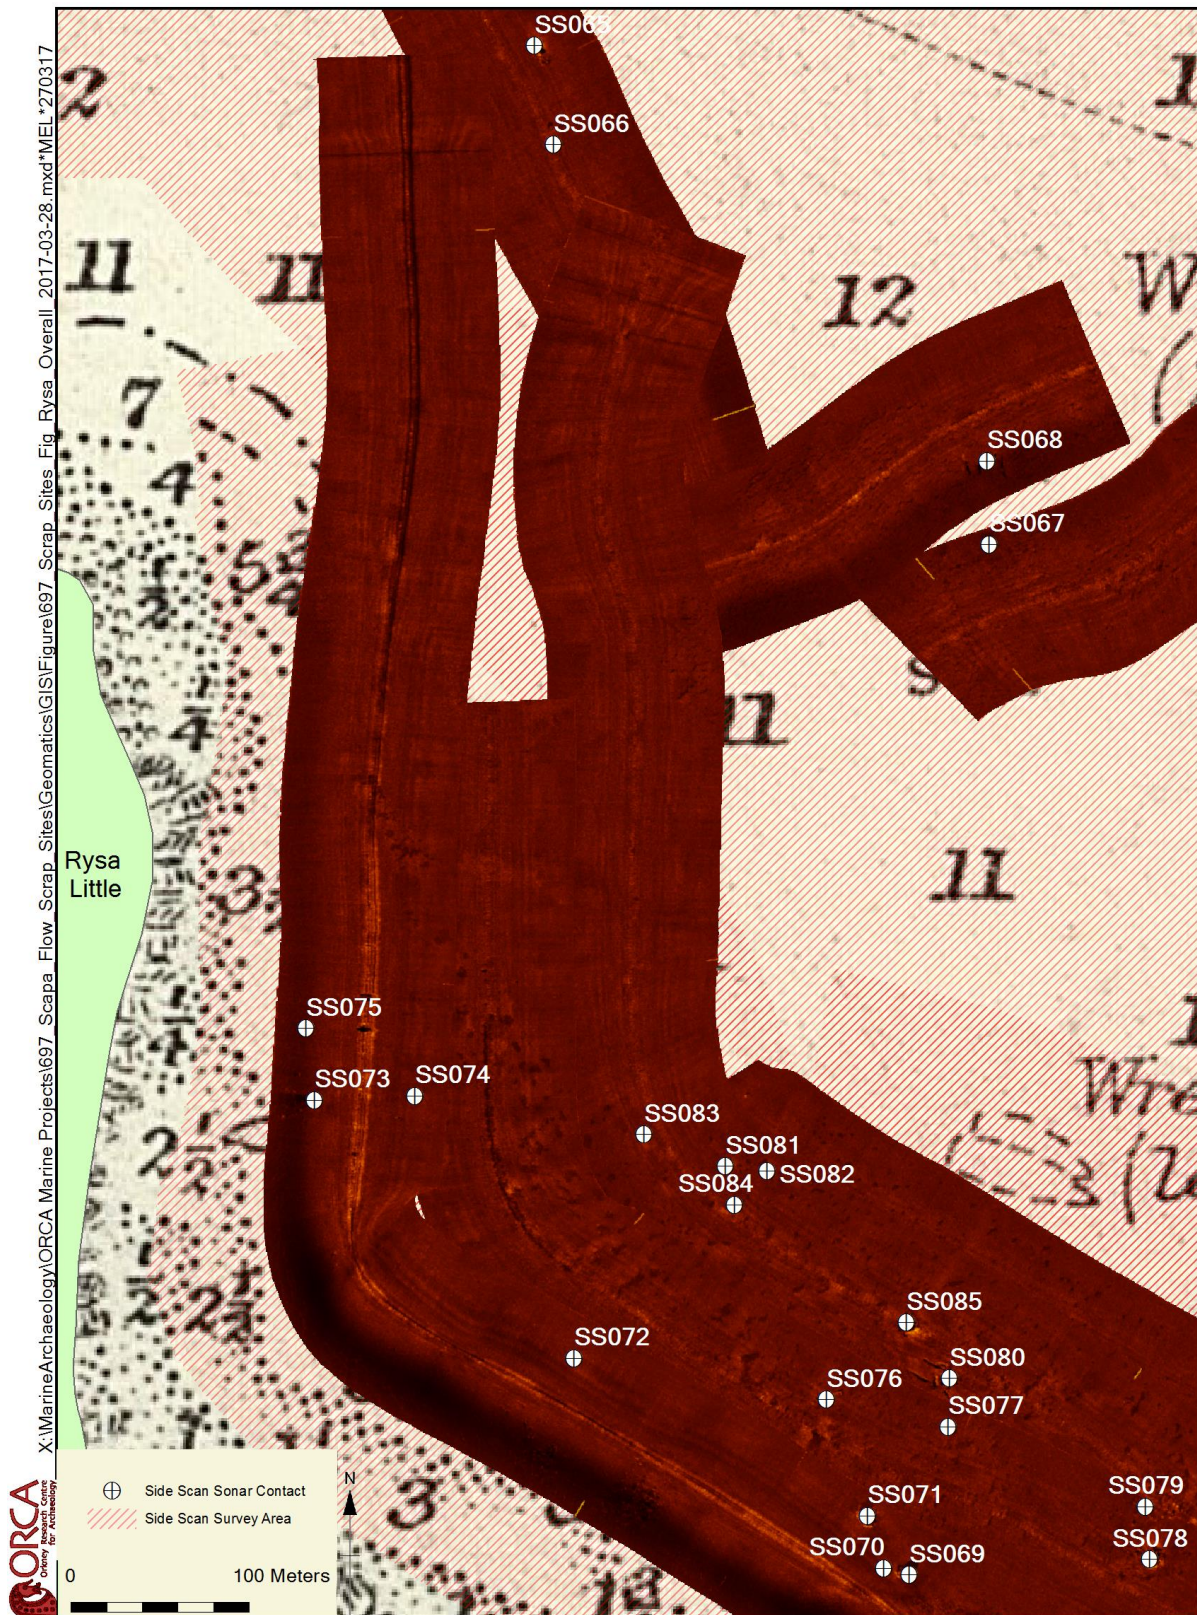
The side scan sonar survey of Rysa collected medium frequency data (325kHz) and focused high frequency data (780kHz). This provided an overview of the area. Anomalies SS065, SS066, SS067, SS068, SS069, SS070, SS071, SS072, SS073, SS074, SS075, SS076, SS077, SS078, SS079, SS080, SS081, SS082, SS083, SS084 and SS085 (ref. Appendix 1) were identified in the area of the salvage operations at Rysa.

Figure 10 Side Scan Sonar image of anomalies located at Rysa Little
