ROINEACH MHOR, GLEN CLOVA, ANGUS

Historic Building Recording

For KDM Architects on behalf of Mr Hugh Niven

15/00494/FULL

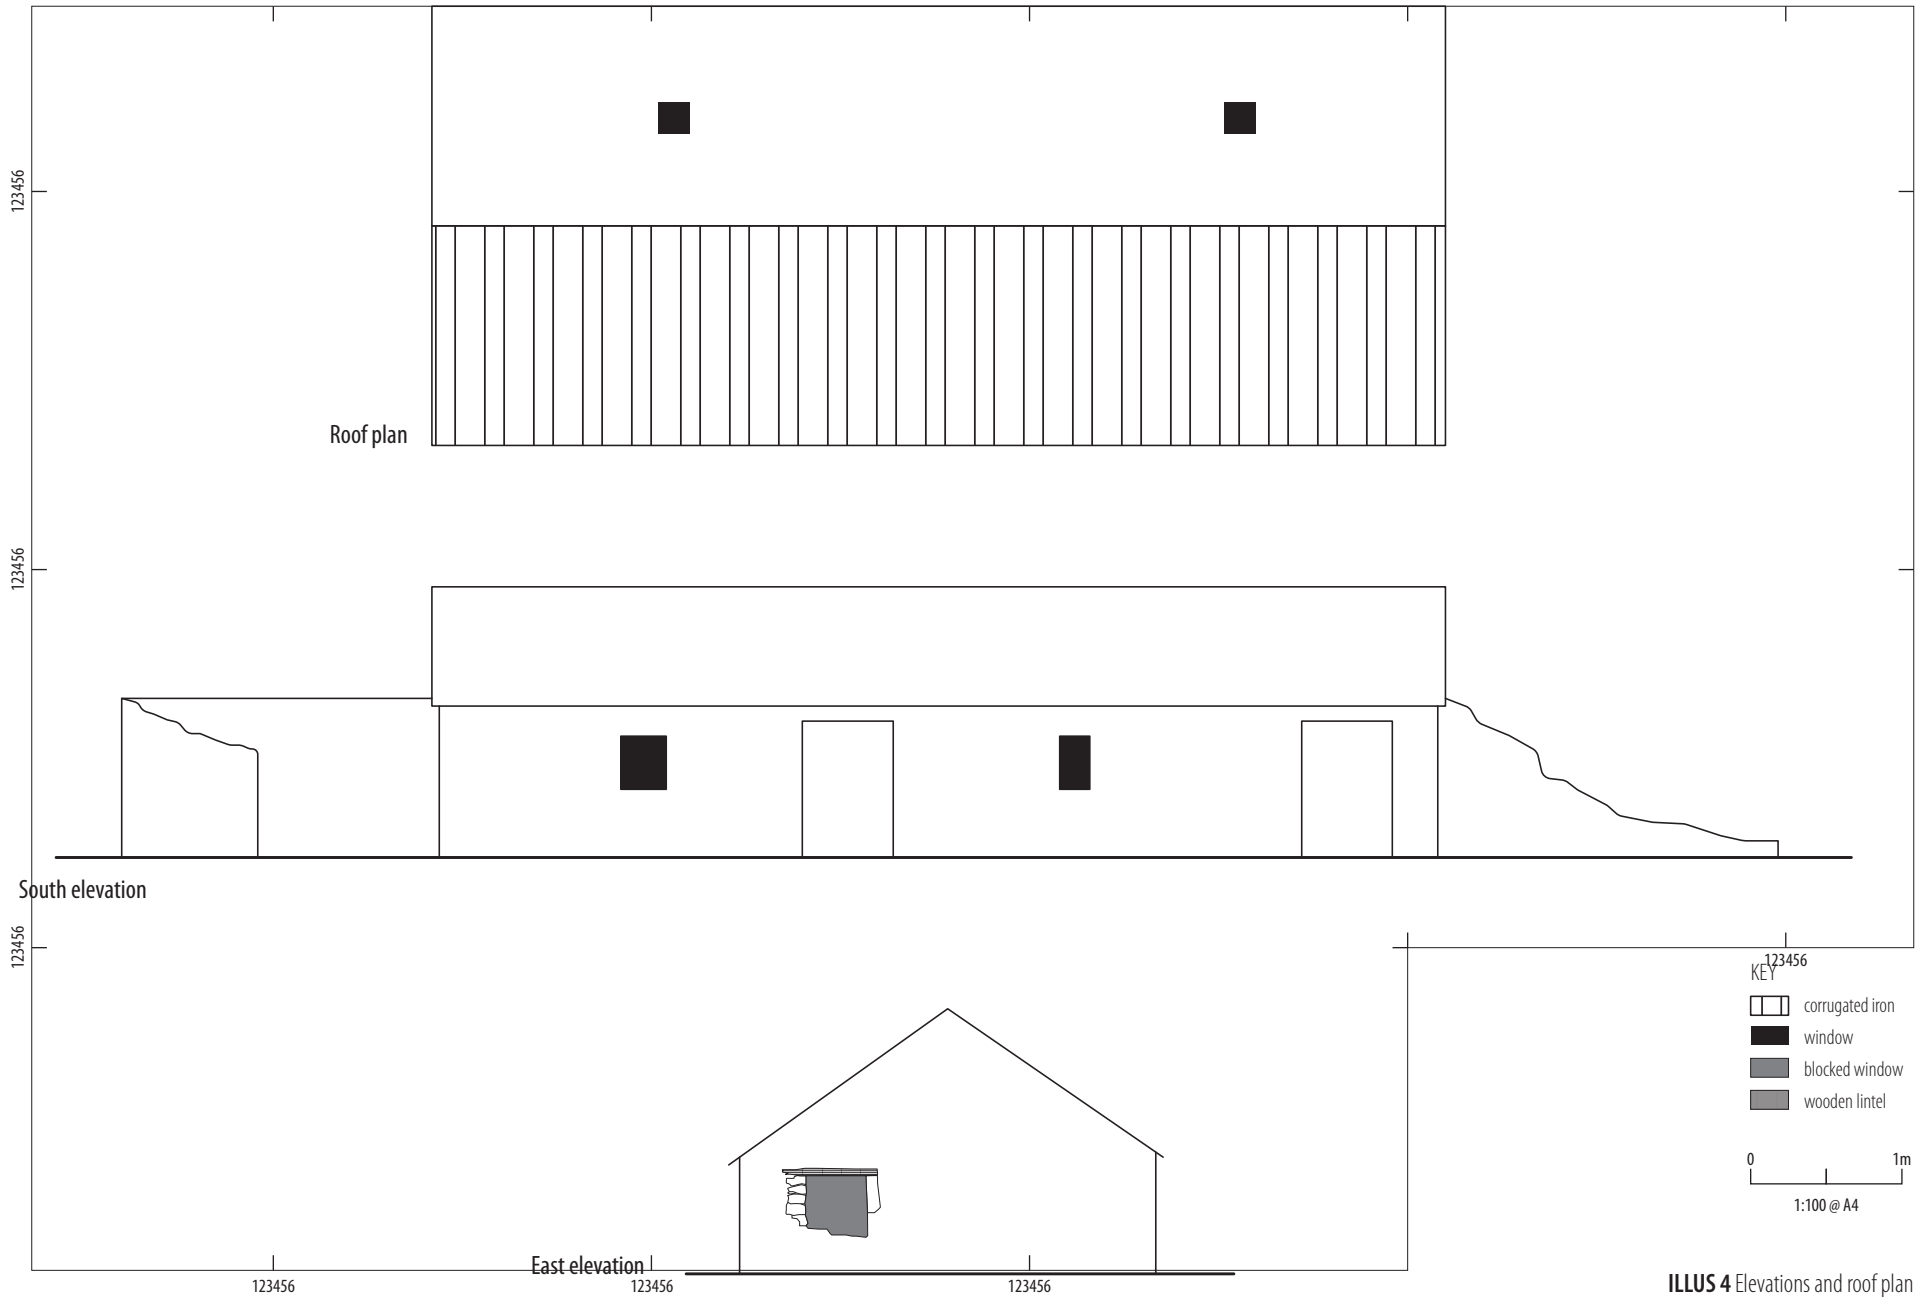
ILLUS 4 Elevations and roof plan

The roof exhibited evidence of repair, as shown by the different materials on the north and south-facing aspects. The north side was roofed with slates, which appeared to be original. Two unglazed openings were present on the northern side measuring c0.4m by 0.4m, located mid-way up the roof, approximately 3m from the west and 2.5m from the east. The underside of the tiles was clad

with stone. The east and west elevations showed the north side of the roof was repaired with cement infill, possibly a patch repair in the eaves. The south-facing roof was clad with corrugated iron panelling, trimmed with lead flashing. On the east and west elevations, wooden planks used as flashing were visible and followed the pitch of the roof. Rounded ridge tiles were present along the apex.

The repair to roof material may have represented the fourth phase, with the replacement of slate tiles for corrugated iron panels on the south facing roof pitch. Although no evidence for roof collapse was evident, it is likely that damage to the roof on this side had necessitated replacement and repair.
