Scapa Flow Orkney

Scapa Flow 2013 Marine Archaeology Survey Final Report

March 2014

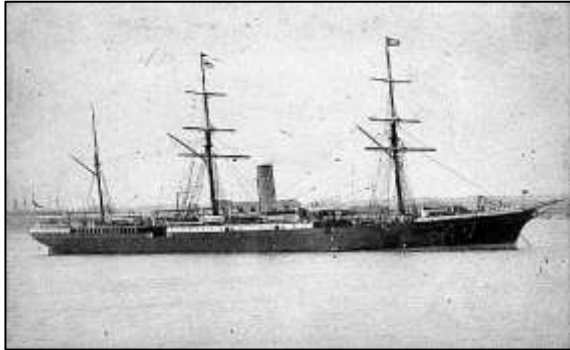
Although historic photos of the SS Aorangi as a blockship only show two masts (**Plate 7**) visible, earlier images confirm that the vessel originally had three masts (**Plate 8**). This suggests that the aft mast fell over before or while the ship was used as a blockship.

PLATE 7: HISTORIC IMAGE OF AORANGI BEFORE THE VESSEL WAS SCUTTLED AS A BLOCKSHIP SHOWING THE PRESENCE OF 3 MASTS

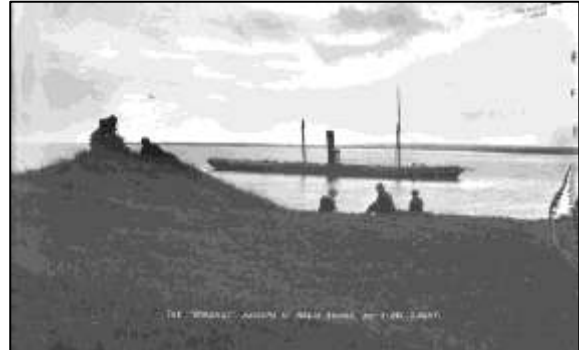
PLATE 8: HISTORIC IMAGE OF AORANGI AS A BLOCKSHIP WITH ONLY TWO MASTS IN SITU (COPYRIGHT ORKNEY LIBRARY AND ARCHIVE – TK263)

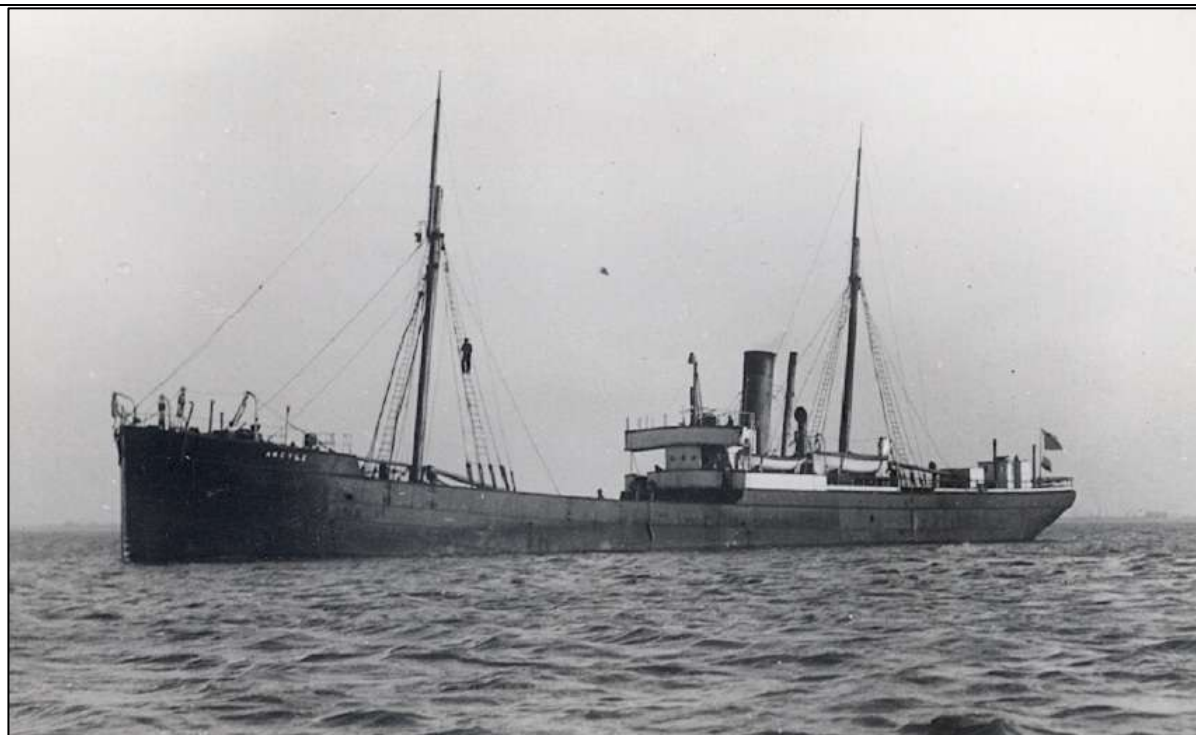
Historical documents and images confirm that these are the remains of the SS Argyle - note the corrected spelling (**Plate 11**).

PLATE 11: HISTORIC PHOTOGRAPH SHOWING THE ARGYLE WITH CORRECTED SPELLING (ARGYLE NOT ARGYLL AS RECORDED IN OTHER SOURCES) (COPYRIGHT KEVIN HEATH COLLECTION)

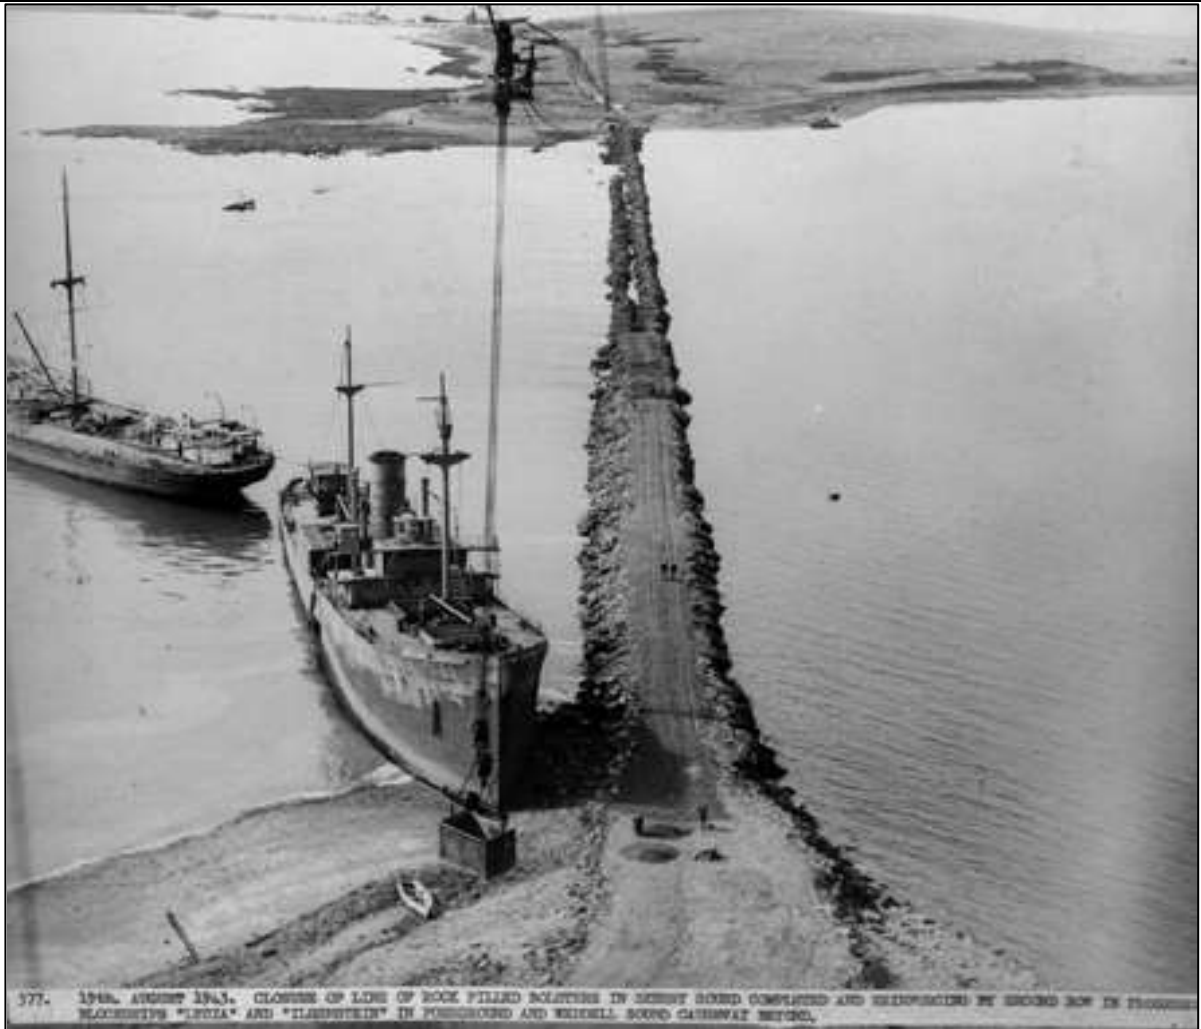
This wreckage is known to come from the MV Lycia. The only diesel blockship sunk in Skerry Sound, the remains are from a diesel vessel. This is further confirmed by historical documents and images which record how the vessel broke down (**Plate 13**).

PLATE 13: HISTORIC PHOTOGRAPH OF LYCIA AS A BLOCKSHIP (COPYRIGHT ORKNEY LIBRARY AND ARCHIVE L1618-4)

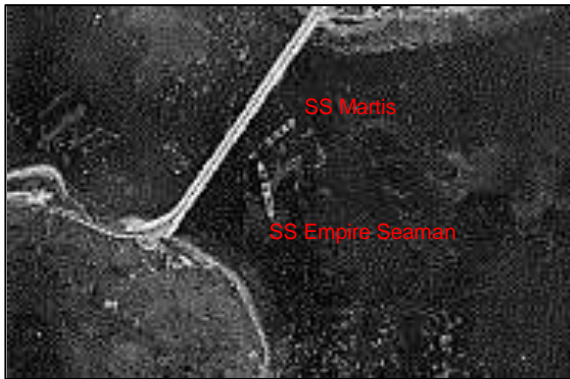
Historical documents and image confirm that these are the remains of the SS Martis (**Plate 14**). The bow, stern and superstructure were salvaged by Metal Industries in the 1940s (Wood 2008: 123).

PLATE 14: HISTORIC PHOTOGRAPH OF MARTIS AND EMPIRE SEAMAN AS BLOCKSHIPS (COPYRIGHT ORKNEY LIBRARY AND ARCHIVE - L1248-1)

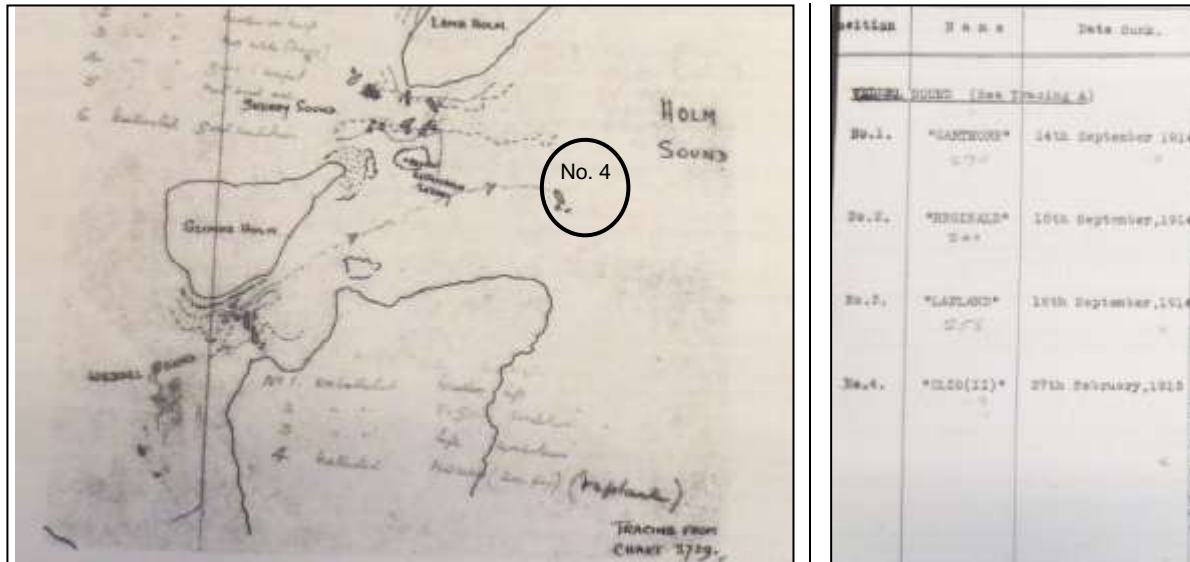
The vessel labelled Clio (II) is only noted on the ADM drawing of the blockships in the positions they were sunk (**Plate 15**). It was never added to the chart and subsequently disappears from the record.

PLATE 15: SKETCH MAP SHOWING LOCATIONS OF BLOCKSHIPS AS THEY WERE SUNK (ADM 1-8428-216). CLIO II IS INDICATED IN POSITION CIRCLED.

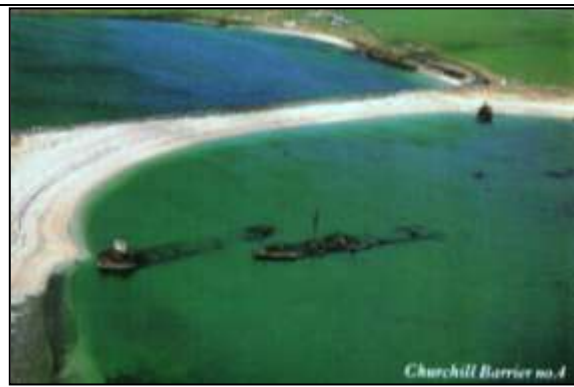
CHURCHILL BARRIER 4				
<p>Historical photographs and maps demonstrate that all the blockships positioned at Churchill Barrier 4 are covered in sand. The only vessel still exposed above the sand is the top of the bridge of the SS Collindoc (Plate 16), which is several hundred metres inland. This coverage is the result of coastal accretion exacerbated by the construction of the Churchill Barriers. Historical photographs show the remains before the sedimentation documenting the extent of the coverage (Plate 17). These remains were not surveyed as part of the project.</p>

PLATE 17: HISTORIC POSTCARD OF THE COLLINDOC AND OTHER CHURCHILL BARRIER 4 BLOCKSHIPS (COPYRIGHT CHARLES TAIT).

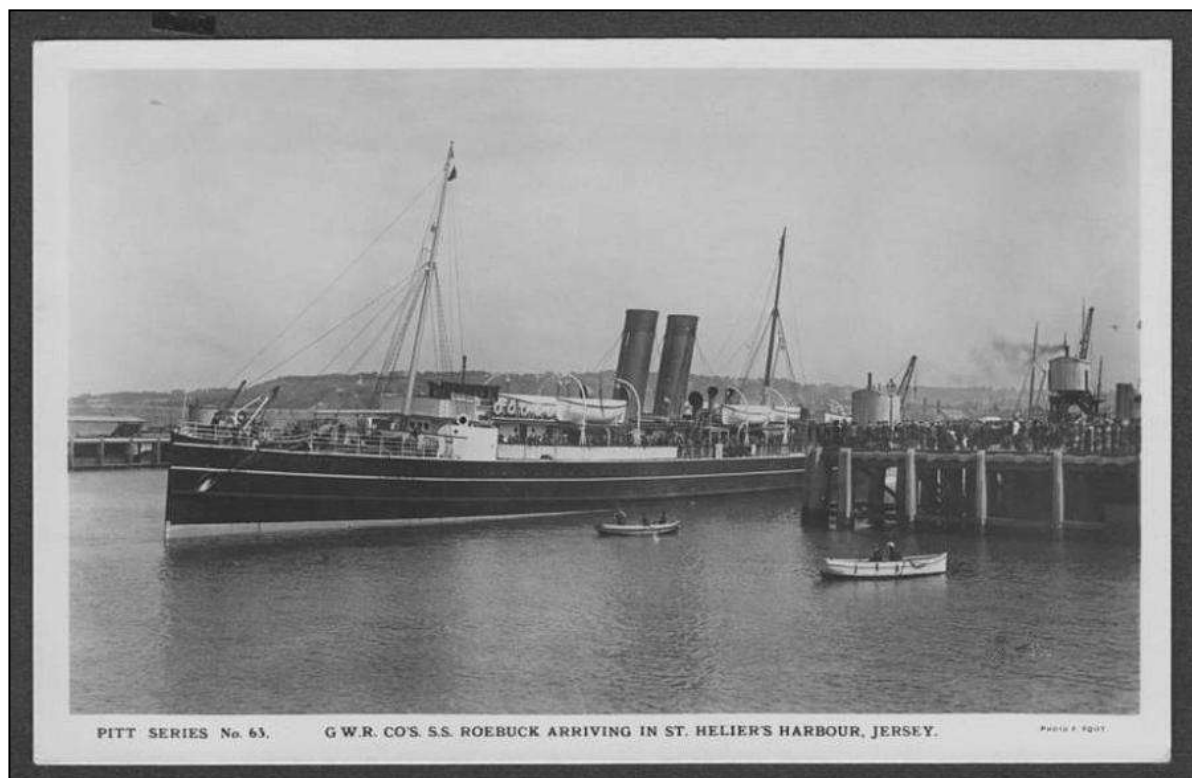
Historical documents and photographs (**Plate 18**) examined in conjunction with the UKHO record confirm that these are the remains of the HMS Roedean. The site is marked with a buoy and is occasionally visited by recreational divers.

PLATE 18: HISTORIC POSTCARD OF HMS ROEDEAN AS ROEBUCK II (KEVIN HEATH COLLECTION)

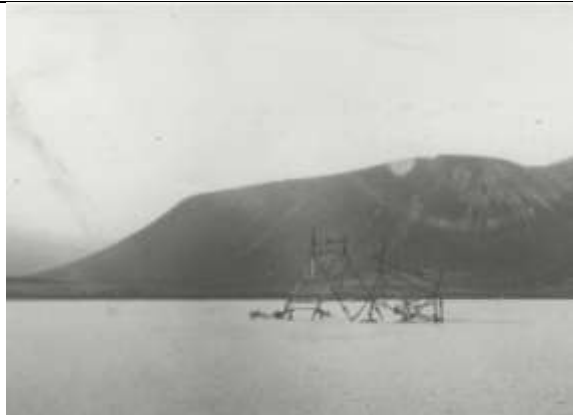
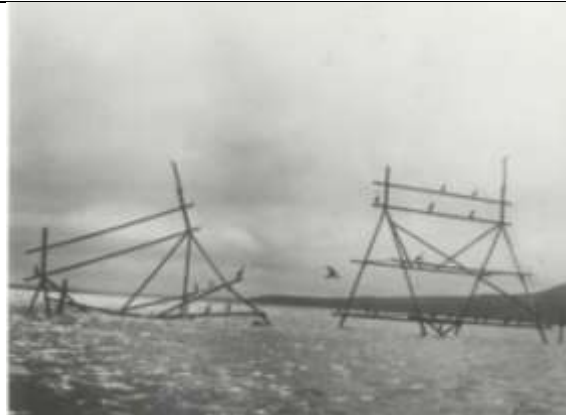
The remains of railway lines, known to have come from hurdles based on photographic evidence (**Plate 21**) were seen by scallop divers in Burra Sound. Reports indicate that these are now completely flat with remains standing flush with seabed with some of the sections part buried in sand. The remains lie in 4m water,

PLATE 21: HISTORIC PHOTOGRAPHS OF HURDLES IN BURRA SOUND

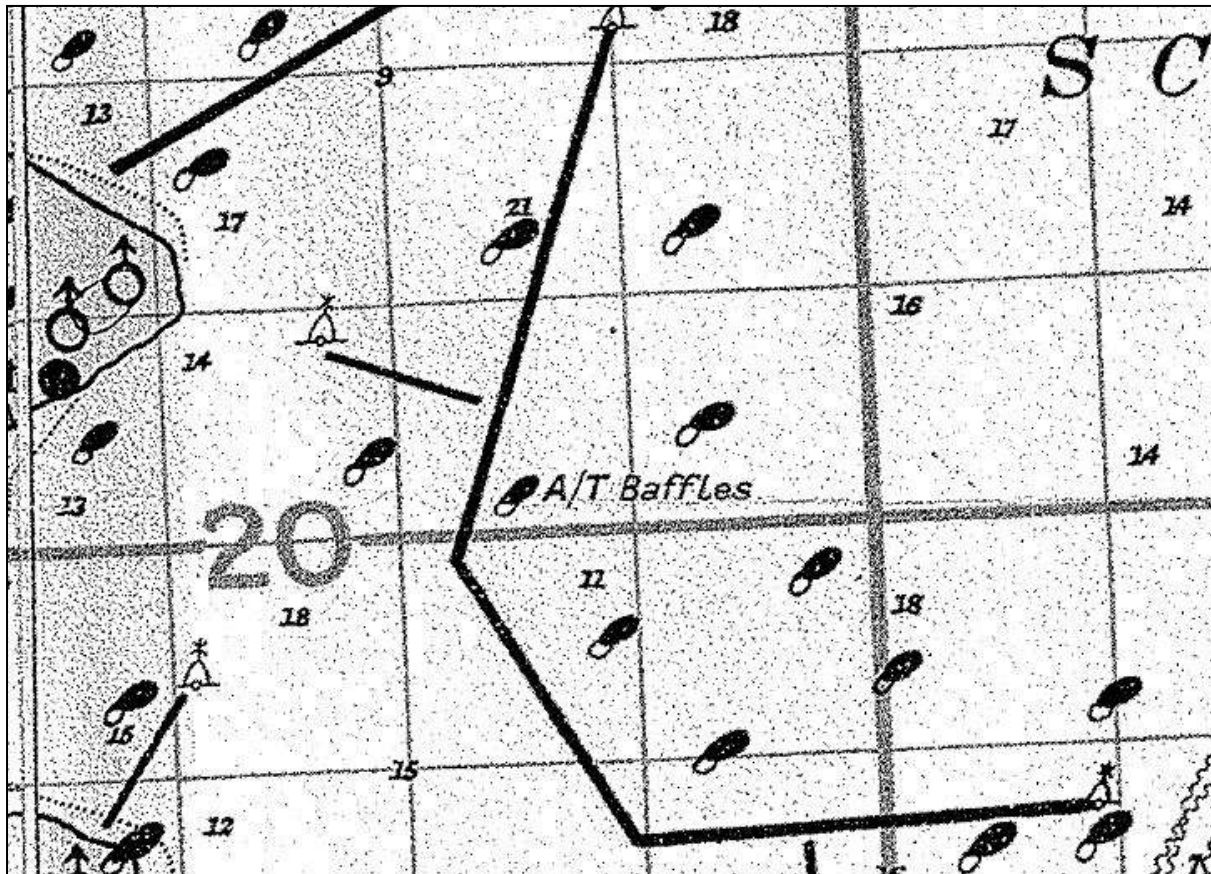
Surveys were requested at several sites east of Cava and north of Flotta charted as either wrecks or foul ground. Historical maps of Scapa Flow indicate that boom defences were deployed in this area during World War II (**Plate 22**). These are not from the WWI as boom nets were not a popular choice of defence at that time.

PLATE 22: HISTORIC CHARTS OF SCAPA FLOW SHOWING LOCATIONS OF BOOM DEFENCES EAST OF CAVA AND NORTH OF FLOTTA. BLACK LINES REPRESENT BOOM NETS.
