Investigation of an uncharted wreck located in Scapa Flow, Orkney.

Final Report

Submitted to: Historic Environment Scotland
- Philip Robertson

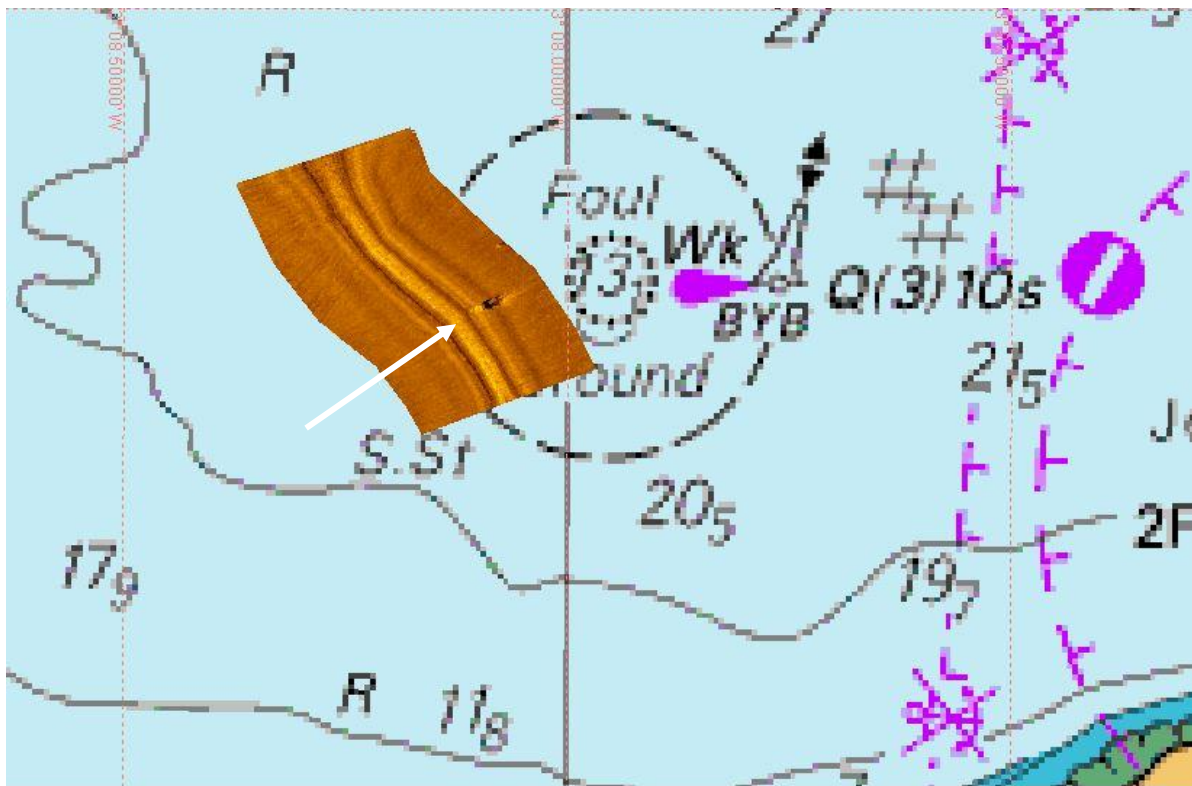
A side scan survey was carried out on the 18th June 2016, prior to the dive survey. The location of the site and the side scan survey coverage is shown in Figure 1. The sonar image is shown in Figure 2 and illustrated what appeared to be wreckage on the seabed of approximately 30m in length by 10m wide and standing approximately 4m off the seabed. No distinctive features could be distinguished in the sonar image.

Figure 1: The side scan survey coverage showing the position of the wreck (white arrow) relative to that of the SS Prudentia (marked above as "Wk"). The coastline of Flotta is just shown to the south-east.

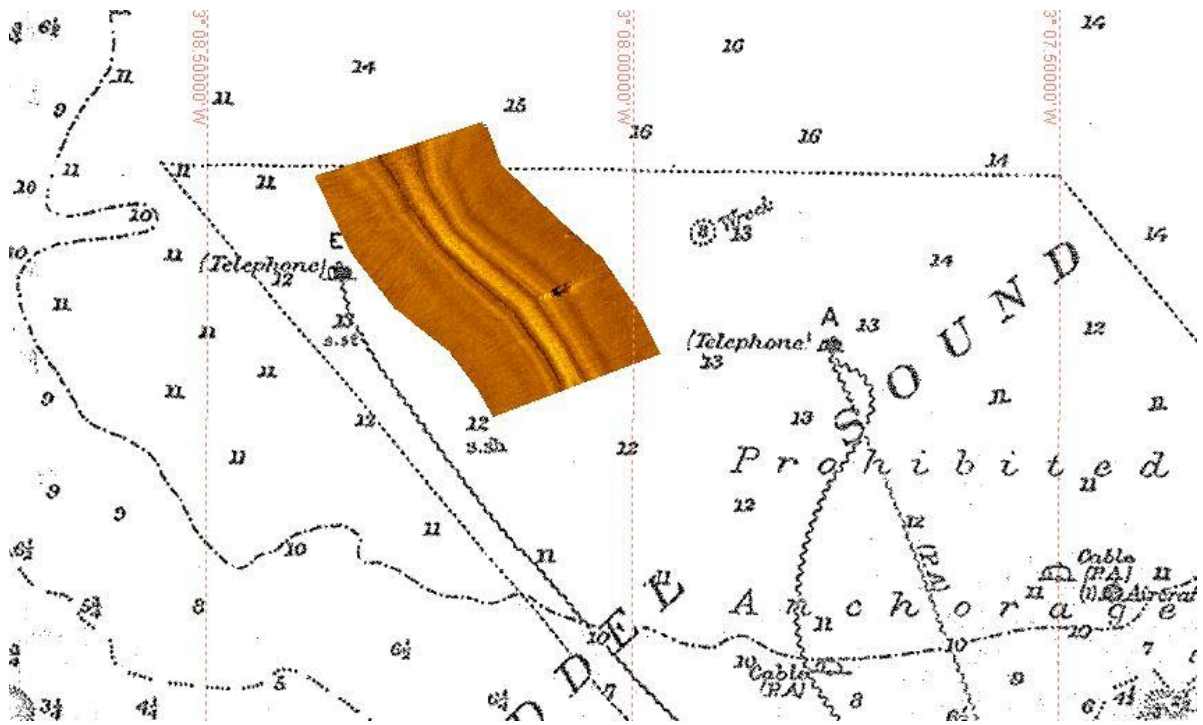
The significant length of cable located forward of the wheelhouse was an interesting feature of the site. Its steel reinforcing contained seven or eight, plastic coated wires. One possibility is that this was a communications cable, several of which were known to be deployed in that area by the British Navy during World War 2. These were deployed from land, out along the seabed to an offshore buoy, where naval vessels could literally "plug in" to get telephone communications. A map showing two of these cables located to the north-west of Flotta, along with the area covered by the side scan survey during this project, is shown in Figure 22. The cable seen at the wreck site was clearly coiled up however and what it was doing on the vessel is unclear. The vessel may have been in the process of deploying or recovering the cable, although its disorganised state is not typical of a deployment or recovery operation. The possibility also exists that the cable has simply been dumped and landed on the wreck coincidentally. Further survey work might focus on the cable and whether or not it runs away from the wreck site and if this was a WW2 communications cable, could the circular object located 60m north of the wreck site be the offshore communications buoy?

Figure 22: Admiralty map of the area around the wrecksite. This shows the presence of two telecommunications cables on the seabed which run out from the island of Flotta and terminate at offshore buoys marked E and A. Naval ships would moor to the buoys and plug into the cable to get telephone communications with shore. These cables are not shown on modern charts. Georeferenced side scan data shows the wreck is located in between the two cables.

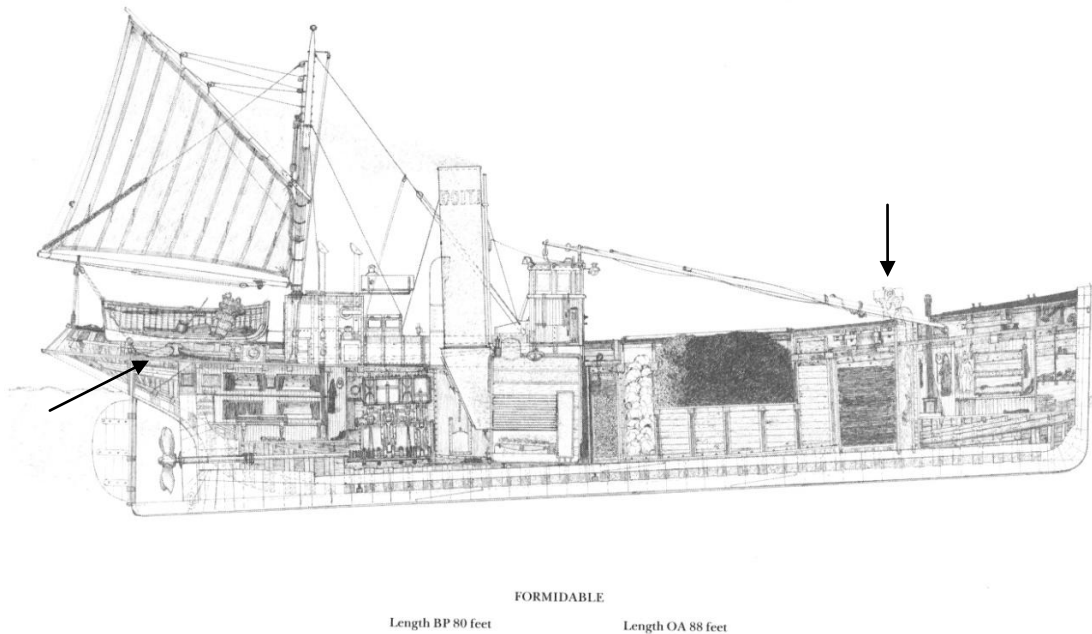
Figure 23: General layout of a steam drifter from Frost (1985). The size, layout and type of remains corresponded closely to that pictured above. The capstan winch and the spare propeller on the aft deck are indicated by arrows.

In terms of the vessel's identity, the size, components and layout of the vessel suggest very strongly that she was a wooden steam drifter. The general layout of a steam drifter is shown in Figure 23, which shows the same components and layout as those found during this project. The shape of the wheelhouse, the spare propeller on the aft deck and the capstan winch on the foredeck were also highly characteristic of the drifter specification.

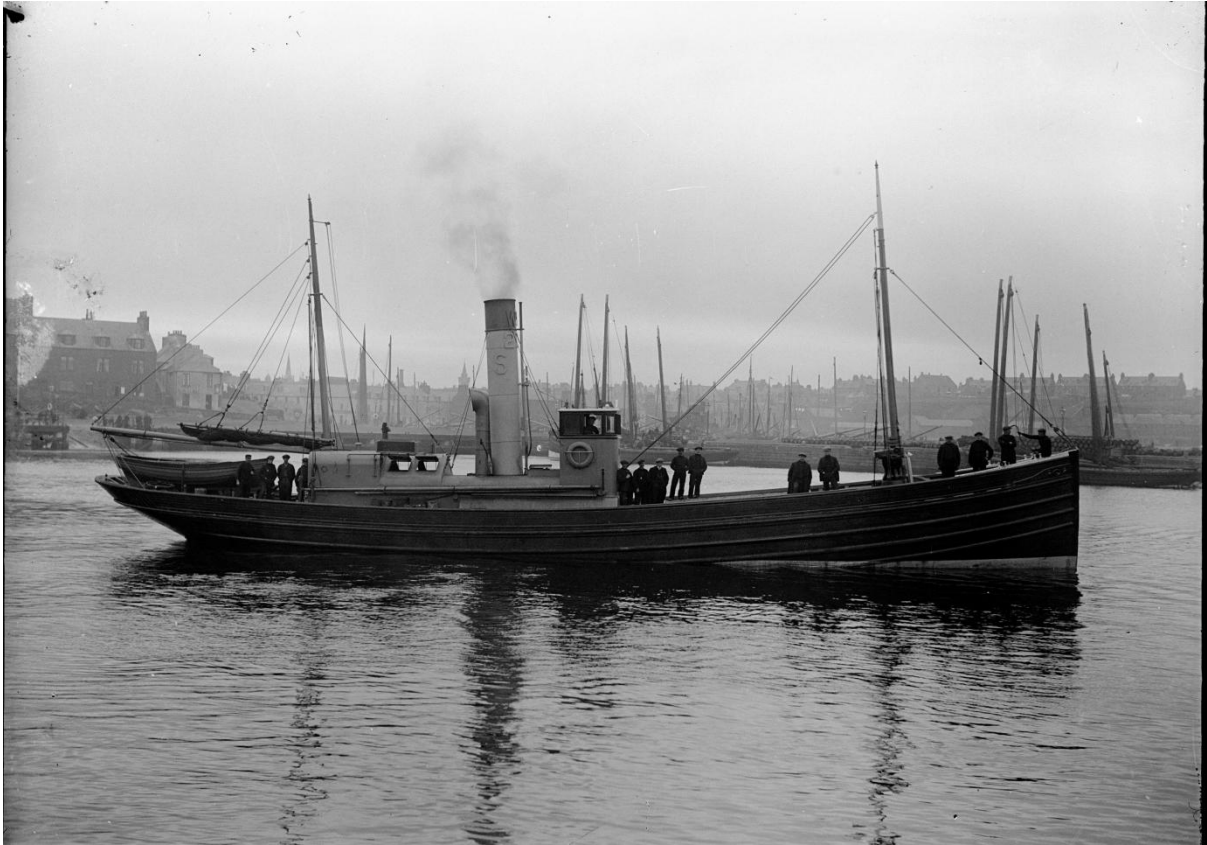
Figure 26: Steam drifter Chance shown in Wick Harbour (circa 1908). Image courtesy of Wick Heritage Centre.

of the Wick registered drifter (HMD) Chance (88 feet, 92 GRT), which was lost in Scapa Flow, on the 26th January 1916, during WW1 (see Figure 26). Additional supporting evidence for this identification is the position of the shackles on the funnel, which correspond to that shown in Figure 27, the rectangular maker's plate (oval plates were more common) and the presence of curved glass in the wheelhouse (the Chance had curved panes of glass on the front corner windows).

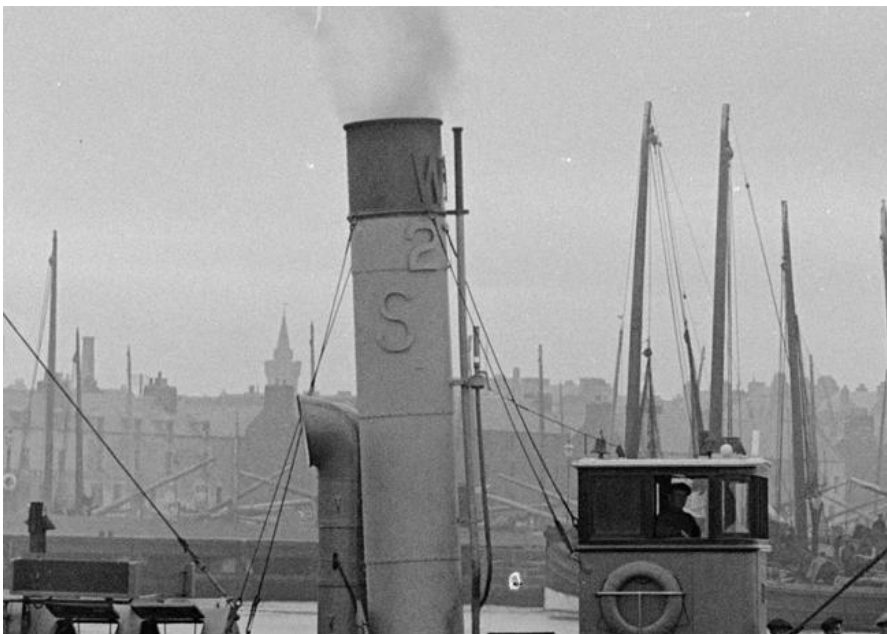
Figure 27: Close up showing the registered fishing number in raised letters attached to the exterior of the funnel. Note the presence of a shackle just above the "2" which corresponds exactly to the shackle found beside the "2" on the funnel at the wreck site.
