Scapa Flow Underwater Salvage Sites Survey: Phase 2 Report

This report was compiled by SULA Diving and ORCA Marine (University of the Highlands and Islands) on behalf of Historic Environment Scotland.

15th January 2019

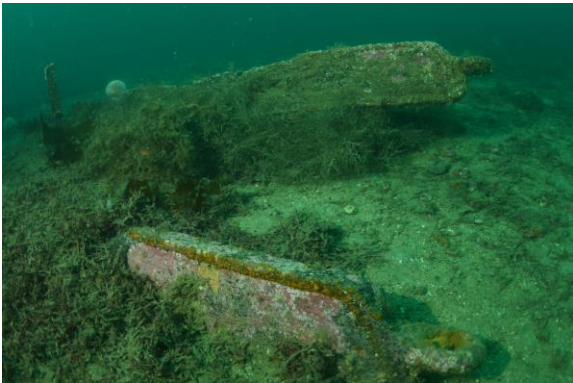
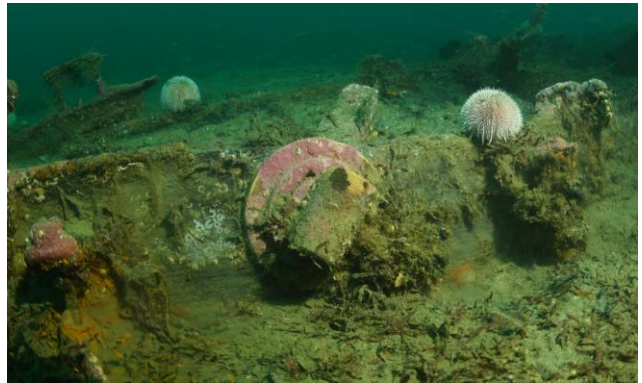
Plate 10: Diver photographs of SS003 showing timber members and steel end fittings (left) and brass sockets (right) from SMS Moltke gangway.

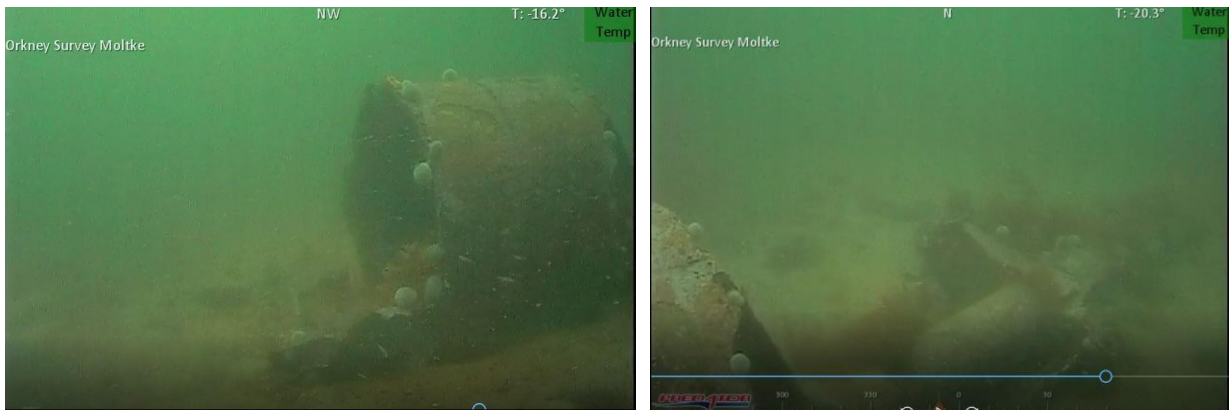
Plate 12: Images from the Shiptime Project ROV footage showing the remains of the spotting top (left) and of the mast support below where the crow's nest would have been located (right).

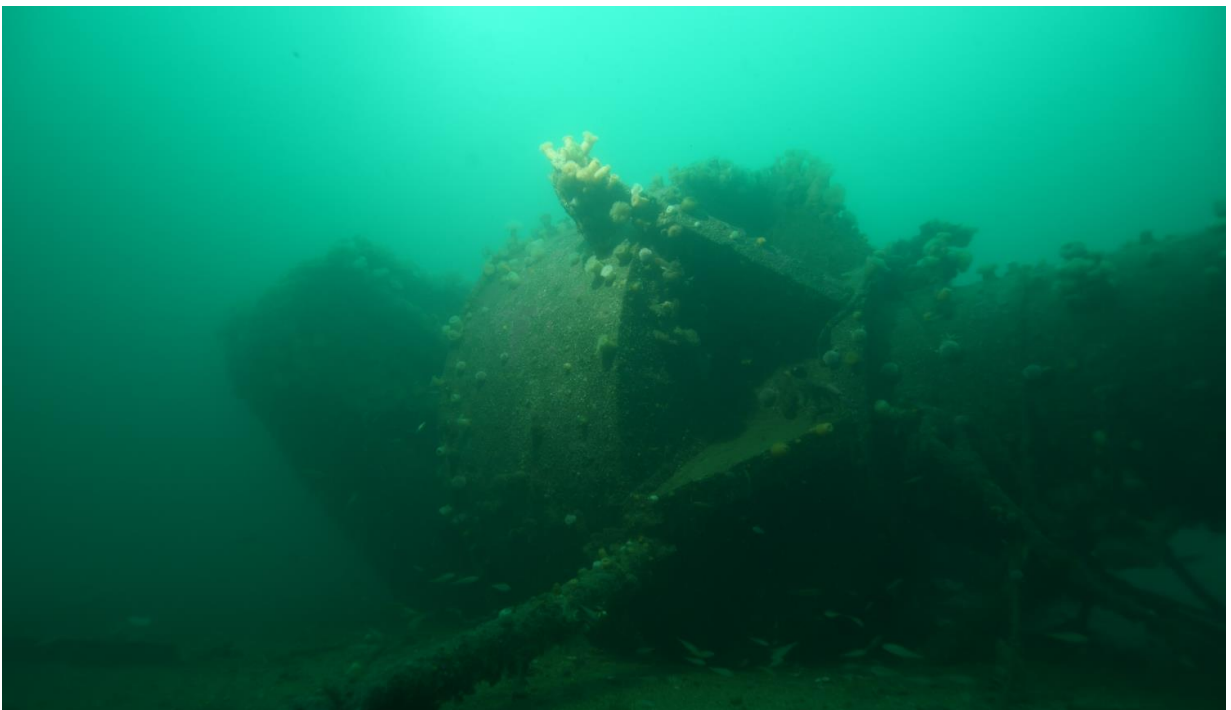
Dive surveys succeeded in mapping out almost the entire site and collected more detailed images of the forward mast and spotting top (Plate 24) and associated bridge and wreckage (Plate 25). The following additional items were observed (in the order of heading south-east from the foremast):

Plate 24: SMS Kaiser forward mast showing splinter proof control room (top) and underside of spotting top (bottom).

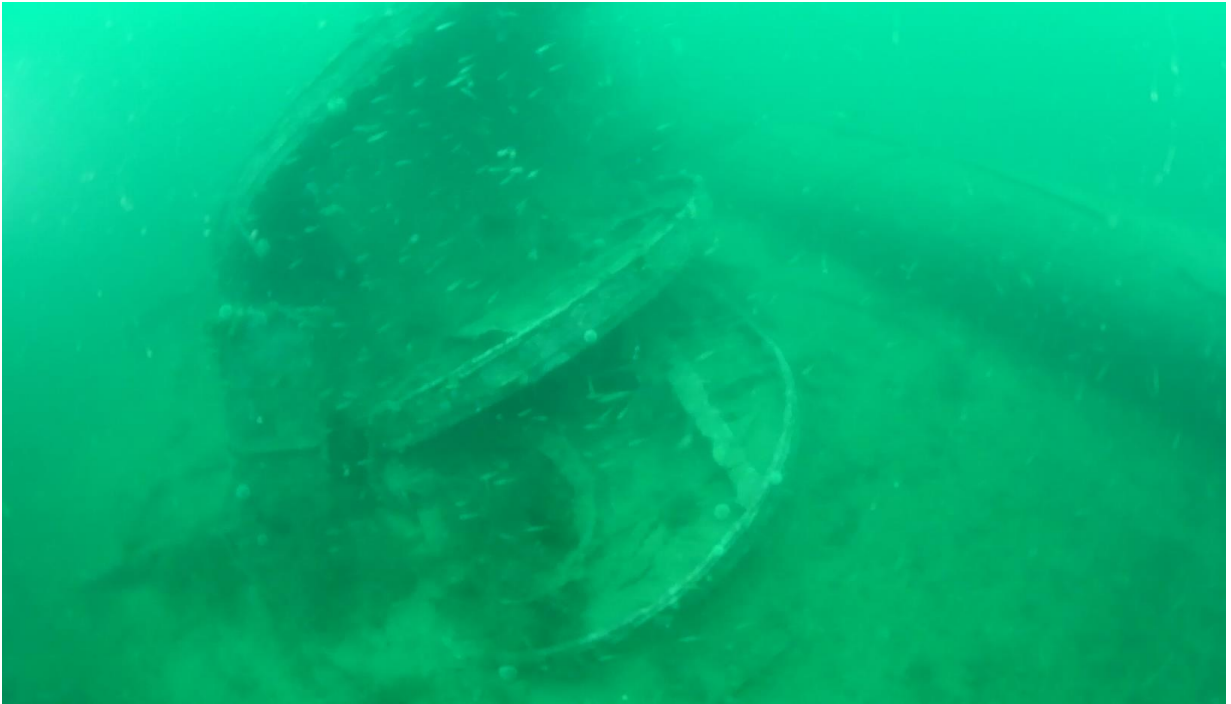
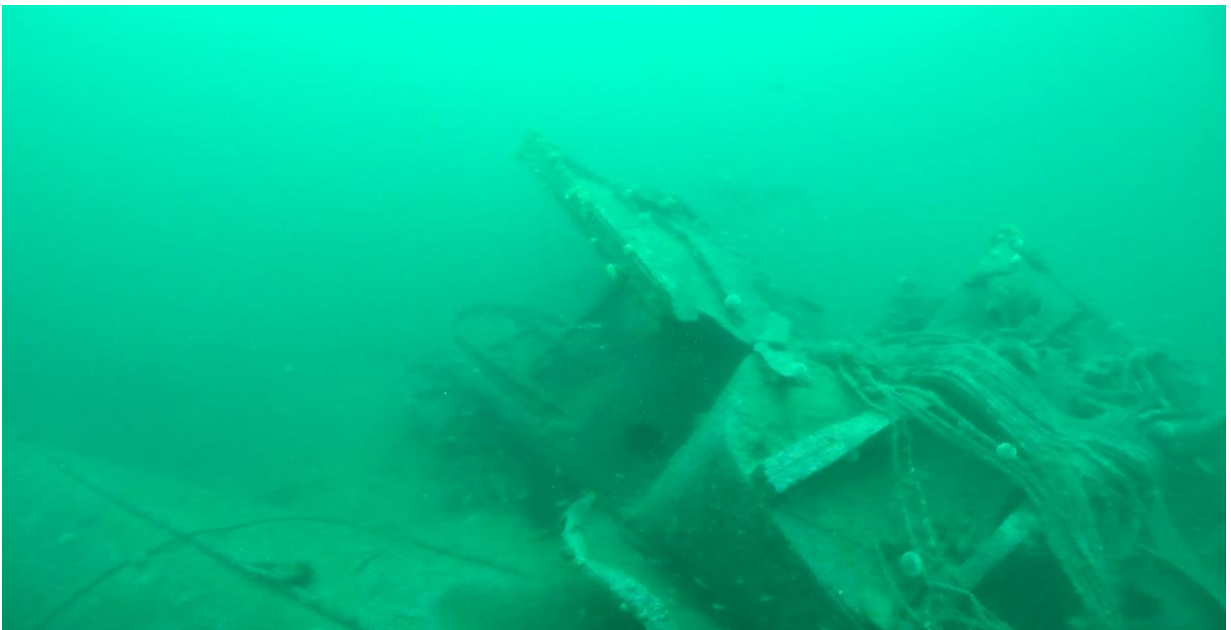
Plate 25: SMS Kaiser wreckage at base of forward mast comprising searchlight platforms (top) and bridge structure (bottom).

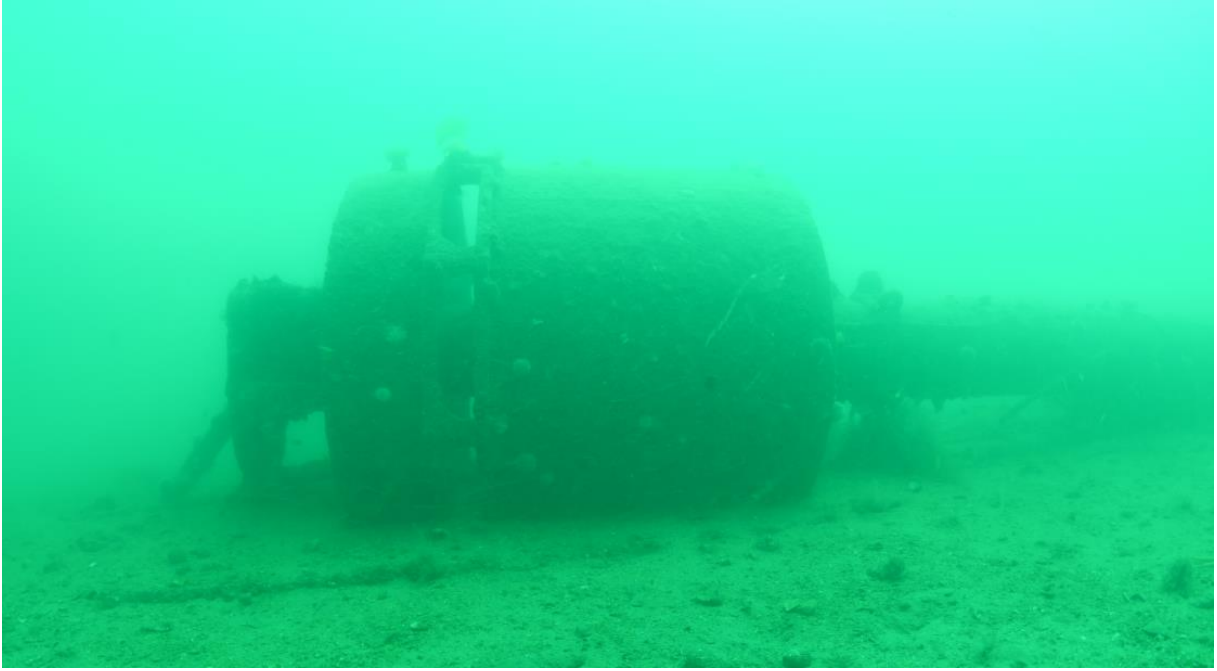
Plate 31: Prinzregent Luitpold primary salvage site, forward mast with splinter-proof spotting top (SS045).

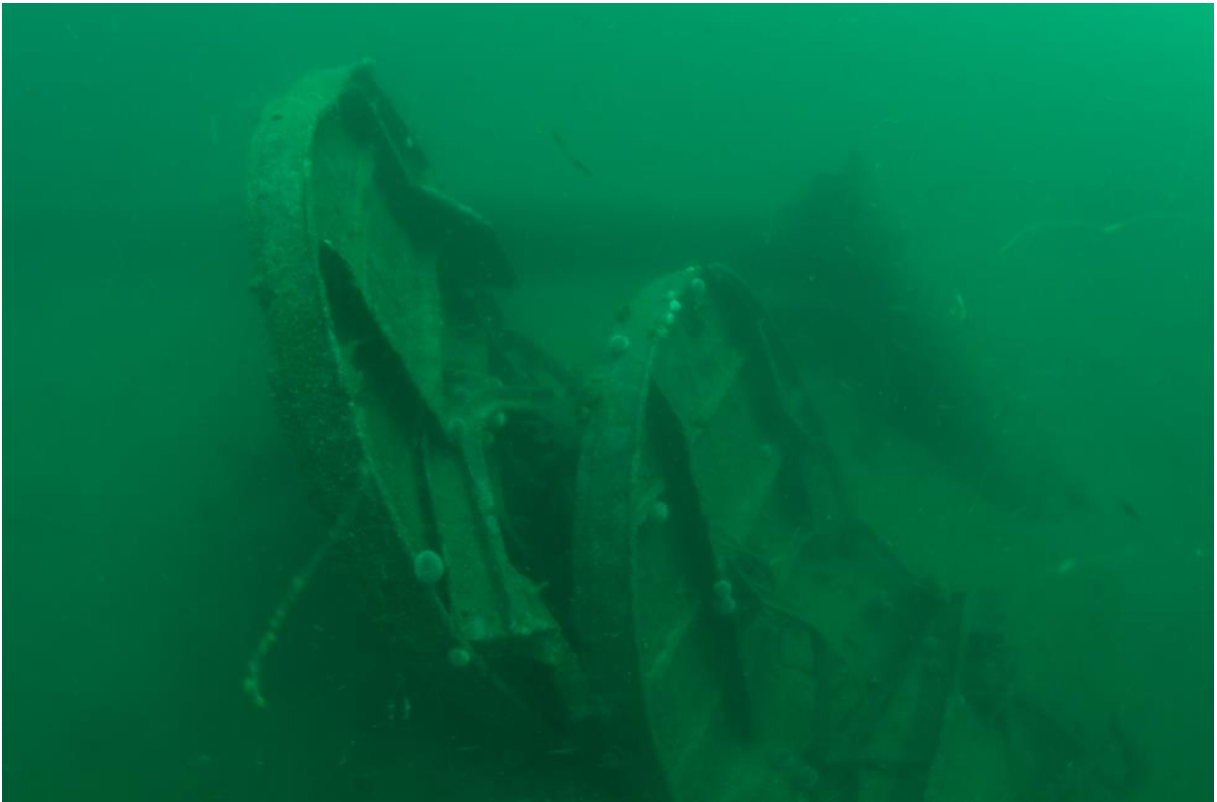
Plate 32: Prinzregent Luitpold primary salvage site, forward searchlight platforms (SS045).

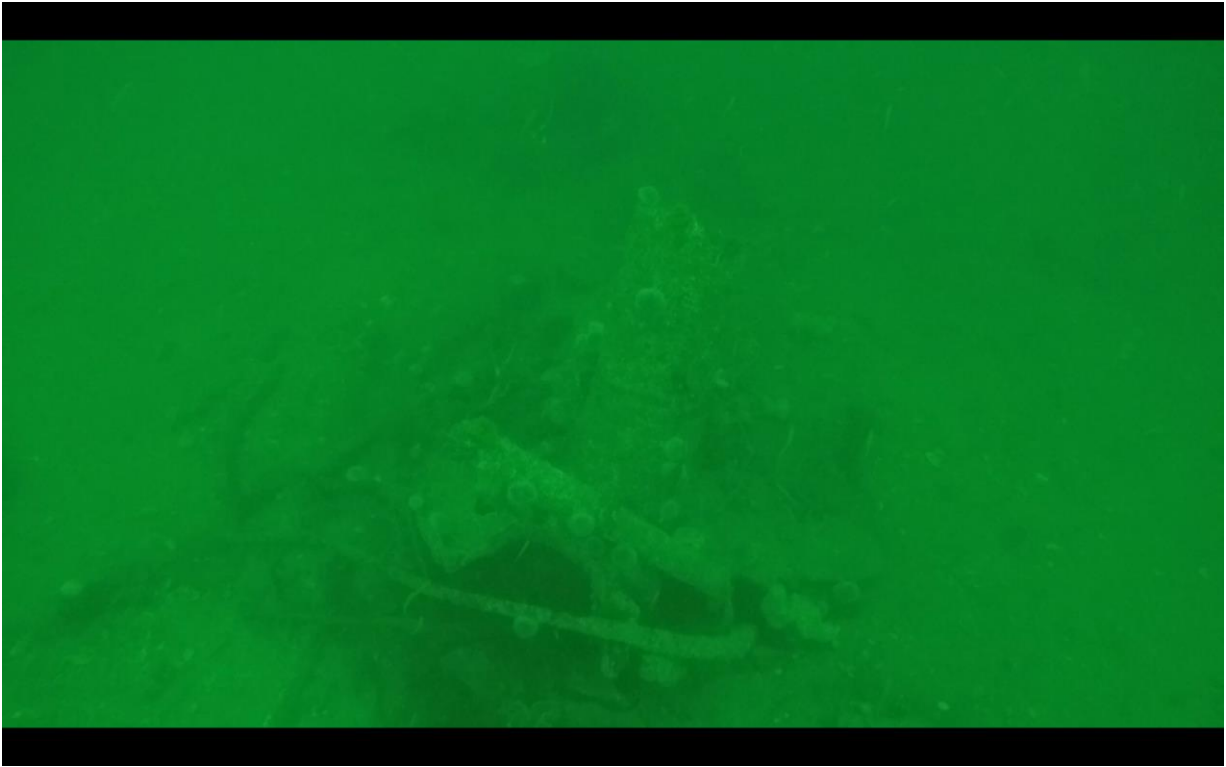
Plate 36: SMS König Albert primary site, foremast remains (SS057).

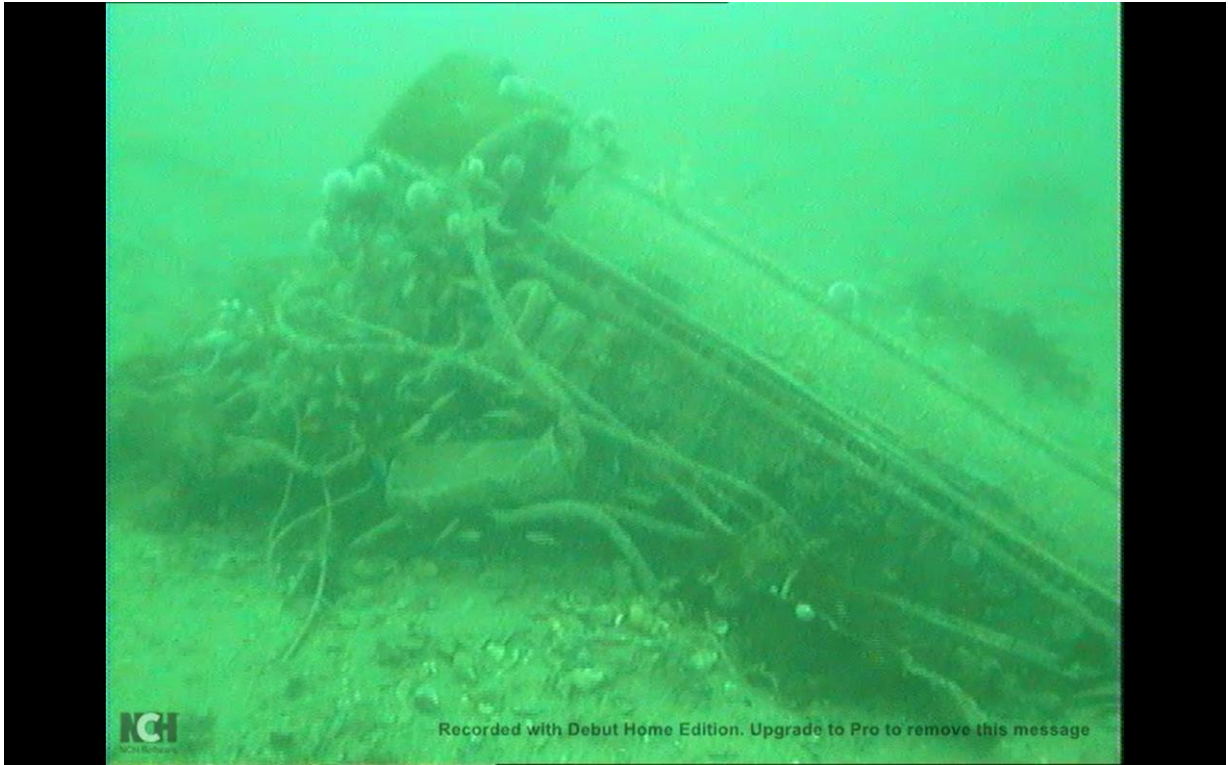
Plate 38: SMS König Albert primary site, pinnacle diesel engine (SS058) lying upside down on seabed.

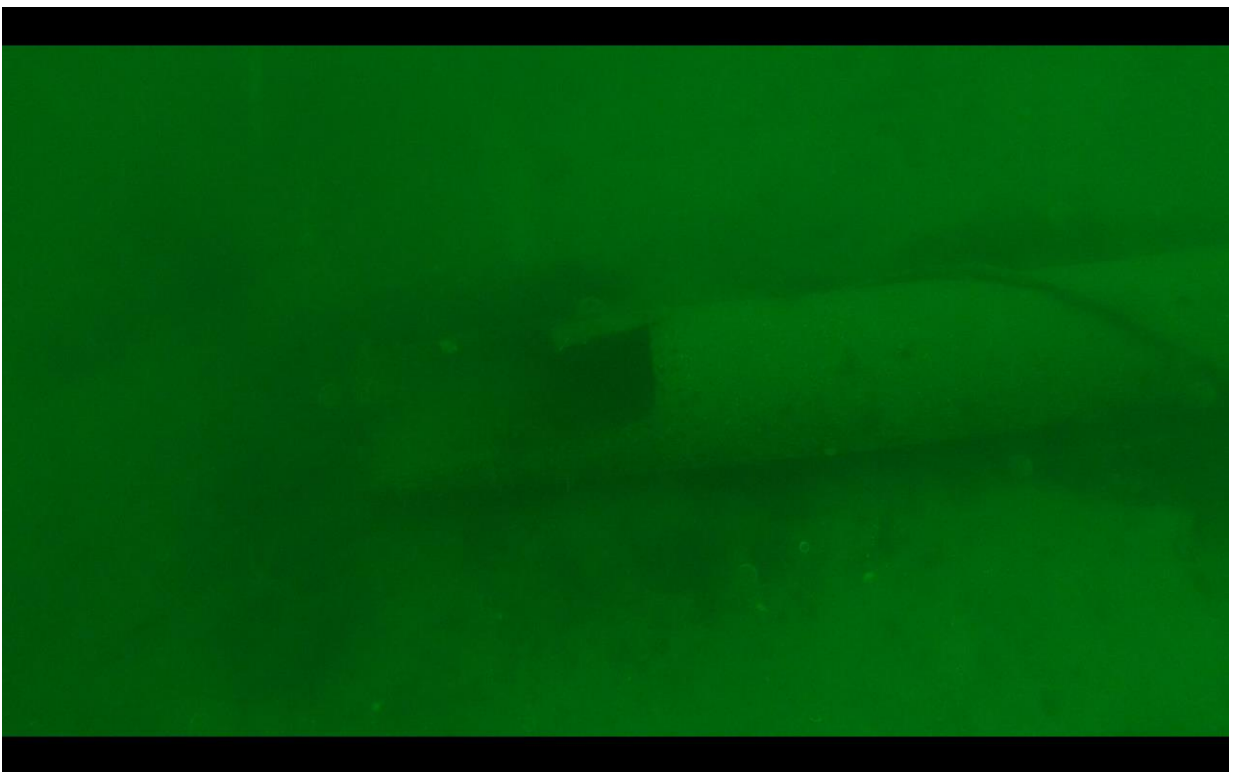
of a samson post (most likely the forward post) and a small mast or davit (Plate 42, Plate 43 & Plate 44). The tubular object was initially thought to be the forward mast, however the ROV footage showed no features that would be associated with a mast, e.g. rigging attachment points, rungs, spotting top, brackets, etc. Alternatively, it may be a boom, given that a samson post was located a few meters away. However, none of the terminal features of a boom were present either and as such its origin remains uncertain without additional survey work.

Plate 43: SMS Kaiserin primary site, samson post boom (SS055).

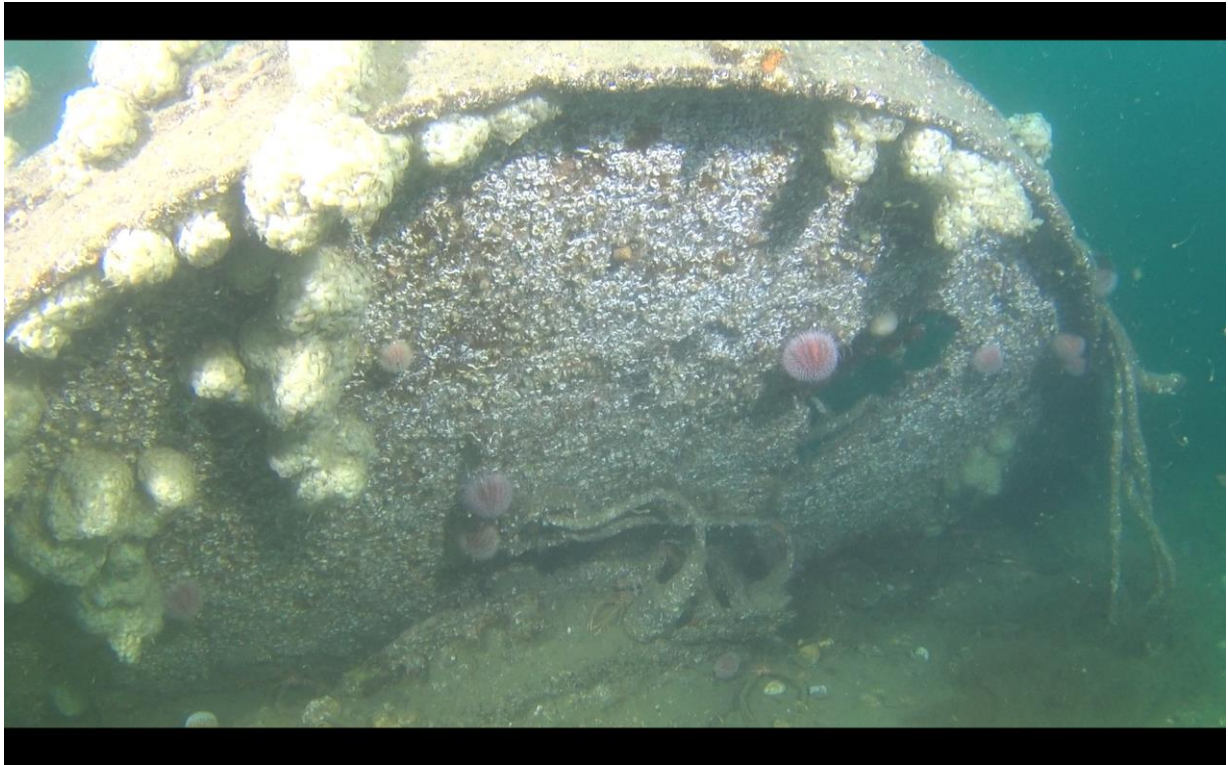
Ground-truthing results generally corresponded to the salvage archive for SMS *Kaiserin* that indicated that the remains of the bridge structure (forward and aft), foremast, samson posts and aft mast were removed from the hull at the primary salvage site. There were some anomalies however. Only one samson post was found on the site and the presence of the foremast on the site was also uncertain. The diver's sketch from the archive suggested the foremast was sticking out of the seabed with spotting top intact. It would be easy to assume that the long structure protruding from the seabed to the south-east of the site was the foremast depicted in the diver's sketch. However, no evidence of a spotting top was observed and its location on the site makes it more likely that this was the aft mast. The mast-like structure to the north-west of the site is in the correct area but a lack of distinguishing features prevents a certain identification. It is possible that despite the foremast being snapped, it was still attached by guy wires and subsequently dragged away when the vessel was towed from the site. A relatively interesting assemblage of artefacts remain at the site, with the searchlight remains being the most noteworthy.

Plate 46: SMS Kaiserin primary site (SS053), aft searchlight platforms (image courtesy of B. Wade).

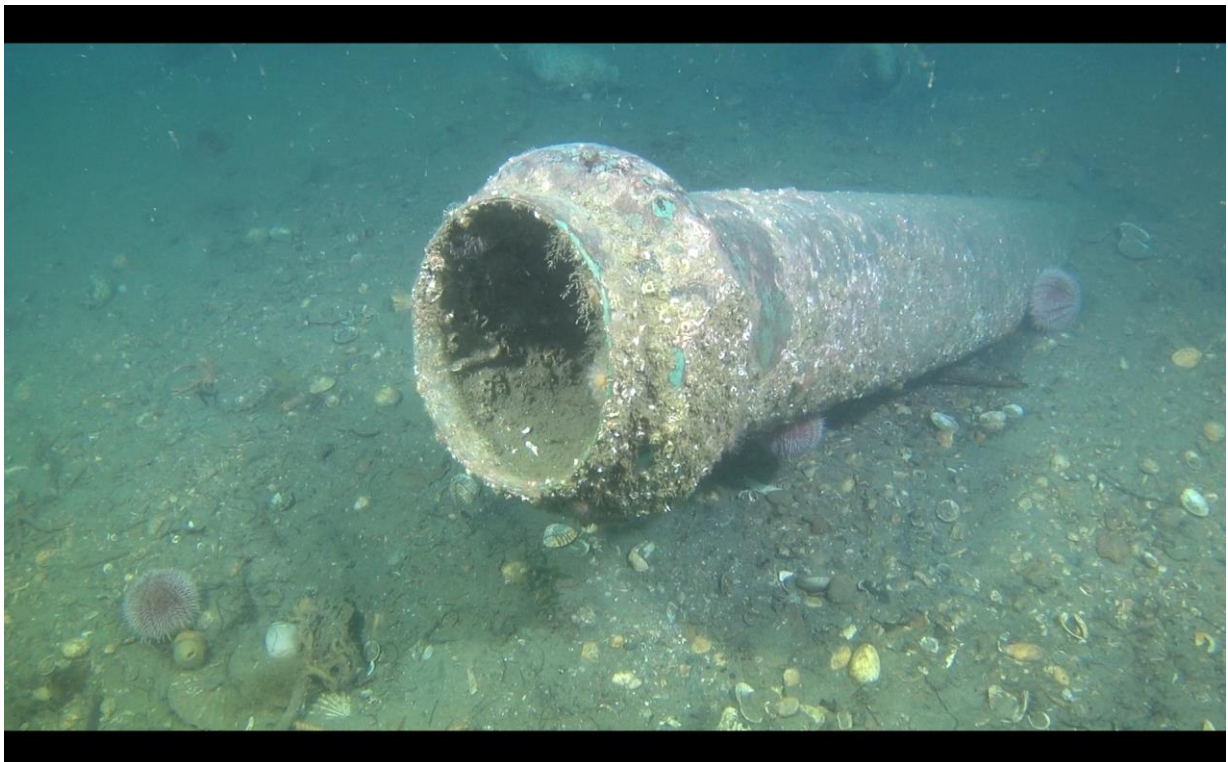
Plate 47: SMS Kaiserin primary site, brass pipe projecting from seabed (image courtesy of B. Wade). A second similar pipe, which was almost entirely buried, can just be seen in background.

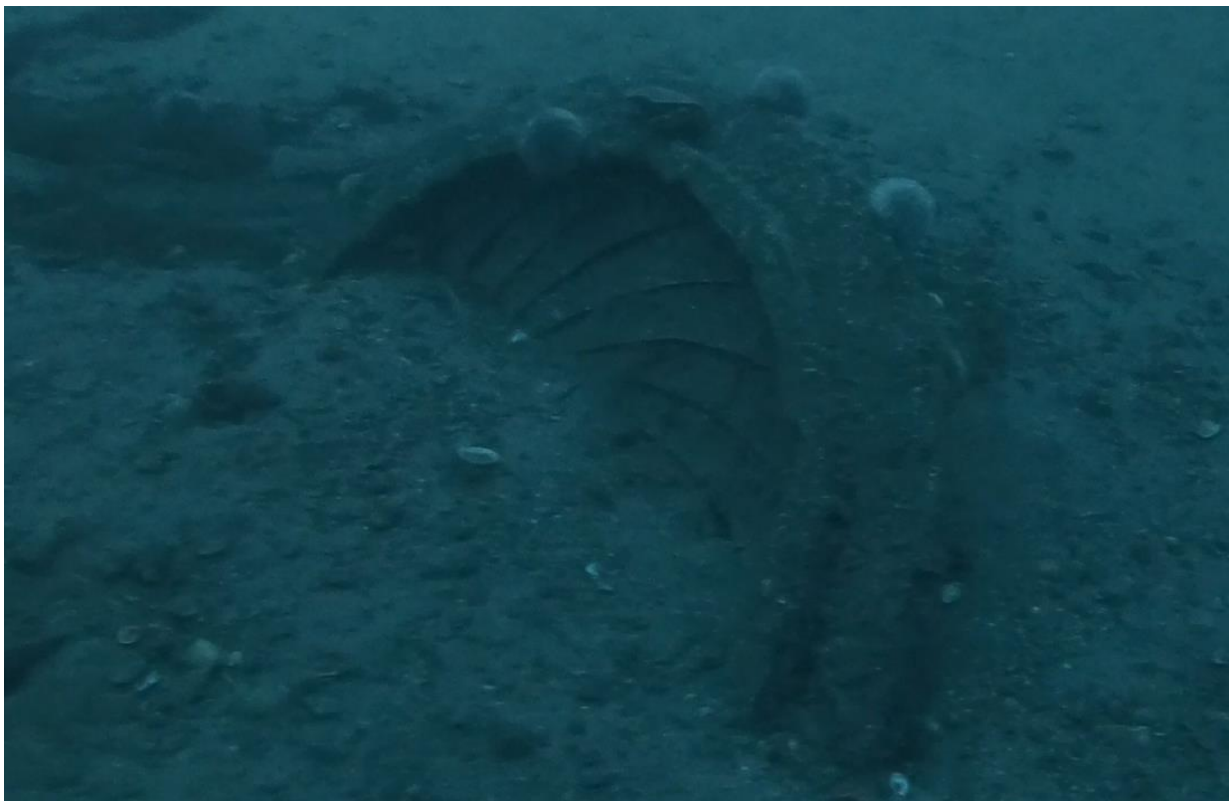
Plate 48: SMS Kaiserin primary site, searchlight remains, partially buried with intact front grill with inset of (top) and iris (bottom). A similar searchlight unit from a German ship is also shown (top right) (G. Staff Collection).

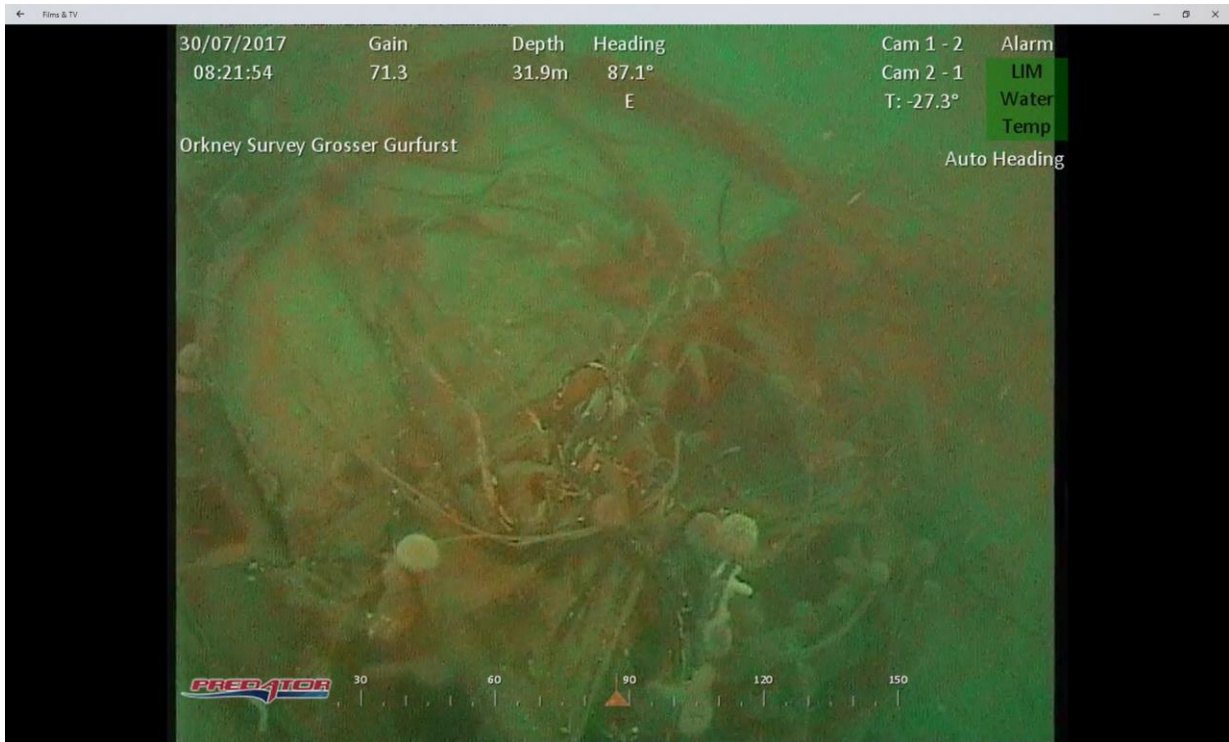
Plate 50: SMS Friedrich der Grosse primary salvage site, searchlight platforms adjacent to aft mast.

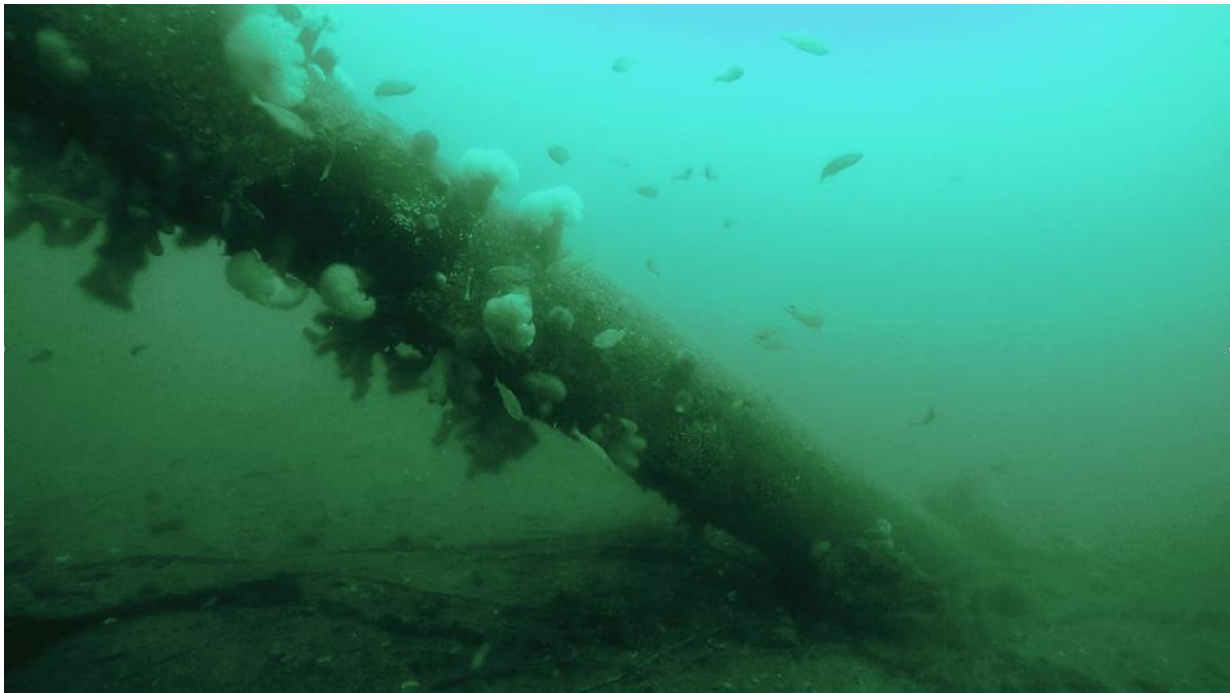
Plate 51: SMS Friedrich der Grosse primary salvage site, showing aft mast protruding from seabed.

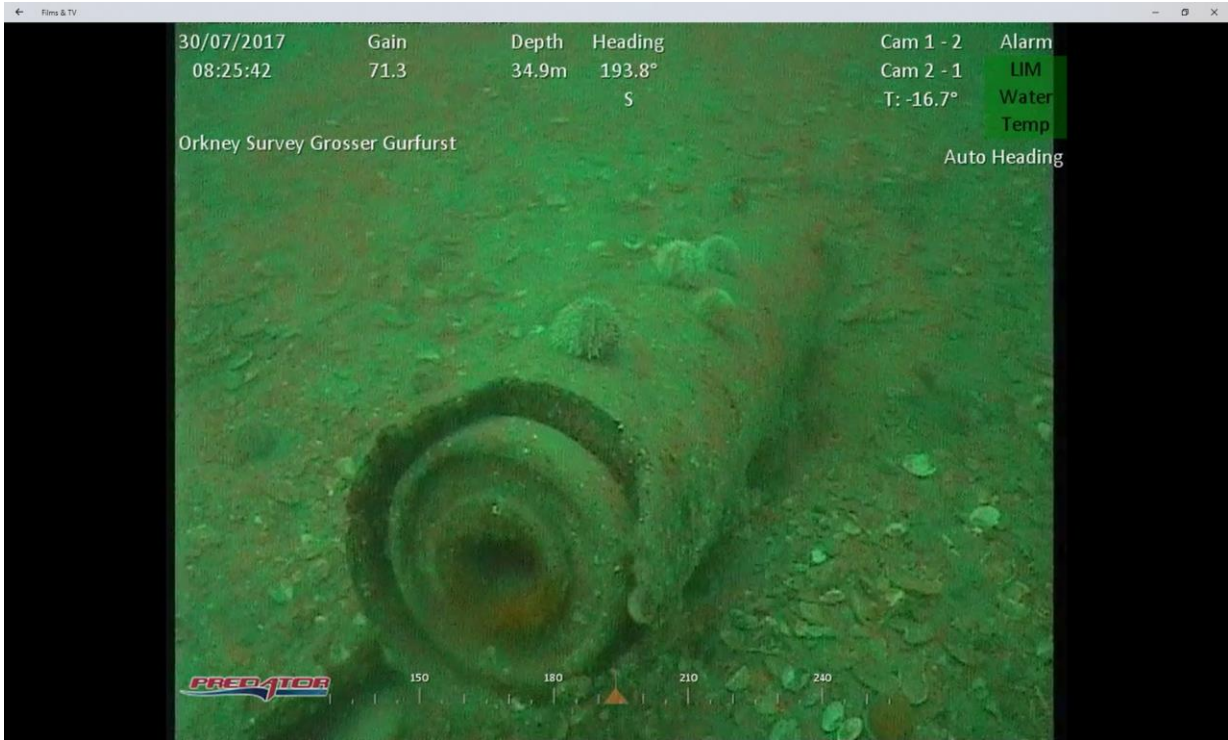
Plate 52: SMS Friedrich der Grosse primary salvage site, sub-colibre liner casing.

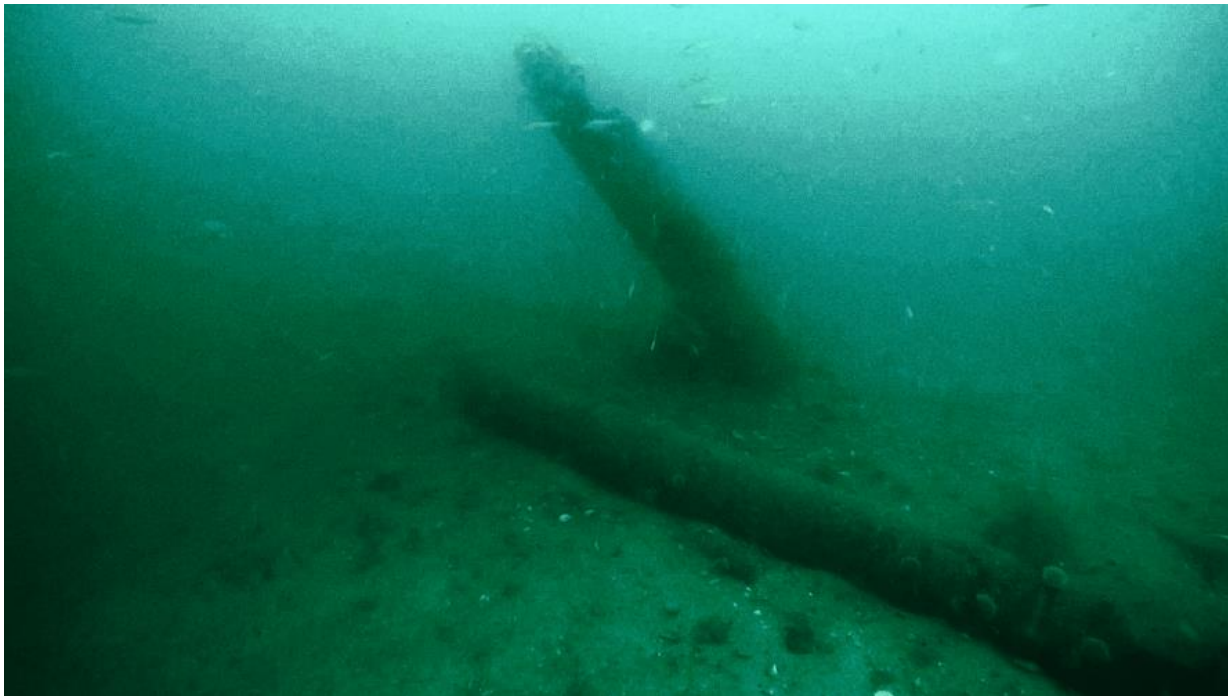
Plate 53: SMS Friedrich der Grosse primary salvage site, boom sections.

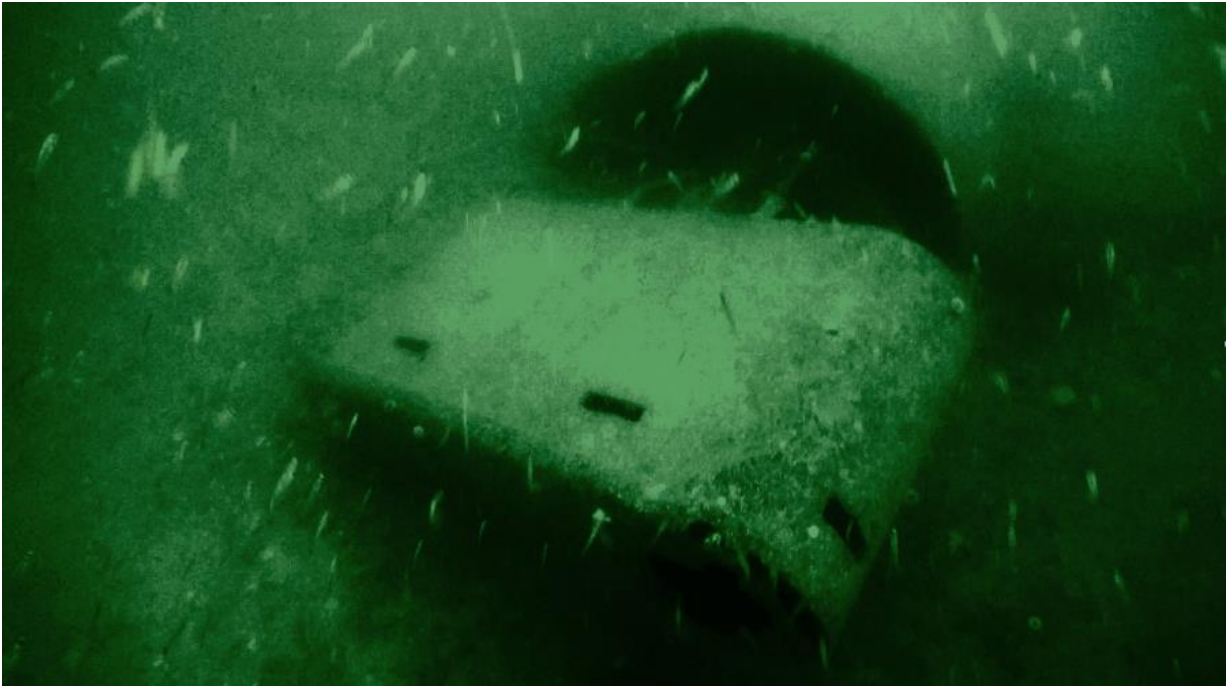
Plate 54: SMS Friedrich der Grosse primary salvage site, forward mast and splinter proof control room.

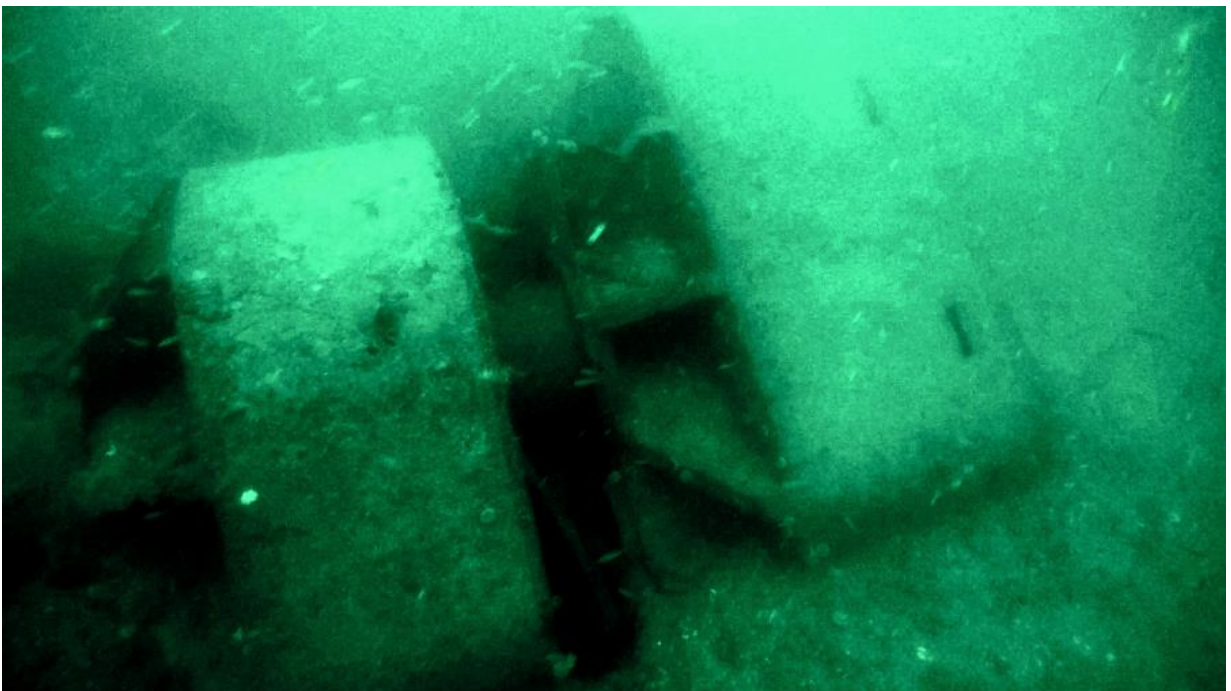
Plate 55: SMS Friedrich der Grosse primary salvage site, forward mast, spotting top and splinter proof control room.

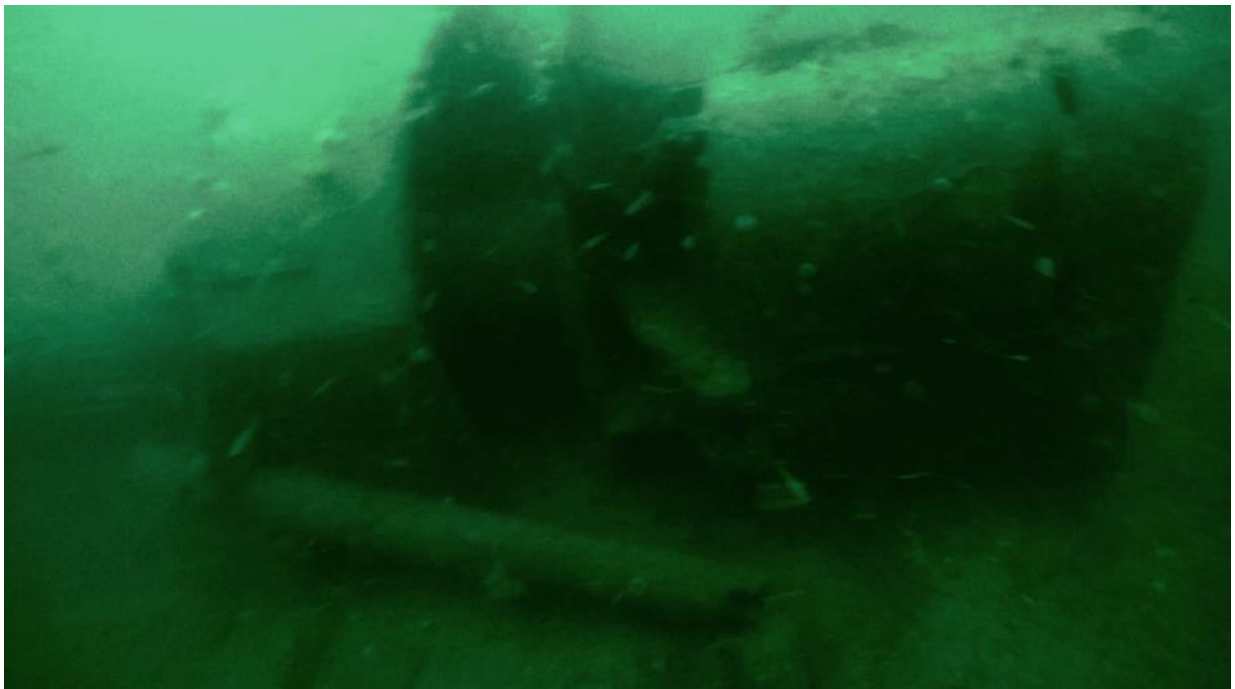
Plate 58: SMS Grosser Kurfürst primary salvage site, forward mast spotting top and splinter proof control room.

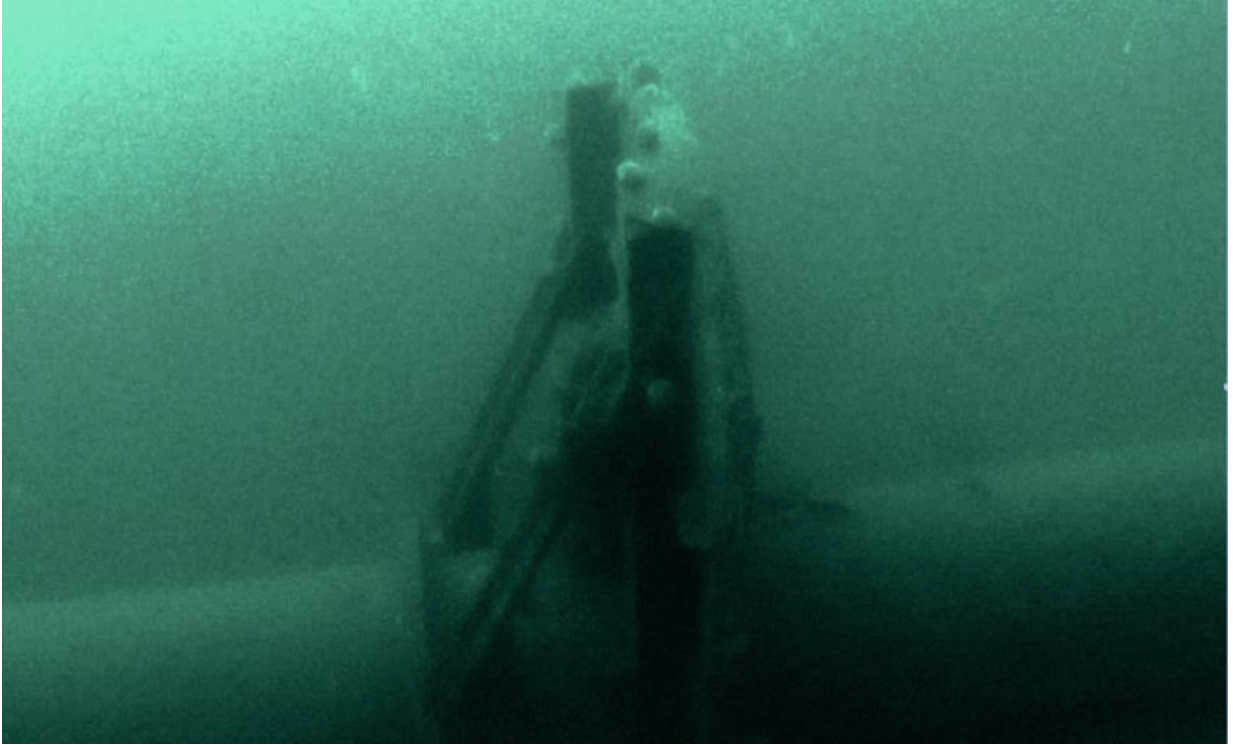
Plate 69: SMS Derfflinger, small forward-facing platform on middle leg of tripod mast, primary site.

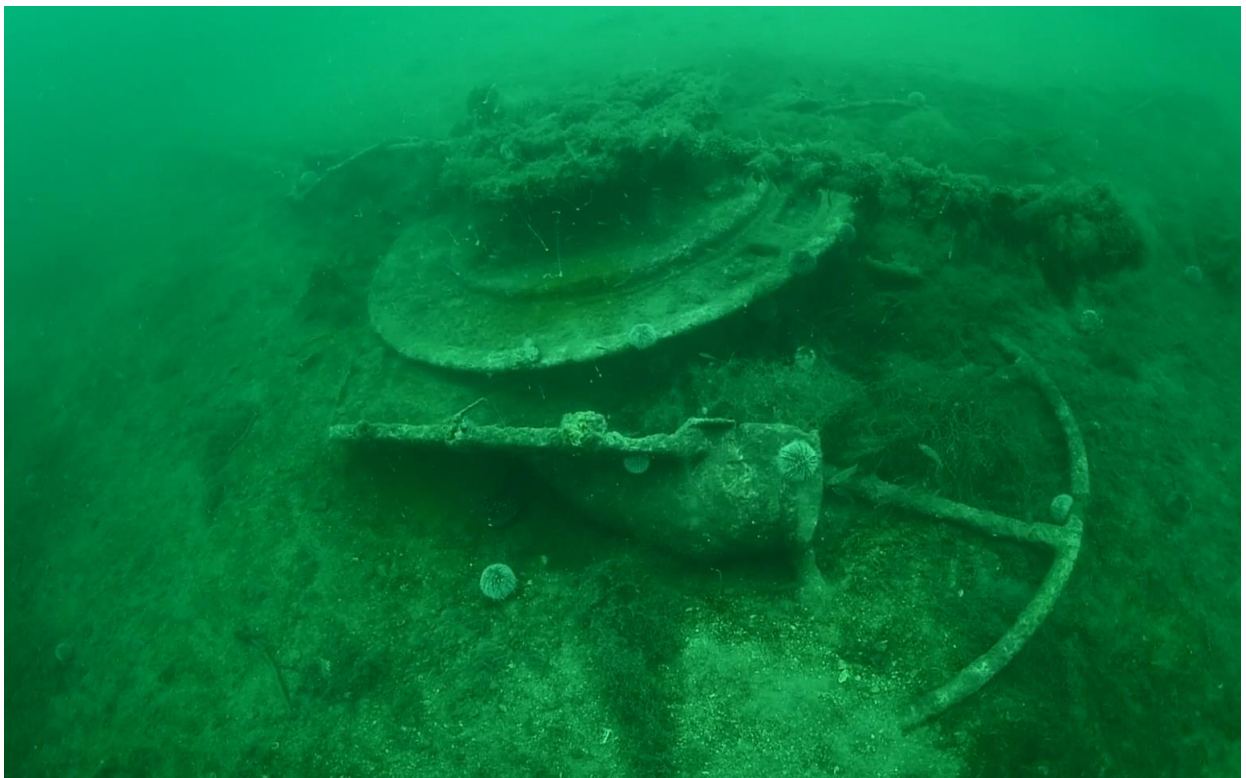
Plate 71: SMS Derfflinger, tertiary site, main anchor capstans (SS087). The chain pipe cover is visible in the foreground of the lower image.

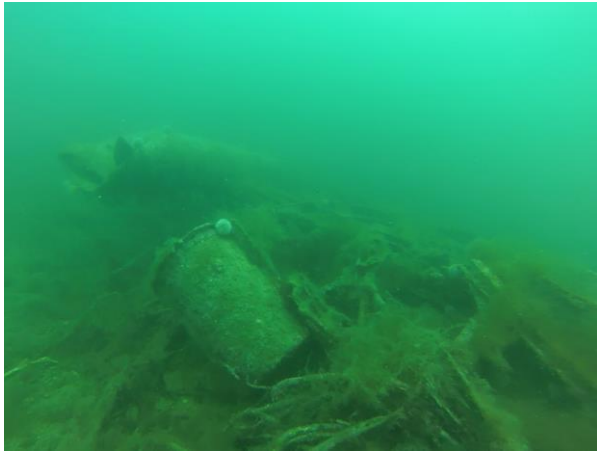
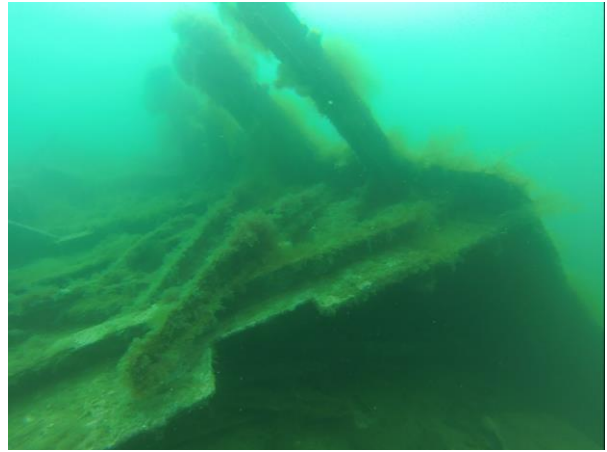
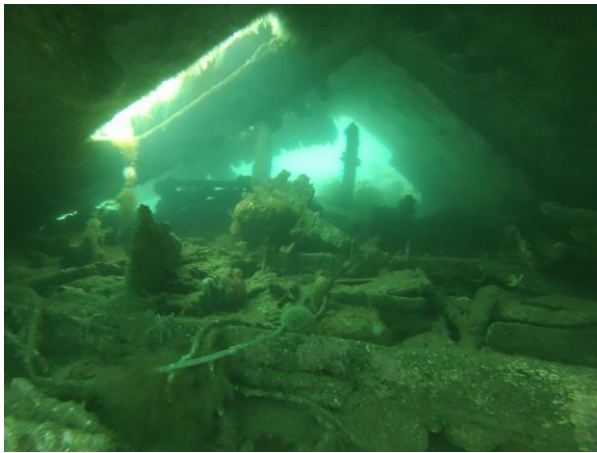
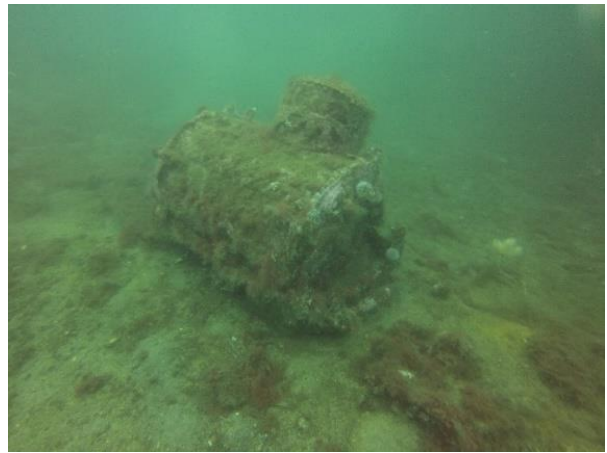
Plate 74: SMS Bremse, primary salvage site, showing miscellaneous wreckage, deck plating and a small boiler (images courtesy of OSAC).

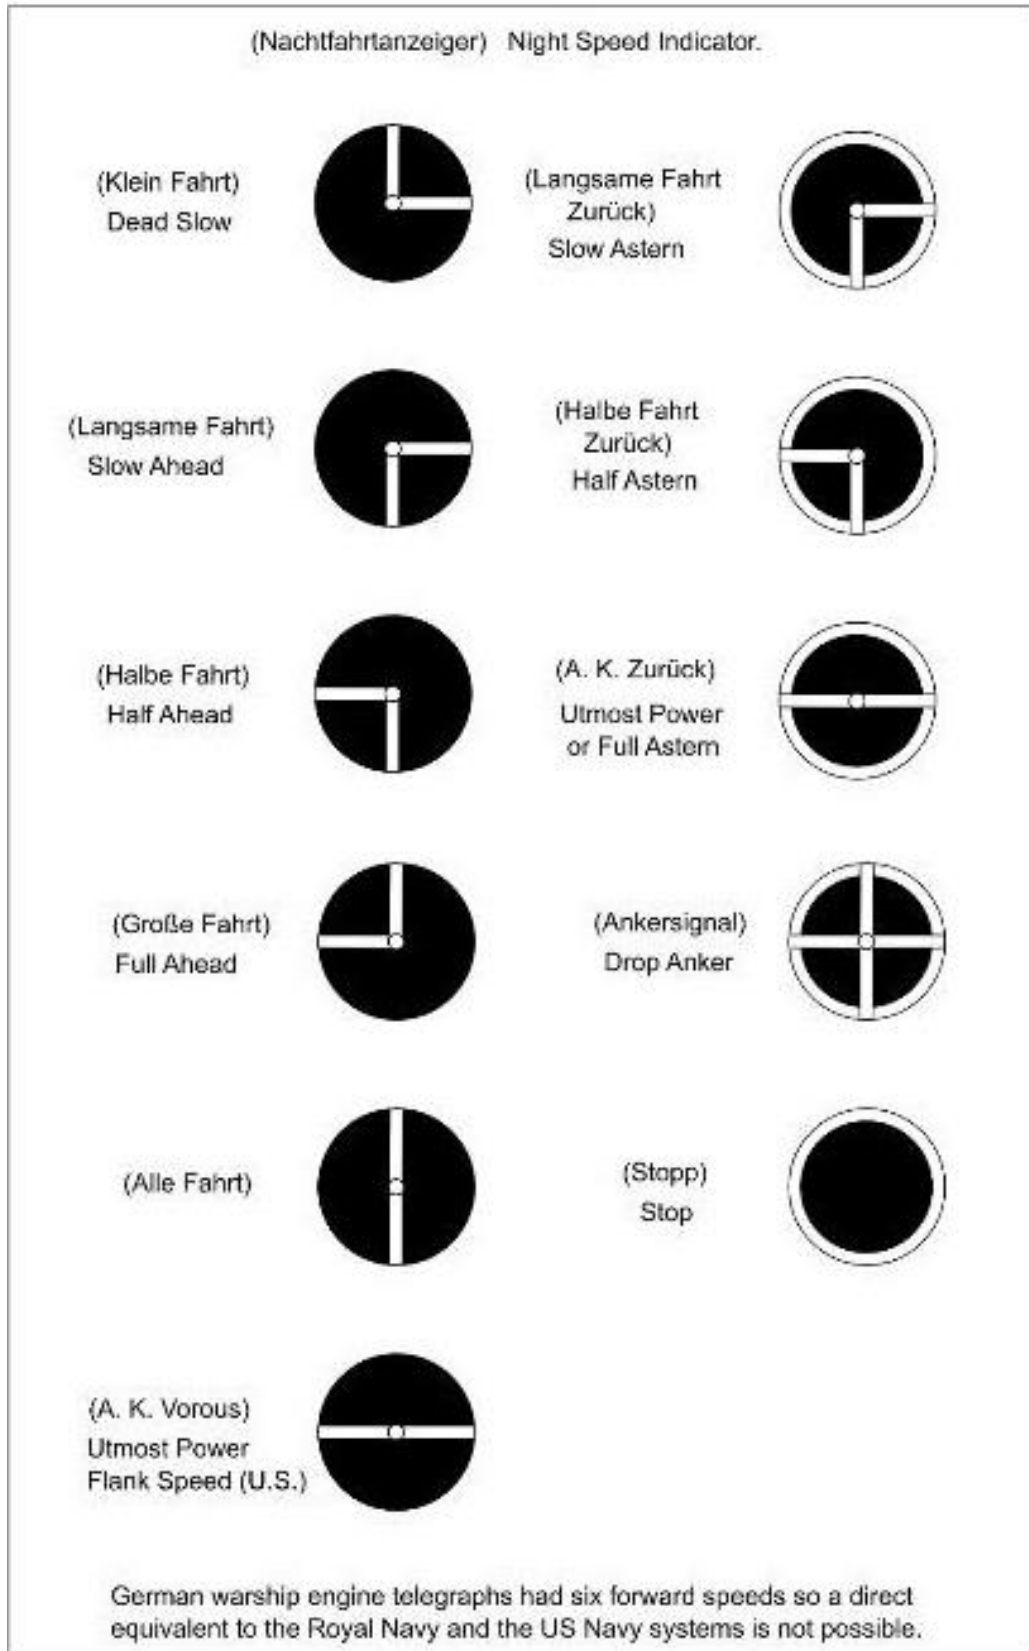
Plate 77: Night speed indicator signals and commands (Samuel, 2018).

lined with small bulbs which could be illuminated in different sequences corresponding to different commands. They were rear facing to be visible to following ships only and therefore could not be seen by enemy ships (Samuel, 2018). Different lighting configurations are shown in (Plate 77). This was the only example of its type in the salvage site project.
