Scapa Flow Underwater Salvage Sites Survey: Phase 2 Report

This report was compiled by SULA Diving and ORCA Marine (University of the Highlands and Islands) on behalf of Historic Environment Scotland.

15th January 2019

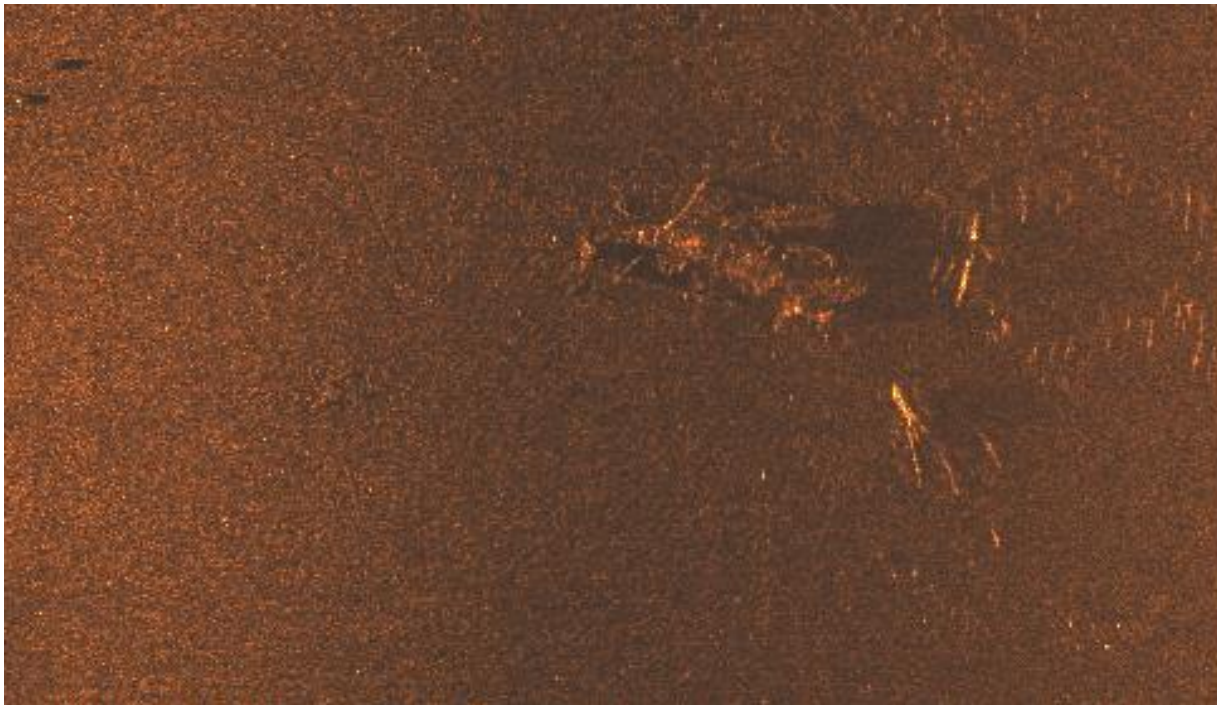
Figure 16: Side scan image of SMS S36 wreck site to west of Cava.

The side scan image of the *S36* (Figure 16) site shows a large deposit of indistinct wreckage located in shallow water on the west side of Cava. A ground-truthing survey was carried out by a team of volunteer divers from BSAC on the 13th April 2018. Video footage taken during the survey shows the wreck to be well broken down with only a couple of pieces of wreckage standing higher than 2m off the seabed (Plate 79). The hull appears to have been completely stripped of all fittings apart from through hull valves which would have been left to maintain watertight integrity for towing to final sinking position. All engines and boilers had been removed, as had the propellers, although both propeller shafts were still in place (Plate 80). Numerous deck fittings including bitts and cleats were also present. This class of destroyer was fitted with a bow rudder, and the steering mechanism and a section of the bow is exposed at low water (Plate 81).

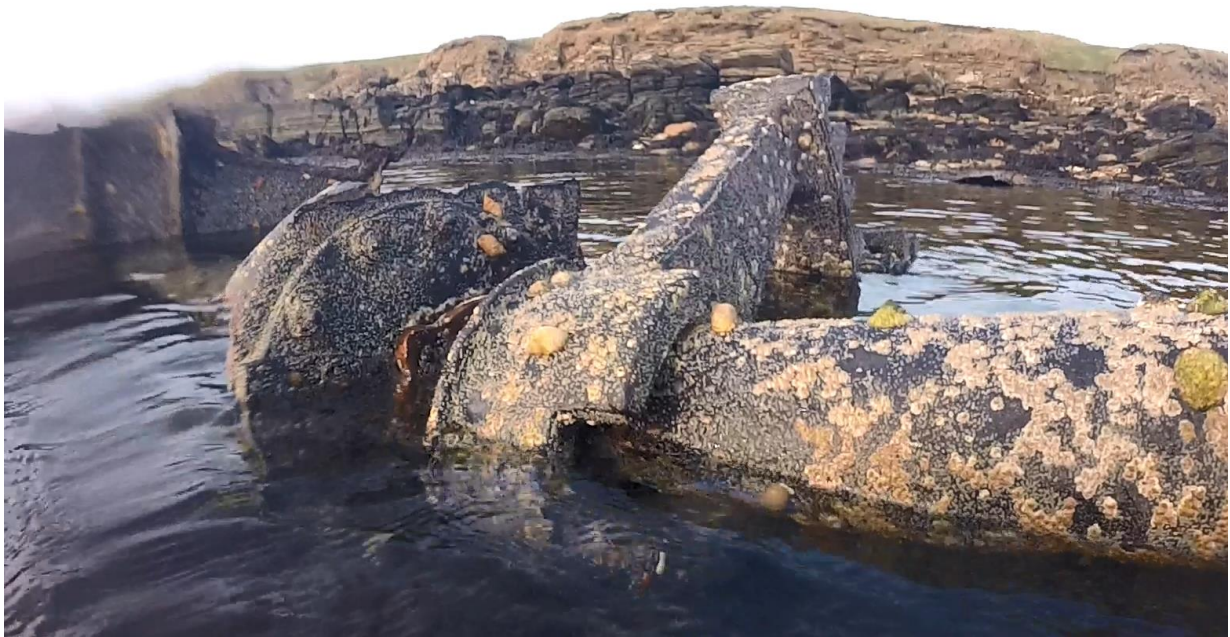
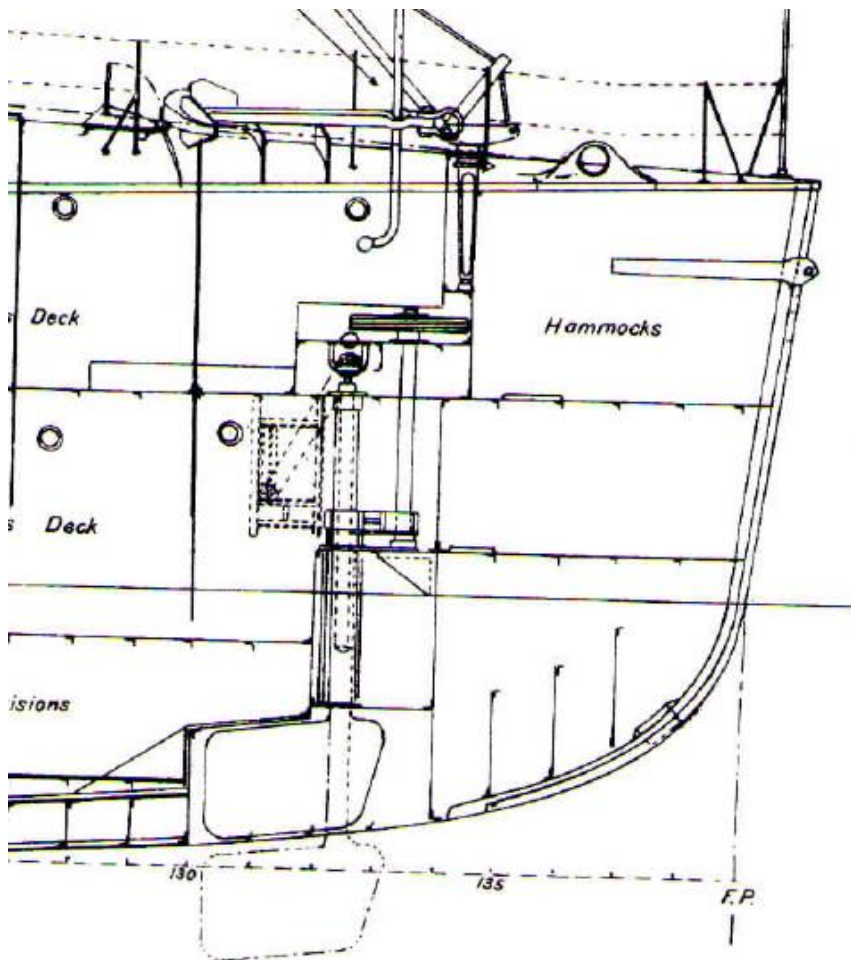
Plate 81: SMS S36 at Cava, bow steering gear remains (top, image courtesy of P. Balazy) and a schematic of the bow rudder arrangement (bottom).

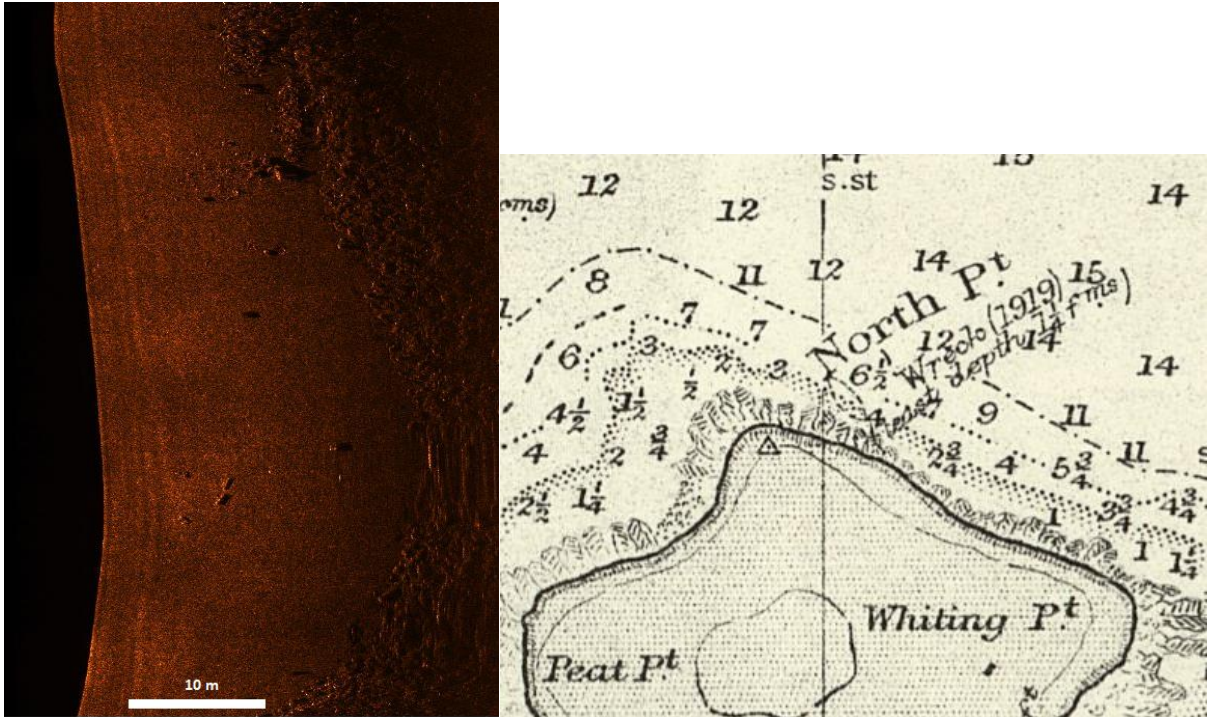
Figure 18: Side scan image of the V78 salvage site (left) and UKHO chart 3729 (1923) showing its original location on the north side of Fara (right).

The side scan image for the V78 site is shown alongside the corresponding section of the Admiralty chart for 1923 (Figure 18). UKHO Wreck card number 1027 (created in 1919) related to V78 and its salvage in 1925. The wreck was deleted from hydrographic charts in 1930, although the wreck card entry was only amended to “DEAD” in 1965.

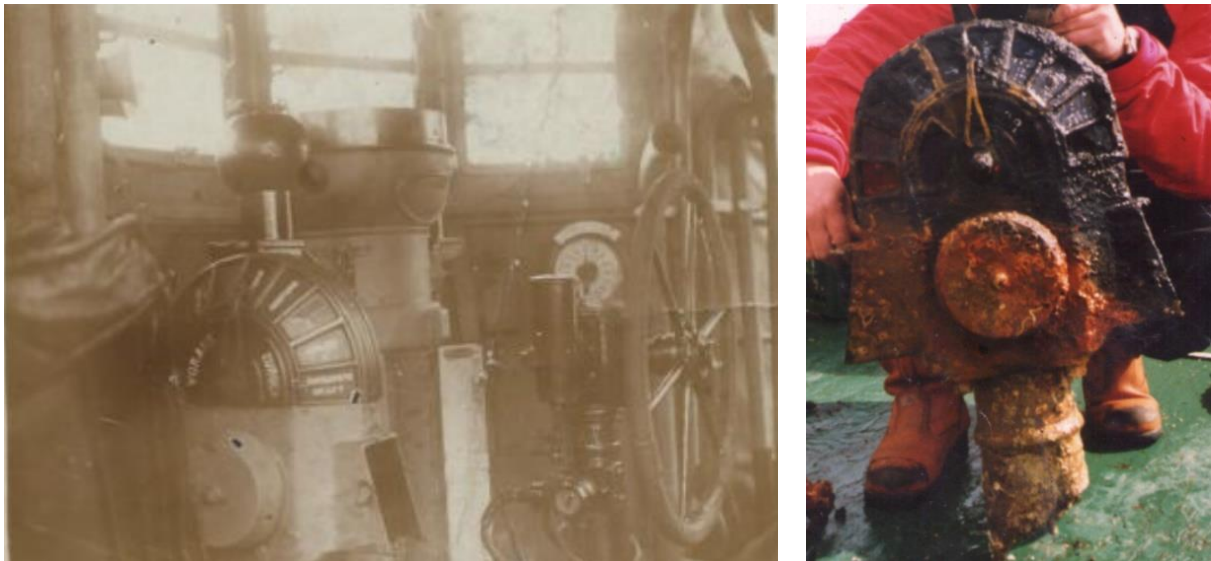
No ground-truthing was carried out as part of this project. The area was dived in 1998 by one of the authors of this report, and the remains of a funnel and a base of the bridge section were found hard pressed into the sand. A ship’s telegraph was recovered (Plate 84) marked V-78 and is now in a museum in Stettin, Germany (RoW Droit number 754/99). Only very small items are thought to be present on the site, including a large number of brass flag Inglefield clips, most likely from the signal room.

Plate 84: Telegraph on a German destroyer (left) and the telegraph from V78 after recovery in 1998 (right) (K. Heath Collection).

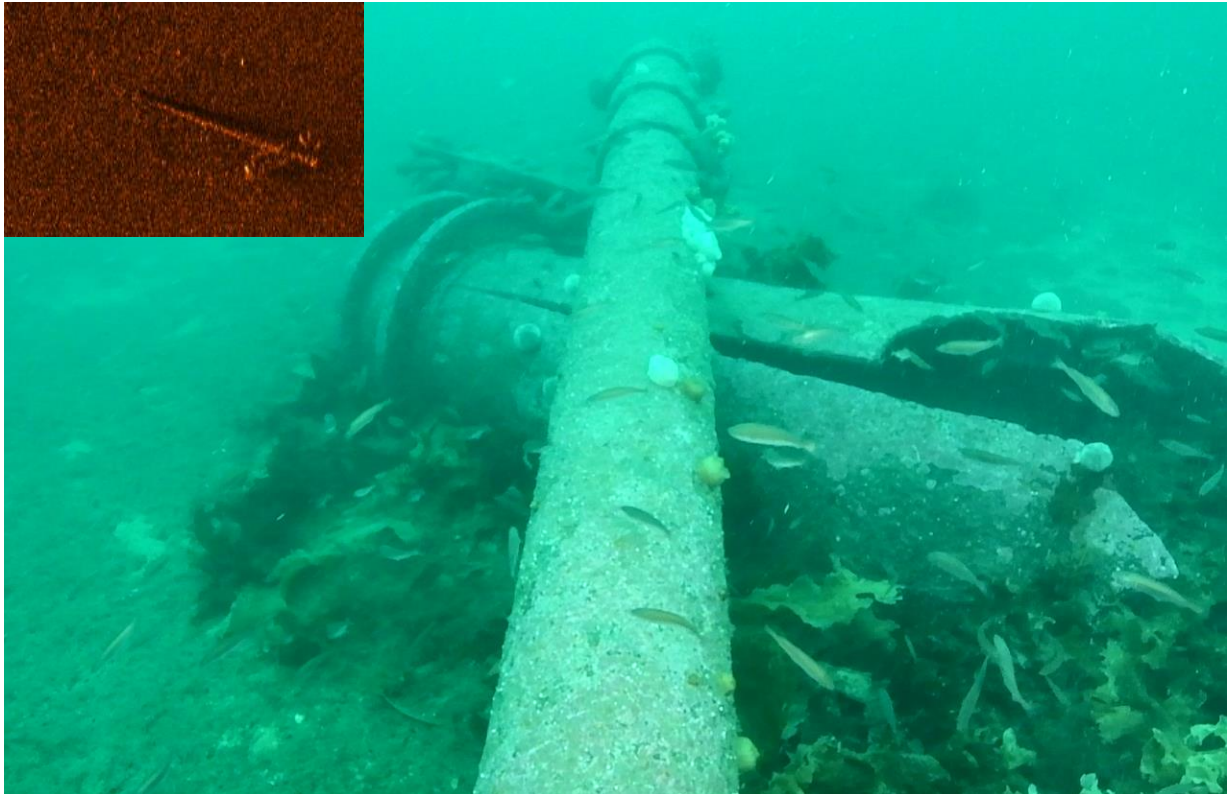
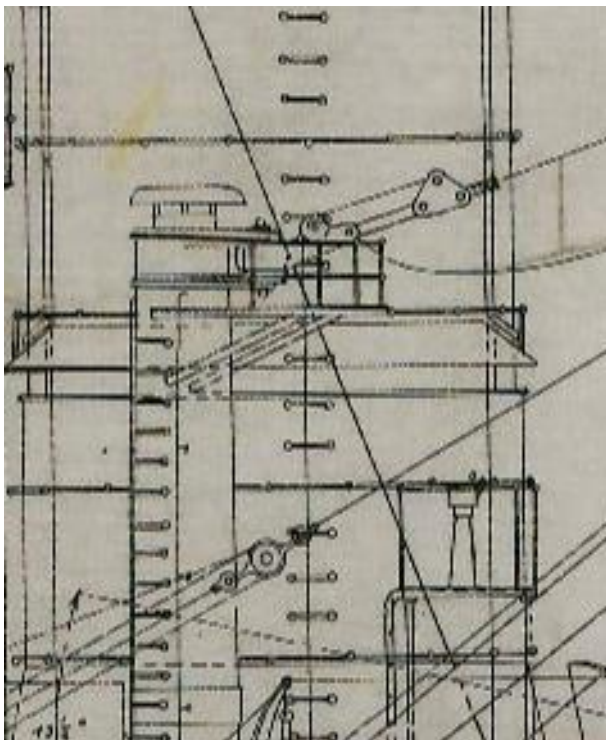
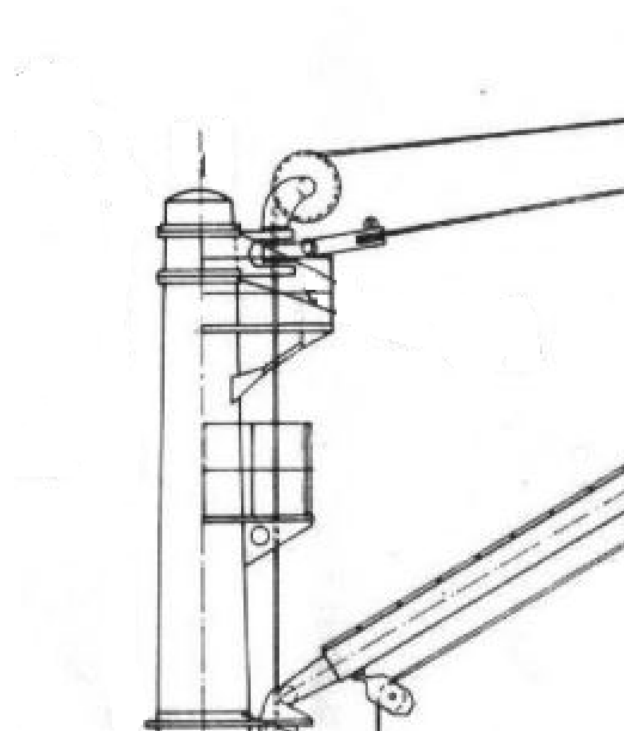
This isolated contact was located at the northern end of Gutter Sound on the “sandbar” often referred to in the salvage reports. The salvaged vessels had to be able to clear this feature in order to reach Lyness and, consequently, some work was done here to remove further any obstructions. It was surveyed by remote camera and subsequently by divers on the 9th October 2018. A samson post complete with boom was found at the site, with no other wreckage visible, which is shown alongside the side scan sonar image in Plate 86. The post showed clear evidence of blasting.

Although material from several different ships may have been left here, including from SMS *Bayern*¹⁹, further investigation showed that the style of samson post found at the site was typical of a *Kaiser* class vessel, as the arrangement at the head of the post is different to the *Bayern* class vessels (Plate 86 & Plate 87). As noted above, samson posts were missing from the primary salvage sites of SMS *Prinzregent Luitpold* and SMS *Kaiserin* (those from SMS *König Albert* are thought to be accounted for elsewhere) and this artefact may belong to one of those two vessels.

Plate 86: Side scan contact 101 (image as inset) located in Gutter Sound was a samson post and boom (top) typical of Kaiser-class vessels. Samson post detail from Kaiser-class (left) and Bayern-class vessels (right) (B. Forbes Collection).

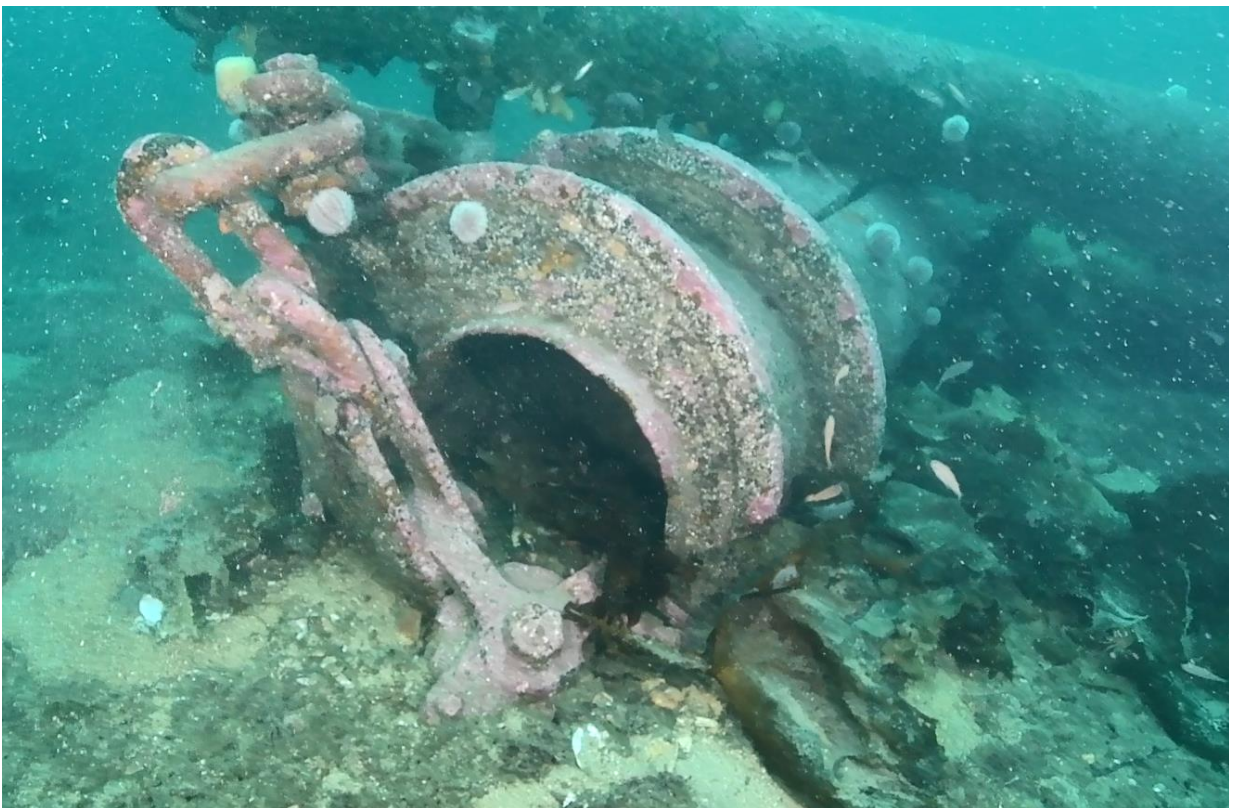
Plate 87: Top of samson post showing tri-plate arrangement, Gutter Sound.

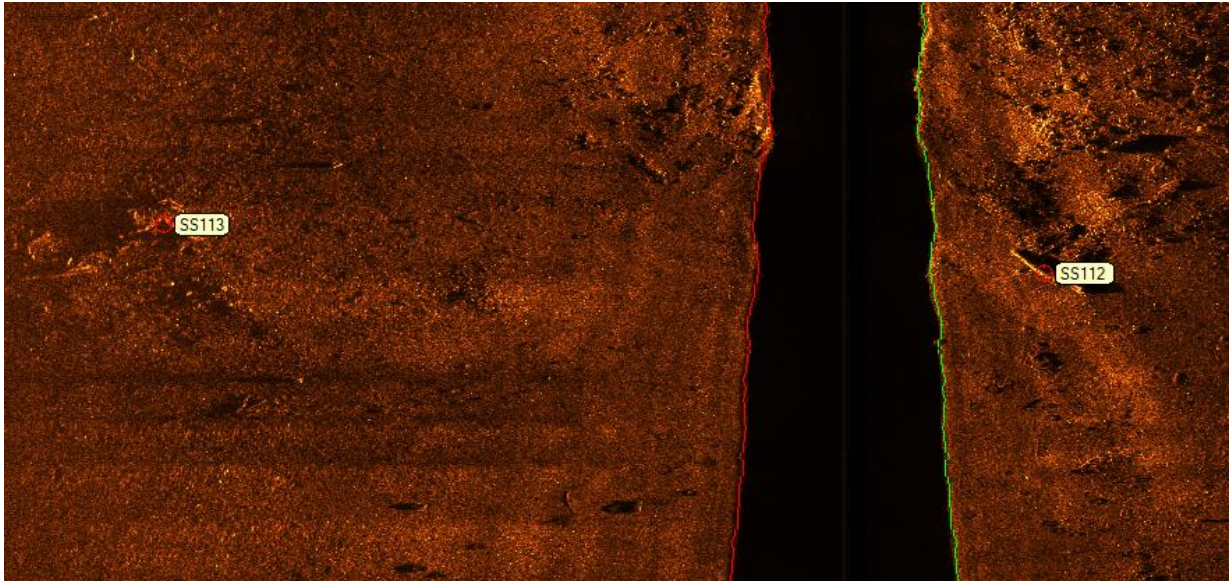
Figure 19: Side scan image of contacts SS112 and SS113 located off Lyness pier.

Two sonar contacts were detected just off Lyness pier (Figure 19) and were surveyed by divers on the 3rd and 9th October 2018. The closest one to the pier (SS112) was a mast section while the contact further out (SS113) comprised an area of metal debris consisting of a small platform, electrical wires and a short section of mast (Plate 88). As Lyness was a focal point for much of the salvage work after the ships had been raised and cleared of any obstructions that would prevent towing, it is almost impossible to say which vessel these artefacts might have originated from. Several other sonar contacts were detected nearby had been previously investigated and found to be funnel remains (Christie, et al., 2013). SMS *Moltke* was known to have caught some of its remaining superstructure on the seabed just off Lyness pier that halted the towing operation (Aberdeen Press & Journal, 1st September 1927).

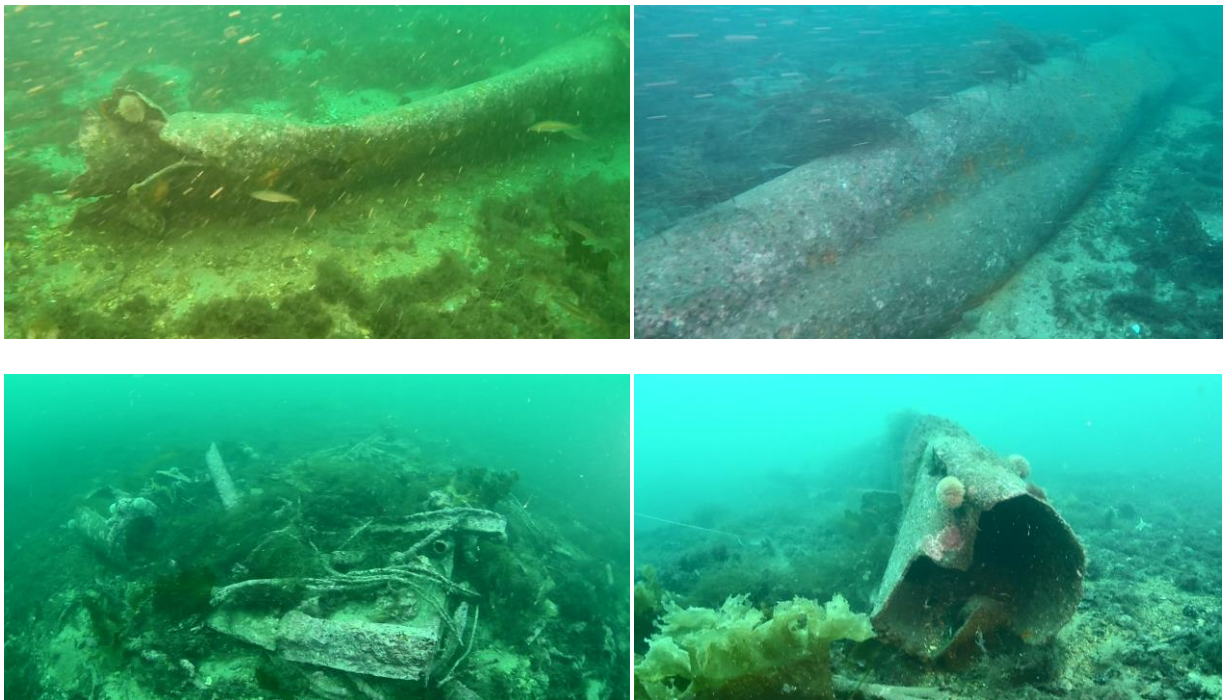
Plate 88: Remains of a mast section at SS112 (top) and the remains of a mast and mixed wreckage at SS113 (bottom).

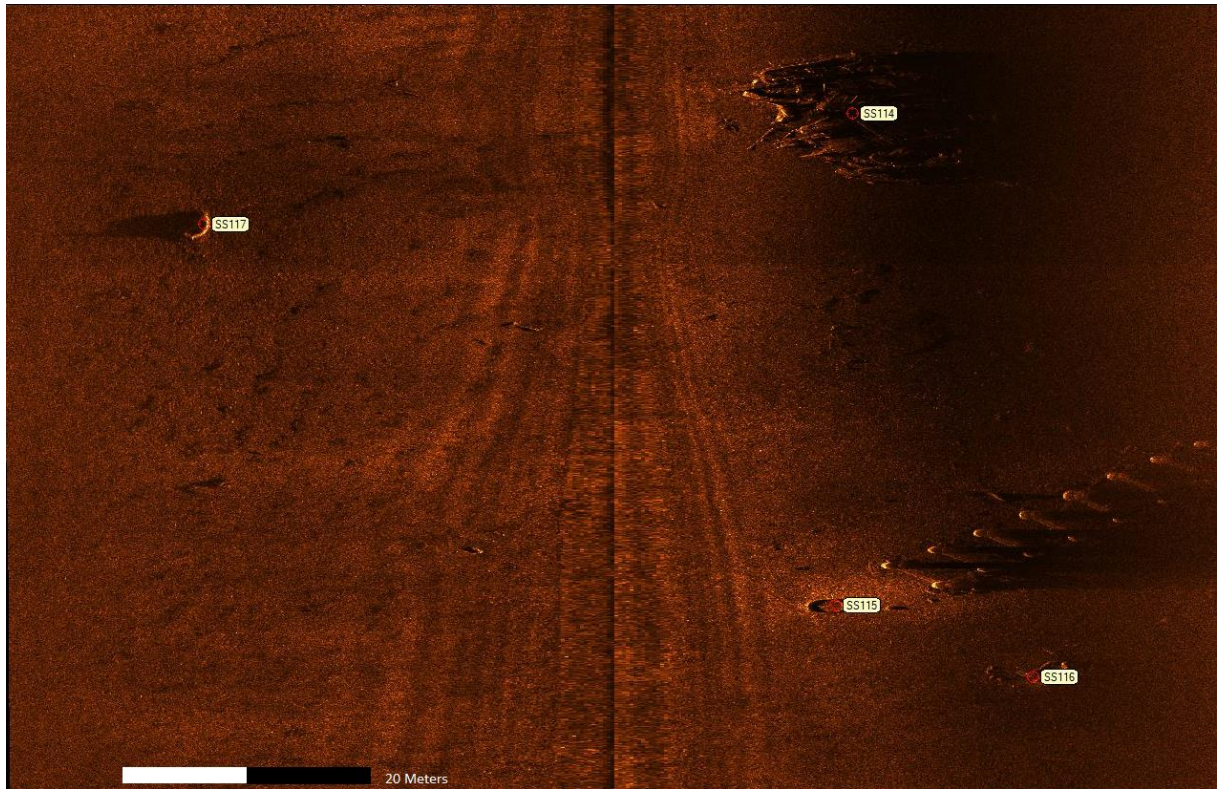
Figure 20: Side scan contacts off Rinnigal pier, Hoy.

Several sonar contacts were recorded off Rinnigal pier, located across the mouth of Ore Bay to the south of Lyness (Figure 20 & Figure 21). Although Rinnigal pier was built during World War Two by the Navy to supply its operations on Hoy, the pier and adjacent area was used subsequently by various salvage companies that worked both the German fleet and HMS *Vanguard*.

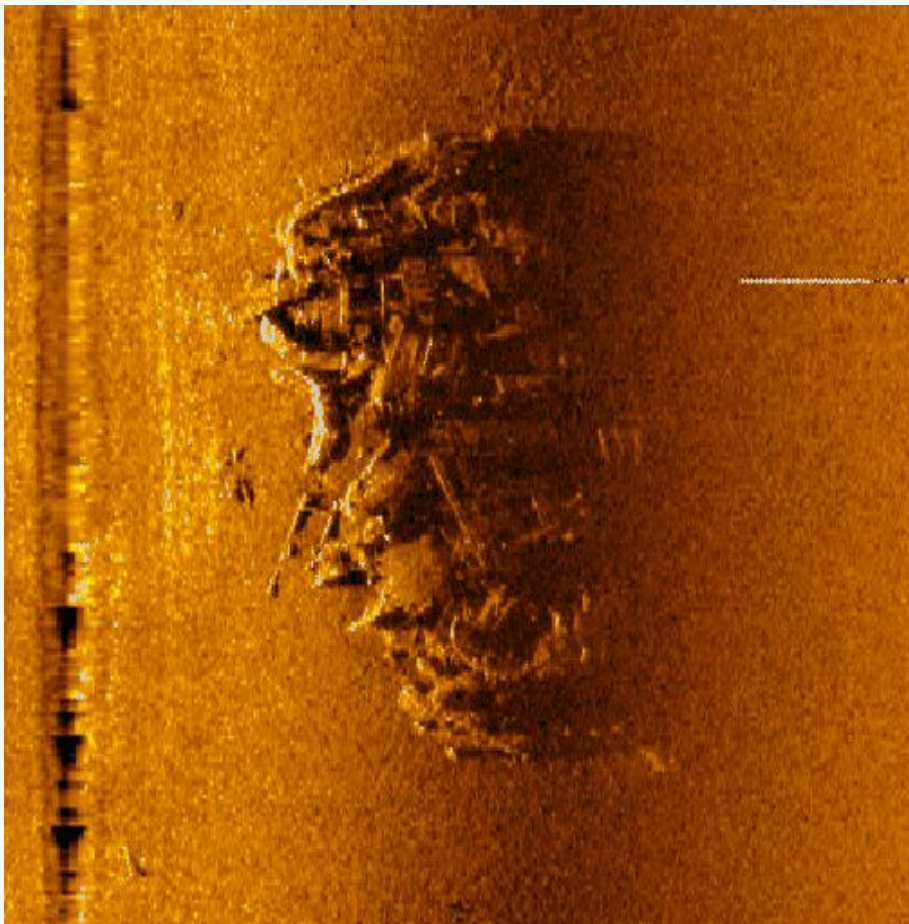
Figure 21: Side scan image of the salvage barge (SS114) located east of Rinnigal pier.

The sites were inspected by diving on the 23rd May 2018. SS114 was a previously known barge and not related to wartime activities, but is included here for completeness. It was used in the construction of the Flotta oil terminal in the 1970s and was one of two barges that sank in a gale in January 1976. The Scapa Flow Salvage Co Ltd, which at the time was undertaking salvage works on some of the remaining vessels of the High Seas Fleet, received the contract to raise both barges and hired in the German lifting barge *Roland* to do the lift. One of the barges was found to be badly damaged and a large section of this was taken to Rinnigal and sunk close to the shore to the east of Rinnigal Pier. Images of the barge taken during its salvage and of its present condition on the seabed are shown in Plate 89.

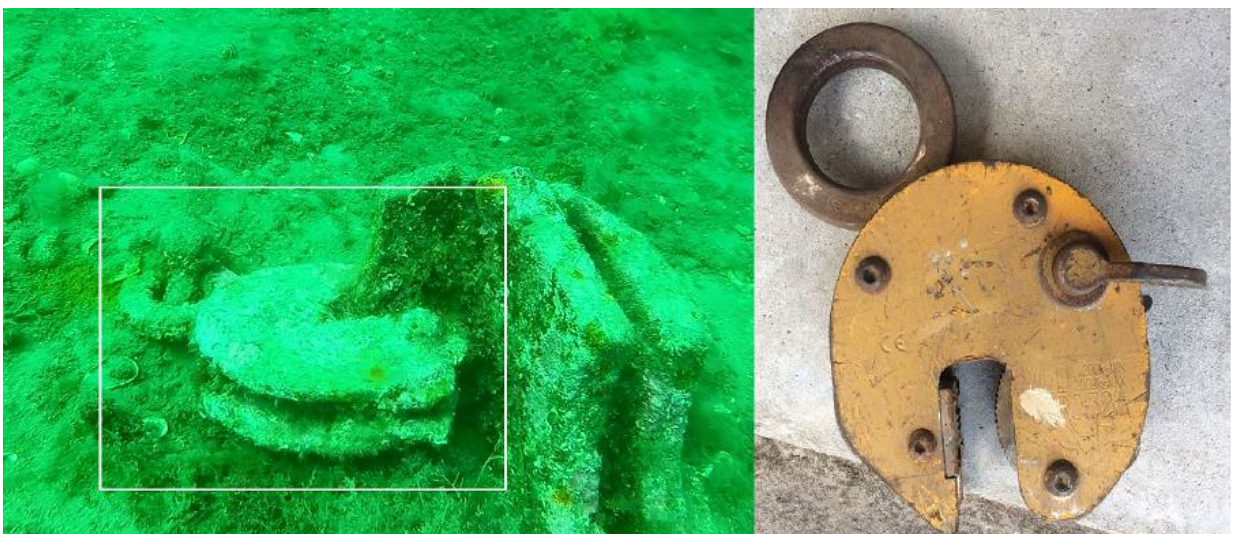
SS116 was an area of debris to the west of Rinnigal Pier and mainly comprised broken-up outer casing from turbines, which were salvaged from German vessels and cut up to access the non-ferrous turbine blades (Plate 91). The origin of this debris is unknown. One piece of casing still has some of the original salvage equipment attached: a plate clamp which was most likely used to recover this debris but was lost (Plate 92).

Plate 92: Turbine casing (left) with plate clamp attached (SS116) and an example of a similar clamp (right).

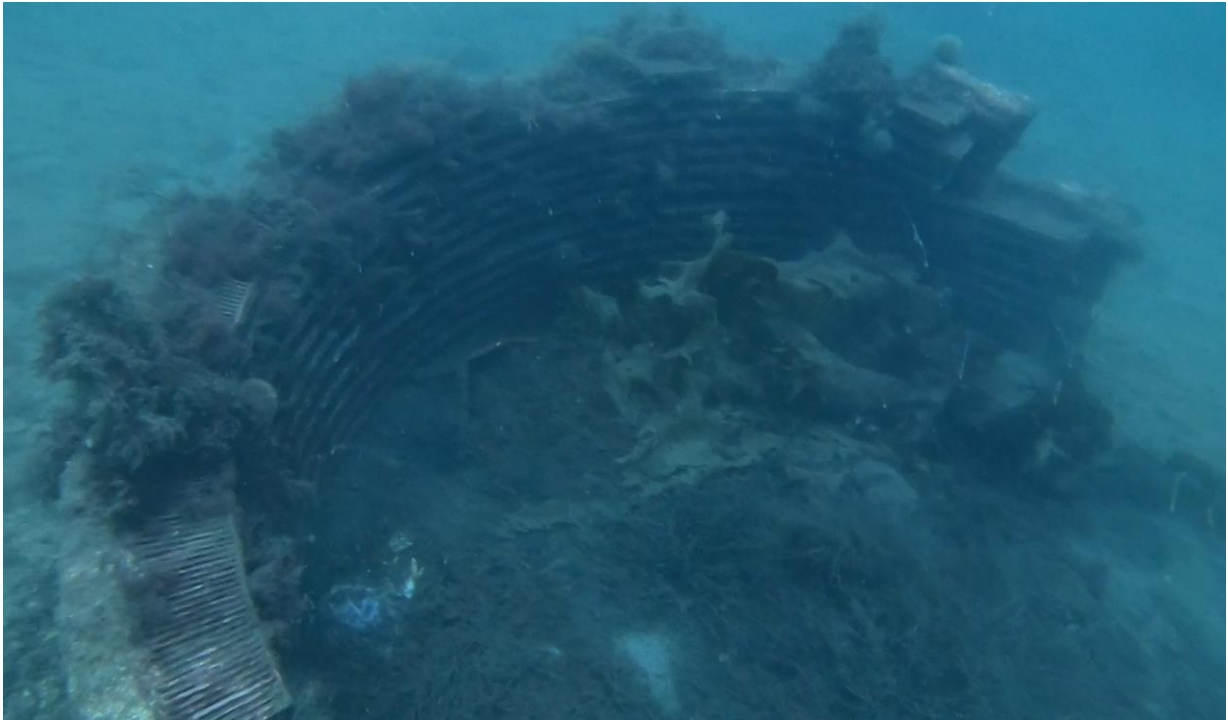
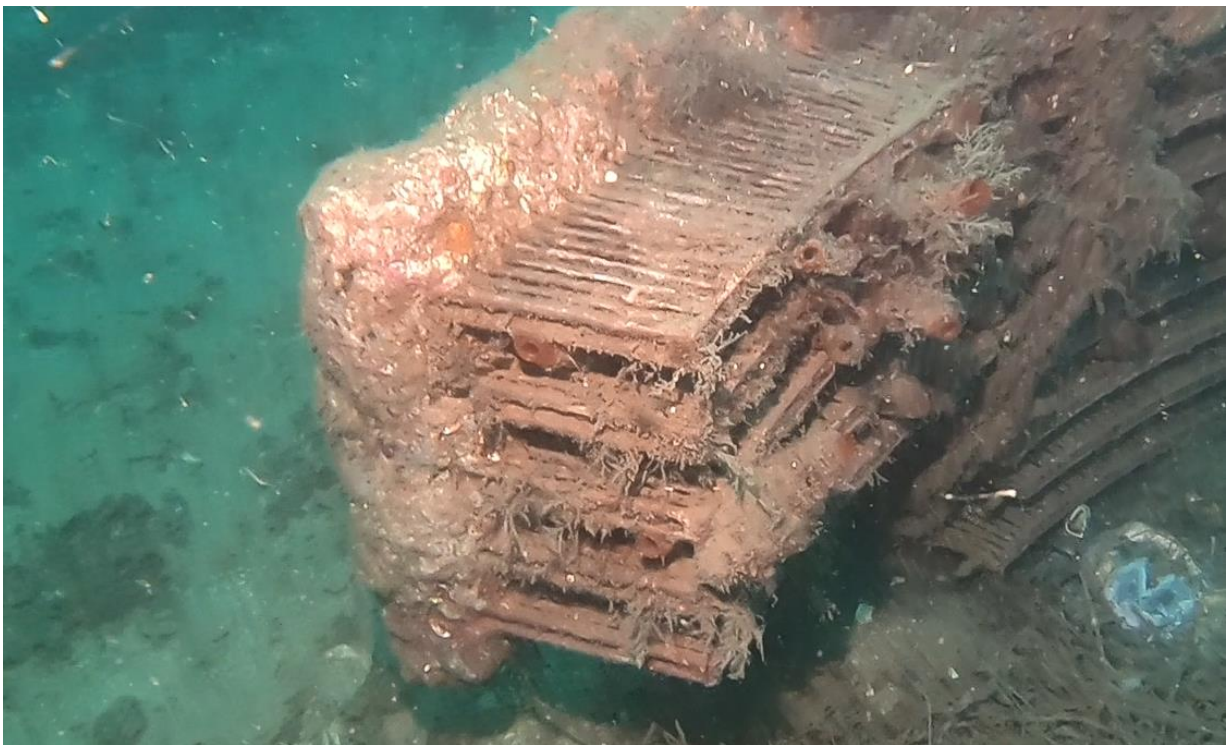
Contact SS117 was found to be half a turbine casing with most of the turbine blades still in place (Plate 93).

Plate 93: Turbine casing (SS117, top) and non-ferrous turbine blades (bottom).

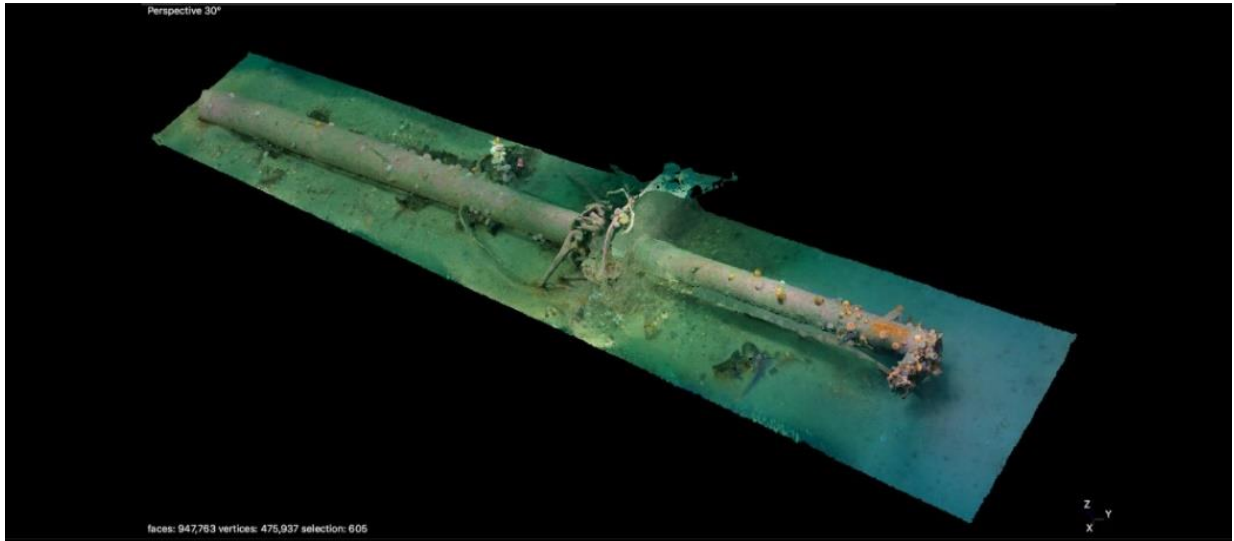
This isolated mast-like structure located west of Cava was inspected by volunteer divers in October 2018. Video footage confirmed it to be a mast and crow's nest, with the remains of a wooden top mast, most likely the aft mast of a *Kaiser*-class battleship (Plate 94 & Plate 95). Masts were usually left at the primary salvage sites, either having snapped off when the vessel settled upside down on the seabed, or later removed by divers as it would have impeded towing. As seen in the case of SMS *König Albert* however, it was possible for detached masts to remain attached to the ship by wire stays, and therefore be dragged away with the vessel. It is possible therefore that this mast may have become detached from a vessel while in tow, since it is located on the route that would have been taken from the primary salvage sites to Rysa and/or Lyness. There was no indication at the site which vessel the mast may have come from. The aft mast/crow's nest remains for most vessels included in both Phase 1 & 2 projects can be accounted for, either at their primary or secondary salvage sites. However, only a short section of aft mast was identified at the SMS *Kaiserin* primary site. It is possible therefore that the mast at SS118 is from the *Kaiserin* and could have been dragged to its present location during its tow to Rysa but further work would be required to establish this for certain.

Plate 95: SS118, still image of 3D mosaic (image courtesy of R. Priestly & A. Hatt)

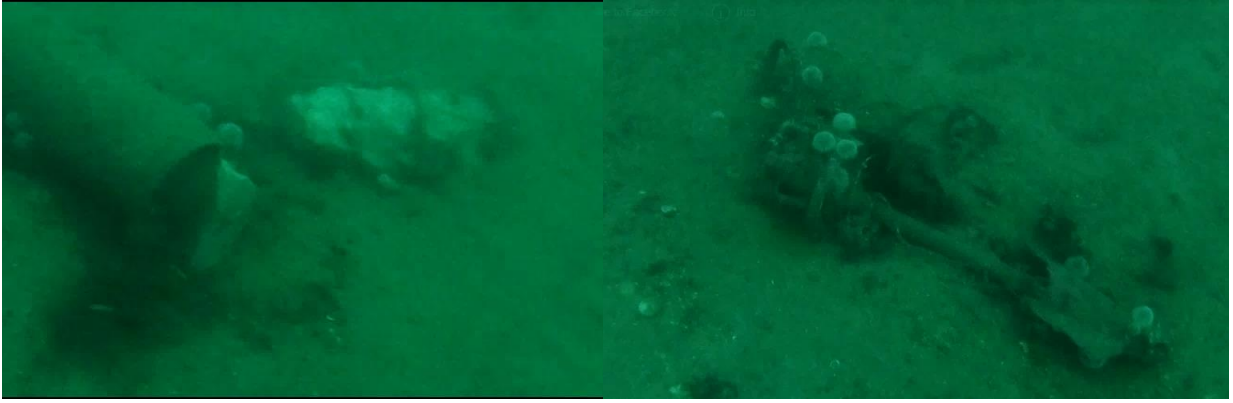
This contact was located west of Cava close to SS118, and inspected by remote video on the 31st October 2018. It was found to be the remains of a torpedo, with afterbody, air cylinder and what appeared to be a live warhead all lying in a detached state (Plate 96). No further survey work was conducted on the site and the matter was immediately reported to the Harbour Authority (OIC Marine Services) to deal with.

Plate 96: Torpedo remains at SS119, showing detached air cylinder and warhead (left) and afterbody (right).

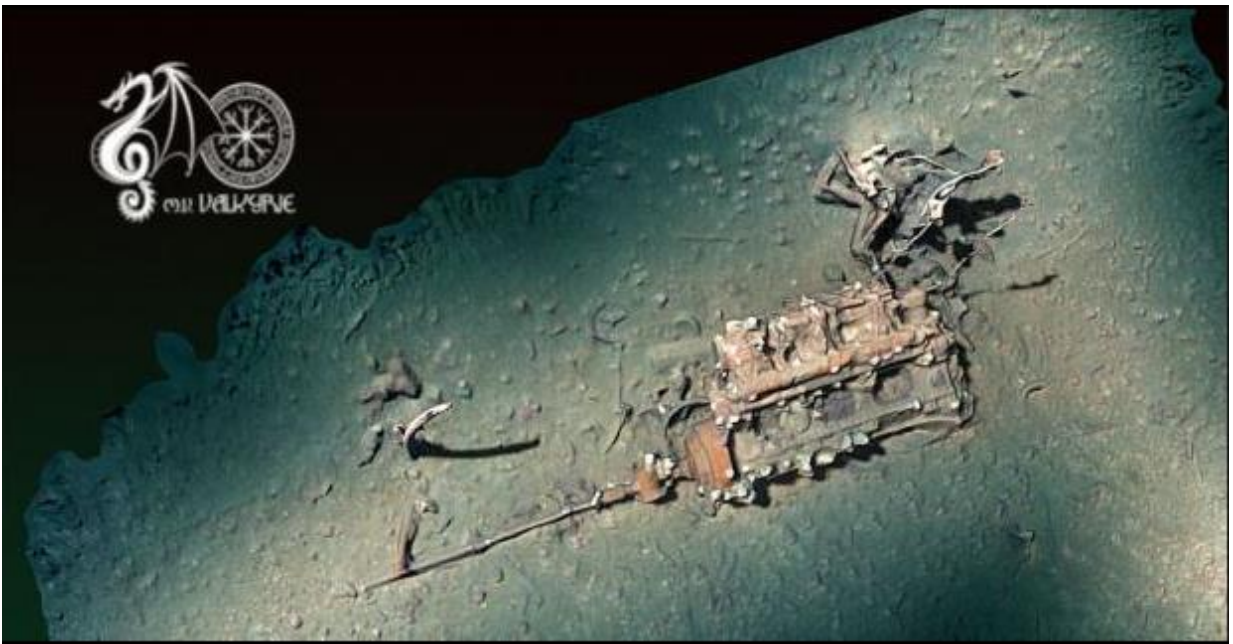
Contact SS120 was dived by volunteer diver Simon Brown off MV *Valkyrie* in May 2017 and was found to be the remains of a German diesel pinnace (Plate 97). Although broken down, all of the fixtures and fittings were laying loose around the wreck site, including half the wooden ships wheel, the brass wheel hub, six portholes, two of which had fallen into the engine, and the prop shaft (but no propeller). A brass shell case was also found nearby but it was not clear if this was associated with the pinnace.

Plate 97: Still image of German pinnace diesel engine (SS120) taken from a 3D model (image courtesy of S. Brown, 3Deep).
