Scapa Discovery: Archaeology in the Flow

A survey of the site of the remains of an unknown pinnace near Lyness.

Author: Bob Anderson, Jo Porter

December 2014

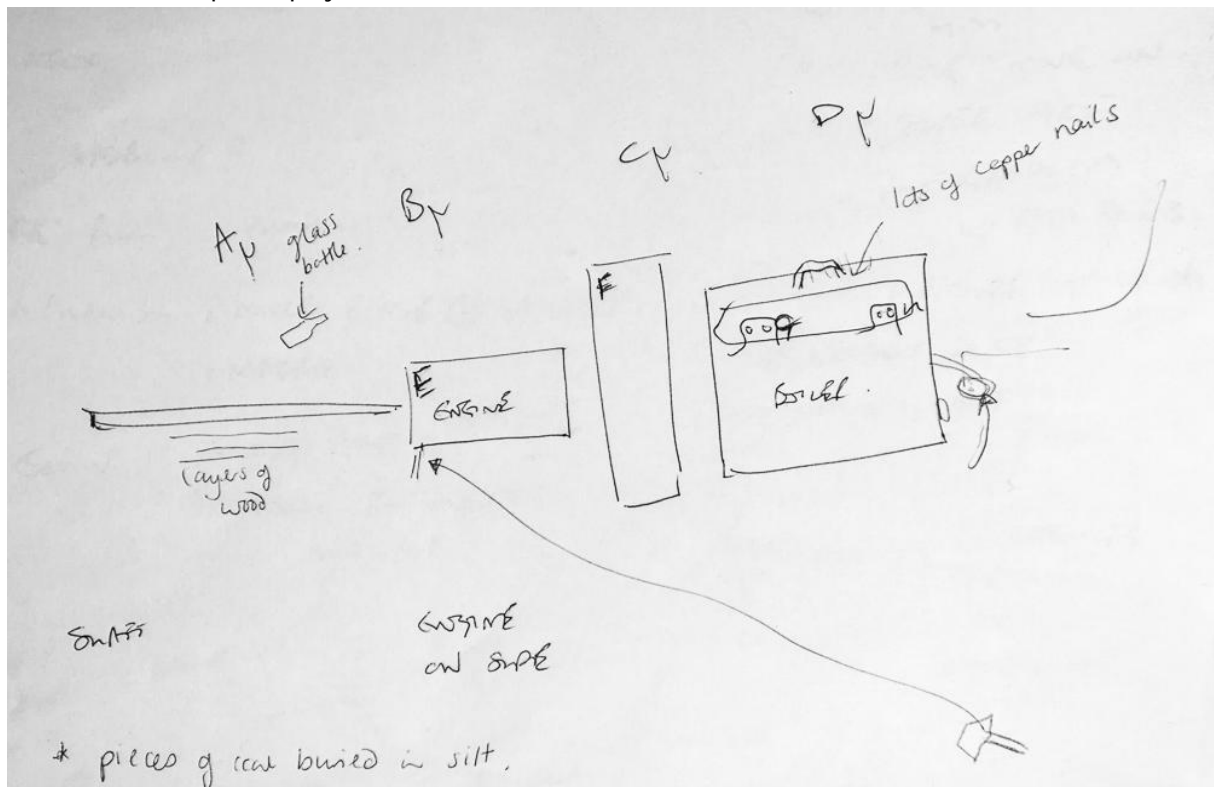
Image 1. Map showing relative position of datum and measurement points.

The points A,B,C,D were datum points marked using steel pins about 2ft long that were hammered into the seabed. The points E,F,G,H were prominent points on the wreckage.

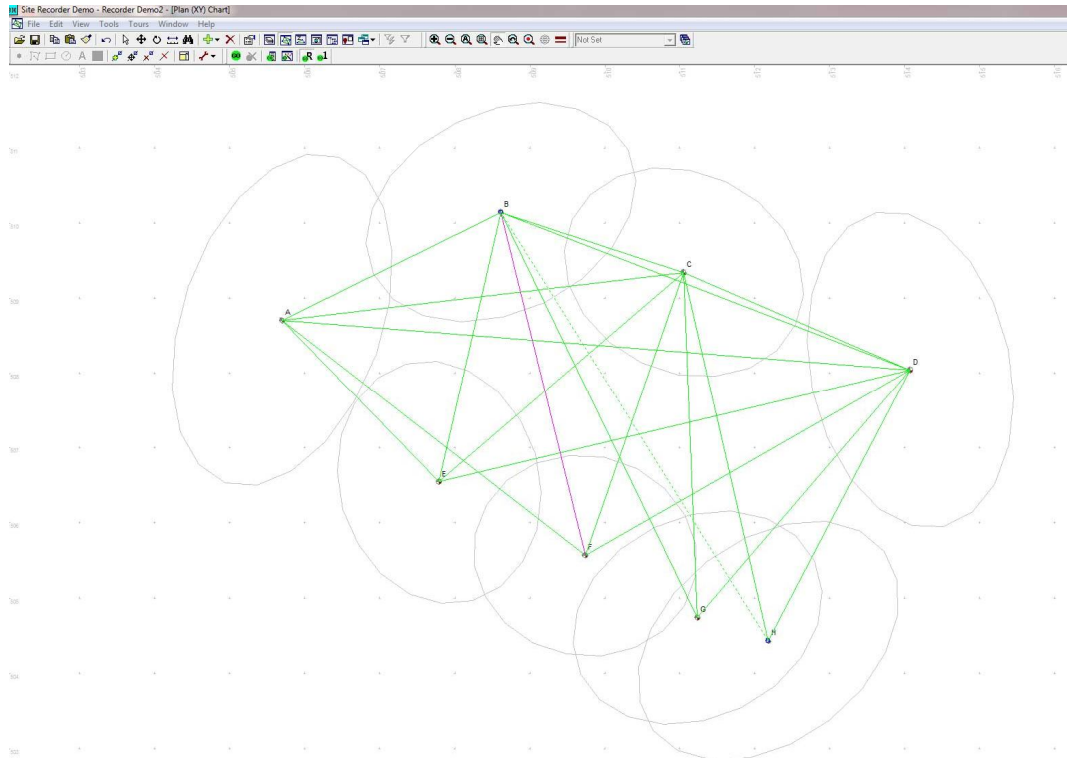
Image 2. The results from the Site Recorder software.

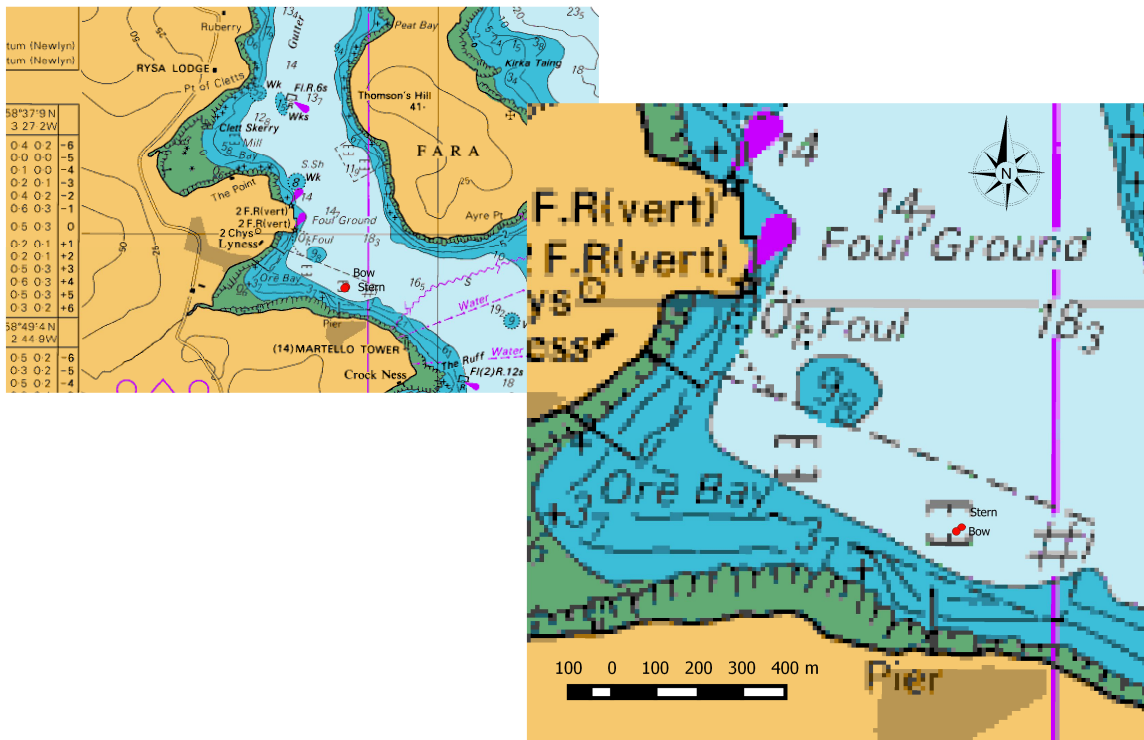
Image 3. A map showing the position of the pinnacle wreck site.

Further work is needed to develop a working protocol for taking a more accurate position of an object up through the water column to a recording device on the surface and eliminate parallax error.

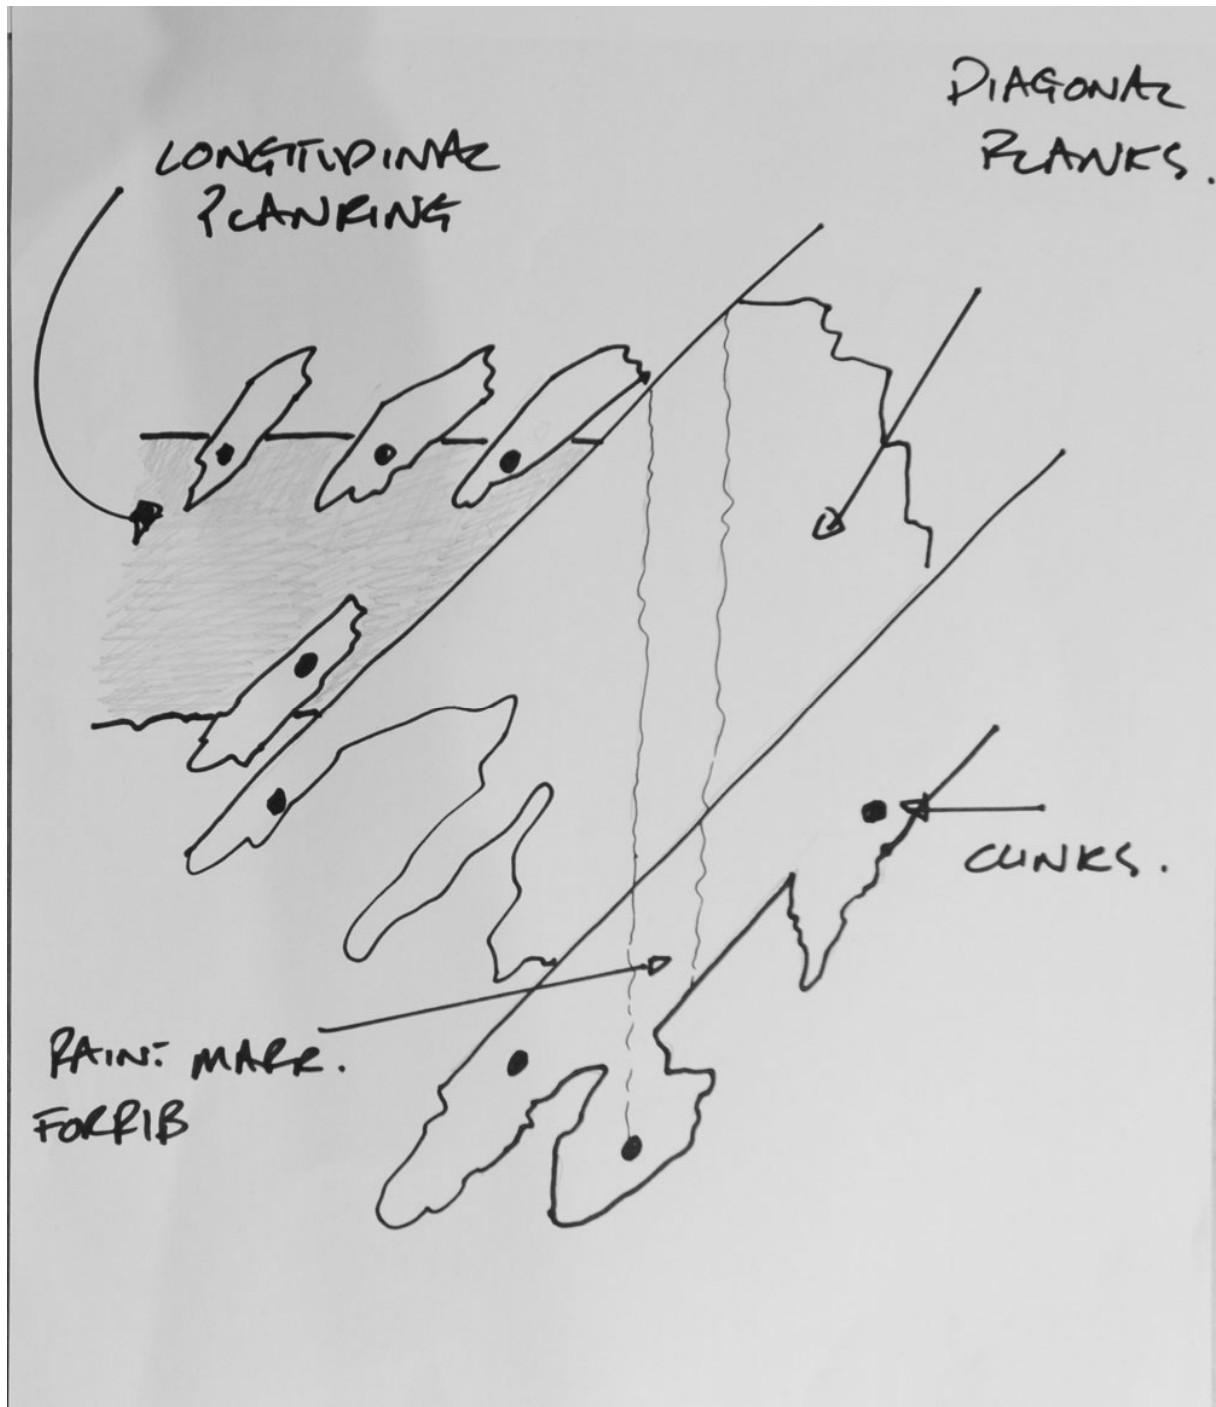
Image 8. A sketch of the photomosaic image of the hull close up to highlight relevant features.

This form of hull absorbs bumps well and gives a relatively lightweight robust construction. In addition, the hull stays watertight despite the boat remaining out of the water for considerable periods of time and in often in hot weather which would have caused the planks to shrink and thus leak in other forms of construction. However, when damage is done, it is complicated both to find and to repair.

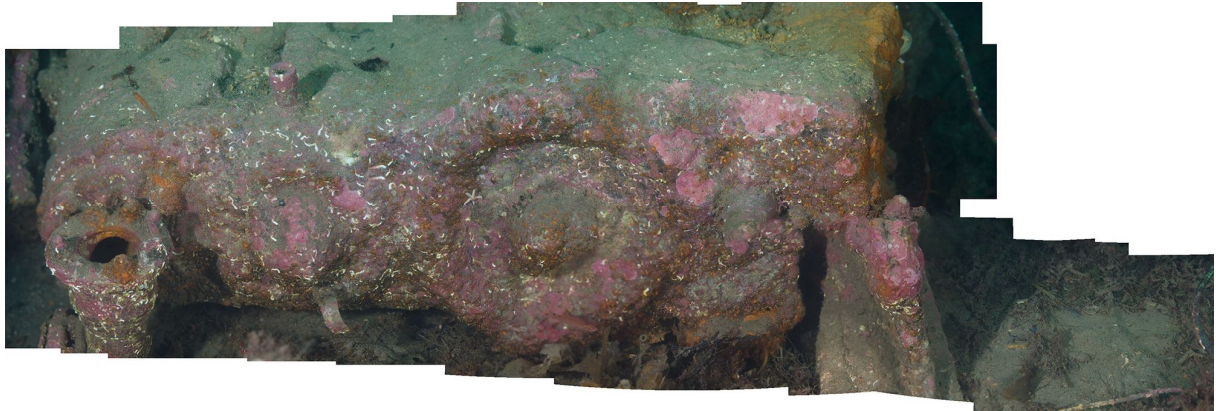
Image 9. A photomosaic of the top of the cylinder block on the engine. This is the small image size, the full size version can be found in the files section of 11. Appendix 2.

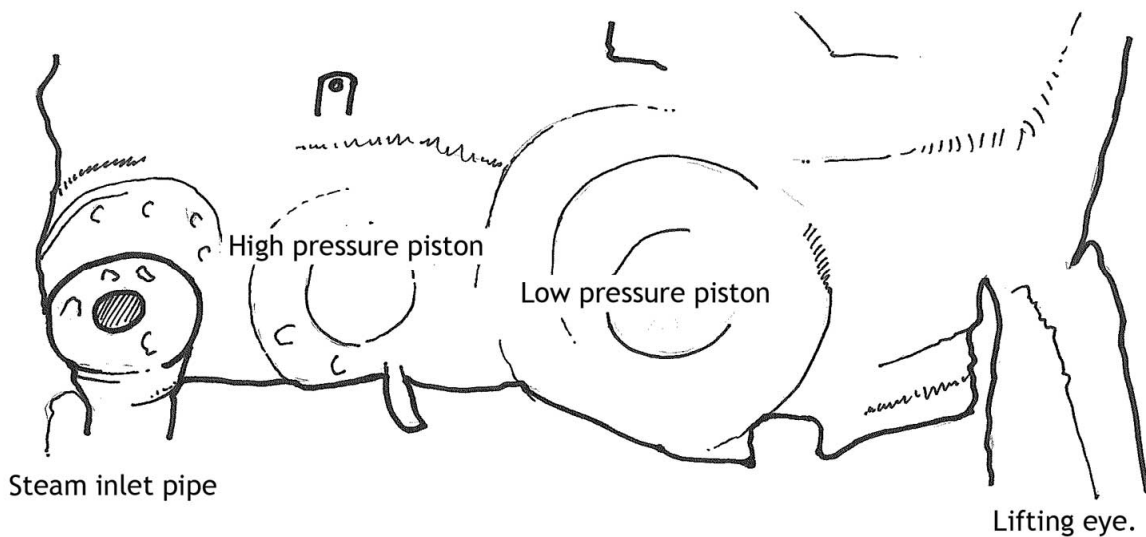
Image 9a. An explanation of Image 9, the top of the engine photomosaic..

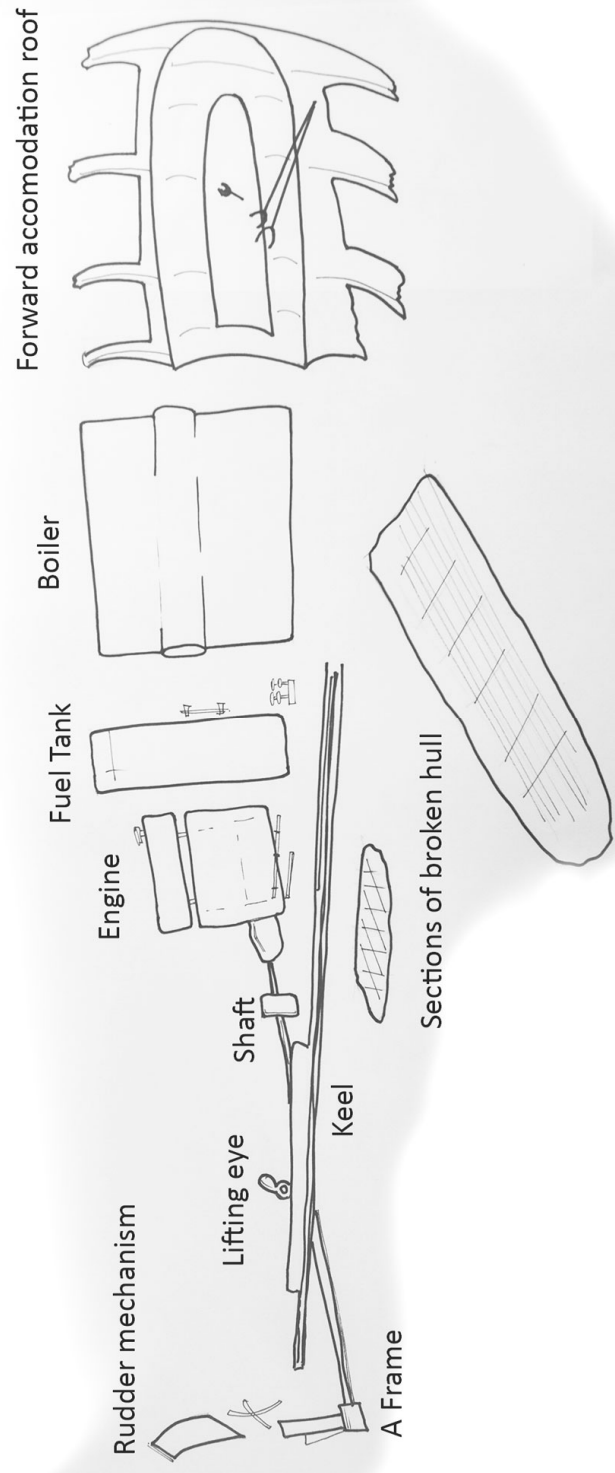
Image 10. Site Map 1: Site map made during Dive 1 by Team 1 during Site Recorder exercise labelled to show important wreck features.

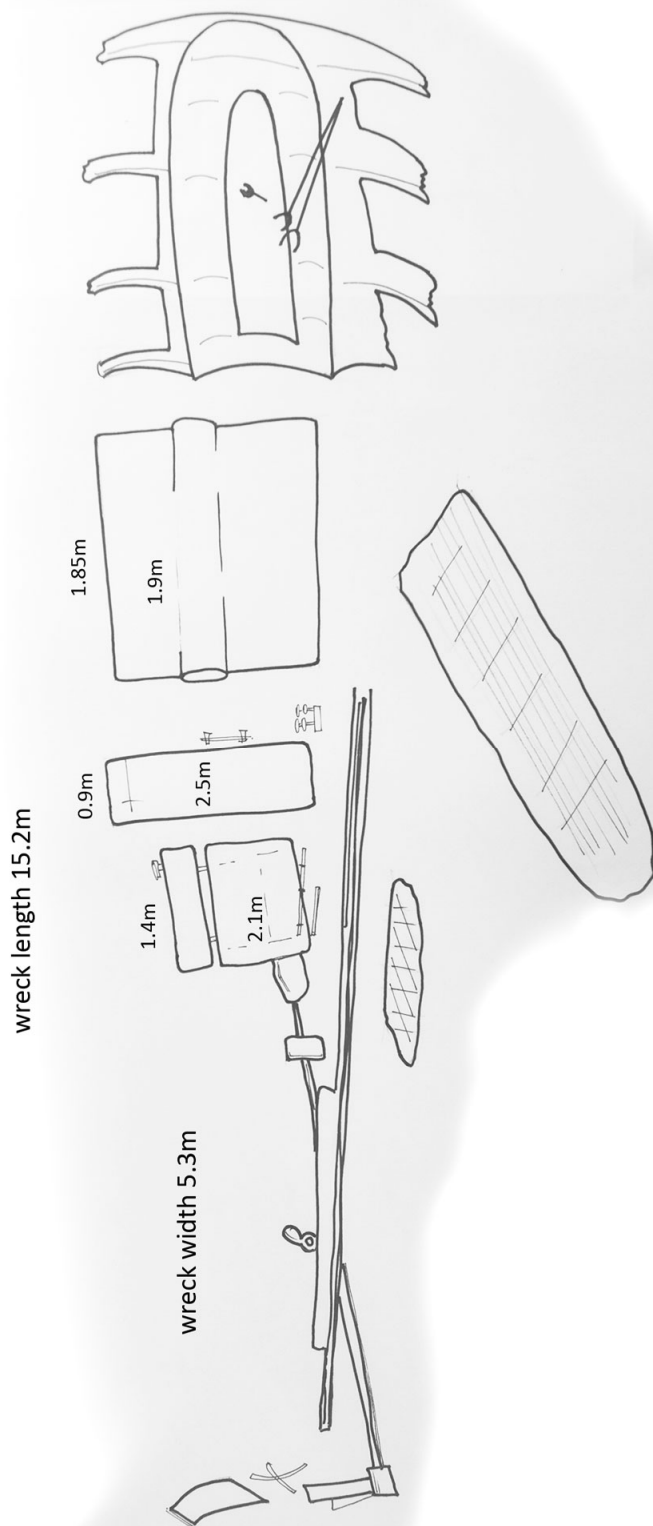
Image 11. Site map 2: Site map made during Dive 1 by Team 1 during Site Recorder exercise labelled to show dimensions of important wreck features.

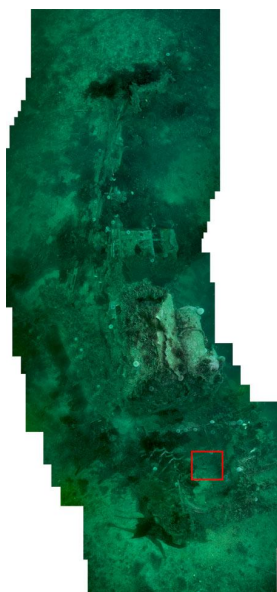
Image 12b: The red box marks the area enlarged to produce the spanner image.

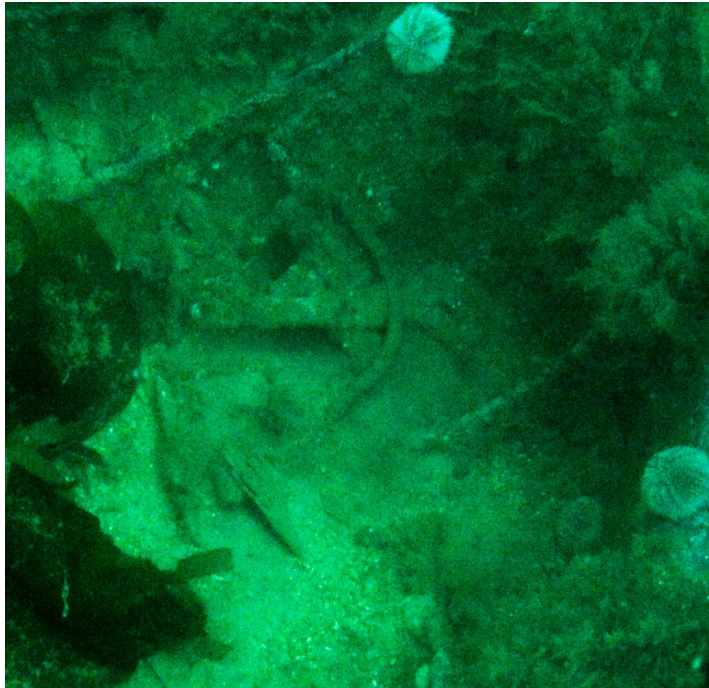
Image 12c. The image of the spanner at 100% zoom from the full size mosaic.

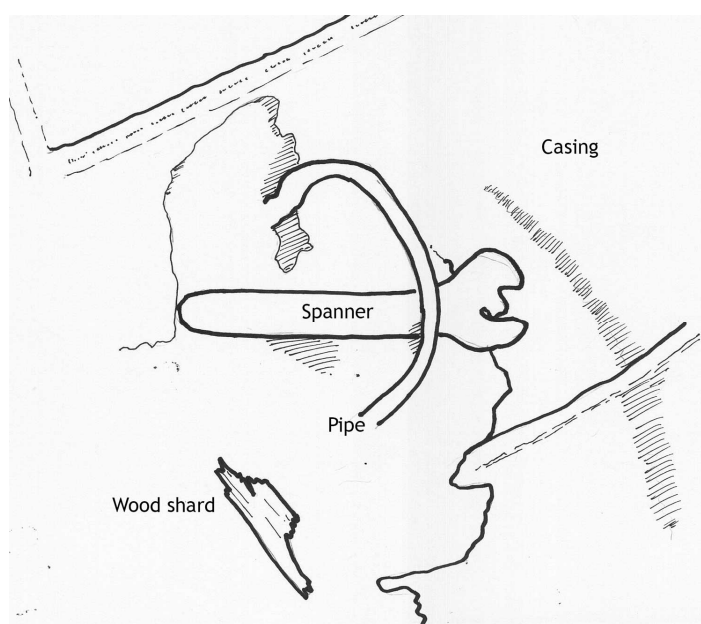
Image 12d. Detail from the spanner Image 12c. above.

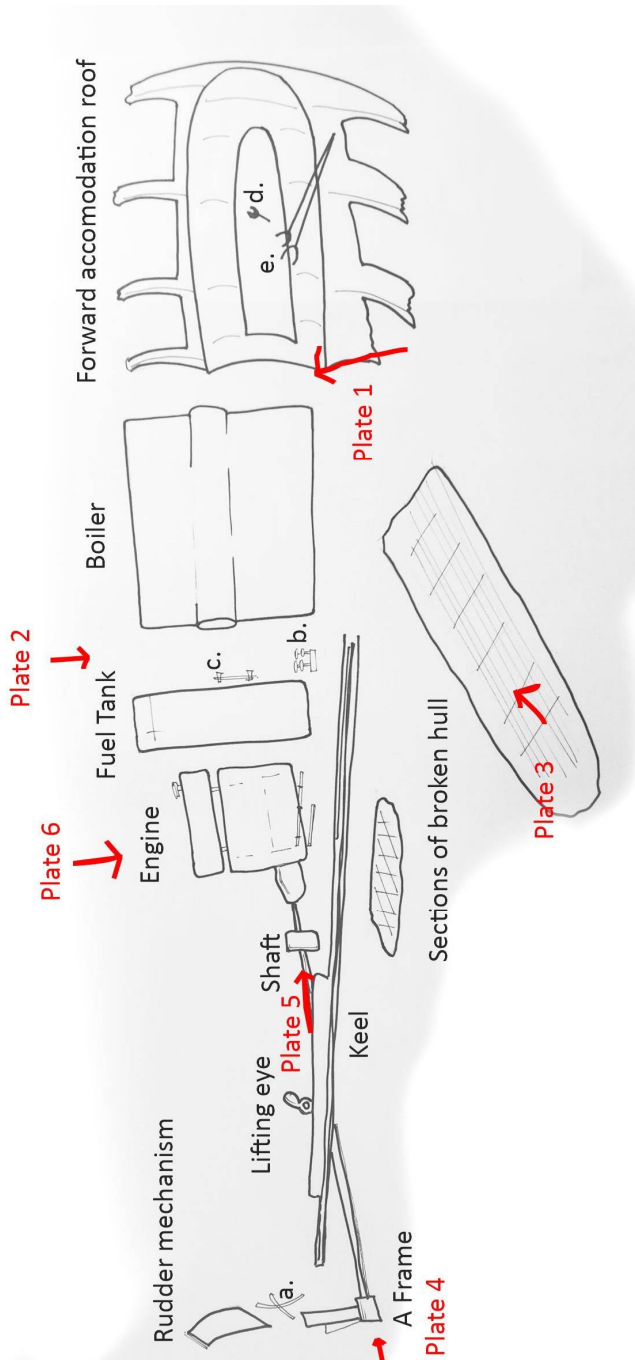
Image 13. Site map to show location of camera for wide angle panorama photographs shown below. Key: (a) Brass rubbing strips from the transom, (b) valve chest, (c) pump, (e) unknown structure that resembles a metal crutch, (d) spanner.

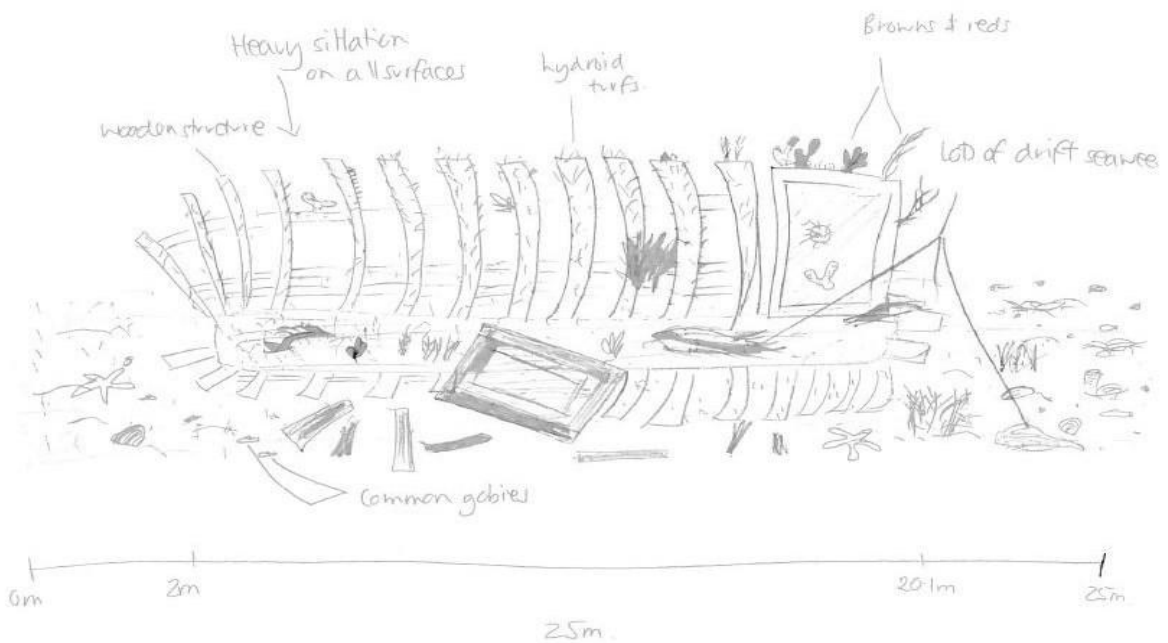
Image 24. Sketch by Rebecca Grieve (RG)

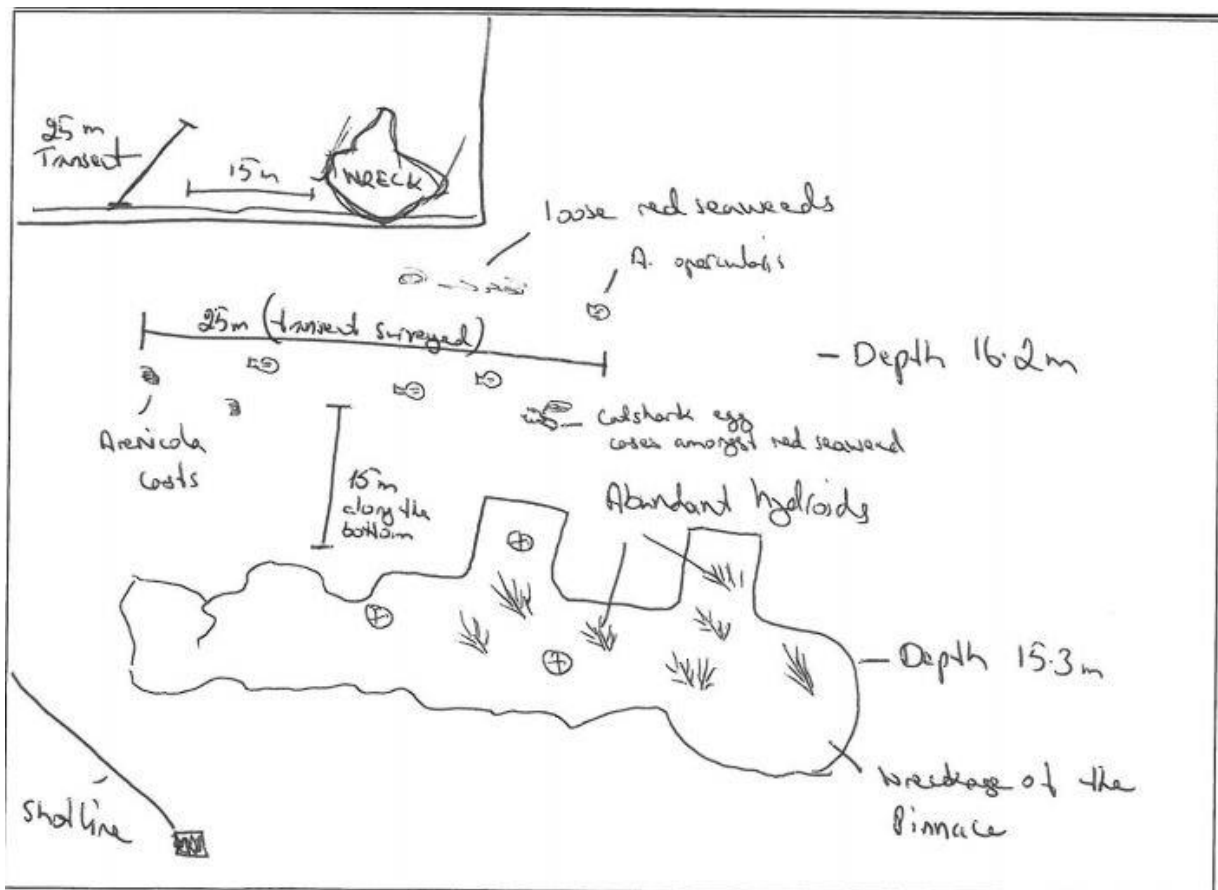
Abundant pink encrusting alga present on the surface of the wreck, with a dense hydroid turf. Sea urchins were common as was red seaweed cover.

Image 25. Sketch by Jenni Kakkonen (JK)
