Excavation and Recovery of the Carpow Logboat, Perth and Kinross.

Data Structure Report

David Strachan BA MIFA FSA Scot

February 2007

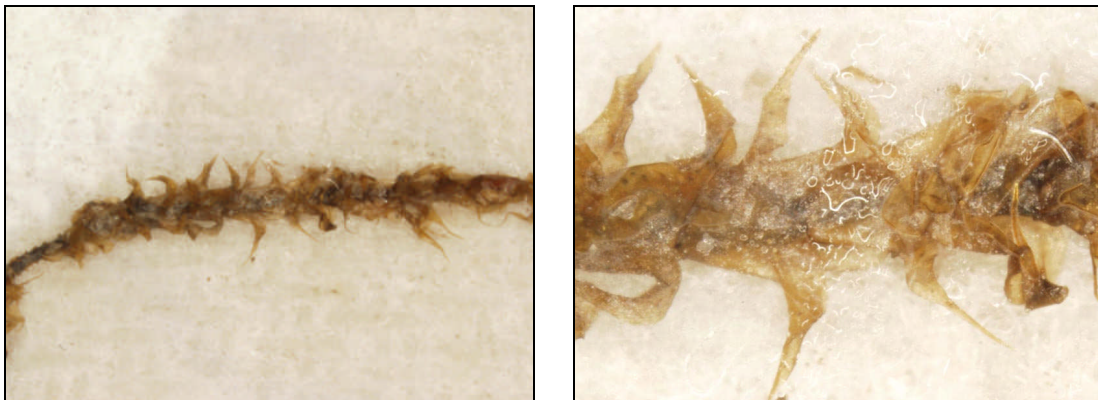
Illus 22: Detail of the moss caulking from the inner transom groove.

The *in situ* moss caulking from the inner transom groove has been identified by Dr David G. Long, Bryology Section of the Royal Botanic Garden, Edinburgh, as *Rhytidiadelphus squarrosus* (Hedw.) Warnst., or 'Springy Turf-moss' (Illus. 22). It is a very common moss of disturbed grassland, heathland, upland woods and usually with an acid soil.

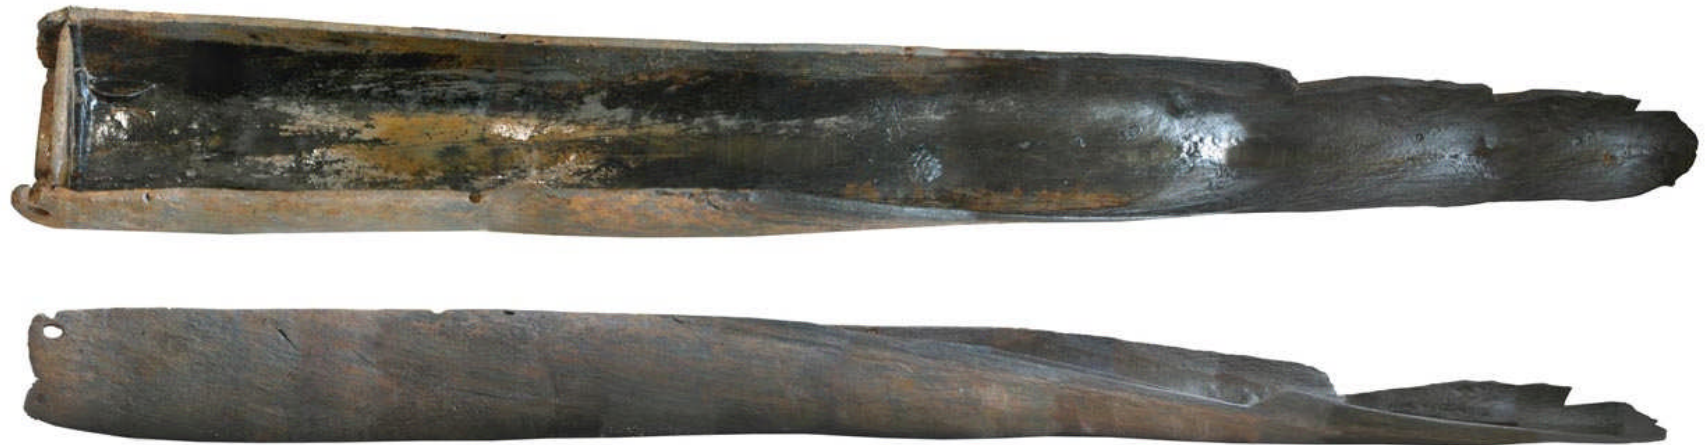
There are two significant basal splits in the hull (F26 A and F26 B) both originating at the stern (Illus. 23). In addition to the possible repairs to the stern discussed above, split F26 B has a total of seven repairs over the length of the hull, taking the form of small patches of tar-like material, possibly tree-sap, which has been applied to the split. Notably F5 to F9 are all roughly equally spaced, which may suggest that they were contemporary. Of these F9 is exceptional in its size and appears to have been made up of several patches applied over time.

Feature No.	Description	Measurement
F1	group of three (?) dimples A-C. A is much more prominent.	A: 45mm diameter, 12mm deep B: 45mm diameter, 4mm deep C: 50mm diameter, 3mm deep
F2	knot with hairline crack running towards prow. Knot is evident on outside of the vessel.	350mm diameter
F3	possible raised feature. Darker in colour than surrounding wood. Trapezoidal in shape.	90mm (vertical) by 50mm and 70mm (horizontal)
F4	pronounced knot. Raised on inside of vessel, hollow on exterior.	170mm diameter, 30mm raised (interior) 120mm by 80mm, 50mm deep (exterior)
F5	resin repair (along basal split). Pronounced repair, sub rectangular in shape.	140mm by 70mm, 30mm raised (distance between F5 and F6: 240mm)
F6	resin repair (along basal split). Sub circular in shape.	60mm in diameter, 10mm raised (distance between F6 and F7: 250mm)
F7	resin repair (along basal split). Amorphous in shape.	80mm by 50mm, 15mm raised (distance between F7 and F8: 290mm)

F8	resin repair (along basal split). Sub circular in shape.	40mm in diameter, 4mm raised (distance between F8 and F9: 240mm)
F9	resin repair (along basal split). Large repair. Sub circular. Made up of smaller composite repairs.	230mm by 180mm, 30mm raised
F10	'plug' feature. Possible gauge hole. Circular in shape. Raised circumference and depressed centre.	50mm by 40mm
F11	resin repair. Sub circular in shape.	35mm by 20mm, 5mm raised
F12	resin repair. 'Figure of 8' in shape.	40mm by 30mm in shape
F13	various linear marks – possibly excavation damage	
F14	possible repair made up of accreted material on the inside of vessel.	40mm by 50mm, raised 7mm Position: 400mm down from top of strake
F15	resin repair on basal split.	40mm by 50mm, raised 5mm
F16	support/mount (?) feature at stern of vessel (port side)	390mm by 130mm, maximum height 90mm
F17	support/mount (?) feature at stern of vessel. (starboard side). Top of support has been sheared off.	380mm by 130mm, maximum height 80mm

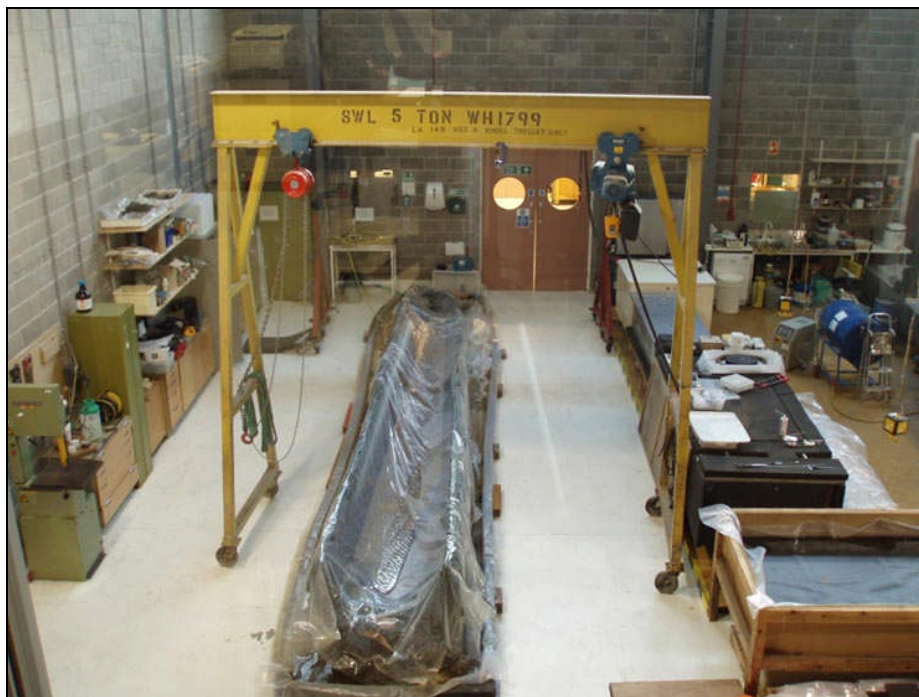
The initial stages of conservation of the log-boat are now almost completed. The main emphasis of work over the past few months has been to facilitate the recording of the log-boat and to carry out the analytical work needed to assess its condition. This has meant keeping the log-boat accessible, and yet maintaining it in a wet state. This has been accomplished, very successfully, using “leaky” hoses and capillary matting to distribute tap-water over the whole surface of the boat. A small pump and float switch are used to pump out the tap-water from the bund housing the boat into the drain. This continuous washing will also effectively desalinate the wood (Illus. 26).

Illus 26: The logboat in the Granton laboratory.

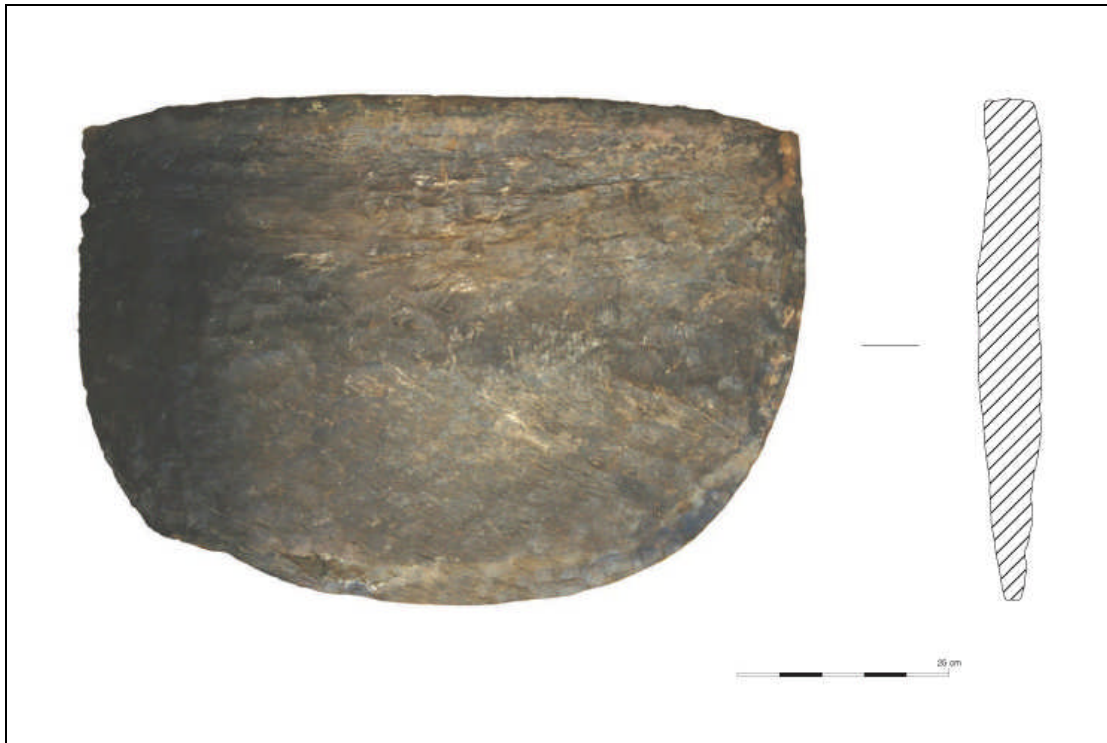
The cleaning has been successful in revealing well-preserved tool-marks on the transom board. These are of a form and shape consistent with a Bronze Age date for the boat, being narrow and short (Illus. 28). It also revealed quantities of moss in the gap between the transom and the hull, as well as details of the slot(s) into which the transom was fitted.

Illus 28: The removed transom showing wood-working detail.

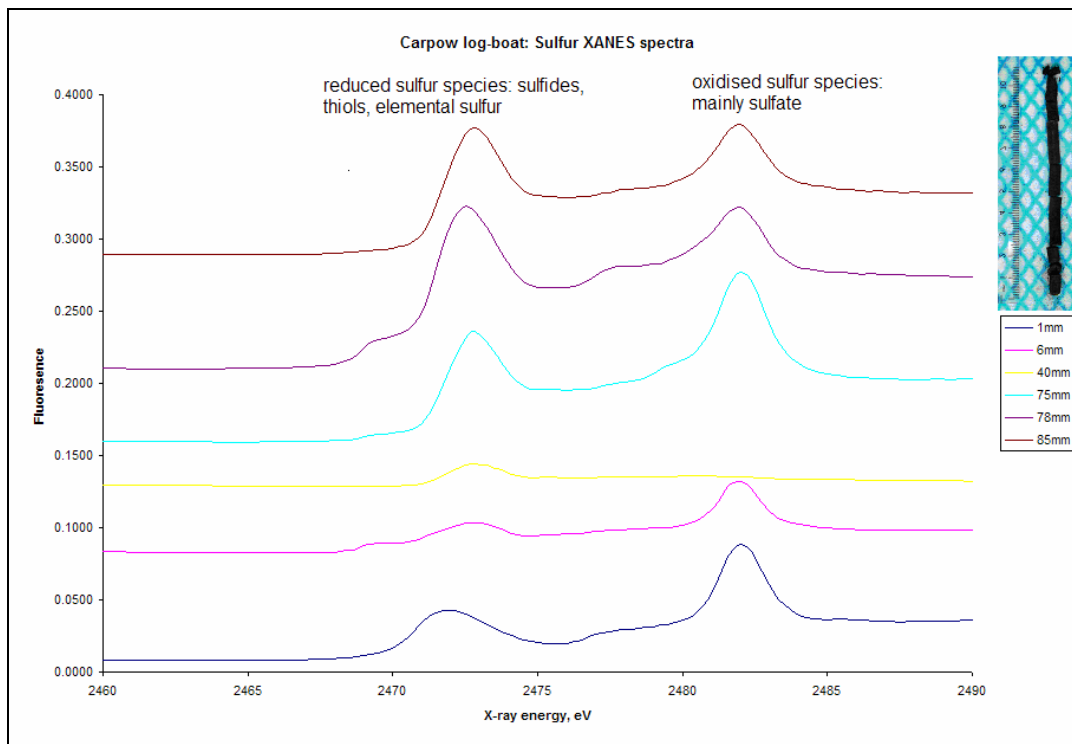
The spectra shown in Illus. 29 and 30 are for one core, and show the relative amounts of reduced and oxidised sulfur compounds at various depths. The relative height of the lines gives an indication of the total sulfur content. The results indicate that the reduced sulfur species are more prevalent on the outside of the boat, but there are some on the inside of the hull. The centre of the hull, at a depth of 40mm, shows very little sulfur compared to the near-surface sample spots.

There is a significant possibility that these compounds will oxidise into sulfuric acid once the conservation process is complete, although it may take several years for the problem to become apparent, as happened with the Swedish warship the *Vasa*. However, NMS have been working on this problem, in collaboration with the Mary Rose Trust, and have found at least one potential solution: treatment with calcium phytate. This is a compound found in seeds, and acts as an iron-chelating agent to prevent oxidation in the seeds, enabling them to remain dormant and viable for considerable periods of time. Results with a modern respirometer indicate that treatment of marine wood with low levels of calcium phytate dramatically reduce the oxidation rate, and should prevent acid generation. This treatment may be easily incorporated in the PEG impregnation phase.

Illus 29: X-ray absorption sulfur near-edge spectra of a core from the log-boat showing the types and relative amounts of sulfur compounds at various depths within the wood.
