Halligarth

Site Survey Report

RCAHMS was asked to undertake a survey of Halligarth, Unst, Shetland by the National Trust for Scotland in spring 2014. The building is listed and currently on the Buildings at Risk Register which also meant that it was a candidate for investigating as part of RCAHMS' Threatened Buildings Survey.

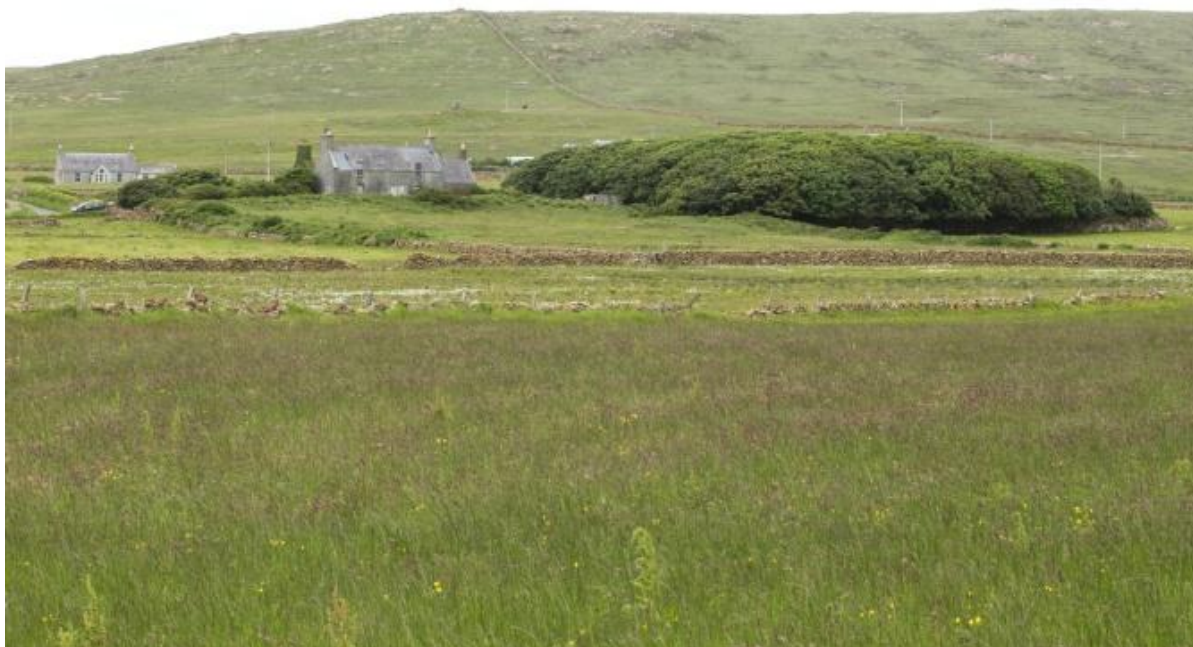
Distant view of Halligarth House from south, with wood to north east (RCAHMS: DP194673)

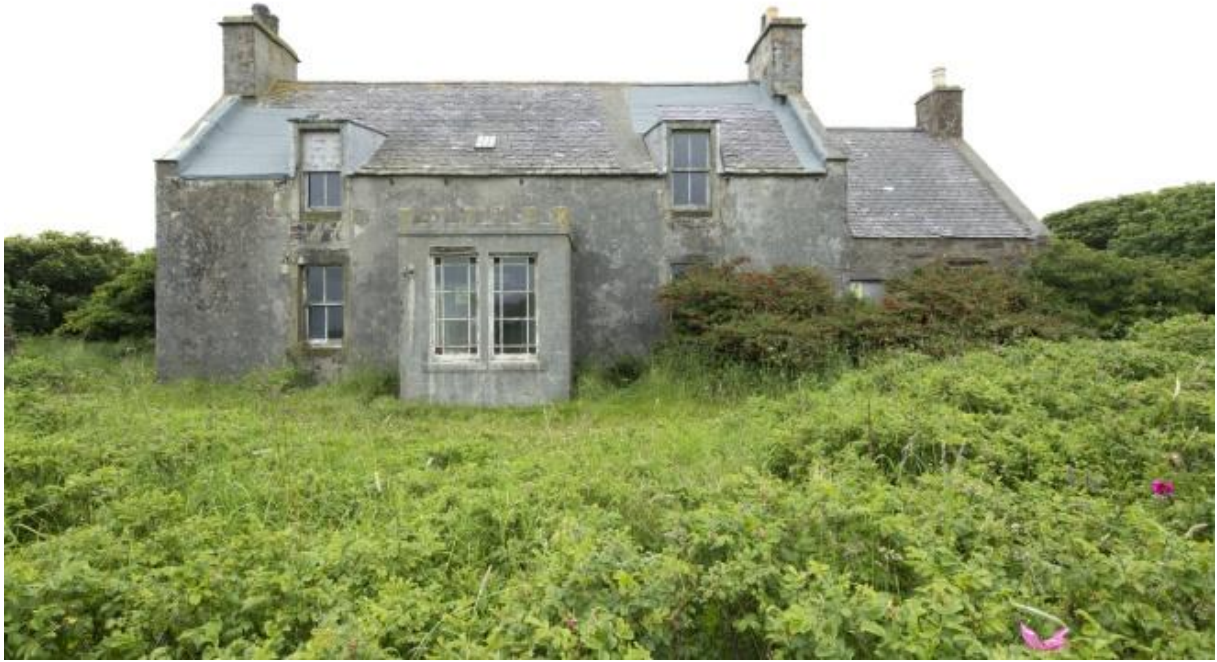
South range, main block, view from south east (RCAHMS: DP 194614)

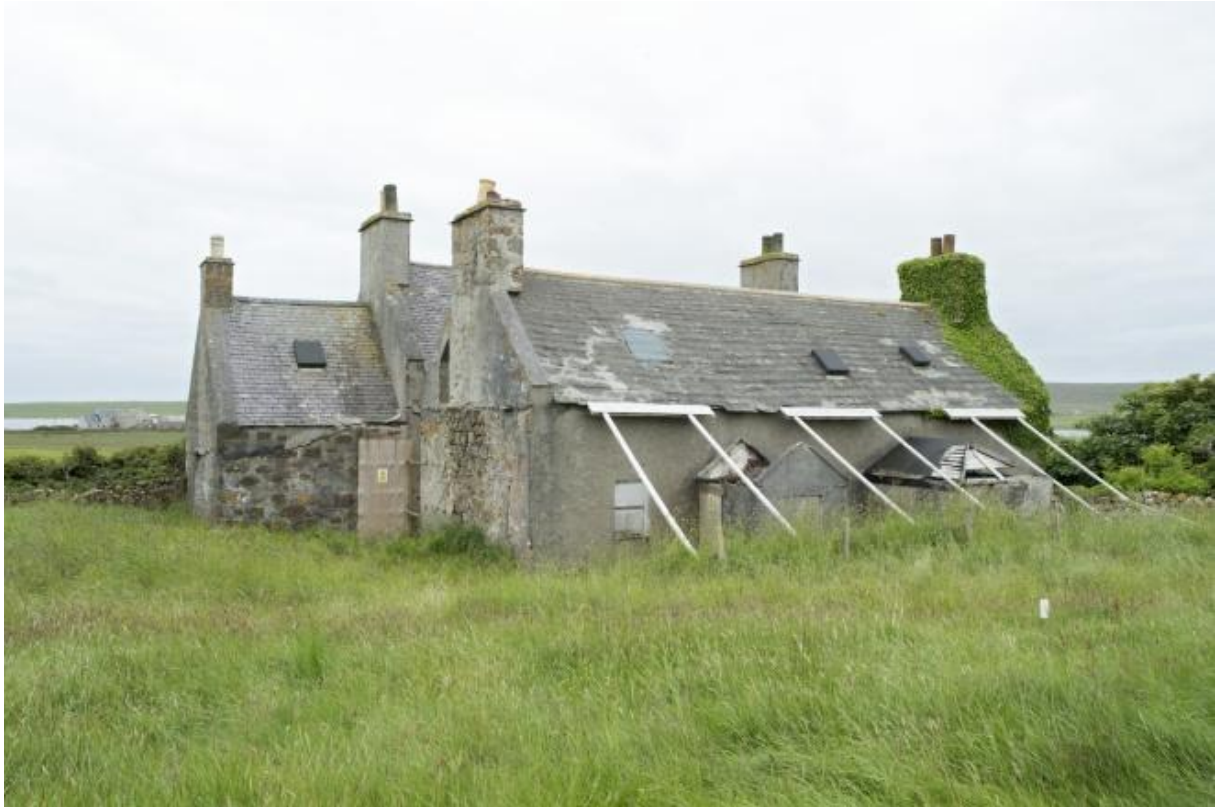
General view from north west (RCAHMS: DP 194630)

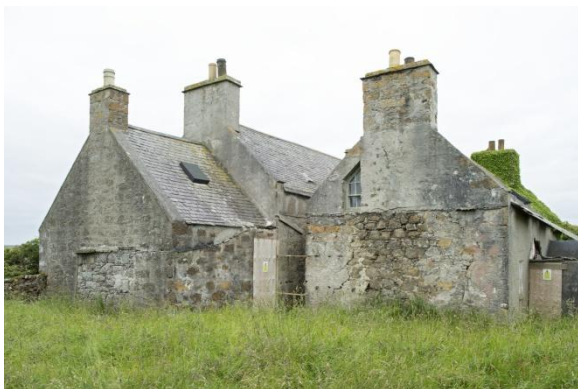
Left: View from north showing both ranges, east extension and narrow gap (RCAHMS: DP 194628)

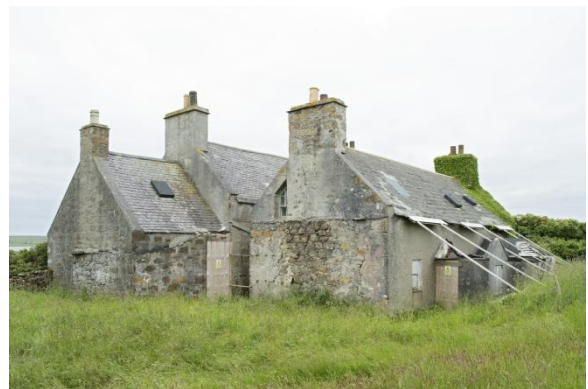
Right: General view from north (RCAHMS: DP 194629)

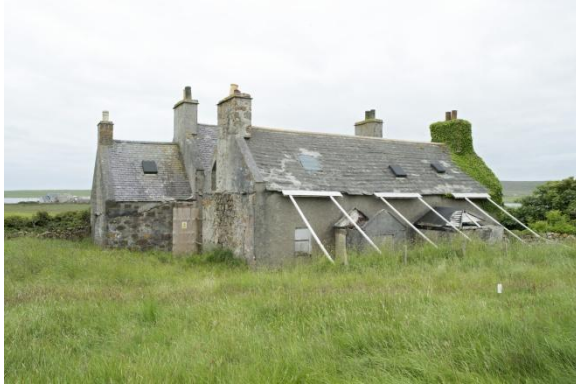
Left: General view from north (RCAHMS: DP 194630)

The North Block consists of a five bay, single storey building with bedrooms contained within the roof space, and with two small projecting blocks on the north front. The walls are constructed of random rubble, which appears to have been harled originally, and now is covered in a cementitious render. The rubble construction is partially exposed on the east gable. The roof is covered in stone slates with a ceramic ridge. Cement has been applied in an attempt to improve the waterproofing qualities of the roof. However, this has in fact led to its complete failure: it has become a single mass and is beginning to slide down and breakup. Timber 'flying buttresses' have been installed to counteract the downwards slide.

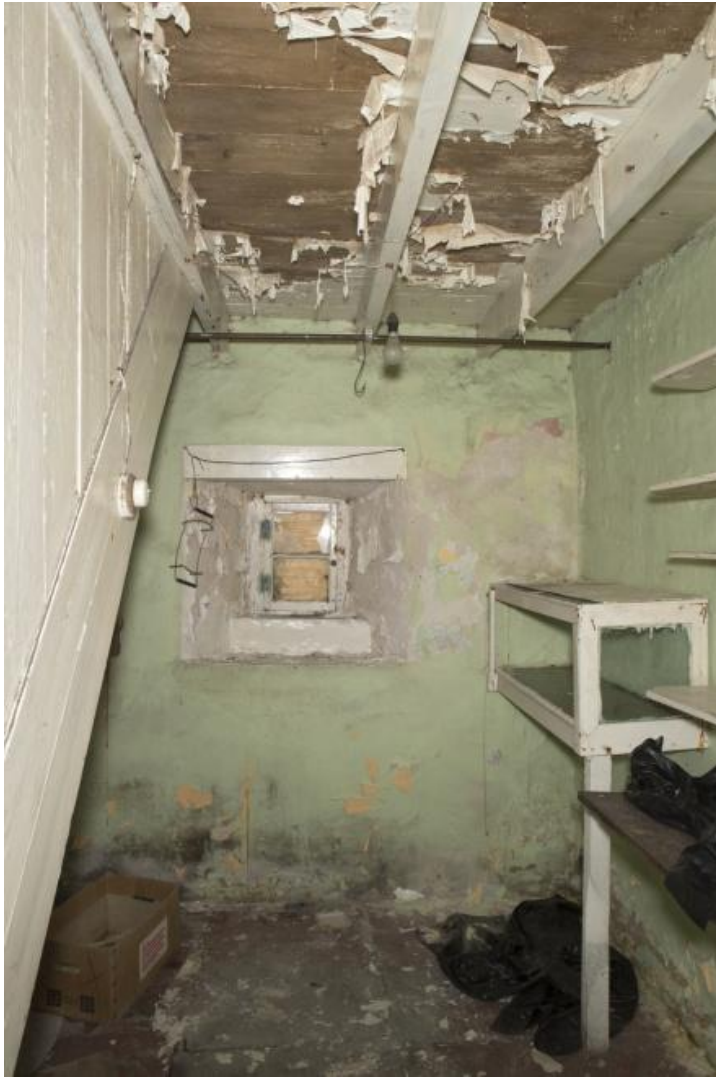
North Block, ground floor, pantry (0.4), view from south east (RCAHMS: DP 194662)

The rest of the North Block is at a lower level, one step down. The pantry (0.4) and the passageway (0.5) have a continuous stone flagged floor. These flagstones are of a much more random size rather than the uniform size of the flagstones in the kitchen (0.8). The staircase (0.7) is constructed of timber in a simple straight flight with timber boarded walls. The flagstone floor appears to predate the staircase since the irregular pattern of the flags does not relate to the staircase structure or to the south partition wall of the pantry (0.4). There are simple shelves lining the walls of the pantry, and the window has an unusually wide splay on both sides.

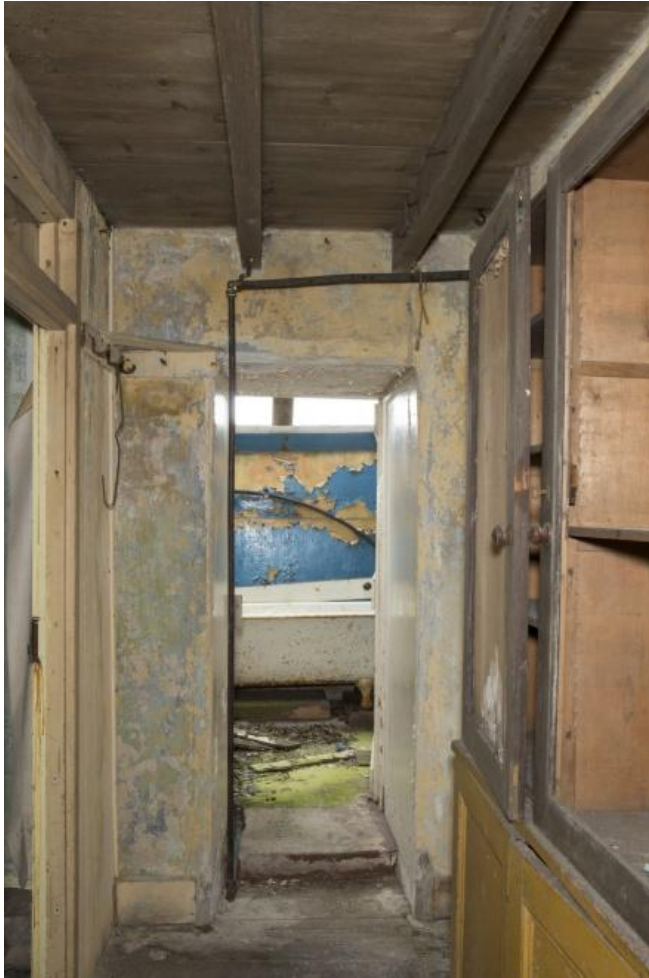
North west range, ground floor, corridor (0.2) to bathroom (0.3), view from south east (RCAHMS: DP194661)

To the west lies a wide passageway (0.2) leading to the bathroom (0.3) extension. The latter appears to be principally constructed of asbestos sheeting and originally had a hipped, slated roof. The passageway (0.2) was at one time part of the sitting room (0.1), which is at the west end of the block. The entrance door to the original, larger room, and now to the passageway (0.2), is set at a slight angle which suggests an alteration rather than an original design intention. The ceiling of the passageway has exposed joists and floor boards of the floor above. The sitting room (0.1) and passageway (0.2) have plastered walls. The sitting room (0.1) has a substantial fireplace, and windows on the north and west walls which are both two-over-two timber sash and case. The ceiling of the sitting room is boarded. There is a plain four panel door with a small fan light over.

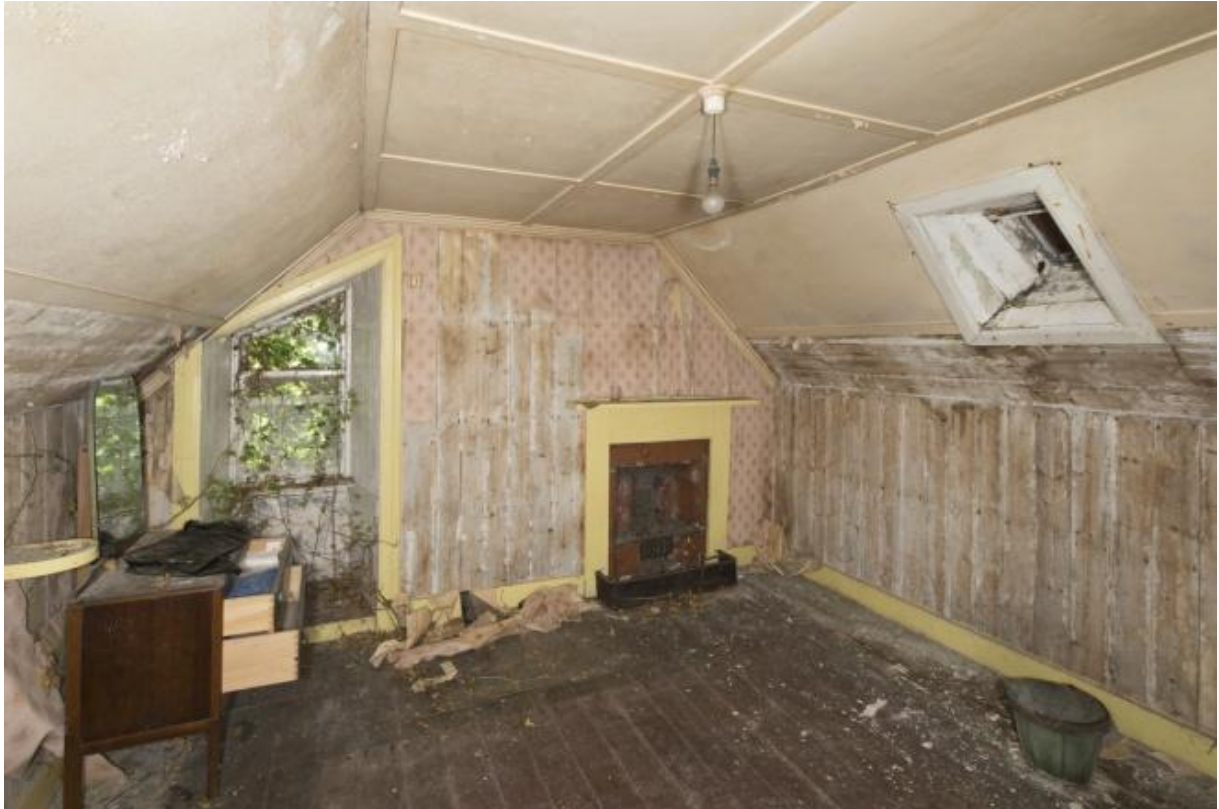
North Block, first floor, south bedroom (1.1), view from east (RCAHMS: DP194668)

The first floor contains two bedrooms (1.1 & 1.4) and a central box room (1.3). The floors are timber boarded and the doors are boarded with battens. The bedrooms are both fully lined and are mostly contained within the roof space. Both retain fireplaces with plain timber surrounds and cast iron inserts. They are located asymmetrically on the outside gables of the room. Vertical timber boarding is visible in the West Bedroom (1.1). Both rooms have windows in the gable walls that consist of a lower square section of two panes and an upper triangular section of four panes, fitting the pitch of the roof. They are lit by roof-lights. The east bedroom (1.4) has a single blocked window embrasure on the north wall. This is now at floor level, which suggests possibly that the floor level has been raised. There is no other evidence of blocked windows which may be extant if the panelling was removed. The central box room (1.3) is T-plan shape which means it projects into the east bedroom (1.4). It is lit by a roof light, and there is access to the roof structure of the north block which shows that the stone slates are pegged with softwood pegs, laid on a sawn softwood roof structure. There is no evidence of sarking (DP194672).

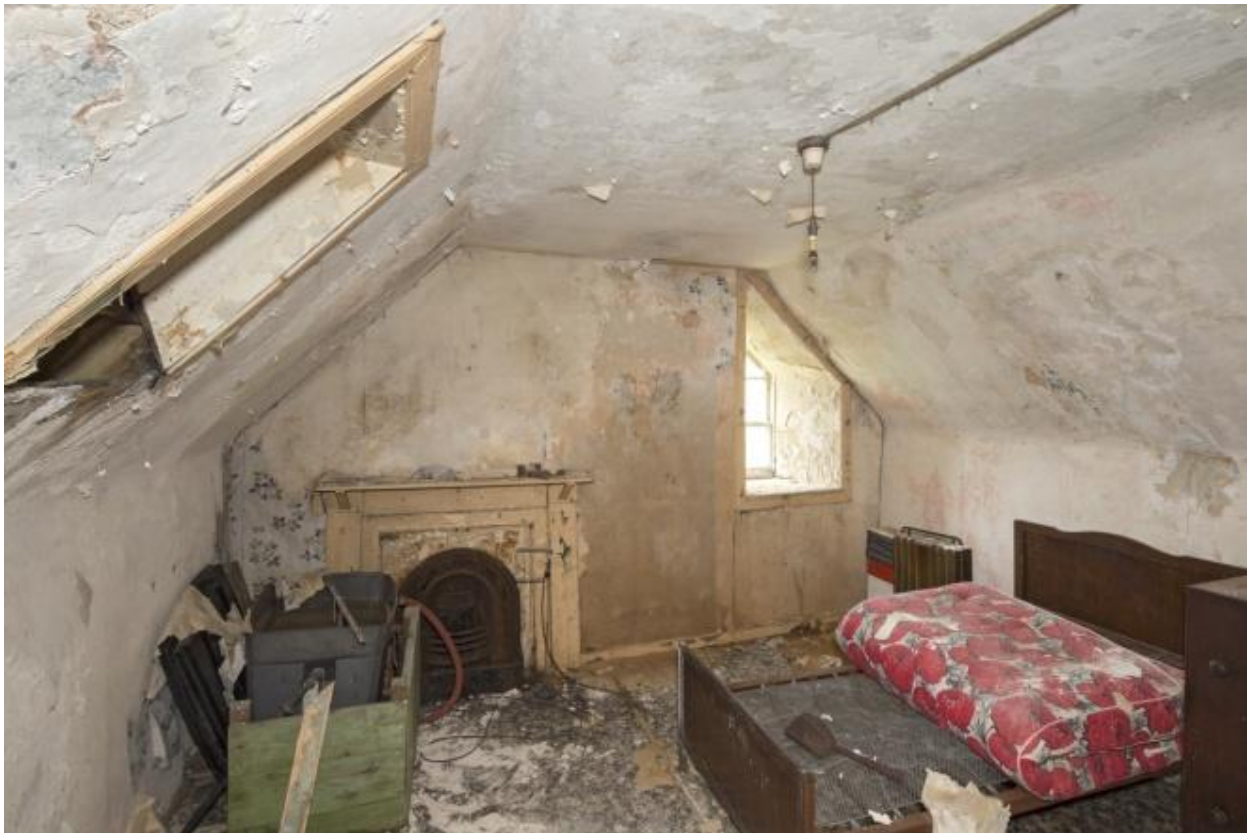
North Block, first floor, north bedroom (1.4), view from south west (RCAHMS: DP194669)

This earlier building, before the 1832 alterations, may have been two storied, hence the survival of a first floor window embrasure in the North Block east bedroom (1.4). These alterations probably included re-roofing, altering the layout, raising the first floor level to improve the headroom on the ground floor, inserting a new staircase, and laying a new flagstone floor in the kitchen (possibly onto the earlier floor, hence the step up to a higher level). Without the removal of the render the extent of these alterations is difficult to determine. The insertion of new interior walls into an existing structure would explain the odd angle of the original door into the sitting room (0.1 and 0.2) at the west end of the block. Money was not lavished on the alterations since soft wood pegs were used for the roof, which have exacerbated the problems in this area.

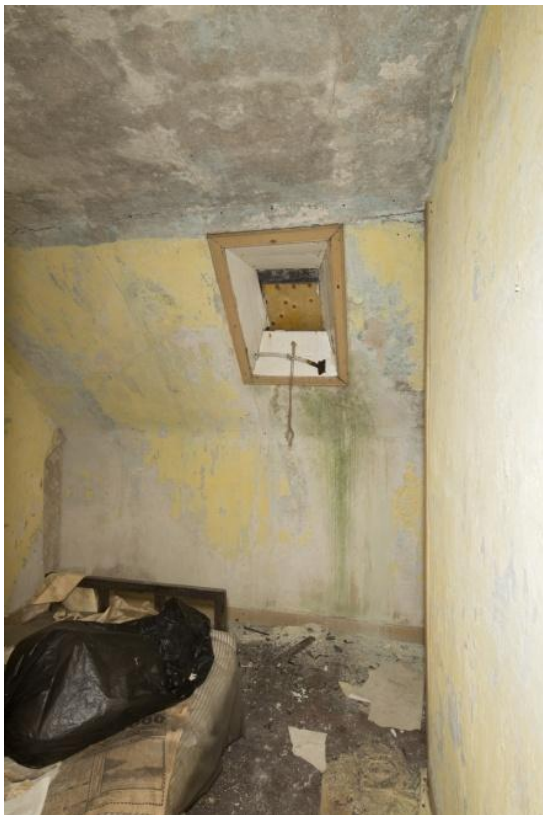
North Block, first floor, box room (1.3), view from north west (1.3) (RCAHMS: DP194671)

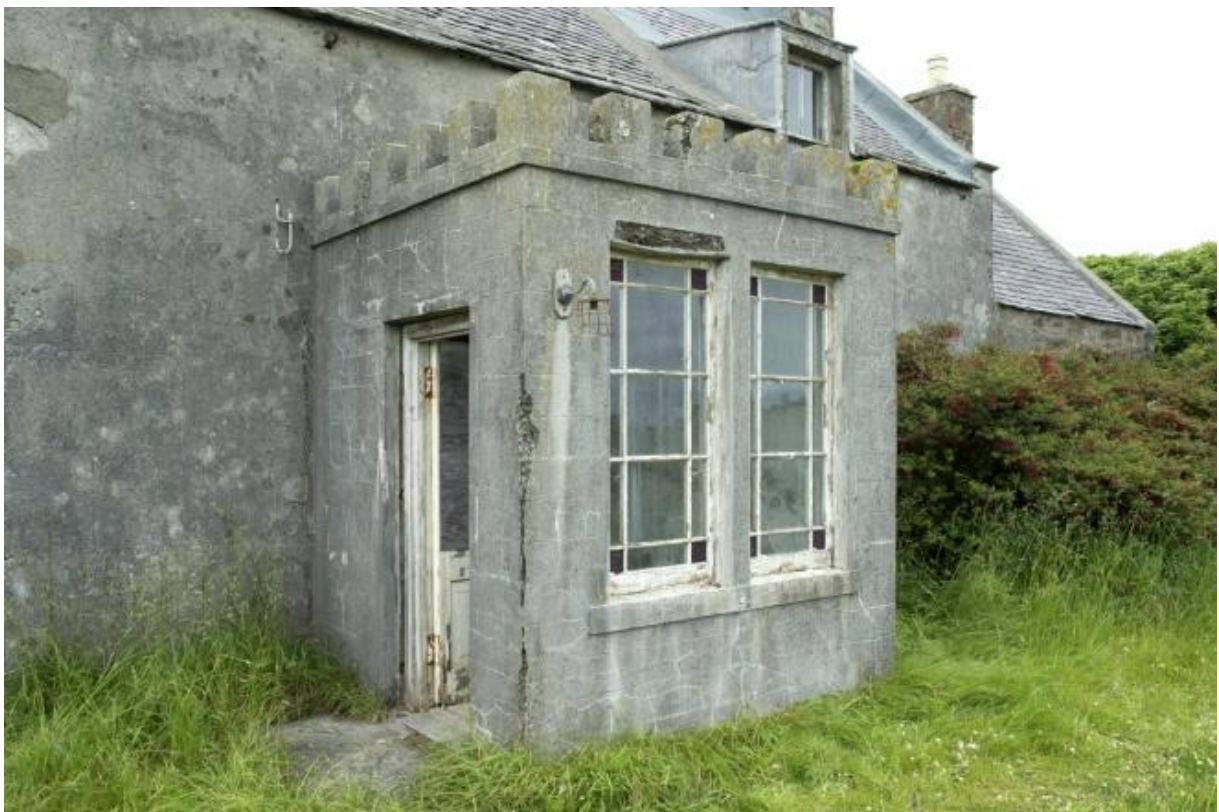
1914 entrance porch, view from south (RCAHMS: DP 194618)

The castellated porch (0.20) is built of concrete which is scored to imitate ashlar. It has a flagstone floor and a pair of original margin astragaled windows with red tinted pressed glass squares in the corners. The block is divided into three main spaces: a parlour (0.12) to the west, the central hall (0.13) and staircase (0.14) and the original dining room (0.18) to the east, beyond which is the later office/den (0.19).

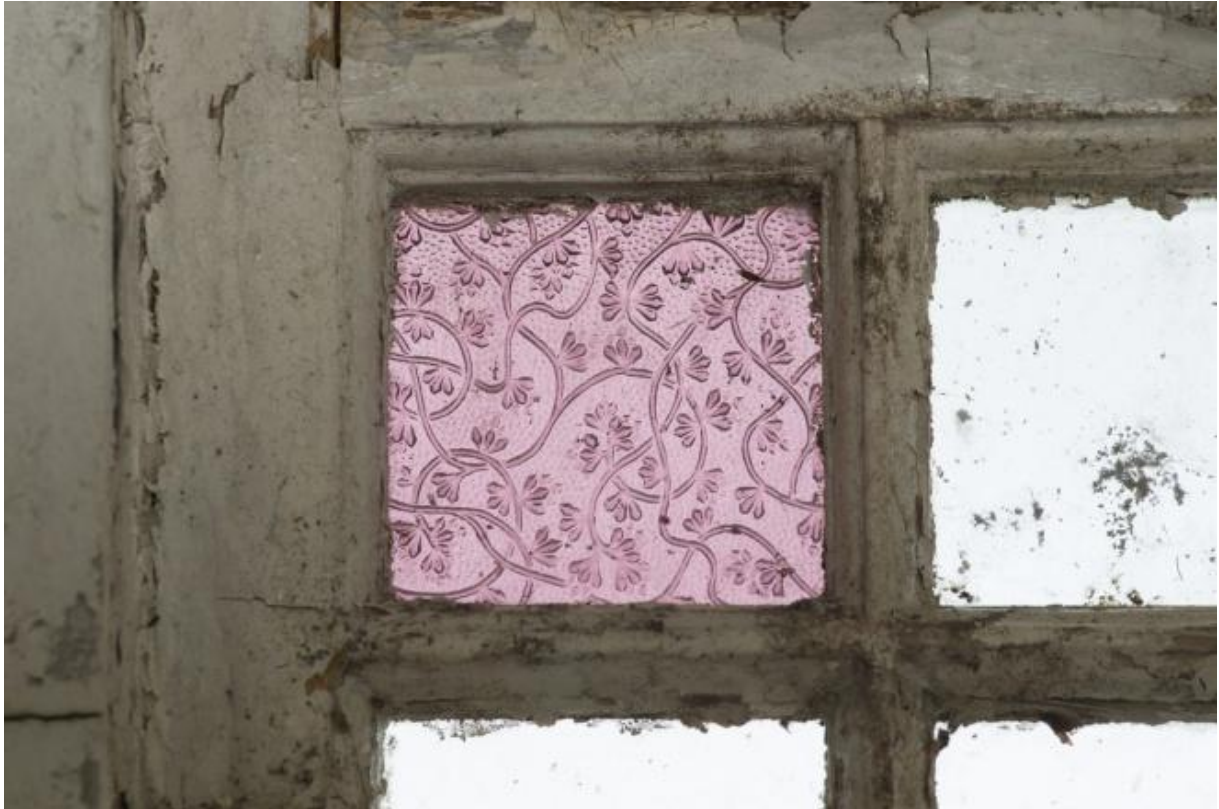
South Block, ground floor, entrance porch (0.20), detail of coloured glass (RCAHMS: DP194646)

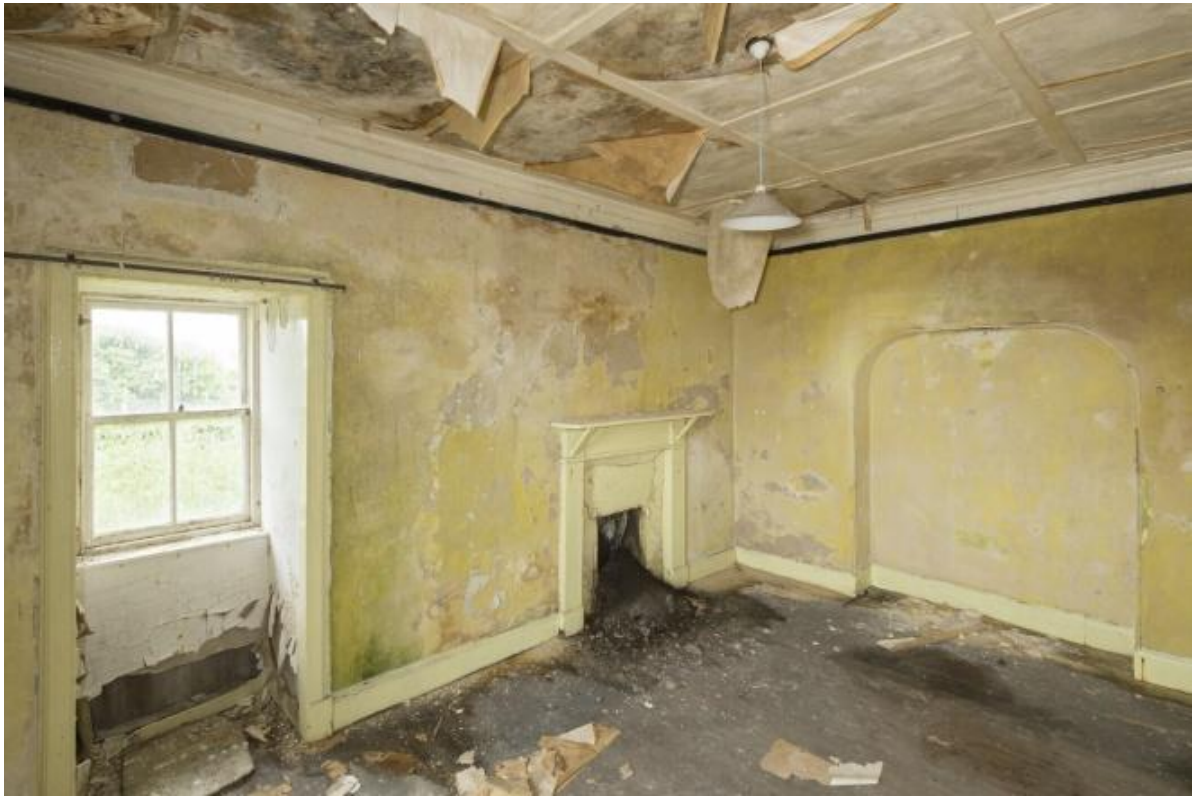
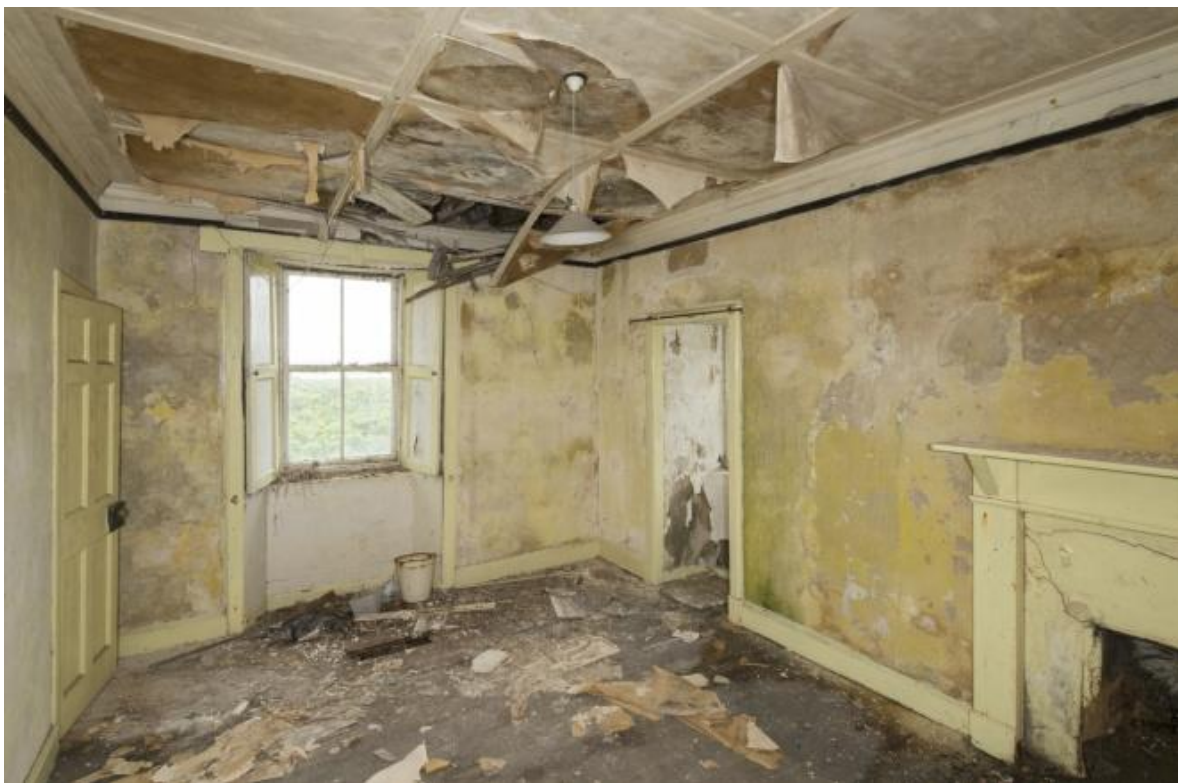
South Block, ground floor, parlour (0.12), view from east (RCAHMS: DP 194639)

South Block, ground floor, parlour (0.12), view from north (RCAHMS: DP 194640)

The parlour (0.12) is a simply plastered room with run cornice, a timber boarded floor and a six panel door. The ceiling has been altered and is now of plasterboard with plain wooden battens. The fireplace, placed off centre on the west wall, has a plain timber surround with a deep mantle shelf supported on struts. On the north wall is a recess which could have been a buffet or sideboard recess, but this seems less likely as it has no architrave and is relatively low. It was probably created to accommodate a piece of furniture. There is a blocked doorway at the north end of the east wall. This wall is not square with the others in the room but is set at a slight angle, suggesting that it is a later insertion. The small window on the west wall does not have splayed ingoes. It replaced a doorway, clearly evident from the outside. Both windows have two-over-two timber sash and case frames.

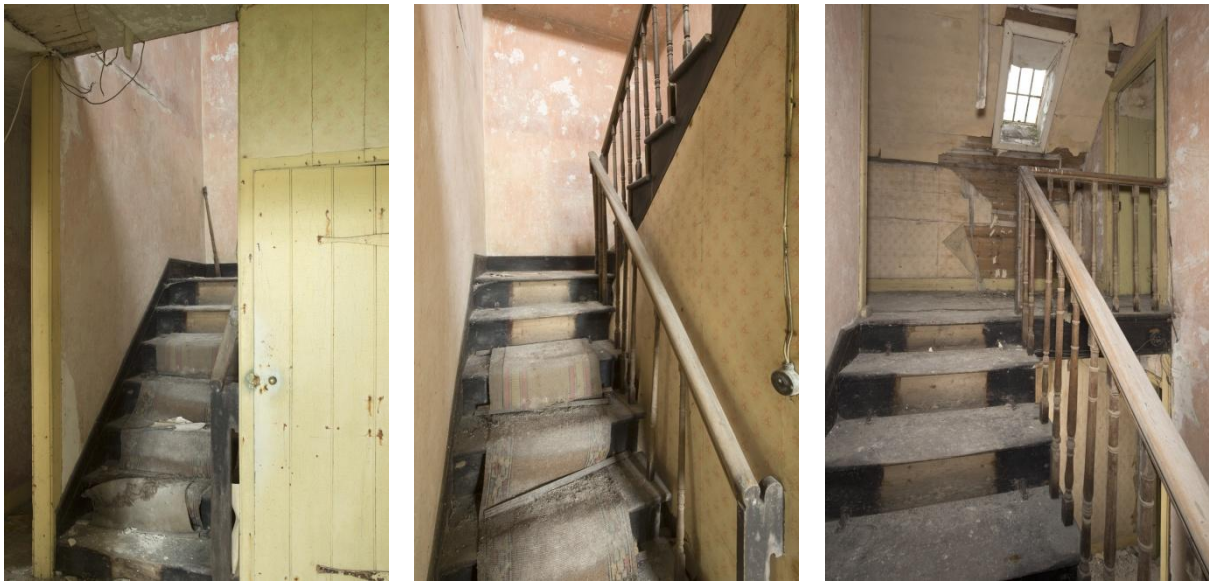
Left: South Block, ground floor, staircase (0.14) and press, view from east (RCAHMS: DP 194649)

Middle: South Block, ground floor, staircase (0.14), view from south east (RCAHMS: DP 194650)

Right: South Block, first floor, staircase and landing (0.14 & 1.2), view from northwest (RCAHMS: DP 194652)

The stair hall (0.13) gives access to the parlour (0.12) to the west, the dining room (0.18) to the east and, via a narrow corridor, to a pantry (0.15) and then the North Block. The walls and ceiling are plastered. The floor is timber but the floor of the under stairs cupboard (0.17) is laid with flagstones. The dog-leg staircase (0.14) is made of timber with simple but elegant turned balusters. The handrail terminates in a plain timber upright rather than a newel.

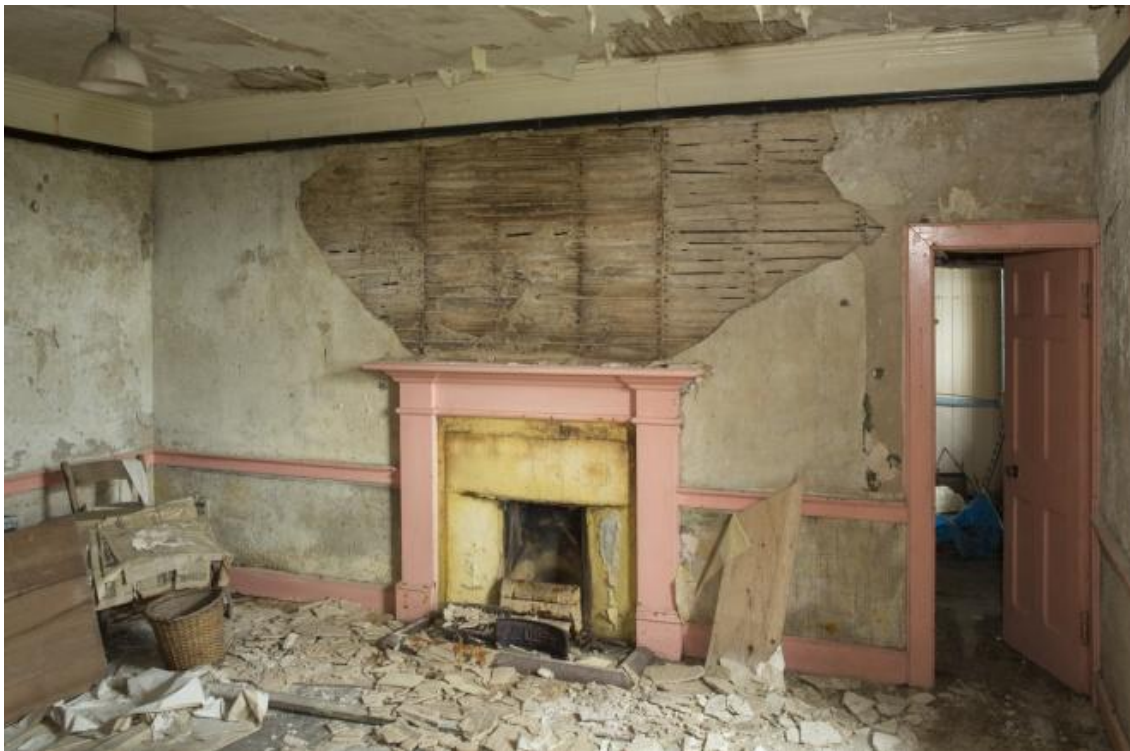
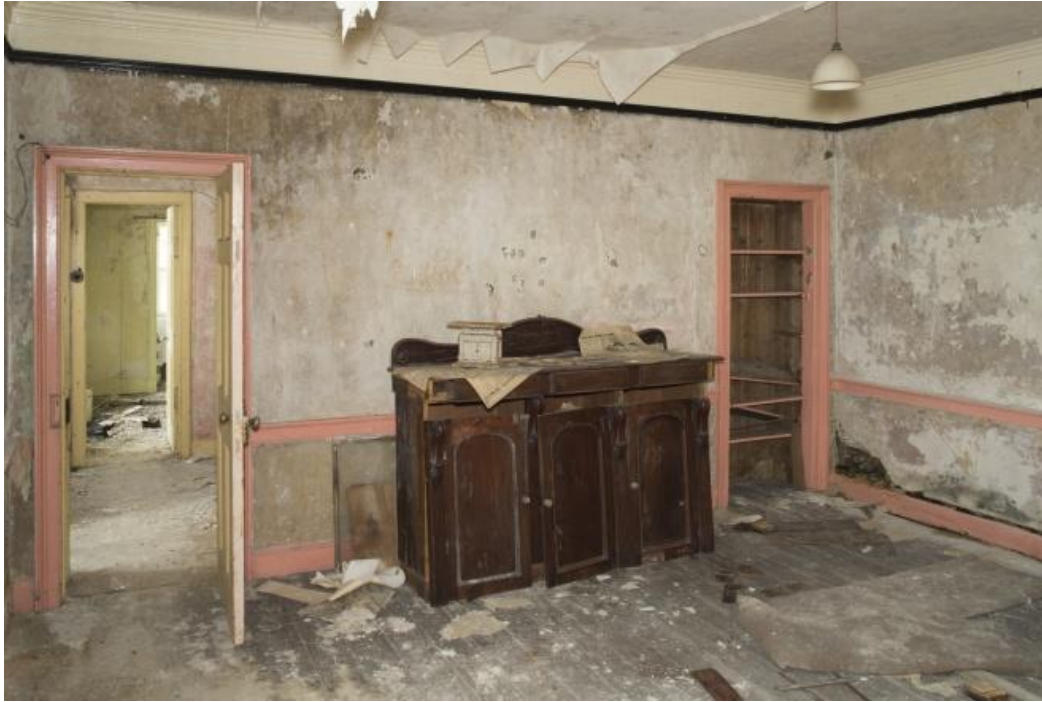
South Block, ground floor, dining room (0.18), view from south (RCAHMS: DP 194642)

South Block, ground floor, dining room (0.18), view from east (RCAHMS: DP 194644)

The dining room (0.18) is the most formal room in the house with its dado rail and cornice. The room is plastered and has a timber floor. The symmetrical arrangement of six panelled doors on the west wall opposite the central fireplace on the east wall emphasises the formality of the principal reception room. The timber chimneypiece is a restrained Neoclassical design with a mid 20th century insert (DP194643). The narrow six panel door on the east wall is a later insert to gain access to the office/den (0.19). The window is a timber two-over-two sash and case.

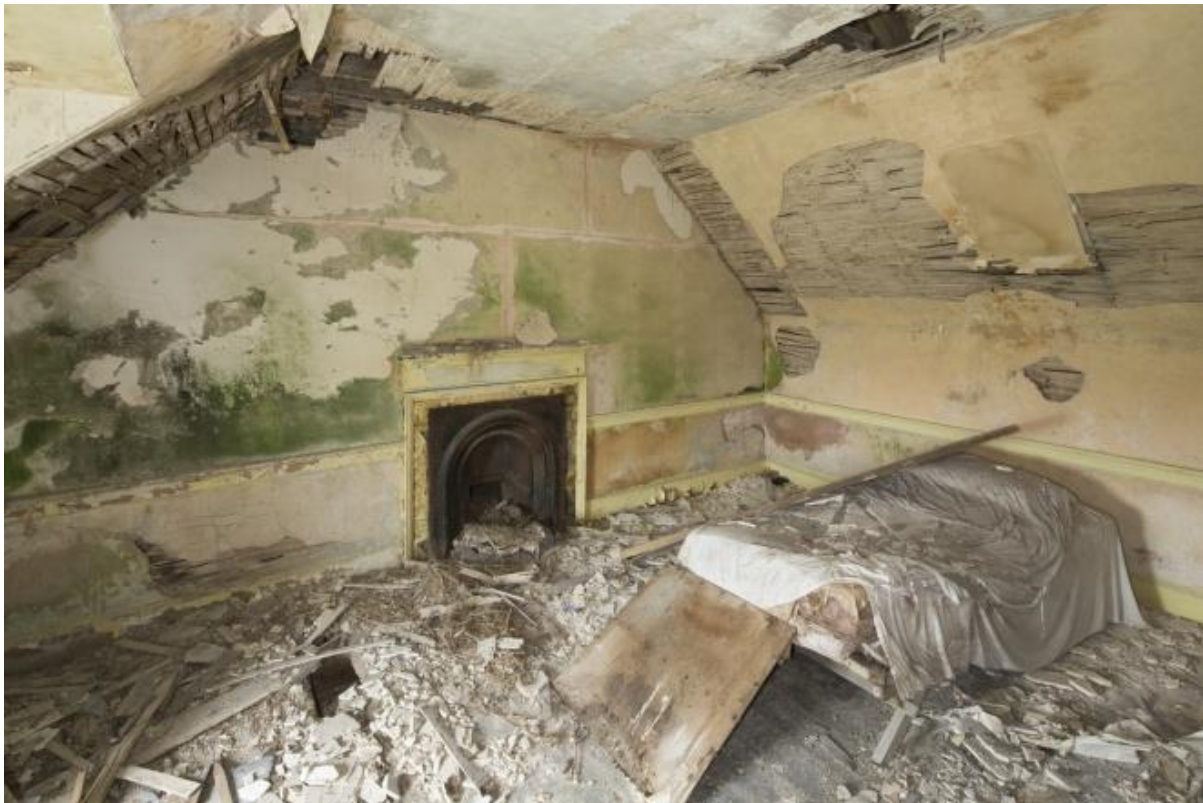
South Block, first floor, south bedroom (1.5), view from east (RCAHMS: DP 194653)

The first floor rooms rise partially into the roof space, the flooring of which is timber boarding throughout. The landing (1.6) is lit by a skylight. The west bedroom (1.5) is rectangular and, like the dining room (1.18), has a dado rail and cornice, denoting a room of importance. On the west wall there is a centrally positioned fireplace. This is stone with a timber mantle shelf on a reeded frieze. It has a mid 19th century cast iron insert (DP194654). This room may have originally been intended as a first floor drawing room. It is lit by a dormer window, a timber two-over-two sash and case, on the south wall. There is a built-in cupboard on the south wall, immediately adjacent to the entrance door.

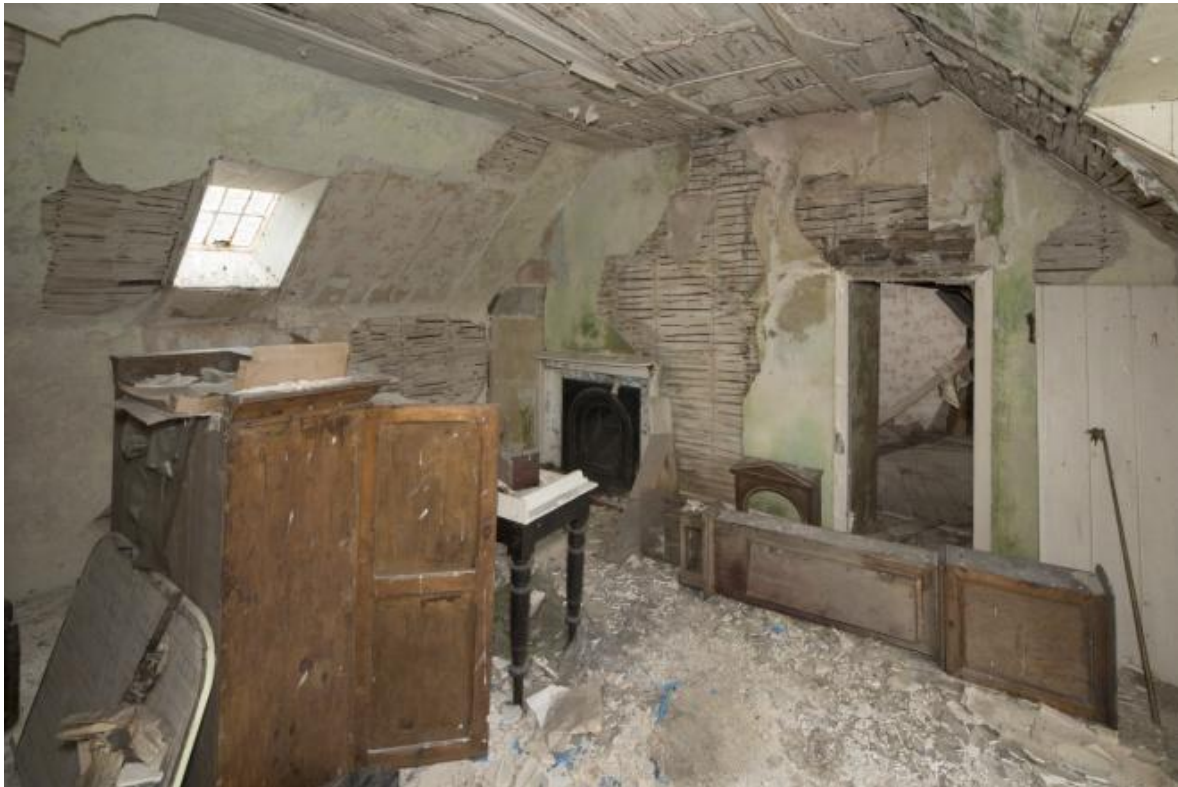
South Block, first floor, north bedroom (1.8), view from south (RCAHMS: DP 194656)

The east bedroom (1.8) is the largest bedroom in the house. It has an irregular shape because the landing projects into the room. The room is lit by a dormer window to the south, a timber two-over-two sash and case, and a skylight to the north. There is an off-centre fireplace on the east wall with a timber mantleshelf and mid 19th century cast iron insert. The walls were originally plastered but now the laths are visible. A Box Room (1.7) is accessible from this room, located north of the stairs. A large shelf in the box room projects over the staircase. Another doorway leads through the east gable to the attic of the extension which it is lit by a skylight. (DP194657) The attic is lined out and papered and was presumably used as a bedroom. There is no access to the roof space above the bedrooms.
