Replacement Overhead Line (YX route) Ben Cruachan Hydro Power Station to Dalmally Substation

Walkover Survey and Archaeological Excavation

Report No: 3303

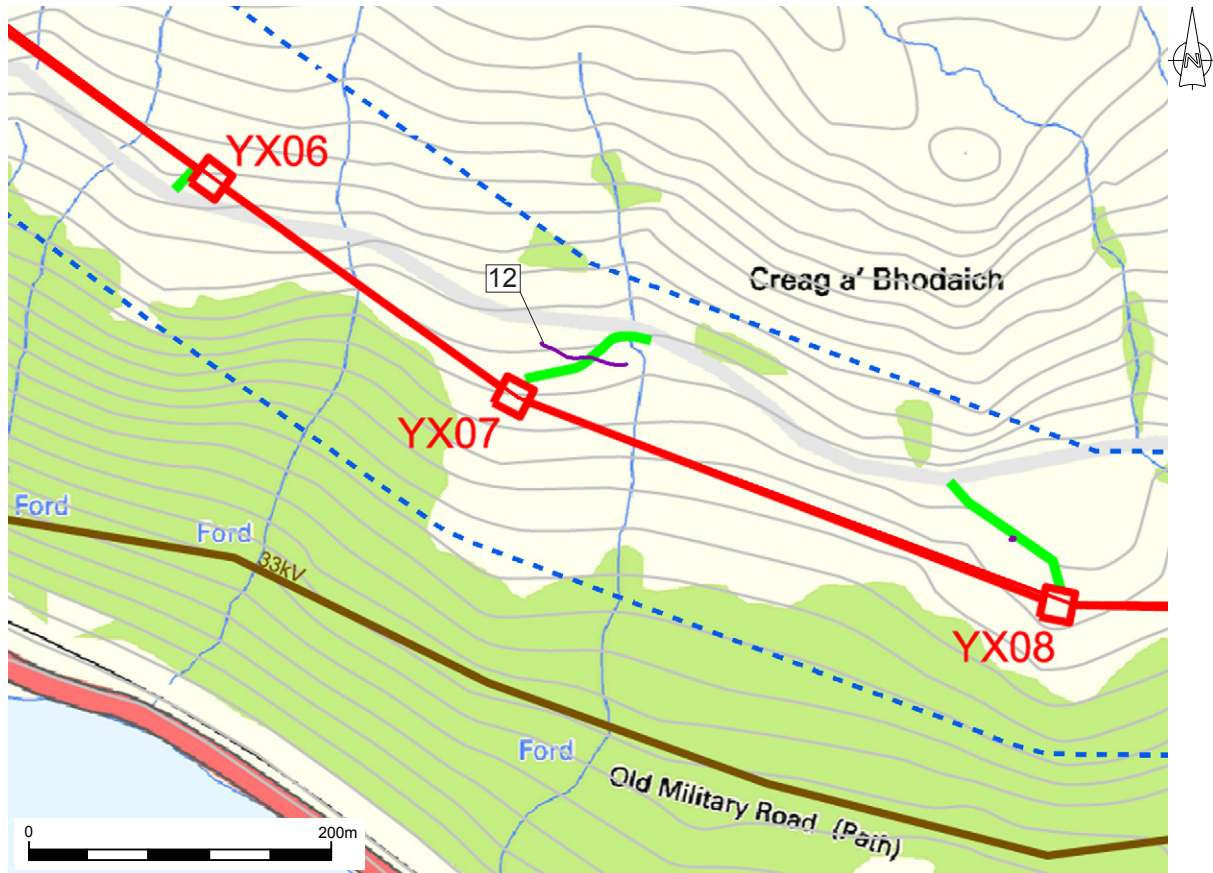
Fig. 6 - Location of Site 12 and access track

Site 12 (NGR: NN 0916 2652) (Fig. 2) is a bank aligned roughly east to west. It traverses a steep hillside which is covered in grass, heather and bracken, just to the north-east of Tower YX07. The bank runs from the edge of a deep water-cut gorge to the east and merges with a timber post and wire fence c.50m to the west which runs parallel with the existing road. The previously constructed access track between the road and Tower YX07 was found to bisect the site, and had destroyed a roughly 3.5m long segment as it crossed the bank at an oblique angle (Fig. 3).

Following the walkover survey, mitigation measures comprising hand excavation and recording of the damaged section of the bank at Site 12 were carried out.
