HISTORIC
ENVIRONMENT
SCOTLAND | ÀRAINNEACHD
EACHDRAIDHEIL
ALBA

Middlefield Beam Engine House, Thornton, Fife [NT29NE 6](#) (NT 29193 97269)

Survey and Recording Section, Heritage Management Directorate, HES, 2018.

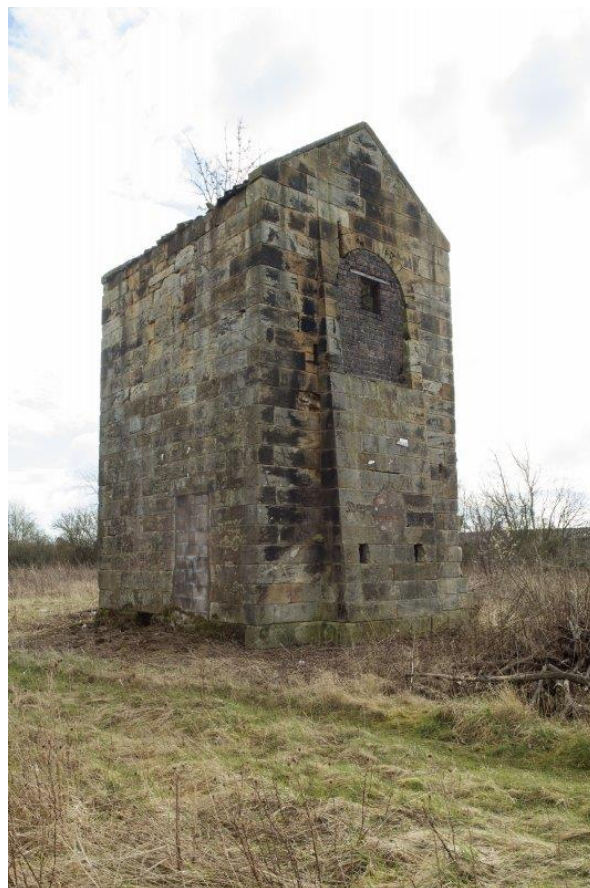
View from north west [DP 231994, HES]

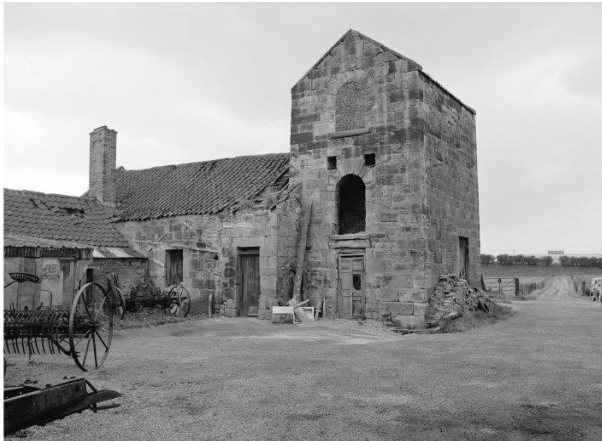
Left: View of Pump Engine House from north east showing the now demolished south range (left). It is unclear if the chimney was related to the original boiler for the beam engine, although one would assume it would have been of ashlar construction and not brick, as here. Note the east door into the engine house and the ground level change (centre) [SC454960, 1974, JR Hume]

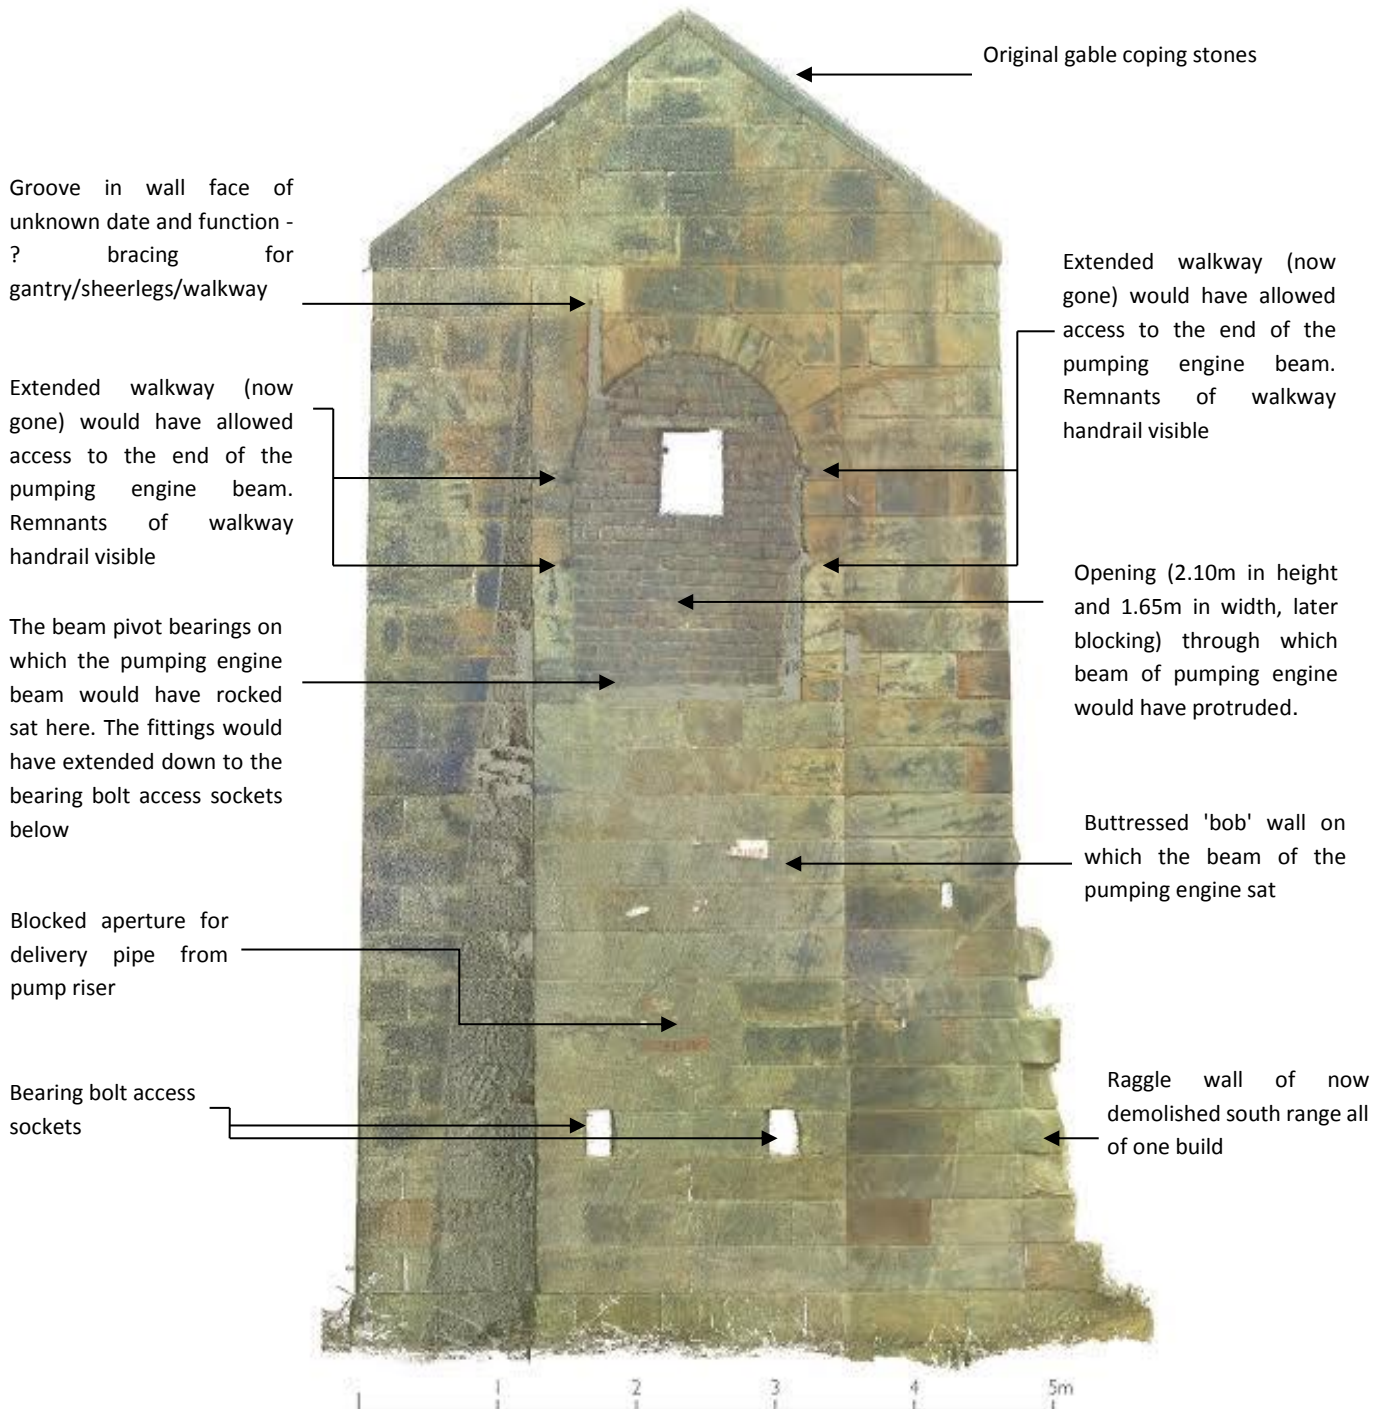
West elevation

Groove in wall face of unknown date and function - possibly associated with external walkway/ sheerlegs/ gantry?
