HISTORIC
ENVIRONMENT
SCOTLAND | ÀRAINNEACHD
EACHDRAIDHEIL
ALBA

Middlefield Beam Engine House, Thornton, Fife [NT29NE 6](#) (NT 29193 97269)

Miriam McDonald, Industrial Survey, Survey and Recording Section, Heritage Directorate, HES, 2018.

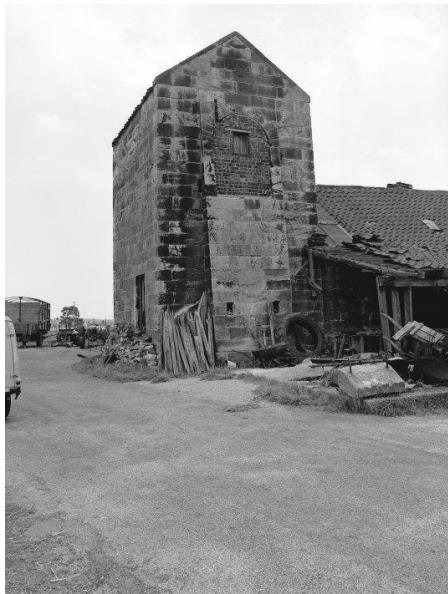
Left: View of Pump Engine House from west, showing the now demolished south range (right). Some of the now demolished buildings may have been part of the colliery. The low footings visible in front of the west wall is the backfilled shaft down which the pump rods of the engine ran. Men may also have used the shaft to get out of the mine workings at the end of their shift. [SC 454959, 1974, John R Hume Collection, National Record of the Historic Environment]

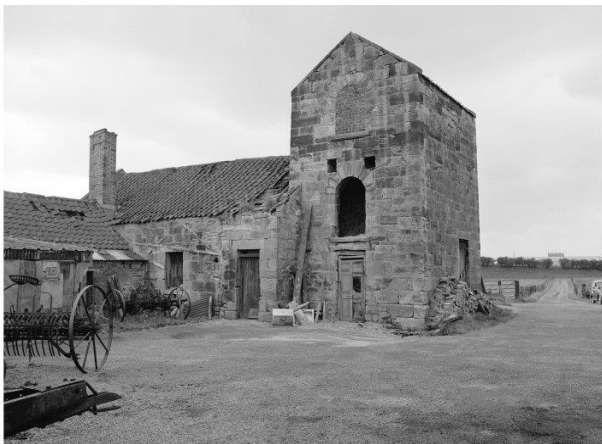
Left: View of Pump Engine House from north east showing the now demolished south range (left). It is unclear if the chimney was related to the original boiler for the beam engine, although one would assume it would have been of ashlar construction and not brick, as here. Note the east door into the engine house and the ground level change (centre) [SC454960, 1974, JR Hume]

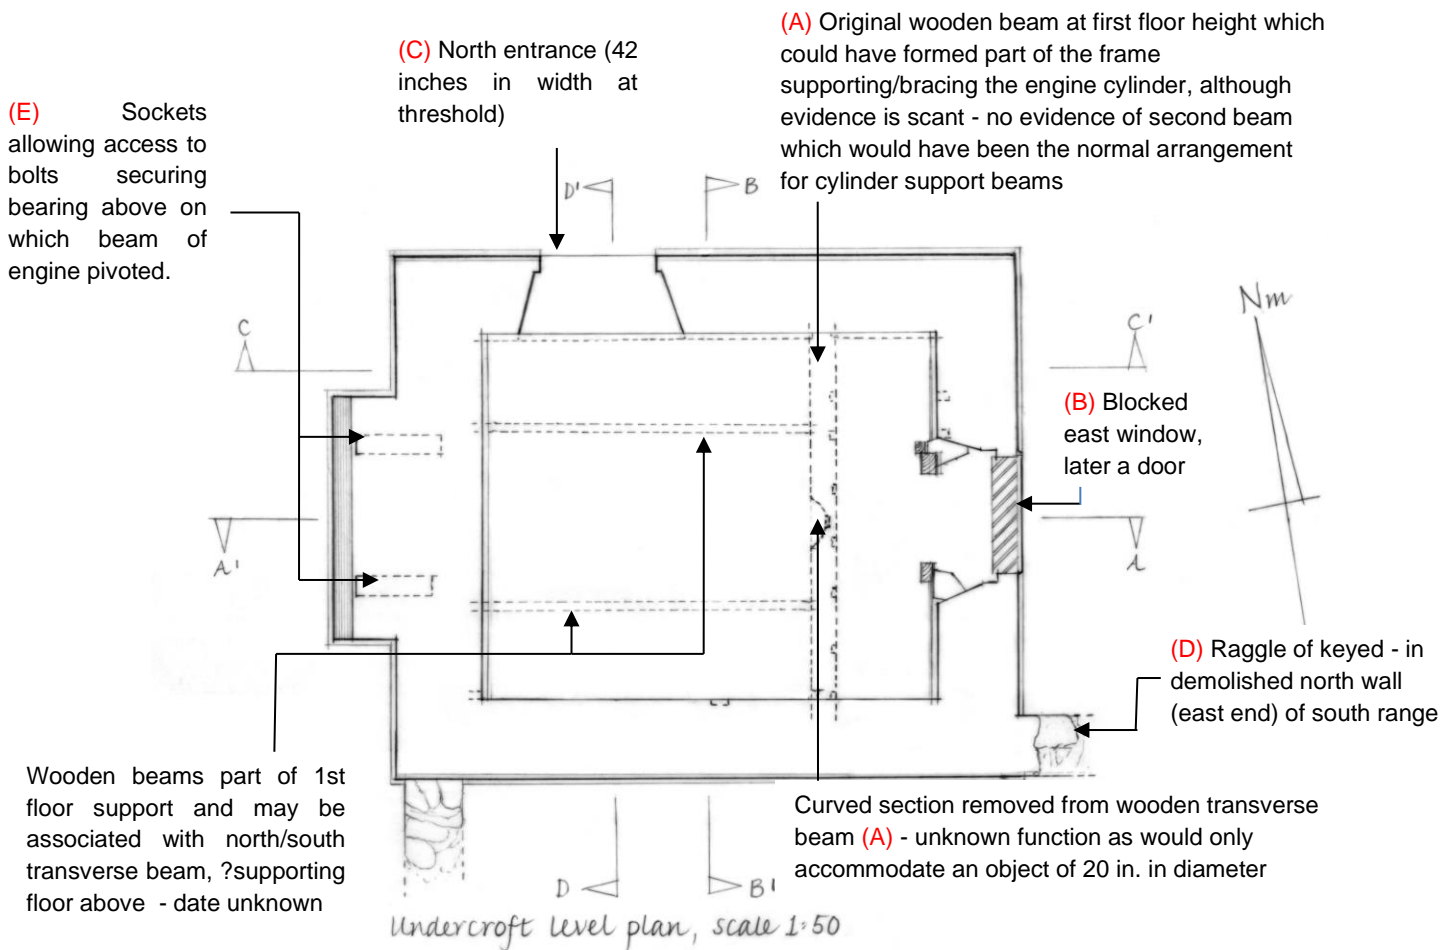
Ground level floor plan

The floor was covered in loose earth and debris on the dates of survey. When the engine house was being converted into a dwelling, the floor was found to be some 0.5m from the ground surface by the builder working on it. It had been mooted that there would have been a backfilled sub-basement where the cylinder base fixings and voids for original pipework would be visible. This was not the case.

There is a timber beam (see Ground Level Plan, (A)) running north/ south measuring 3.85 m (14ft 4in.) by 0.24m (9in.) in depth by 0.29m (11in.) in height at this level which appears to be original (and has been kept as part of the conversion into a dwelling). There is a section cut out of this beam which looks very like a collar steadying something against it. When this cut out section is extrapolated, it would have accommodated something of a diameter of approximately 0.5m (20in.). This seems unlikely to have been the cylinder due to its size. Neither is it centrally positioned on the beam to link with the piston in the cylinder and the rocking beam above. It may have cradled some other part of the engine or have nothing to do with the building when in use as an engine house. The other mystery is why there is only one heavy beam at this level. In all historic engravings of early beam engines, the cylinder of the beam engine is always shown supported or braced by two beams (also supporting a working floor/platform) and anchored by a 'collar' bolted to the beams, on either side. There is recently blocked east window (see Ground Level Plan, (B)) at ground level which would have maximised natural light for the engine operator. The north door measures 1.067m (3ft 6in. or 42in.) in width at its narrowest point (see Ground Level Plan, (C)) at ground floor level.

There are sockets visible at exterior ground/ first level in the buttress of the west gable or 'bob' wall (see Ground Level Plan, (E)) which provided access to a bolting system for securing the beam engine pivot bearing onto the west wall at the second level opening (it is through the opening on the second level that the west half of the rocking beam protruded). This wall measures 1.25m (4ft 1in.) in thickness at ground level. The voids extend up into the buttress but the extent of these could not be ascertained. There is a possibility that a separate condenser box could have been located here (see 1877 section drawing above, p.6).

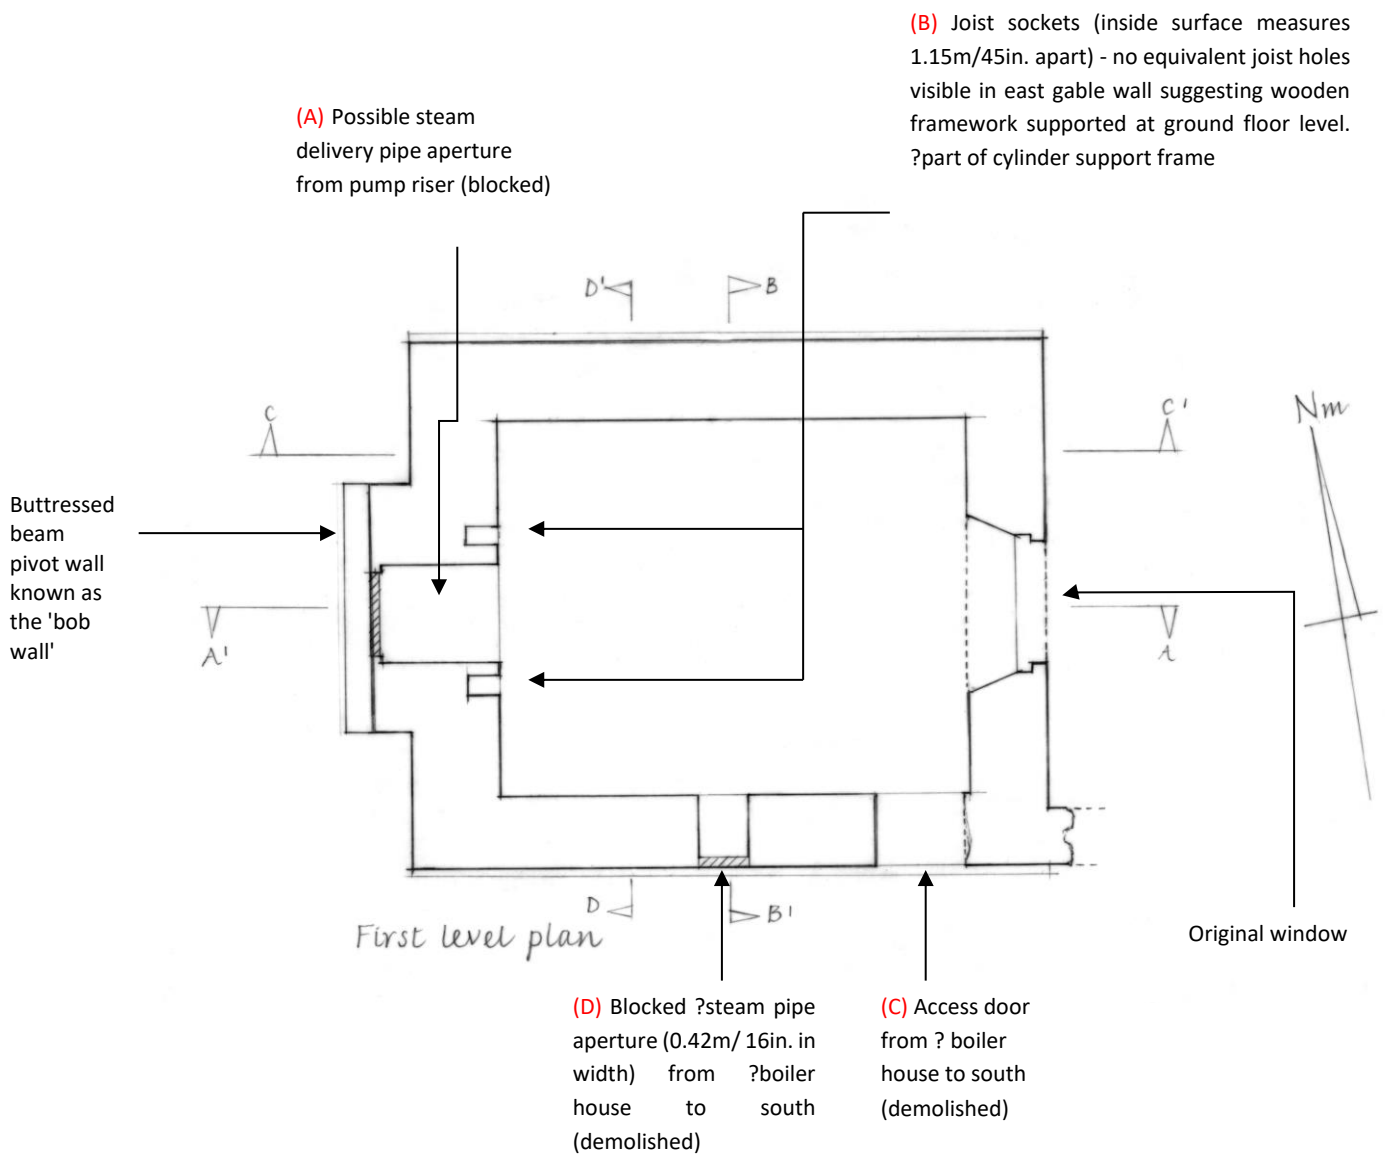
First level plan

The first floor level is where, latterly, the cylinder, the probable delivery pipe from the pump riser, steam inlet pipe from the boiler house to the cylinder would have been located along with other mechanism of the pumping engine. The probable delivery pipe from the pump riser aperture in the west wall is blocked but clearly visible (First level plan, (A)).⁽¹⁹⁾ This aperture is well executed, again showing the high quality of this engine house.

There are two socket holes visible in the bob wall (west gable wall) interior, above the possible steam delivery pipe aperture from pump riser, measuring 0.30m (15in.) in height by 0.19m (7½in.) in breadth (First level plan, (B)). The inside surfaces of these beams sockets are (1.15m/ 45in.) apart. There are no matching socket holes in the east gable. It is possible that these joist sockets held timbers which supported the cylinder on a partial frame all trace of which have now gone.

On the south wall there is an access door (First level plan, (C)) to what would have been the first storey of the now demolished (possible) boiler house. There is also a wall aperture through which inlet steam pipes to the engine's cylinder probably ran (First level plan, (D)). This aperture is not as well executed as the steam outlet in the west gable or 'bob' wall showing possible later modification.

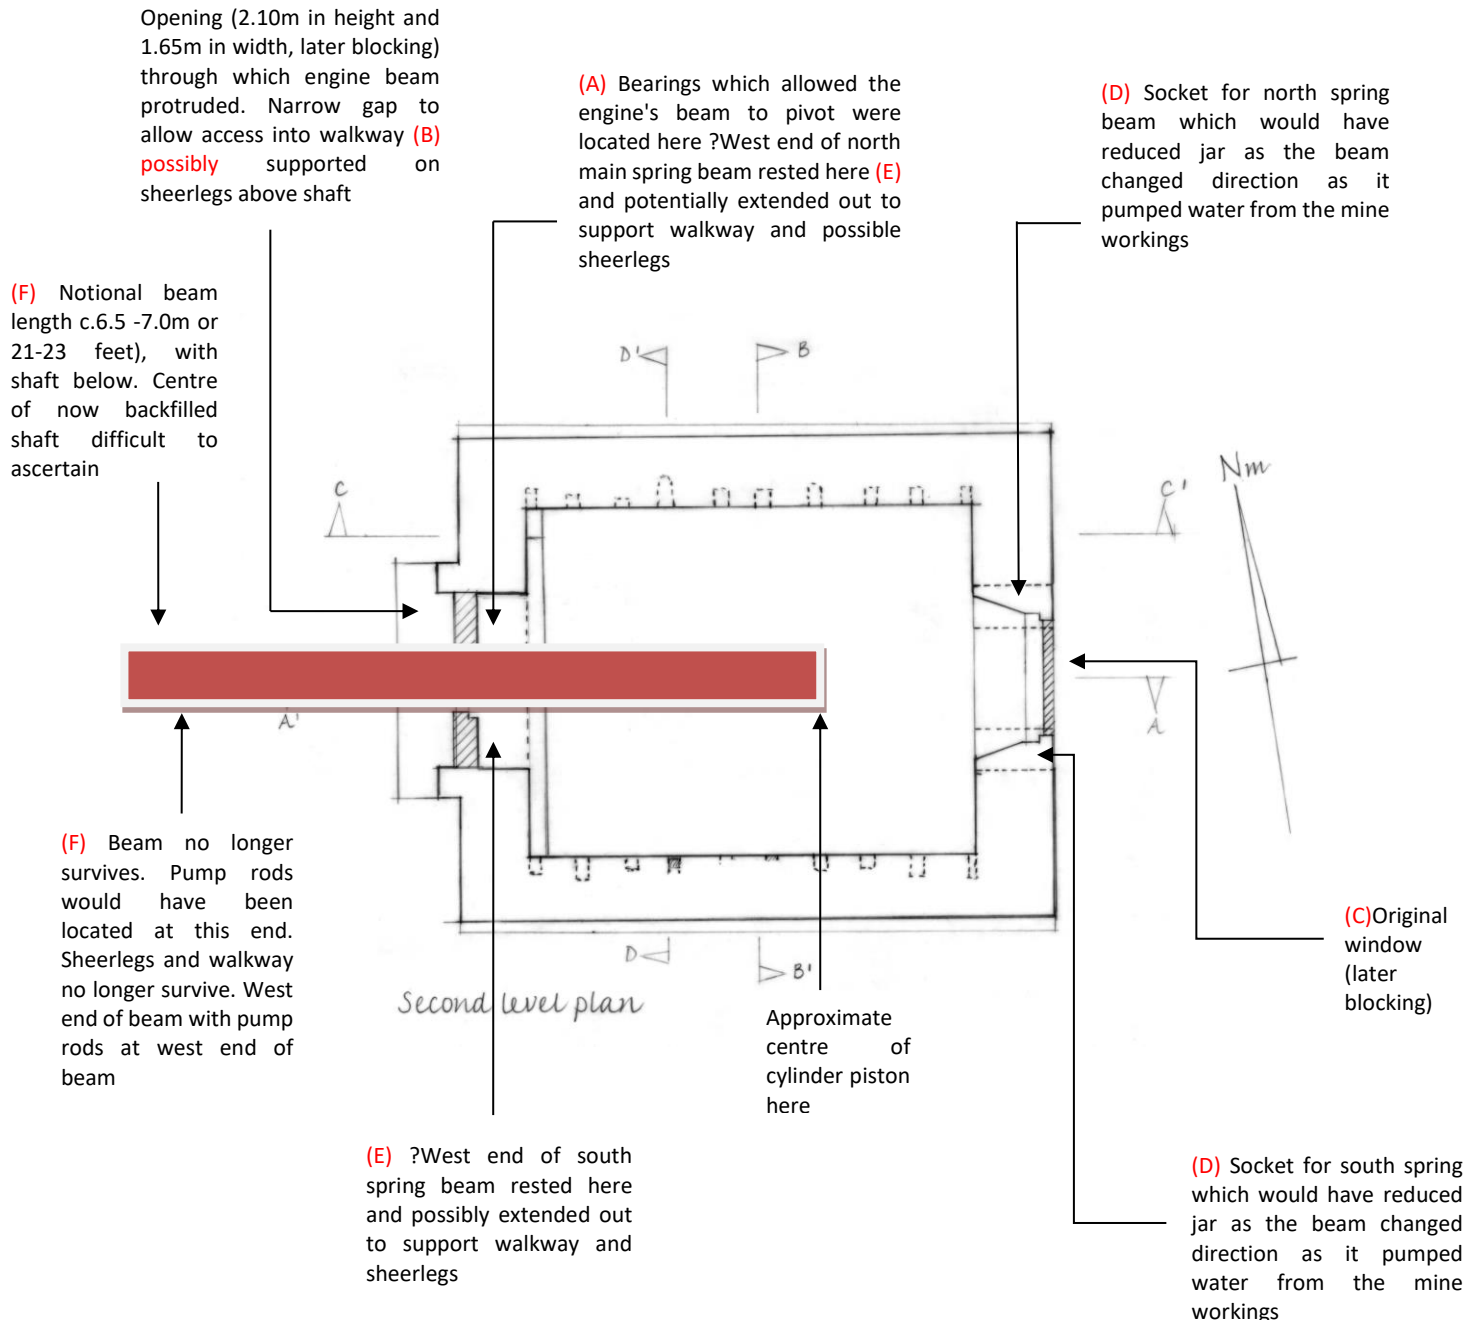
Second level plan

The second level is where the beam of the pumping engine was located. It would have pivoted on bearings anchored to the west wall (Second level plan, (A)). A walkway (for which there is evidence of surviving railing fittings) would have extended out and around the exposed west end of the beam. Joist holes for the floor survive (although eroded) which would have supported a mezzanine floor or walkway 'wrapped around' the engine (Second level plan, (B)).

On the west wall is an original arched window - the original frame has long since been removed (Second level plan, (C)). The beam sockets on the east wall (Second level plan, (D)) are not mirrored on the west beam pivot wall (Second level plan, (E)). The beams that would have slotted into these holes are often referred to as 'spring beams' as part of their function was to absorb the jar created by the engine changing direction (in a rocking motion). They may have extended to the base of the bottom of the opening in the bob wall (Second level plan, (F)) and continued as the inspection walkway to the framework that would have sat above the shaft. The bearing(s) on which the engine beam pivoted on the 'bob' wall would have allowed clearance for it to rock up and down.

been of timber. The beam opening measures some 2.10m (6ft 10½in.) in height and 1.65m (5ft 5in.) in width with a later brick blocking with inserted window. The distance from the ground to what would have been the centre of the beam at the horizontal would have been approximately 6.0m (20ft).
