**THE CILLE-BHARRA CHURCH-GROUP,
EOLIGARRY, BARRA, WESTERN ISLES:
HISTORIC BUILDING SURVEY OF
ST BARR'S CHURCH & THE SOUTH CHAPEL**

Client: Benjamin Tindall Architects, on behalf of Andrew Kerr

31 May 2002

Christopher Lowe, Magnar Dalland & Mike Middleton

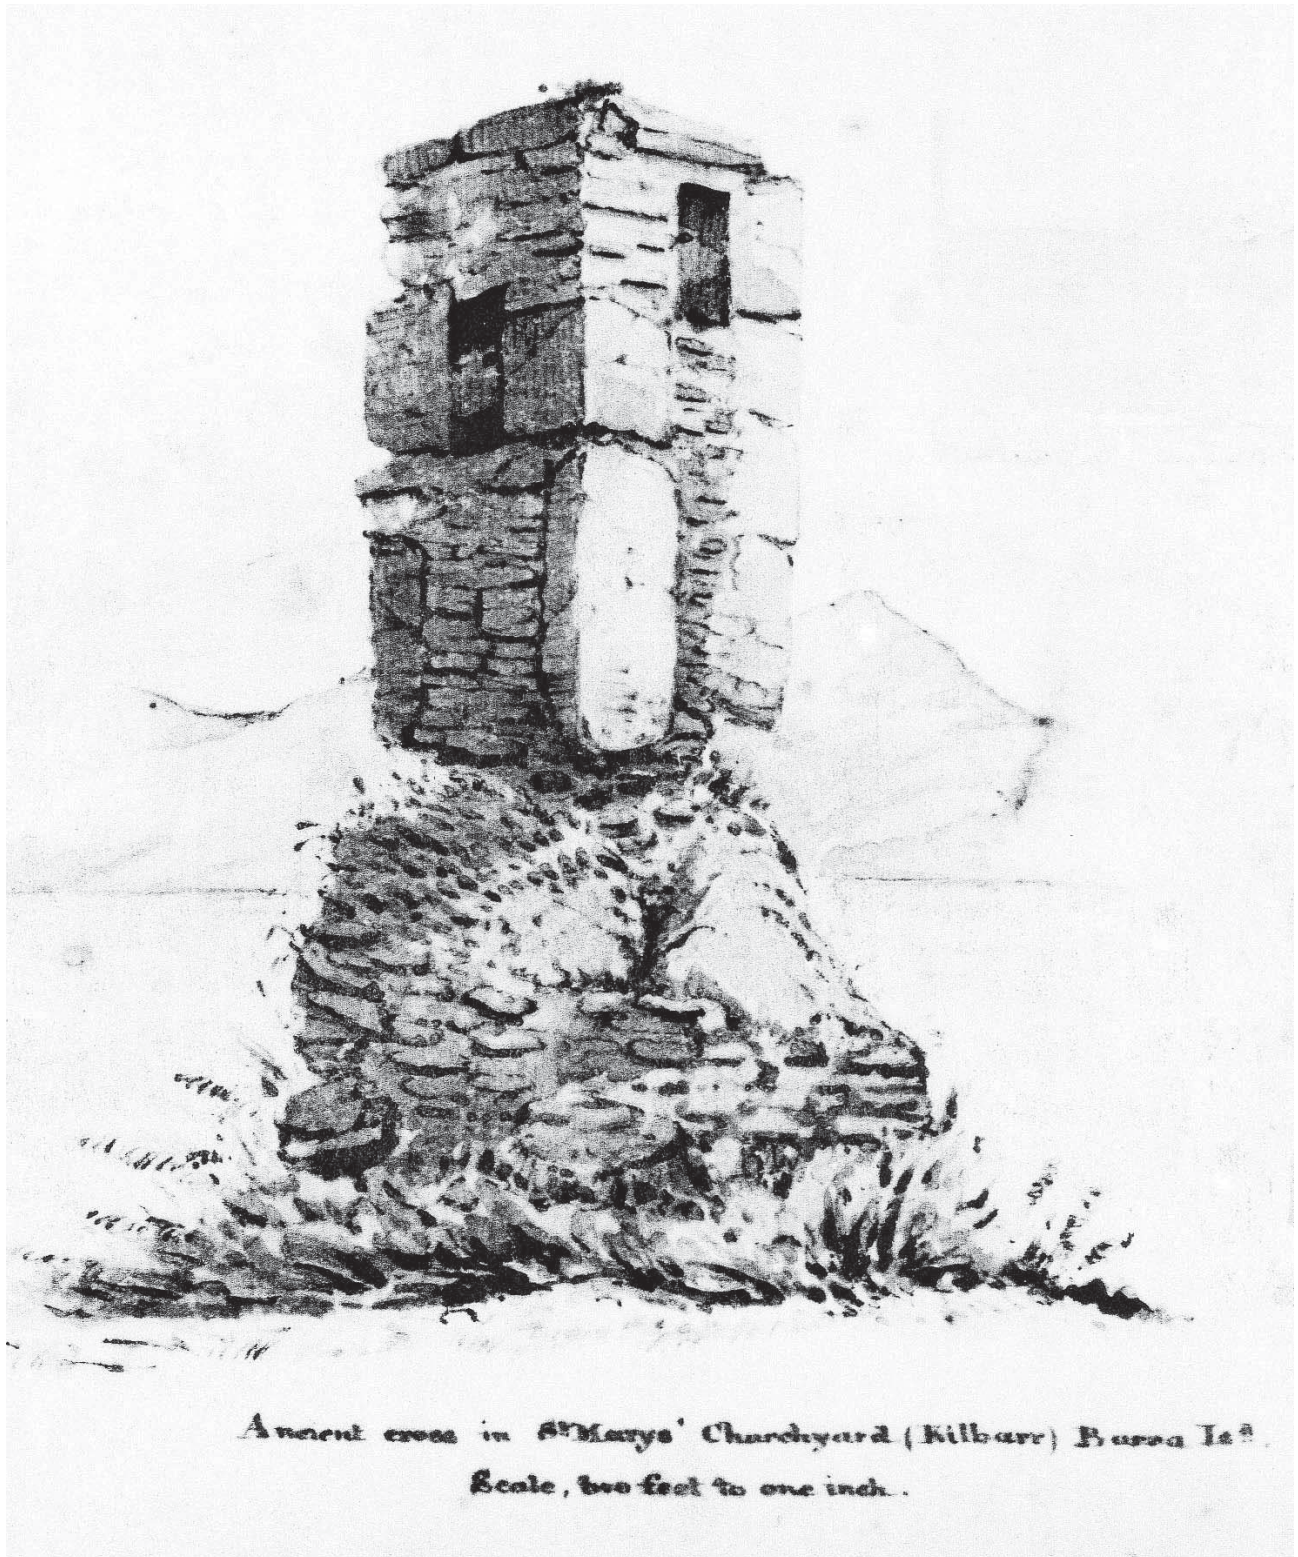
Figure 2 - 'Ancient cross in St Mary's churchyard, Kilbarr'

Little attention has previously been given to Martin's description of the 'St Christopher's altar'. Possibly it may be identified with 'the pedestal of a cross' that is referred to by the compiler of the *New Statistical Account* (1845, 206) in 1840. It is said to have been located near the church-group. These two descriptions, on their own, appear to have little in common. They may, however, be linked by a recently discovered drawing, by Adolphus Edge (1863), entitled 'an ancient cross in St Mary's Churchyard, Kilbar' (Figure 2).

Edge's drawing depicts a stone-built monument. It is roughly 5' (1.5 m) tall with sides 1' 6" (0.45 m) long and stands, somewhat precariously, over a stone base (or gable?) roughly 5' (1.5 m) wide and 3' (0.9 m) high, making the monument roughly 8' (2.4 m) high overall. In the two visible faces of the monument are niches, roughly 4" (0.1 m) wide and 12" (0.3 m) high, presumably intended for the display of religious artefacts. Although stone-built, rather than the single stone implied in Martin's account, the overall height of the monument and its apparent religious significance, as implied by the presence of the niches, may suggest that Martin's 'altar', the NSA's 'pedestal' and Edge's 'cross' are one and the same feature. The structure may have been dismantled during the course of the late-nineteenth-century reorganisation of the graveyard (Figure 1b). Interestingly, the 'cross' is still remembered in traditional accounts from the area; certainly, the monument was still resorted to in the period after the clearance of 1825 (information from Micheil a' Ghлиндich, via Andrew Kerr pers comm).

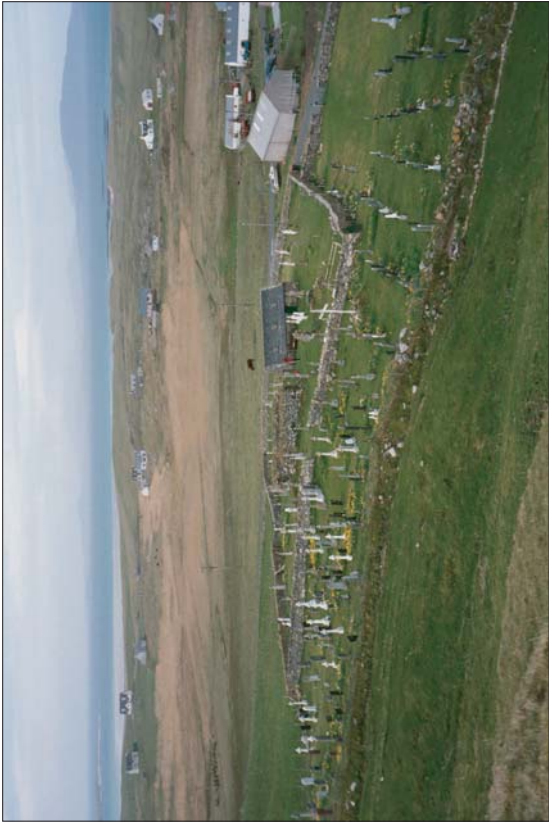
The surviving elements of the church-group (Buildings Nos. 2 – 4) lie clustered together in the south half of the late nineteenth-century walled graveyard (Plate 1). Inside the enclosure but previously un-noted, are two pronounced breaks-of-slope. Clearly artificial or at least man-modified, these divide the enclosure into a series of platforms.

Comparison of the 1876 and 1901 Ordnance Survey maps suggests that the later rectilinear enclosure roughly overlies its curvilinear predecessor. However, parallel with, and roughly 4 m to the south-east of, the later enclosure, there is a pronounced 'grass-mark', formed by a broad swathe of lush green grass, roughly 3 m wide (Plate 1). The feature may signify the site of the external ditch recorded by Macculloch (1824, 4).

Meanwhile, outwith and to the south of the early cemetery, there is a large stone cairn (Plate 1), up to 3.5 m in diameter and 0.8 m high. On it has been recently erected a large wooden cross. The feature has not previously been recorded and it is therefore of uncertain antiquity. Speculatively, however, the cairn may represent or subsume Martin's 'altar', the NSA's 'pedestal' or Edge's 'ancient cross'. For what it is worth, the view from the cairn of the seascape of South Uist and beyond is not dissimilar to the background shown in Edge's drawing.

Plate 1: View of church group, facing N, with cairn in centre ground and possible line of enclosure ditch to E.

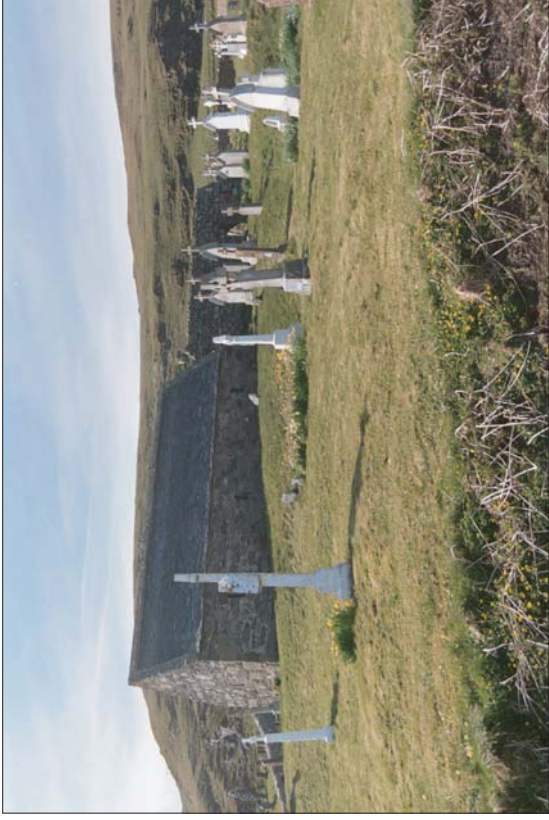
Transposition of Muir's survey plan onto the modern map-base indicates that Building No.1 lay on the lowest platform (Plate 2), near the north edge of the enclosure and close to the road, as indeed previously described (Muir 1885, 53, 281). Although there are no visible remains of the structure, it may be significant that cross-marked Stone B lies just to the west of the projected position of the building; Stone C, meanwhile, is located a few metres to the south. This strongly suggests that the grave-markers were positioned with reference to Building No.1, allowing perhaps a greater antiquity for that building than, for example, Muir believed.

Plate 2: Site of Building No.1 in foreground, facing SW, with Buildings Nos. 2 & 3 in background.

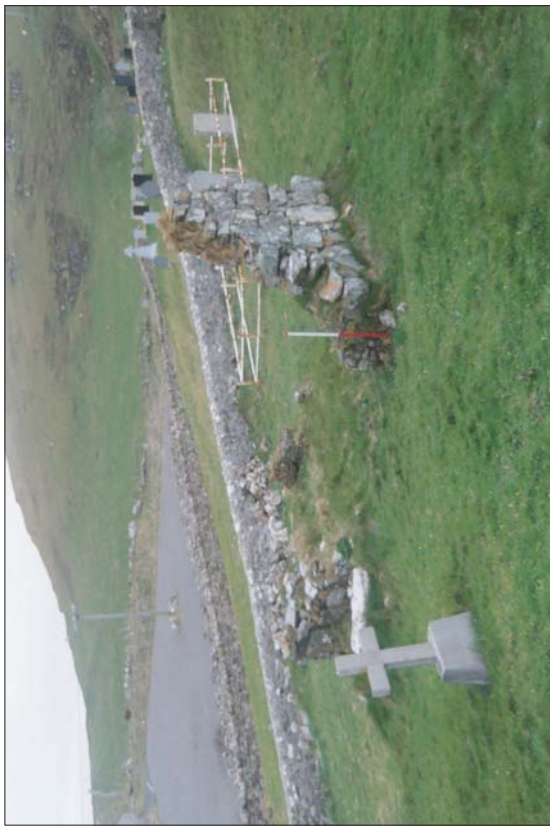
Plate 15: Building No.4, facing SE.
