**Date: 8<sup>th</sup> October 2004**

**Project Code: MNB03**

**Marine Hotel, 18 Cromwell Road, North Berwick,  
East Lothian: Desk-Based Assessment and  
Historic Building Survey**

**MARINE HOTEL, NORTH BERWICK**  
**DESK-BASED ASSESSMENT AND STANDING BUILDING SURVEY**

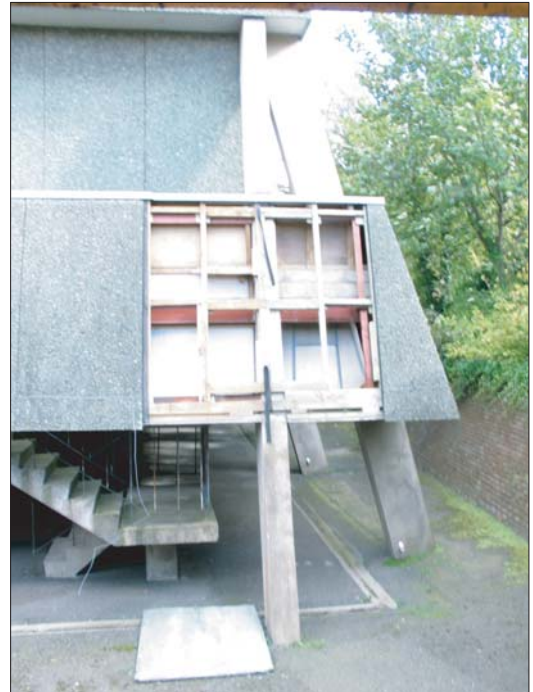
Plate 14: Building D, south-west corner looking east

Attached to the north-west end of the Marine Hotel is Building D, a later 20<sup>th</sup> century conference suite (see Figure 1; Plates 14-16). This extension is constructed mostly of concrete, and is raised above a car-parking area by concrete piles. Building E (see Figure 1; Plate 13) is a later 20<sup>th</sup> century squash court, constructed of brick, breezeblock and concrete cladding, with a corrugated iron roof.
