Minor Archaeological Services Call-off Contract East Range, Stanley Mills, Stanley, Perth & Kinross (PIC043)

Historic Building Survey, April and May 2022
Report No. HES-PIC043-2022-01

Author	Graeme Carruthers MA MCIfA
Illustrator	Sam Griffith BA MSc PhD
Approver	Bruce Glendinning BSc PgDip MCIfA
Commissioned by	Historic Environment Scotland
Date issued	September 2022
Version	2
OASIS Reference	cfaarcha1-437611
Planning Application No	21/02111/LBC
Grid Ref	NO 11473 32800
CFA Report No.	4189
HES Report No.	HES- PIC043-2022-01

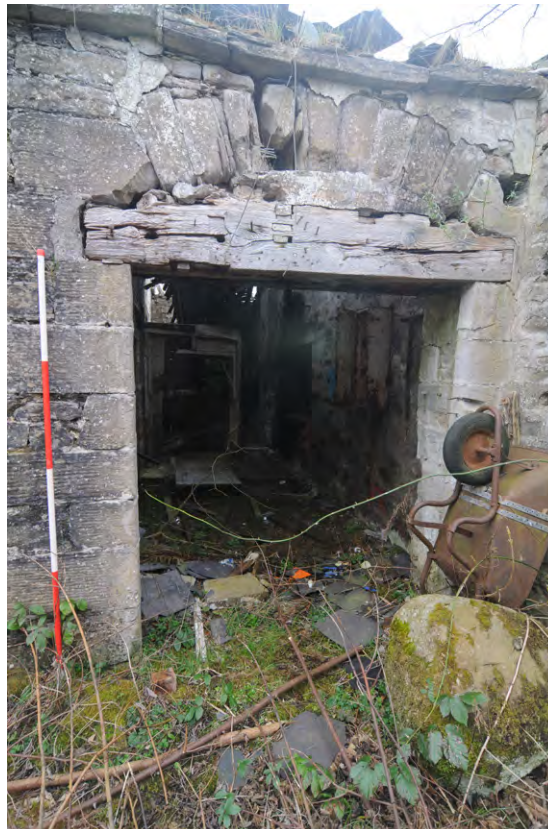
Fig 6: Phase 1, detail of reused lintel on doorway (029)

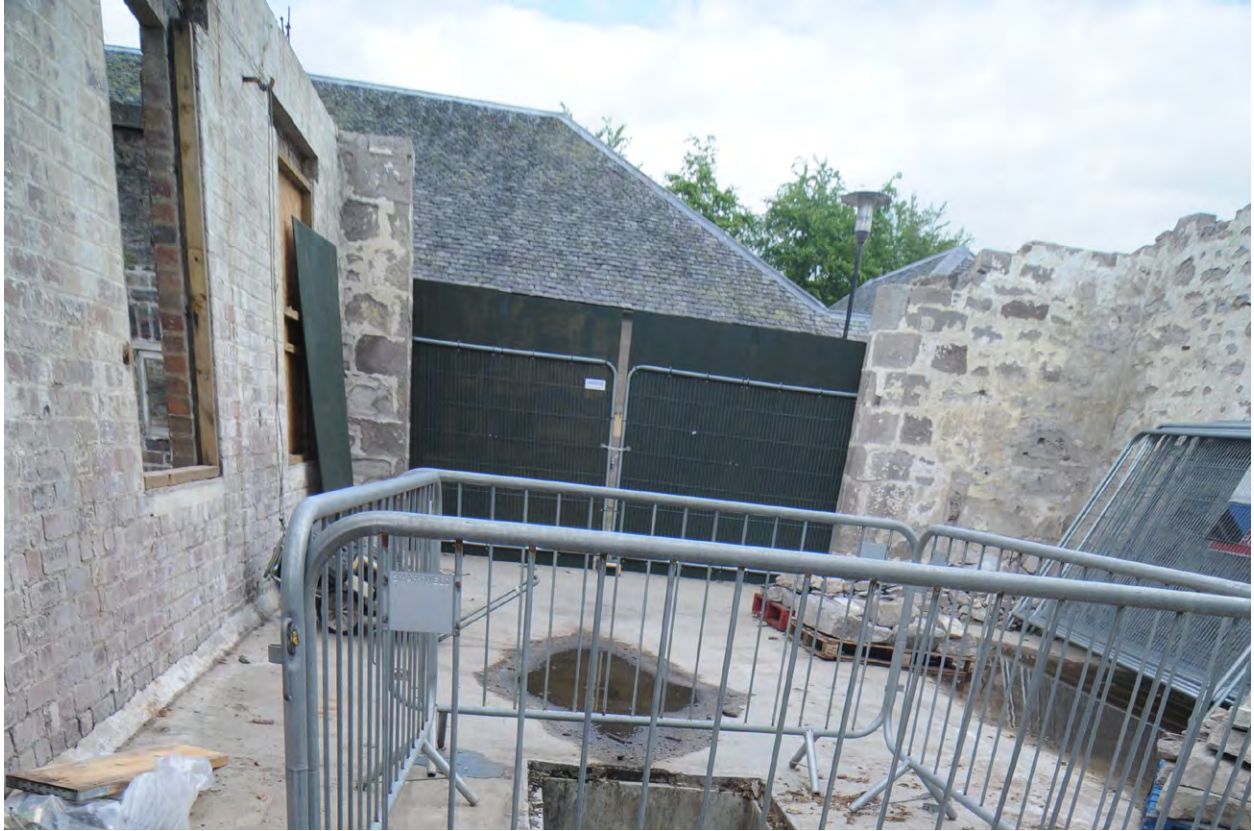
Fig 23: Phase 5, Garage, Unit 6, vehicle inspection pit

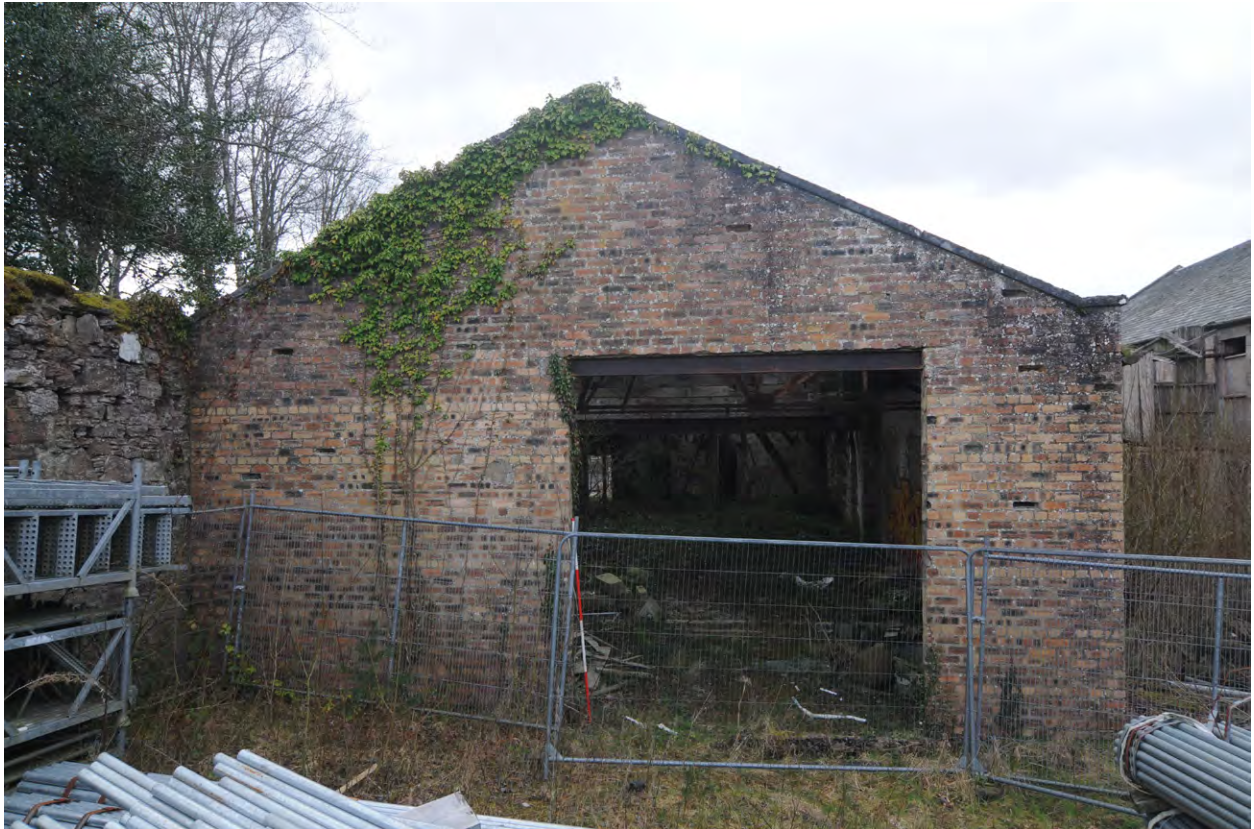
Unit 4 was a brick-built extension on to the northern end of Unit 3, abutting the rubble-built eastern boundary wall (023) which formed its eastern side. The north-facing gable wall (026) contained an offset double doorway (027) with an iron I beam lintel (Fig. 26).

Fig 26: Phase 6 external north-facing elevation, Unit 4, showing doorway (027)

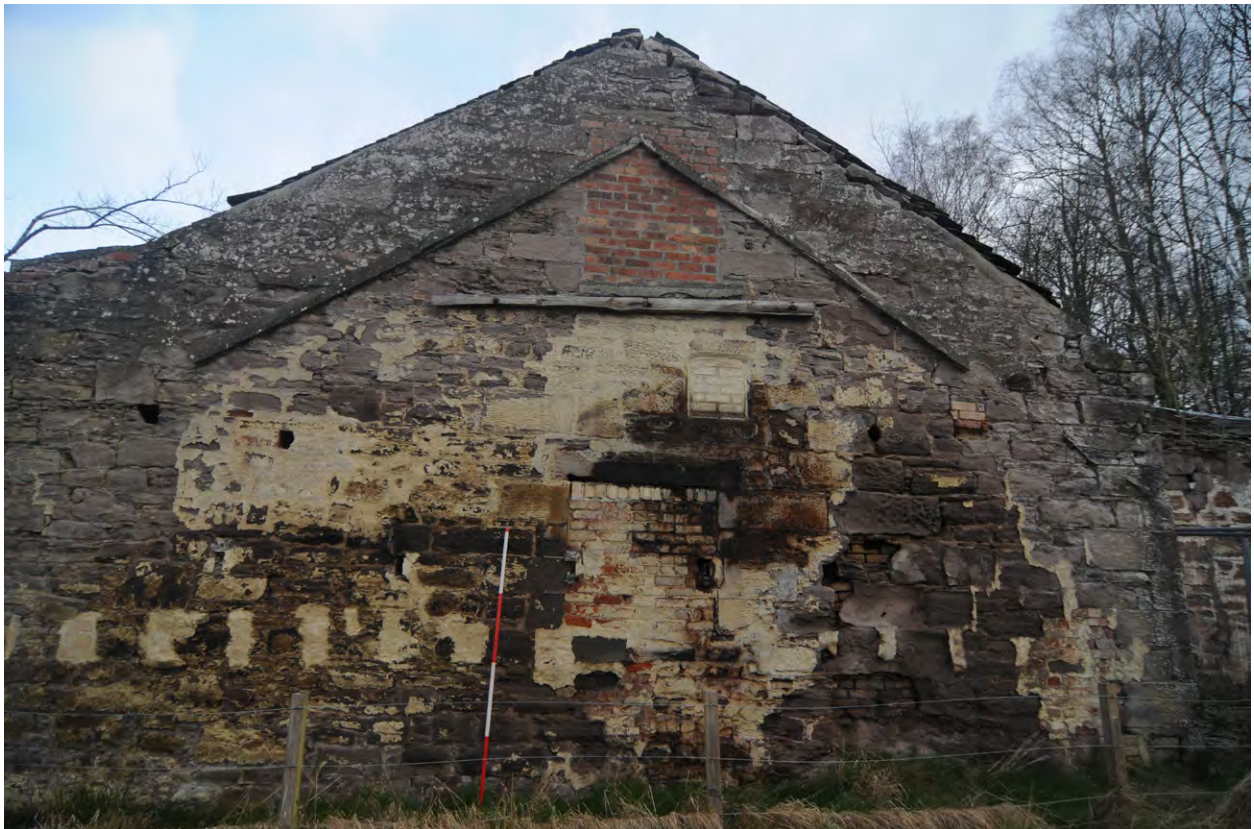
A raggle line (**004**) for the gable of the now missing building was visible, lower than but as wide as the gable for Unit 1 (Fig. 10). Windows (**003**) would likely have been blocked to facilitate the construction of the missing building, as the raggle line (**004**) cut across the window (**003**). Ten blocked floor joist holes were also present on this elevation to the west side, which must also relate to the now missing building.

Fig 10: Phase 2 remains of raggle line of missing building and blocked windows (003) and (007)

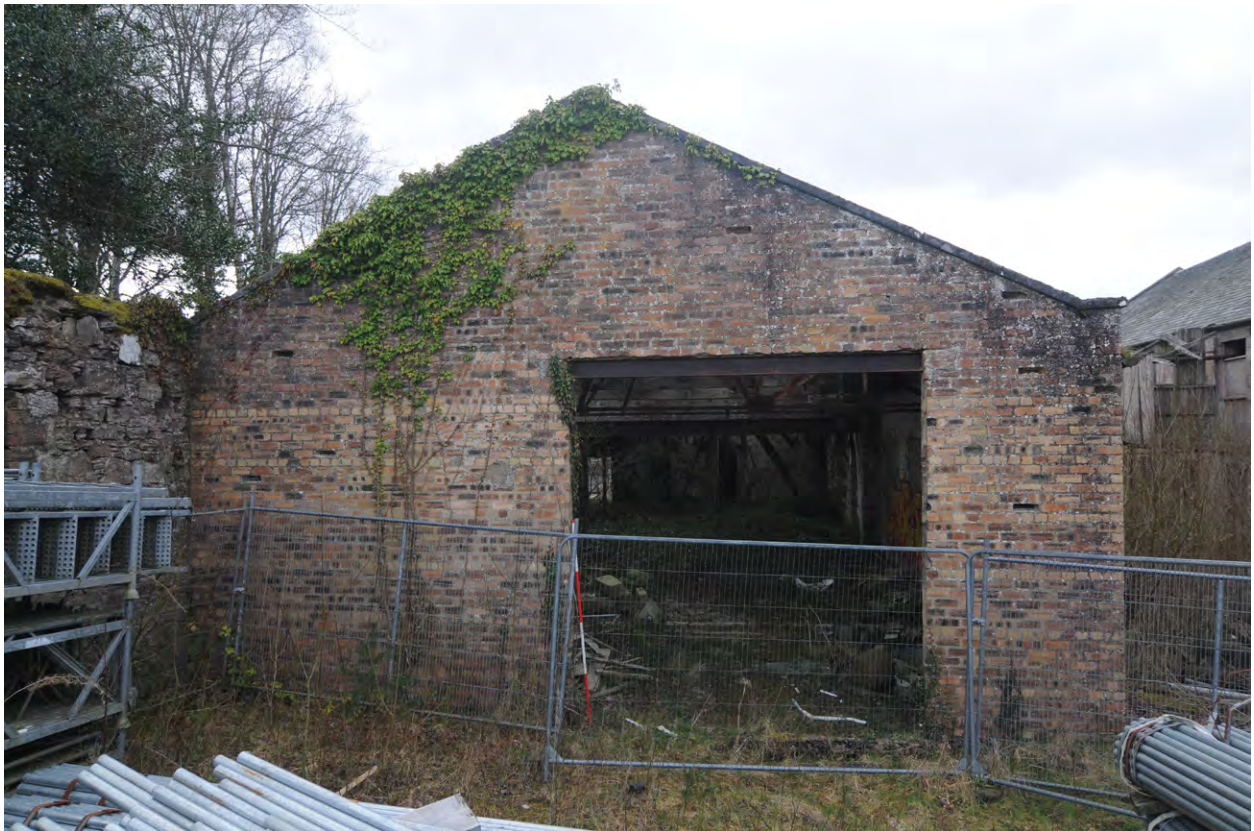
Fig 26: Phase 6 external north-facing elevation, Unit 4, showing doorway (027)
