## Information on Vacant Properties and Land Report

For  
Broadford Works

Aberdeen

May 2017

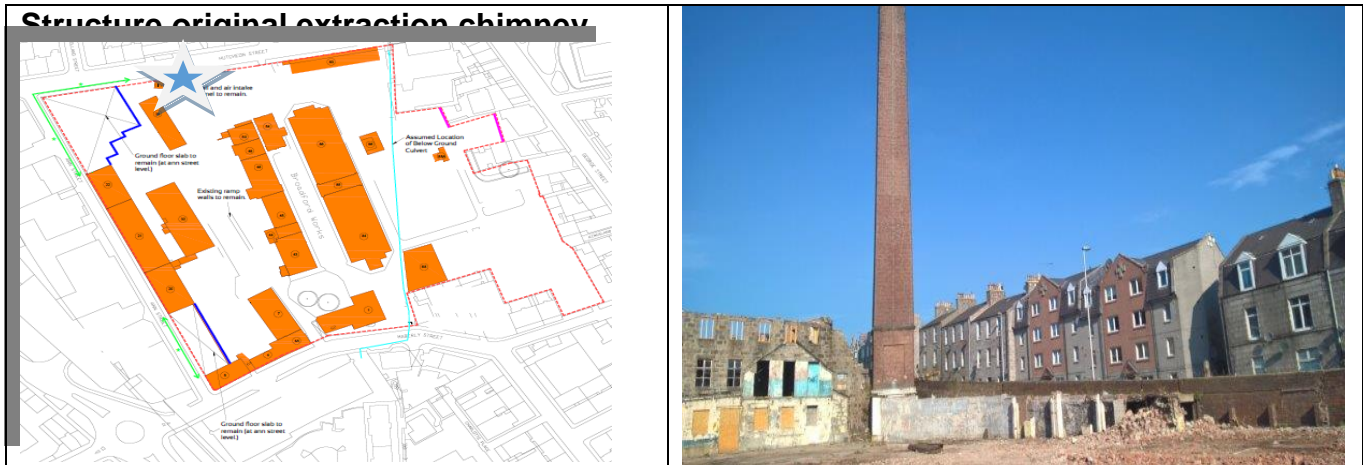
**A detailed survey of this structure has not been conducted whilst it is not thought to contain any asbestos products it must be treated as such until proven otherwise**

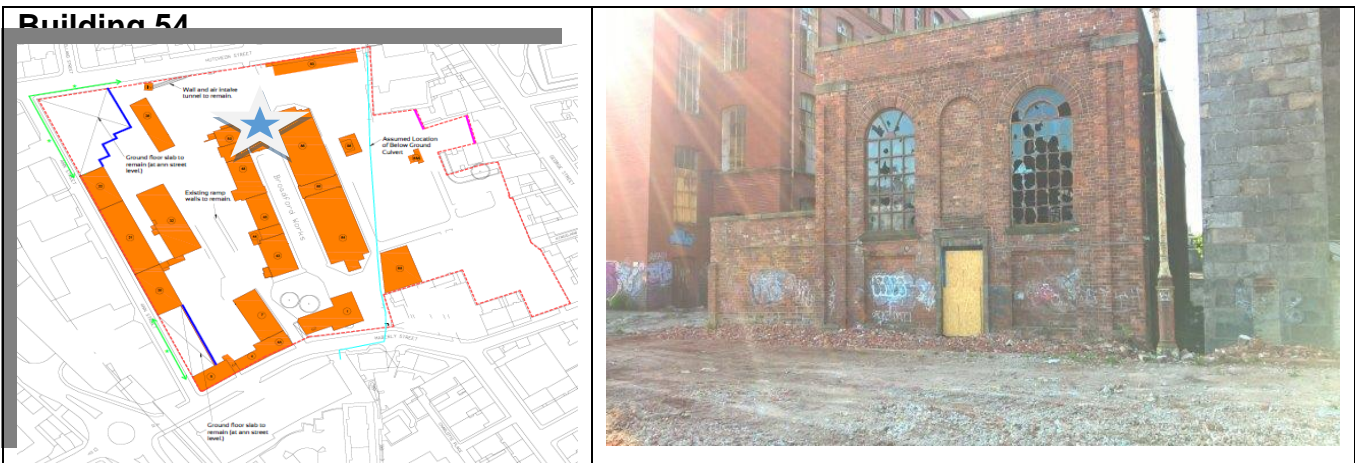
**A detailed survey of this structure has not been conducted whilst it is not thought to contain any asbestos products it must be treated as such until proven otherwise**

**Treat building/structure as having pigeon infestation and preventative measures to protect from Psittacosis (This is currently on programme to be cleaned)**

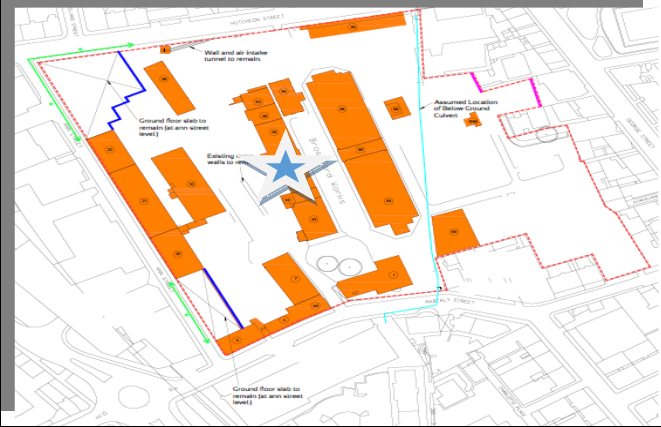
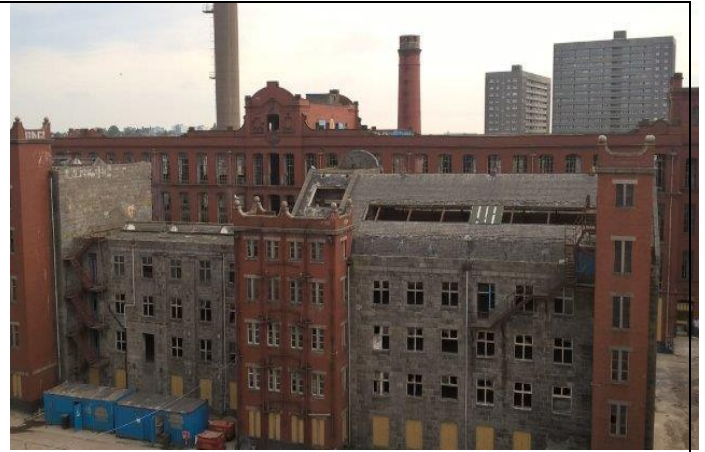
**Grey Mill Buildings 44-50**

**This building has had asbestos removal conducted on it and is asbestos free in all open areas, less for the burnt area on the ground floor which due to conditions may well have some fuse box type materials within the debris.**

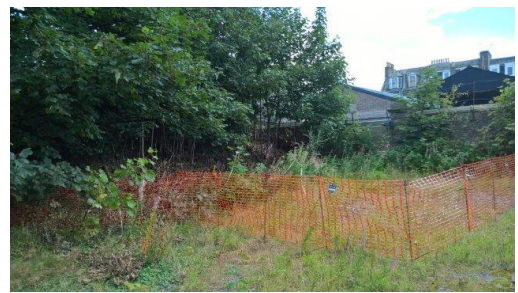
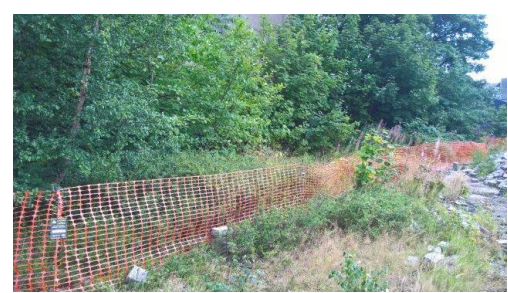
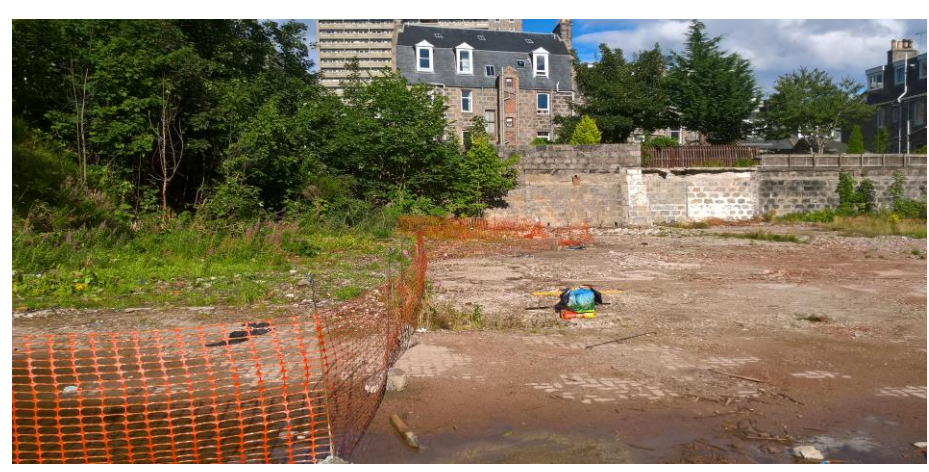
Areas have been demarked and are now no entry areas. Treatment of these areas has now been started.
