# EDINBURGH CASTLE CABLE REMEDICATION WORKS

ASSESSMENT AND RECORD OF ARCHAEOLOGICAL IMPACTS

**PROJECT NAME** Edinburgh Castle Cable Remediation, Edinburgh  
**CLIENT REF** -  
**HEADLAND REF** ECCR18  
**SERVICE** Assessment of archaeological impacts

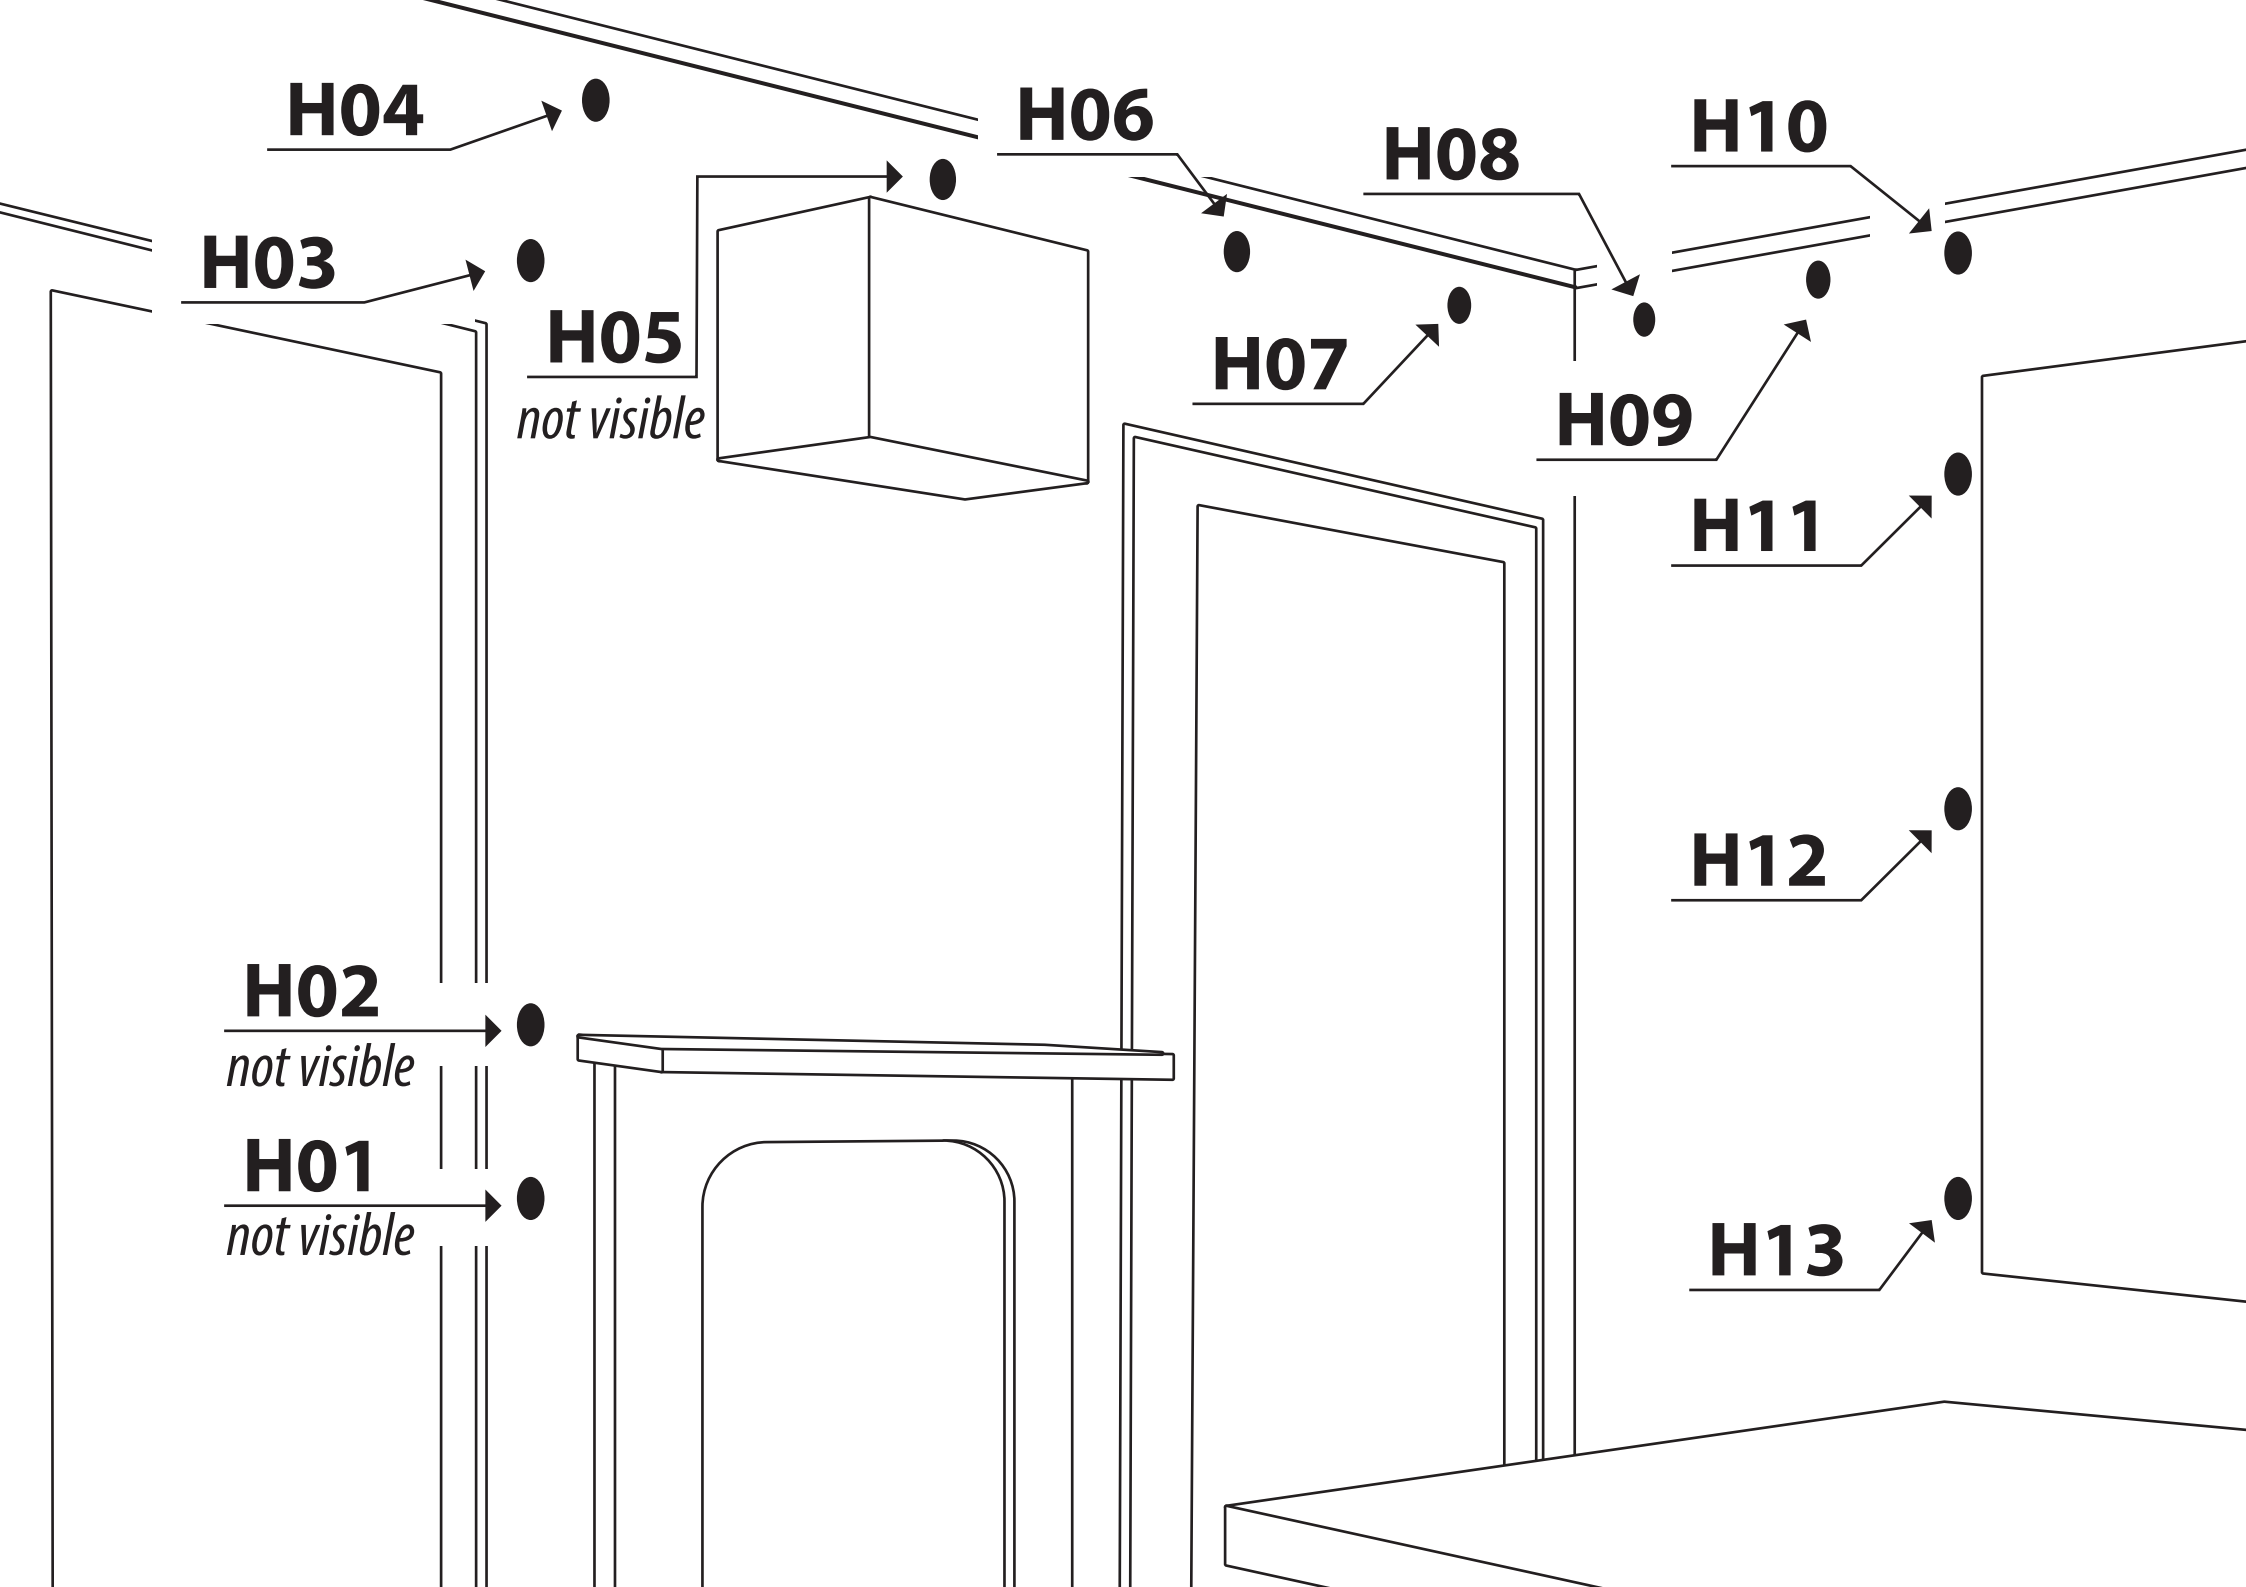
From the inspection it appears that the drilling has resulted in some minor damage to the underlying structure in two instances. The largest impact is in Hole 11 where the drill encountered a wooden beam and penetrated to a depth of approximately 4mm through the wood and 1mm into the stone. The damage in Hole 12 is minimal and comprises scuffing to the surface of the stone. There has been a minor impact to the visual appearance of the plaster surface within the room, however, there does not appear to have been any further impact on the structural fabric of the building in the other 11 holes.

**ILLUS 3** Additional damage to the plaster after removal of the rawl plug from the bottom hole on the south-west wall **ILLUS 4** Exploratory hole into plaster around Hole 11 showing area of damage **ILLUS 5** Exploratory hole into plaster around Hole 12
