South Church, Moray Street, Elgin: Historic Building Recording Report

On Behalf of:	Grant & Geoghegan Unit 4 Westerton Road Business Centre 4 Westerton Road South Keith AB55 5FH For: J Maunder
National Grid Reference (NGR):	NJ 21510 62538
AOC Project No:	22857
Planning Application No:	14/01399/LBC
OASIS No:	194999
Prepared by:	Diana Sproat
Date:	19th November 2014

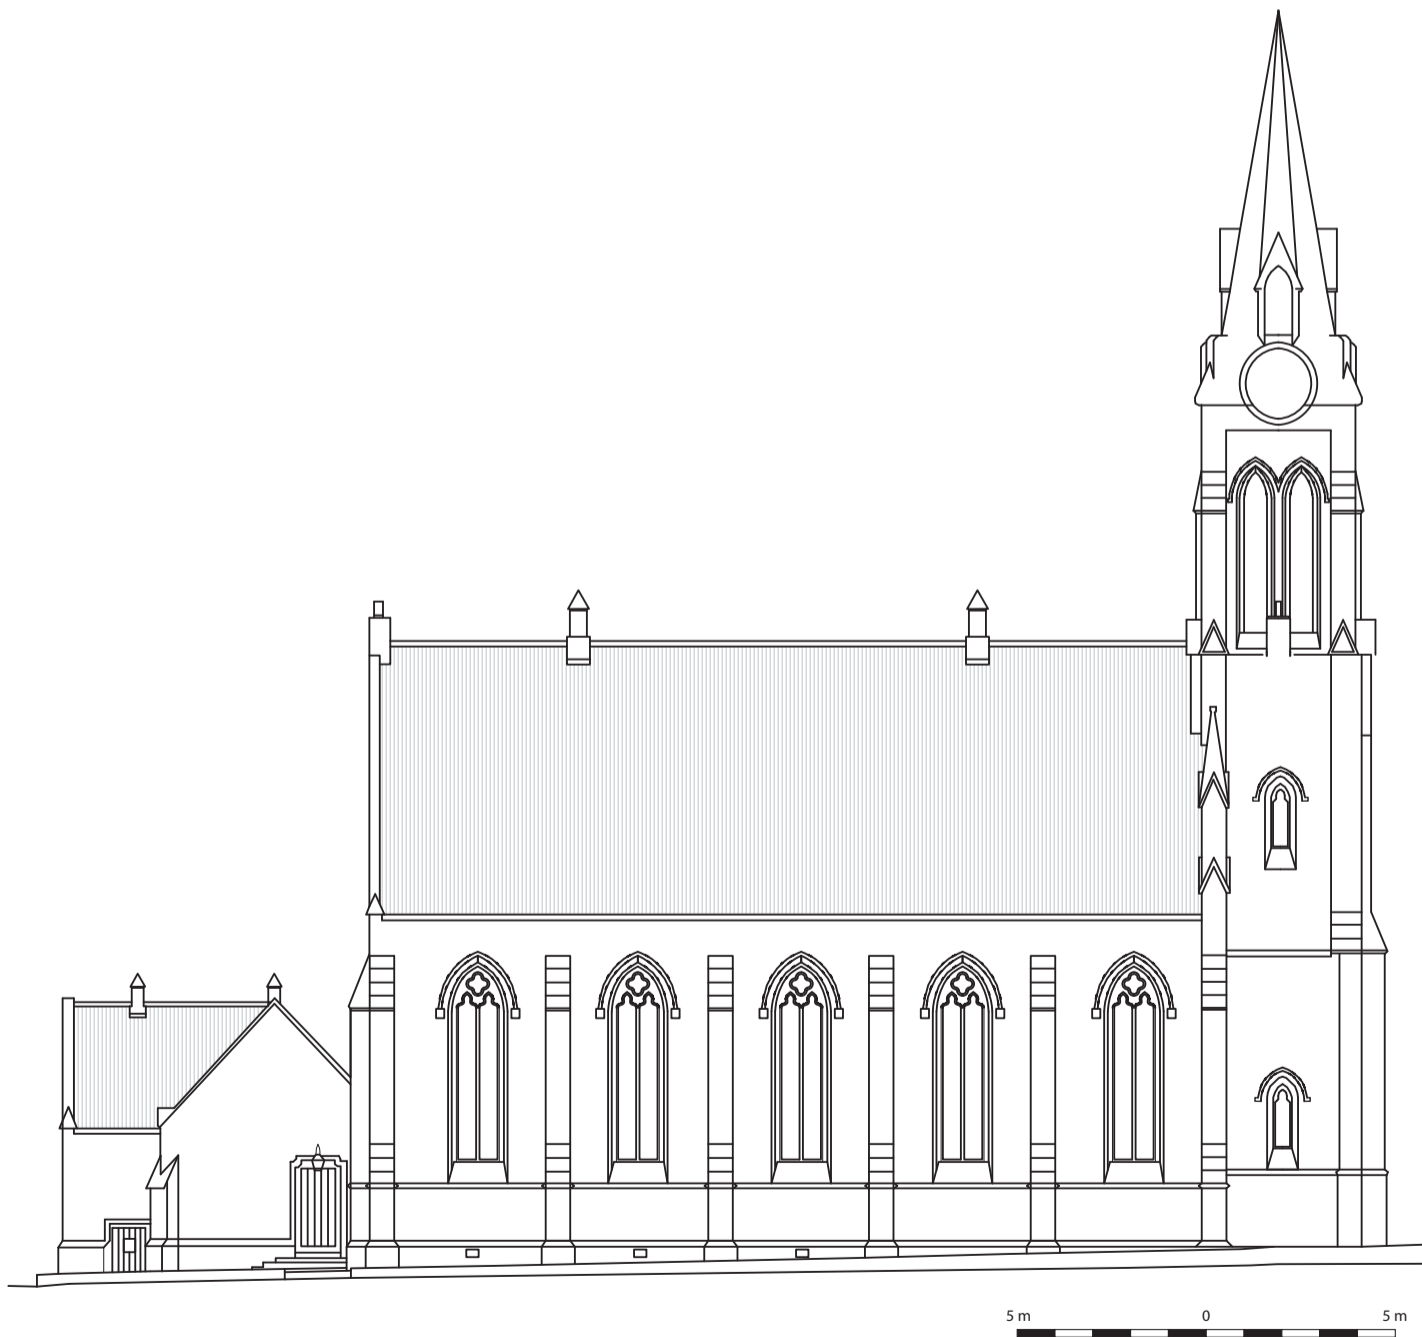
Figure 8: South Church, north-east elevation (provided by Grant & Geoghegan Ltd)

- 5.3 The north-east and south-west elevations are relatively identical with a row of five double lancet windows flanked by corner buttresses topped with Gothic-style pinnacles (Figures 8 & 9; Plates 15 - 17). As with the main entrance the stops to the hood moulds over the lancet windows feature small head carvings (Plates 18 – 27). The windows themselves are plain stained glass with an open louvered window to the upper half (Plate 28) and there are small cast-iron vents to the footing below each (Plate 29).

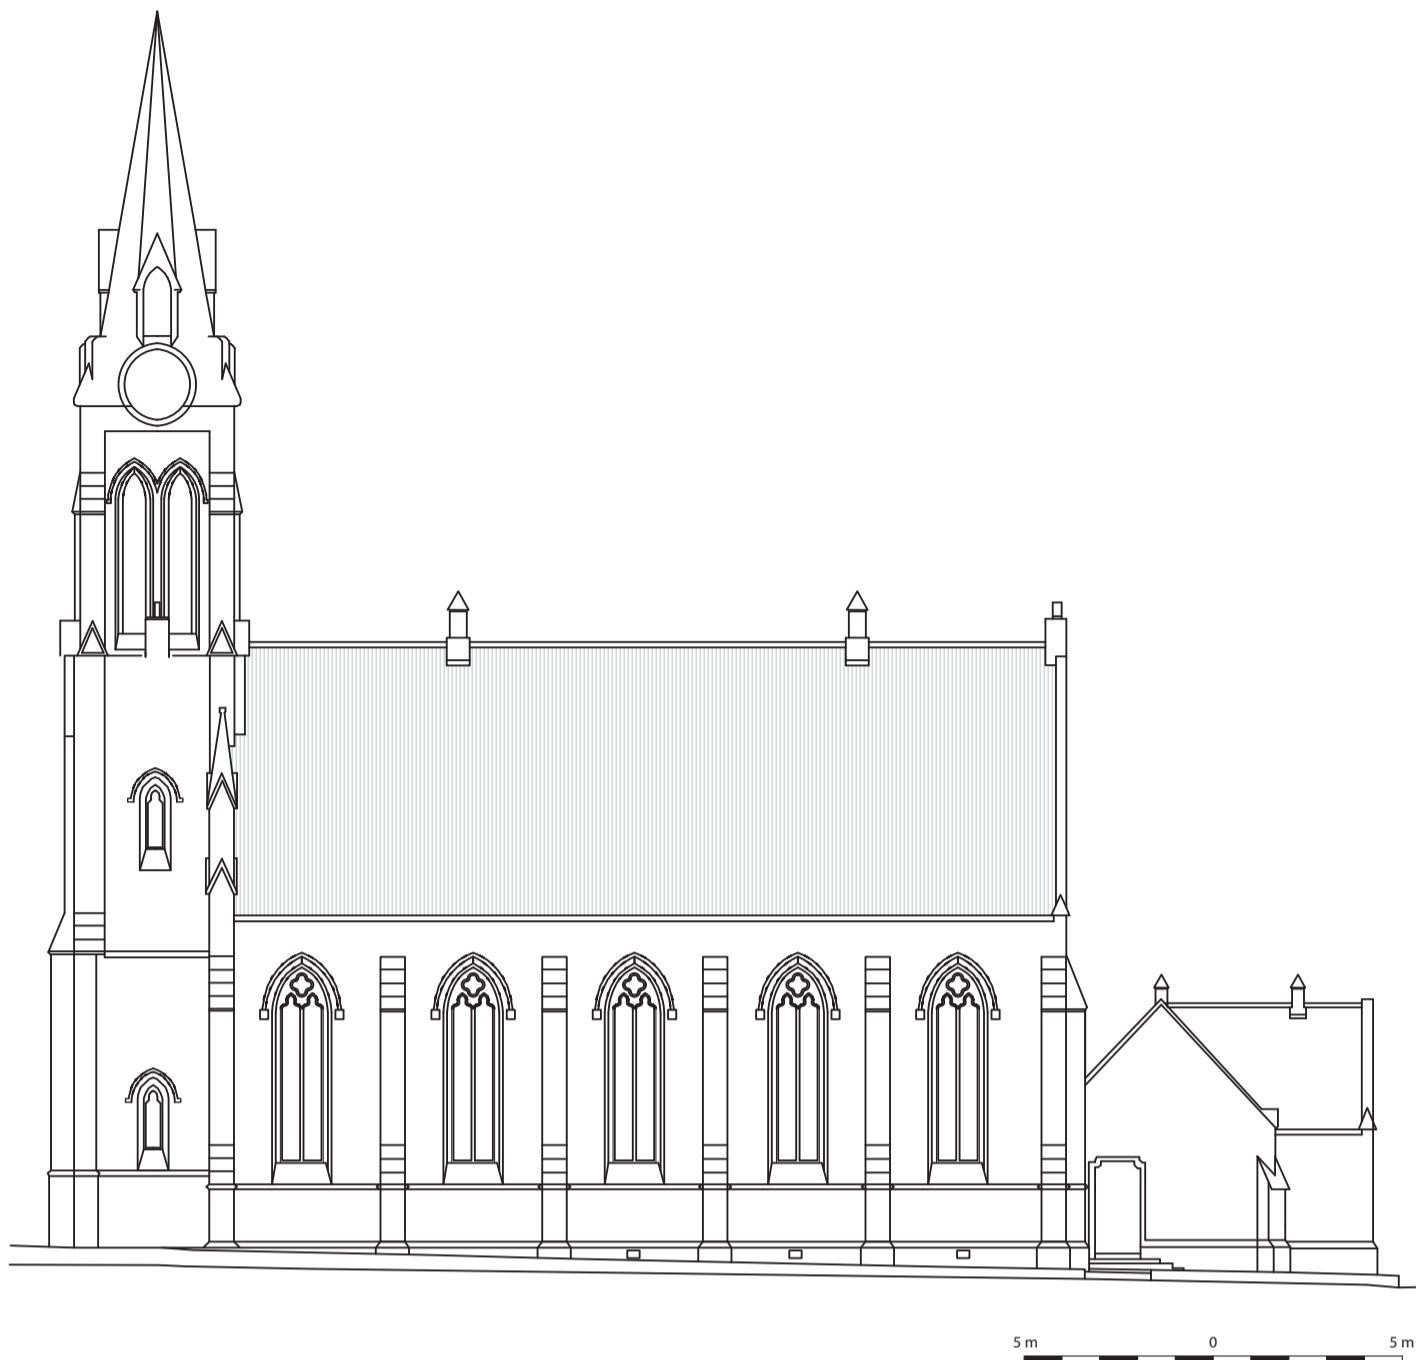
Figure 9: South Church, south-west elevation (provided by Grant & Geoghegan Ltd)

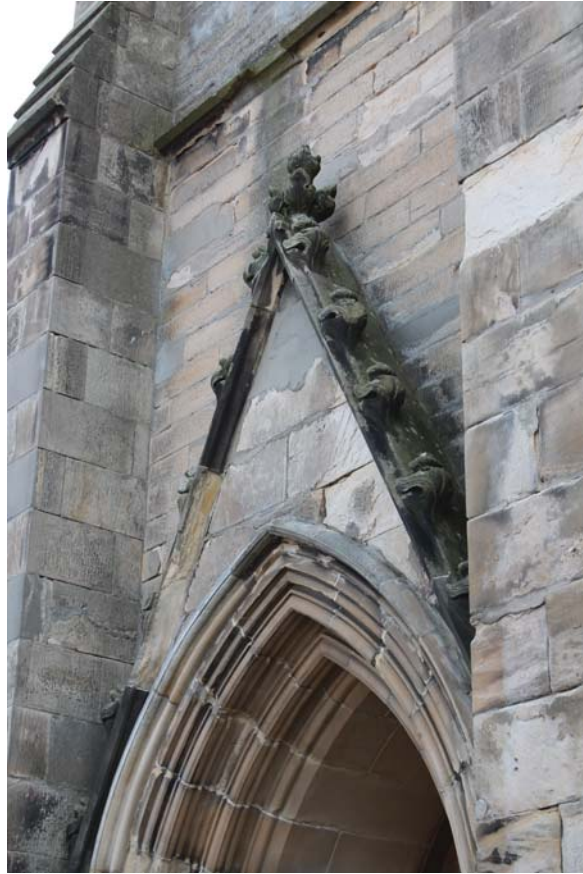
Plate 7: South-east elevation, detail of decorative stonework above main door

- 5.2 To the north-west is the main tower and main entrance to the church (Figure 7). The doorway is framed by a typically Gothic pointed arch flanked by two orders of columns with plain moulded heads and footings with a projecting triangular arch over (Plates 7 – 9). The stops to the outer pointed arched hood mould also feature carved heads of a woman (east) and man (west) (Plates 10 & 11). The outer body of the church is then dominated by a large lancet window to each side with an upper small thin lancet window above the main entrance. The third stage of the clock tower then has features to all four sides, including a pair of belfry openings below the clock with cusped lancet windows with triangular hood moulds to the base of the spire (Plates 12 & 13). To the east and west elevations of the main entrance is another smaller lancet window lighting the main porch (Plate 14).

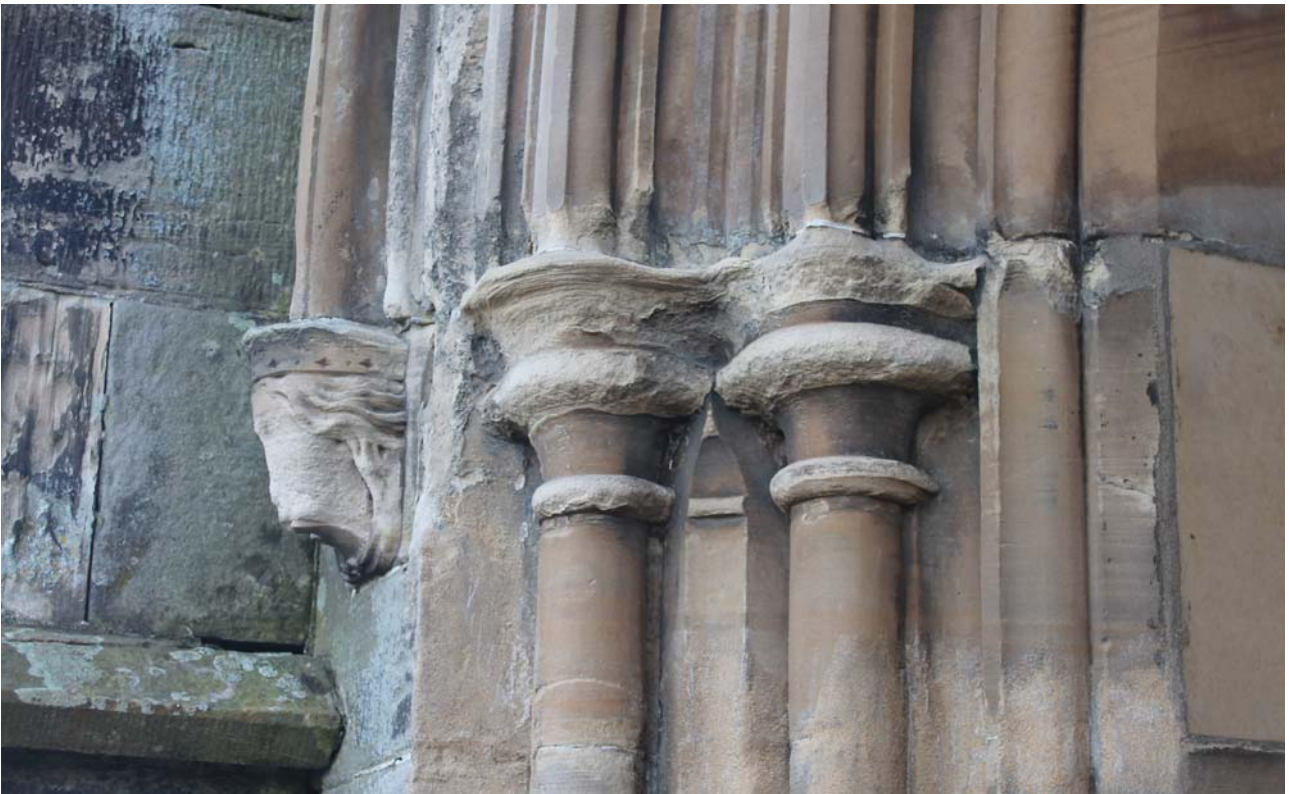
Plate 8: South-east elevation, detail of capitals to the main doorcase on the south-west side, from the north

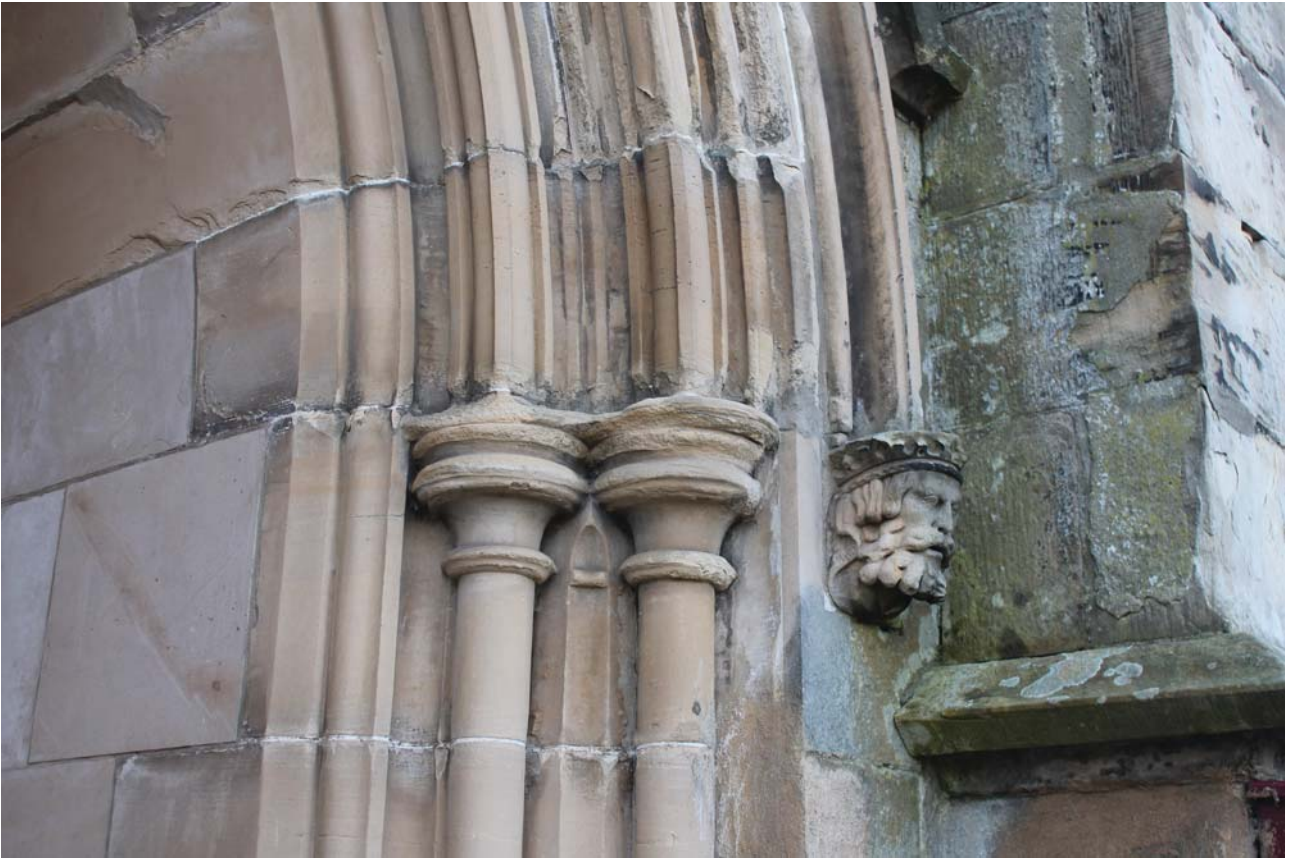
Plate 9: South-east elevation, detail of capitals to the main doorcase on the north-east side, from the east

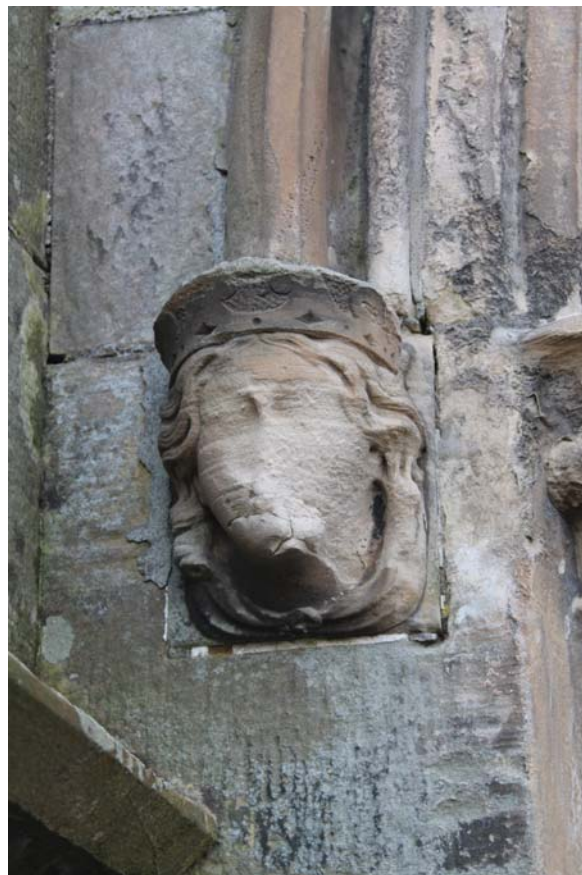
Plate 10: South-east elevation, detail of the carved figure/stop to the hood mould on the main doorcase on the north-east side, from the north-west

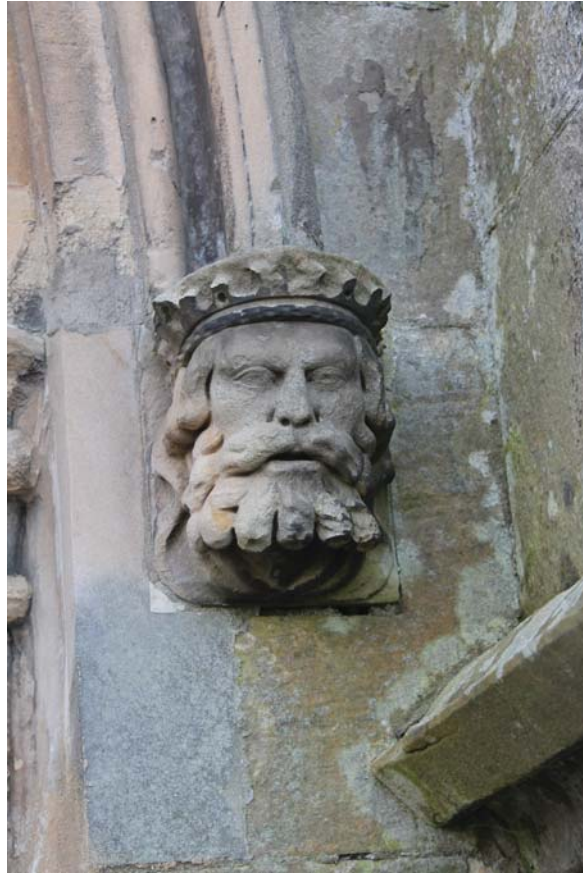
Plate 11: South-east elevation, detail of the carved figure/stop to the hood mould on the main doorcase on the south-west side, from the north-west

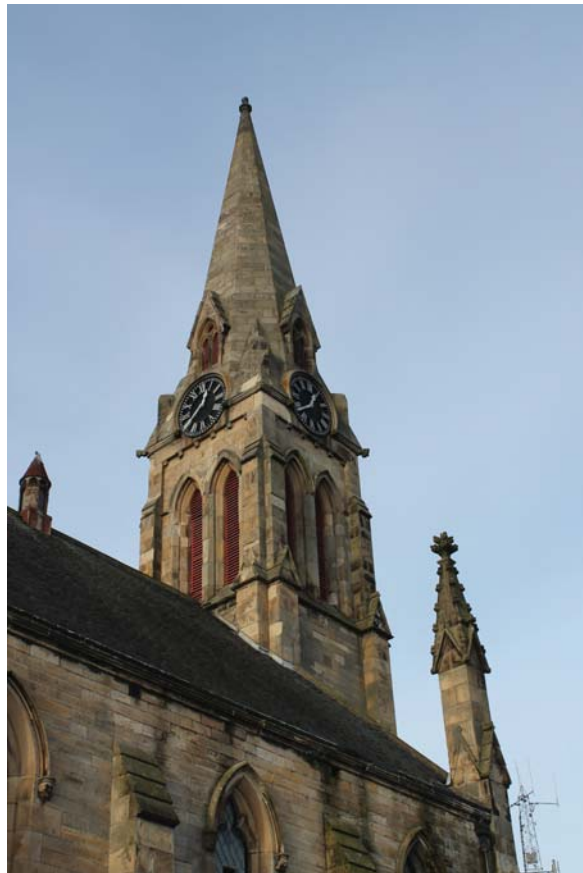
Plate 12: Detail clock tower and spire from the east

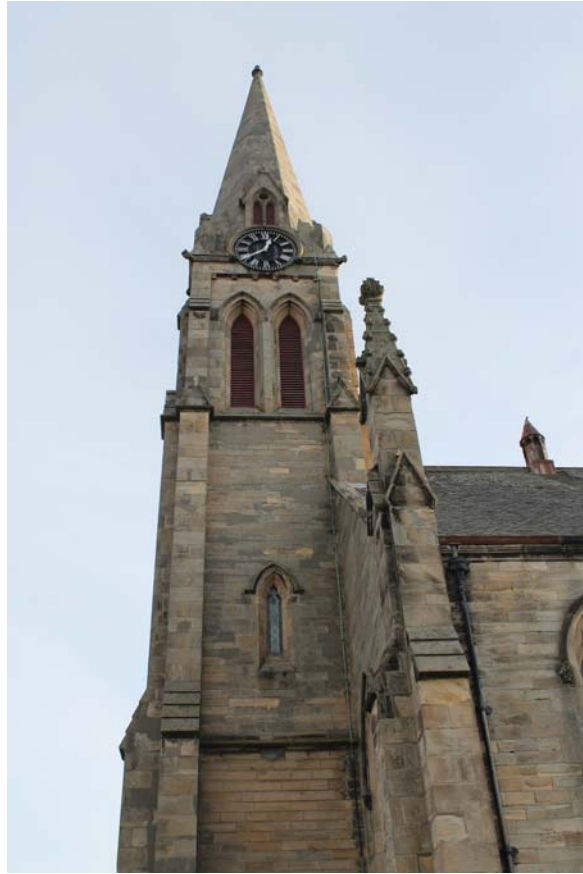
Plate 13: Detail of clock tower and spire from the south-west

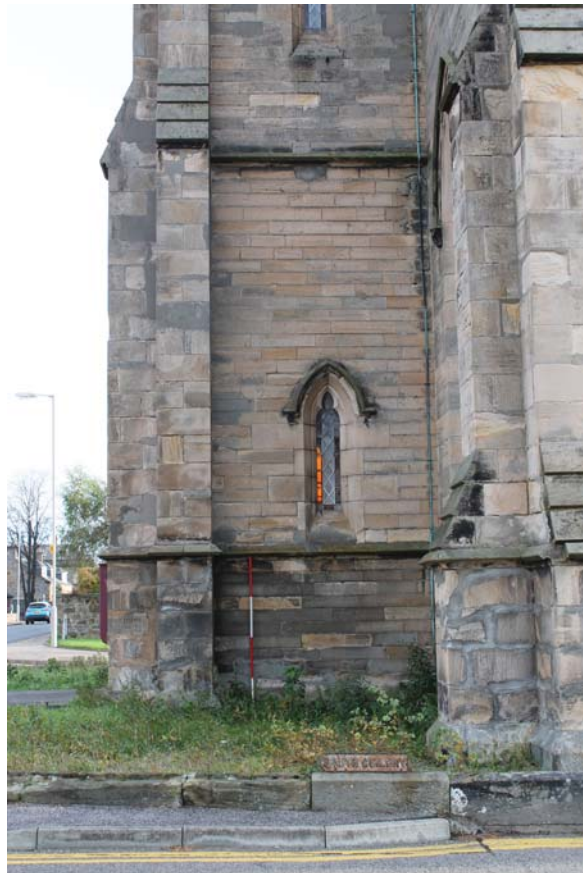
Plate 14: South-west elevation, detail of small porch window in the north-west side, from the south-west

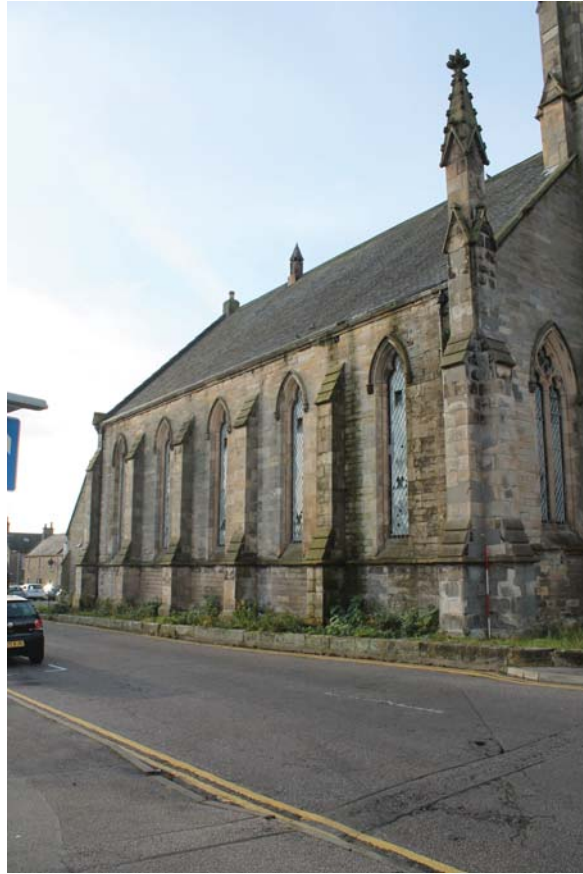
Plate 15: North-east elevation, general view from the north

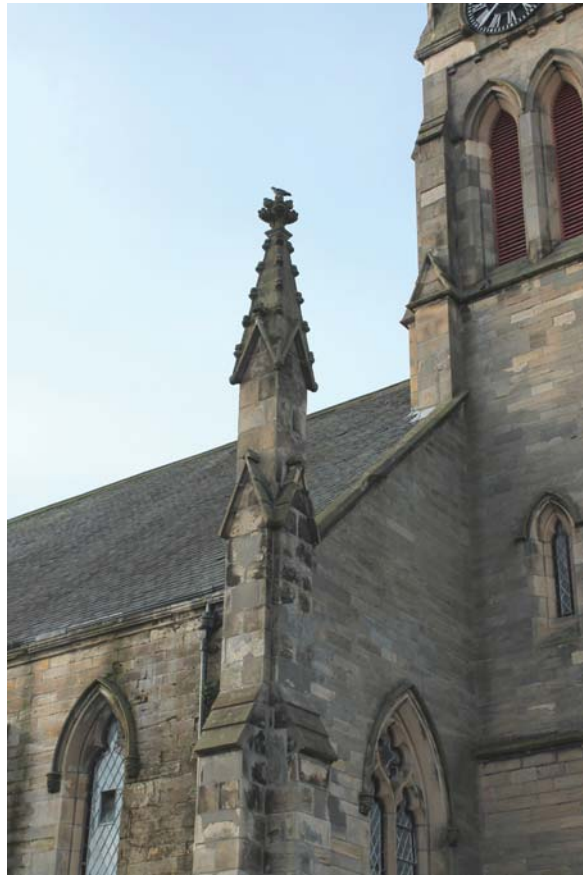
Plate 17: North-east elevation, detail of corner buttress from the north

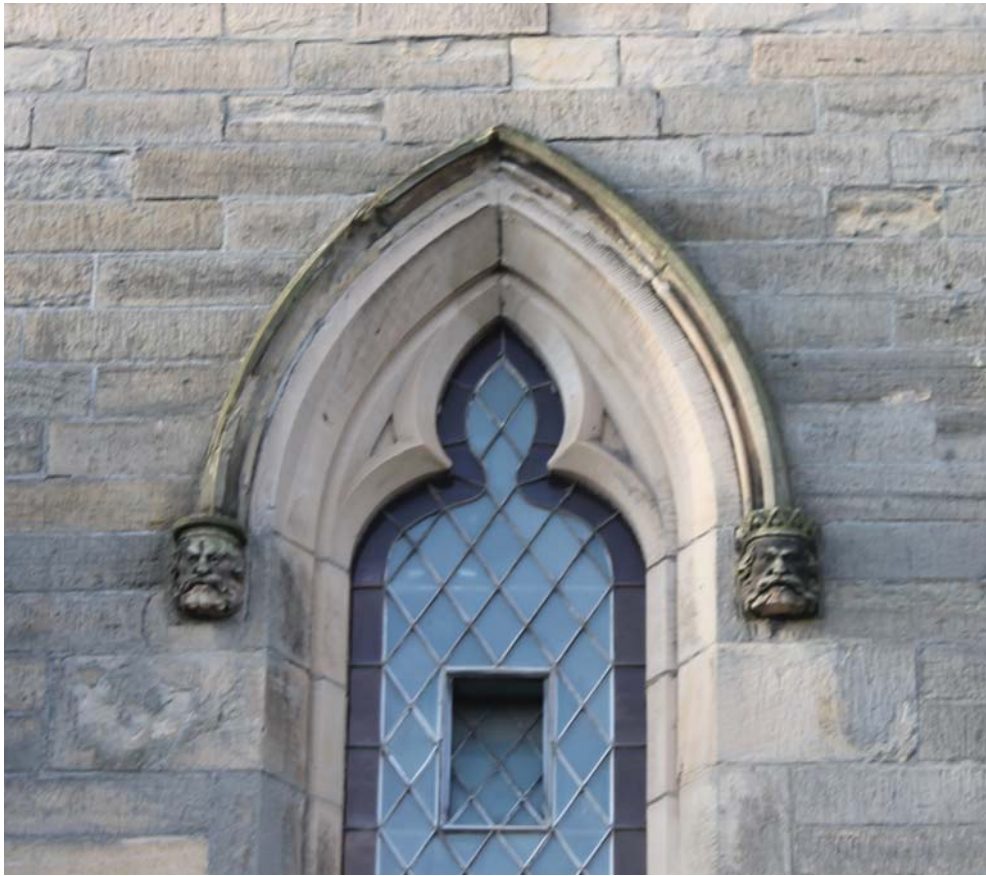
Plate 21: North-east elevation, detail of hood mould over central window from the north-east

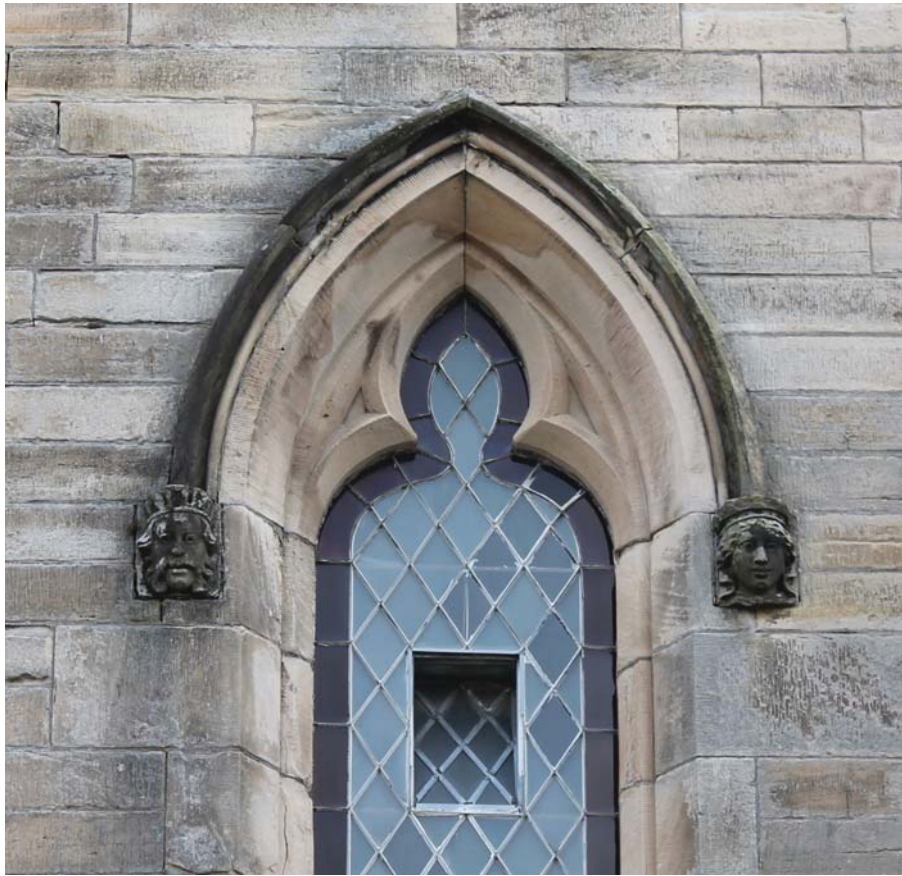
Plate 23: South-west elevation, detail of hood mould over north-westernmost window from the south-west

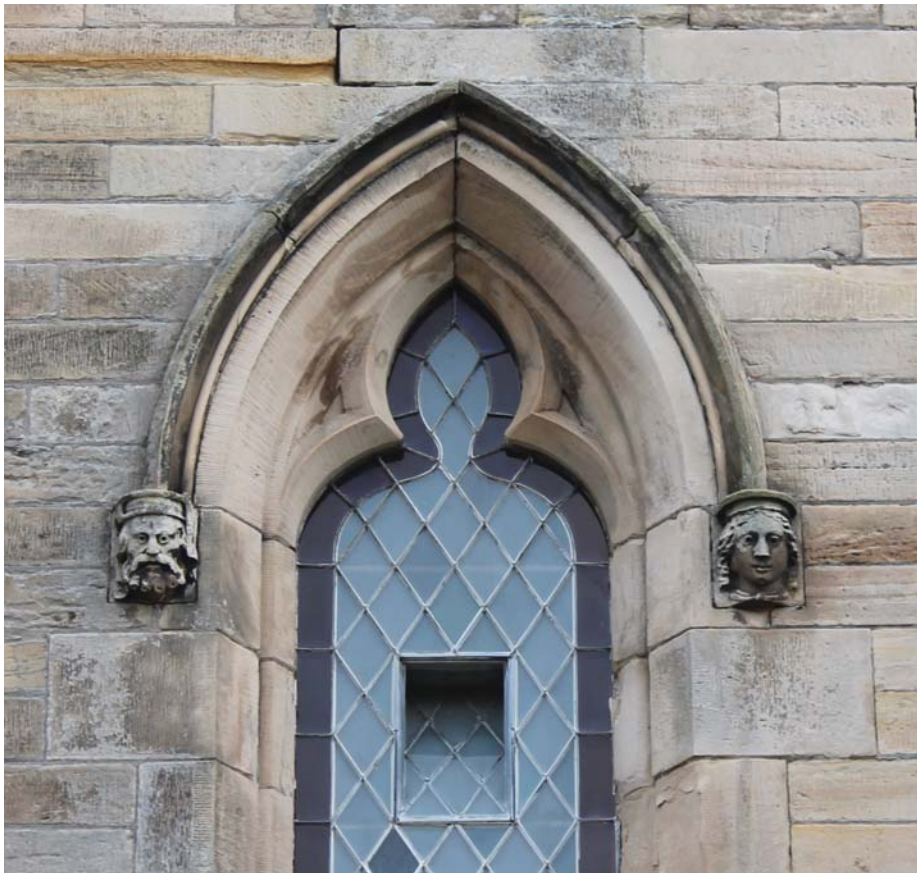
Plate 24: South-west elevation, detail of hood mould over second north-westernmost window from the south-west

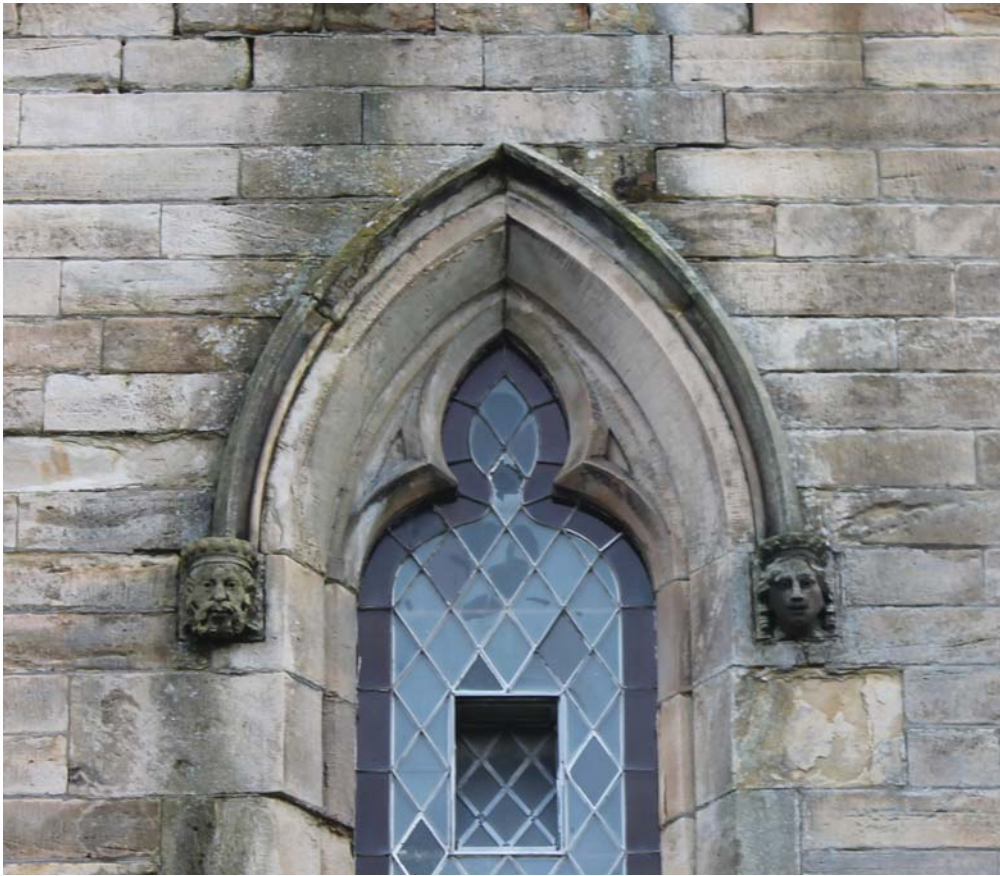
Plate 25: South-west elevation, detail of hood mould over central window from the south-west

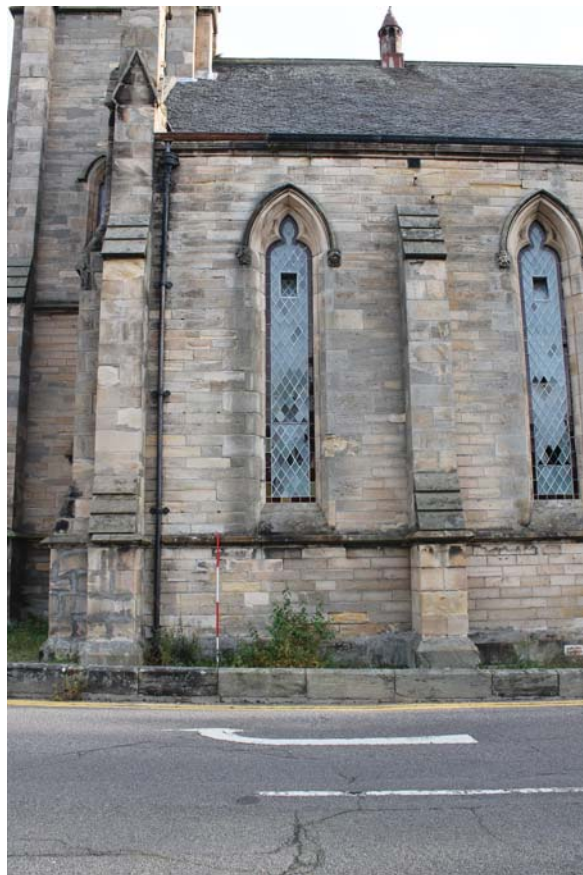
Plate 28: South-west elevation, detail of north-westernmost window from the south-west

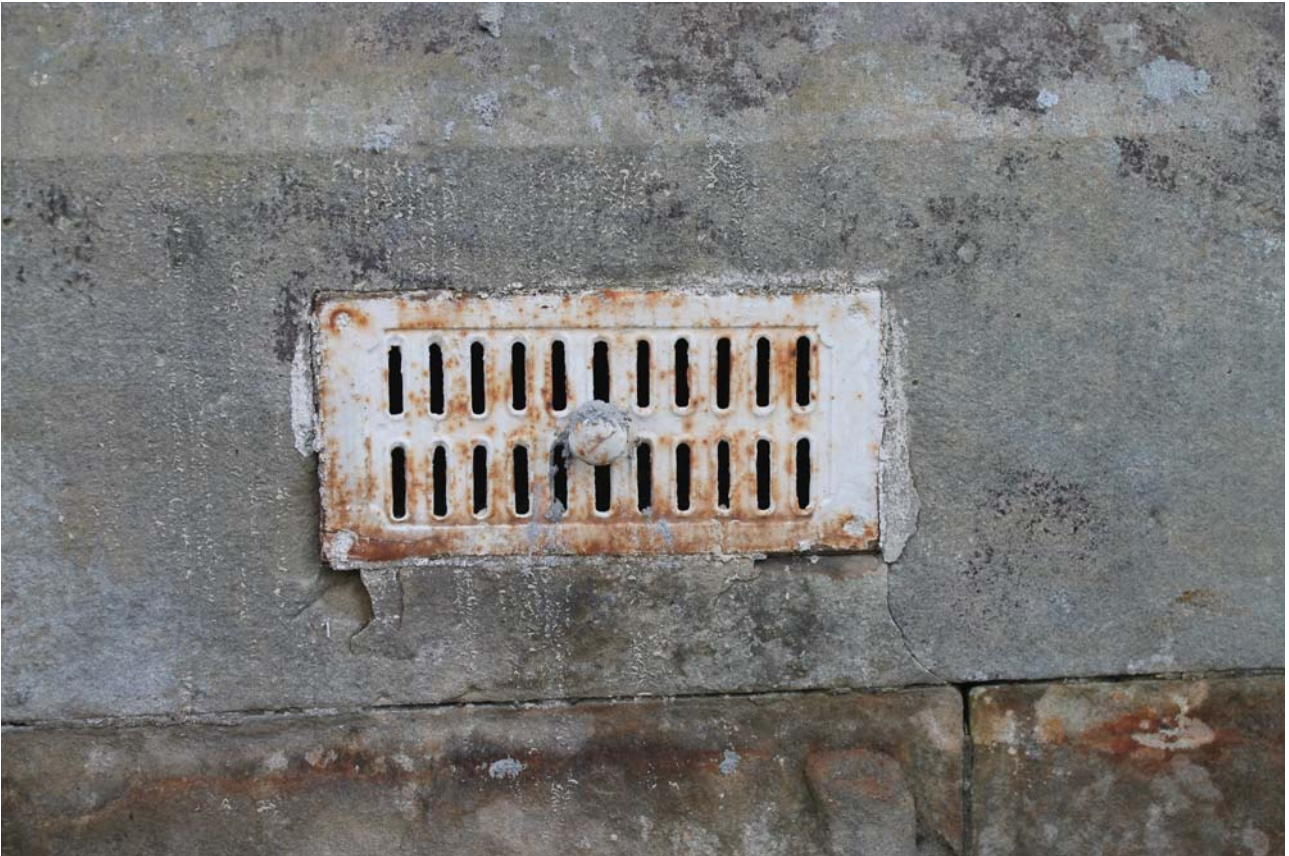
Plate 29: South-west elevation, detail of vent below window from the south-west

- 5.4 The rear of the church – as identified above in Section 4 – has had an extension (Figure 10; Plate 30). The longer rectangular original part of the church can still be seen behind, however, with the small lancet windows partially obscured by it. The north-east and south-west elevations of the original also each have a low-set doorway - the south-west of which has been blocked – which is chamfered and flat arched with a flush surround (Plates 31 & 32). The corners are then defined by a corner buttress and the pitched roof to each side rises to another cross finial to mimic the clock tower (Plate 33). Small circular iron vents are located below in the footing (Plate 34). The south-east elevation of the original then has a double lancet and thin single lancet window to each side; these probably flanked a large doorway prior to the extension. This small extension then consists of a three lancet window to the rear south-east elevation to a gable, also with cross finial. The extension has partially blocked the dominance and effect of the large upper gallery windows to the main body of the church, which features a central rose window (Plate 35).

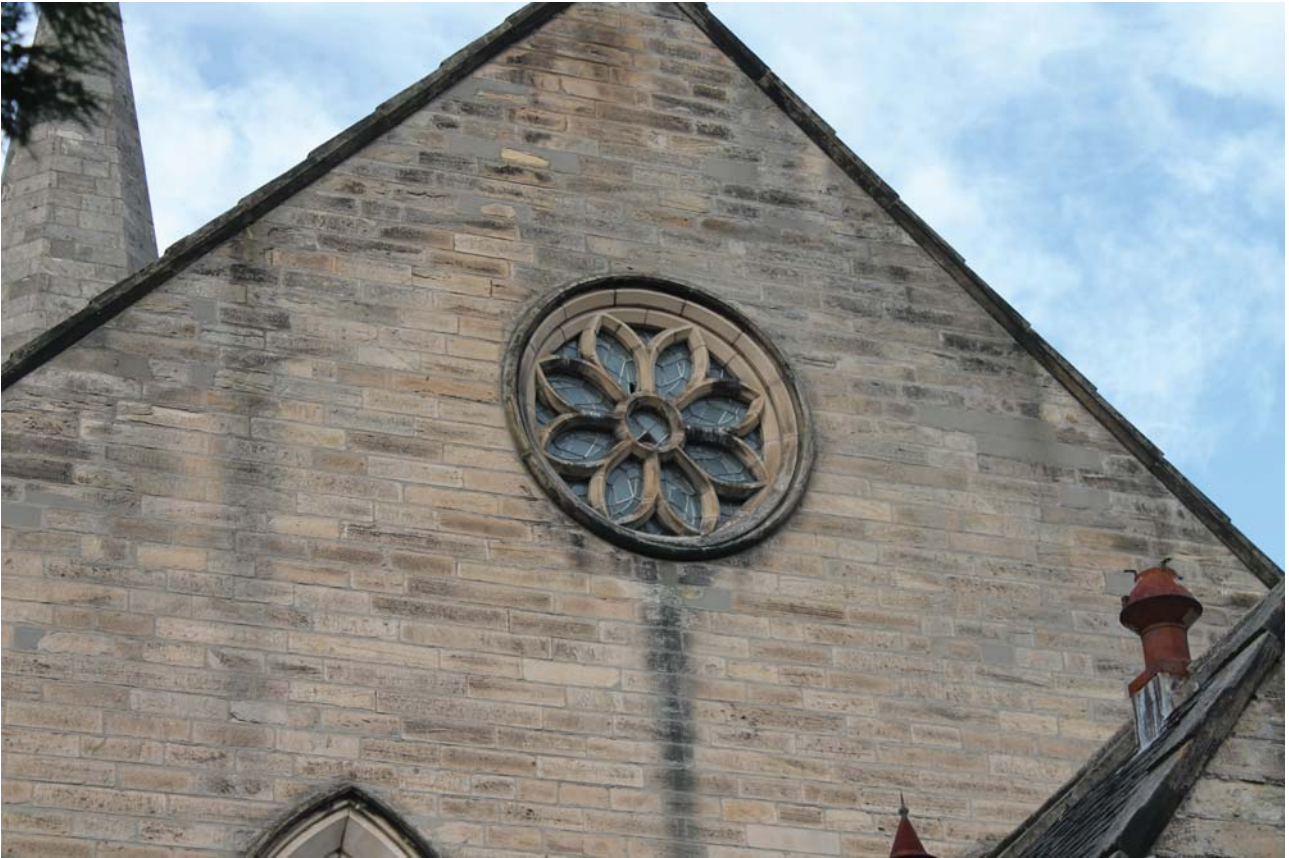
Plate 35: South-east elevation, detail of circular first floor window to the upper gallery from the SSE

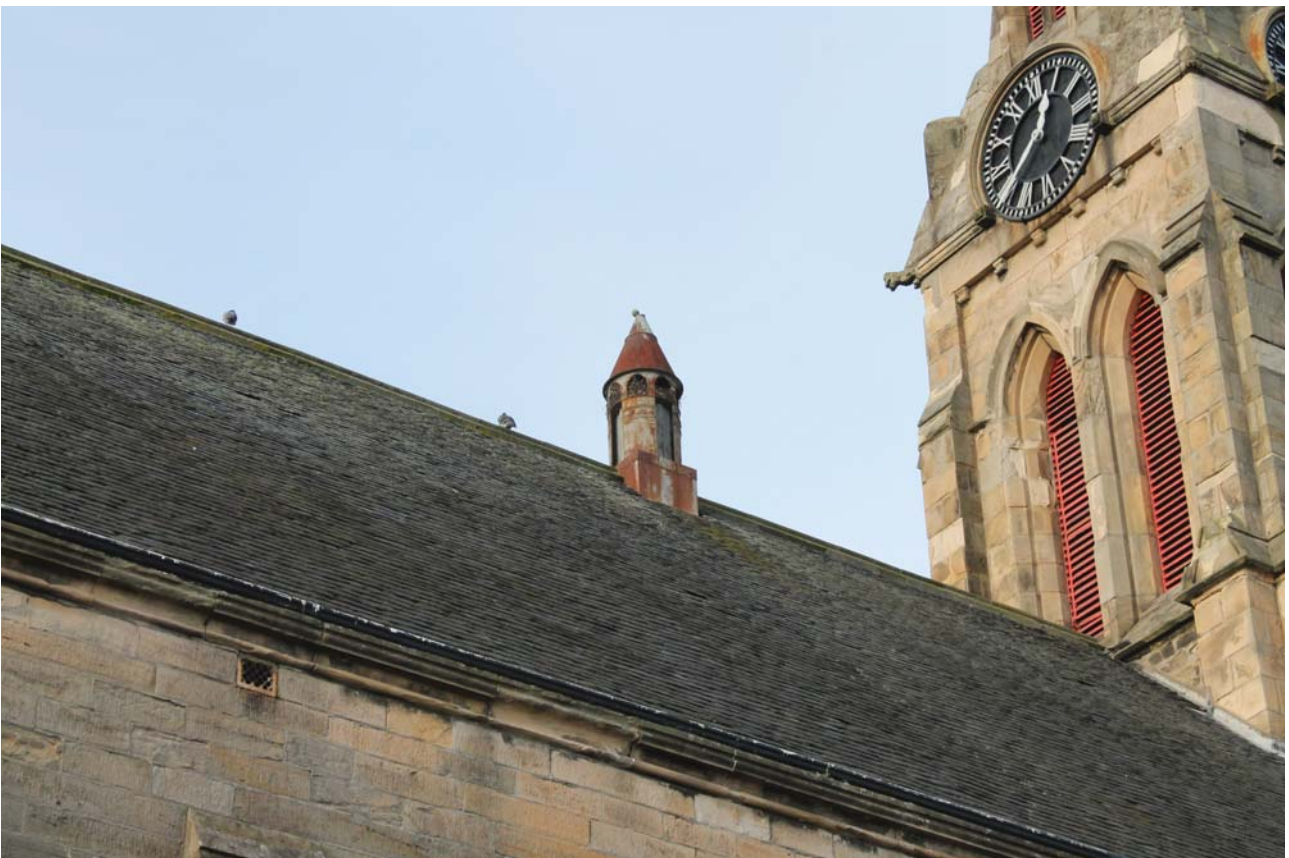
Plate 36: Detail of vent on the apex of the roof of the main body of the church for the east

- 5.5 The slate roof is certainly not original, although does have stone flashing to the ridge (lead elsewhere). It also features a number of steel vents to the apex (Plate 36).

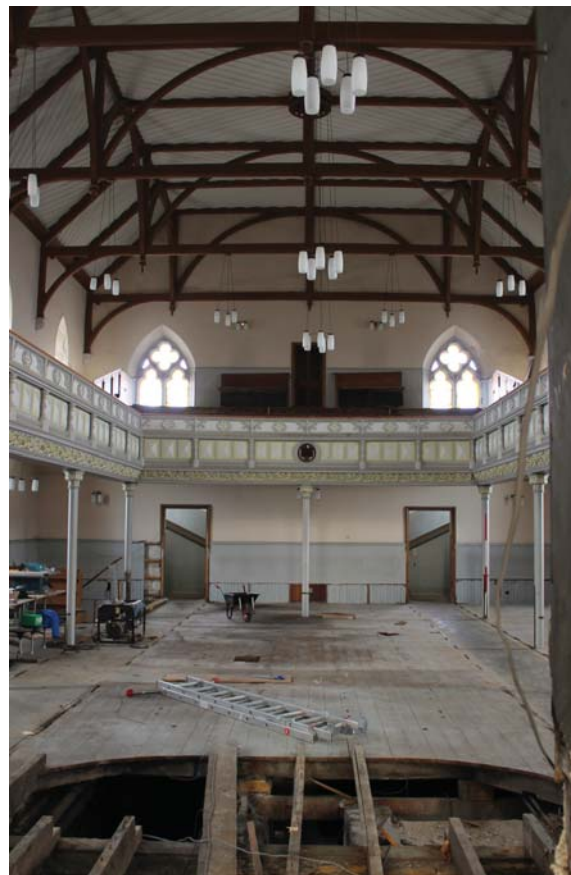
Plate 40: Room 0/1, general view from the south-east

- 5.7 Starting first with the main nave of the church, Room 0/1, this consists of a five by one bay space with timber floorboards and rendered walls, flanked by timber octagonal columns supporting an upper gallery (Plates 40 – 44). Although the floorboards do exist, there are a number of places where they have been lifted up and these have exposed the thin stone foundations of the church (Plate 45). The pews, as said, have now been removed, although the marks where they were located can still be seen on the timber panelling to the lower

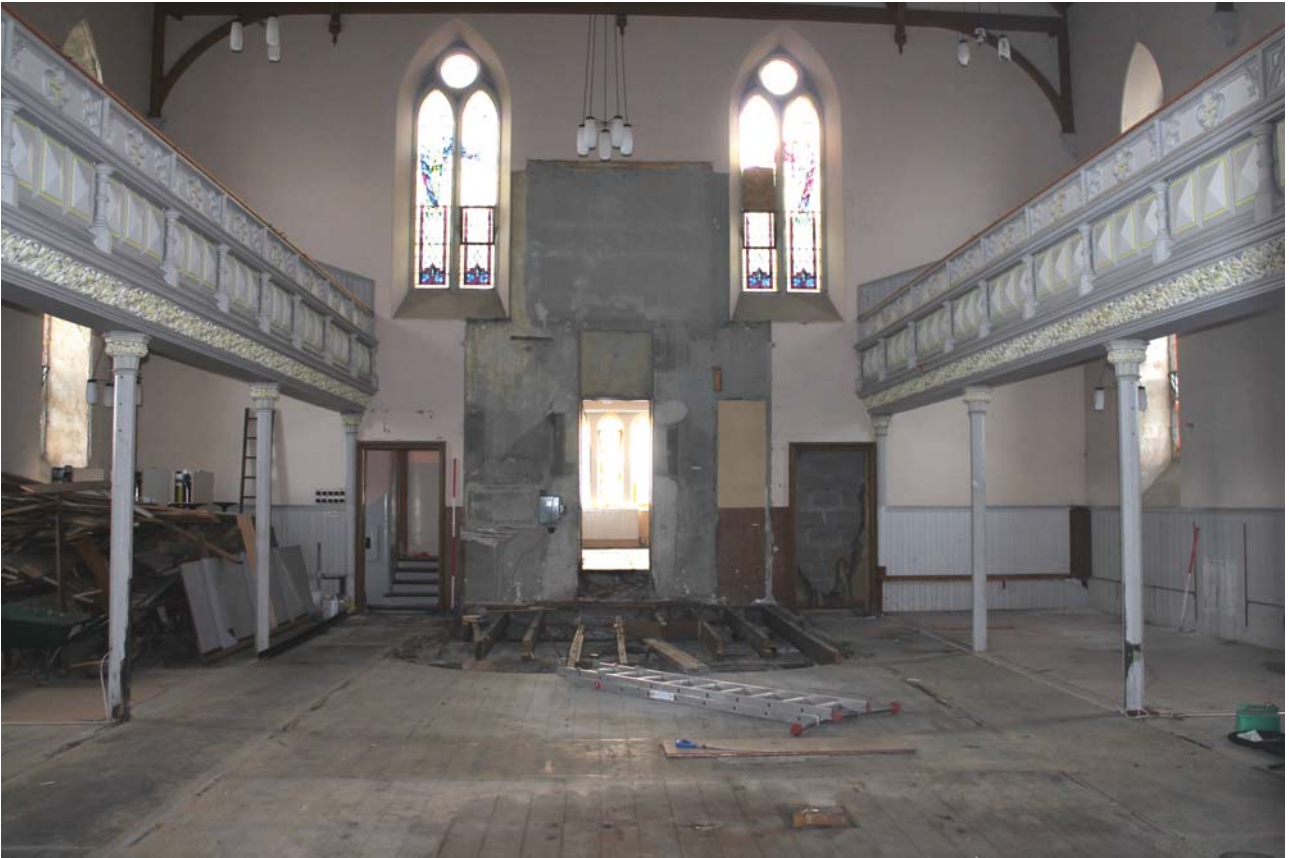
Plate 41: Room 0/1, general view from the north-west

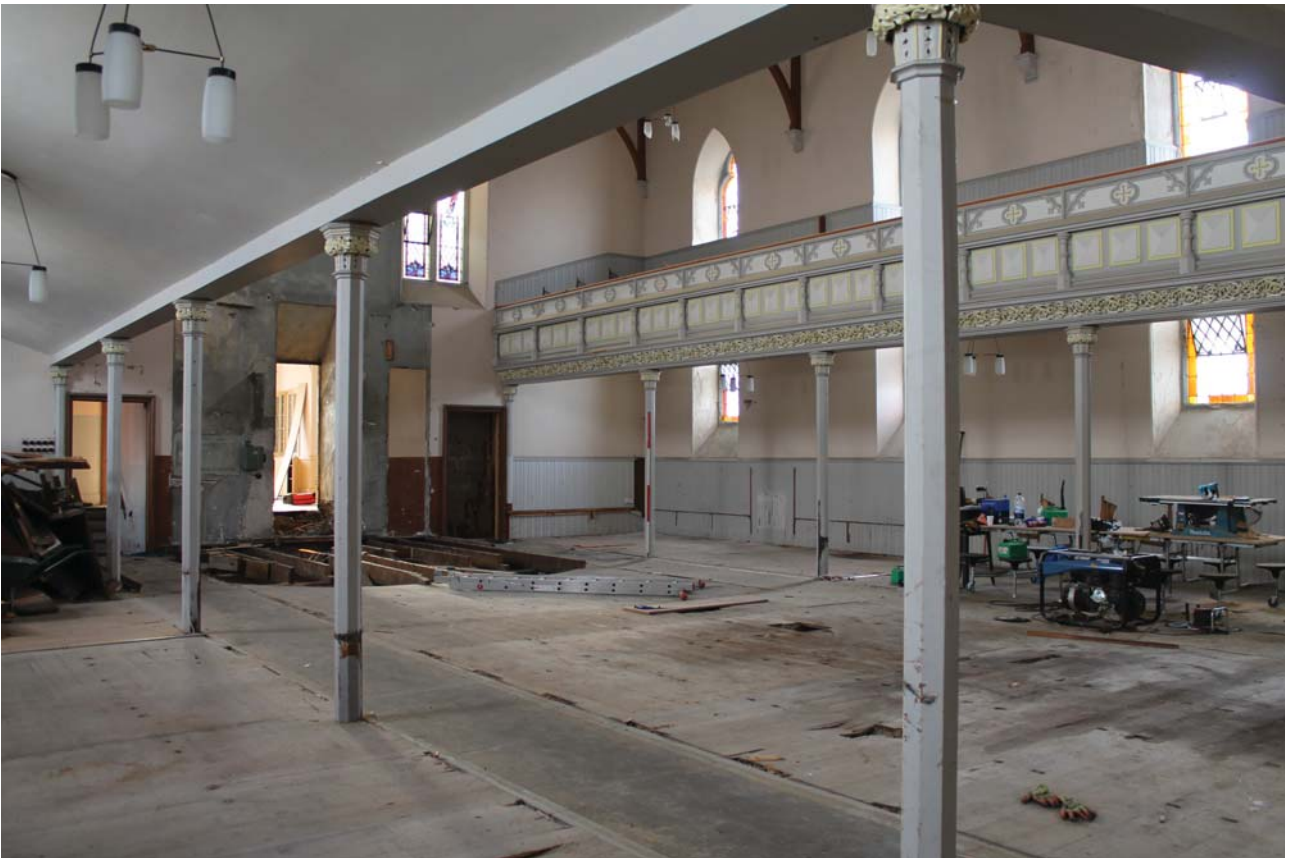
Plate 42: Room 0/1, general view from the north

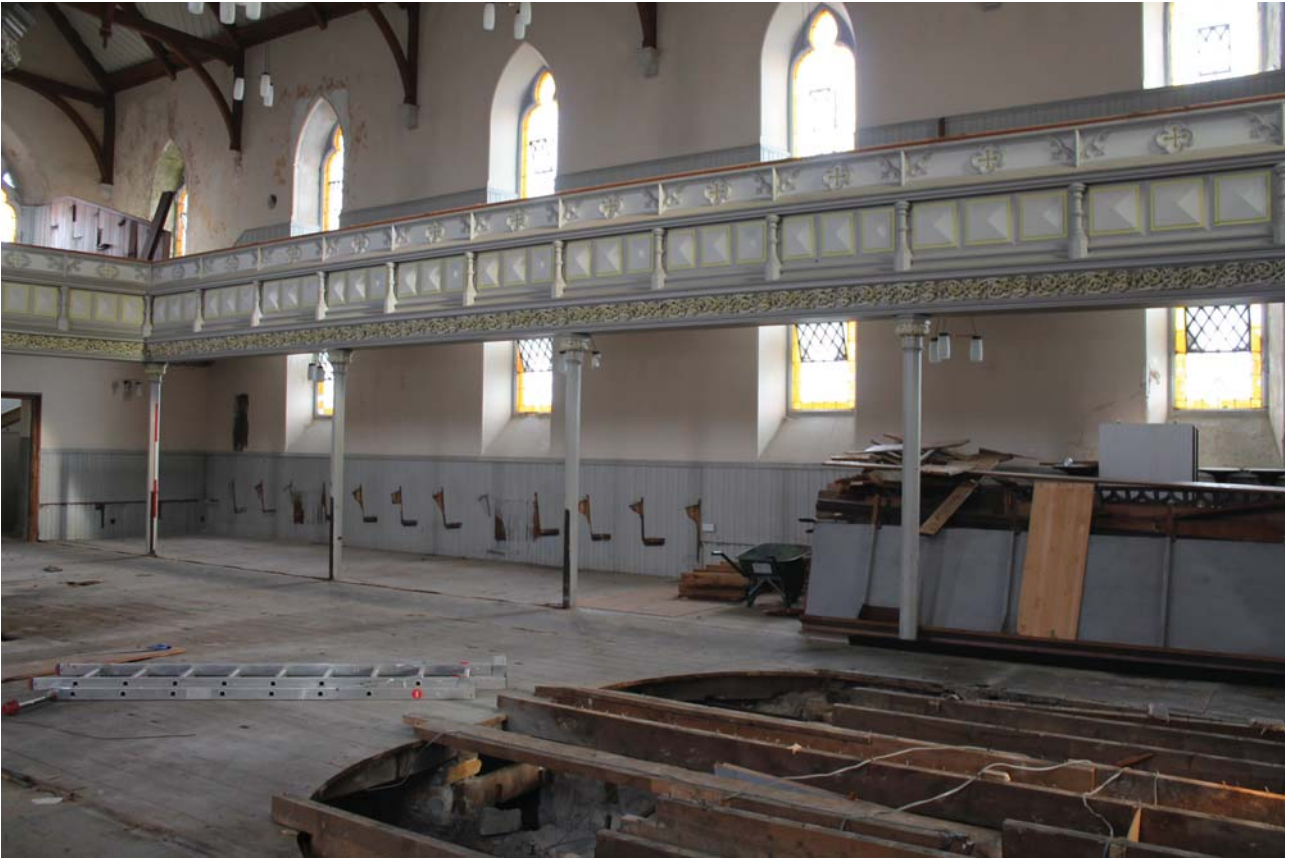
Plate 43: Room 0/1, general view of the south-west wall from the north
