South Church, Moray Street, Elgin: Historic Building Recording Report

On Behalf of:	Grant & Geoghegan Unit 4 Westerton Road Business Centre 4 Westerton Road South Keith AB55 5FH For: J Maunder
National Grid Reference (NGR):	NJ 21510 62538
AOC Project No:	22857
Planning Application No:	14/01399/LBC
OASIS No:	194999
Prepared by:	Diana Sproat
Date:	19th November 2014

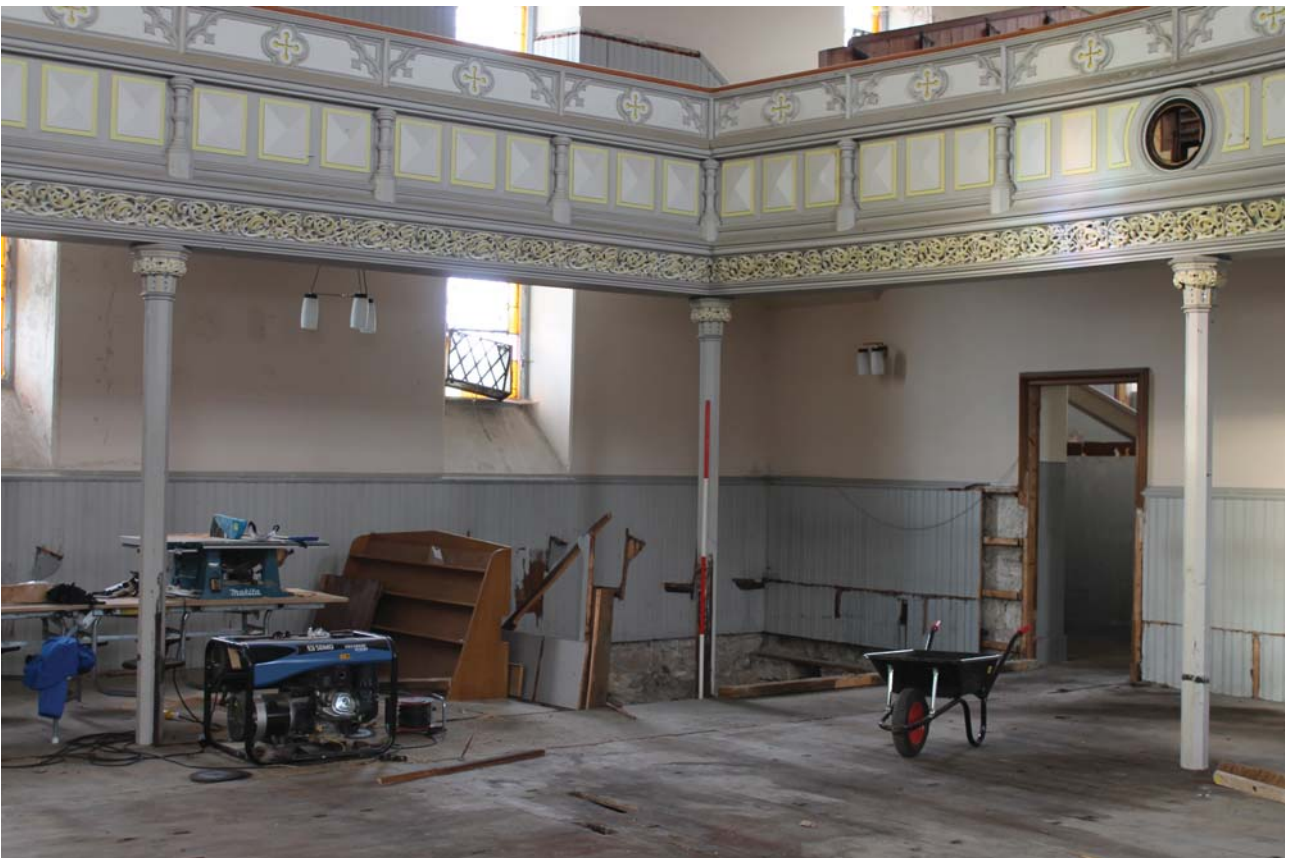
Plate 44: Room 0/1, general view from the east

- 5.7 Starting first with the main nave of the church, Room 0/1, this consists of a five by one bay space with timber floorboards and rendered walls, flanked by timber octagonal columns supporting an upper gallery (Plates 40 – 44). Although the floorboards do exist, there are a number of places where they have been lifted up and these have exposed the thin stone foundations of the church (Plate 45). The pews, as said, have now been removed, although the marks where they were located can still be seen on the timber panelling to the lower

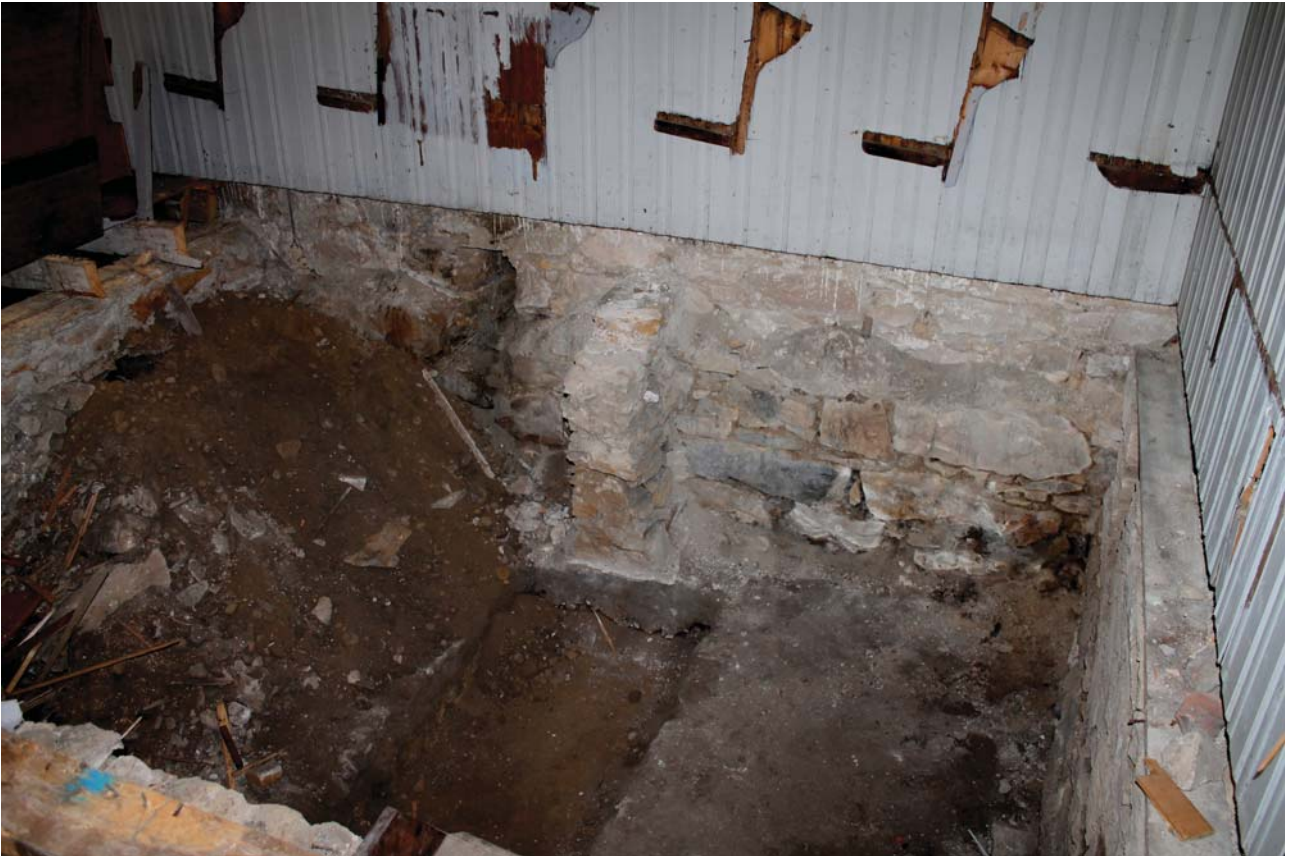
Plate 45: Room 0/1, detail of the excavation trial pit in the western corner showing the stone foundation walls from the NNE

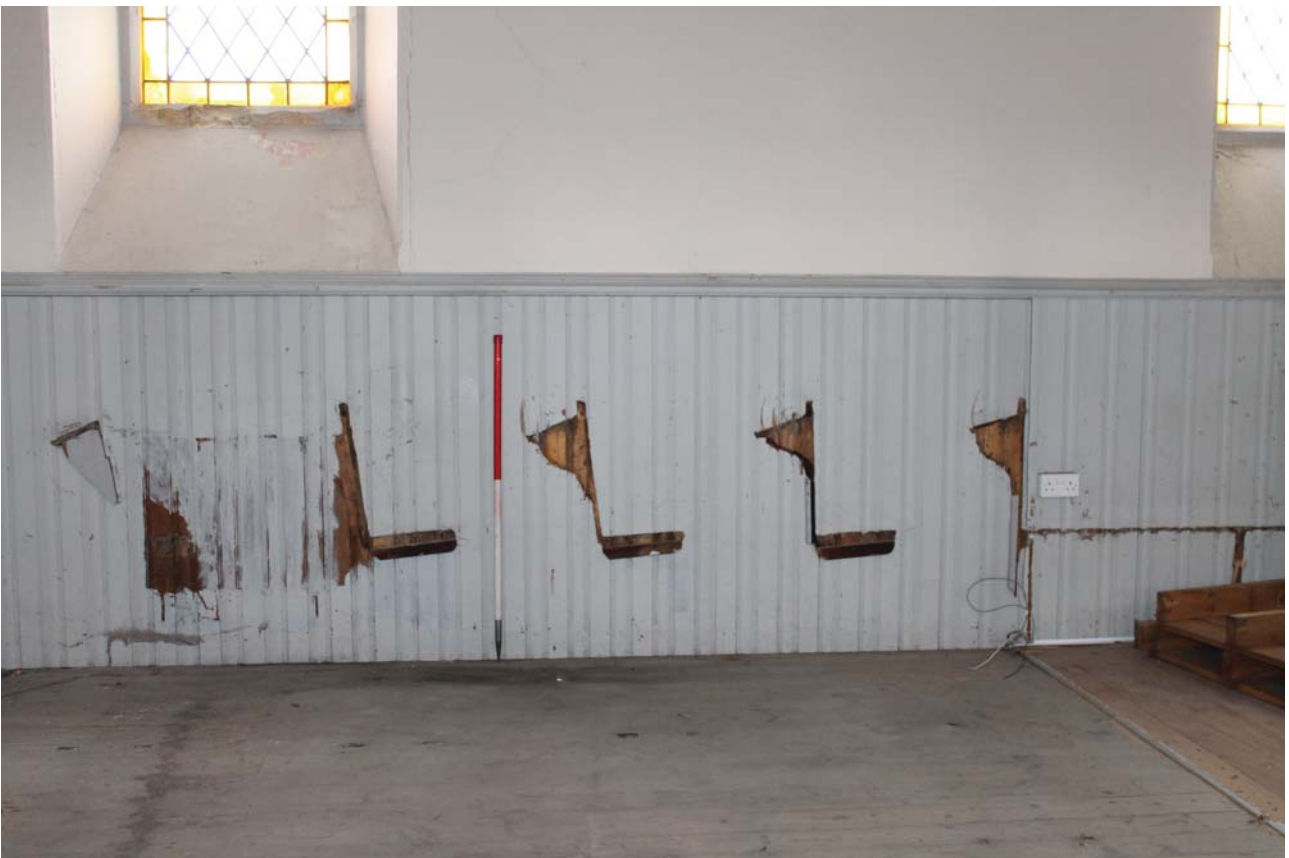
Plate 46: Room 0/1, detail of the shapes of the pews leftover after their removal on the timber panelling of the north-east wall, from the south-west

part of the walls (Plate 46). The surviving timberwork supporting and forming the upper gallery is also quite fine and a nice survival within the church (Plate 47). The panel above the columns has a plaster frieze of entwined vines and buds, above which is a larger panel of shaped balustrades with a rectangular infill below a further upper frieze featuring a quatrefoil design inside its own distinct decorative panel. The whole is painted a nice shade of grey and yellow, although it is unknown whether this is a copy of an original scheme. The main entrance into the nave is to the south-east wall, although any original mouldings around the doorway have been removed (see Plate 41). This leads straight into the larger former vestry/meeting room (0/3) behind. It is flanked by a doorway to each side the one to the south-west a small recessed cupboard, the one to the north-east leading to the small entrance to the side to the north-east through a discreet corridor (Plate 48).

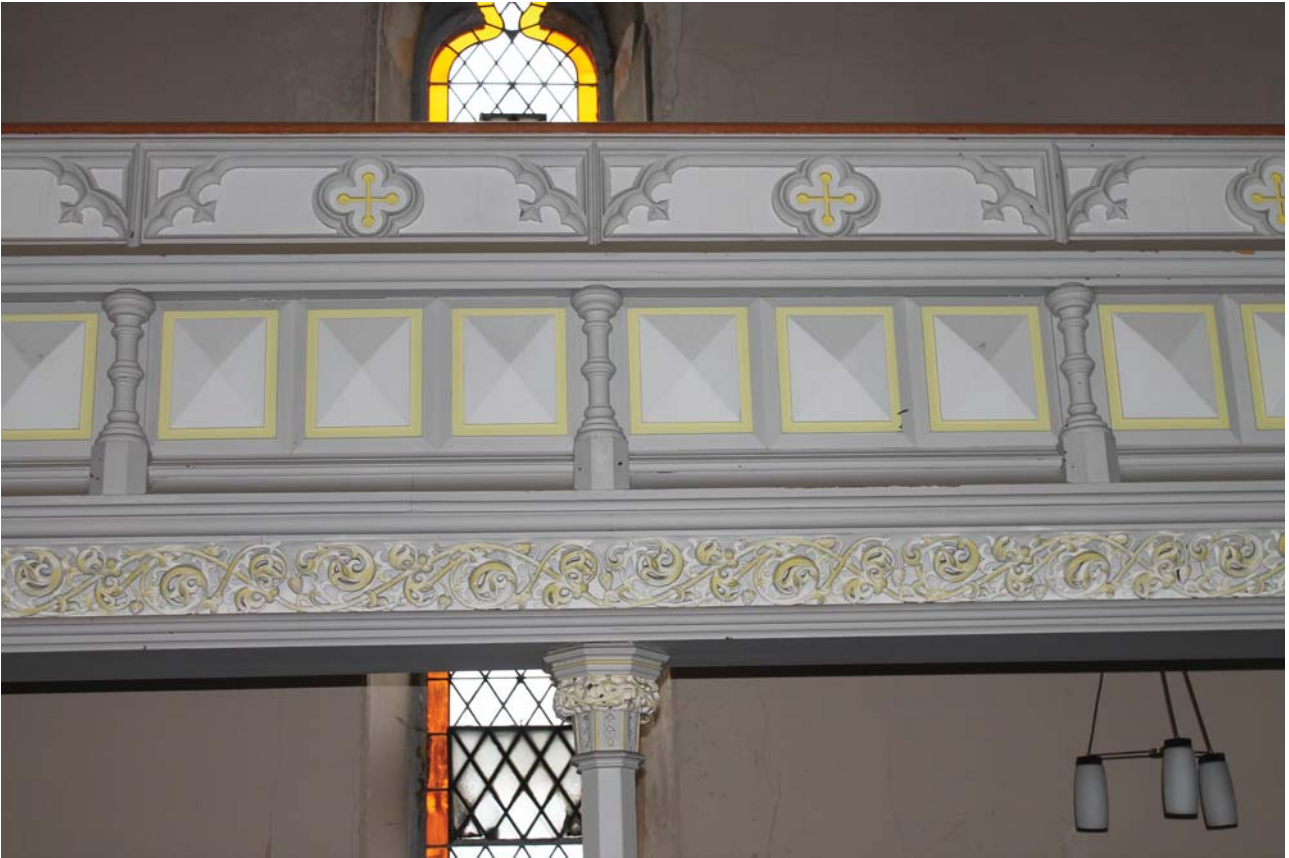
Plate 47: Room 0/1, detail of the column capital and frieze and balcony to the upper gallery from the north-east

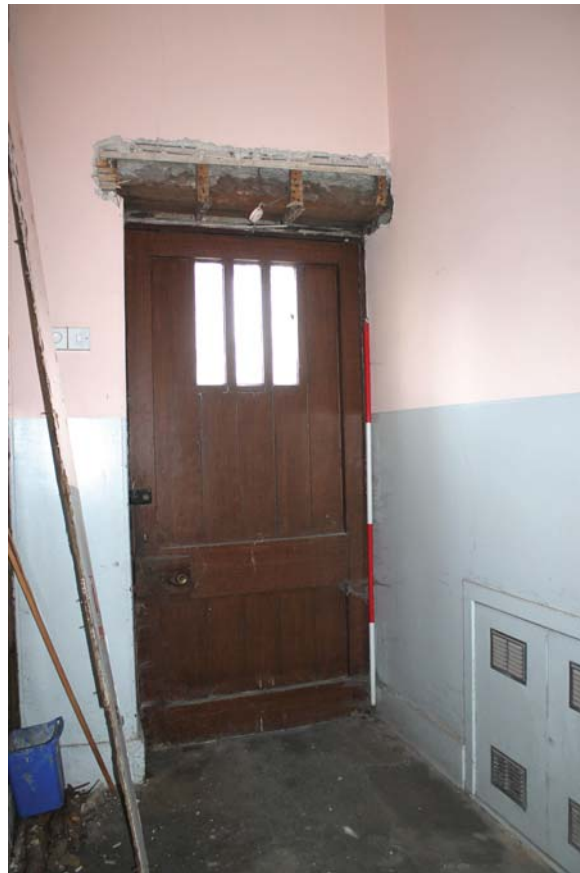
Plate 48: Room 0/2, detail of the present main entrance to the side (north-east) wall, from the SWW

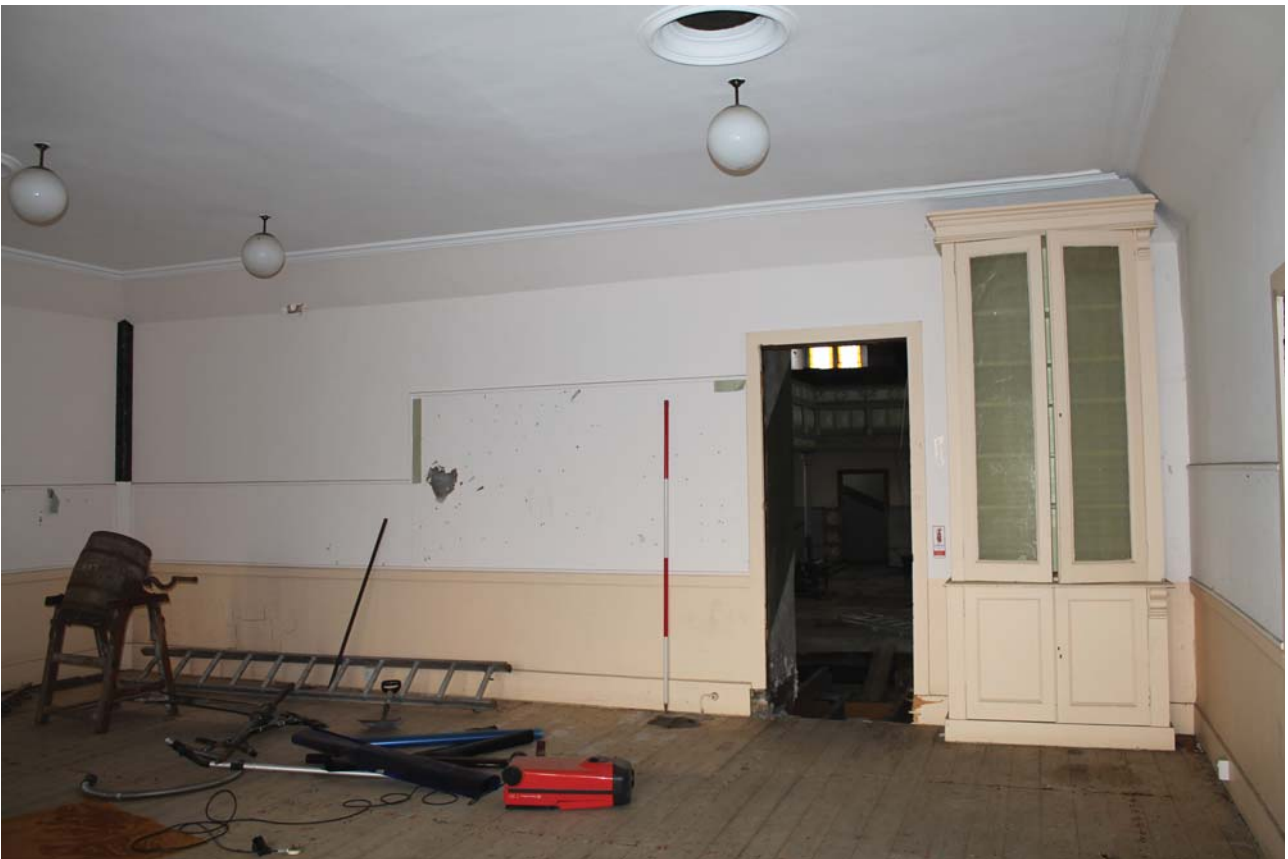
Plate 49: Room 0/3, general view from the SEE

- 5.8 The rear former entrance and extension is now one open room (0/3) to the south-east side (Plates 49 – 52). It is a large L-shaped room with timber floorboards and rendered walls with low timber panelling. The door to the nave is through a plain opening in the north-west wall and the blocked original doorway to the south-west wall is covered over and cannot be seen on the internal side. The exterior windows on the south-east wall consist of the double and single to the original build and the triple lancet window adjacent belonging to the extension. To the north-east, a small doorway leads through to the small toilet, Room 0/4, a later addition with a dividing partition separating the original windows on this side (Plates 53 & 54). The 1868 plan shows us the original layout of this area prior to the extension (see Figure 5). The two external doorways were open and had curved steps to the approach. The south-west side was then subdivided into a small room, as was the north-east side, although a stair is also depicted here, indicating another possible entrance to the upper galleries on this side. A door is also shown leading to the exterior on the south-east wall and – curiously – there is no central doorway depicted leading to the nave, creating a private space, which indicates that this may have been a later addition when the small extension was added. Hence access to the nave was a lot more controlled, with the south-west entrance leading to the downstairs pews and the north-east doorway leading to the upper gallery.

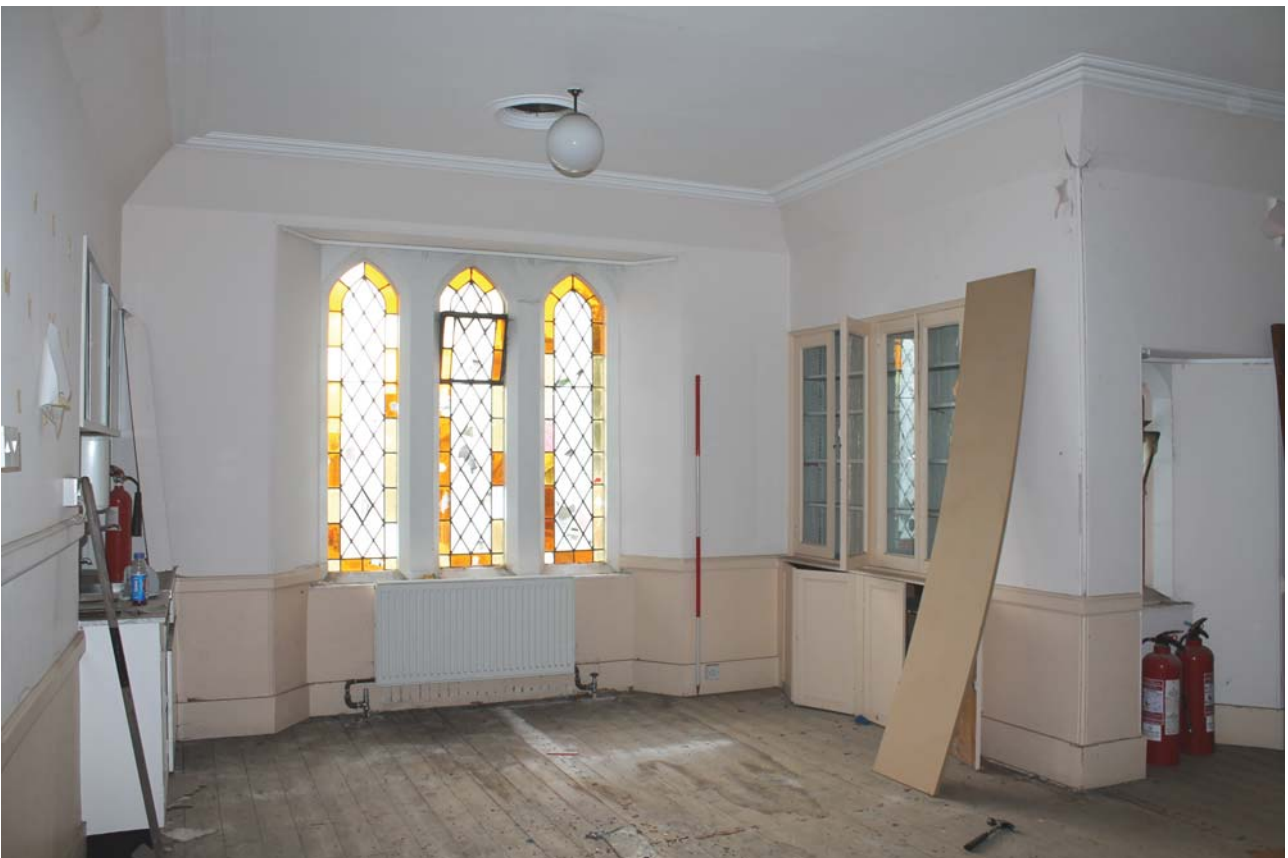
Plate 50: Room 0/3, general view from the NNW

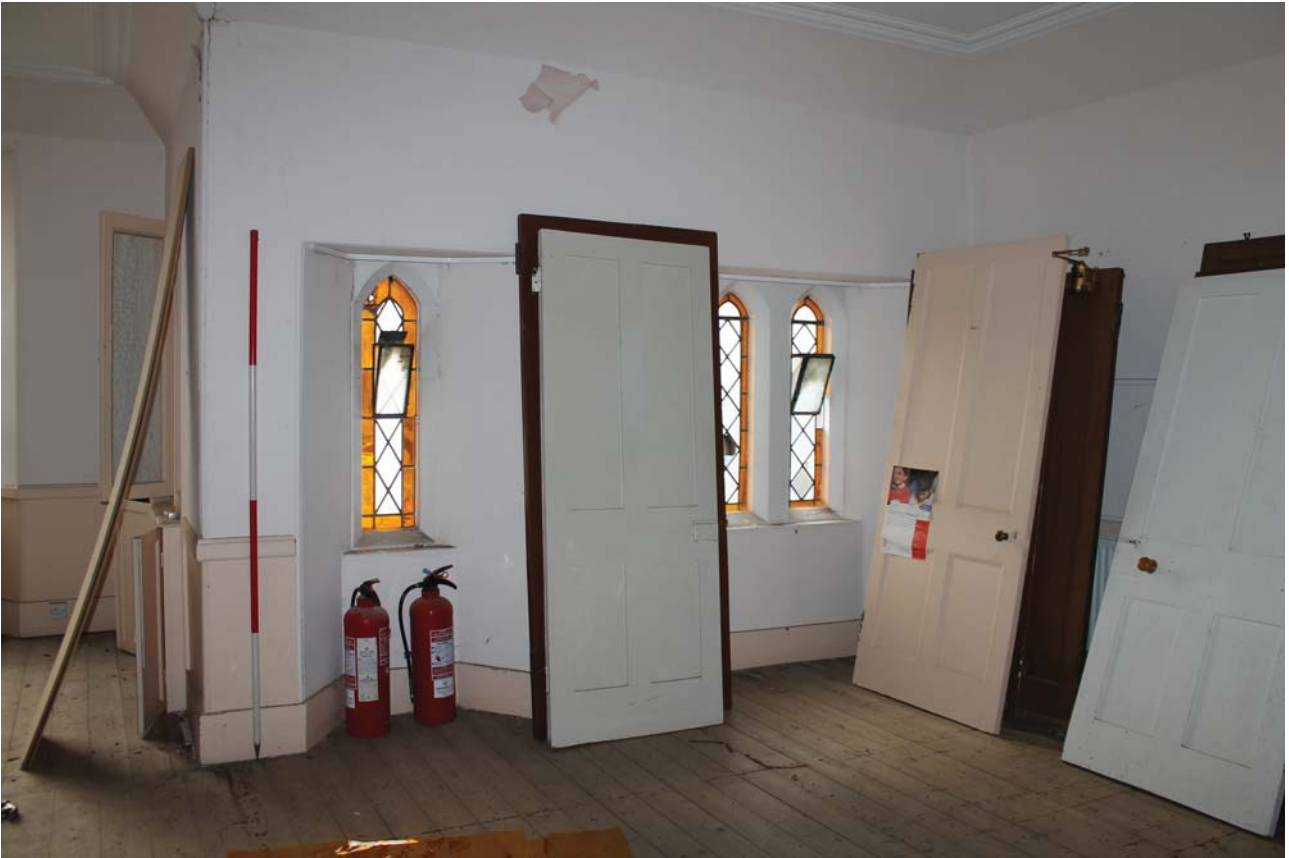
Plate 51: Room 0/3, general view from the north

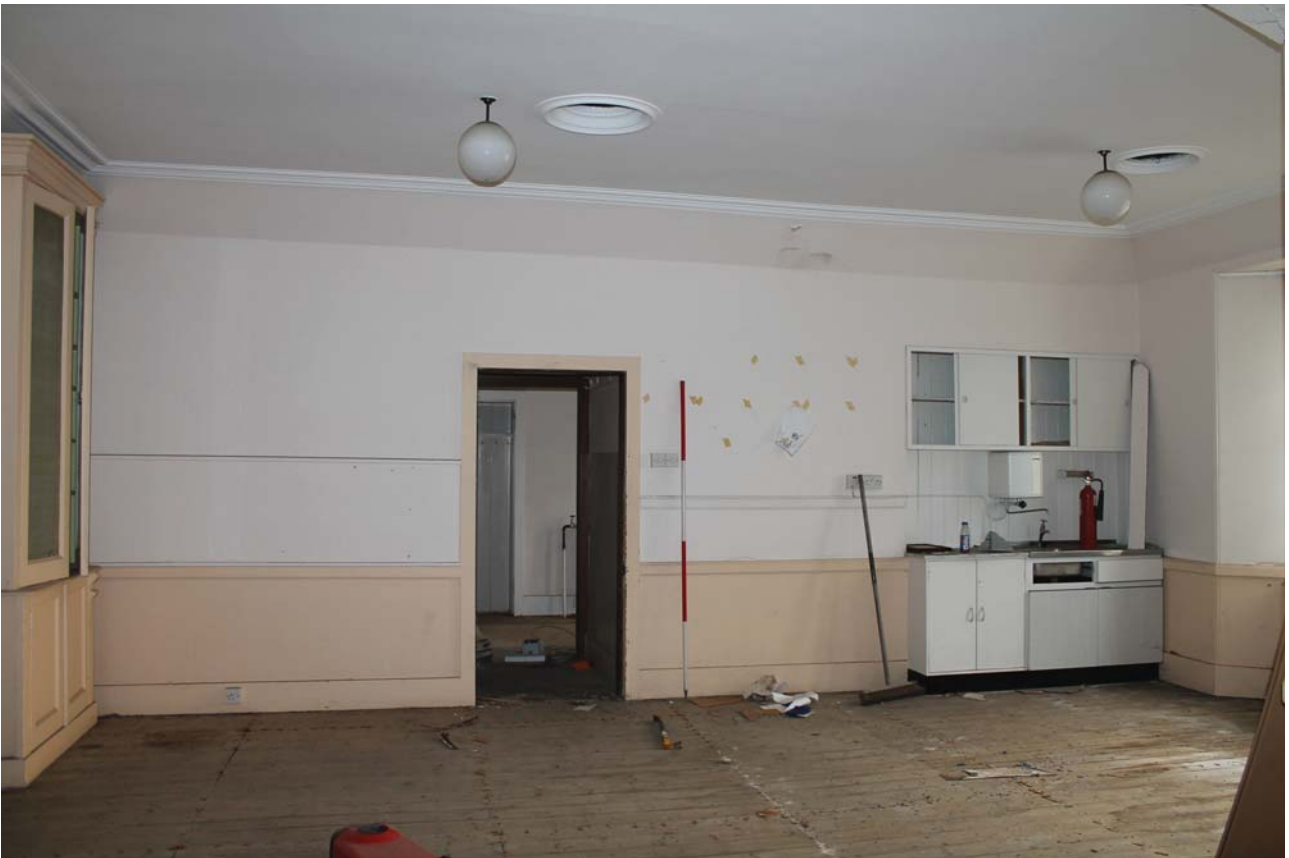
Plate 52: Room 0/3, general view from the SWW

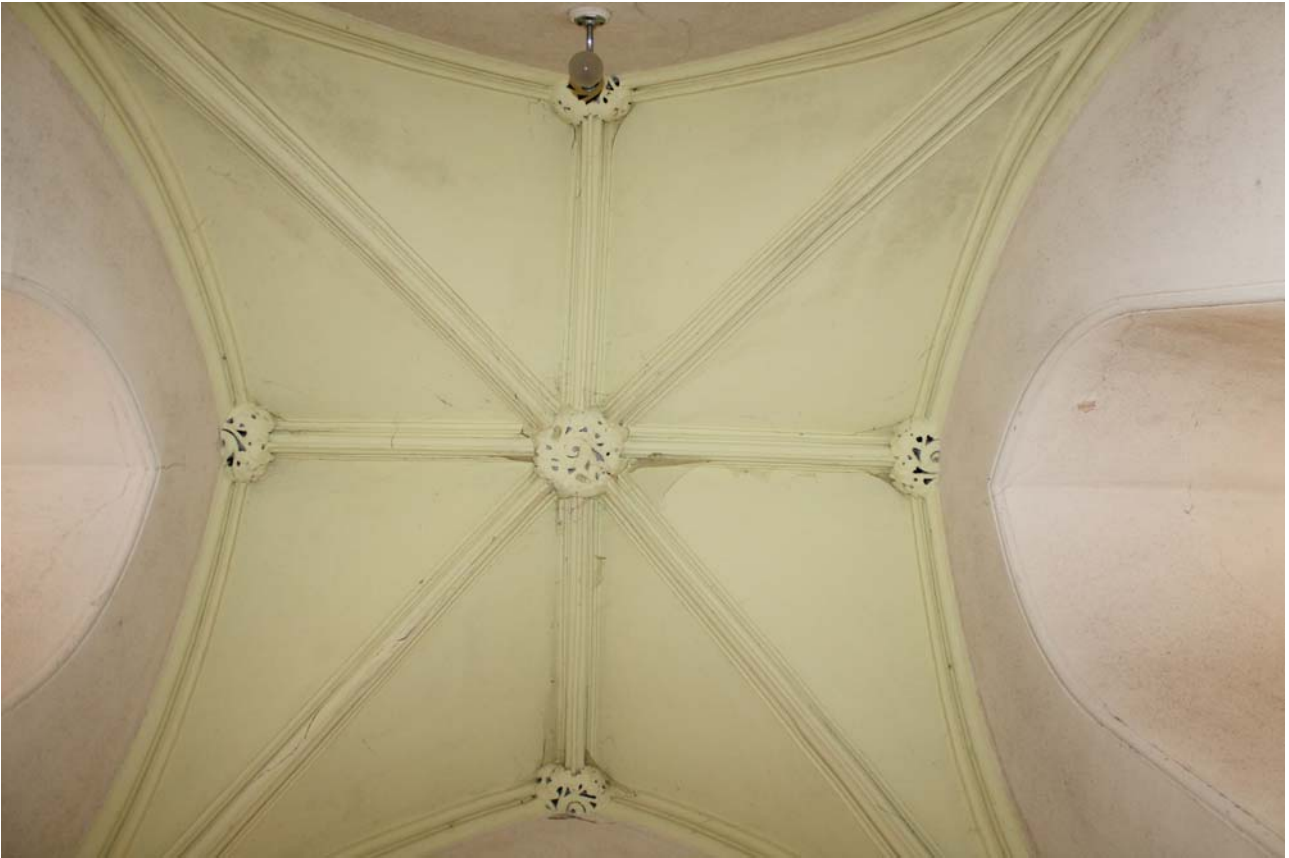
Plate 61: Room 0/5, detail of decorative roof of porch

- 5.9 The main entrance of the church at the north-west end, Room 0/5, also provides access to the upper galleries and consists of a long corridor with a stairwell to the north-east and south-west ends with a small porch below the clock tower. There are two smaller doors to the south-east wall leading to the nave. The corridor has rendered walls with timber panelling (although some has been removed) and rendered ceiling with a moulded cornice (Plates 55 & 56). The main doorway to the porch mimics the main entrance in a chamfered opening (Plate 57). The porch itself has the main doorway with (modern replacement) vertical timber panelled pointed arched doorway and terra cotta floor tiles (Plates 58 & 59). The two small lancet side porch windows are to the north-east and south-west (Plate 60). It also has a decorative ceiling in the style of a ribbed vault with plain decorative boss and stop to the corners of the ribs (Plates 61 & 62).

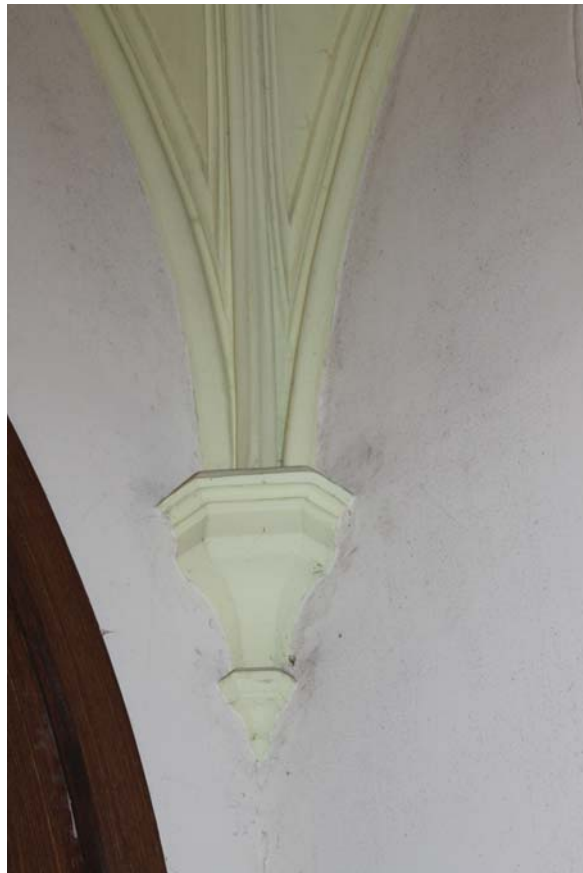
Plate 62: Room 0/5, detail of decorative moulding of porch in the north corner from the south

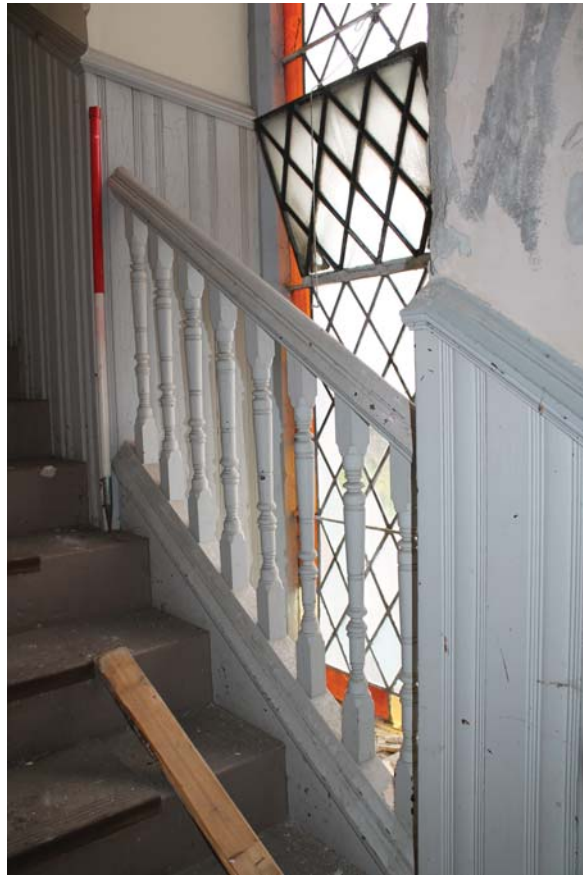
Plate 63: Room 0/5, detail of railing to the stairwell window in the south-west wall from the north

- 5.10 The upper gallery is accessed to the north-west via the main stairs with timber panelling all the way up and railings in front of the stained glass window in this bay (Figure 12; Plate 63). The gallery curves round the nave to the north-west side (with a small door to the clock tower) with timber panelling below the rendered walls throughout (Plates 64 – 67). The ceiling is false with a later roof installed, in keeping with the Gothic style of the building, complete with circular covers for the vents (Plates 68 – 70). There are railings in front of the plain stained glass windows which all have small top-opening louvered windows to the upper part (Plate 71). Against the north-east wall, the second bay from the south-east has two large levers, presumably for operating the ventilation system (Plate 72). The two larger windows in the south-east wall are more decorative than the rest with depictions of angels (Plates 73 & 74).

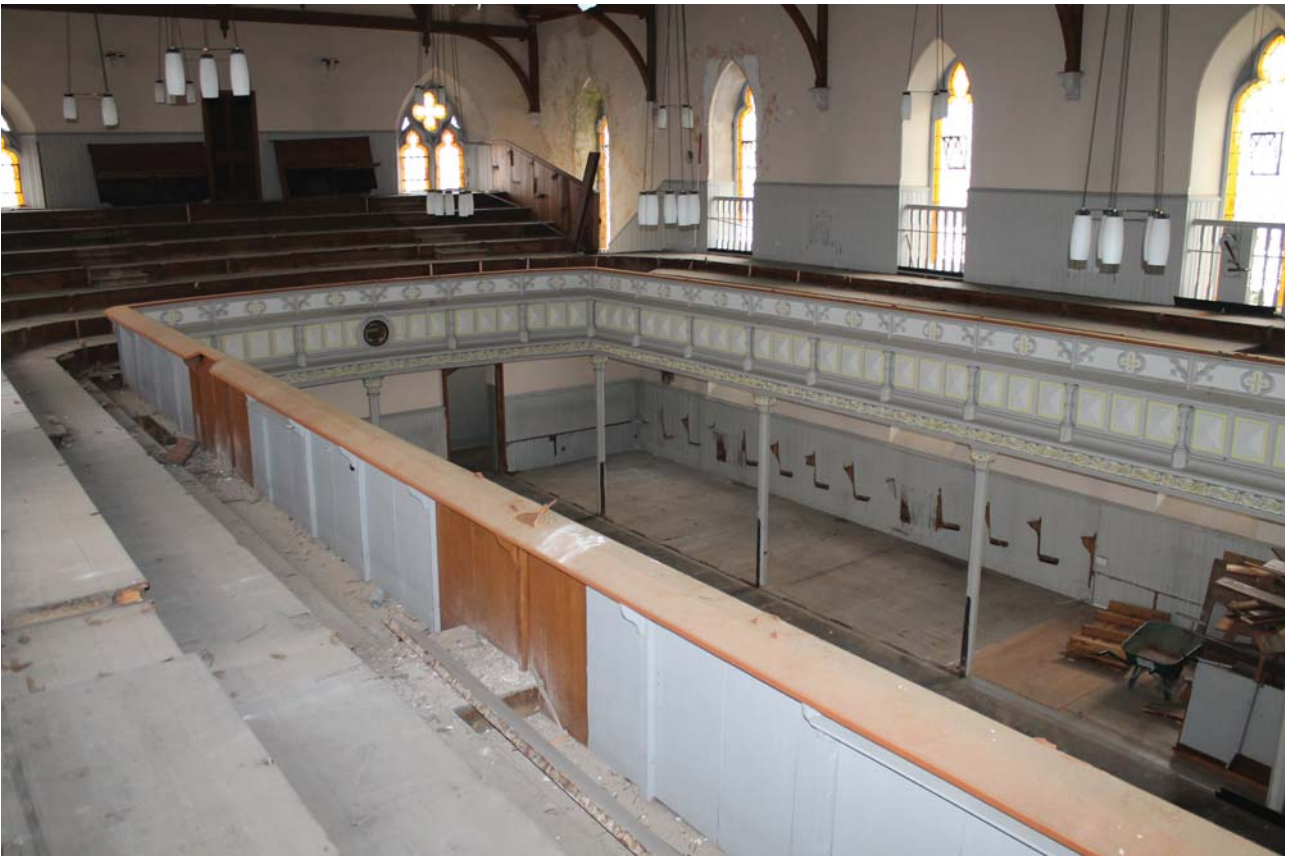
Plate 66: Room 1/1, general view from the south

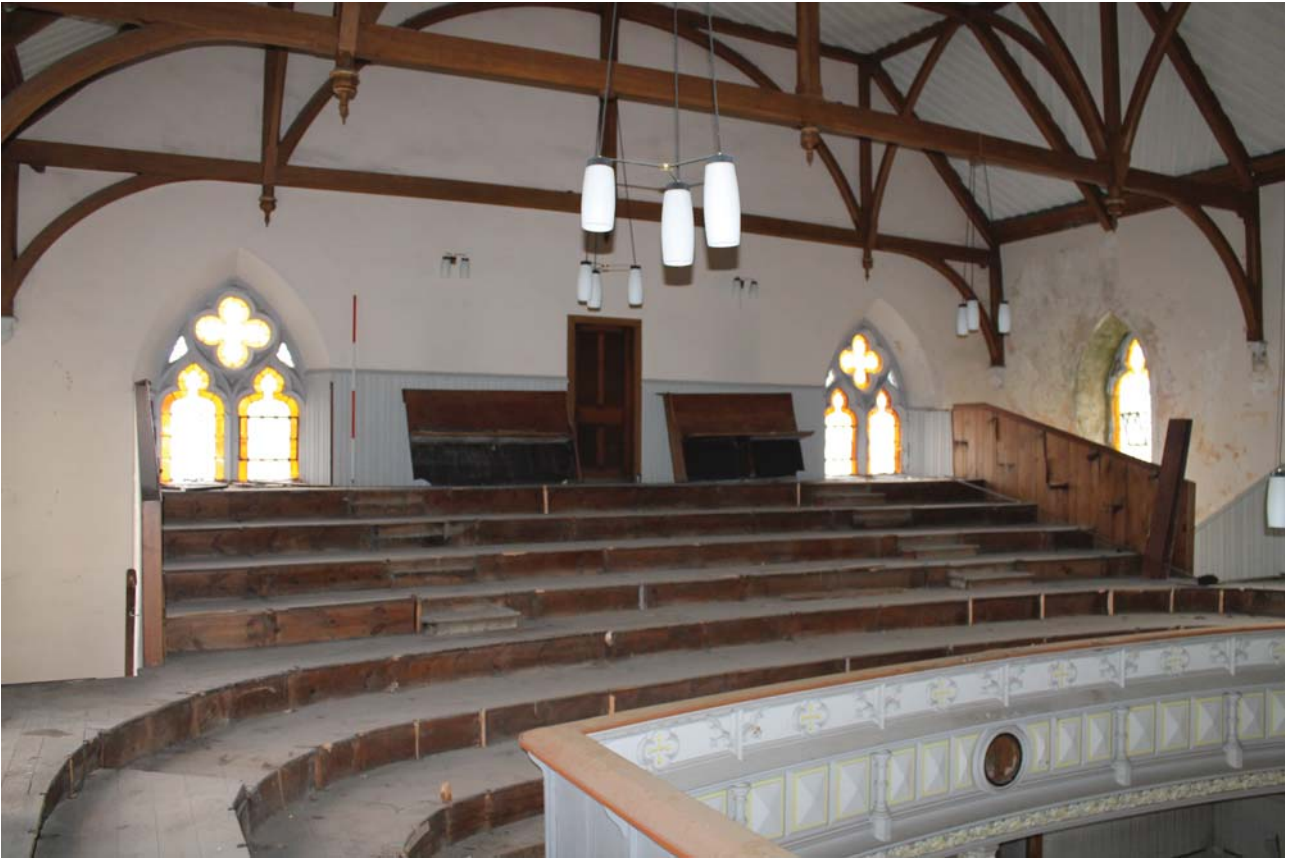
Plate 67: Room 1/1, general view of the rear seating gallery from the south

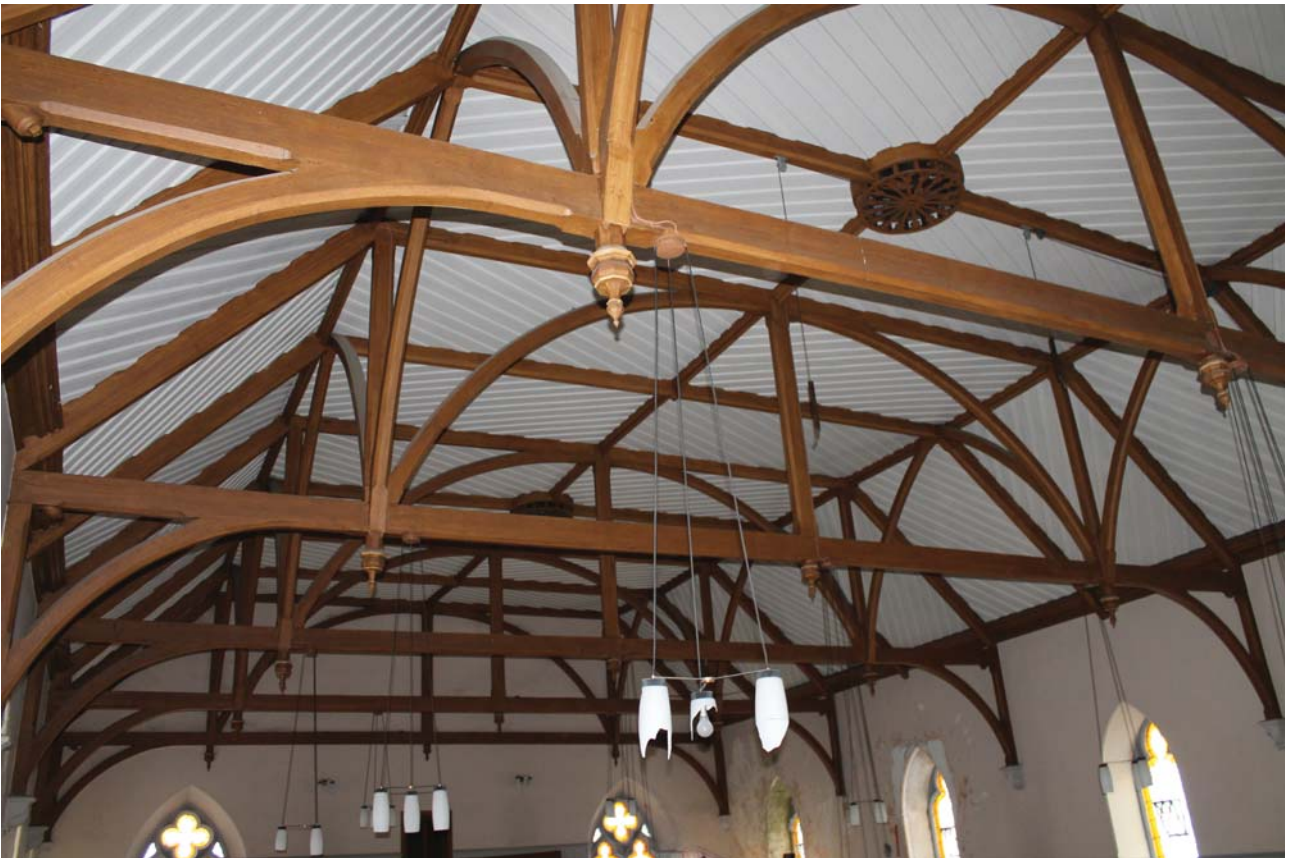
Plate 68: Room 1/1, general view of roof from the north

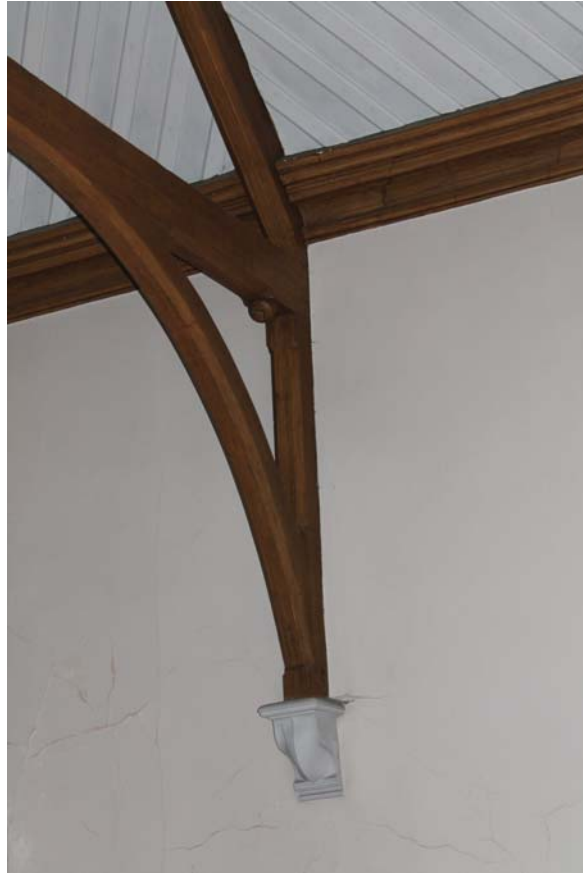
Plate 69: Room 1/1, detail of corbel and base of rafter on the south-west wall from the north

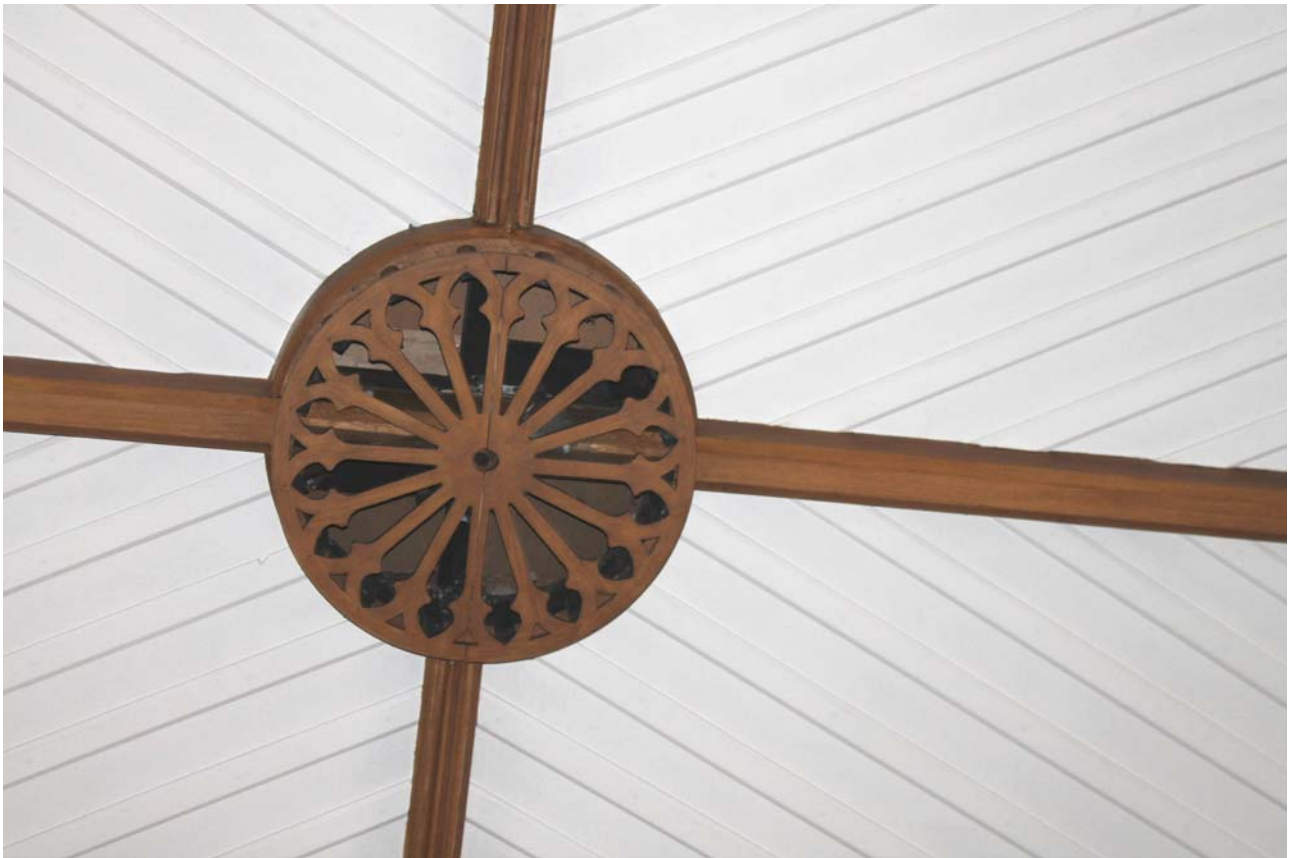
Plate 70: Room 1/1, detail of circular vent in the roof

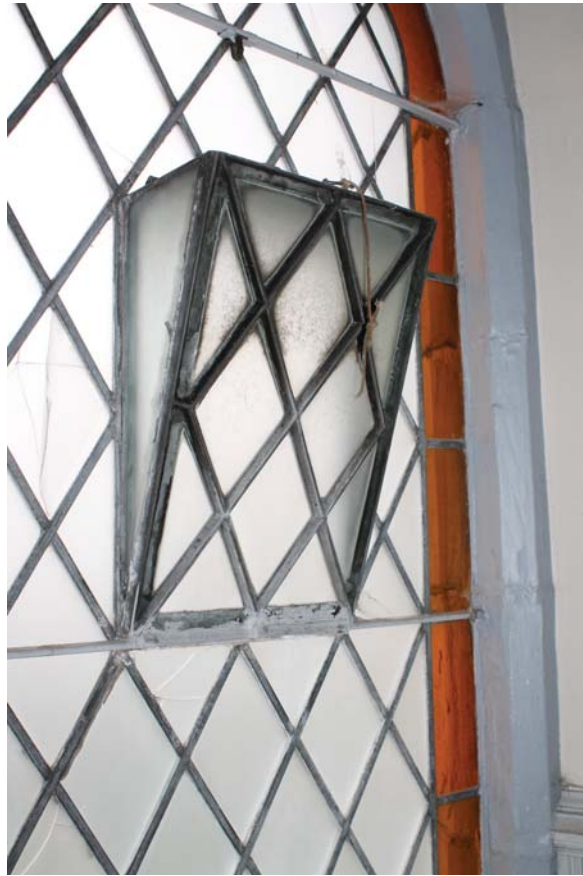
Plate 71: Room 1/1, detail of louvered window of the main window in the north-east wall from the west

32 – 33	Room 1/1	Detail of gutter beneath window in NE wall	W	29/10/2014
34 – 35	Room 1.1	Detail of louvered window in stained glass window win NE wall	W	29/10/2014
36	-	Registration	-	29/10/2014

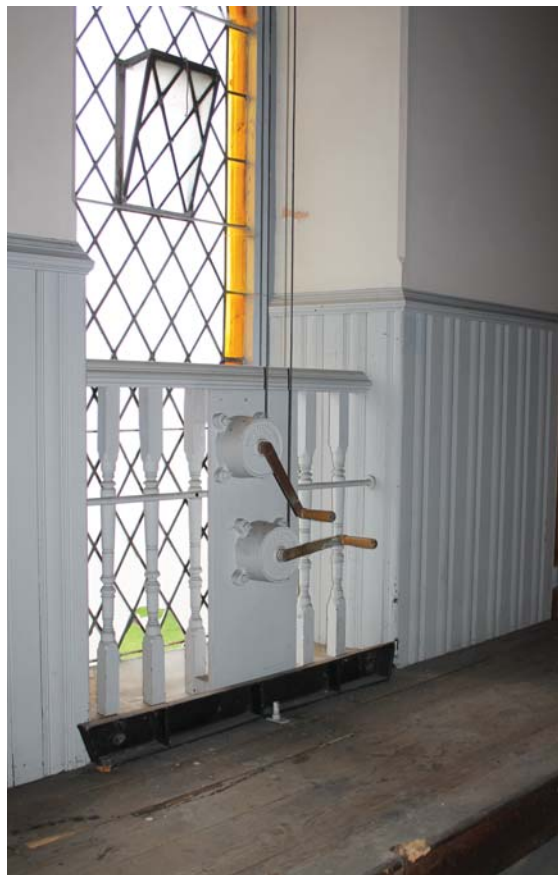
Plate 72: Room 1/1, detail of mechanism for operation of the ventilation system in front of window in the north-east wall from the west

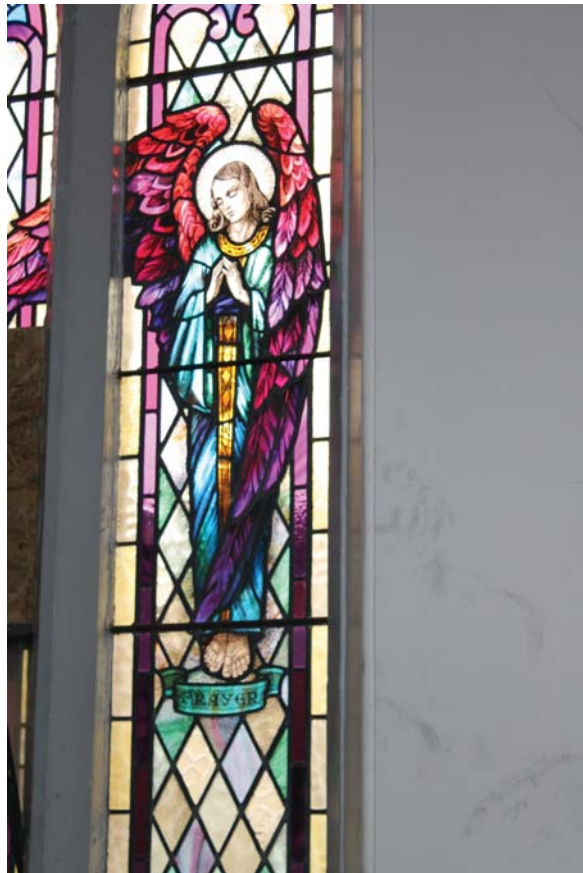
Plate 74: Room 1/1 detail of stained glass window in the south-west side of the south-east wall from the west

Frame	Area	Description	Taken From	Date
1 – 2	Room 1/1	Detail of stained glass window in the SE wall (SW side)	W	29/10/2014
3 – 5	Room 1/1	Detail of roof	NW	29/10/2014
6 – 8	Room 1/1	General view	NW	29/10/2014
9 – 10	Room 1/2	Detail of looking into the base of the clock tower	SE	29/10/2014
11 – 13	Room 1/1	Detail of mechanism for operating ventilation system in ceiling on the NE wall	W	29/10/2014
14 – 15	Room 1/1	General view	SW	29/10/2014
16 – 17	Room 1/1	General view	W	29/10/2014
18 – 19	Room 1/1	Detail of balcony	SW	29/10/2014
20 – 21	Room 1/1	General view	S	29/10/2014
22 – 23	Room 1/1	General view	SE	29/10/2014
24 – 25	Room 1/1	Detail of roof	S	29/10/2014
26 – 27	Room 1/1	General view looking down at ground floor level	S	29/10/2014
28 – 29	Room 1/1	General view	S	29/10/2014
30 – 31	Room 1/1	General view	W	29/10/2014
32 – 33	Room 1/1	General view looking down at ground floor level	W	29/10/2014
34 – 35	Room 1/1	General view	N	29/10/2014
