Pencaitland House, East Lothian: Ground Penetrating Radar Survey

# **Data Structure Report**

# Report No. 1107

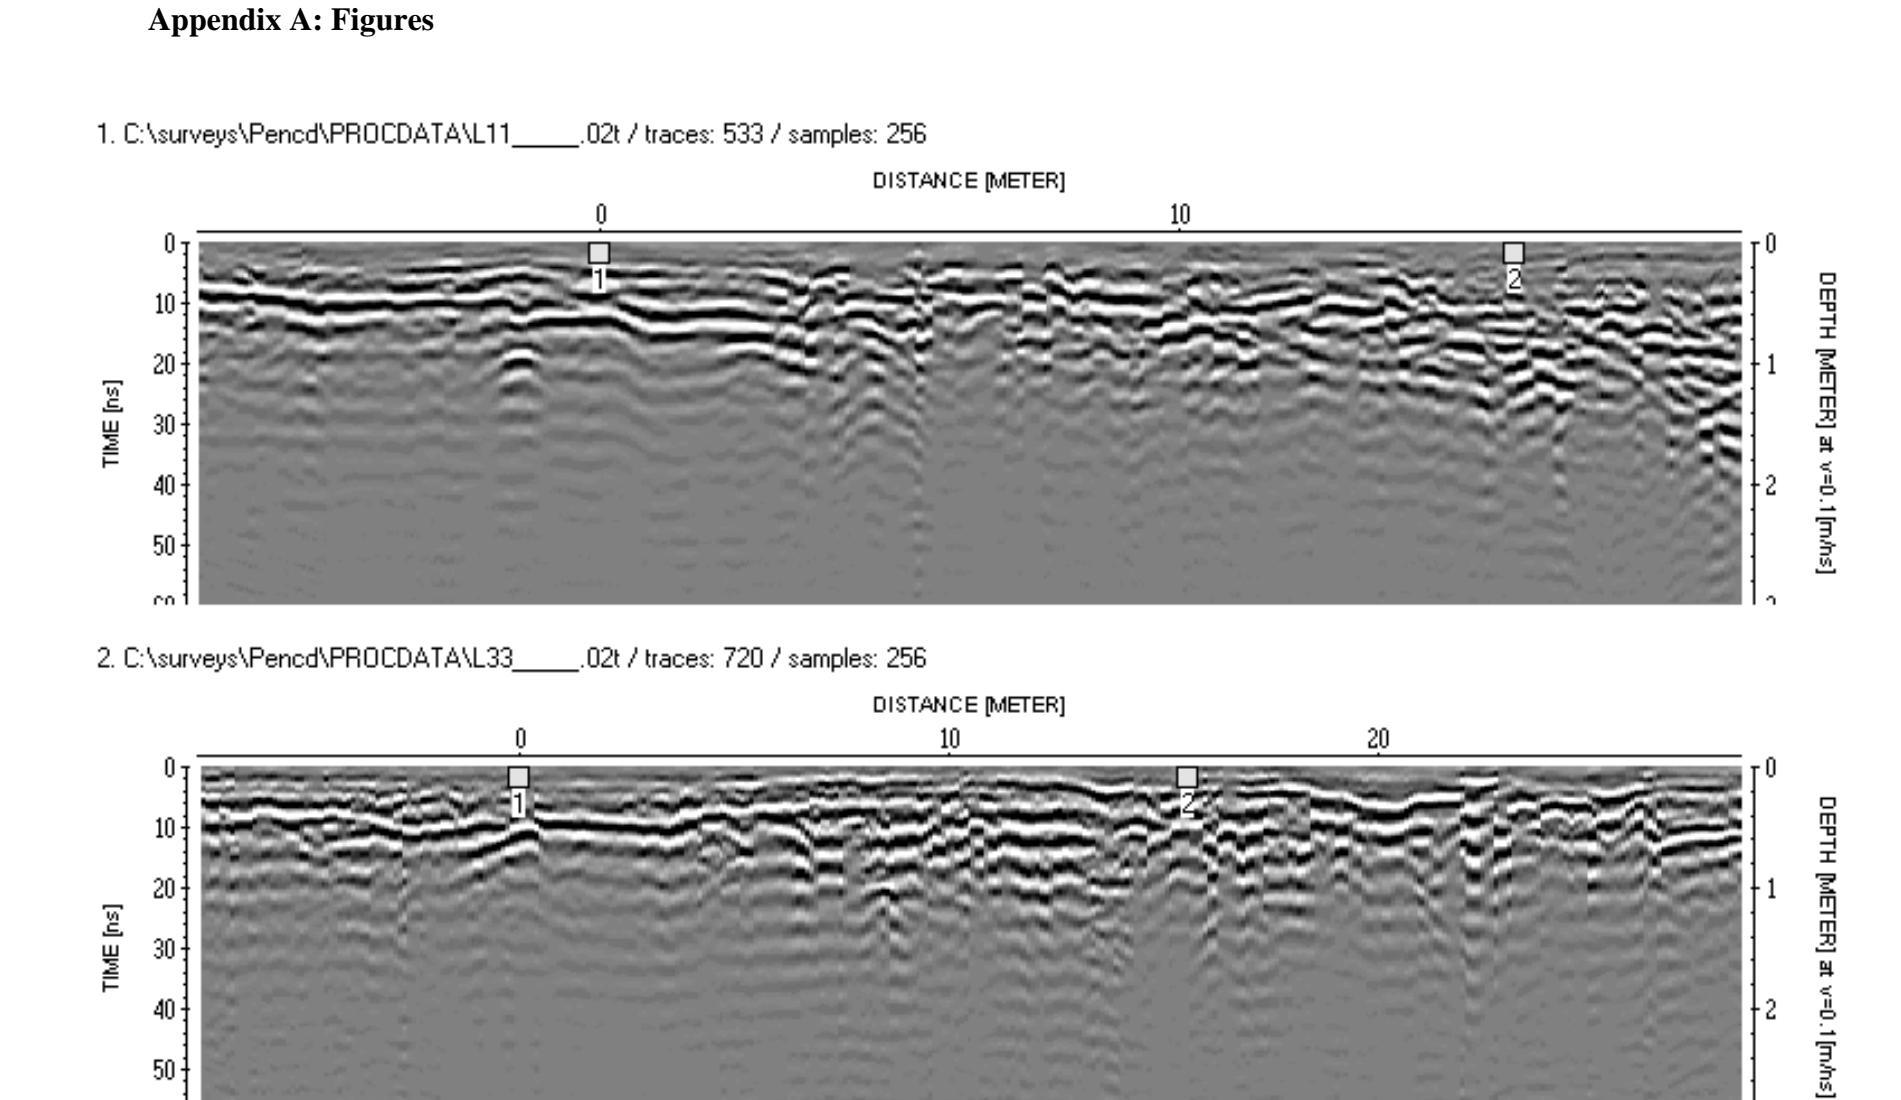
Figure 1: Typical Output from Area 1 - Transects 11 & 33

Typical output is shown in Figure 1 (transects 11 and 33). Much of the area appears to be relatively densely packed with strong anomalous signals, probably indicating the presence of building remains. The existence of discrete surfaces is indicated by continuous black/white banding across the plots. Repeat signals in the vertical direction indicate the presence of standing remains although there is also some ringing (repeated echo effects) from near surface objects. Areas of interference patterning suggest the possibility of backfill, again containing significant amounts of building materials. The general impression of the output is relatively chaotic. This is not unusual for an area where one or more buildings have been destroyed and the ground subsequently levelled for later re-use.

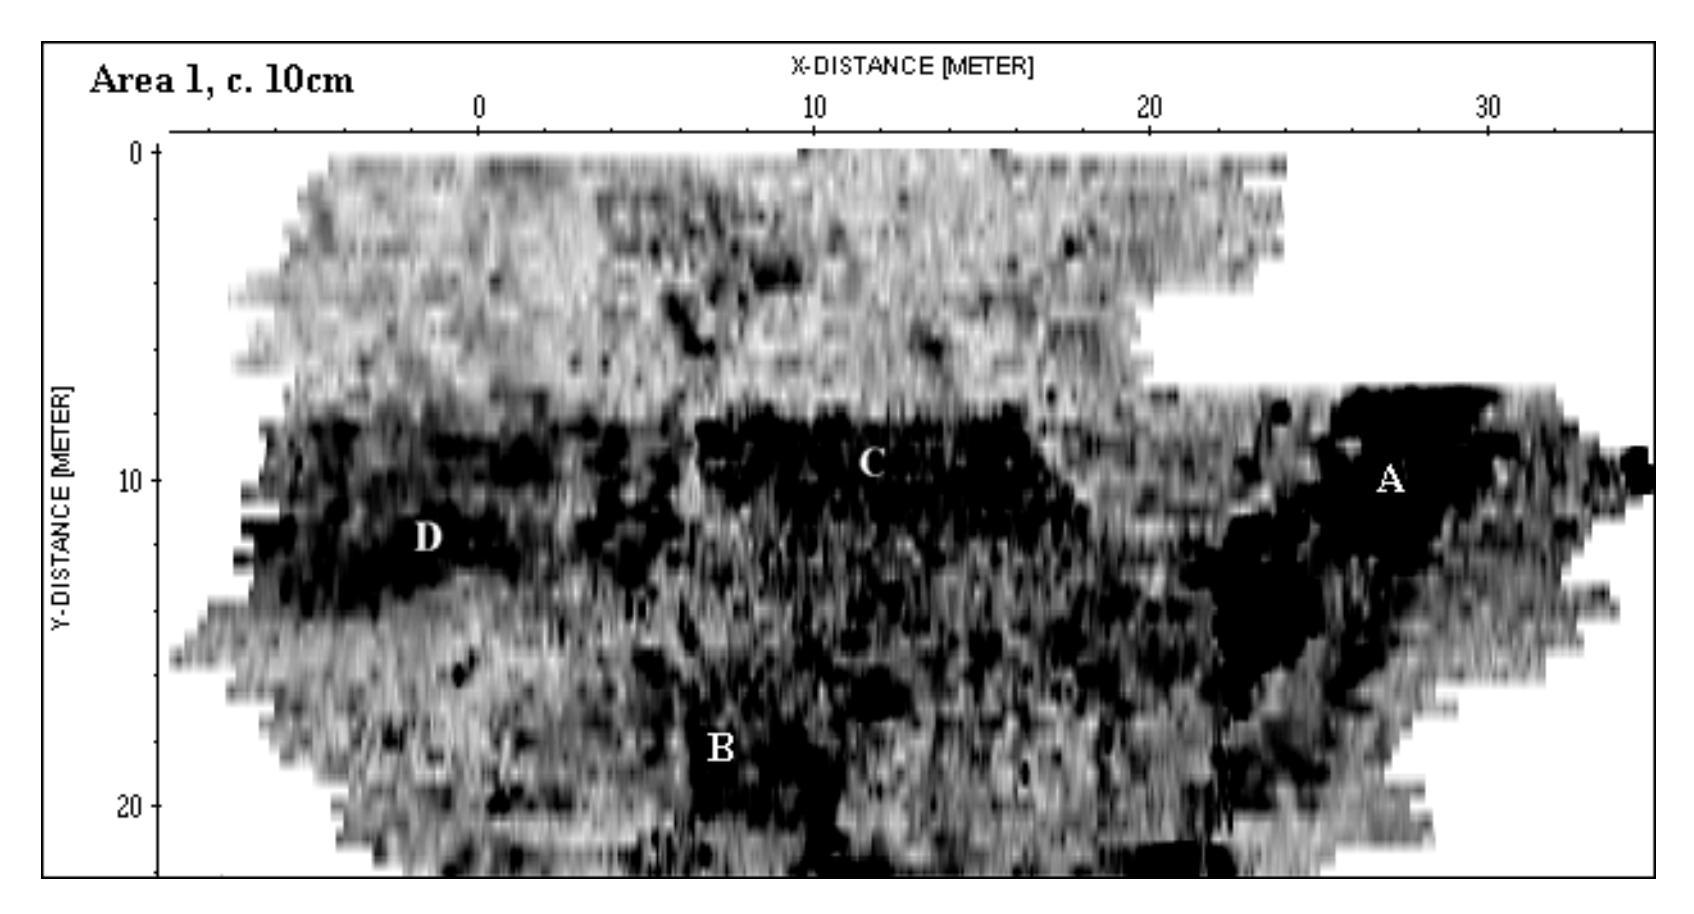
Figure 2: Area 1 10cm Timeslice

In the **10cm** timeslice, the black curvilinear feature marked "A" corresponds to a densely packed surface close to the current ground surface. In the 2-dimensional data, the ringing (echo effects) associated with this type of hard surface are clearly visible: see Figure 15. The principal problem with ringing is that it can mask other signal returns with a genuine depth association. The dark area in the lower right hand side is a similar but much smaller feature.

The area of strong signal return marked "B" consists of a similarly dense surface but appears to correspond to possible building remains. Area "C" corresponds to the position of the current gravel drive and probably therefore relates to the construction of the drive. Although there are underlying signals consistent with building construction, at this depth this appears to be a levelled surface. Area "D" also appears to relate to the levelling of the site, rather than underlying construction: compare the area before marker 1 on Figure 16: transects 19 and 24 are typical.

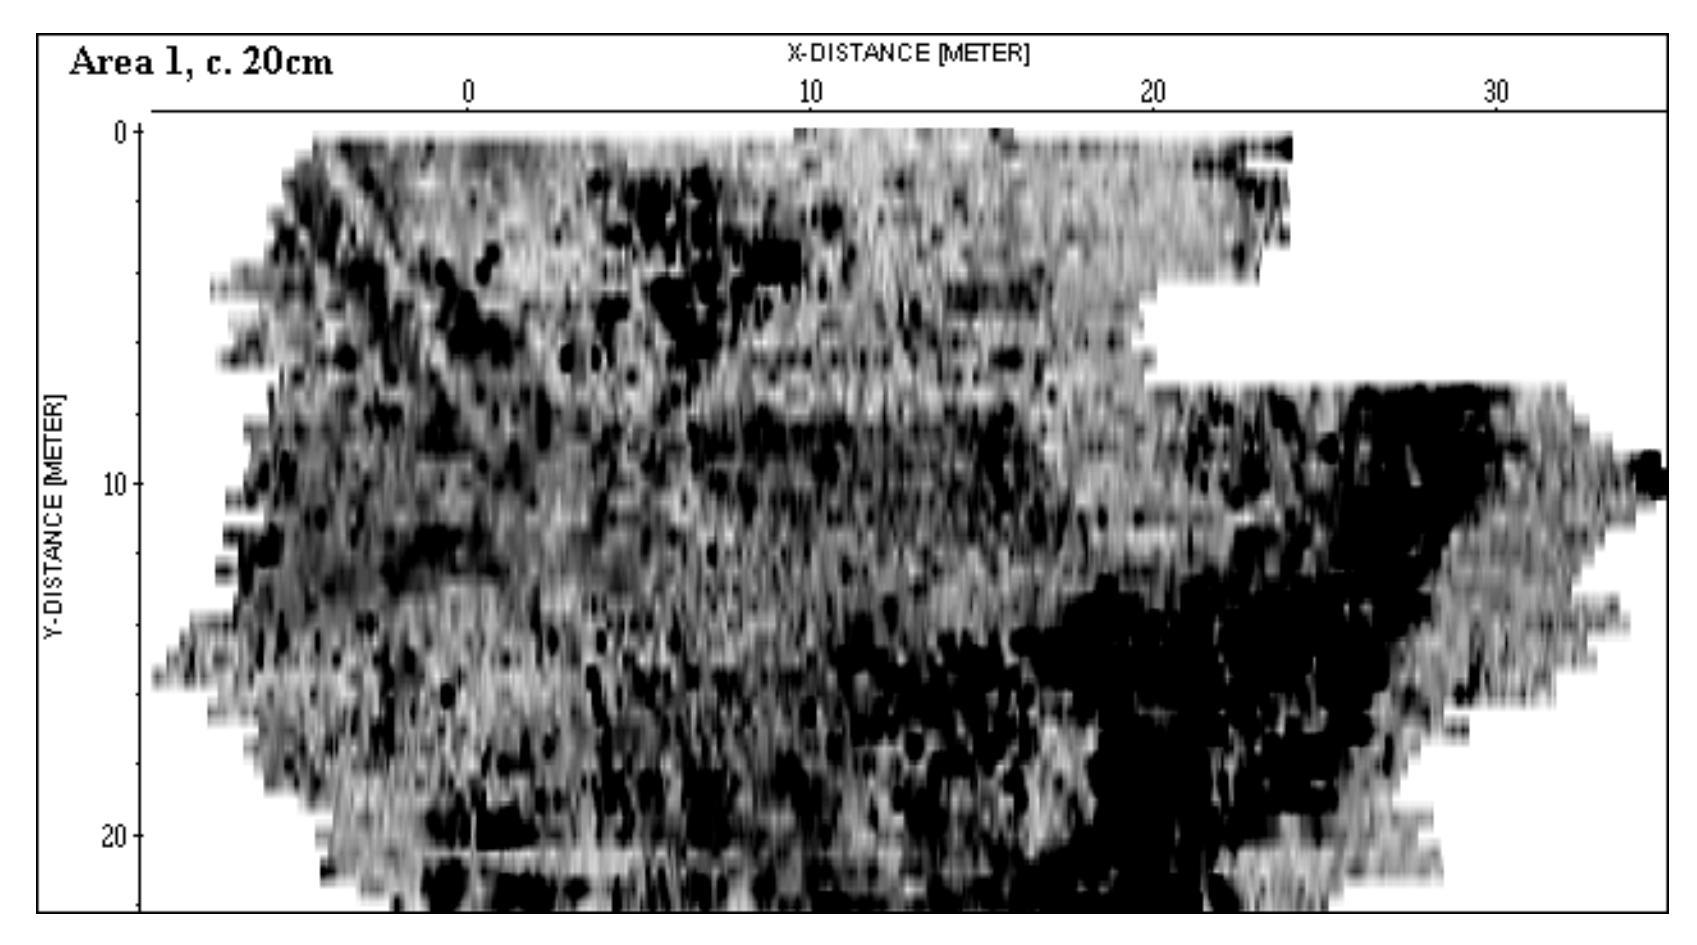
Figure 3: Area 1 20cm Timeslice

In the **20cm** timeslice, area "A" becomes more extensive: the footprint appears as a square/rectangular surface combined with a curvilinear feature. Taking into account the ringing pattern visible in the 2-dimensional data (which is indicative of a hard surface close to the present day one), this suggests a possible former road/drive, possibly connected to a small building of more recent date than the original house. The ringing in transect L24 (Figure 16) is typical.

In the NE (top left) corner, a linear feature has appeared which appears to be a utility: the trench and trench sides are clearly visible. The construction is not typical of modern utilities which typically depict disturbance in the area of the trench and then, as depth increases, the line of the utility. This appears to be a channel marked by the position of solid material on either side of the trench.

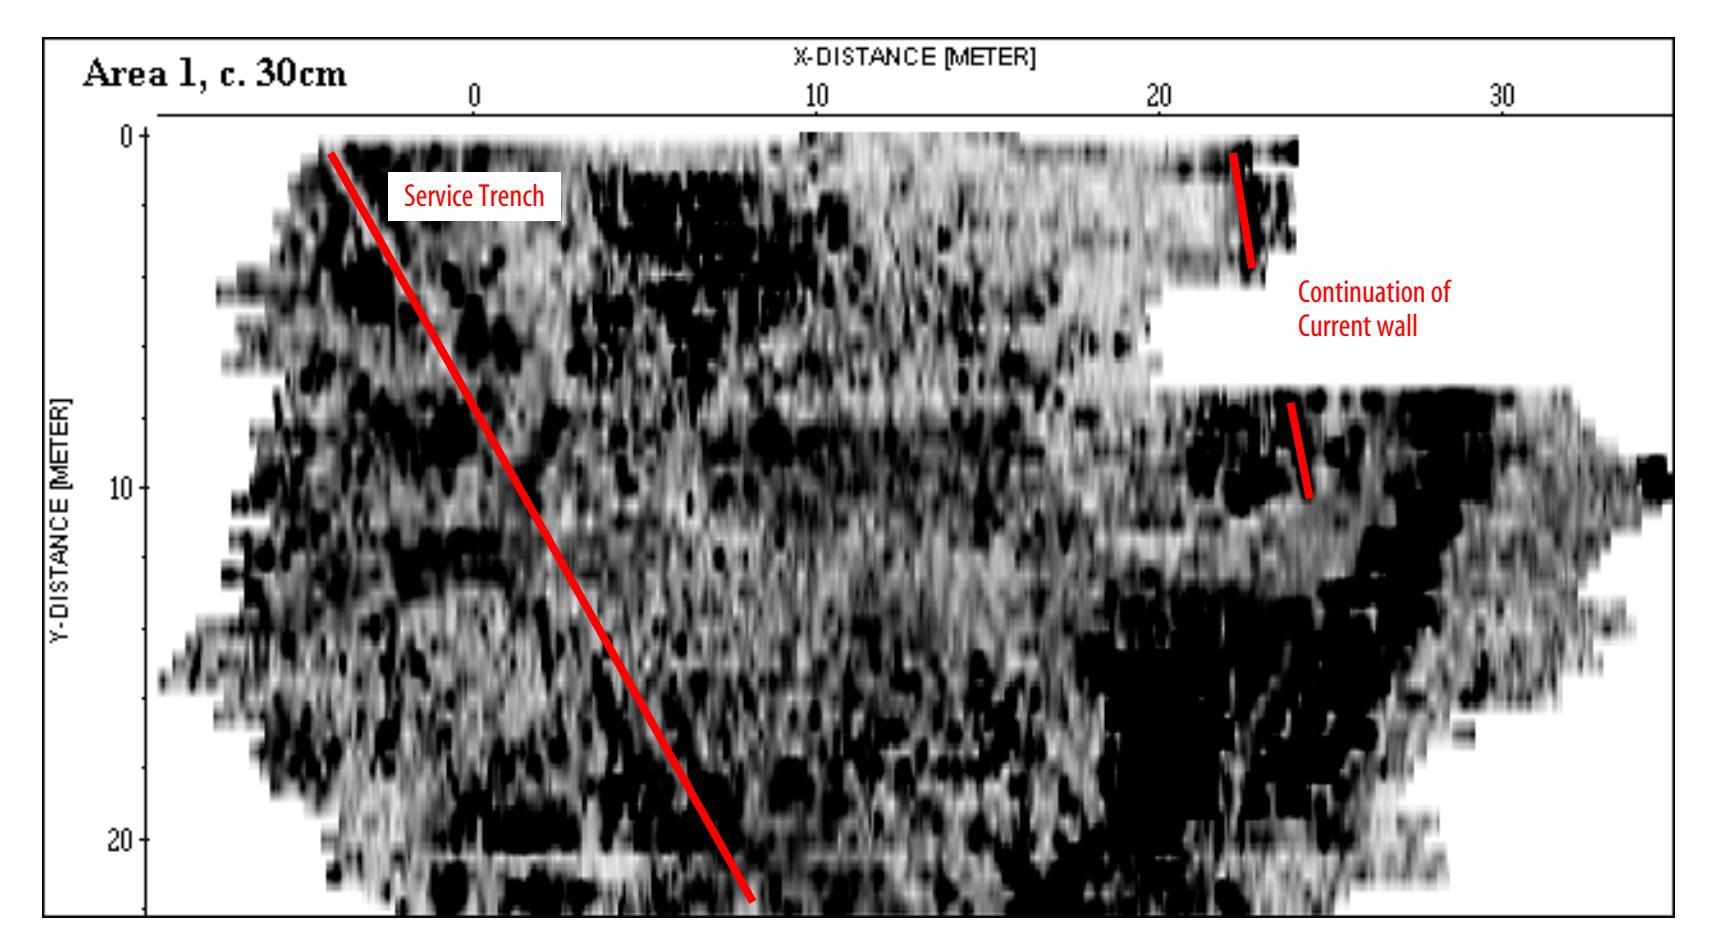
Figure 4: Area 1 30cm Timeslice

The utility trench is still clearly visible in the **30cm** timeslice. In the SE (top right) corner, the dark line running approximately East/West is the continuation of the existing wall observable on the East side of the current boundary wall between the East and West Houses. Note that since the data has not been topographically corrected, that this raised area is not at the same level as the remainder of the timeslice. The strong signal returns associated with Area "A" are beginning to

resolve into 2 separate features, as described above (at 20cm). This is also observable in the 2-dimensional data. It seems that the footings for the two constructions may be similar. The remaining dark areas appear discontinuous both in 3-d and in 2-d (the central portion of transect 11 in Figure 15 is typical). The 2-dimensional data suggests that these are areas of backfill i.e. containing quantities of building materials used to produce one or more level surfaces.

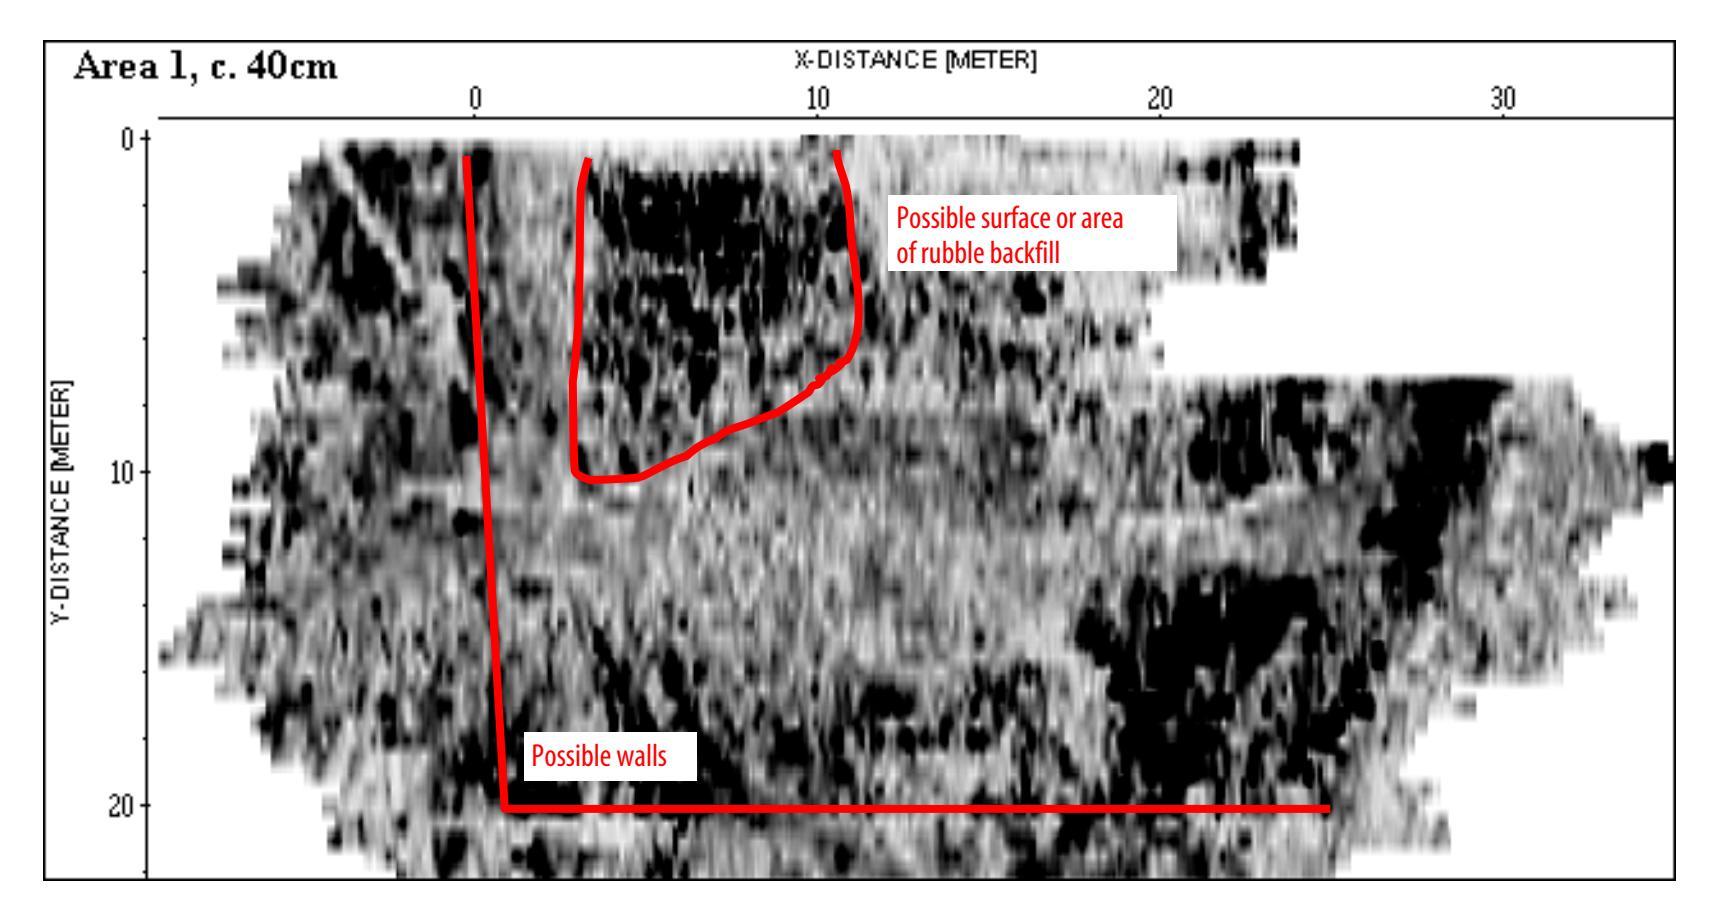
Figure 5: Area 1 40cm Timeslice

The possible utility trench is still visible in the **40cm** timeslice although its central portion is not visible. A new linear feature is just visible along the x = 0 line i.e. survey line 1. This does not correspond to a feature above ground: the survey base line was chosen with reference to potential area coverage and accuracy of long term recording. This line meets another at right angles at c. y = 20m. It appears likely that these lines correspond to part of the outline of the former main house. The separation of the two features forming area "A" is much clearer at this depth.

As in the previous timeslice, the dark mottled area between x = 3m & x = 10m; y = 1m and y = 8m, corresponds to an area of densely packed signals. This is likely to be either backfill or a surface made up of many individual densely packed elements. The wall beneath the small mound in the SE (upper right hand) corner is still visible: a growing spread of adjacent building material accompanies it on both sides, suggesting that the mound is based on the wall, augmented by rubble.

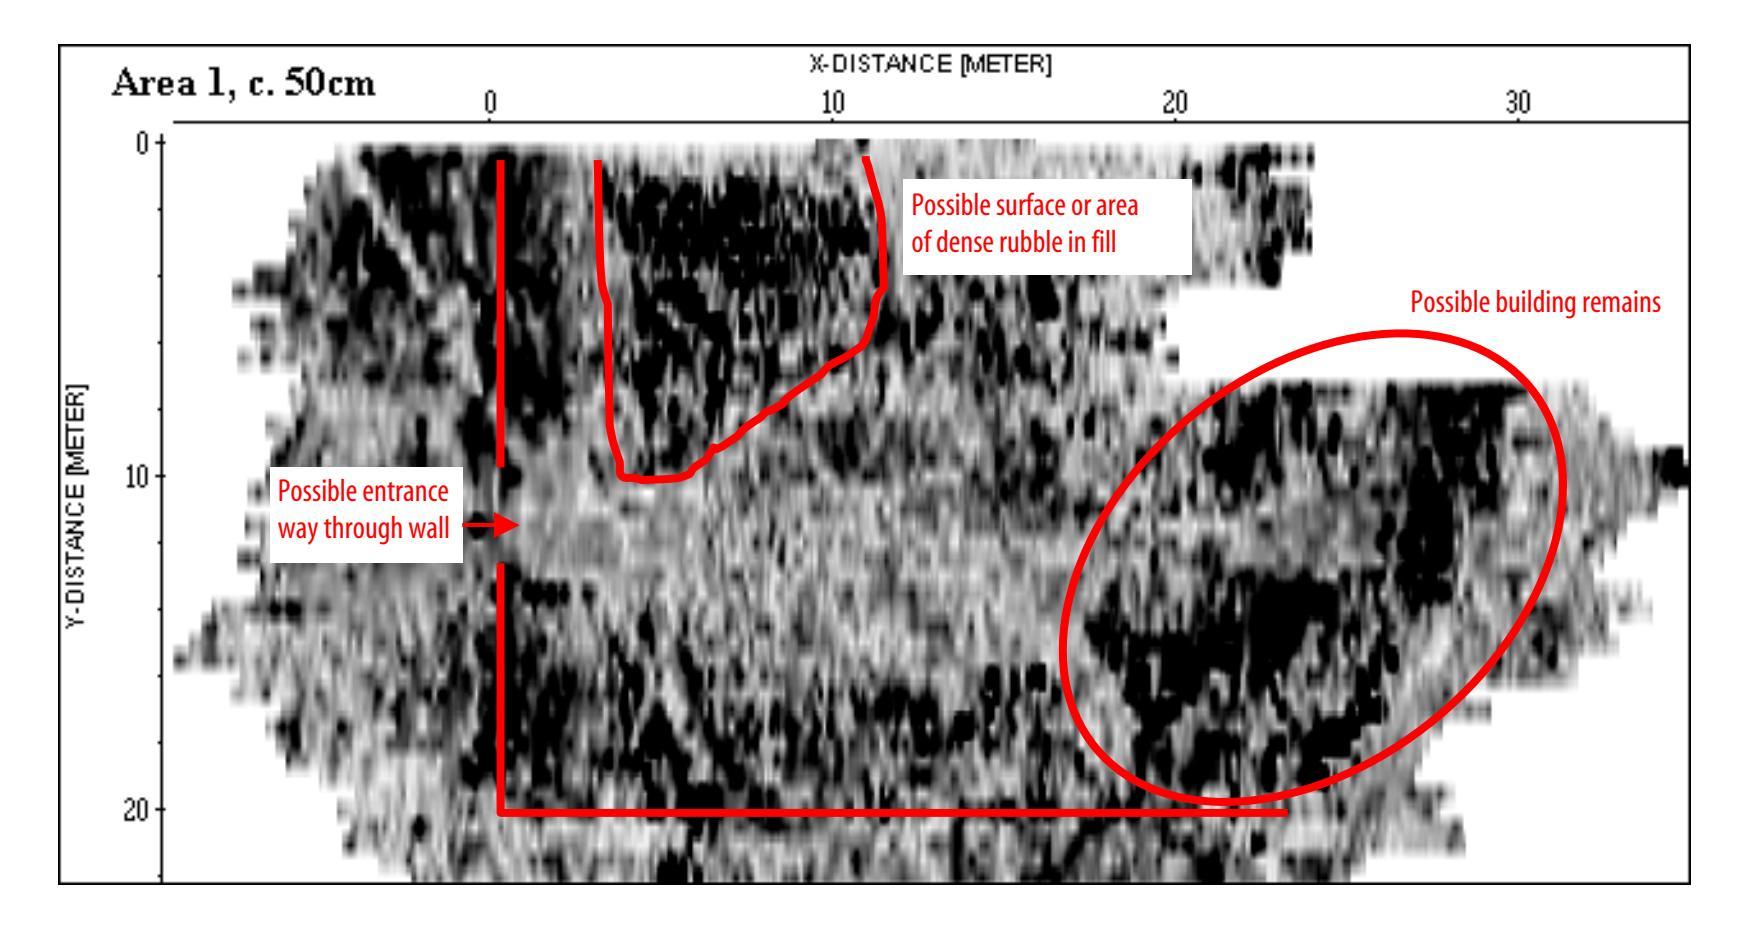
Figure 6: Area 1 50cm Timeslice

Both the possible utility trench and the 2 right-angled probable walls are clearly visible in the **50cm** timeslice. Between y = 10 and y = 12.5 along line 1, there is a gap which does not appear to relate to the intrusive trench and may therefore be an entrance to the former building. The mottled area (noted above) is virtually unchanged but has resolved into a triangular shape. The signal pattern in the former area "A" has become much more diffuse and appears at this depth to relate to the 2 right-angled possible walls. This would imply that there are underlying building remains *in situ* in this area, effectively masked in the 2-dimensional data by the hard surface above them. If this is a correct interpretation, it also dates the possible road/drive and the small building to post-destruction of the main house. There has been at least one such building: at the time of the survey mention was made of a former garage.

Although the pattern of the signals in the SW sector of the survey area is relatively diffuse (consistent with backfill often associated with post-destruction debris), the overall outline is similar in shape to the relevant end of the house footprint in the old Ordnance Survey 1-inch map. In the SE corner (top rhs), the raised area adjacent to the dividing wall between the 2 existing properties appears to consist primarily of building rubble.

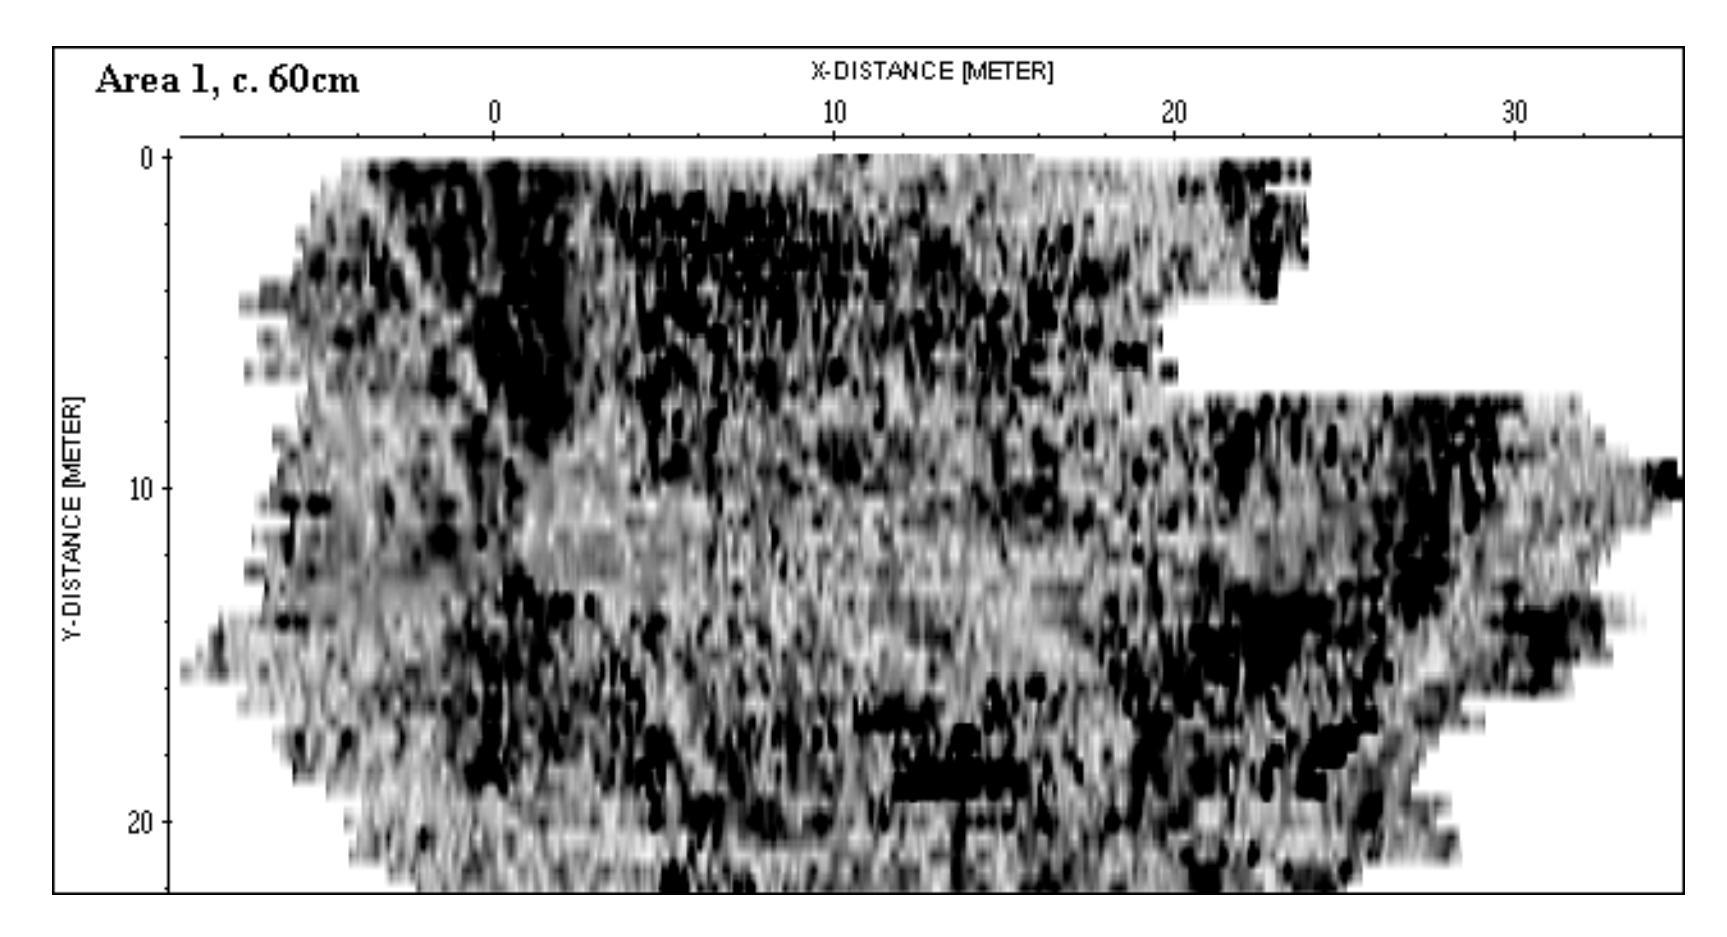
Figure 7: Area 1 60cm Timeslice

The **60cm** timeslice is very similar to that at c. 50cm: the beginnings of possible room outlines are visible in the southern sector (rhs). Along survey line 1 (x = 0), a split has appeared so that the strong signal returns are aligned on either side of what appeared previously to be the limit of the building. This central line now appears as less dense relative to the materials on either side.

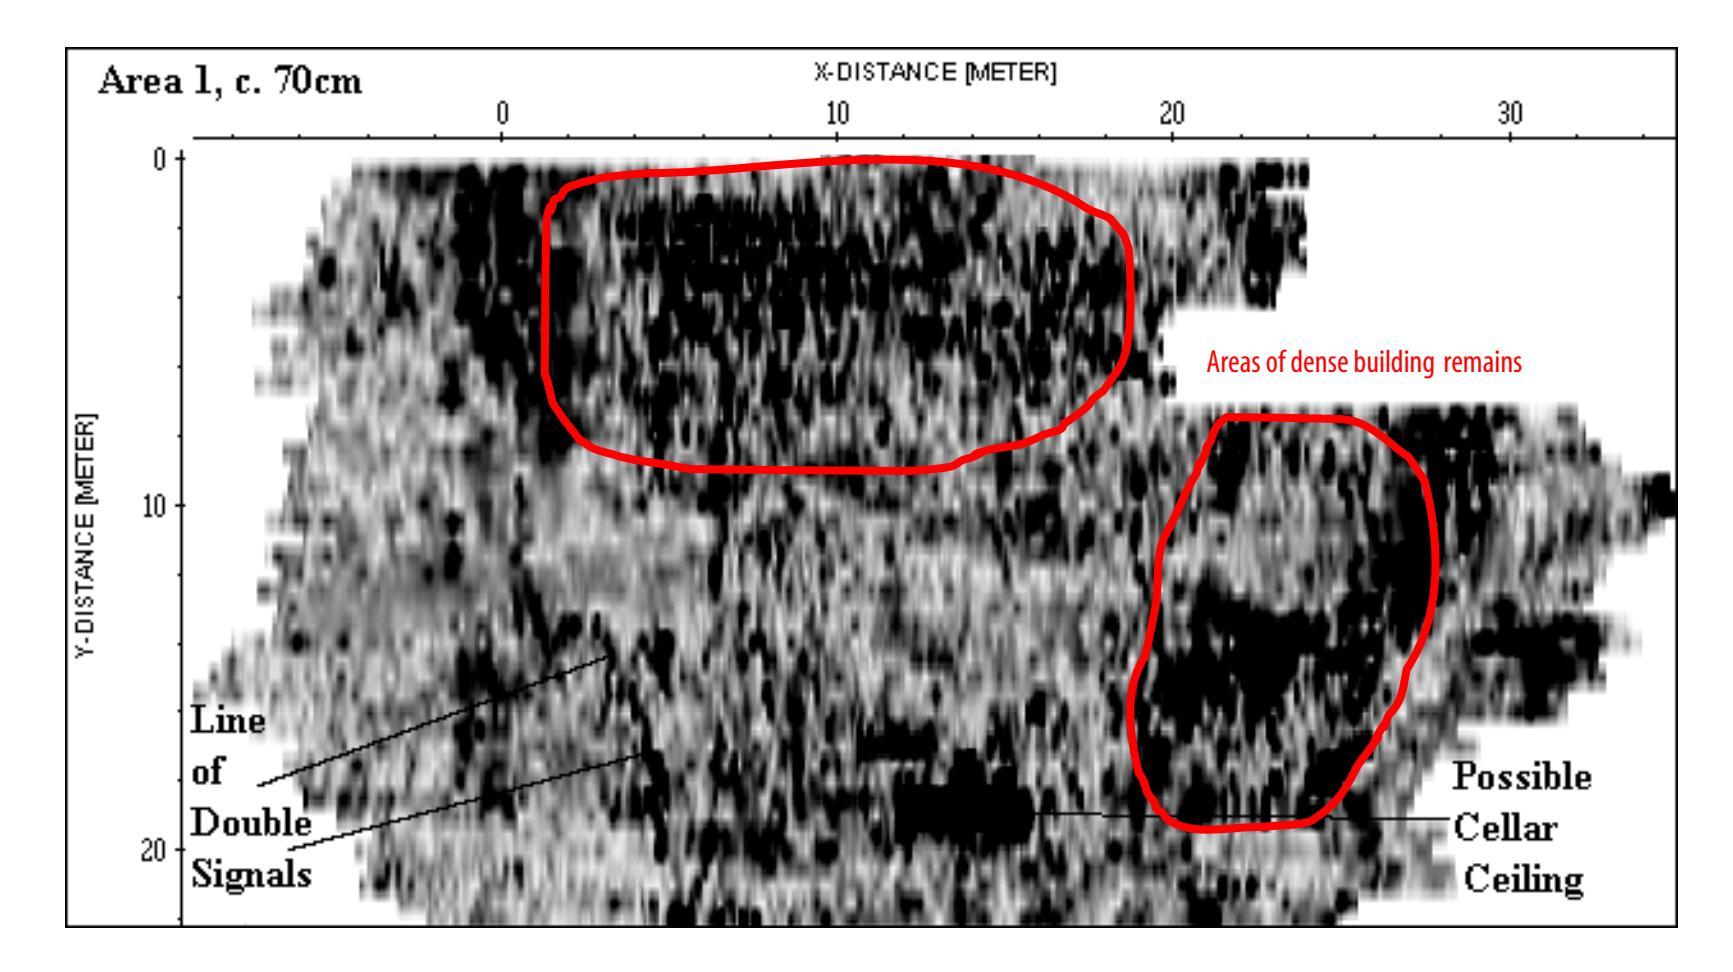
Figure 8: Area 1 70cm Timeslice

There are a number of interesting changes in the **70cm** timeslice. Along the line of the trench previously described as being a possible utility, a line of dark signals

indicates the position of the potential utility itself. This line is only partial, running from (x = 2.7, y = 13) to (x = 4.9, y = 20.5). It is completely missing from the NE sector, presumably removed subsequently. In the 2-d data, there are at least 2 closely spaced hyperbolae, indicating more than 1 construction within the same defined space. Alternatively, this could represent two base slabs to the same construction, provided that they were sufficiently small.

There is a large, mostly rectangular area near to the middle of the western sector of the survey area whose footprint measures approximately 4.2m by 2m although the shape is irregular. The 2-dimensional data at this point shows clearly that this upper surface continues in the horizontal direction but that beneath it lies another deeper surface. Measured at 0.3m/ns (the velocity of transmission of radio waves in air), the distance between the two surfaces is between 1.6m and 2m. It is also clear that the floor/cellar ceiling gives a stronger electromagnetic response and is measurably thicker than the surrounding floor area. There are some signals between the possible cellar floor and ceiling, indicating that the area is not completely devoid of contents. Figure 17 shows the results from transects 36 and 37. From run 37 onwards the pattern is relatively regular from one transect to the next. The first transect to show the returned signals from the possible cellar is run 36: the irregularity relative to subsequent runs suggests that there are some major differences in construction. This may be a reflection of an entry point.

The split observed along survey line 1 where, at higher levels, an apparent limit to the former building lies, is more exaggerated. There is a considerable quantity of building remains in the eastern sector and relatively little to the west.

In the southern sector, a number of dividing lines suggests a possible room layout. Although the dark areas between y = 20 & y = 24 are within the area where ringing is visible, these reflections do seem to represent underlying construction since some signal variation is discernible in the 2-dimensional plots.

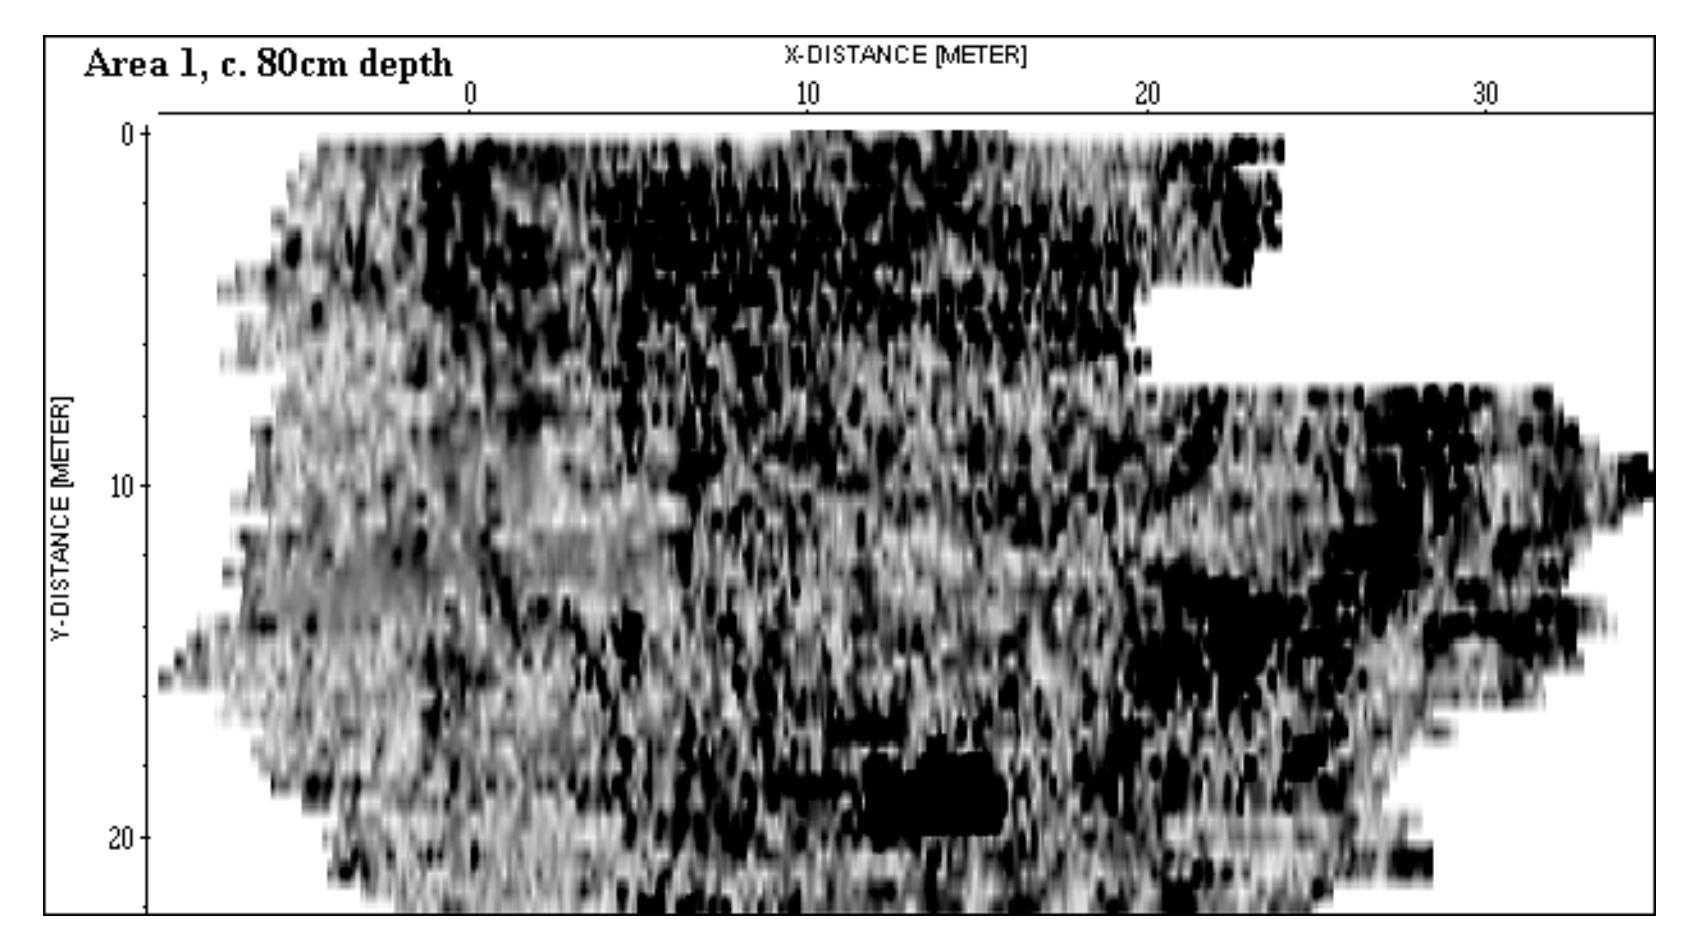
Figure 9: Area 1 80cm Timeslice

The **80cm** timeslice is very similar in content to the 70cm one. By **90cm**, however, a new linear feature has appeared along the line y = 20.5m (transect 41). As Figure 18 illustrates, this is a continuous surface which is probably linked to a similar feature visible in the southern third of the profile. This latter signal appears to curve upwards: in reality the current ground surface dips and this is almost certainly a level feature. Some of the wall construction is also visible in this and the following transect profile.

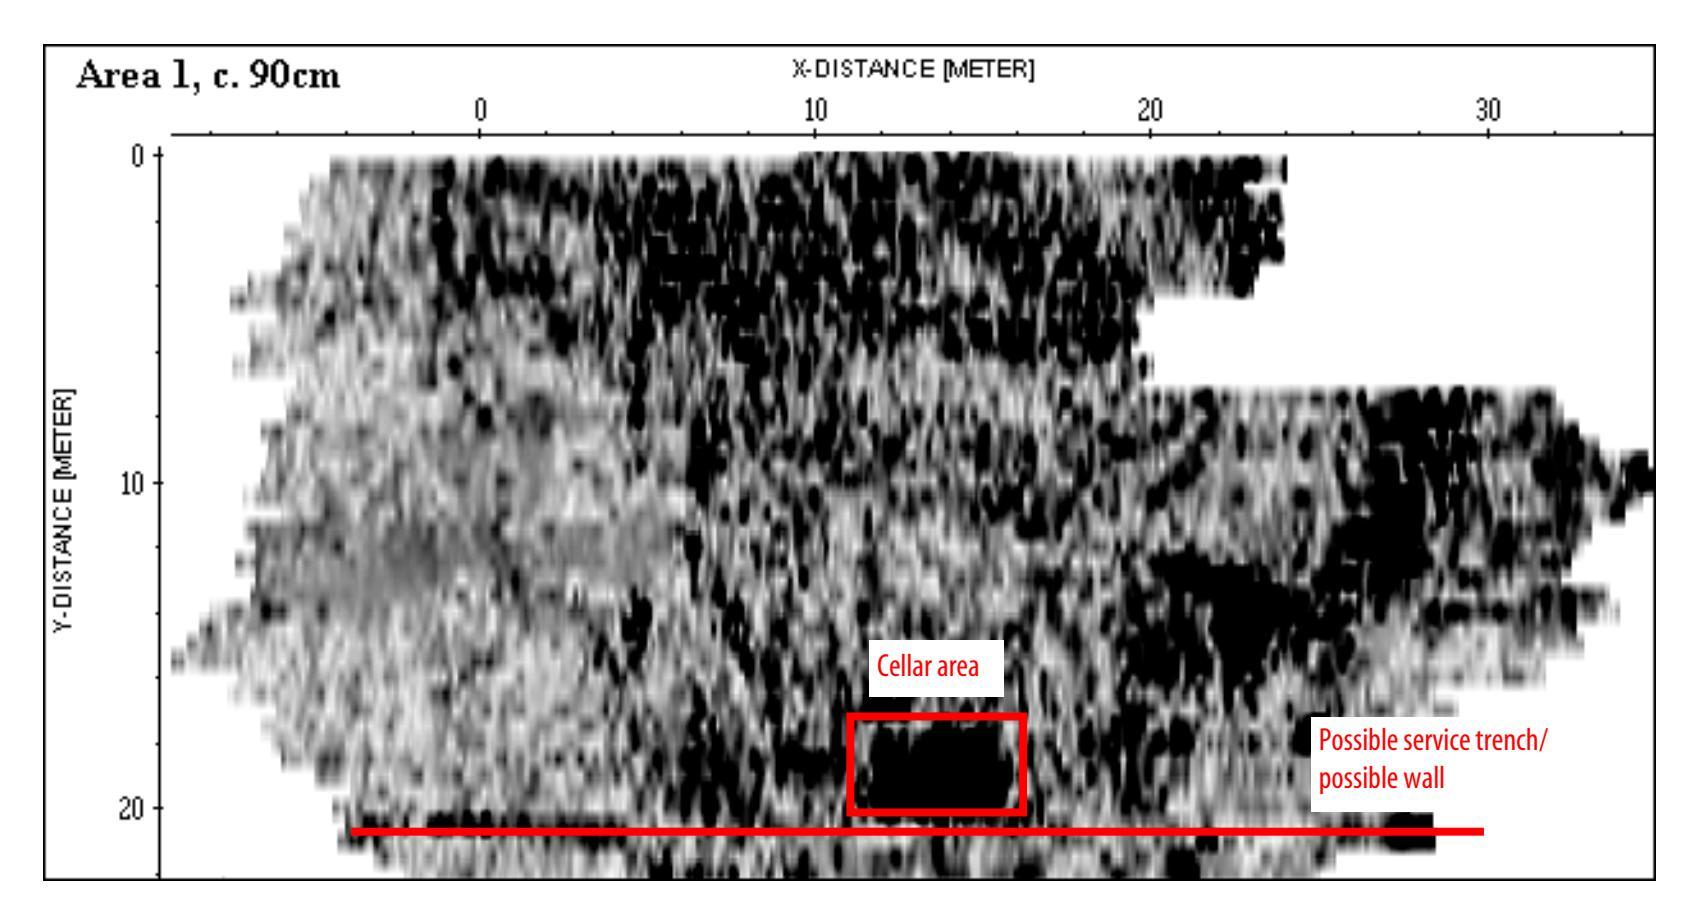
Figure 10: Area 1 90cm Timeslice

The cellar is clearly visible in both timeslices. The possible northern edge to the main house is indicated only by a few metres of signal, to either side of survey line 1, in the general vicinity of the eastern edge but nowhere else. A stronger parallel line has appeared along the x = 4m line with a central break. It is possible that this represents an earlier phase of the house and that a c. 4m extension to the north is of later date.

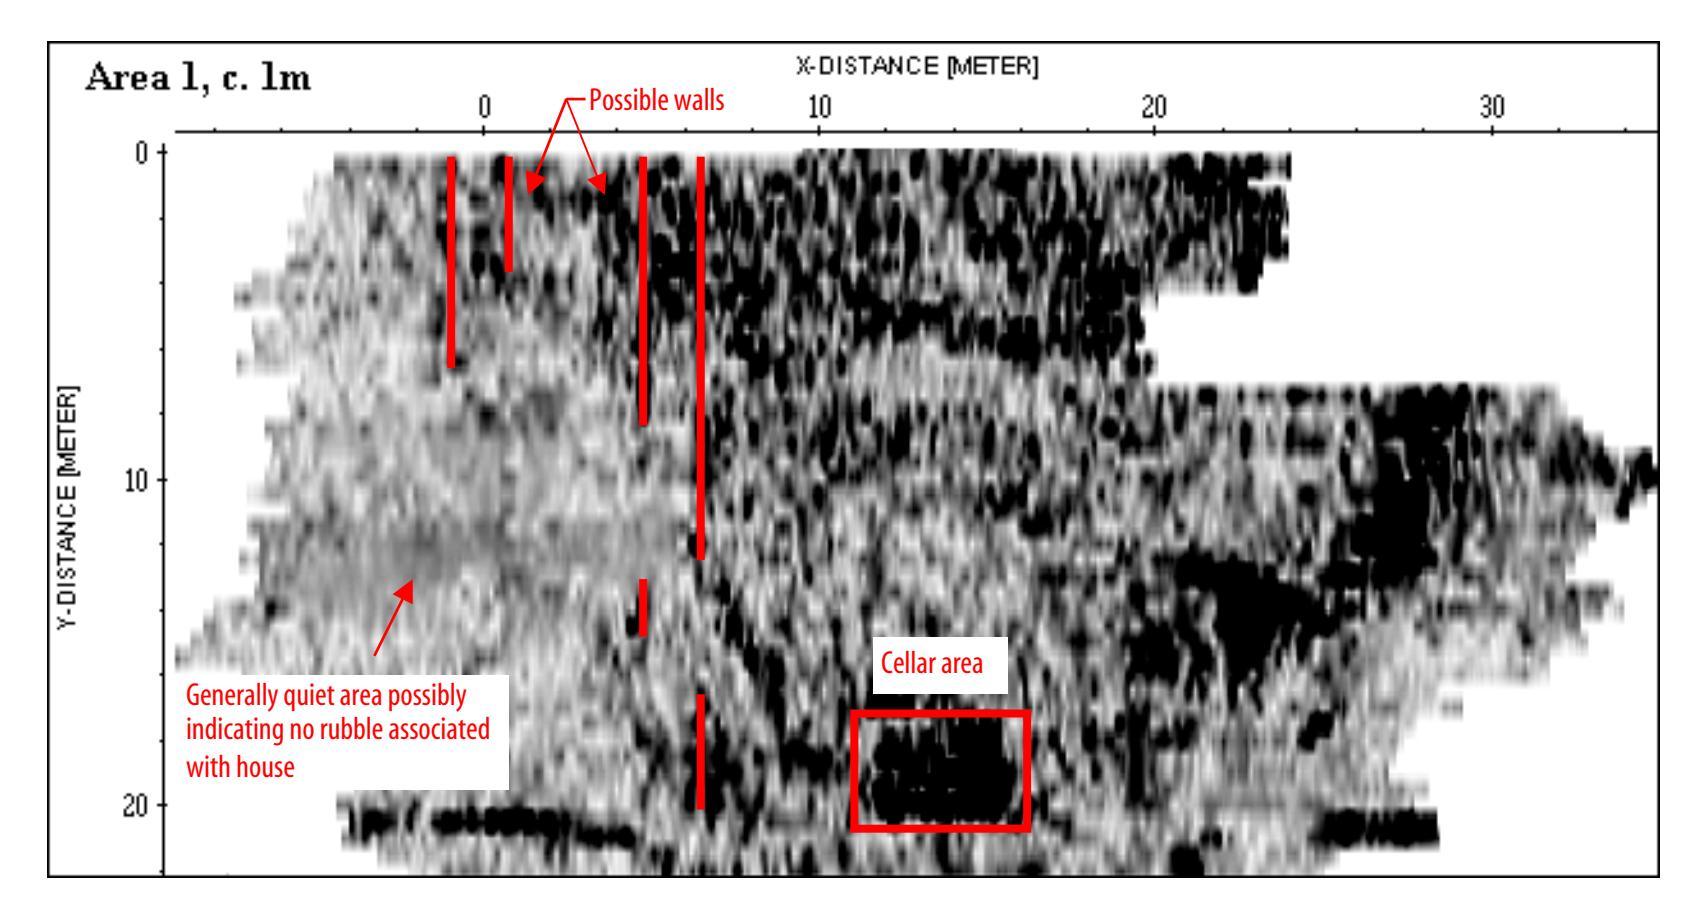
Figure 11: Area 1, 1m Timeslice

By **1m** depth, two parallel lines with a slightly bowed shape towards the north have taken over as the northern limits of the house. Compared with the shallower patterning, this also suggests phased development of the main house. The signals representing the cellar continue to be strong reflections relative to their surrounding area, indicating a complete difference in material. This is as expected i.e. the

difference in the cellar relative to its surrounding environment is what makes it a suitable GPR target.

The linear feature, which first appeared in the 90cm timeslice, is also clearly visible in this one. The northern edge appears to join the house outline and it is reasonable to assume they are related features.

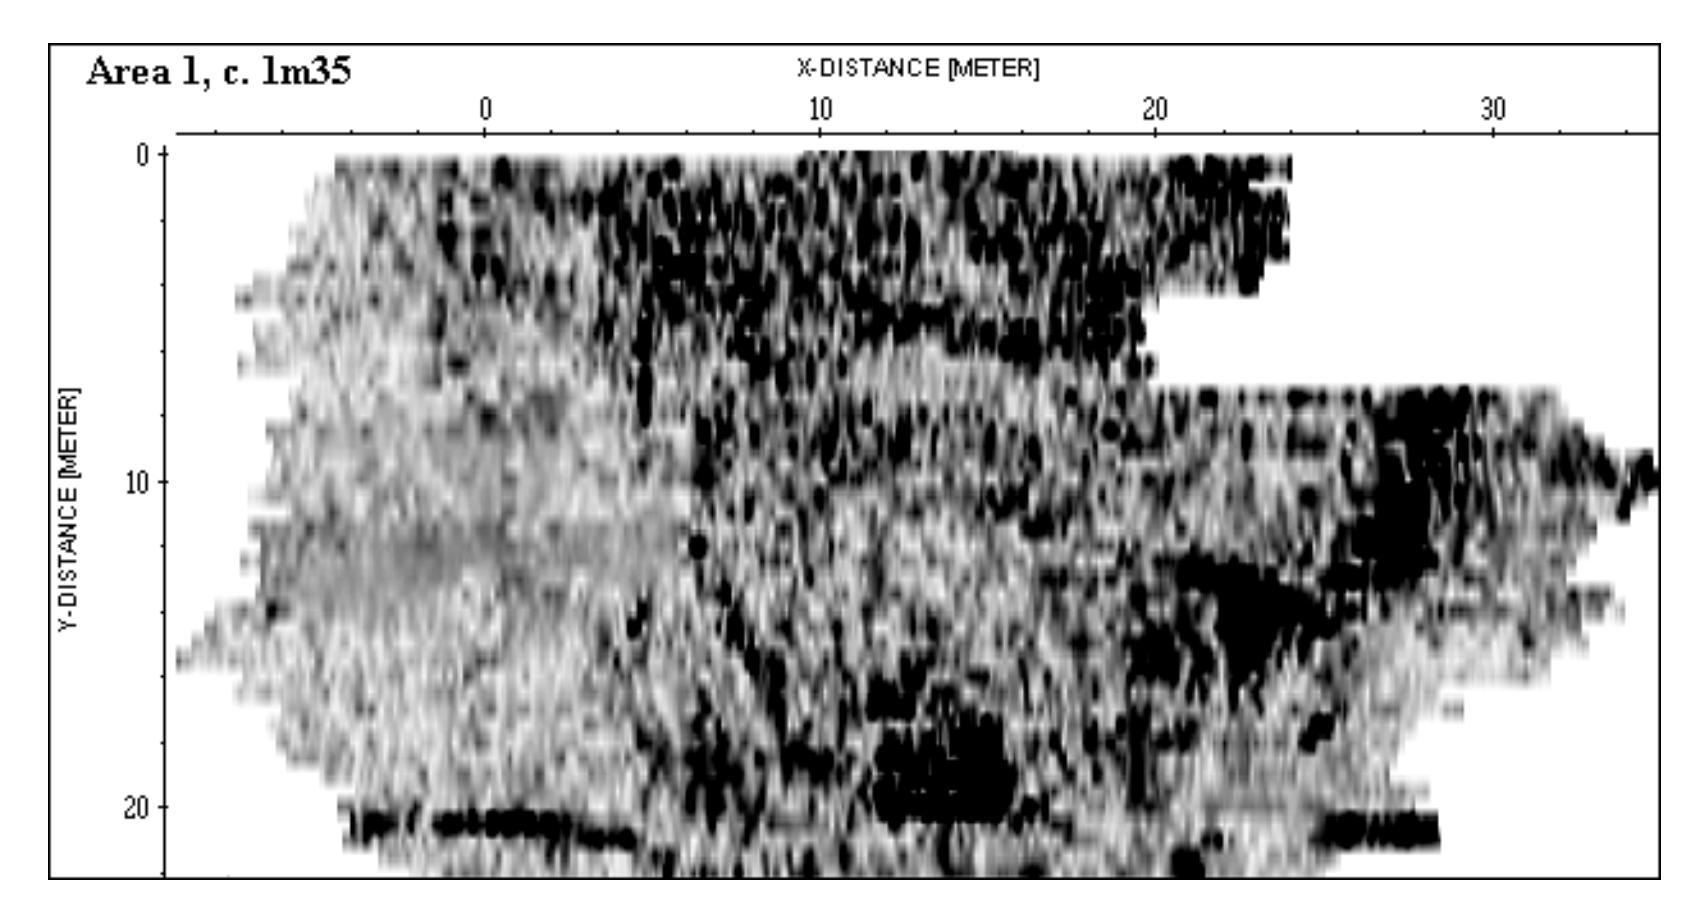
Figure 12: Area 1 1m35 Timeslice

Below 1m depth, the changes in patterning are much less frequent. The **1m35** timeslice is almost identical to the previous one, at 1m. In defining these depths, it needs to be remembered that transmission velocity varies with the medium through which the radio waves are travelling. The timeslices represent a cross section in time, but not necessarily space. The physical cross section will have been distorted by the radio waves crossing the air void in the cellar at three times the speed that they pass through the ground. In addition, since the GPR data has not been contoured, there is also a slight distortion where the modern surface rises (in the SE corner) or dips (in the SW corner).
