Pencaitland House, East Lothian: Ground Penetrating Radar Survey

# **Data Structure Report**

# Report No. 1107

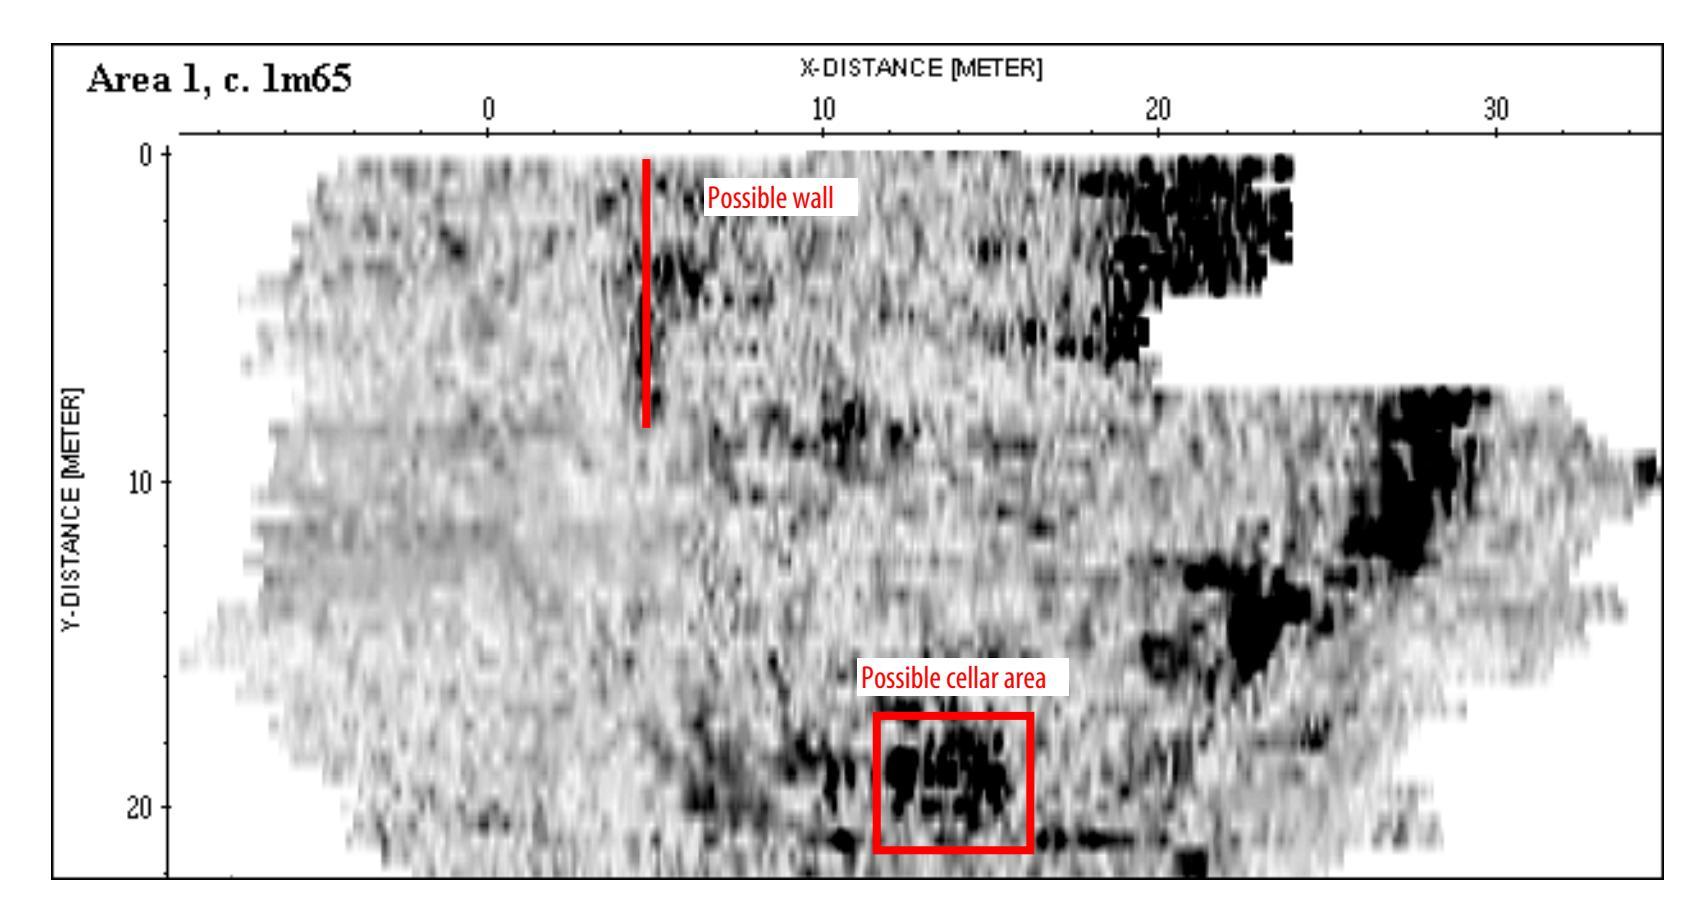
Figure 13: Area 1 1m65 Timeslice

By **1m65** there are relatively few features still visible. There is a faint outline of a moderately large square/rectangular building whose northern edge lies close to the x = 4m line. Some remnants of signal are visible from the area of the cellar. The two areas of strong reflected signal to the south are likely to be ringing, echo effects from features lying above. Beneath the mound in the SE (top right hand) corner, there is a spread of building material. By **2m**, only the latter three features are visible.

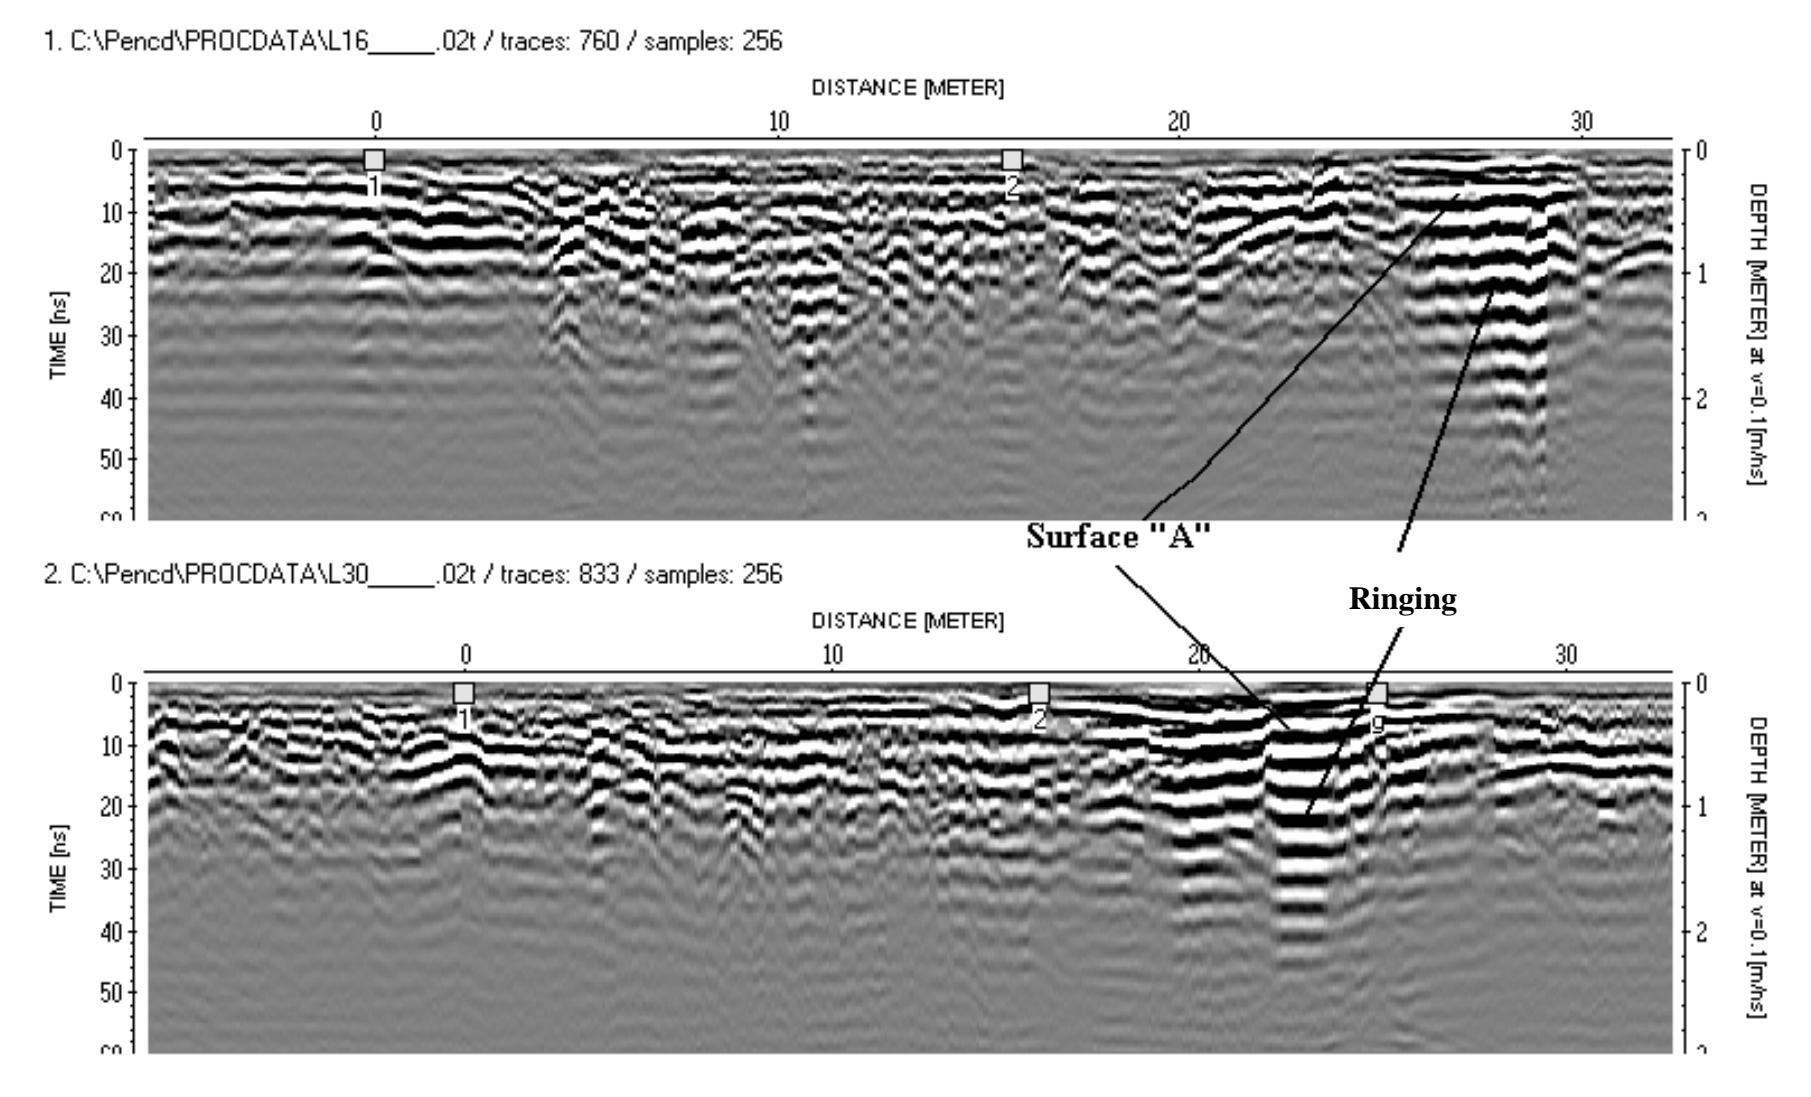
Figure 15: Transects 16 & 30

In the **10cm** timeslice, the black curvilinear feature marked "A" corresponds to a densely packed surface close to the current ground surface. In the 2-dimensional data, the ringing (echo effects) associated with this type of hard surface are clearly visible: see Figure 15. The principal problem with ringing is that it can mask other signal returns with a genuine depth association. The dark area in the lower right hand side is a similar but much smaller feature.

resolve into 2 separate features, as described above (at 20cm). This is also observable in the 2-dimensional data. It seems that the footings for the two constructions may be similar. The remaining dark areas appear discontinuous both in 3-d and in 2-d (the central portion of transect 11 in Figure 15 is typical). The 2-dimensional data suggests that these are areas of backfill i.e. containing quantities of building materials used to produce one or more level surfaces.

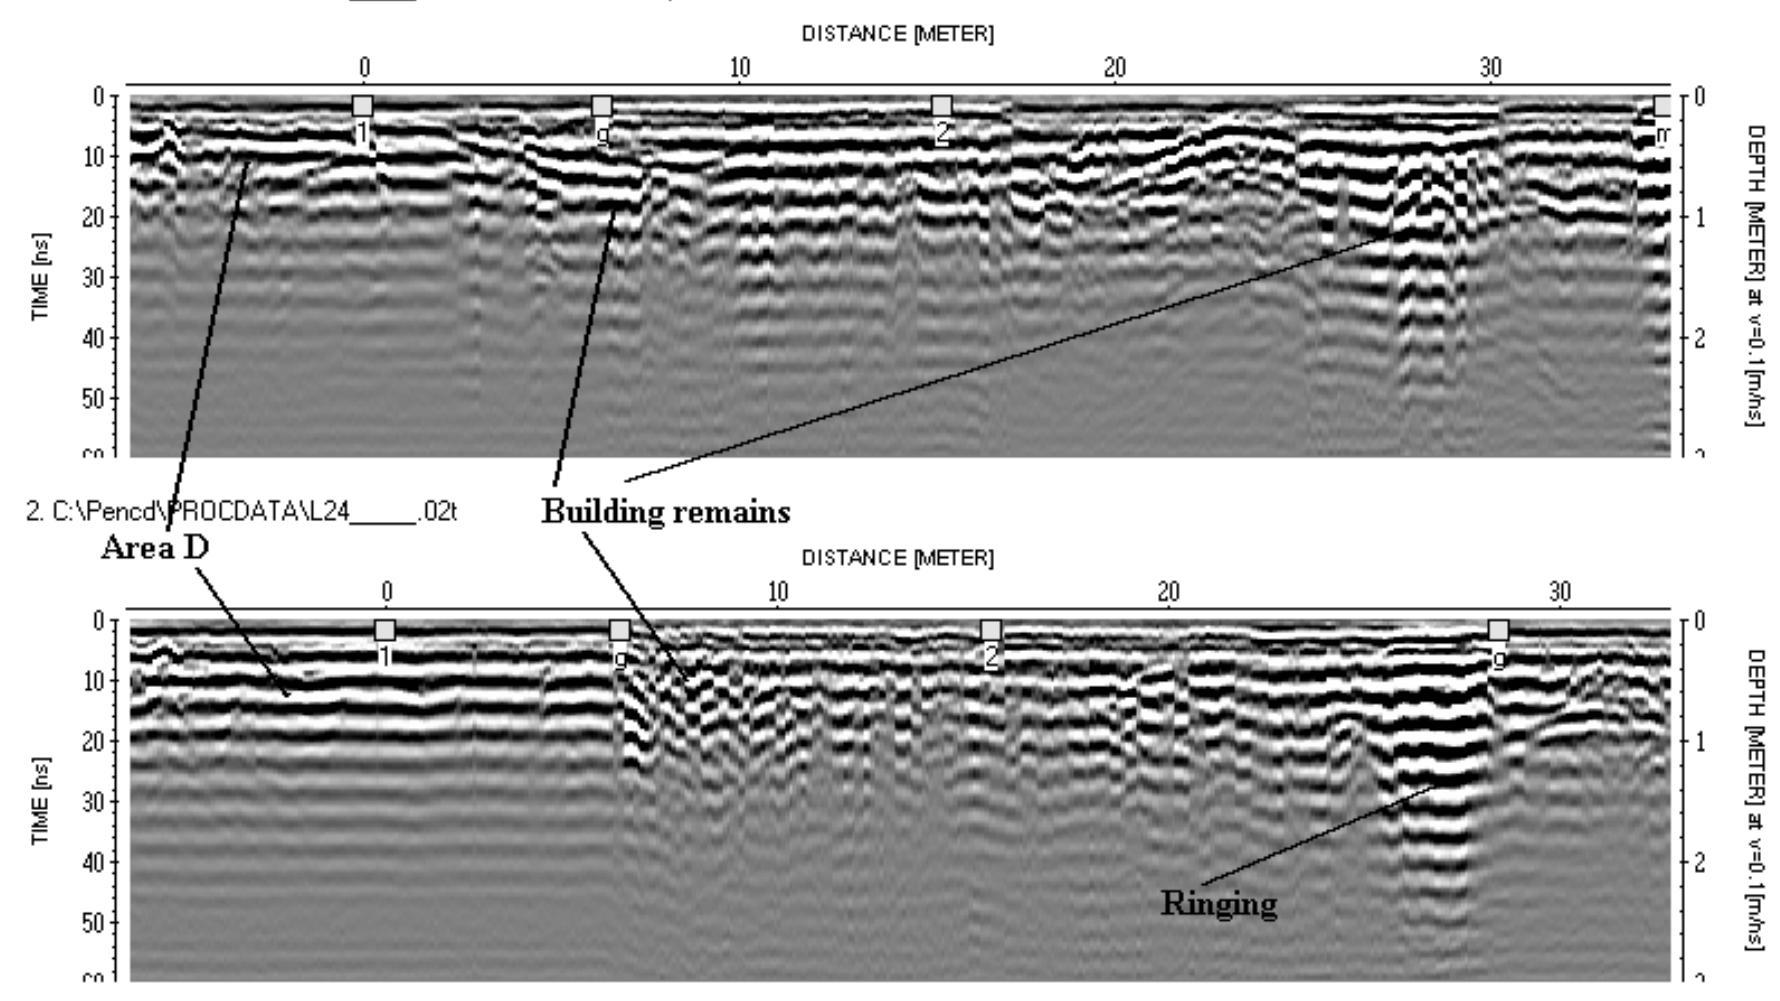
Figure 16: Transects 19 & 24

The area of strong signal return marked "B" consists of a similarly dense surface but appears to correspond to possible building remains. Area "C" corresponds to the position of the current gravel drive and probably therefore relates to the construction of the drive. Although there are underlying signals consistent with building construction, at this depth this appears to be a levelled surface. Area "D" also appears to relate to the levelling of the site, rather than underlying construction: compare the area before marker 1 on Figure 16: transects 19 and 24 are typical.

In the **20cm** timeslice, area "A" becomes more extensive: the footprint appears as a square/rectangular surface combined with a curvilinear feature. Taking into account the ringing pattern visible in the 2-dimensional data (which is indicative of a hard surface close to the present day one), this suggests a possible former road/drive, possibly connected to a small building of more recent date than the original house. The ringing in transect L24 (Figure 16) is typical.

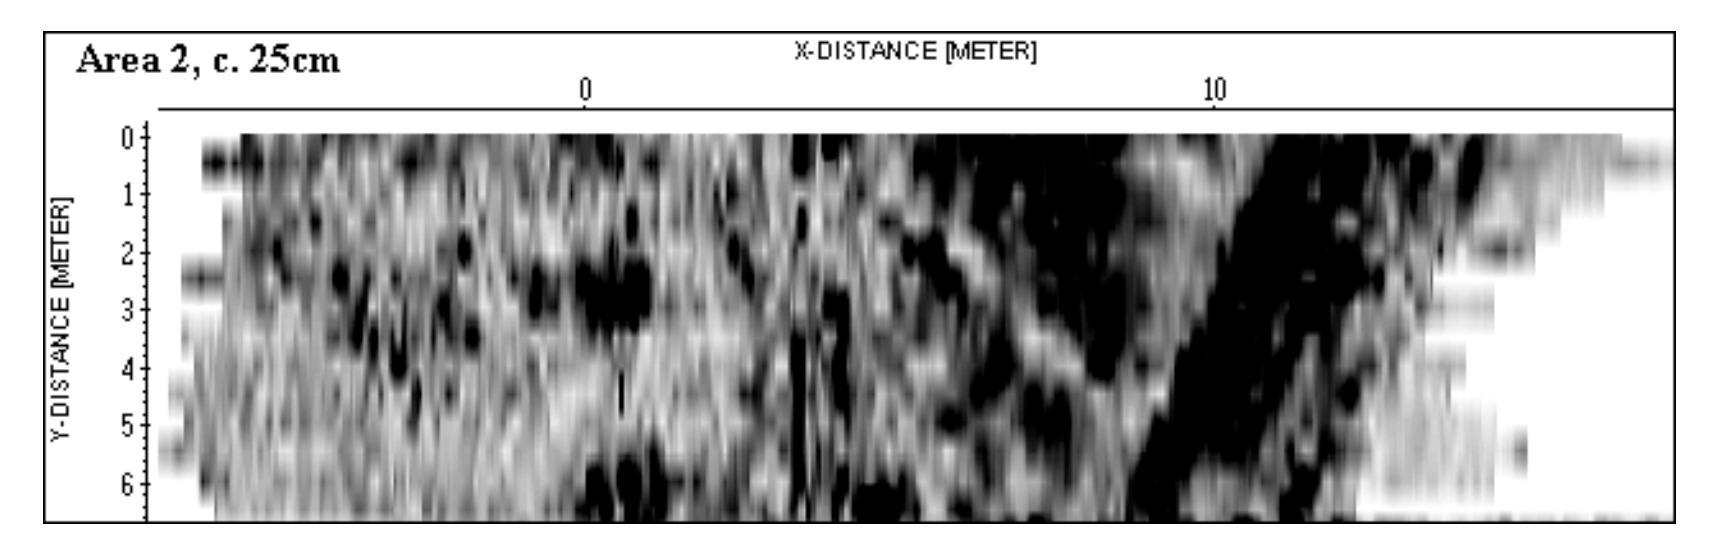
Figure 20: Area 2 25cm Timeslice

By the depth of the **25cm** timeslice (Figure 20), two of these signals have amalgamated into the relatively thick linear feature visible in this timeslice: the third line is still separately visible to the east. A dark triangle to the west indicates a hard surface close to the present day surface. The thin line marking x = 3.5 is a reflection of a modern feature, the line of stone marking the edge of a cultivation bed.

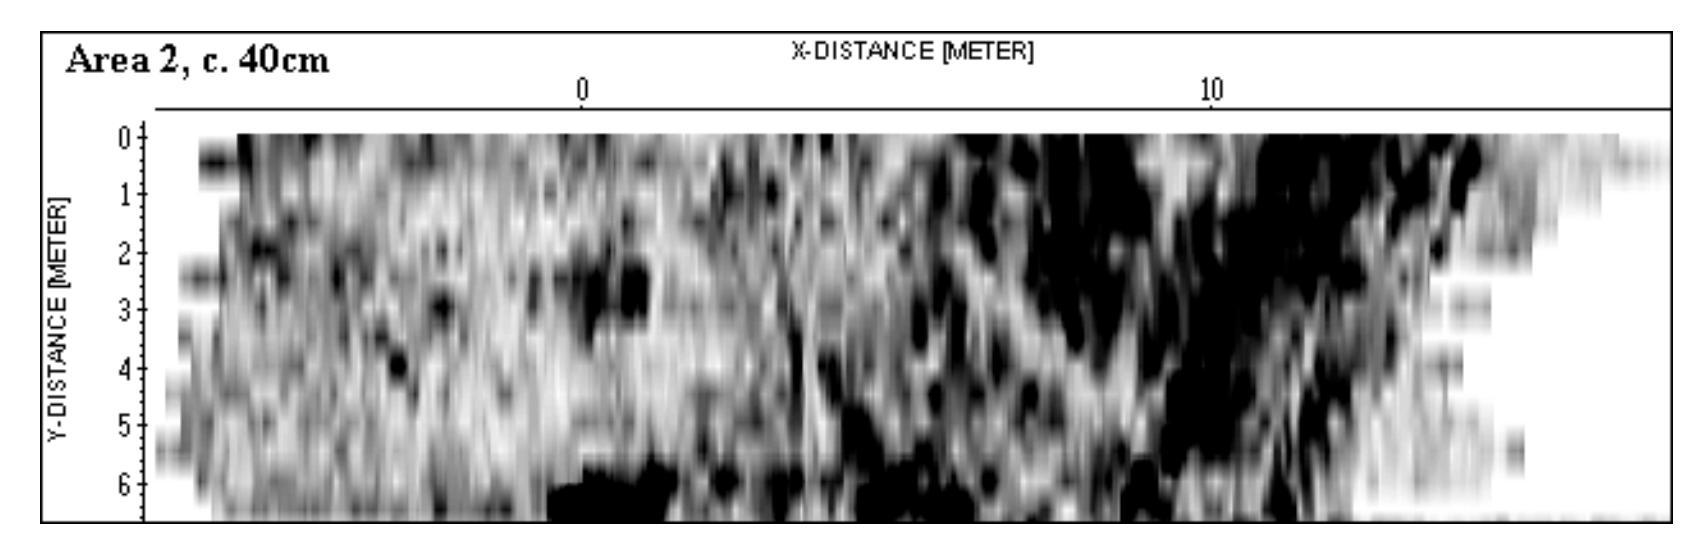
Figure 21: Area 2 40cm Timeslice

The linear and surface features appear to join up in the **40cm** timeslice (Figure 21). This subsequently resolves into a series of parallel lines, with the suggestion of a corner to the north and a curvilinear feature curling towards the north & south in the **55cm** timeslice (Figure 22). The **65cm** timeslice (Figure 23) is similar except for the gradual disappearance of an anomaly apparently at the centre of the circular feature. In the 2-dimensional data, this appears to be a fraction of a compacted surface close to

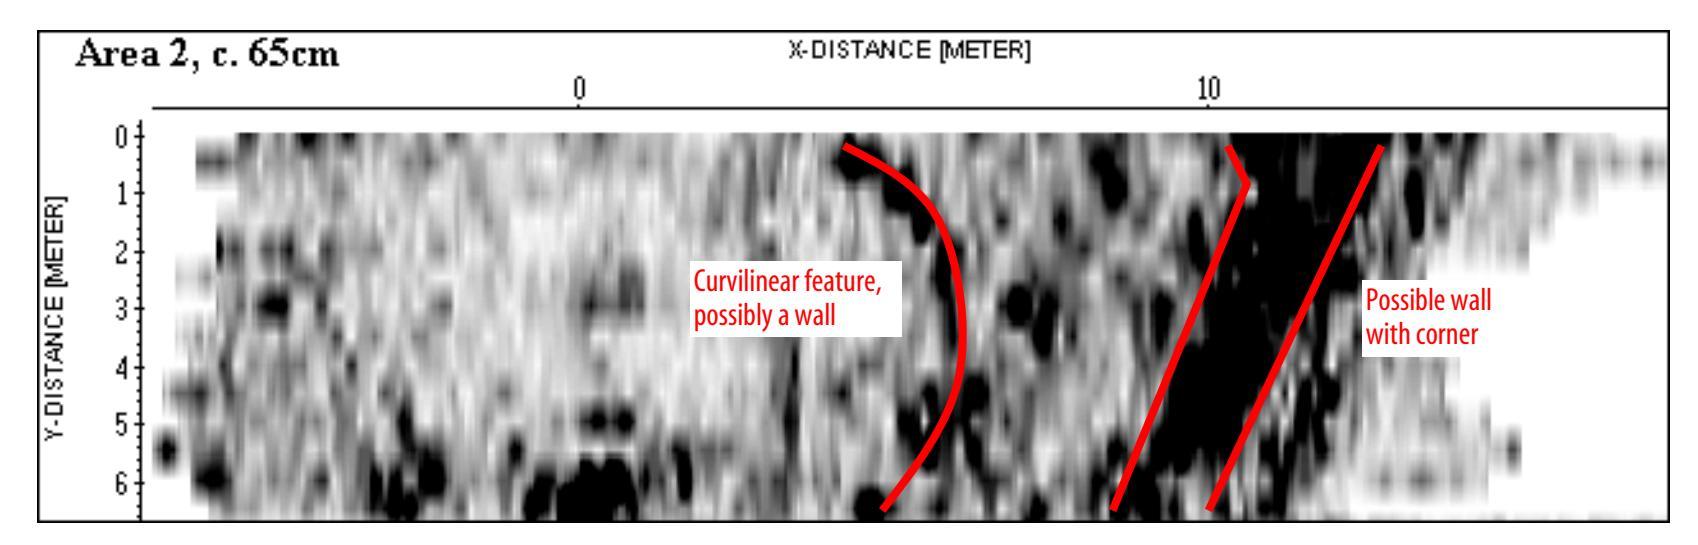
Figure 23: Area 2 65cm Timeslice

the present ground surface and the likelihood is, therefore, that this is ringing (echo effects) caused by the surface above. As such, the feature is likely to post-date the destruction of the main house.

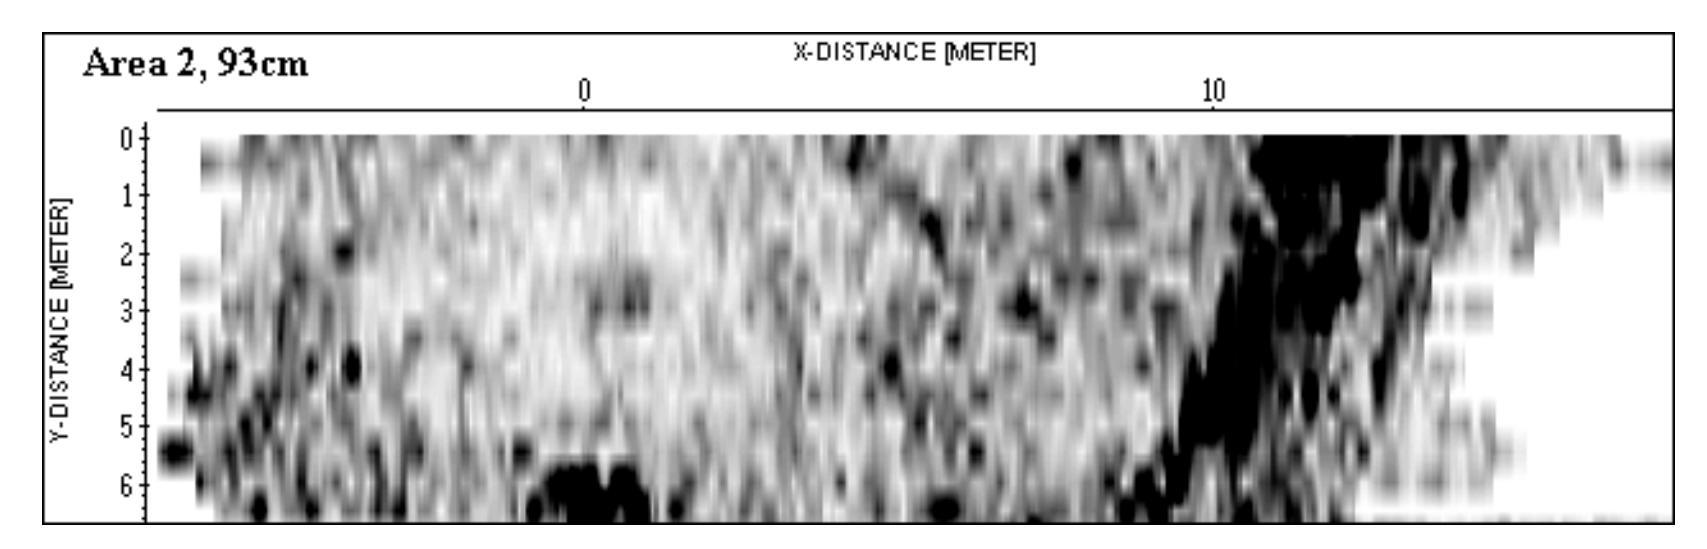
Figure 24: Area 2 93cm Timeslice

By **93cm** most of these features have disappeared, visible only as minor reflections: see Figure 24. The main linear feature and a short anomalous area near the base line (survey line 4) remain. The 2-dimensional data suggests that both are related to building construction. By the **1m50** timeslice, these, too, are diminishing (Figure 25).

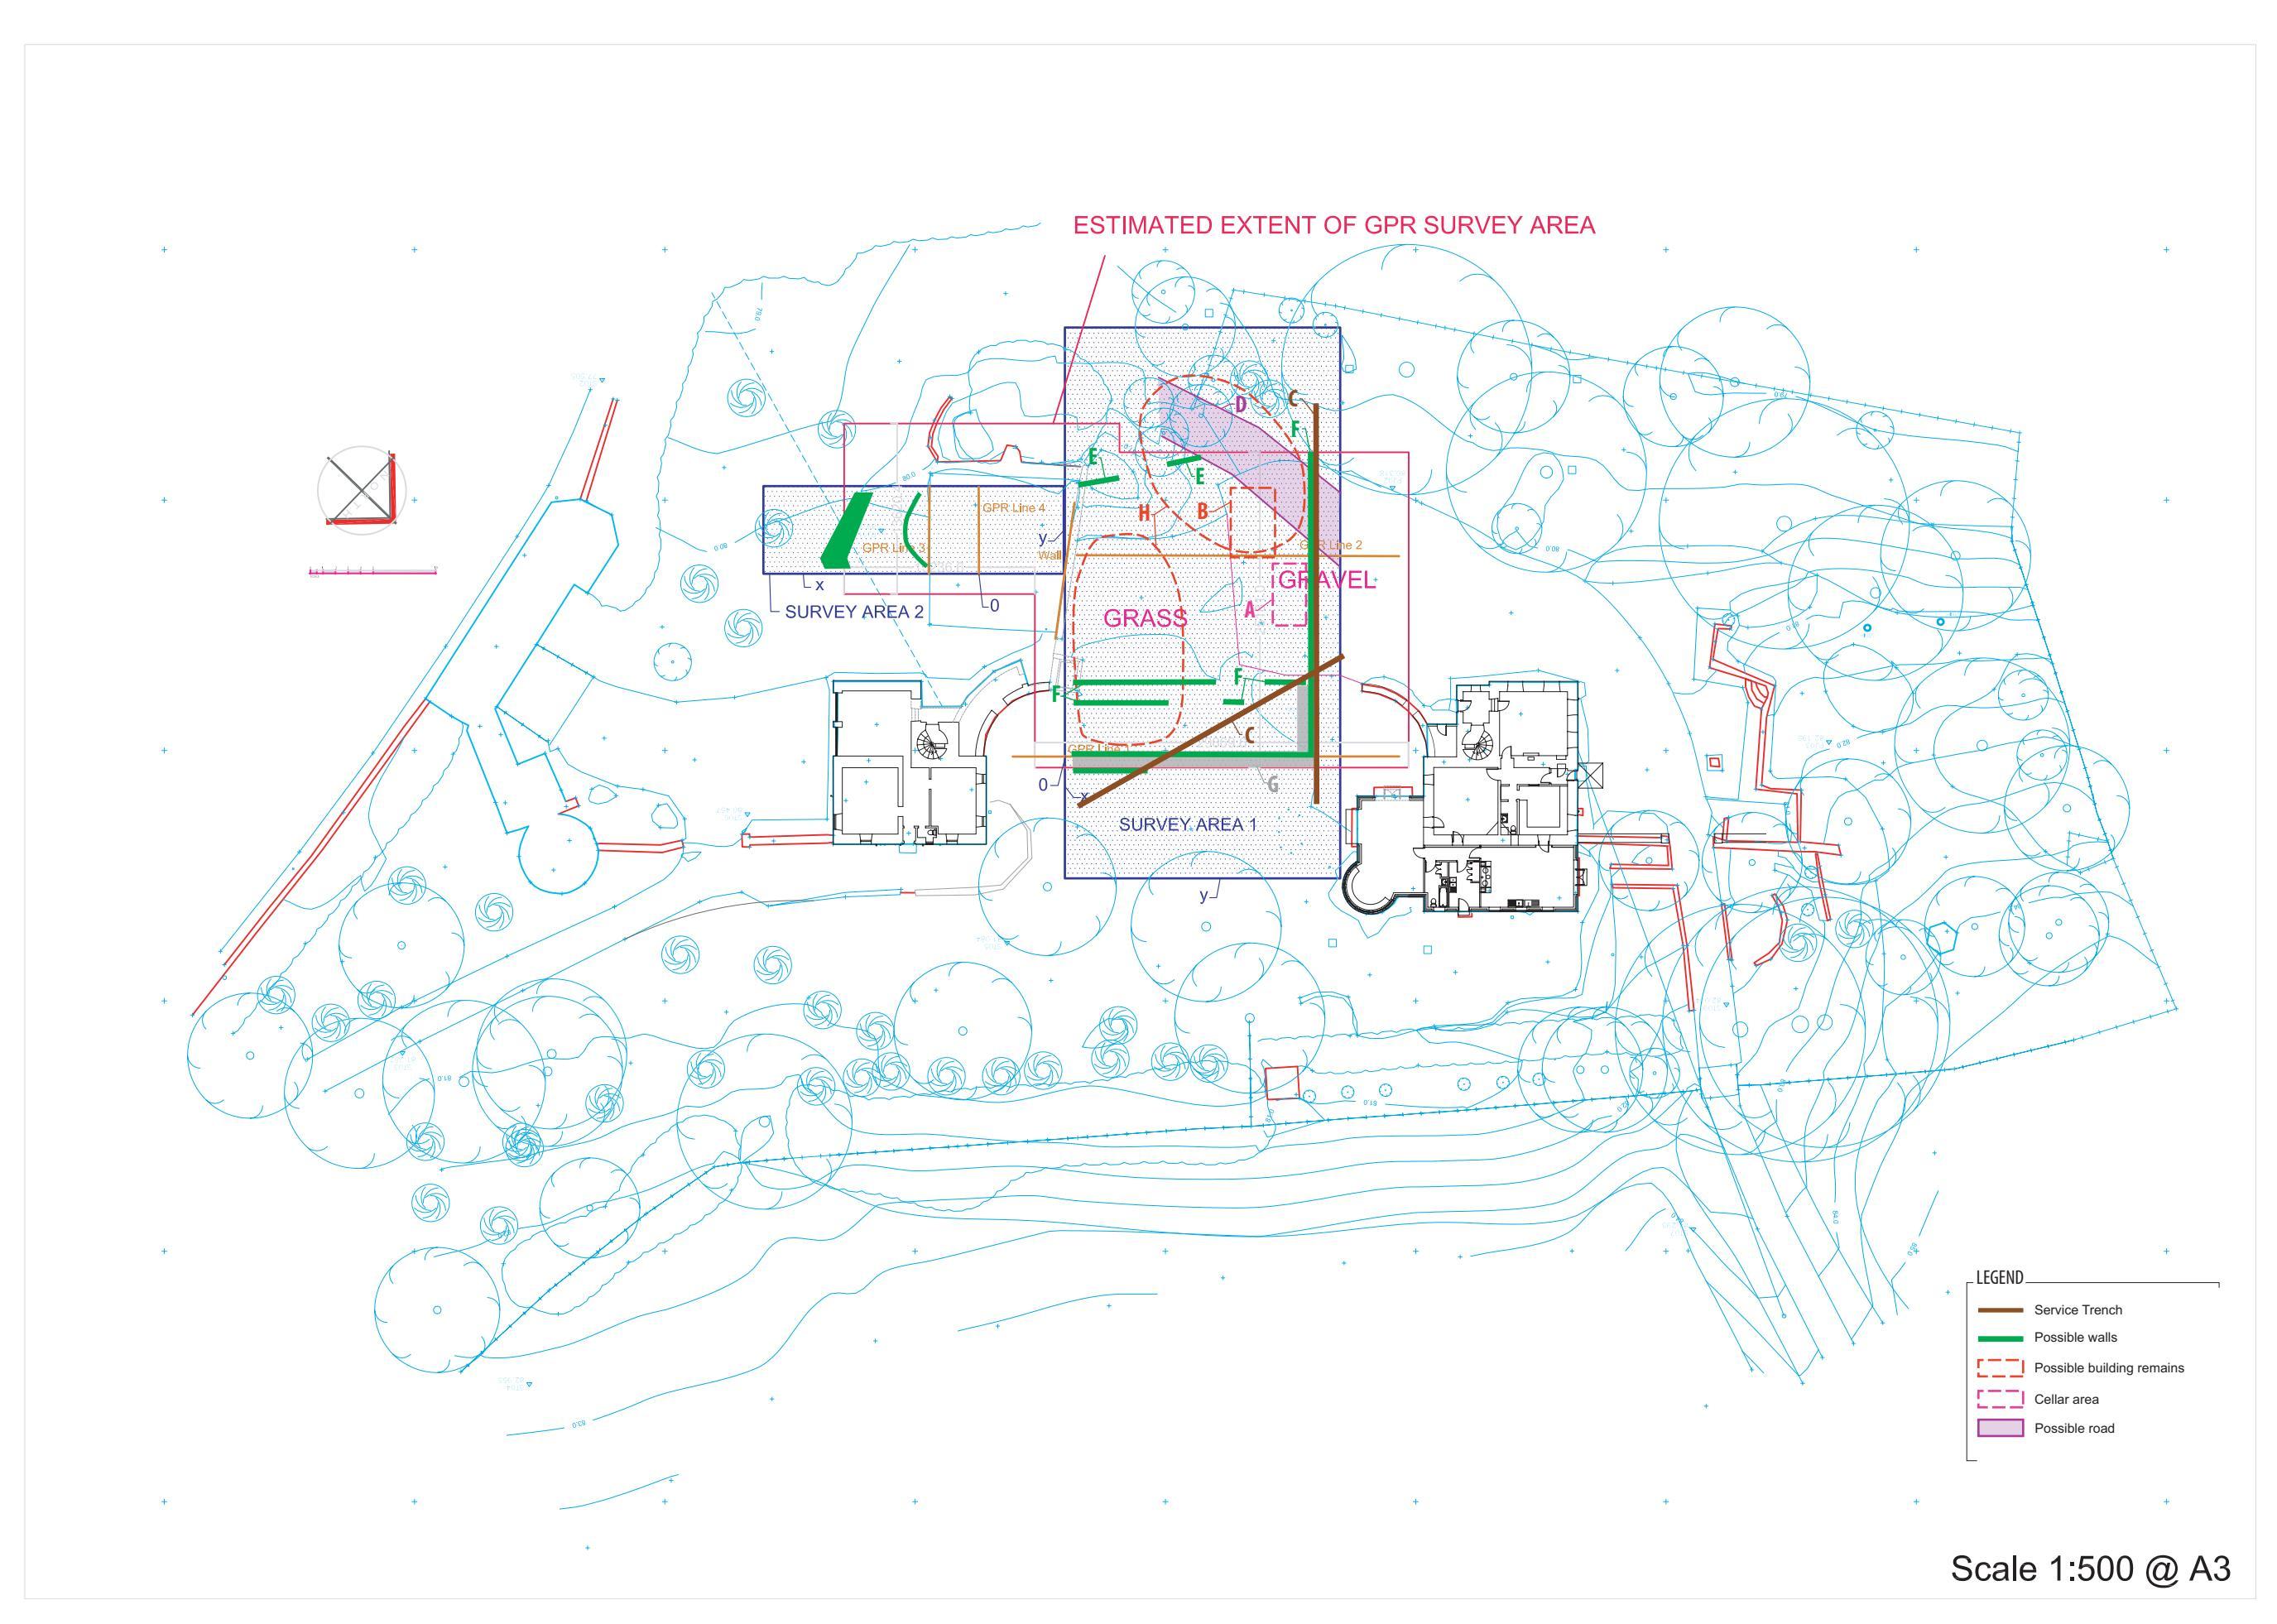
Fig. 26 - Interpretation Plan.

The detailed findings in each timeslice have been described above. The area is relatively complex but there is good evidence for the following features, annotated on Figure 26:

- A possible cellar (A);
- A small square/rectangular building which post-dates the destruction of the main house (B);
- A large linear feature of relatively solid construction which may have served as a the conduit for a former utility (C);
- A possible former road/driveway which post-dates the destruction of the main house (D);
- Partial continuity of an existing wall from the garden of the East House into that of the West House beneath the small mound in the garden of the latter (E);
- Other *in situ* building remains (F);
- Possible evidence of extension of the main house towards the north (G);
- Levelling of the site following the destruction of the main house (H).

The more limited investigation in Area 2 confirms that there are building remains buried in this area also. It is not possible to interpret the patterning but it is evident that there are significant building remains *in situ*. If a fuller ground plan is required, this part of the GPR survey could be extended.
