The Fishing Village of Port Henderson, Gairloch. Centred on NGR NG 7542 7379

Fishing Village of Port Henderson. Section A An Sguman, centred on NG 74879 73799 GPS

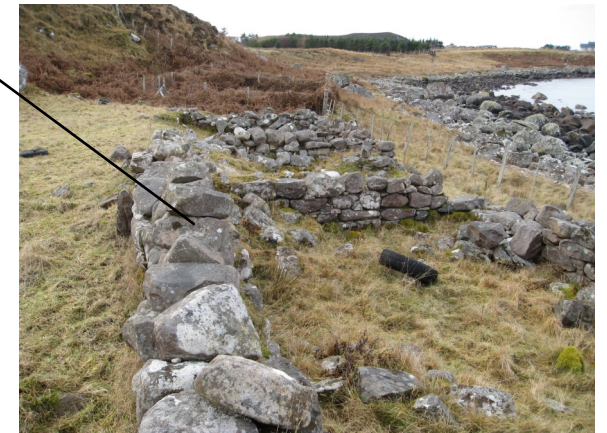
Looking E down onto Section C

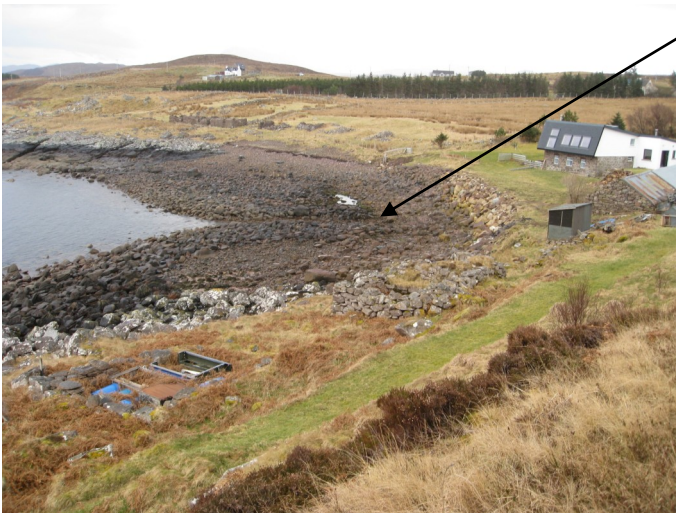
Port 1

- 1 Situated at An Sguman and known as 'Port an Sguman' this was the main port associated with the salmon station.
- 2 Situated on the shore below croft 10 was a port called 'Port Alasdair Dhuinn' (brown haired Alasdairs port). This is no longer visible.
- 3 'Port an T- Seada' (the port of the shed) is situated on the shore below the boat builders shed on croft 22.
- 4 'Am Port Beag' (the little port) is on the shoreline below croft 13.
