MOSSETBURN OVERBRIDGE, INVERERNE ROAD, FORRES

HISTORIC BUILDING SURVEY OF A WWII PILLBOX
HBR (LEVEL 1)

commissioned by Bam Nuttall, on behalf of Network Rail

September 2016

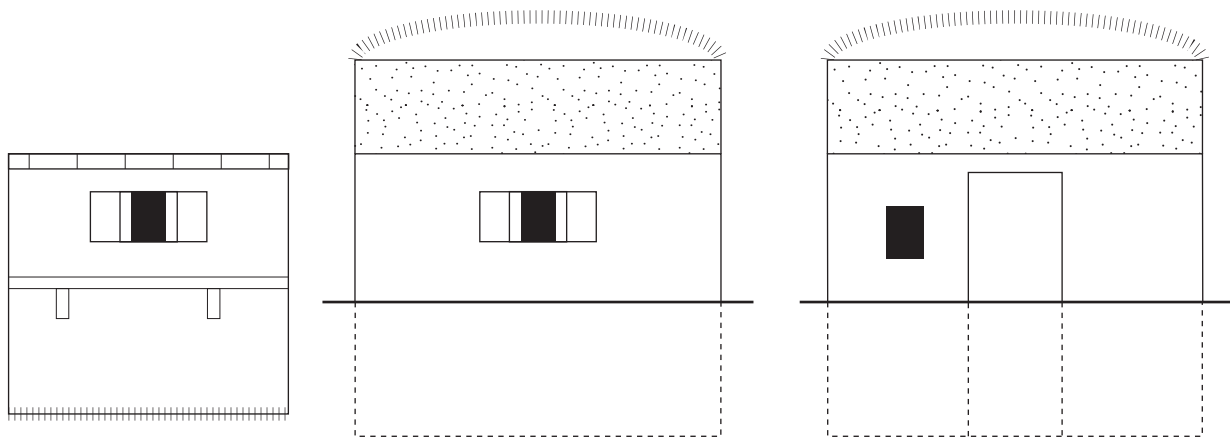
ILLUS 2 Plan and elevations of the pillbox

The pillbox was hexagonal in plan with a single entrance and observation window on the south-east wall and rifle loopholes in the remaining five walls (Illus 2). The structure was cut below the existing ground surface leaving only the upper half of the walls exposed (Illus 3 photo). The external height of the pillbox including the 0.62m thick concrete roof was 1.6m. The internal height from the earthen floor to the ceiling was 1.82m making the whole structure including the roof 2.44m tall. The walls on all six sides had been constructed of large squared masonry blocks with peck-marked stone observed in some areas forming a wall 0.6m thick on all sides. The walls had been capped by the thick roof formed of prefabricated concrete sheets (Illus 4 photo). To the north side of the structure a layer of bricks had been placed at the top of the stone wall in order to form a level surface for the roof. The roof had also been topped with a thick layer of turf.

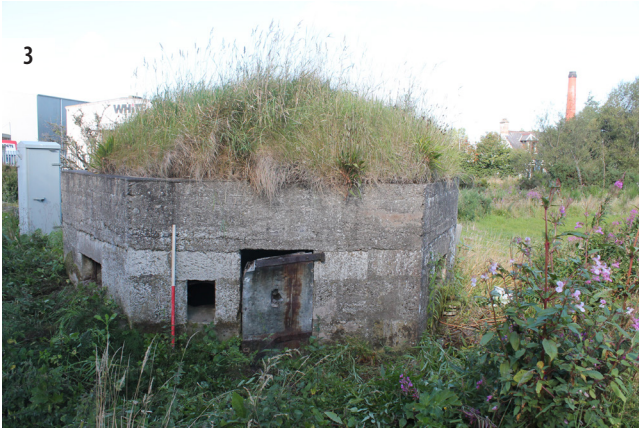
ILLUS 3 General view of the pillbox facing west **ILLUS 4** Detailed view of the underside of the concrete roof **ILLUS 5** Detail of the entrance blast wall facing north-west **ILLUS 6** Detail of the loophole on the north facing wall **ILLUS 7** Detail of the stepped opening of the loophole

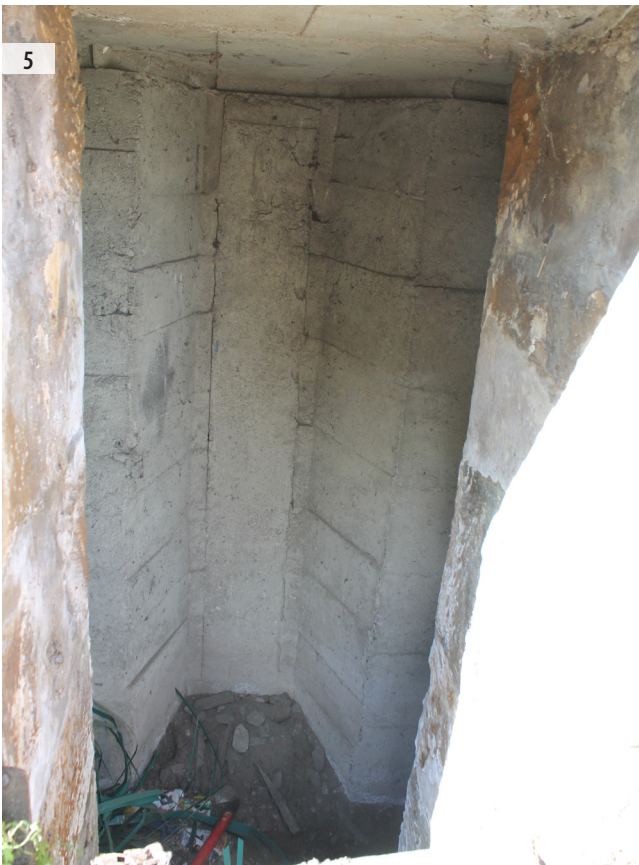
The entrance was 0.61m wide with a thick metal sheeted timber door, although it was unclear if this was the original fixture or had been a replacement in order to keep the public from entering the structure. Entry to the pillbox was limited due to an internal Y-shaped concrete blast wall forming additional protection to the internal spaces of the pillbox (Illus 5 photo). A small 0.35 x 0.25m observation window was located to the north-east side of the door. Due to the external elevation presenting only the upper half of the wall of the structure the window on this side was almost at ground level. Only the upper half of the door was exposed. It was not clear if this was originally open to the base of the door, possibly with steps as no evidence for this was identified.

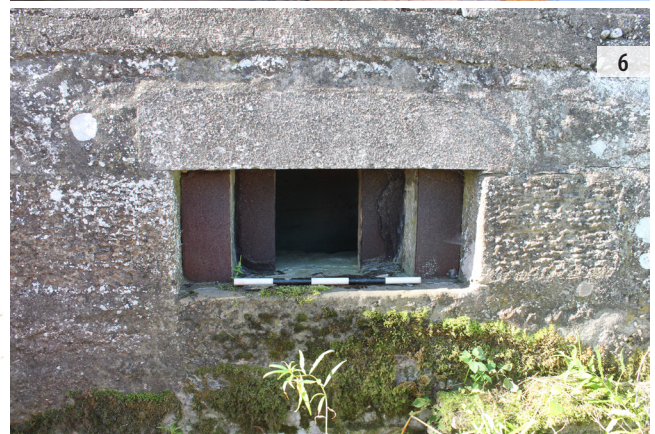
The single loopholes found on the remaining five walls were identical (Illus 6 photo). The openings were all 0.78m x 0.32m in size and again only 0.42m above ground level on the external elevations, although internally they were 1.29m above the floor surface. The loopholes were essentially designed for riflemen and had internal splayed sides although these has been modified/reinforced with the insertion of a inset stepped stone design that featured steel plates to

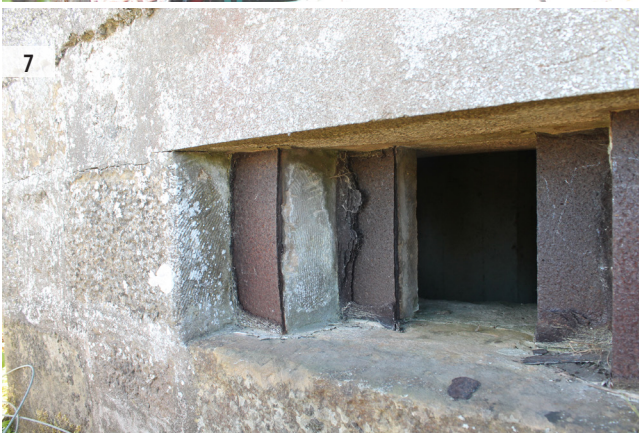
the two stepped outer faces (Illus 7 photo). This narrowed the actual opening to a width of only 0.26m. The loophole lintels as with the surrounding walls were constructed of squared stone masonry.

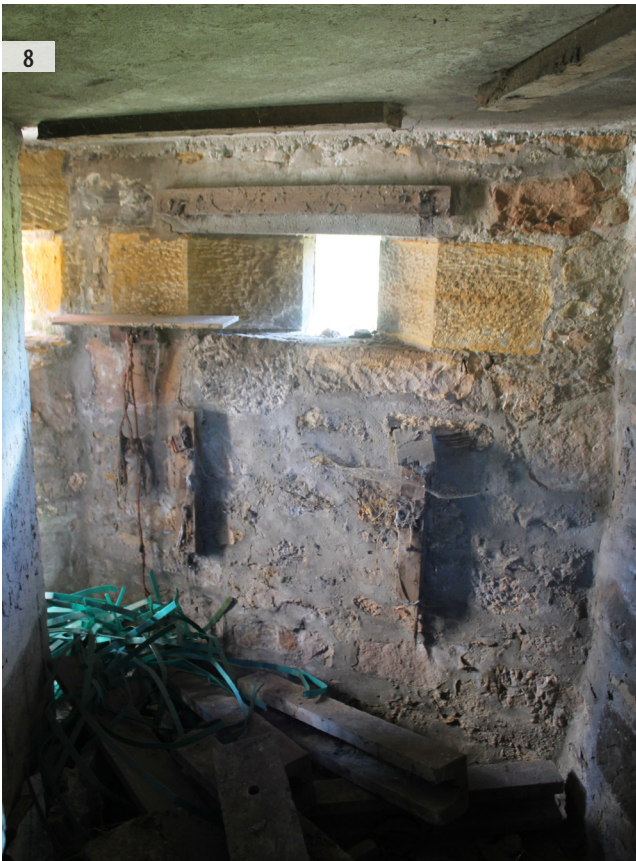
ILLUS 8 View of the southern internal area of the pillbox **ILLUS 9** Detail of the internal concrete dividing wall **ILLUS 10** General view showing the sightlines of the pillbox to the east **ILLUS 11** General view showing the sightlines of the pillbox to the west

The internal division of the pillbox comprised two compartments 1.62m wide (Illus 8 photo) divided by a 0.24m thick concrete wall (Illus 9 photo). Access to each side was gained by openings at each end. The dividing wall was a continuation of the Y-shaped blast wall located at the entrance. The two areas were very sparse with little surviving evidence of any original fittings. A few timber planks attached to the walls below the loopholes indicated the location of shelving that would have provided support for the rifles.

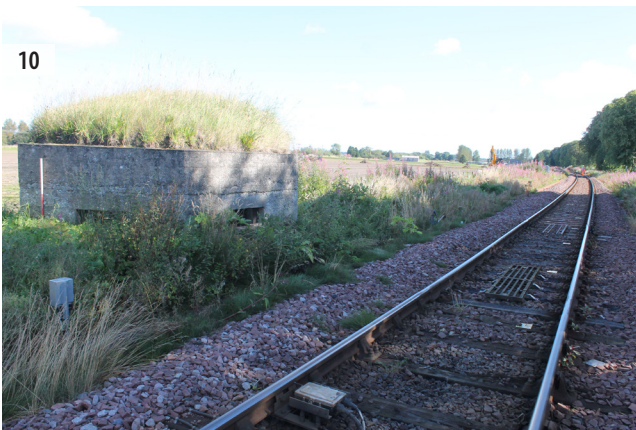
sightlines from within the structure gave good views along the line both to the east (Illus 10 photo) and west (Illus 11 photo) plus across the fields to the north. It may also have been placed there as additional cover to protect the airfield to the south-west.
