Minor Archaeological Services Call-off Contract East Range, Stanley Mills, Stanley, Perth & Kinross (PIC043)

Historic Building Survey, April and May 2022
Report No. HES-PIC043-2022-01

Author	Graeme Carruthers MA MCIfA
Illustrator	Sam Griffith BA MSc PhD
Approver	Bruce Glendinning BSc PgDip MCIfA
Commissioned by	Historic Environment Scotland
Date issued	September 2022
Version	2
OASIS Reference	cfaarcha1-437611
Planning Application No	21/02111/LBC
Grid Ref	NO 11473 32800
CFA Report No.	4189
HES Report No.	HES- PIC043-2022-01

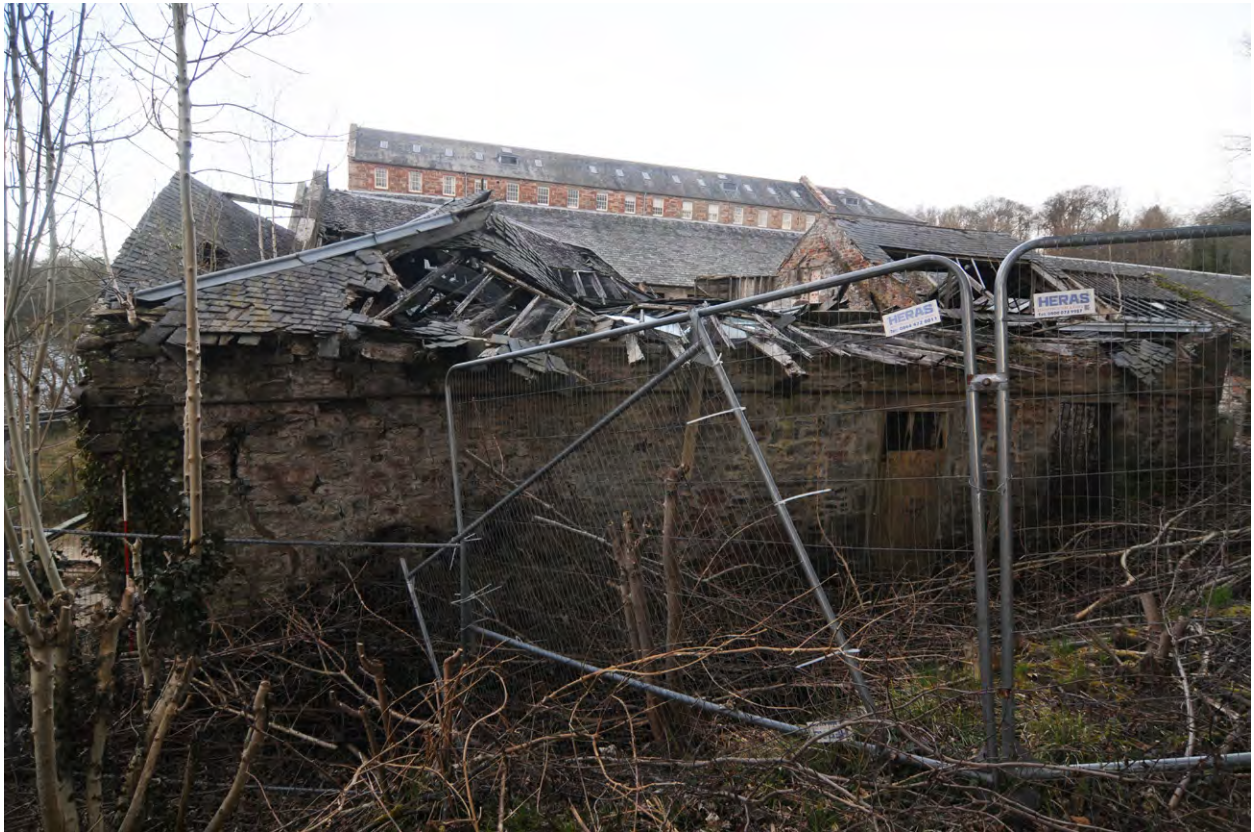
The eastern wall of Unit 2 is stone rubble built (016) and contains a door (017) with long and short quoins and a window to the north (018), also with long and short quoins and an iron grill (Fig. 11). An iron tie rod bar (019) runs along the length of the elevation, connecting to tie plate 020, and to tie plate 013 on the south-facing elevation. The wall of Unit 2 is set slightly forwards from Unit 5.

Fig 11: Phase 3 external east-facing elevation

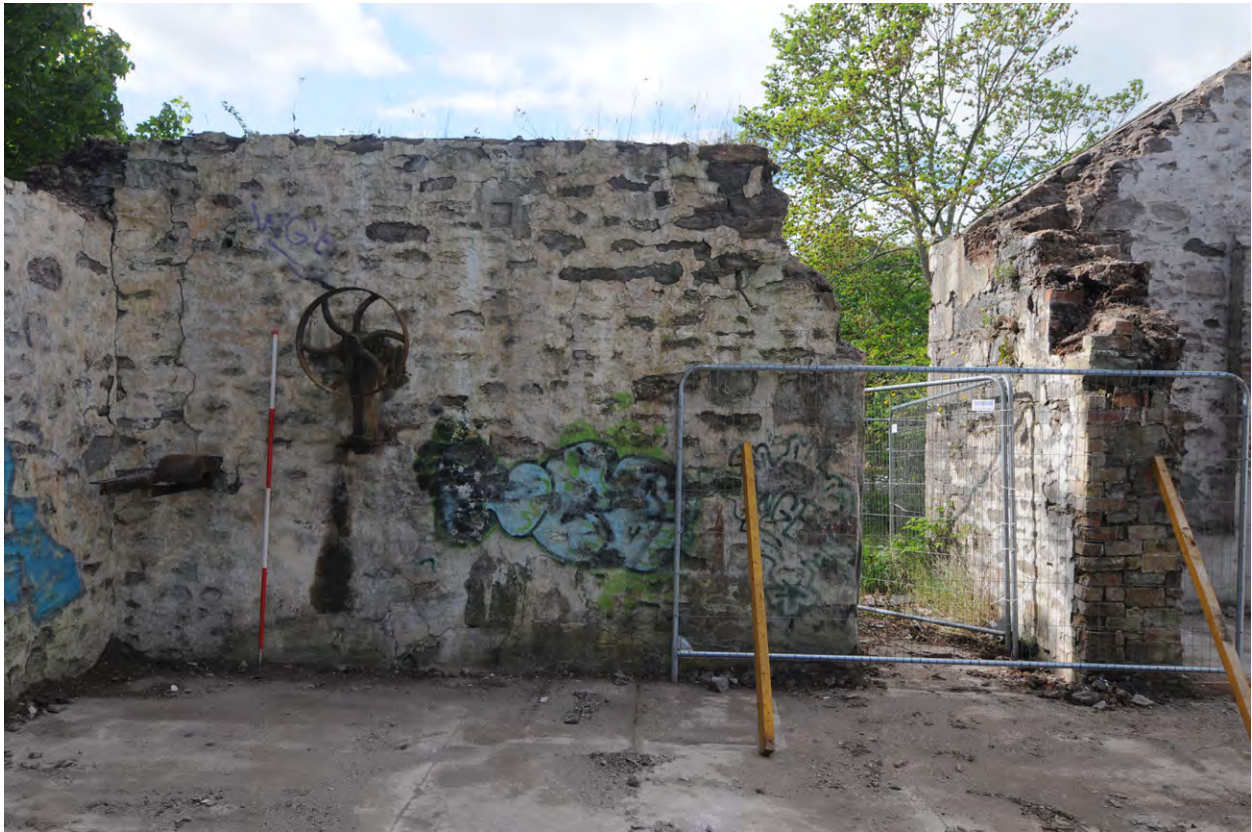
Fig 13: Phase 3, internal north-facing elevation showing support bracket (057) and flywheel (058)

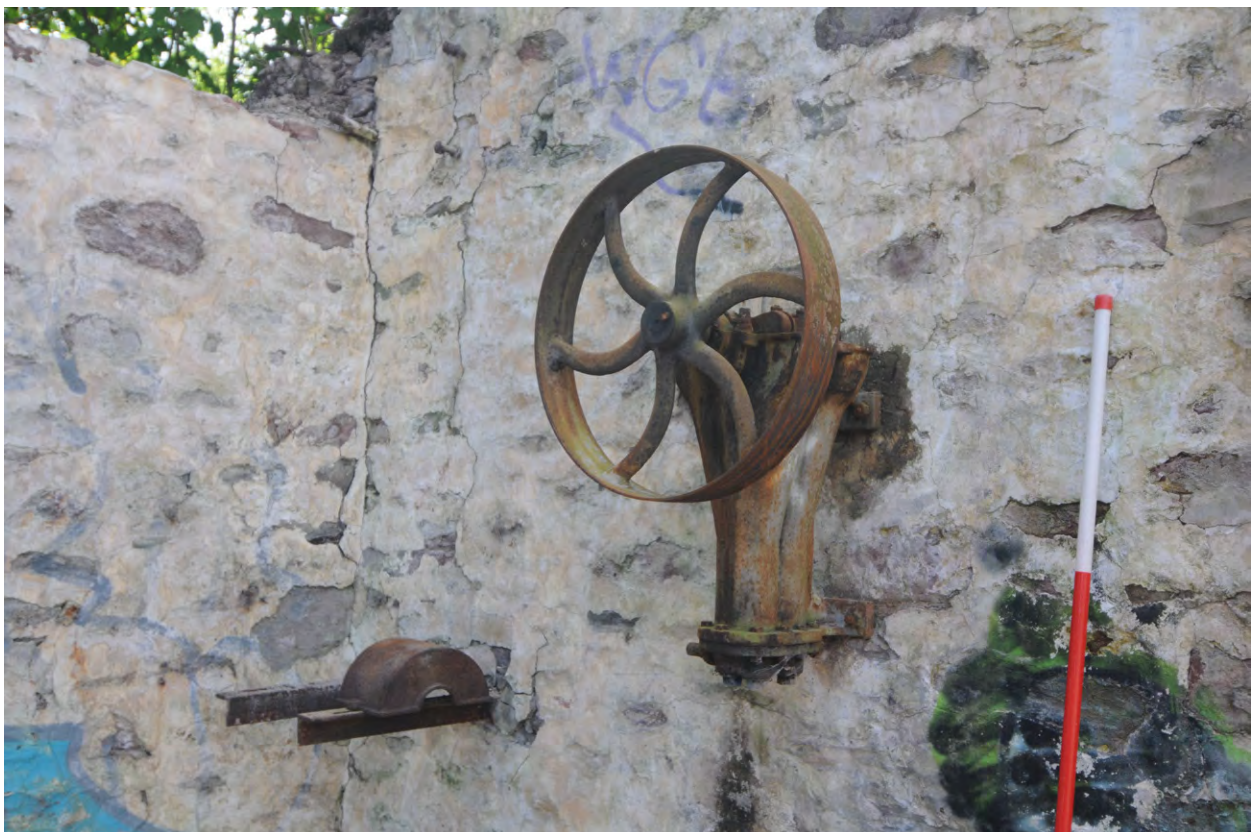
Fig 14: Phase 3, detail of support bracket (057) and flywheel (058)

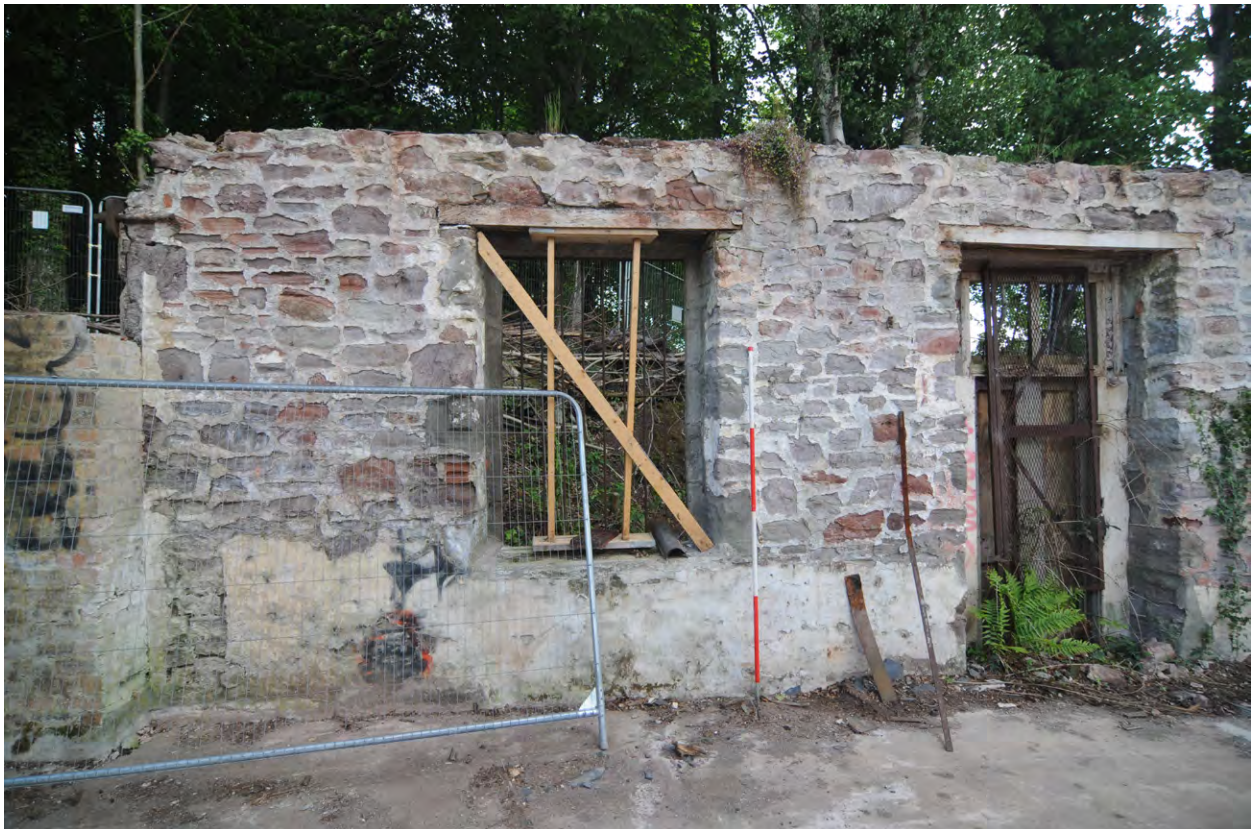
Fig 16: Phase 3, internal east-facing elevation showing doorway (017) and window (018)

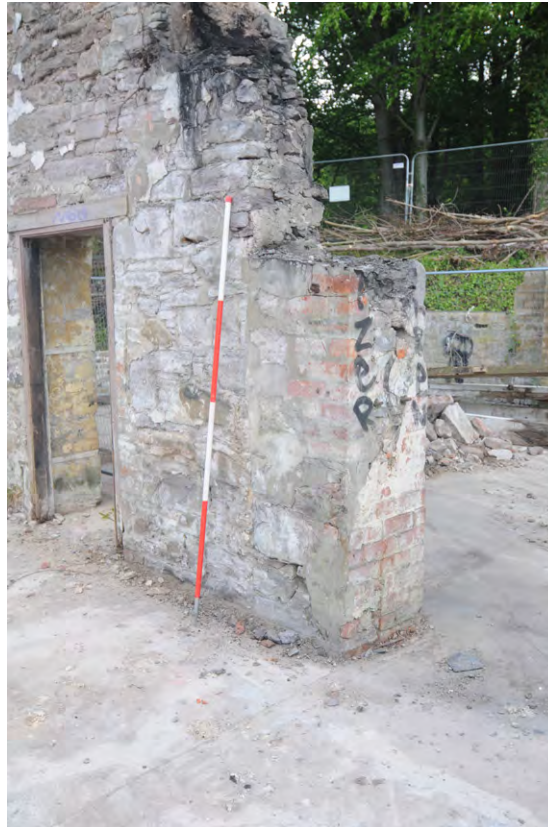
Fig 18: Phase 4 Unit 2/3, remains of brick support column (053) for roof support I beam
