396–410 GORGIE ROAD, EDINBURGH

Historic Building Recording

commissioned by 3DReid Architects

November 2014

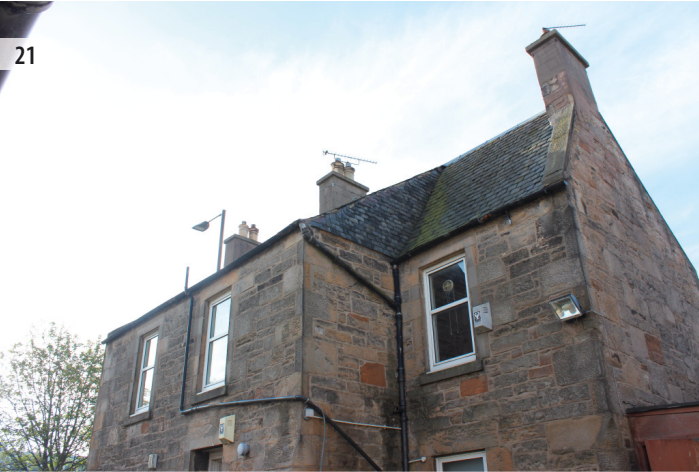
PHOTO 21

window surrounds of broached ashlar sandstone. The rear corners had been swept at ground floor level (Photo 020). Some of the stonework was in poor condition, especially where it had been tooled. Some of the masonry was of a different character (described below), but the whole appears visually consistent due to a fairly recent re-pointing. The three chimneys, one on each gable and one off centre, laterally (serving a fireplace on the ground floor) also appear to have been re-rendered. The pitched slate roof was in good condition, formed to a steeper angle to cater for the recessed north-eastern corner (Photo 021). Modern uPVC sash windows had been installed to replace timber originals.

398 Gorgie Road, oblique view of north-east external elevation

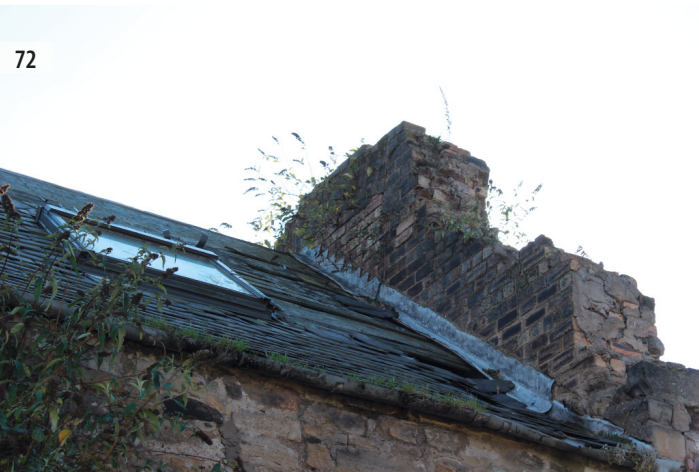
PHOTO 72

Gorgie Mill, general view of remaining section of north-east external elevation of demolished three-storey stone building

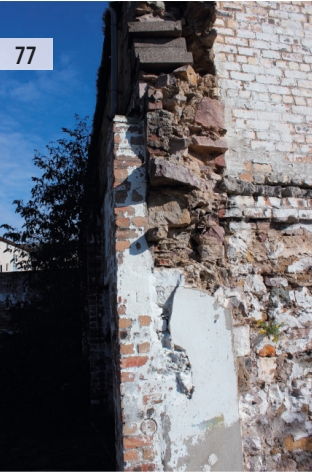
PHOTO 77

Gorgie Mill, detail view of demolished three-storey stone building – wall section

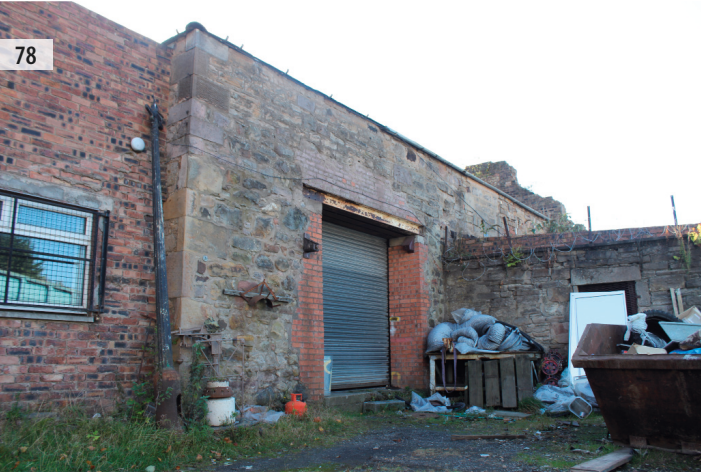
PHOTO 78

Gorgie Mill, oblique view of north-west external elevation

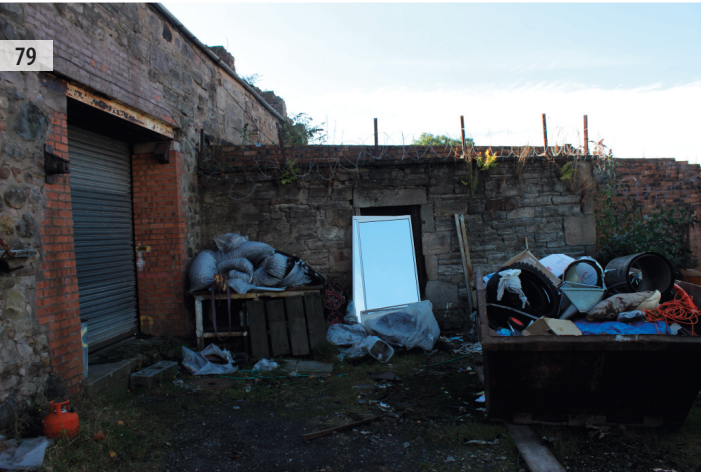
PHOTO 79

Gorgie Mill, general view of boundary wall between north and west yards

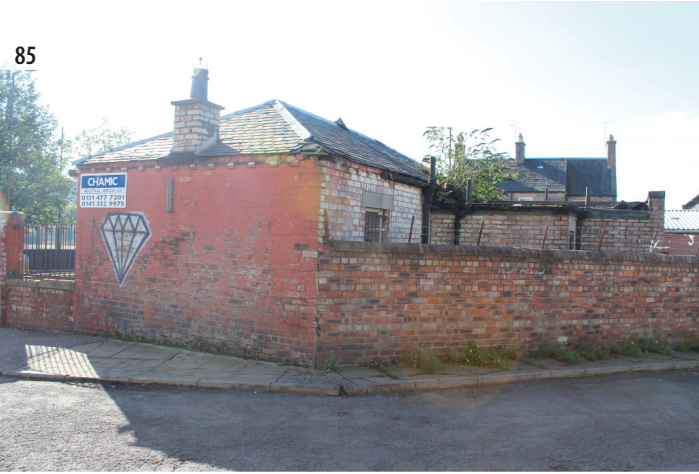
PHOTO 85

396 Gorgie Road, general view of north-east external elevation

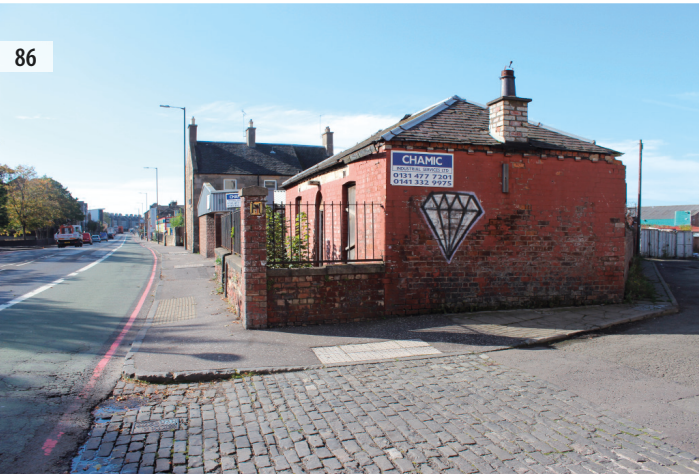
PHOTO 86

396 Gorgie Road, general view of north-east external elevation

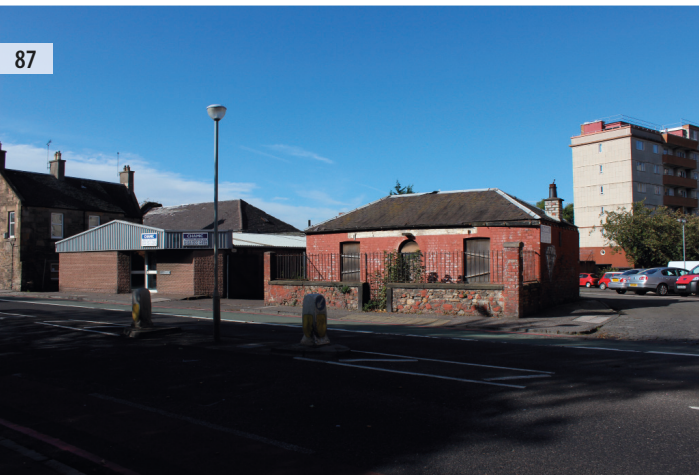
PHOTO 87

396 Gorgie Road, general view of south-east external elevation

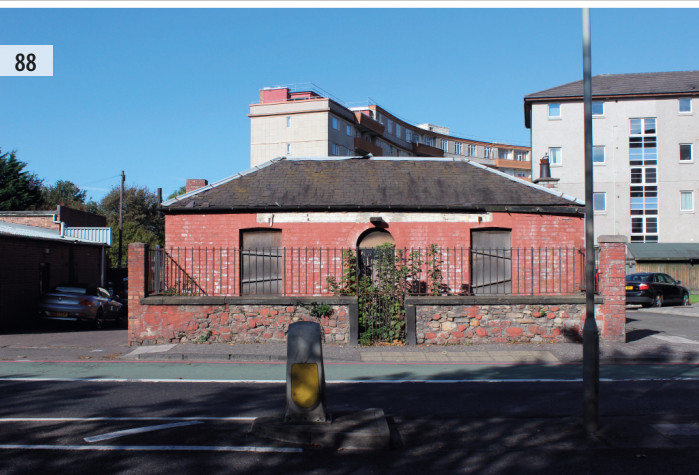
PHOTO 88

396 Gorgie Road, general view of south-east external elevation

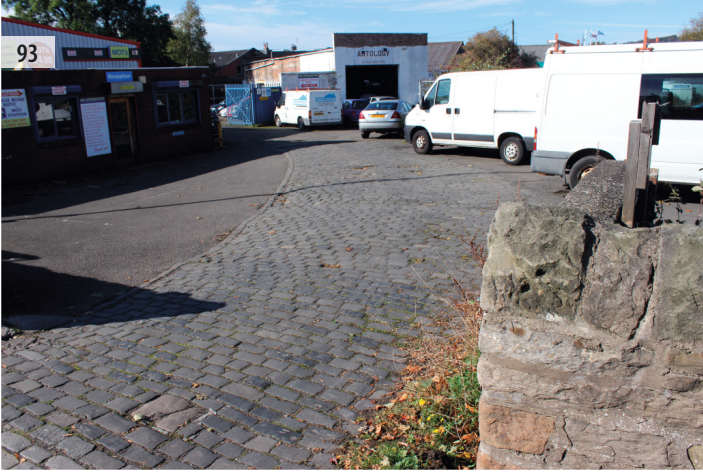
PHOTO 93

Gorgie Mill, general view of cobbled road south-west of Gorgie Mill
